TROUBLESHOOTING TURBOMACHINERY USING STARTUP AND COASTDOWN VIBRATION DATA

Ed Wilcox

Machinery Team Lead

Lyondell/Equistar

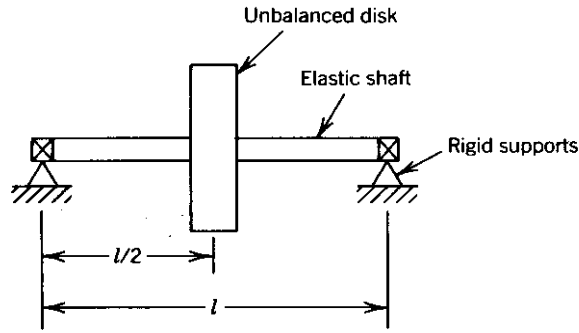
Figure 1. The Jeffcott Rotor. (Courtesy Vance, 1988)

A basic understanding of rotordynamics is required to best interpret transient vibration data. A simplified model of a between-bearing rotor is provided by the Jeffcott rotor (Figure 1). The unbalanced disk is located in the center of the massless rotor on rigid supports. The only damping in the system is due to the viscous drag of the air. While the Jeffcott rotor is a very simple model, it can provide a wealth of insight into the effects of synchronous vibration in turbomachinery. An endview of the Jeffcott rotor shows the relationship between the center of mass (M) and the geometric center (C) (Figure 2). The synchronous phase angle (β) is the difference between the unbalance vector (U) and displacement vector (R). The amplitude of synchronous whirl and phase angle for the Jeffcott rotor as it passes through the rotor's first balance resonance (critical speed) is shown in Figure 3. The response amplitude equation is shown in Equation (1).

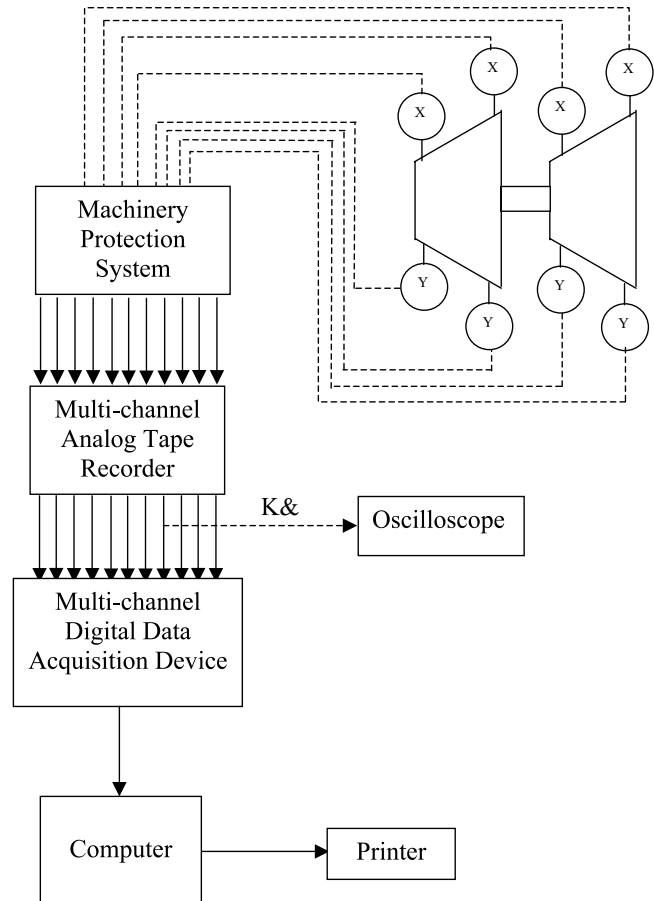
Figure 10. Diagnostic Equipment Required for Startup/Shutdown Data.

value. For this reason, the voltage change produced by the keyphasor should be set up correctly in the software and monitored during the data acquisition using the oscilloscope shown in Figure 10.

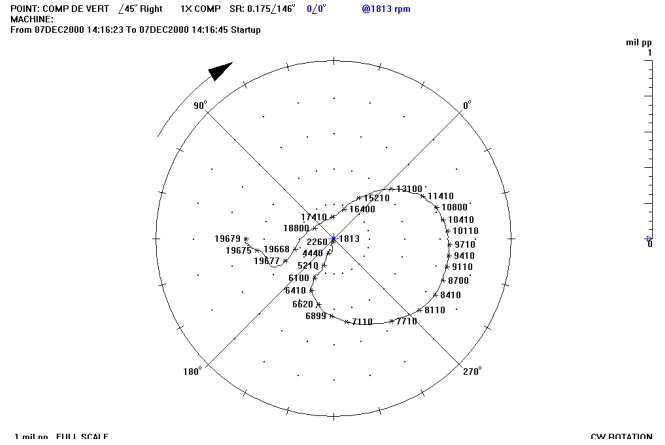
Figure 13. Polar Plot of Centrifugal Compressor Drive-End Bearing.

Polar plots show the same data as Bodé plots, just in a different format (Figure 13). Sometimes, polar plots make it easier to determine when the rotor has transversed its critical speed, because the phase change is obvious (i.e., every 180 degrees on the plot). For example, from the Bodé plot shown in Figure 12 it is not immediately obvious that this rotor is approaching its second critical. However, one look at the polar plot in Figure 13, and it is very clear.

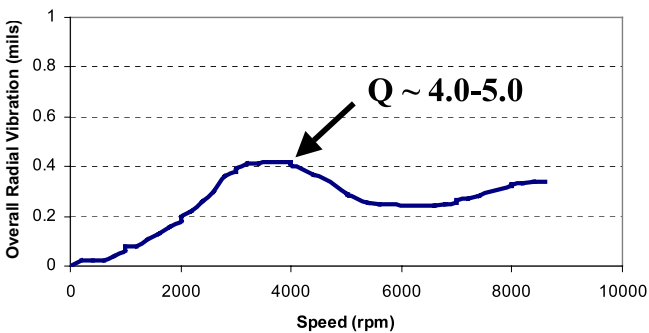
Figure 17. Transient Data from Mechanical Test at OEM Facility.

Records of the transient vibration data from the mechanical test from the original equipment manufacturer (OEM) were found showing the shaft radial vibration during startup (Figure 17). Additionally, transient data were recorded during several of the compressor shutdowns (Figures 18 and 19). Although the synchronous radial vibration had increased from 0.4 mils to 4.0 mils (i.e., Figure 19), the measured amplification factor had remained approximately the same (~ 4 to 5). This indicated that the damping produced by the bearings was the same, which meant that unbalance was probably the source of the problem. At the next available opportunity, the compressor bearings were inspected and found to be in excellent condition. The rotor was pulled and found to be heavily fouled with an oil catalyst residue. The bearings were reused and the rotor cleaned. The vibration dropped to approximately 0.5 mils with the clean rotor. Additionally, it was determined that if the compressor tripped, process gas that contained oil would leak back through the discharge check valve into the compressor, which was causing the fouling. If the compressor was shut down normally, a control valve was closed that prevented gas from backing into the compressor. Knowing that the source of vibration was probably deposits on the rotor allowed maintenance to be prepared for a rotor changeout (i.e., spare rotor prepared, rigging available, additional crews), which reduced both maintenance costs and operational downtime.

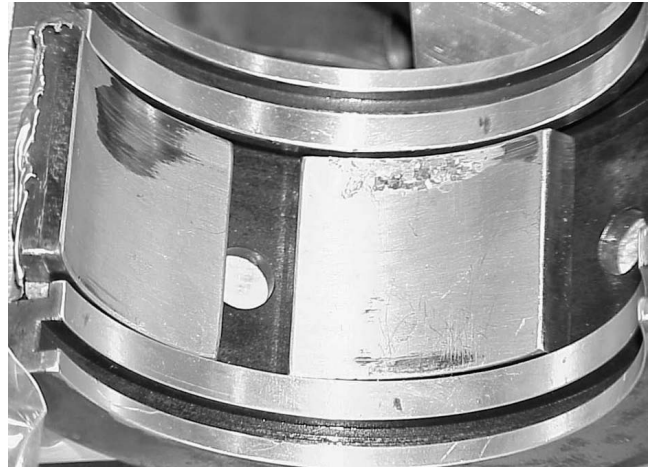
Figure 24. Damaged Radial Bearing.

A centrifugal compressor experienced a large increase in synchronous radial vibration, mostly on the inboard end (3 to 4 mils) and was shut down to inspect the bearings. The excessively high vibration had severely damaged the radial bearings (Figure 24) as well as the bearing housing itself. Due to business constraints, the bearings/housings were replaced/repared and the compressor was restarted, although the cause of the high vibration was unknown. On startup, it was observed that the measured first critical speed had increased from approximately 4500 cpm to 6800 cpm (Figure 25). Since the thrust load had increased, this seemed to indicate that the rotating labyrinth on the balance piston might be rubbing the abradable stationary, which would raise the first critical by effectively decreasing the bearing span. The radial

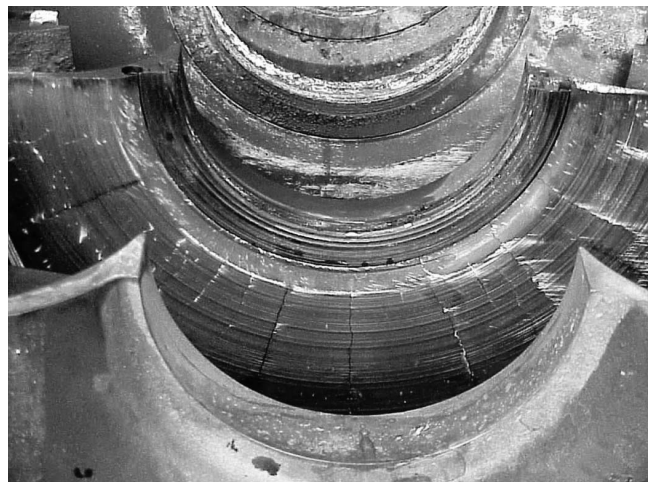
Figure 26. Damaged Inlet Guide Vanes/Diaphragms.

vibration stayed at high, but acceptable, levels for three months until the compressor was shut down for a scheduled unit outage. A rub was found in the machine, but not at the balance piston seal. One of the diaphragms had broken and was being forced forward against the rotor (Figures 26 and 27). The diaphragm was repaired and the measured first critical returned to normal (Figure 28).

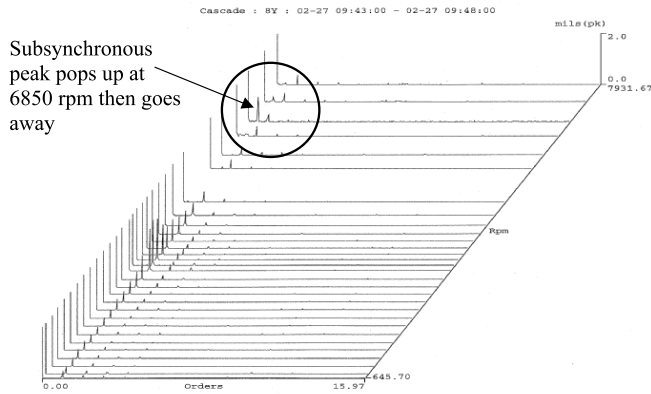
Figure 32. Waterfall Plot Showing Subsynchronous Vibration Appear, Then Disappear.

nonsynchronous vibration problems that may appear (and disappear) at different rotational speeds. One of the most common problems diagnosed with these plots is oil “whirl” that turns into oil “whip.” An illustration and example of this are given in Figures 29 and 30. As can be seen, the subsynchronous vibration tracks with the shaft speed until it coincides with the first natural mode of the machine. At this point, it “locks” onto this frequency regardless of the change in rotational speed. This is the point when oil “whirl” turns into oil “whip.” In contrast, Figure 31 shows a centrifugal compressor that is experiencing rotating stall due to a large drop in the molecular weight of the process gas. As can be seen, at design speed (8000 rpm), the rotating stall is exciting the first natural mode of the compressor at 2700 cpm. As the compressor shuts down, the subsynchronous vibration drops away. A different compressor had been experiencing erratic subsynchronous vibration. A rotordynamic analysis of the compressor reveals that if the oil seal rings locked up, the first natural mode became unstable. This was verified, during a startup of the compressor, when the first mode was excited (Figure 32). As can be seen, the subsynchronous vibration appears, then drops away as the compressor starts up.

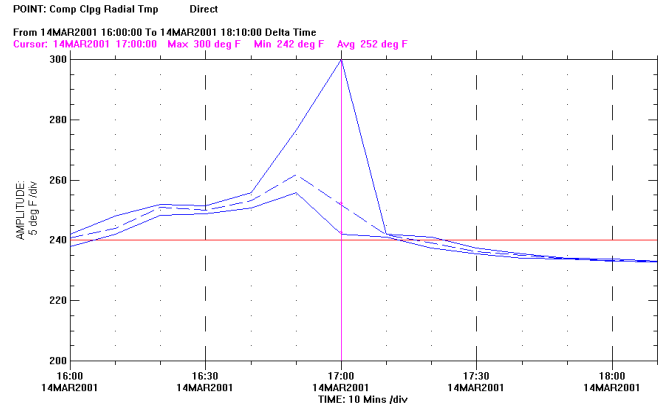
Figure 34. Radial Bearing Temperature Spike During Rainstorm on Centrifugal Compressor.

The drive-end radial bearing temperature of a high-speed centrifugal compressor was excessive after overhaul. The temperature would spike up rapidly to 300+°F (150°C) if it rained on the compressor (Figure 34). The bearing clearance was quite low (0.0045 inch on a 3.5 inch journal at 11,500 rpm), and it was decided that the bearing housing was contracting on the bearing during the rainstorm and reducing the clearance further. The compressor was shut down to install another bearing with higher clearance. The shaft centerline plots of the drive-end (DE) and NDE bearings are shown in Figures 35 and 36 during the coastdown. As can be seen, the drive-end journal did not drop at all

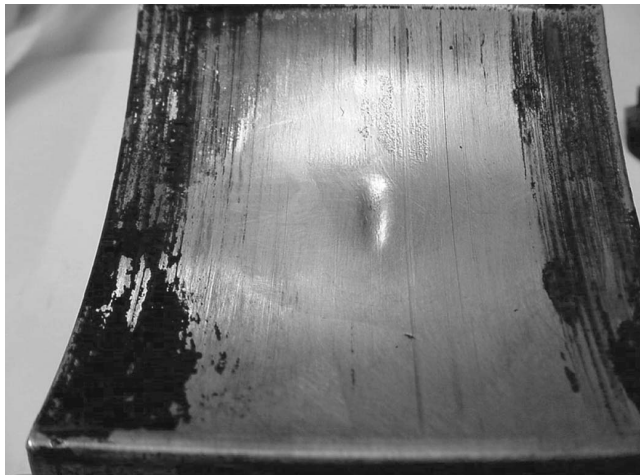
Figure 43. One of the Lower NDE Bearing Pads Showing Dimple Where Babbitt Failed above RTD.
