FULL-LOAD TESTING OF AN ALL-ELECTRIC CENTRIFUGAL COMPRESSOR FOR MISCIBLE GAS INJECTION

ABSTRACT

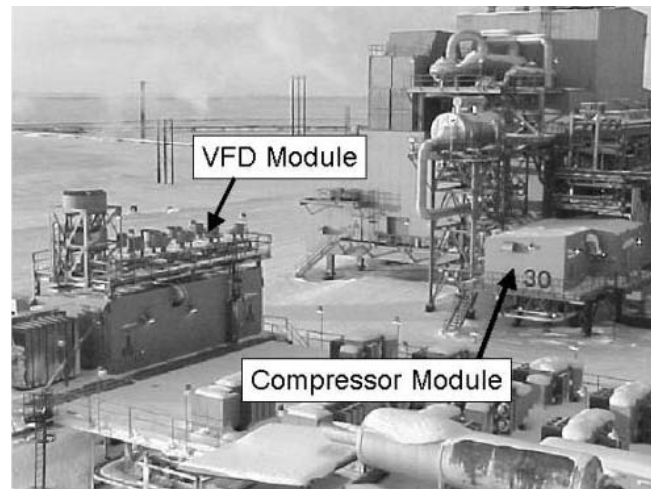
Figure 1. Module Site.

The smaller footprint of this compressor train also allowed for the design of a much smaller module that made a substantial contribution to reducing project costs. Equipment modules on the North Slope provide weather protection for equipment and personnel. Costs for the heating/ventilation/air-conditioning (HVAC) system and the fire and gas systems for such modules are directly related to the size of the module. Therefore reducing the size of the equipment has a beneficial impact on the cost of these ancillary items in addition to reducing the cost of the steel required to build them. Figures 1 and 2 give an idea of the compactness of the two modules.

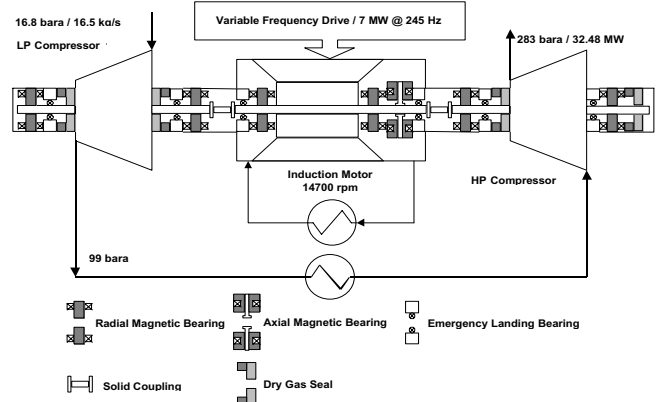
Figure 6. Arrangement of Shafts, Bearings, and Seals.

Figure 6 illustrates diagrammatically the arrangement of the shafts, bearings, seals, and thrust control devices. Figure 7 shows the thrust control scheme.

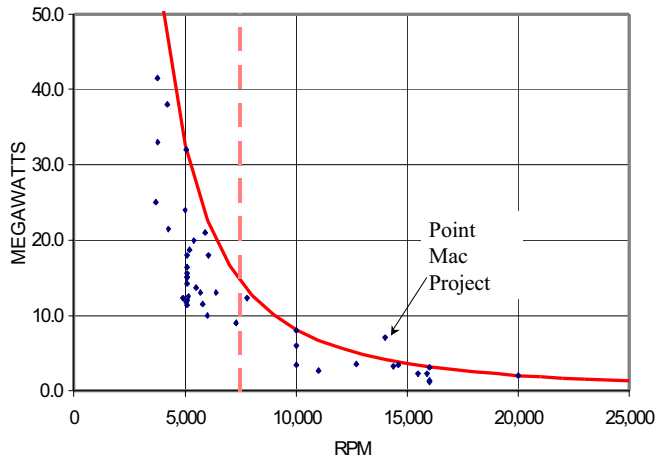
Figure 8. Worldwide Experience of High-Speed Electric Drives.

Although compressors regularly operate at the speeds and powers required for the Point MacIntyre application, the motor and the variable speed drive pushed the frontiers of prior technology. Figure 8 shows the current worldwide experience in high-speed drives. Each dot represents a variable frequency drive (VFD) greater than 1 MW and above 3600 rpm speed. The smooth curve joins the hitherto limiting points from 5000 rpm at 32 MW to 20,000 rpm at 2 MW. It can be seen that the Point MacIntyre application lies well above this line, 74 percent more power than the previous limit at 14,000 rpm and 32 percent faster than any other 7.1 MW drive.

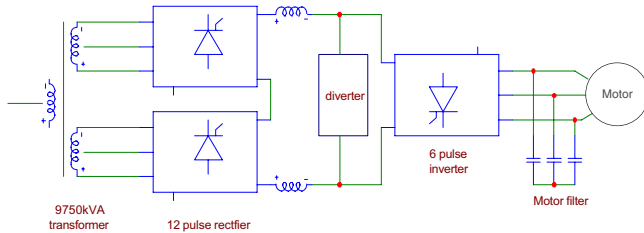
Figure 9. Simplified Diagram of Electric Power System.

The technology used for this high-speed, high power drive is a capacitor compensated induction motor drive as shown in Figure 9. The power is taken from the 13.8 kV site bus and stepped down to 2600 VAC by the 9750 kVA transformer. The transformer has two secondary windings with 30 degree phase displacement to give a 12-pulse current wave shape in the supply, as required to meet the harmonic limits of IEEE 519 (1992). Further details can be found in McBride and Franks (2000).

The inverter uses fast turn-off thyristors to be able to operate at 245 Hz. Although the inverter is only a 6-pulse bridge, the motor filter capacitors trap all the high power current harmonics, thus the motor sees a reasonably smooth sine-wave current.

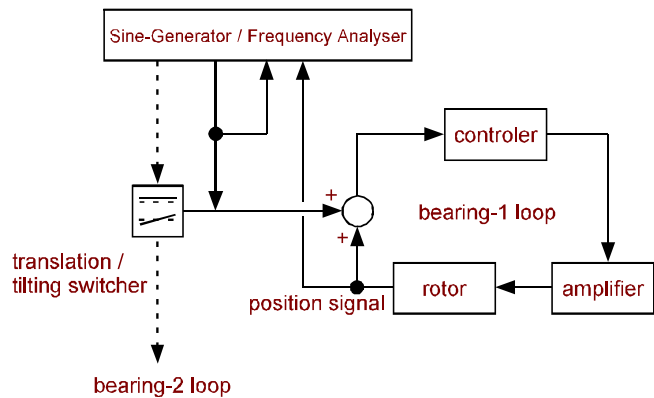
Figure 10. Injection of a Sine-Sweep into the Bearing Controller.

During this full load test, a sine sweep was introduced via the magnetic bearings and the log decrement was measured to verify acceptable stability. Figure 10 is a schematic of the stability test setup. The sine sweep was across a frequency range of zero to 200 Hz. The criterion for acceptability of the test was that the log decrement had to be at least 10 percent. Stability tests were conducted on the HP compressor at three operating points at 100 percent speed with one point being near the surge line. An additional stability test was conducted on the HP compressor at 105 percent speed.

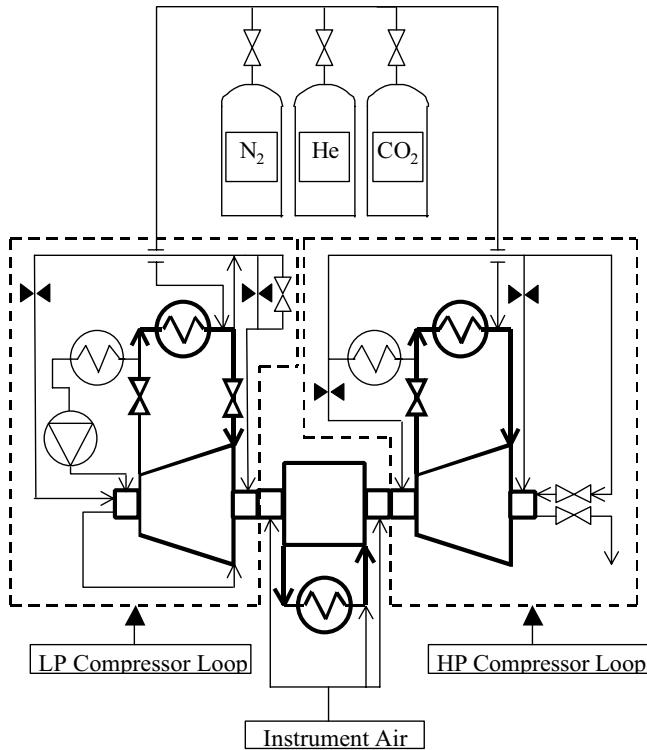
Figure 11. Compressor Test Loop Arrangement, Simplified.

The setup of the compressor test loops is shown in simplified form in Figure 11. Figure 12 is a photo showing the overall test arrangement.

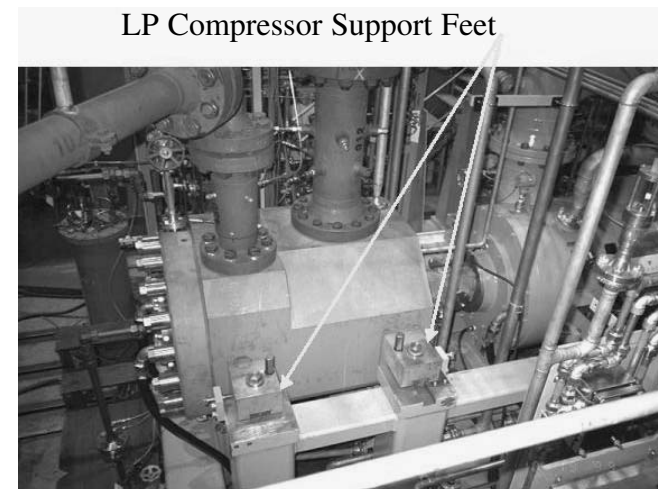
Figure 13. LP Compressor Support Feet.

The axial reaction force from each body is transmitted to the inboard pedestal by a transverse key, shown in Figure 13, designed to allow for radial thermal expansion. This arrangement has been used successfully for years with solid coupled shafts. The key has a shim on its top side to support the body at the correct height for shaft alignment.

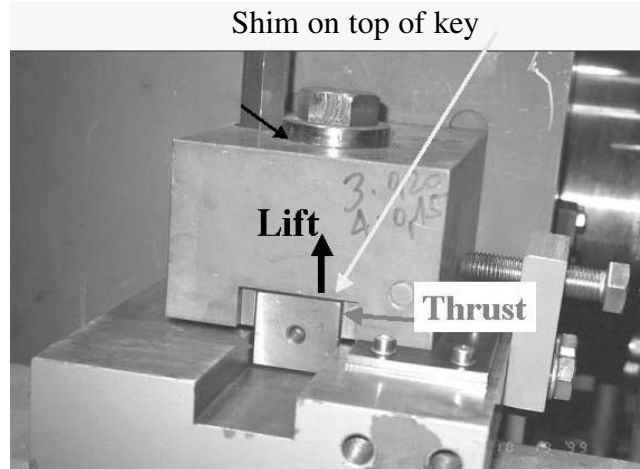
Figure 14. Problem Caused by Shim on Top of Key.

Figure 14 shows that axial thrust and its reaction act on this key in opposite directions, but not at the same elevation. This produces a couple, which tends to rotate the key. Because the shim was on top of the key, any rotation lifts the compressor body causing the problem. To fix the problem, the shim was removed from the top of the key, so that key rotation would not lift the compressor. As shown in Figure 15, a shim was placed beside the key, directly between the foot and the pedestal, to set the vertical alignment. Alignment and magnetic bearing currents have been satisfactory since this change. The silicon iron armatures of the magnetic bearing were replaced with cobalt iron armatures, thus providing additional capacity against any other misalignment problems.

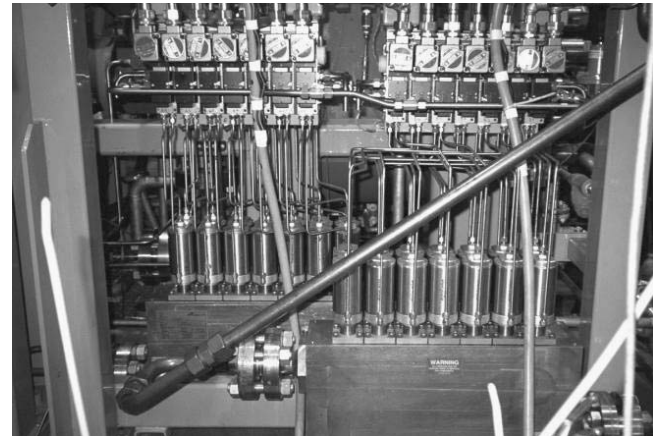
Figure 16. Digital Thrust Control Valve.

This was accomplished using existing hardware. One port of the digital control valve now fails open, and the drive trips off on loss of thrust control. The port size is matched to the system pressure and volume characteristics to approximate the action of the controller while the compressor is coasting to a stop. The fail-open valve is shown in Figure 7. The digital valve is shown in Figure 16. (The valve is called digital because, starting with the smallest port,

each subsequent port has twice the area of the last. Also the ports must be either open or closed.)

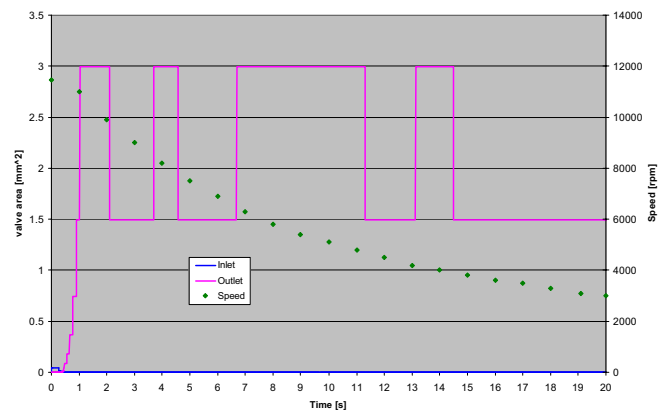
Figure 17. Valve Openings upon Trip.

The port size was calculated using the test loop piping volumes and the test gas composition and states. The calculation was confirmed by tripping the drive with the controller active and observing the digital valve, to see if the port area actuated by the controller was the same as the port area chosen for the blow-down. Figure 17 plots the test results of compressor speed and of port area as a function of the coastdown time. The outlet valve cycled between 1.5 and 3 mm² (0.0023 to 0.0047 in²), confirming the calculated port area. Blow-down calculations for the field installation determined a different port size is required with the compressor installed at Point MacIntyre.

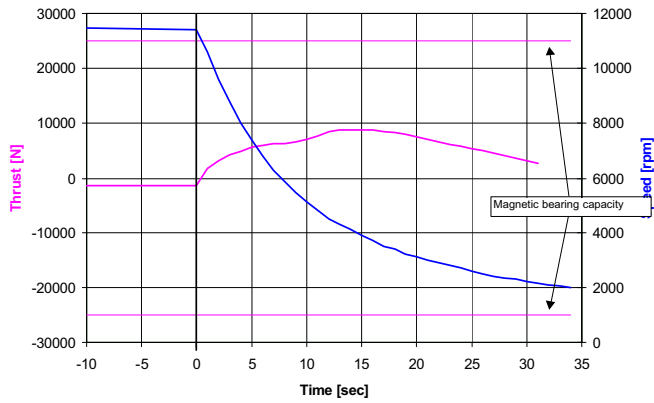
Figure 18. Thrust Panel Failure Test.

To confirm that the thrust control system is fail-safe, the thrust controller power supply was shut off while the compressor was operating at high pressure and at 11,500 rpm. The compressor automatically tripped, as designed, and the fail-open port actuated. Figure 18 shows the resulting thrust, as measured from the magnetic thrust bearing flux, versus time during coastdown. RPM is also shown. The maximum measured thrust was less than 10,000 N (2200 lb) compared to the magnetic bearing capacity of 25,000 N (5600 lb), a comfortable margin.

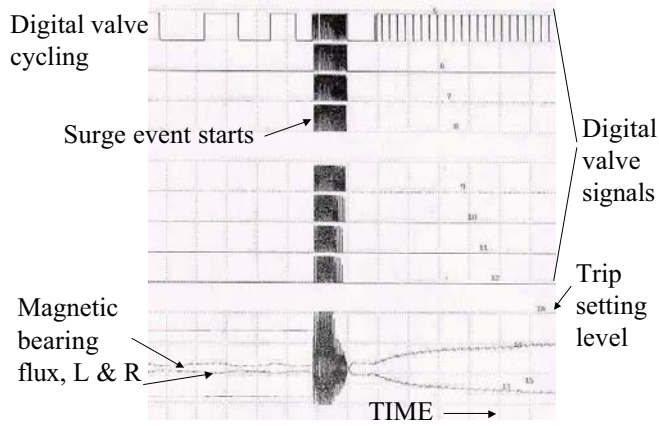
Figure 19. Surge Test of Thrust Controller.

If the compressor surges, the thrust will vary rapidly, and the controller will try to follow. Figure 19 shows the action of the thrust controller when surge was deliberately introduced during the high-pressure test. During the transient, the thrust was measured by the magnetic bearing flux. The thrust force exceeded trip limits, and the drive was tripped. A touch was recorded on the landing bearing, but no damage occurred. This test demonstrated that no damage would occur even if the surge control system failed to prevent surge.

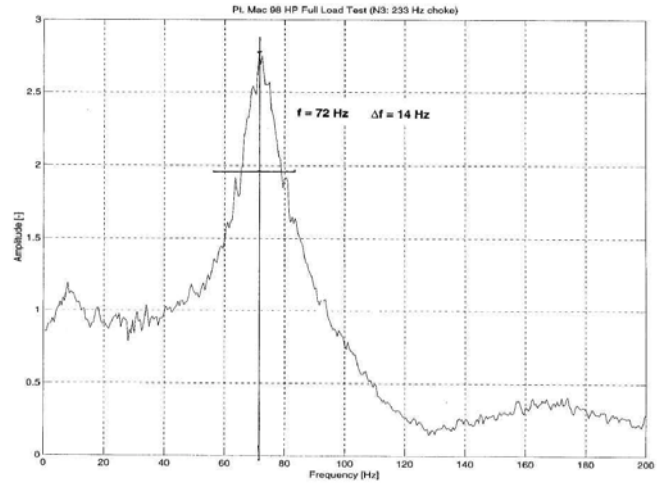
Figure 20. Log Decrement Measurement During High Pressure Test.

Centrifugal compressors operating at the pressure and gas density required for Point MacIntyre raise concerns about rotordynamic stability against self-excited subsynchronous vibrations. With magnetic bearings, the log decrement can be measured at full pressure, full speed operation, to confirm the rotordynamic design. A frequency-swept sine-wave signal was introduced into the magnetic bearing controller to perturb the rotor lateral vibrations. Considering the rotor as a linear dynamic system, the log decrement can be determined by the width of the dynamic response at the fundamental bending frequency. Figure 20 shows, for the 72 Hz mode, a response width of 14 Hz at the half-power point. The corresponding log decrement is 0.61, indicating satisfactory rotor stability.

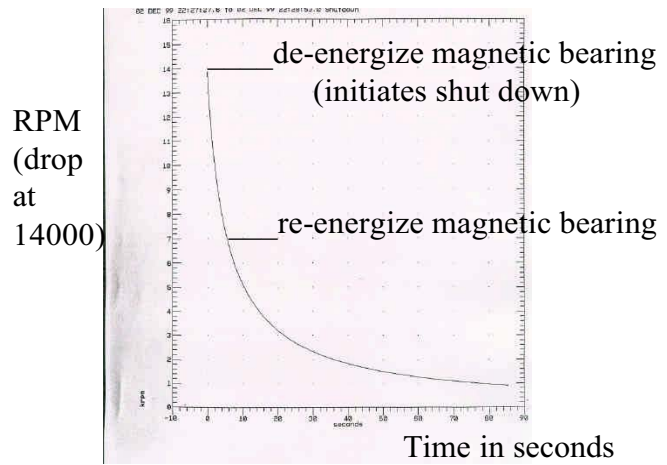
Figure 21. HP Rotor Drop Test—Speed Versus Time.

As discussed under section “THE TEST PROGRAM” above, magnetic bearing control failure was simulated by turning off power to each of the three control cabinets, one test at a time. Thus one body drops onto the landing bearings, while the other two are supported by the magnetic bearings. Bearing control failure initiates a trip of the compressor train, which then coasts to a stop. The bearing control power was reenergized after the rotor response was demonstrated, as a practical step to avoid excessive landing bearing wear on test. Figure 21 shows the HP compressor drop, starting at 14,000 rpm at time zero, with the bearing to be reenergized at 7000 rpm. As the drive had tripped, the train coasts toward 0 rpm, but decelerates ever more slowly because the gas in the test loop is being released simultaneously.

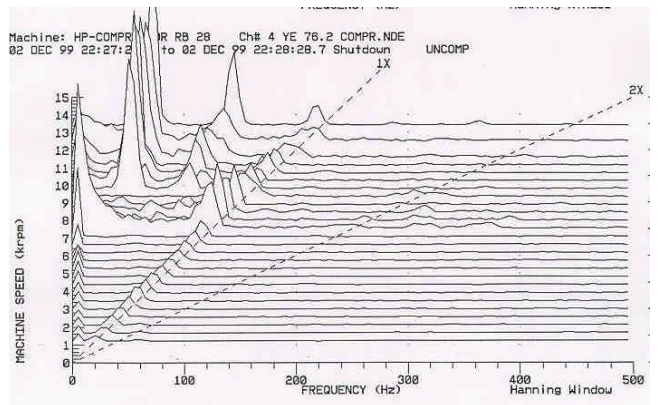
Figure 22. HP Rotor Drop Test—Vibration Spectra Waterfall Plot.

Figure 22 shows a waterfall plot of the vibration spectra during the HP drop test. Initially, at 14,000 rpm, two subsynchronous modes appeared, one at 70 Hz, and a second at 150 Hz. It is interesting to see two instability frequencies, instead of only one as commonly observed. When the magnetic bearing is reenergized, a transient is apparent due to the step function in force driving the rotor back to the center of the bearing. The subsynchronous modes drop out after the spectrum taken at 10,500 rpm. Subsynchronous noise is suppressed after the bearing is reenergized.

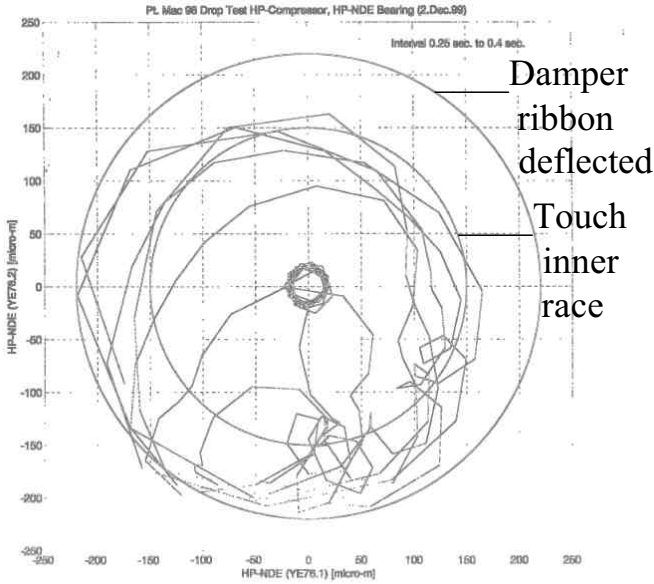
Figure 23. HP Rotor Drop Test—Shaft Orbit.

Figure 23 shows the orbit at the HP nondrive-end bearing during the drop test. The circular orbit at the center, of 20 μm (0.8 mil) diameter, is the synchronous response prior to the drop. The 150 μm (6 mil) radius represents the touch circle of the landing bearing. The 220 μm (9 mil) radius represents the maximum orbit of the landing bearing when the damper ribbon behind the bearing is fully deflected.

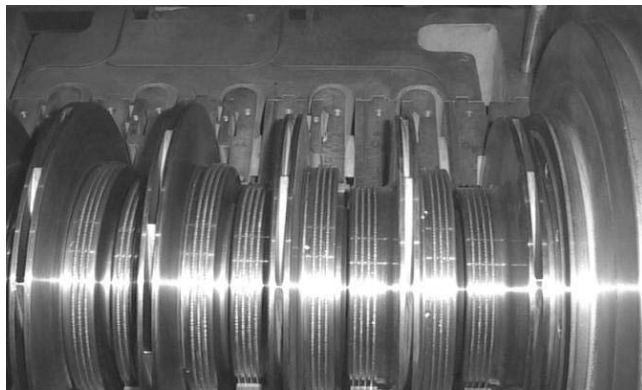
Figure 24. HP Rotor and Labyrinth Seals after Drop Test.

Figure 24 is a photograph of the rotor and its labyrinth seals after the drop test. Figure 25 is a photograph of the stationary portion of the labyrinth seals. Note the swirl brakes at the entry side of the seals. The labyrinths were not damaged by the drop test, showing the rotor vibrations were controlled by the landing bearings.

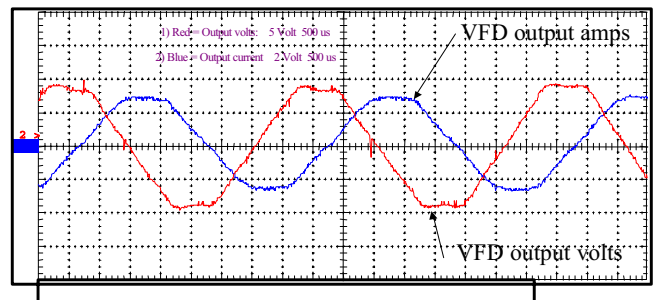
Figure 26. Motor Volts and Amps at Full Speed.

To maximize the benefit of prior experience, the software was adapted from standard versions in use on other high power drives but at lower frequencies. It was found on shop test that the high-speed software was limiting and some of the unnecessary features had to be removed to achieve the full 245 Hz frequency. Inevitably the changes had to be debugged progressively as each one appeared during the test program, but eventually the motor was run stably at full speed at about 6100 kW, which was the maximum load achievable on the test bed. Figure 26 shows the quality of the motor volts and amps at 245 Hz.

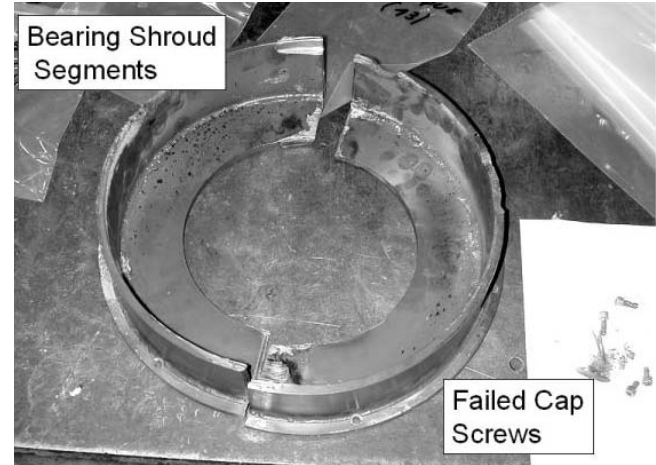
Figure 27. Loose Bearing Shroud.

The machine was in service at design conditions for about two weeks when a short occurred within the stator windings of the motor. An internal shroud, made from copper alloy, was positioned around the rotor short-circuit end ring area. It had broken loose and contacted the stator windings causing the short. Figure 27 is a picture of the bearing shroud that had become loose. The shroud had also contacted the rotor, but did only minor damage to the rotor and was easily corrected by grinding and polishing.

- Removal of the axial shroud around the short-circuit ring area.
- Tinning the copper parts of the bearing housing to protect them from corrosion rather than painting them.
- Bonding the two shroud segments together and to the bearing housing.
- Changing the fixation screws from steel to brass.

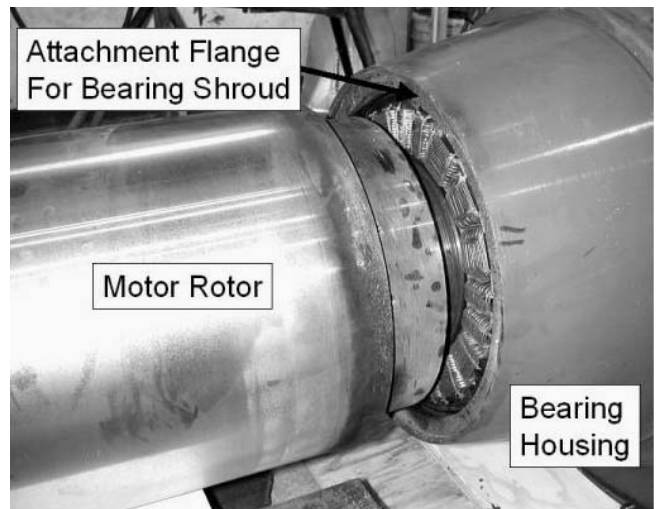
Figure 28. Motor Bearing Housing and Rotor.

This shroud was an axial cylindrical extension of the motor bearing housing and was attached on this bearing housing. Figure 28 is a picture of the motor bearing housing and rotor indicating where the bearing shroud was attached. Inspections of the failed pieces revealed that the cap screws that held the shroud in place had broken or backed out, allowing the shroud to fall into the rotor and into the stator windings. The flanged area of the bearing housing and the shroud were also pitted from arcing.
