FCC HOT GAS EXPANDER RELIABILITY UPGRADE EVALUATION

BP Amoco Corporation

ABSTRACT

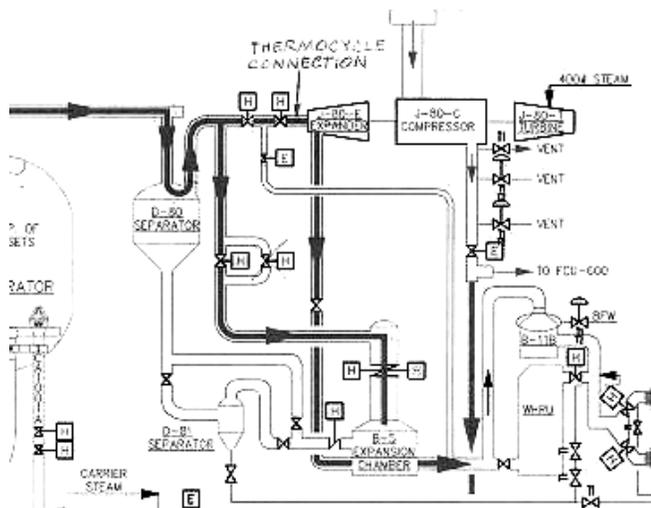
Figure 1. The PRT Train Flow Diagram.

A hot gas expander (PRT) train with a hot gas expander, an axial compressor, and a steam turbine was installed in the early 1980s at this refinery on one of the two fluid cat cracker units (FCCU). This train is intended to supply the combustion air to the larger FCCU, and at times to provide combustion air to our adjacent FCCU. The axial air compressor is driven primarily by the hot gas PRT. Power for the PRT comes from the flue gas generated by the FCCU catalyst regenerator. This regenerator flue gas is considered a "free energy source." This was used as the economic basis for incentives for the original installation of the PRT train. A steam turbine is also part of the train and is used as a supplemental horsepower device to the train. Soon after the startup, the new PRT case bolting developed a series of failures, and after 10 years of service and many case flange repairs, it was decided to replace the intake and exhaust case system. This replacement scope included a new intake case, transition or intermediate case, nosecone, stator, shroud, diffuser, inner exhaust case, exhaust case, and rotor blades. The existing rotor and rotor support system was reused. Figure 1 shows the PRT train flow diagram and Figure 2 shows the modifications made in 1992.

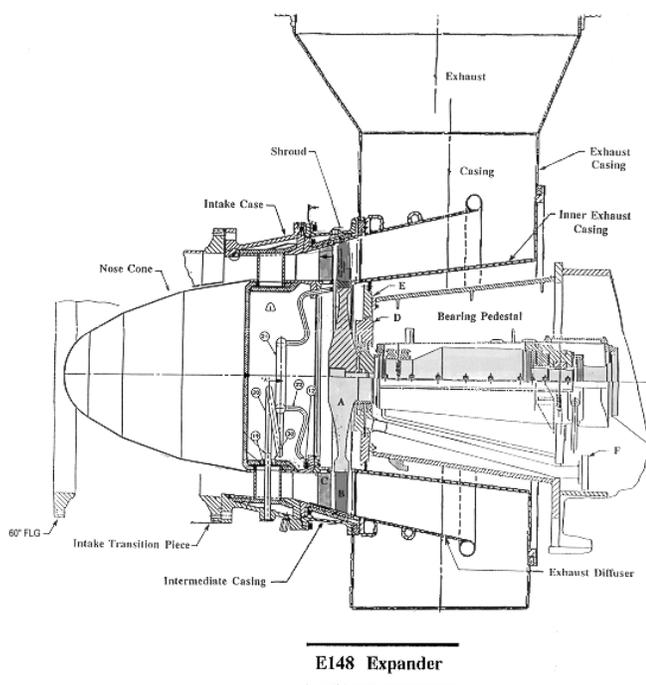
Figure 2. The PRT Cross Section. (All stationary parts and blades except for the base support were replaced in 1992.)

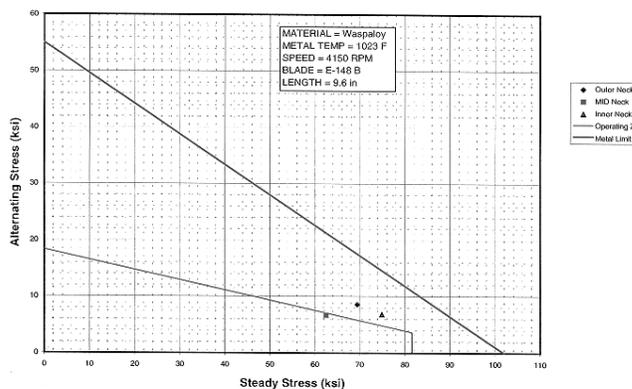
Figure 3. Blade Attachment Goodman Diagram.

The 1982 PRT was “middle-of-the-pack” in the world of PRT installations as far as horsepower and severity of operating conditions. It ran at an almost constant speed of 3950 rpm and never had a blade failure. Conversely, the 1992 machine had longer and heavier cross-section blades and at its design speed (4050 rpm) it was among the most highly stressed machines in the world. By late 1993 the operating speed was higher than design and for most of 1994 it operated near 4150 rpm, which, according to a PRT consultant, created the highest operating blade stresses of any machine in the world. Please refer to Figure 3 for a Goodman diagram for blade stresses and Figure 4 for a blade Campbell diagram. As can be seen from the Goodman diagram, blade outer neck and inner neck were operating above the recommended design stresses.

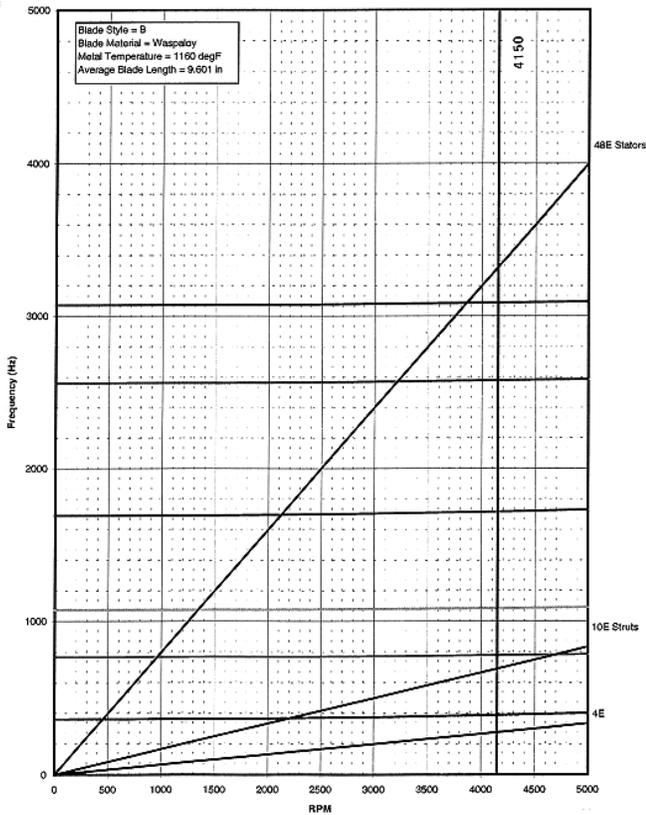
Figure 4. The PRT Campbell Diagram.

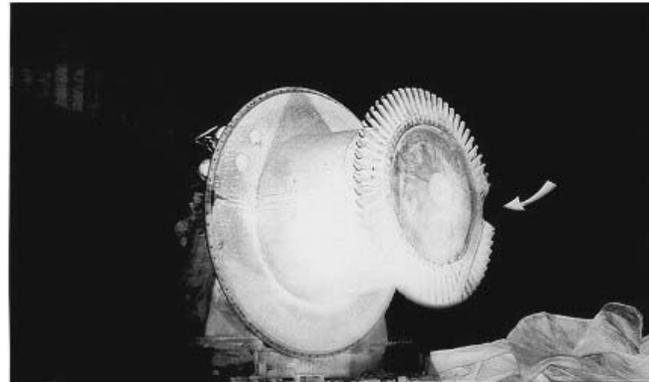
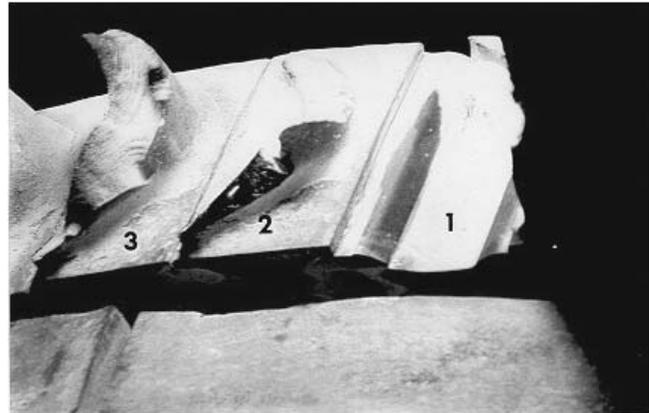
After the 1995 blade failure (Figure 5), which was caused by hot corrosion and high stresses, the blade length was shortened to reduce stresses, to avoid interference of resonant frequencies with known excitations, and to increase the gap between the shroud and the blades. The 1996 failures were due to internal fastener failures on the nosecone baffle plate. These bolts contacted the lead edge of the rotating blades, knocking off the hard coating surface. Later in the year, metallic aluminum contamination in the fresh FCCU catalyst formed a very brittle “Waspaluminoy” material at the high stress area of the blade (Figure 6). This blade failure was

(a) Overall view of the rotor.

(b) Close-up of the section with the missing airfoils.

Figure 5. 1995 Rotor Wreck Due to Blade Failures.

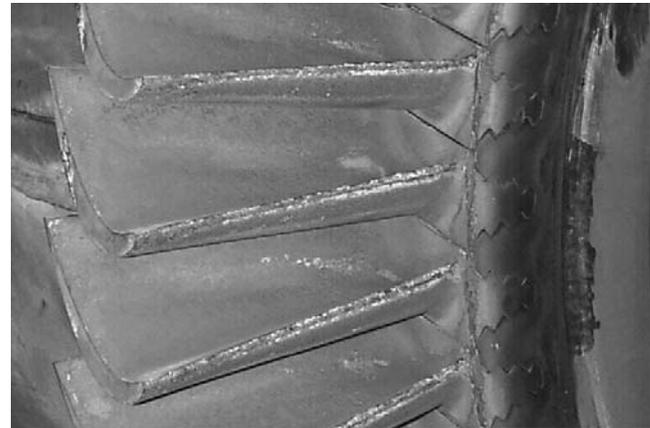
Figure 6. 1996 Blade Failure with Waspaluminoy on Leading Edge.

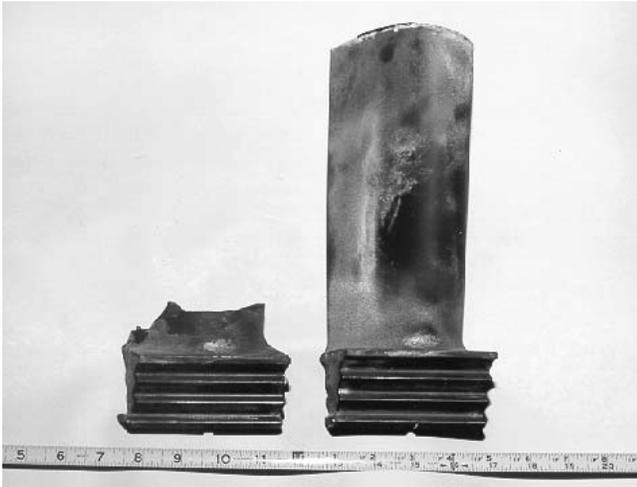
exacerbated by continued operation at maximum allowable blade stress limits due to high operating speed (4150 rpm) and also by periodic low operating speed (less than 3600 rpm) which excited blade resonances (Figures 7 and 8).

Figure 7. 1996 Blade Failure (View One).

Following the 1997 rebuild of the machine we limited operating speed to 4050 rpm, which, according to the consultant, is the highest operating speed of any machine in the world except for one machine operating at 4350 rpm with blades half the length of ours. Operating stresses in 1997 continued to be at the design limit for the material used and, when we experienced blade tip rubs due to catalyst buildup, another failure occurred early in 1998.

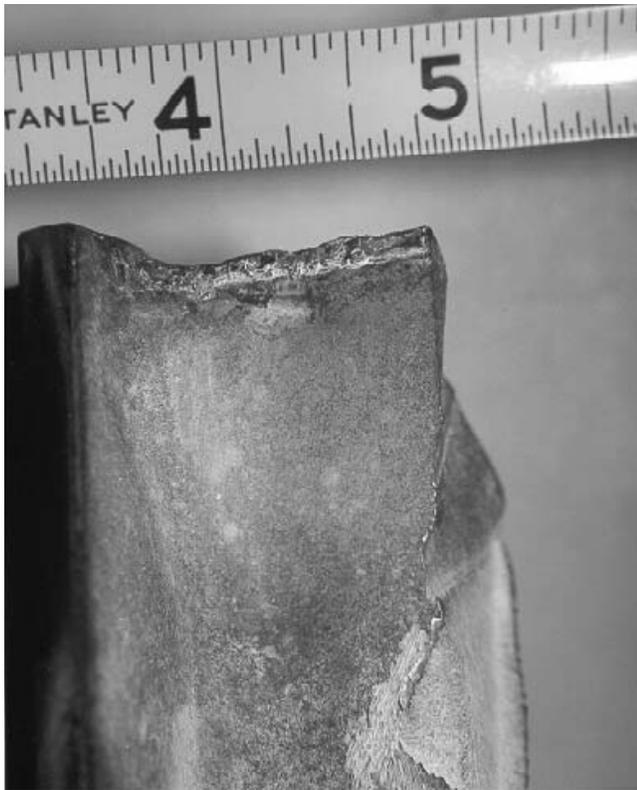
Figure 8. 1996 Blade Failure (View Two).

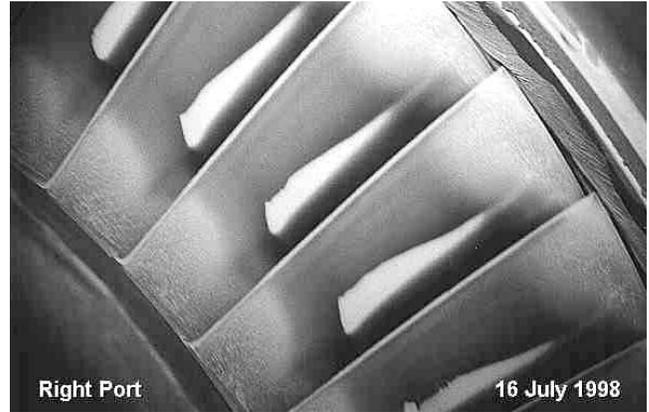
Figure 9. Online Photo of Catalyst Deposit on Blades and Shroud Used for Thermal Cycling.

In 1998, blade material was changed and blade tip clearances were increased. A commitment was made to thermal cycle the PRT to remove catalyst buildup before any future blade tip rubs, with minimal operating interruptions. It has been proven that the increased gap between the shroud and the blades has extended the time between thermal cycles (Figures 9 and 10).

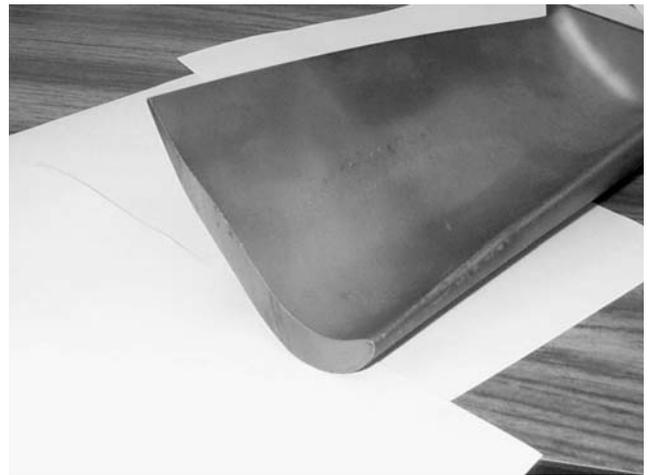
Figure 10. Blade Tip Eroded Due to Rub with Catalyst Deposit on the Shroud.

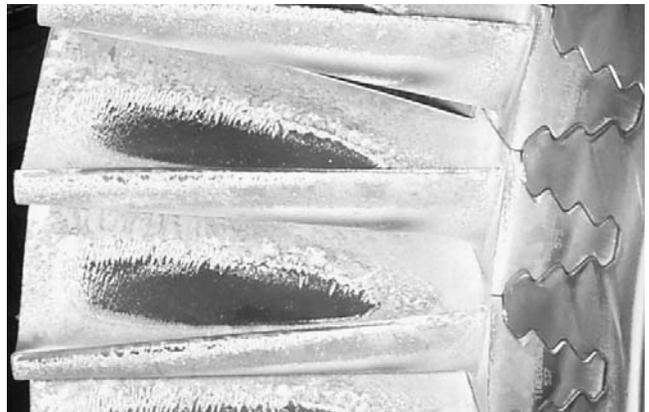
Erosion damage to rotor blades is the most common cause of premature shutdowns and PRT failures. On the 1998 failure there was evidence of erosion of the blade's hard-surface coating. Blades removed in Spring 2000 were found to have considerable erosion as shown in Figures 11, 12, 13, and 14.

Figure 11. Rotor Blade Erosion, February 2000 (View One).

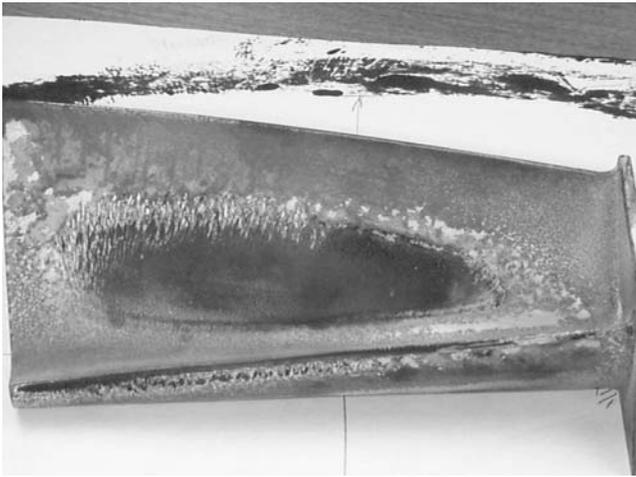
Figure 12. Rotor Blade Erosion, February 2000 (View Two).

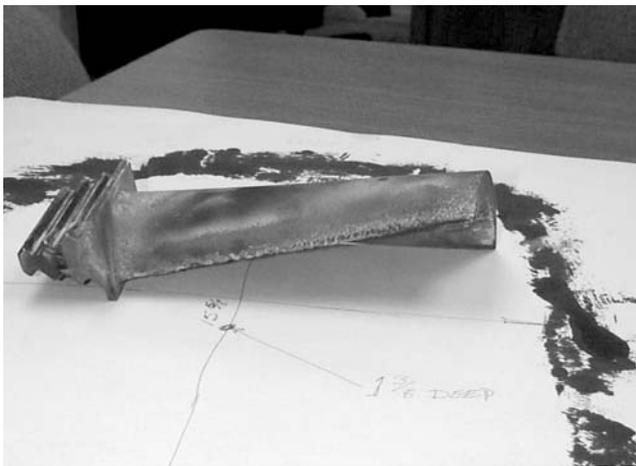
Figure 13. Rotor Blade Erosion Seen on Backside of Leading Edge, February 2000.

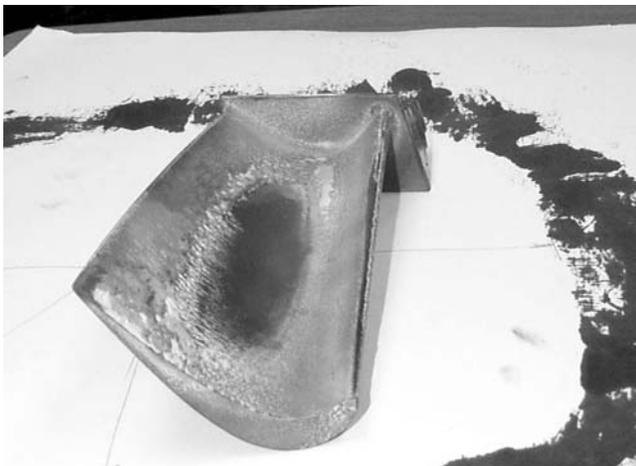
Figure 14. Rotor Blade Erosion Seen from Blade Tip, February 2000.

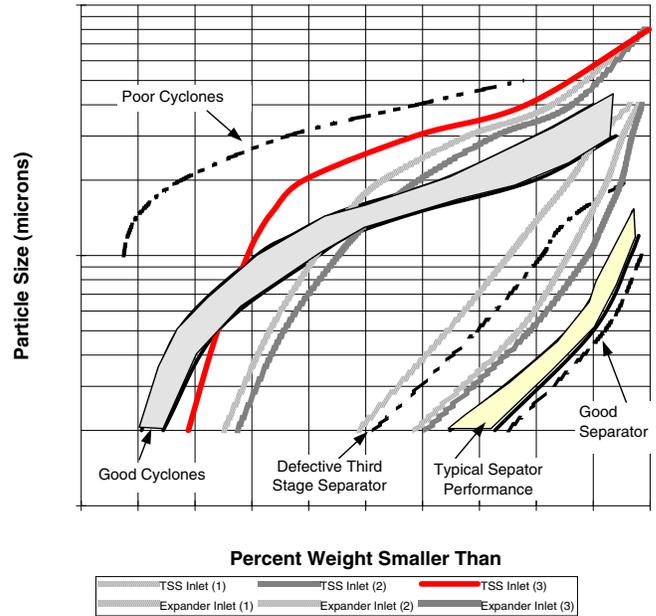
worldwide. The TSS performance analysis and the PRT blade hard surfacing erosion rate indicated that the TSS performance has deteriorated over the years as shown in Figure 15. The consultant recommended improvements to the future isokinetic test procedure. It was also learned that there was very little mechanical inspection history available due to minimal or no inspection of the TSS internal in the past.

Figure 15. FCCU Third Stage Separator Performance, June 1998. (Courtesy of Carbonetto, CONMEC)

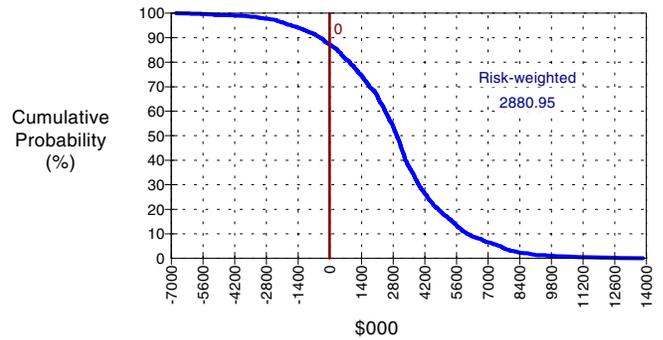
Figure 17. Risk Weighted NPV for Option 5 Relative to Option 1.

Capital cost, maintenance cost, reliability (failure) data, and related costs and incentives were input into the GRisk model. The model provided risk weighted net present value (NPV) (shown in Figure 17), cash flow, internal rate of return (IRR), and sensitivity analysis (shown in Figure 18) as outputs. Scheduled maintenance and turnaround activities were also included in the model. The analysis was done on a project life of 20 years. Financial data such as depreciation scale, inflation, hurdle rate, etc., were used as prescribed by the corporation. The software program results for the final six options are summarized in Table 4.

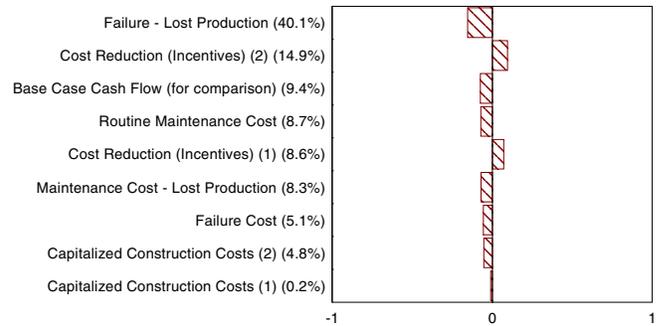
Figure 18. Sensitivity Analysis for Option 5.

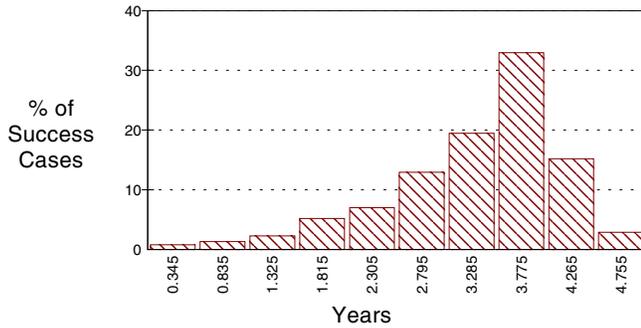
Figure 19. Failure Distribution with Peakedness of 4.

During the software analysis, one of the biggest issues the team wrestled with was of the reliability data for various options. There was not a great deal of PRT reliability data available. The reliability data were arrived at after considerable discussion and analysis from the project team and the PRT consultant. One of the key features of the model was the ability to define the confidence factor (“peakedness”) of individual assumptions and distribution of the input data. Figures 19, 20, and 21 illustrate the effect of “peakedness” on reliability data distribution. The model ran over 2000 iterations of the input distributions to generate an integrated output. Please refer to APPENDIX E for sample input and output data from the software. The sensitivity analysis (Figures 18) clearly showed that “Lost Production” due to a PRT train failure was the biggest single variable that influenced the IRR and net present value (NPV) results.

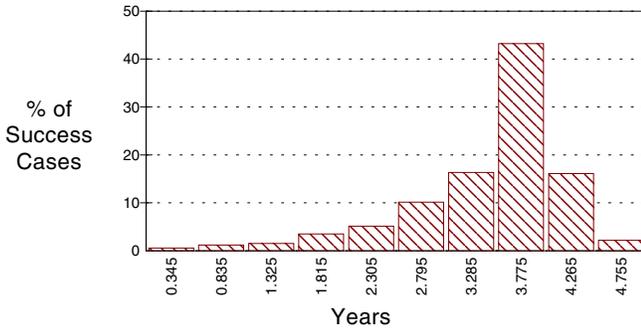
Figure 20. Failure Distribution with Peakedness of 7.

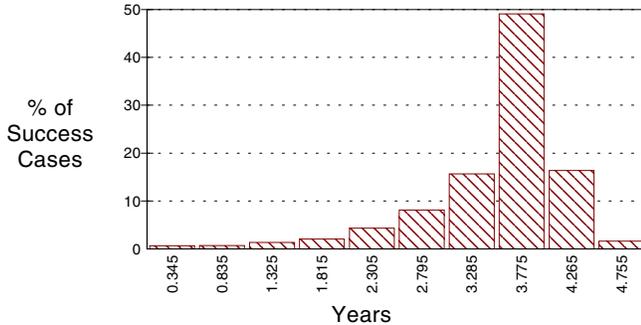
Figure 21. Failure Distribution with Peakedness of 10.
