MAGNETIC BEARINGS AND DRY GAS SEALS— A PROCESS COMPRESSOR APPLICATION

ABSTRACT

The design considerations and features along with manufacturing and operating experiences encountered on a multistage centrifugal process compressor incorporating a dry gas seal and active magnetic bearings immersed in the process fluid are discussed.

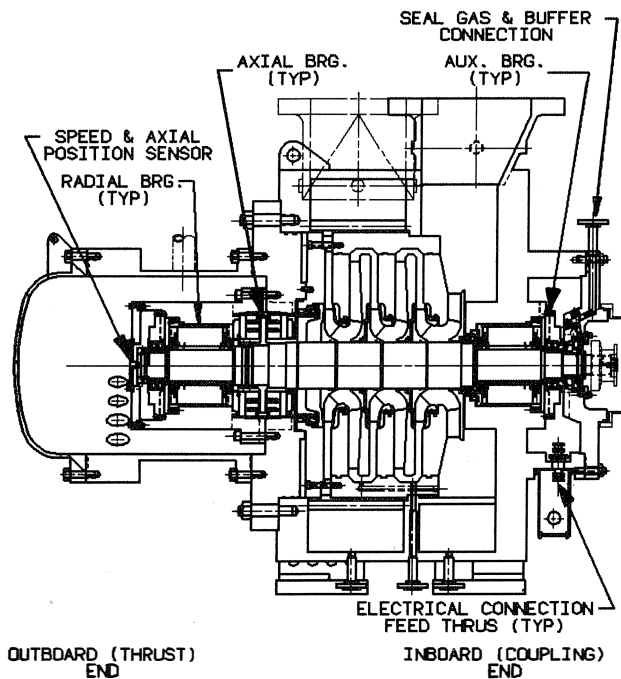
Figure 1. Compressor Longitudinal Section.

To meet the specified process conditions, a three stage compressor rotor was selected. Since an induction motor was specified as the driver, a speed increasing gear was needed to meet the required compressor operating speed. The basic compressor design is similar to the typical vertically split (barrel) compressor that would be used in hydrogen service. The similarity ends however, with the installation of the active magnetic bearings and the single dry gas seal. As can be seen in Figure 1, the entire bearing system is located inside the pressure housing. On the inboard (coupling) end the dry gas seal is located outermost on the shaft next to the coupling. The thrust end is completely enclosed. In operation, seal gas is injected between the single dry gas seal and the inboard end radial bearing. Some of

the gas leaks through the seal and is vented to flare. The rest flows through the inboard radial active magnetic bearing, through a labyrinth that controls the flow and into the process. A nitrogen buffered double carbon ring is used to prevent the gas leaking to the outside from entering the atmosphere through the coupling guard. The configuration of this seal is shown in Figure 2. The double carbon ring also acts as a backup seal in the event of failure of the primary seal [1].

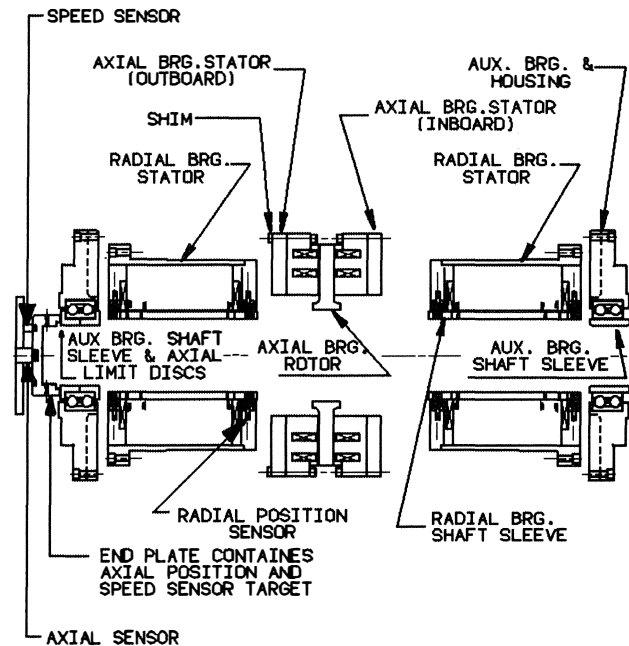
Figure 3. Active Magnetic Bearing (AMB) Components. (Control panel not shown).

Auxiliary bearings are also supplied to support the rotor. These bearings serve two functions: one is to support the rotor when the bearings are not energized; and, the other is to control the rotor and prevent rundown damage in the event of a loss of both normal and auxiliary power.

These bearings are preloaded, angular contact ball bearings with a specified preload. They are sized to suit the particular installation. The outer race is clamped in a holder to provide the preload and to permit installation in the compressor stator. The holder is fitted such that the bore of the auxiliary bearing is held concentric to the bore of the active magnetic bearing stator. The holders are mounted outboard of the active magnetic bearing stators and as close as feasible to them. The shaft under the auxiliary bearing is fitted with a replaceable sleeve. The outside diameter of the sleeve is sized to give a diametral clearance to the auxiliary bearing bore that is approximately one-half the active magnetic bearing clearance (i.e., in this case, 20 mils). Therefore, on complete loss of power to the active magnetic bearing coils, the rotor will drop and run down on the auxiliary bearings rather than the laminations. In addition to the radial clearance, the auxiliary bearing inner race on one end of the machine is located between two axial stops fixed to the shaft. On power loss, these stops limit axial rotor motion and prevent contact between the axial bearing rotor and stators. This clearance is also set at 20 mils. The various hardware items required for the active magnetic bearing/rotor system are shown in Figure 3.

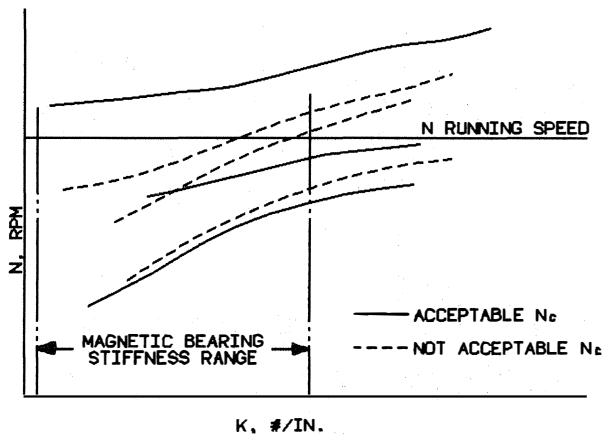
Figure 4. Typical Speed/Stiffness Curve for Rotors Supported on Active Magnetic Bearings.

One of the features available in an active magnetic bearing system is referred to as automatic balancing. This terminology attempts to define a system's operation in familiar terms. We should understand that the system cannot actually "balance" a rotor. However, it can take advantage of the fact that a rotating body, properly controlled, can be made to rotate about its center of gravity rather than its geometric center. This effectively eliminates any rotational forces due to the rotor's inherent imbalance and, hence, reduces the bearing loads. To make use of this feature imposes certain restrictions on the rotor design. Since the automatic balancing works by reducing the bearing stiffness coefficients to very low levels, it is imperative that there are no rotor natural frequencies coincident with the running speed at any stiffness in the stiffness range of the bearing. A graphical representation of this requirement is shown in Figure 4.

Analysis indicated that by stiffening the shaft ends in the area of the bearing rotors we could meet the natural frequency criterion for this machine. To accomplish this, we departed from the normal radial active magnetic bearing rotor design. Rather than use a shaft sleeve with bearing lamination on the OD, we elected, after discussions with the bearing vendor, to mount the laminations directly on the compressor shaft. The lamination assembly was mounted on the compressor shaft with a light shrink fit and clamped axially with a check nut. The outside diameter of the laminations were finished to size according to the bearing design requirement. This approach permitted an increase in shaft diameter in the bearing area without increasing the bearing diameter.

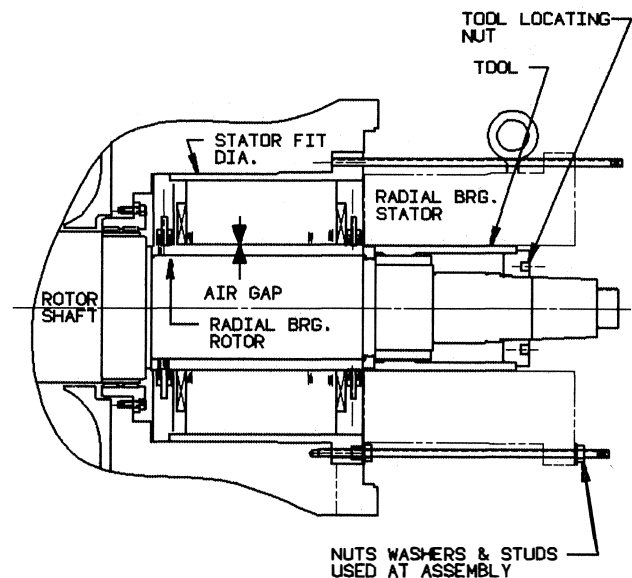
Figure 5. Typical Tool Used to Assemble Compressor. Installation of radial active magnetic bearing stator shown.

The radial bearing stator weighs approximately 300 lb. Assembly and disassembly into the compressor requires that it be pushed into its mounting location while passing over the bearing rotor already installed on the shaft. In order to align the bearing

stator with the shaft and minimize the chance of damage to both the bearing stator and rotor, an assembly tool was required. This tool is simple in configuration, consisting of a tubular shape of predetermined length. The outside diameter of the tool has a thick, baked-on coating of hard nylon. During assembly, the tool is mounted on the shaft and held in place with a nut. The radial bearing stator is lifted with a crane and slid over the tool. Appropriate studs, nuts and washers are used to jack the stator into place. This arrangement is shown in Figure 5. The outside diameter of the tool is larger than the outside diameter of the bearing rotor and smaller than the inside diameter of the bearing stator. The stator outside diameter is stepped in such a manner that as the stator is pulled into its housing; the outside diameter fits mate before the inside diameter moves beyond the tool. This effectively prevents contact between the active magnetic bearing stationary and rotating parts during assembly.

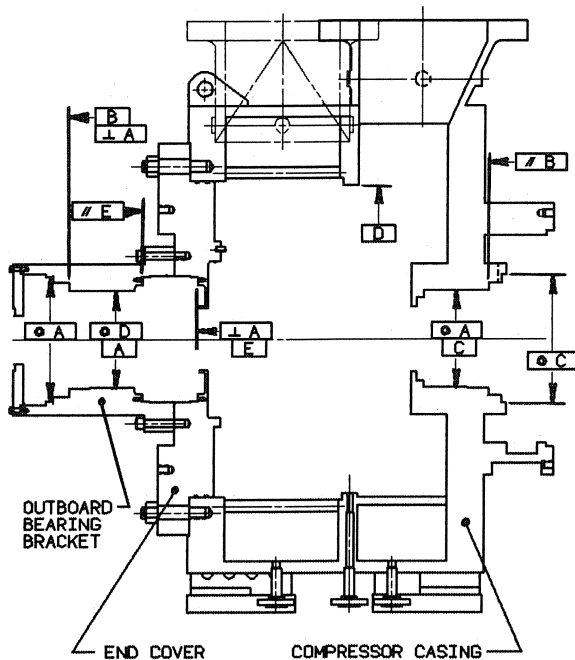
Figure 6. Geometric Tolerancing of Case Assembly Machining.

The compressor casing was finish machined except for the locating fits for the active magnetic bearing and dry gas seal stators. The locating fits were semifinished to allow for final machining later. The compressor case bore that locates the aerodynamic assembly was defined as the datum for all final machining operations. The end cover was finish machined. The

outboard bearing bracket was semifinished except for the mounting surface and bolting provision. These three parts were assembled and dowelled to ensure repeatability during future maintenance. The mounting and locating surfaces for the active magnetic bearing stators were then finish machined to the specified tolerances. The arrangement is shown in Figure 6.

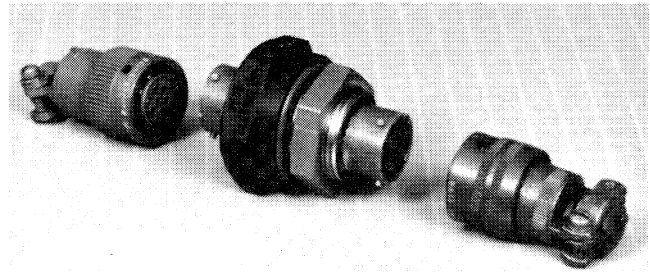
Figure 7. Typical Feedthrough Bulkhead Connector.

The active magnetic bearing stators are similar in design to an electric motor stator. The magnetic field is controlled by an electronic system that gathers data from sensors located at the bearings. Resistance temperature detectors (RTDs) in the bearing stators monitor the temperature. The thrust stators are also equipped with flux sensors. There are also a speed sensor, an axial position sensor and a temperature compensating circuit. These add up to 68 electrical connections (including grounds) that must be brought outside the pressure housing to be connected to the control panel. To make the penetration and to facilitate maintenance, a commercially available bulkhead connector was selected. This "feedthrough" consists of a sealed bulkhead fitting with an MS style connector on each end. The internal connectors are hard wired to the bearing stators; and, the external connectors are wired to the control panel. These con-

nectors were selected with contact sizes suitable for the current and voltage being carried. Power leads and sensor leads were separated to minimize the possibility of electrical interference. Each radial active magnetic bearing stator required three connectors: two for power and one for sensors and RTDs. Each thrust stator required two connectors: one for power and one for flux coil and RTDs. The axial position sensor, the speed sensor and the temperature compensating circuit were wired to one connector. A total of 11 connectors were required. Each connector was specified with several extra contacts to allow for spares. A typical connector assembly is shown in Figure 7.

The sealed bulkhead "feedthrough" connections (Figure 7) have an internal plastic part which supports the pins and sockets. These connections were also at the bottom of the machine and became immersed in liquid. Some of the plastic parts in the connectors have been attacked by the aromatics, resulting in a loosening of the pins and sockets, and a deterioration in the quality of the connection. Subsequent evaluation has found that the damaged components were made of an off-spec plastic.

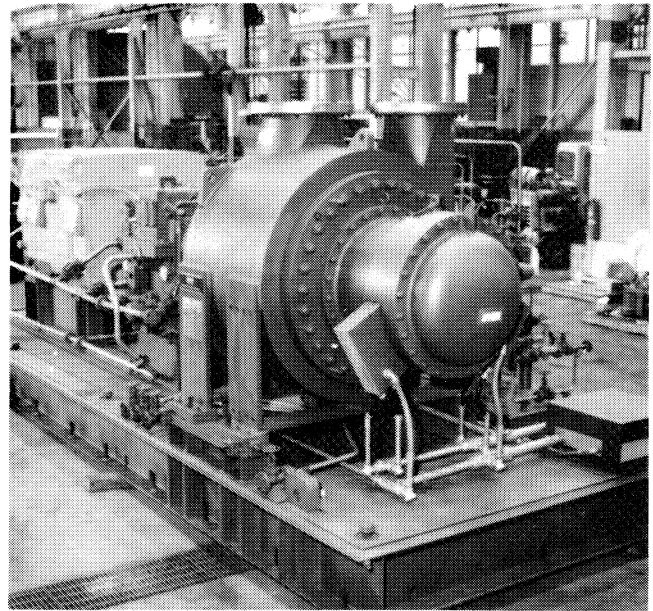
Figure 8. Motor, Gear, and Compressor on Bedplate Ready for Shipment.

These connectors are located in specially machined areas on each end of the compressor. Eight connectors on the outboard (thrust) end are located in the outer pressure housing. Three connectors on the drive (coupling) end are located in the case (Figure 1). Fabricated junction boxes are provided to protect the connectors and to provide a mounting surface for conduit. The junction boxes and conduit can be seen in Figure 8.

With the new active magnetic bearing stators installed the unit was retested with good results. On completion of the testing (both rotors) and after acceptance by the customer, the unit was shipped to the job site. The compressor, speed increasing gear and motor installed on the bedplate are shown in Figure 8, pre-wired and ready to be shipped.

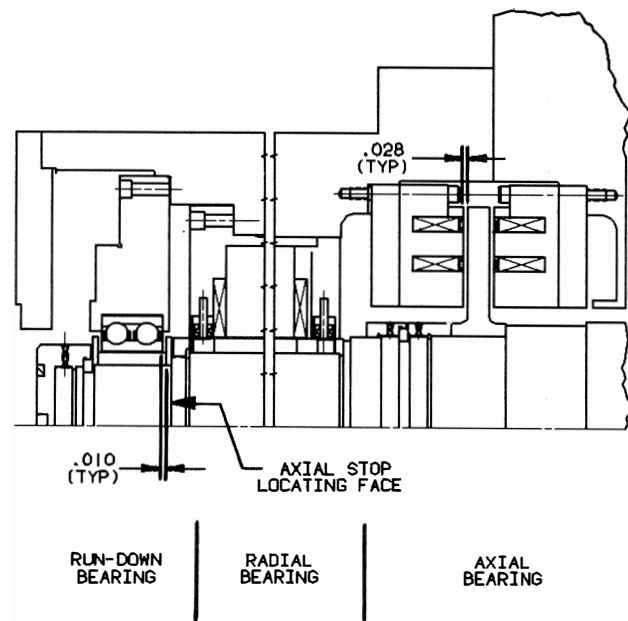
Figure 9. Axial Limit Stops—Outboard Rundown Bearing.

The most difficult part was convincing the mechanics that the specified tolerances for location and squareness were important and needed to be achieved. Setting the axial bearing rotor on the center of a 56 mil end float was, after all, something quite different from normal practice, especially since the location that had to be controlled from this setting was the end float of the outboard rundown bearing.

Obtaining the required clearance between the axial stops for the outboard rundown bearing was simple. It is controlled by the length of the shaft sleeve. When the axial bearing (thrust) rotor is positioned on the center of its 56 mil air gap, the sleeve is positioned so it is centered on the inner race of the outboard rundown bearing. The sleeve is located by the inner axial stop. The axial stop is located by a shaft shoulder. This is shown in Figure 9. Only after several explanations using the hardware and sketches as a guide, did the mechanics fully understand the requirements.
