ABNORMAL VERTICAL PUMP SUCTION RECIRCULATION PROBLEMS DUE TO PUMP-SYSTEM INTERACTION

Bruno Schiavello

Donald R. Smith

Stephen M. Price

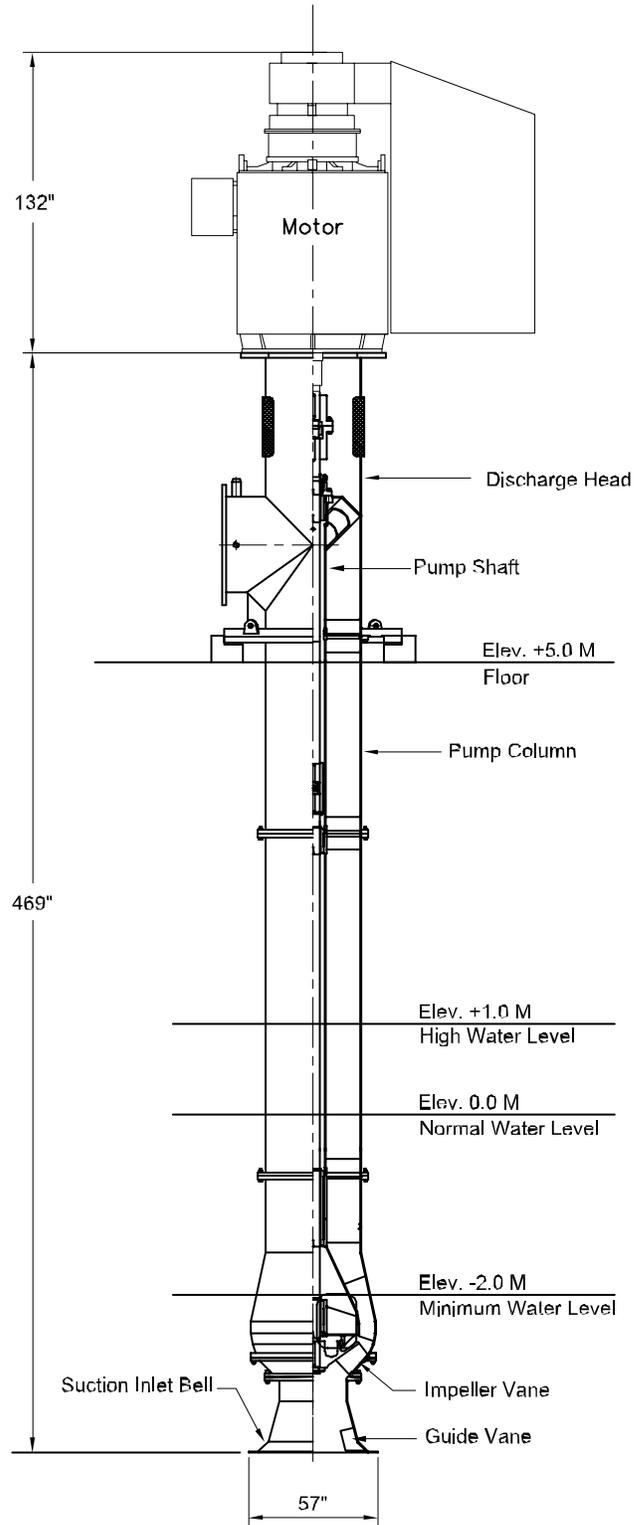
Figure 1. Cross-Section of Vertical Turbine Pump.

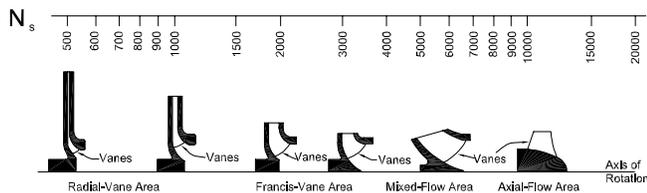
Figure 2. Approximate Range of Specific Speeds for Various Impeller Types.

Vertical turbine pumps, such as these, usually use mixed-flow impellers. A comparison of various impeller designs (centrifugal, mixed-flow, and axial-flow) with their corresponding specific speeds (N_s) is shown in Figure 2 (Karassik, et al., 2001). Specific speed is an index number correlating pump flow, head, and speed at the optimum efficiency point.

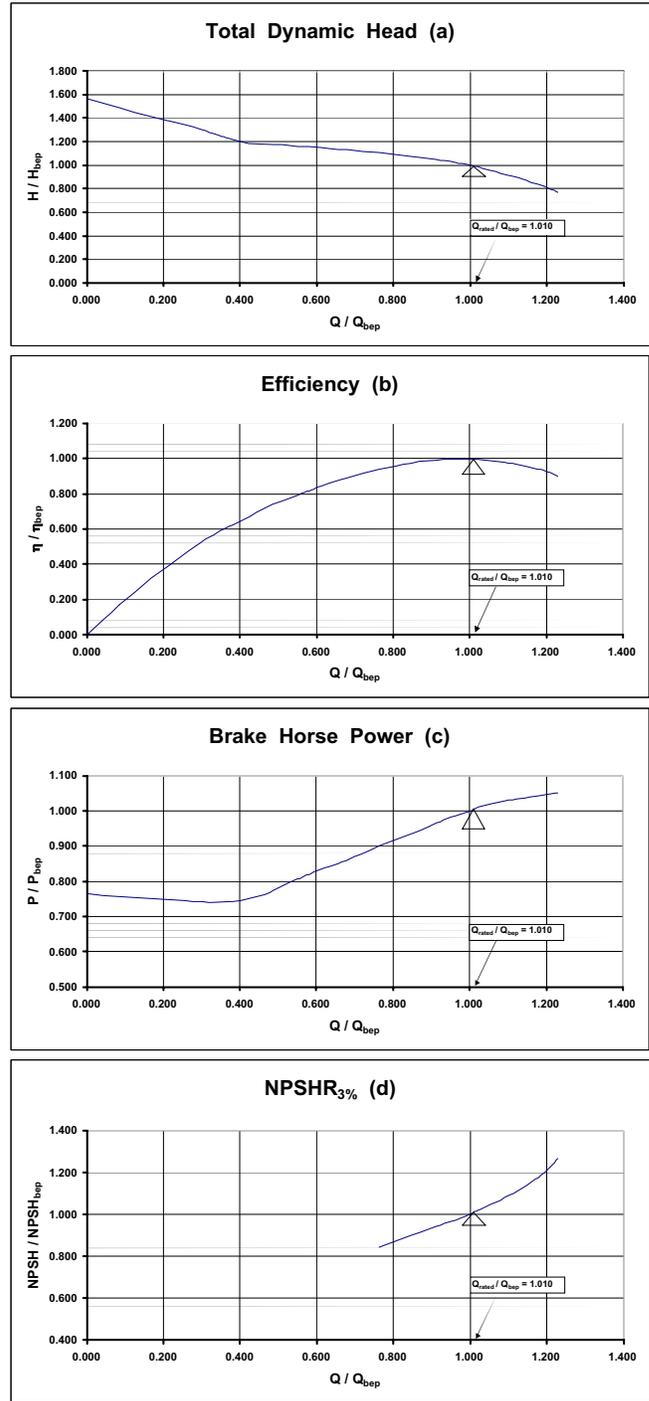
Figure 3. Normalized Shop Performance Curves.

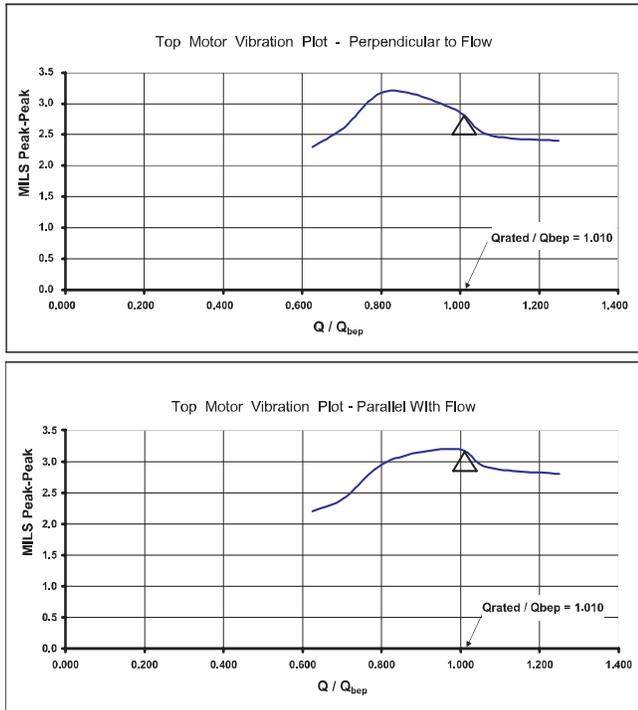
Figure 4. Motor Vibration During Shop Performance Tests.

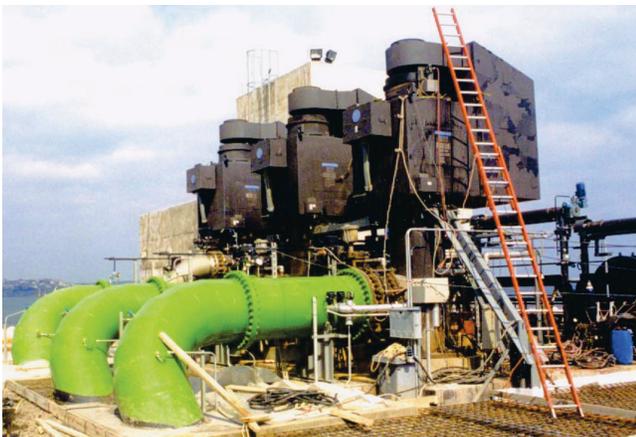
Figure 5. Photograph of Pump Installation at Power Plant.

The vertical pumps were installed in parallel to provide cooling water (“circ water”) for a power plant (Figure 5). The circulating water system can operate with one or two pumps in service. During normal operation, two pumps are in service with the third pump as a spare. The system design flowrates are 65,300 gpm (14,831 m³/hr) with one pump in service, and 56,000 gpm (12,719 m³/hr) per pump with two pumps in service. As shown in Figure 6, both these flowrates are above the pump BEP value.

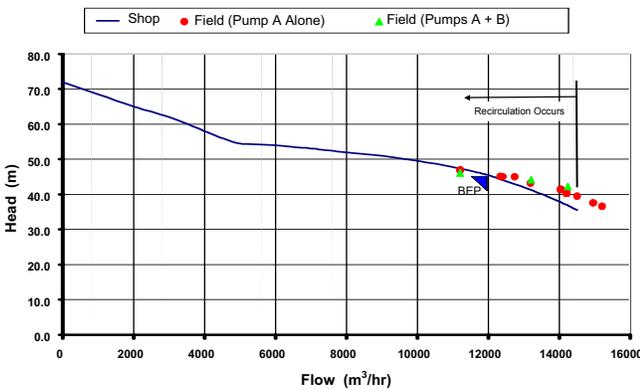
Figure 6. Operating Conditions in Field Versus Shop Test.

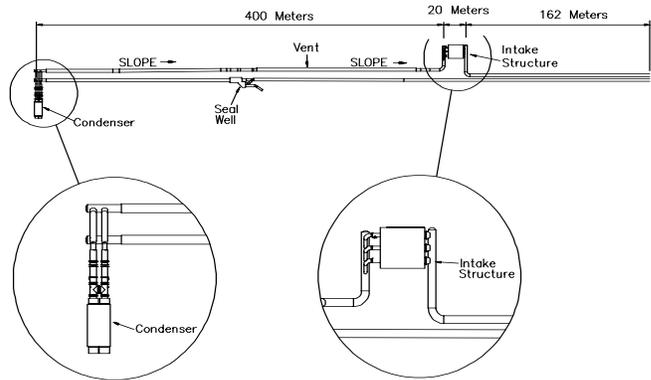
Figure 7. Layout of Cooling Water System.

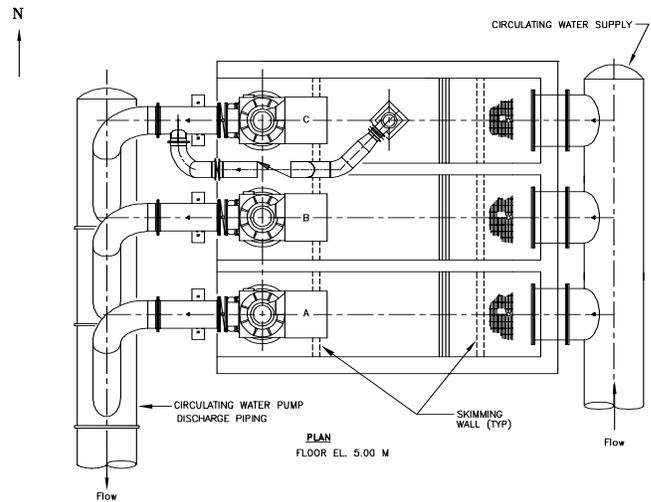
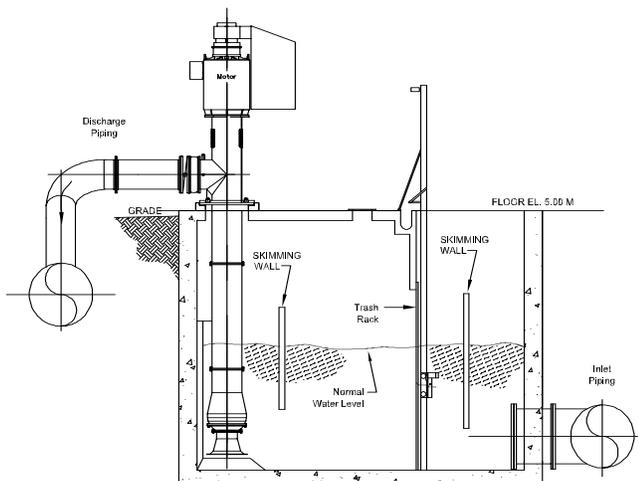
Figure 8. Sketch of Water Intake Structure—Plan View.

Figure 9. Sketch of Water Intake Structure—Elevation View.

The objectives of the hydraulic study were to verify the absence of undesired flow patterns/phenomena (ANSI/HI 9.8, 1998) and, if necessary, modify the design of the pump intake structure. These studies indicated several undesirable flow conditions such as vortices, flow separations, asymmetry in the approaching flow, etc. Several modifications were made to eliminate the undesirable flow conditions at the pump bell. These modifications included: shortening the bay, setting the pump bell approximately 0.5 m (1.6 ft) from the floor, adding a curtain wall between the inlet pipe and the trash rack, adding a second curtain wall near the pump, adding fillets at the wall-floor corners, and adding a flow splitter under the pump bell (Figures 8 and 9).

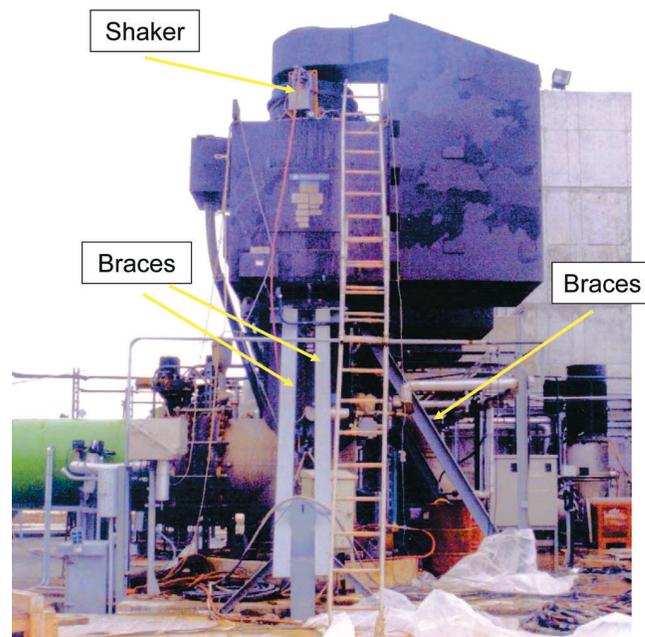
Figure 10. Diagonal Braces Added to Reduce Vibration Levels.

levels, the vibration frequency did not change and the levels were still considered to be excessive, which indicated that there were high-level forces acting on the pump/piping system. Also, since the braces were not intended to reduce pulsation, the condenser vibrations were not reduced.

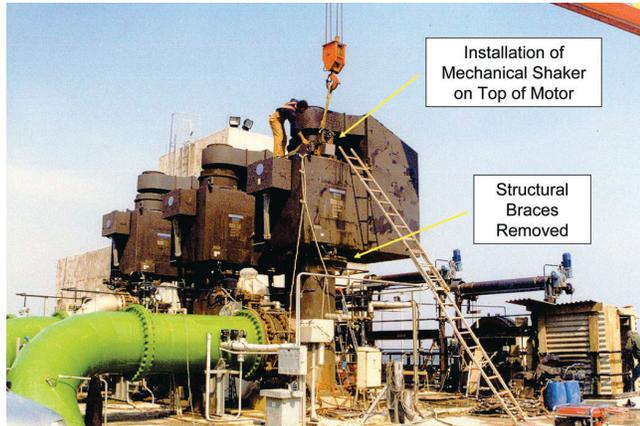
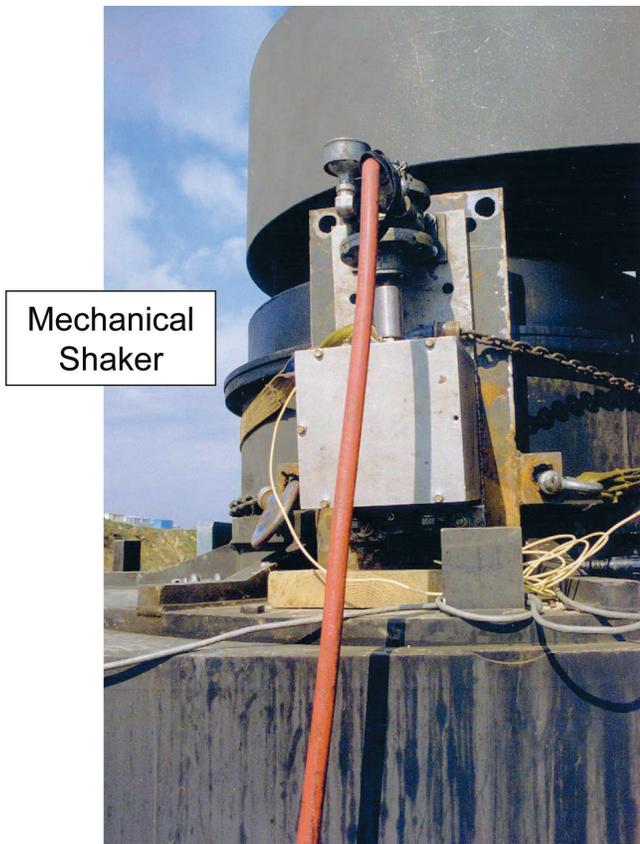
Figure 11. Installation of Mechanical Shaker on Top of Motor.

Figure 12. Closeup View of Mechanical Shaker Attached to Motor.

A variable speed mechanical shaker was attached to the top of the motor as shown in Figures 11 and 12. The shaker was driven by a variable speed air motor over a speed range from approximately 150 to 1000 rpm. The shaker was oriented with the shaft in the vertical position such that the rotating shaking forces were in the same direction as an imbalance on the motor/pump shafts. During these tests, the shaker unbalance was set to 48.8 lb-in. This unbalance would be approximately 10 times larger than the typical API allowable residual unbalance for the motor and pump rotors operating at 600 rpm.

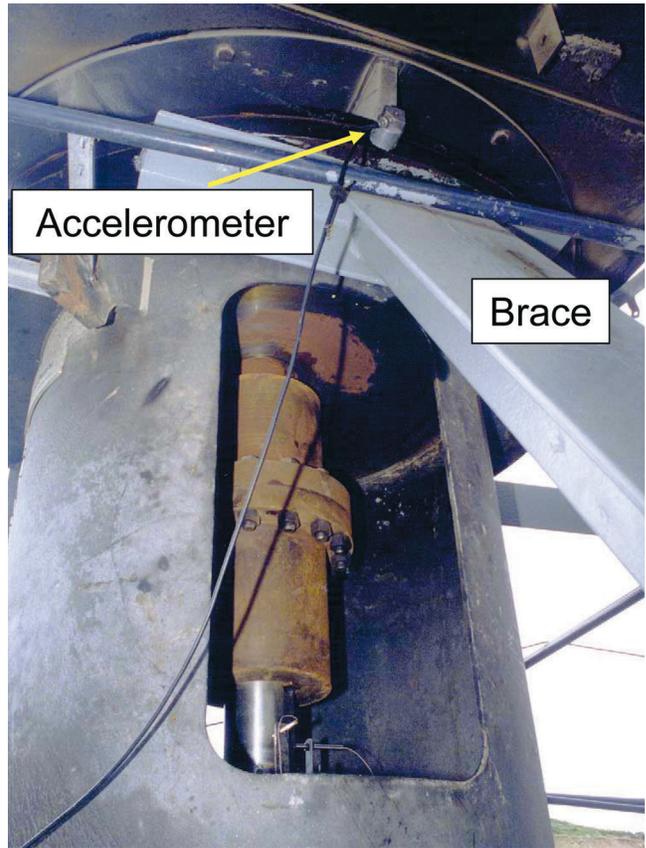
Figure 13. Accelerometer Location at Top of Pump Housing.

the shaft. Accelerometers were also installed at the top of the pump housing (Figure 13). A waterproof triaxial accelerometer was installed on the pump inlet bell to measure the vibrations of the pump column (Figure 14). The acceleration signals were double-integrated to obtain displacements in mils (0.001 inches).

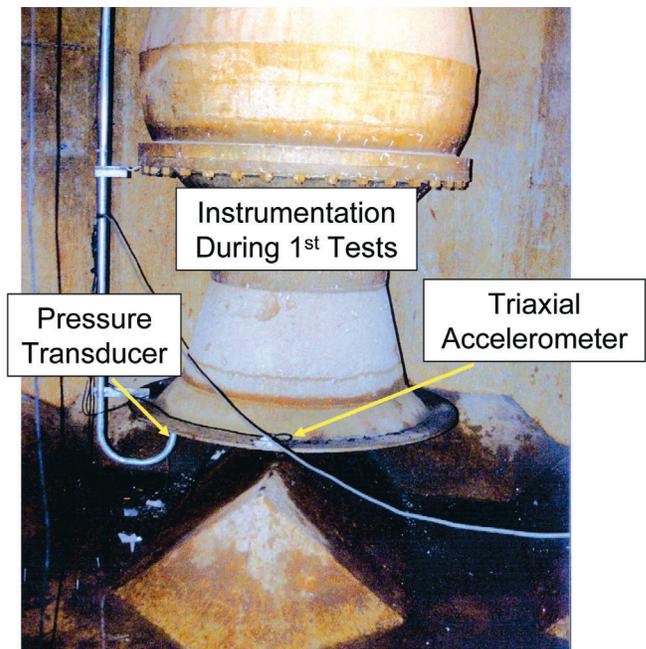
Figure 14. Pressure Transducer and Accelerometer Installed on Pump Suction Bell.

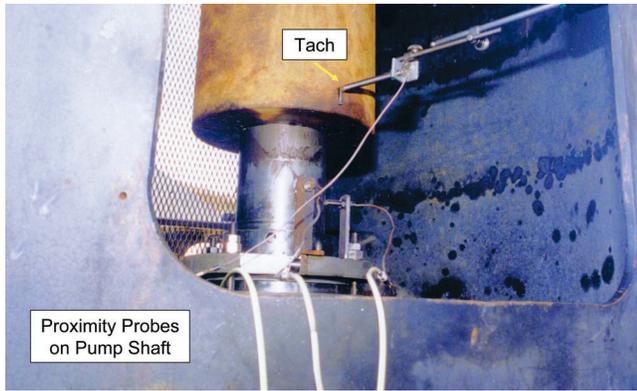
Figure 15. Proximity Probes Installed at Top of Pump Shaft (Near Coupling).

Pump shaft vibrations relative to the pump housing were measured using proximity probes mounted near the coupling (Figure 15).

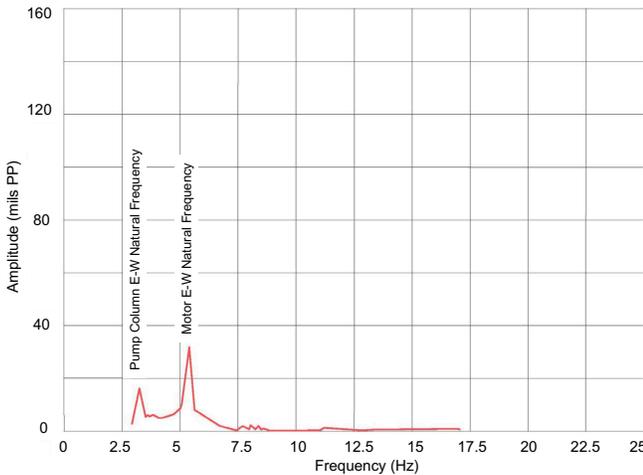
Figure 16. Vibration Responses of Pump Inlet in E-W Direction Due to Shaker (Sump Filled and All Braces Removed).

The mechanical natural frequencies were easily identified from the shaker test data. Typical plots of the vibrations at the pump inlet and the top of the motor are given in Figures 16 and 17. The measured natural frequencies were obtained during the tests with the sump filled with water and with all the braces removed. The directions refer to the flow direction out of the discharge pipe. The parallel direction is in the E-W direction, and the perpendicular direction is in the N-S direction. As shown in Table 2, the major responses had very high amplification factors.

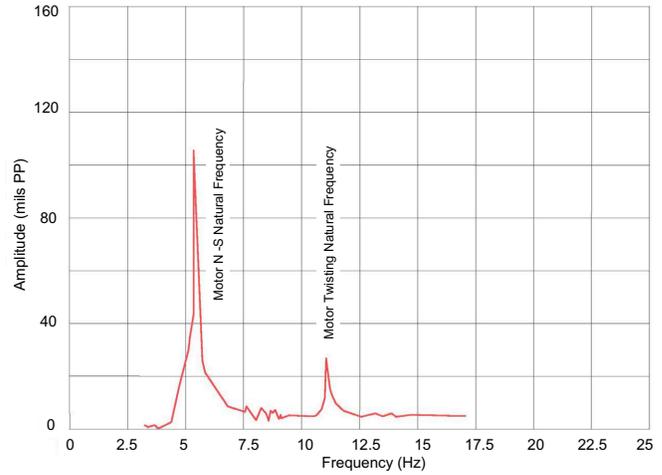
Figure 17. Vibration Responses of Top of Motor in N-S Direction Due to Shaker (Sump Filled and All Braces Removed).

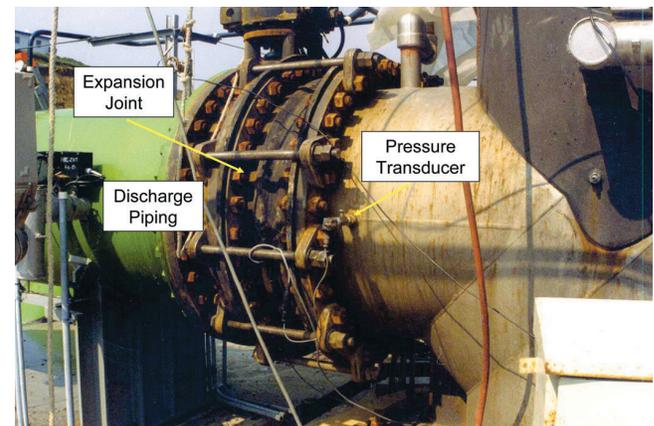
Figure 18. Pump Discharge Elbow Showing Expansion Joint and Pressure Transducer Location.

- *Pump discharge flange*—Test point in the pump discharge head just before the pump flange (Figure 18)

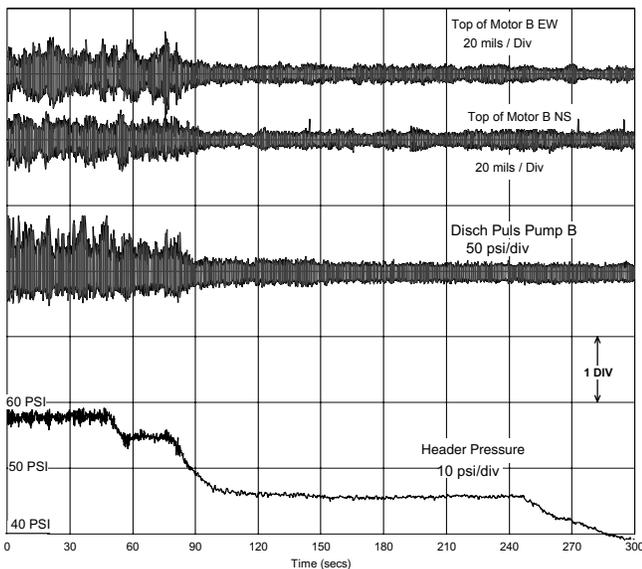
Figure 19. Vibration at Top of Motor and Discharge Pulsation During Throttling Test of Condenser Outlet Valves as Discharge Pressure was Reduced from 3.9 to 2.6 Bar (56.5 to 37.7 PSI).

Data obtained on pump B during throttling tests as the butterfly valve downstream of the condenser was slowly opened are shown in Figures 19 to 24. A sudden reduction in the vibration and discharge pulsation occurred as the discharge pressure was reduced below 47 psi (3.24 bar) (Figure 19).

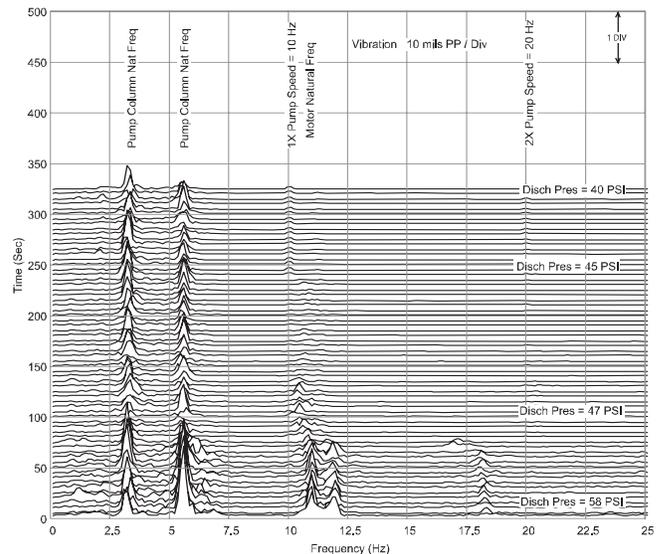
Figure 20. Frequency Spectra of Motor Vibration in N-S Direction During Throttling Test of Condenser Outlet Valves as Discharge Pressure was Reduced from 3.9 to 2.6 Bar (56.5 to 37.7 PSI).

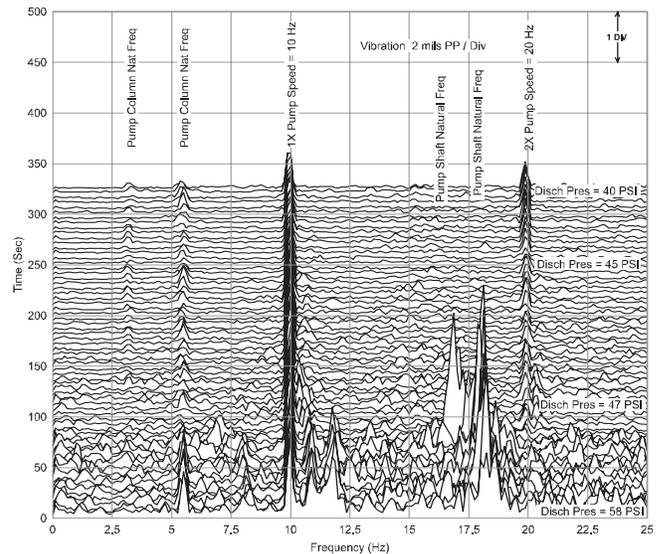
Figure 21. Pump Shaft Vibration Near Coupling During Throttling Test of Condenser Outlet Valves as Discharge Pressure was Reduced from 3.9 to 2.6 Bar (56.5 to 37.7 PSI).

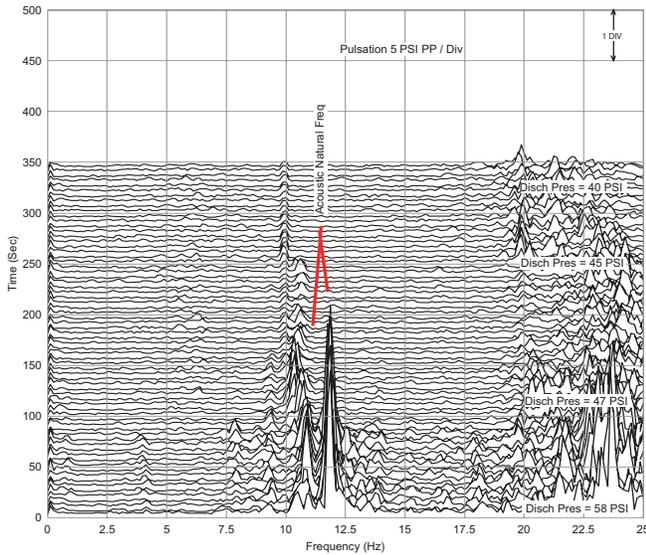
Figure 22. Pump Discharge Pulsation During Throttling Test of Condenser Outlet Valves as Discharge Pressure was Reduced from 3.9 to 2.6 Bar (56.5 to 37.7 PSI).

Pulsation near 11 to 12 Hz (Figure 22) was due to excitation of one of the acoustic natural frequencies of the pump/piping system. Pulsations at this acoustic natural frequency were measured at the pump discharge, in the standpipe, and at the condenser, and were consistent with the acoustical mode shapes predicted for this system. Additionally, pulsation at the condenser at 11 Hz (Figure 23) appeared to excite the mechanical natural frequency of the condenser (Figure 24).

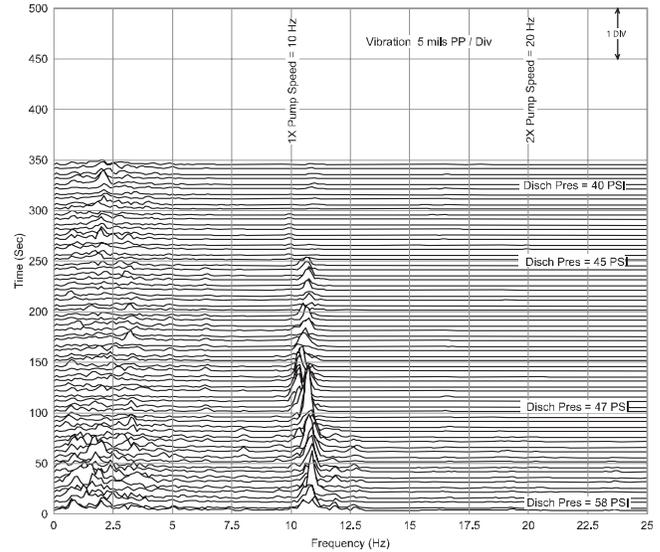
Figure 24. Vibration at Condenser During Throttling Test of Condenser Outlet Valves as Discharge Pressure was Reduced from 3.9 to 2.6 Bar (56.5 to 37.7 PSI).

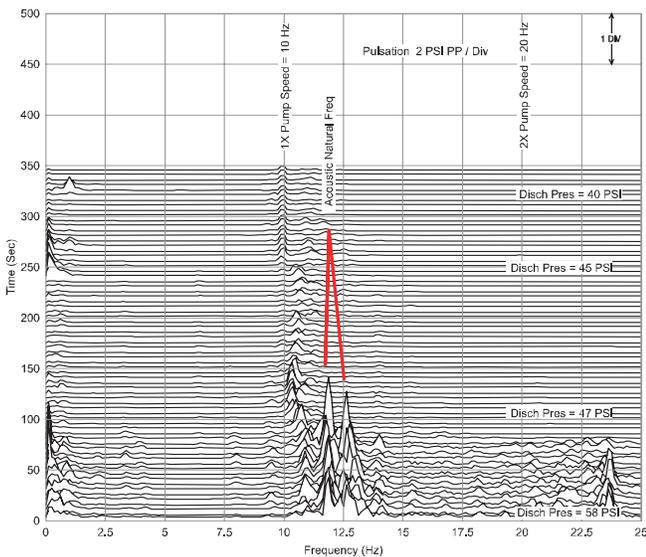
Figure 23. Pulsation at Condenser During Throttling Test of Condenser Outlet Valves as Discharge Pressure was Reduced from 3.9 to 2.6 Bar (56.5 to 37.7 PSI).

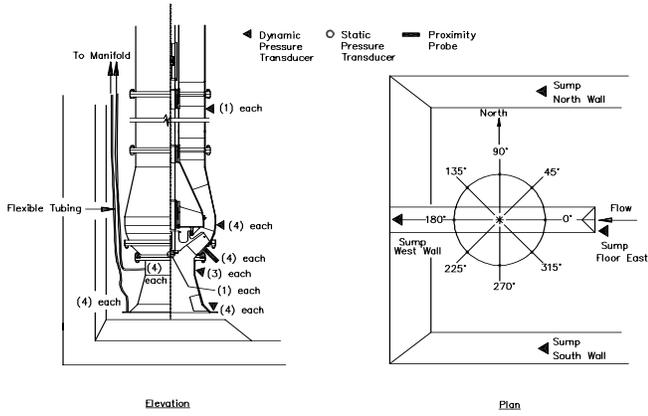
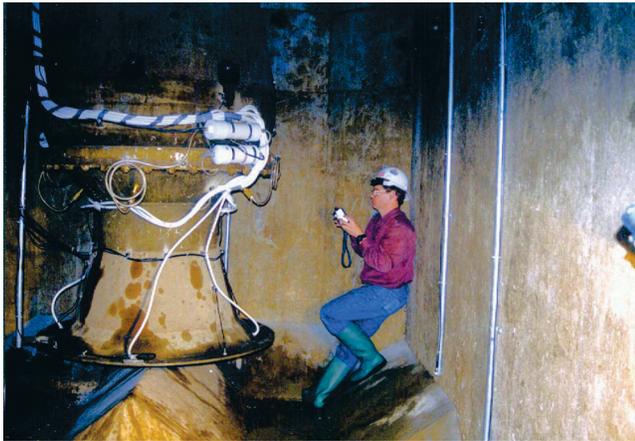
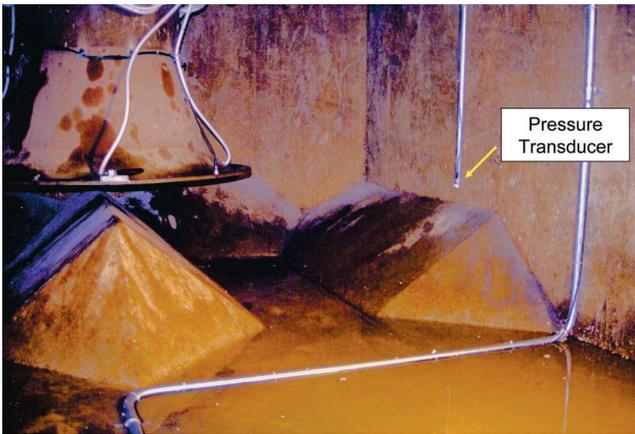
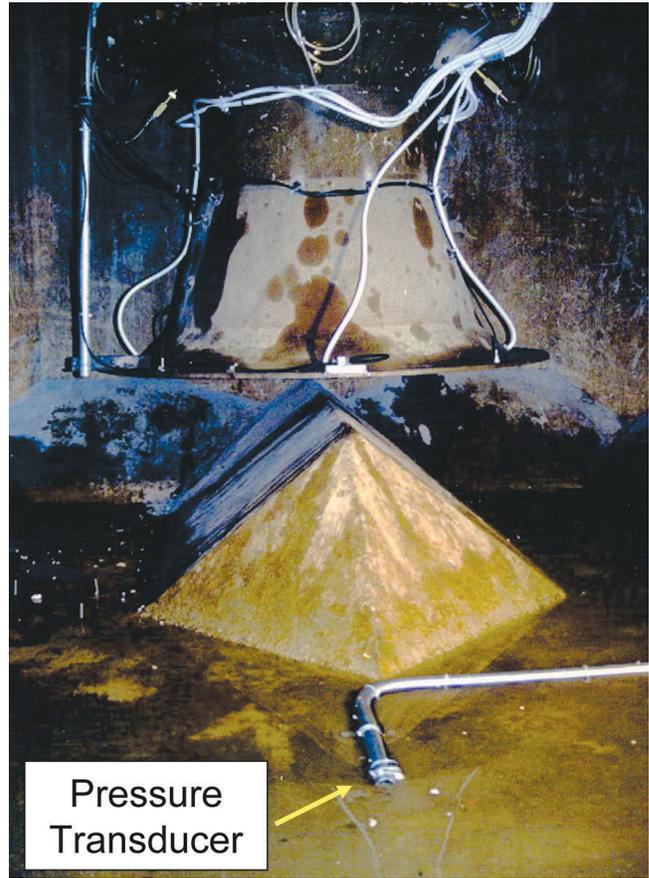
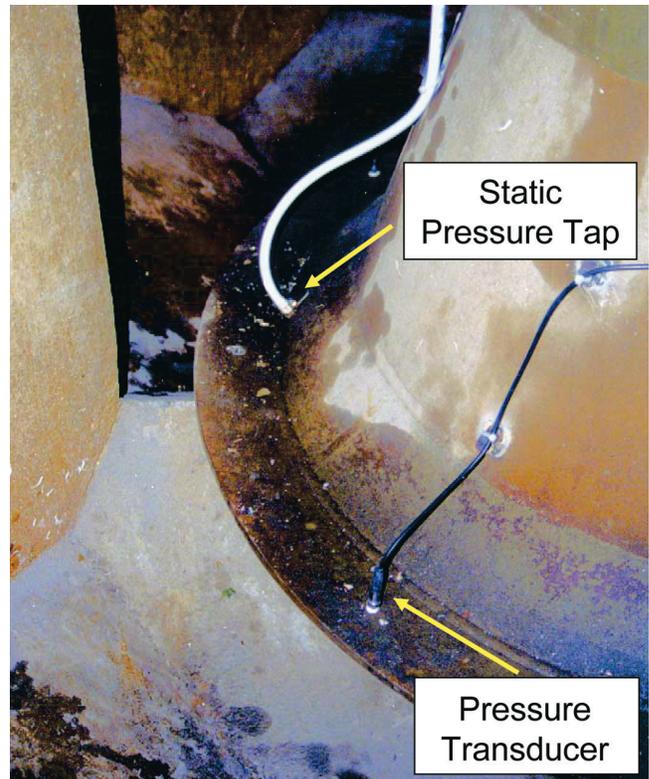
Figure 25. Sketch Showing Locations of Instrumentation on Pump Housing and in the Sump During Second Test.

Figure 26. Instrumentation on Pump Housing and in the Sump During Second Test.

Figure 27. Instrumentation on Pump Inlet and North Sump Wall.

Figure 28. Instrumentation on Pump Inlet and Floor of Sump.

Figure 29. Static Pressure Taps and Dynamic Pressure Transducers on Pump Inlet Bell Housing.

As shown in Figures 25 to 29, flexible tubing was installed at four locations on the inlet bell and at four similar locations 1 inch below the impeller. The tubing was connected to a manifold where the static pressure in each tube could be read using a static pressure transducer installed at the end of the manifold (Figure 30).

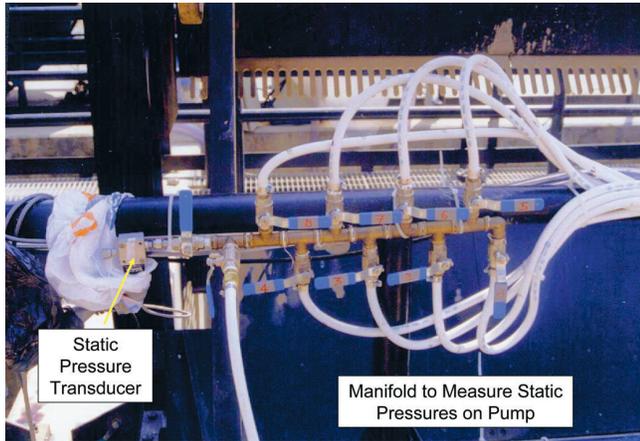
Figure 30. Manifold to Measure Static Pressures on Pump.

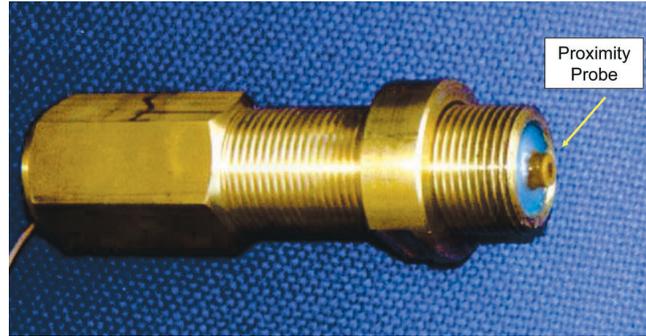
Figure 31. Proximity Probe Installed in Special Probe Holder.

Due to the test schedule, there was not sufficient time to obtain waterproof proximity probes before the tests. Therefore, normal proximity probes were waterproofed by coating the probe tip with epoxy. The probes were installed in special probe holders (Figure 31), which were threaded into the sides of the pump housing (Figure 32). The proximity probes were installed in watertight housings, which were attached to the pump housing (Figure 26).

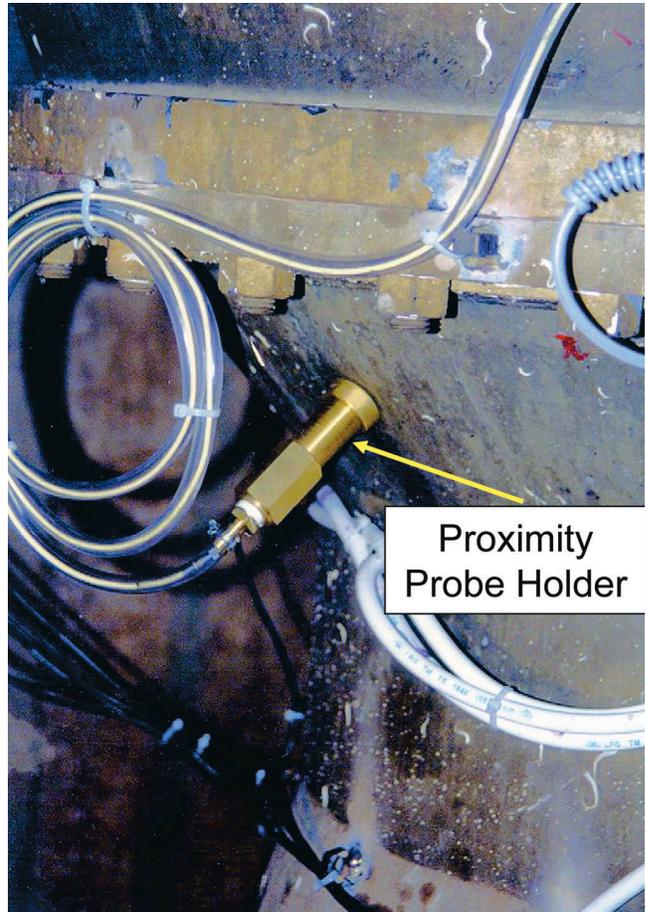
Figure 32. Proximity Probe Installed to Measure Radial Vibration of Impeller Vanes.

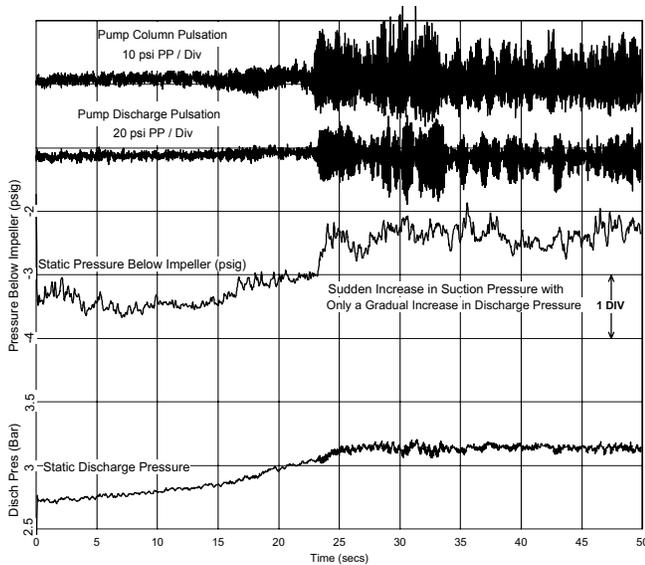
Figure 33. Pulsation and Static Pressures During Throttling Test of Condenser Outlet Valves as Discharge Pressure was Increased from 2.9 to 3.3 Bar (42.1 to 47.9 PSI).

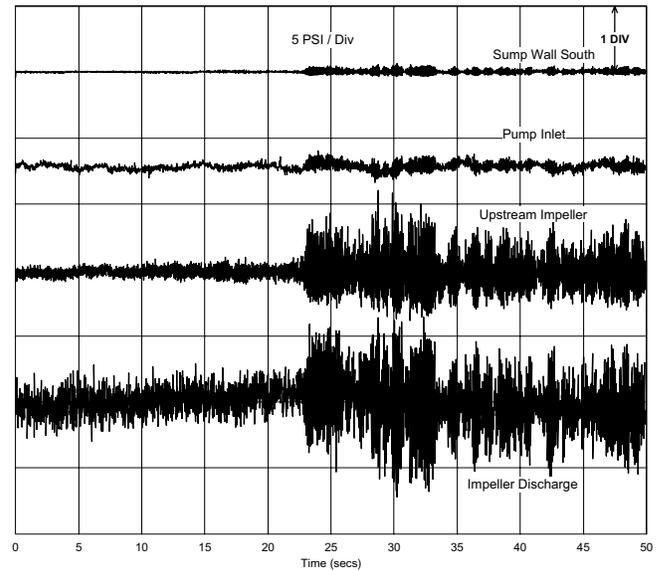
Figure 34. Pulsation at Sump Wall, Pump Inlet, Upstream of Impeller, and Downstream of Impeller at 315 Degrees During Throttling Test of Condenser Outlet Valves as Discharge Pressure was Increased from 2.9 to 3.3 Bar (42.1 to 47.9 PSI).

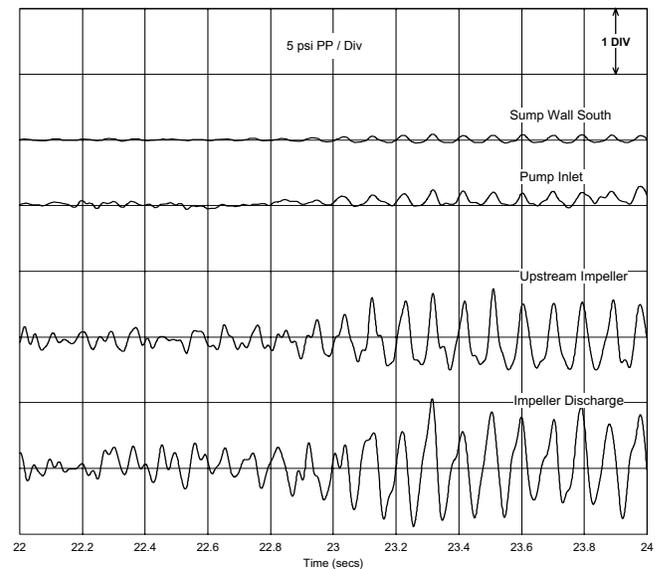
Figure 35. Zoom View of Figure 34 at Start of Recirculation Condition.

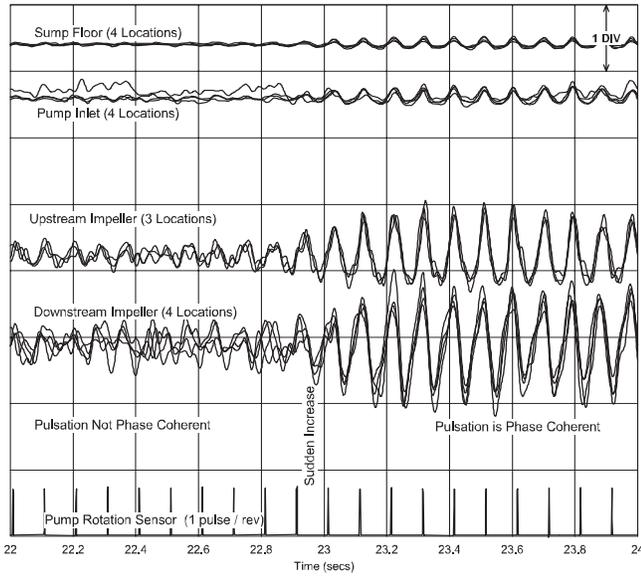
Figure 36. Zoom View of Pulsation at Sump Wall, Pump Inlet, Upstream of Impeller, and Downstream of Impeller at All Locations, and Tach Signal During Throttling Test of Condenser Outlet Valves as Discharge Pressure was Increased from 2.9 to 3.3 Bar (42.1 to 47.9 PSI).

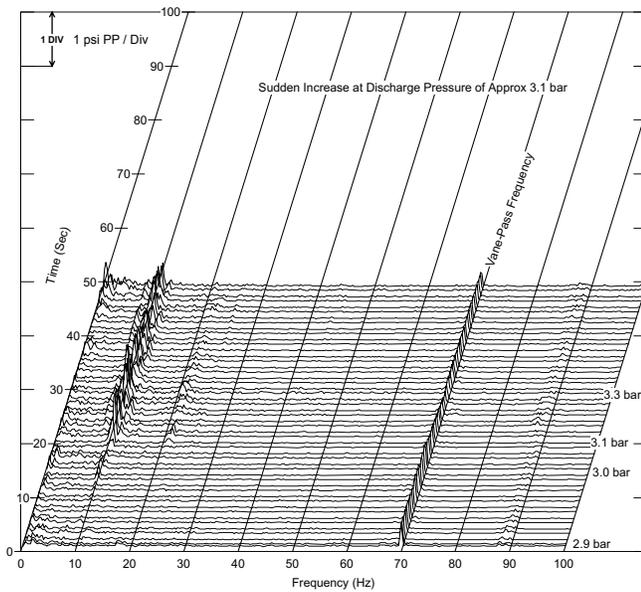
Figure 37. Frequency Spectra of Pulsation at Sump West Wall During Throttling Test of Condenser Outlet Valves as Discharge Pressure was Increased from 2.9 to 3.3 Bar (42.1 to 47.9 PSI).

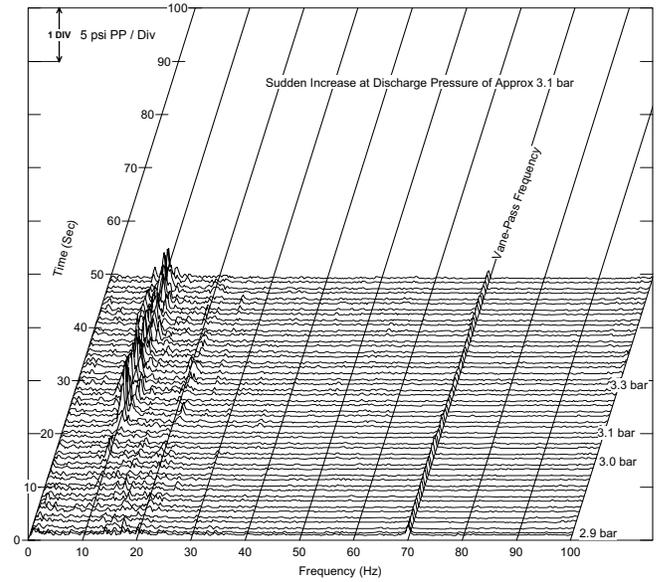
Figure 38. Frequency Spectra of Pulsation at Pump Inlet (135 Degrees) During Throttling Test of Condenser Outlet Valves as Discharge Pressure was Increased from 2.9 to 3.3 Bar (42.1 to 47.9 PSI).

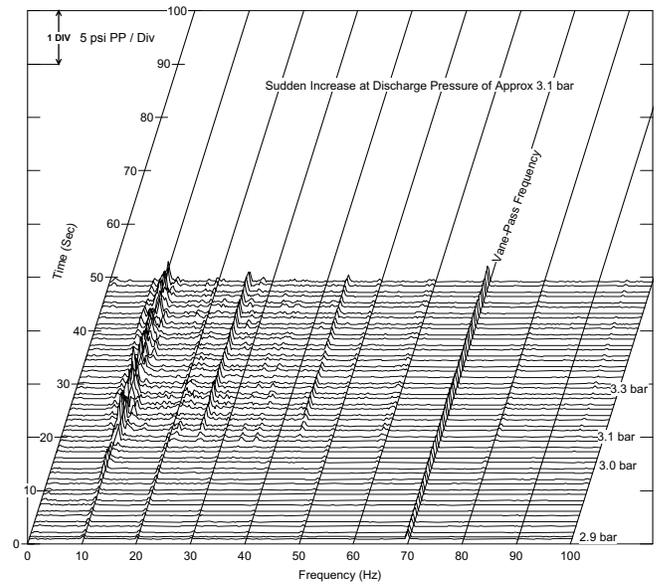
Figure 39. Frequency Spectra of Pulsation Upstream of Pump Impeller (135 Degrees) During Throttling Test of Condenser Outlet Valves as Discharge Pressure was Increased from 2.9 to 3.3 Bar (42.1 to 47.9 PSI).

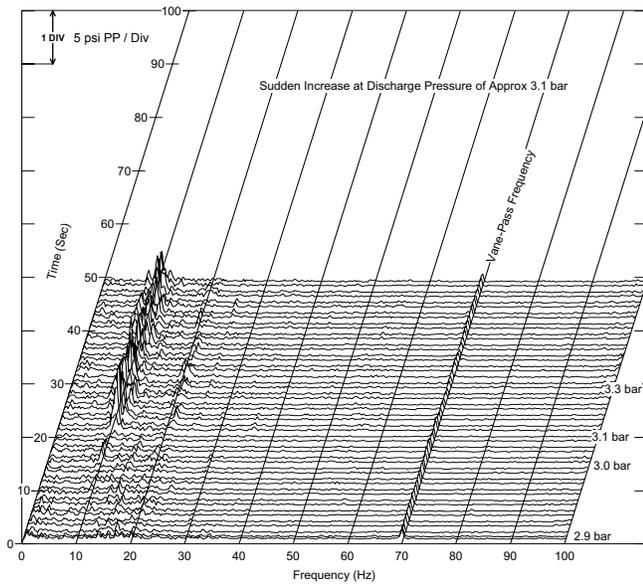
Figure 40. Frequency Spectra of Pulsation Downstream of Pump Impeller (135 Degrees) During Throttling Test of Condenser Outlet Valves as Discharge Pressure was Increased from 2.9 to 3.3 Bar (42.1 to 47.9 PSI).

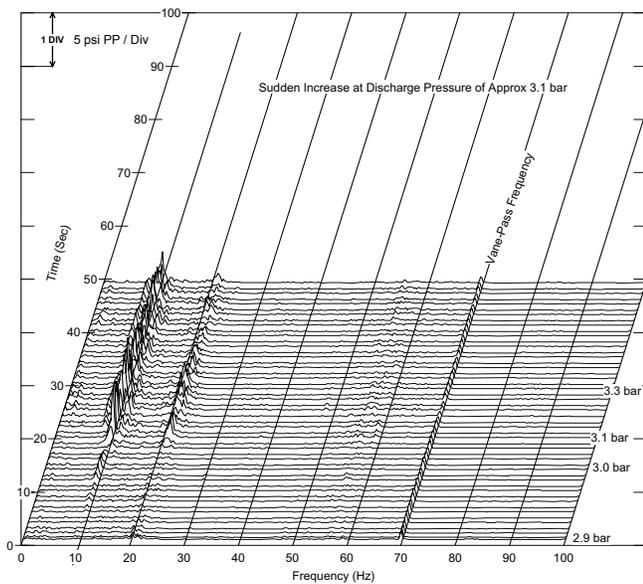
Figure 41. Frequency Spectra of Pulsation in Pump Column During Throttling Test of Condenser Outlet Valves as Discharge Pressure was Increased from 2.9 to 3.3 Bar (42.1 to 47.9 PSI).

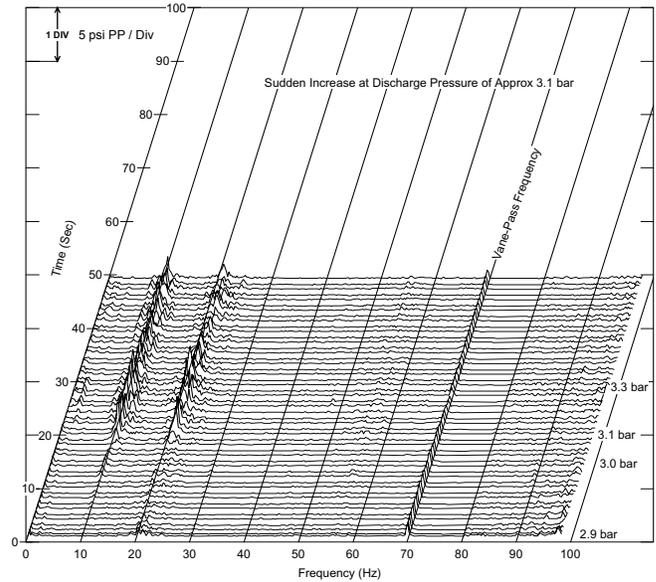
Figure 42. Frequency Spectra of Pulsation at Pump Discharge During Throttling Test of Condenser Outlet Valves as Discharge Pressure was Increased from 2.9 to 3.3 Bar (42.1 to 47.9 PSI).

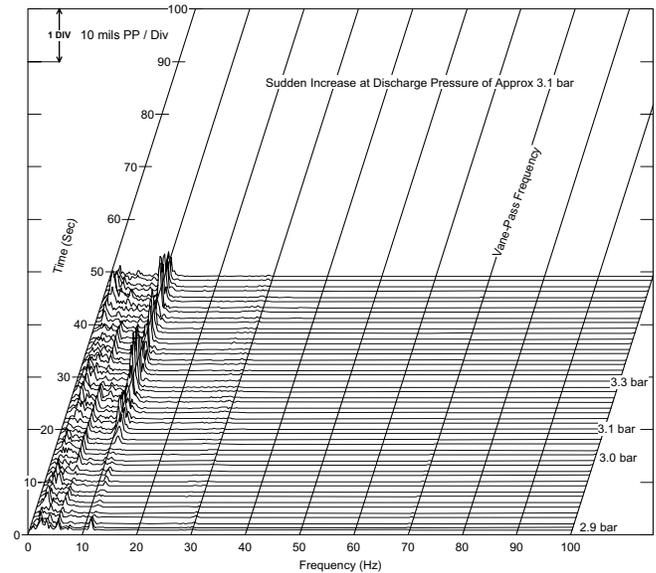
Figure 43. Frequency Spectra of Motor Vibration (N-S Direction) During Throttling Test of Condenser Outlet Valves as Discharge Pressure was Increased from 2.9 to 3.3 Bar (42.1 to 47.9 PSI).

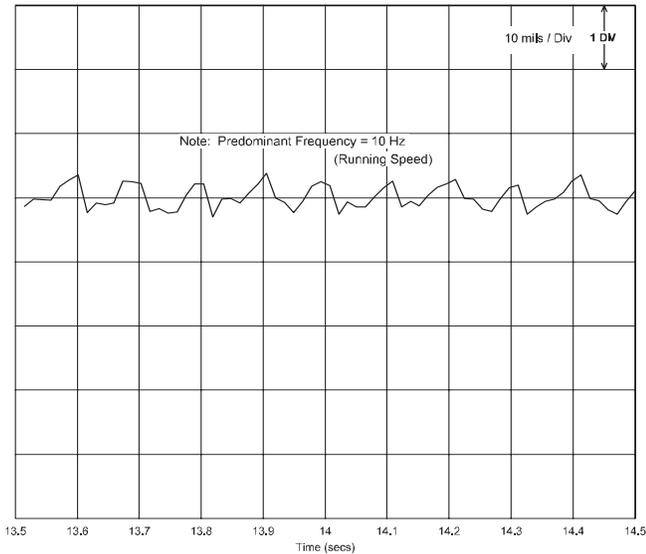
Figure 44. Pump Impeller Vane Vibration During Throttling Test of Condenser Outlet Valves as Discharge Pressure was Increased to 3.0 Bar (43.5 PSI).

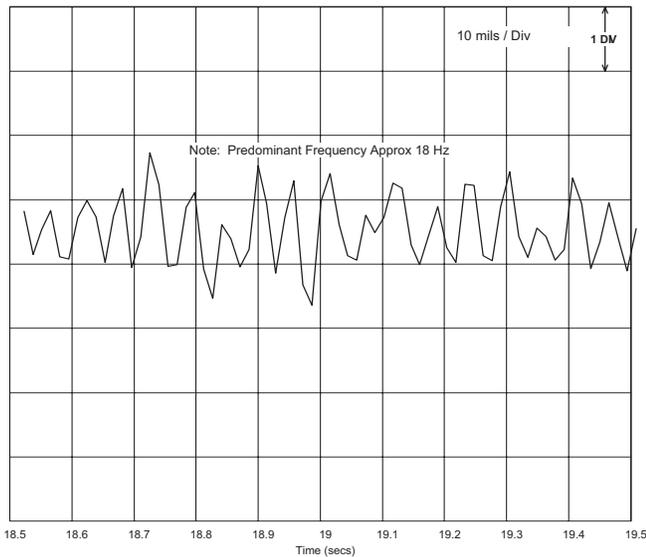
Figure 45. Pump Impeller Vane Vibration During Throttling Test of Condenser Outlet Valves as Discharge Pressure was Increased to 3.3 Bar (47.9 PSI).

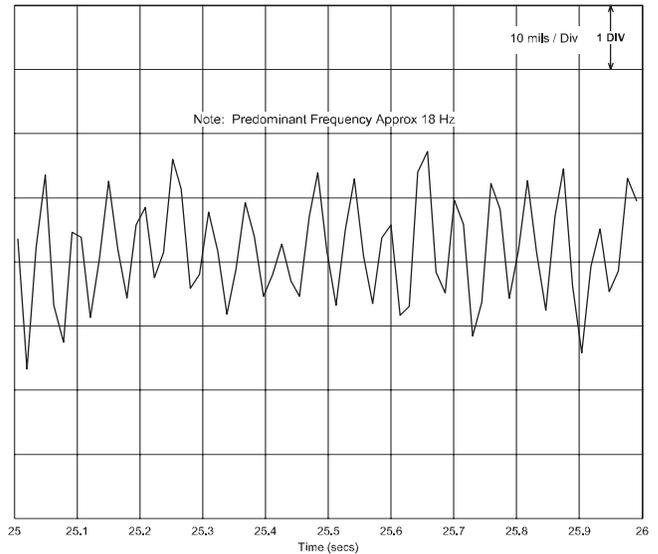
Figure 46. Pump Impeller Vane Vibration During Throttling Test of Condenser Outlet Valves as Discharge Pressure was Increased to 3.8 Bar (55.1 PSI).

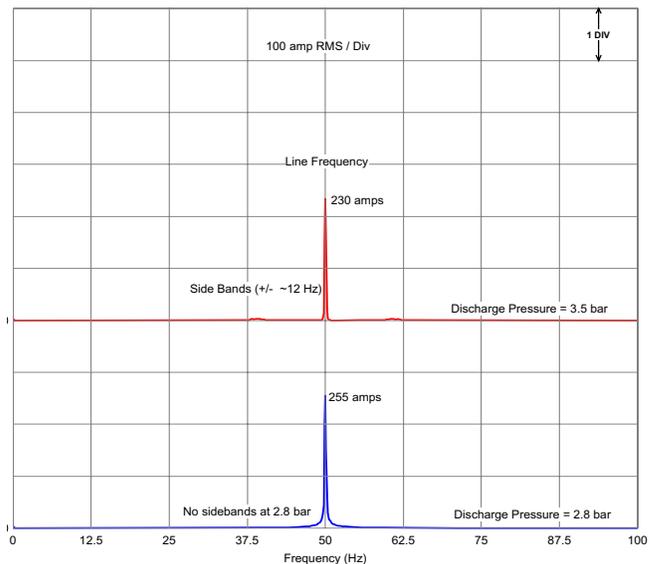
Figure 47. Frequency Spectra of Motor Current During Throttling Test of Condenser Outlet Valves as Discharge Pressure was Increased from 2.8 to 3.5 Bar (40.6 to 50.8 PSI).

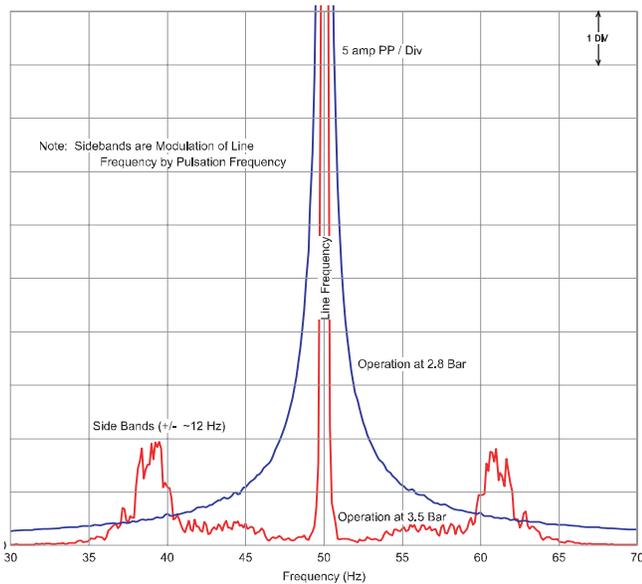
Figure 48. Zoom View of Figure 47.

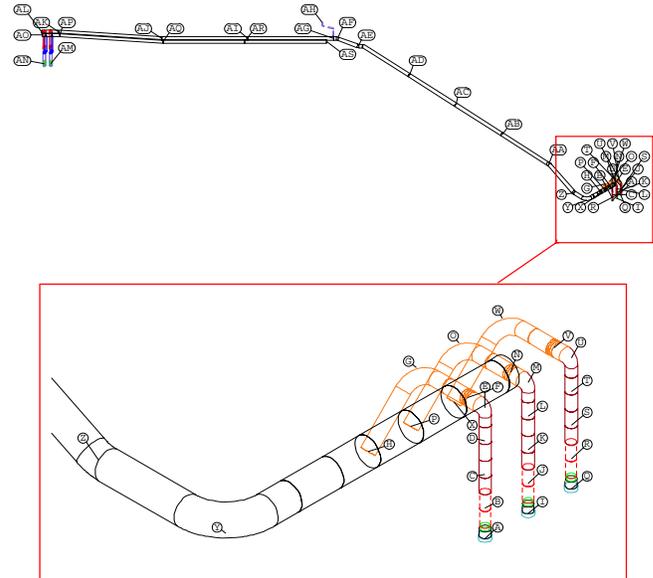
Figure 49. Geometry Plot of Acoustic Model of Cooling Water Pump System.

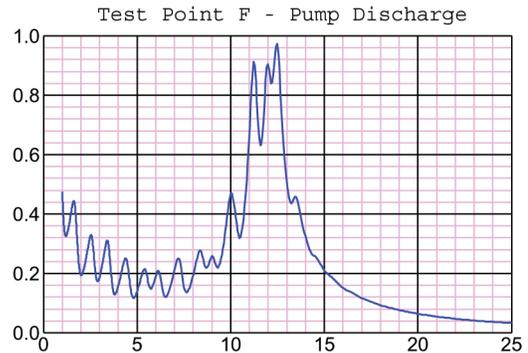
Figure 50. Computed Pulsation at Pump Discharge with Excitation at Impeller of Pump A.

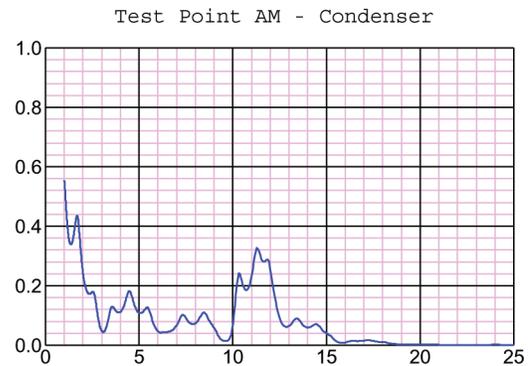
Figure 51. Computed Pulsation at Condenser with Excitation at Impeller of Pump A.

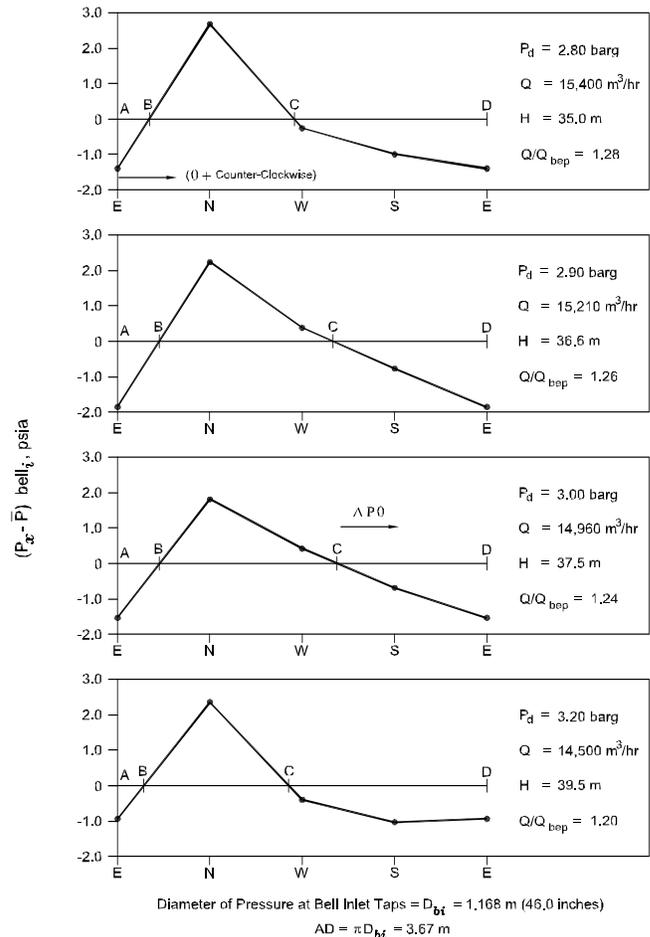
Figure 52. Local Static Pressure Variation at Suction Bell Lip (PSIA).
