ABNORMAL VERTICAL PUMP SUCTION RECIRCULATION PROBLEMS DUE TO PUMP-SYSTEM INTERACTION

Bruno Schiavello

Donald R. Smith

Stephen M. Price

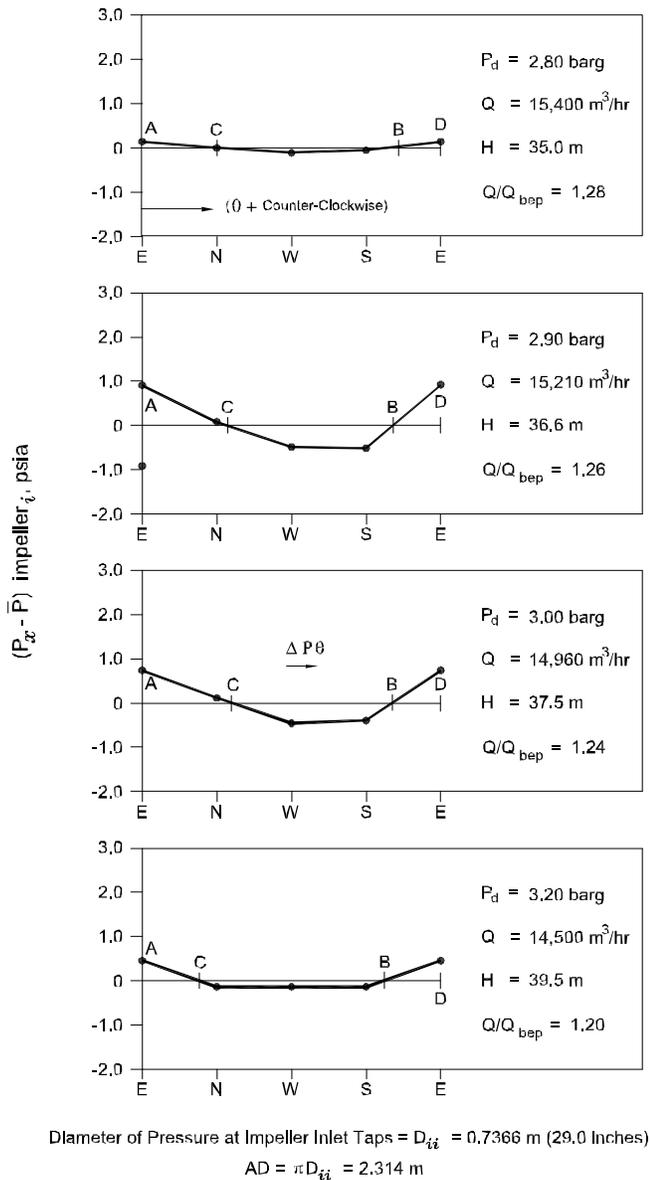
Figure 53. Local Static Pressure Variation at Impeller Inlet (PSIA).

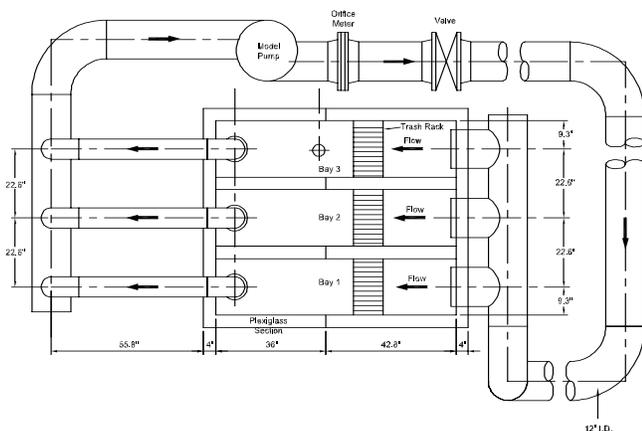
Figure 54. Scaled Model of Circulating-Water Pump Structure, Plan View.

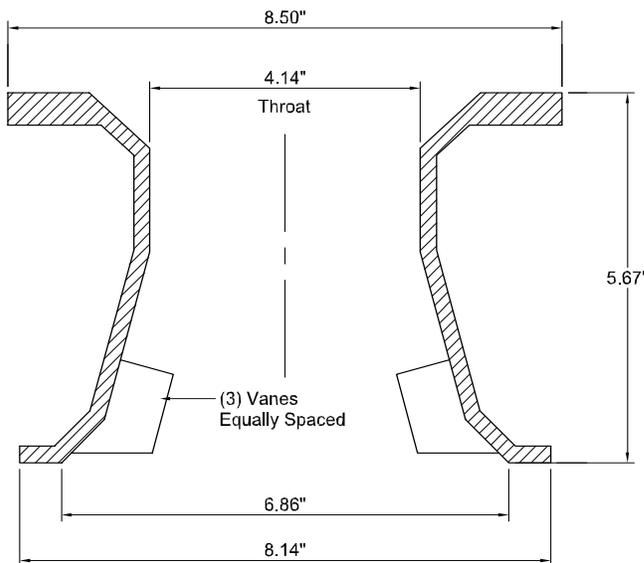
Figure 55. Sketch of Modeled Pump Suction Inlet Bell.

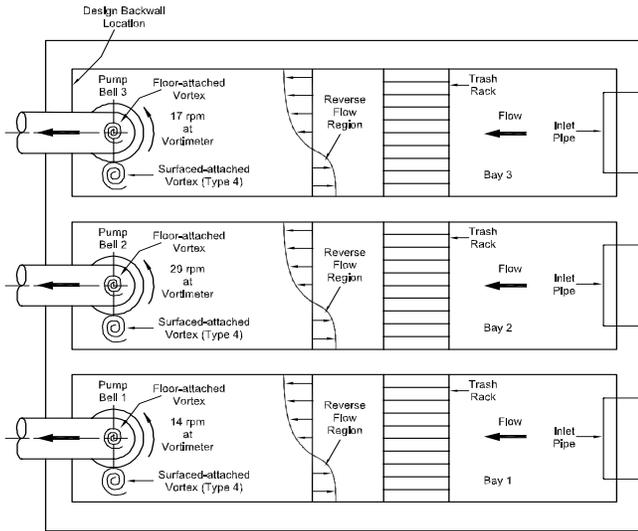
Figure 56. Flow Features in the Original Sump Design.

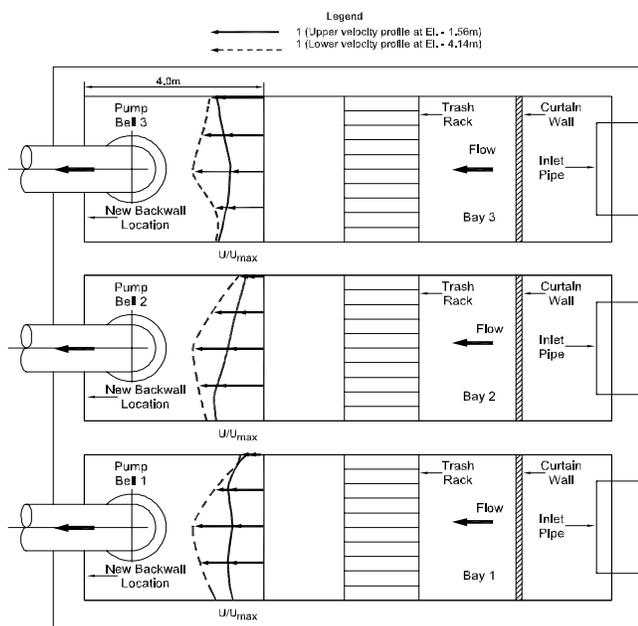
Figure 58. Velocity Distribution for the Approaching Flow in the Modified Sump Design.

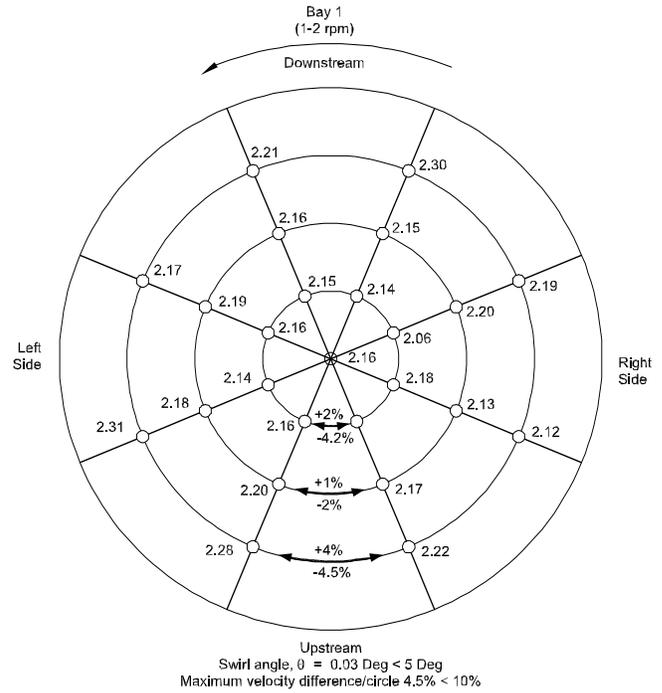
Figure 59. Velocity Distribution at the Throat of the Pump Column in Bay 1 for the Modified Design.

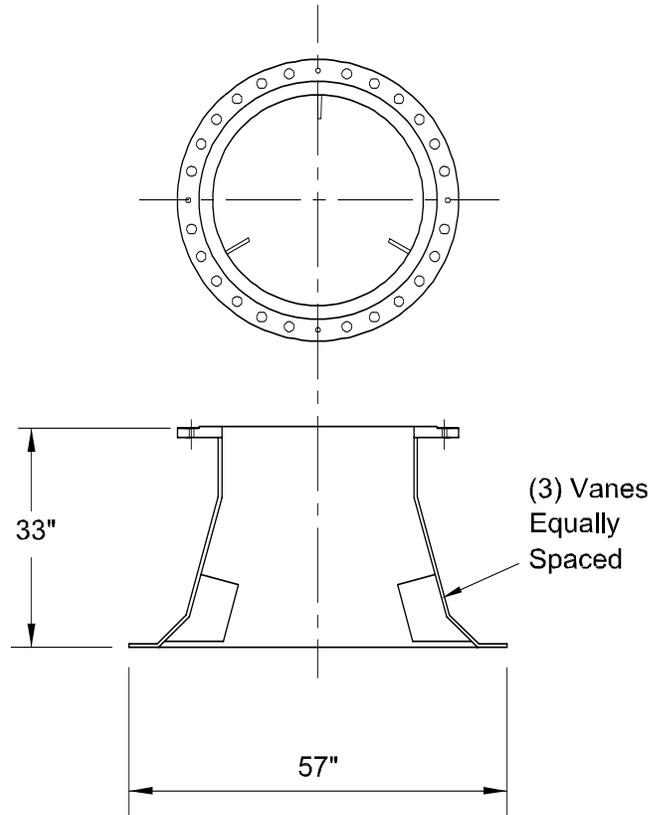
Figure 60. Sketch of Original Suction Inlet Bell.

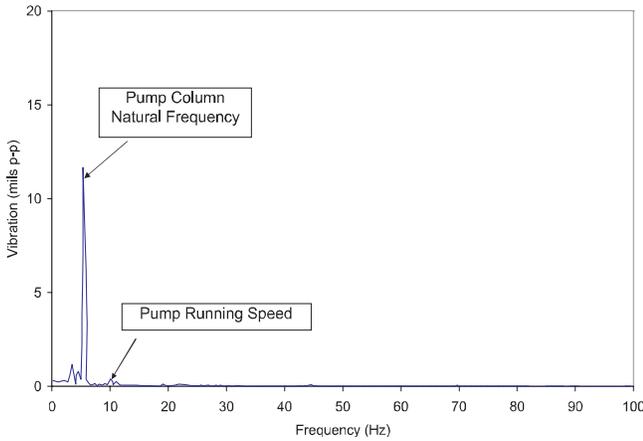
Figure 62. Frequency Spectra of Motor Vibration in N-S Direction (Follow-Up Data Obtained Four Years after Modified Suction Inlet Bell Was Installed).

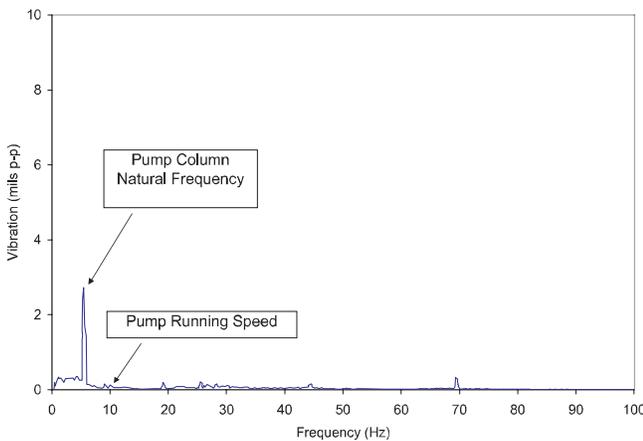
Figure 63. Frequency Spectra of Motor Vibration in E-W Direction (Follow-Up Data Obtained Four Years after Modified Suction Inlet Bell Was Installed).

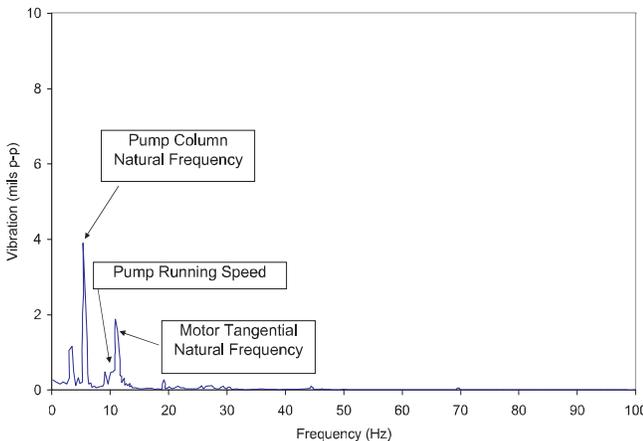
Figure 64. Frequency Spectra of Motor Vibration in Tangential Direction (Follow-Up Data Obtained Four Years after Modified Suction Inlet Bell Was Installed).
