GROUTING OF SMALL PUMP BASEPLATES? IS IT WORTH IT?

Roger L. Jones

Shell Global Solutions (US) Ltd.

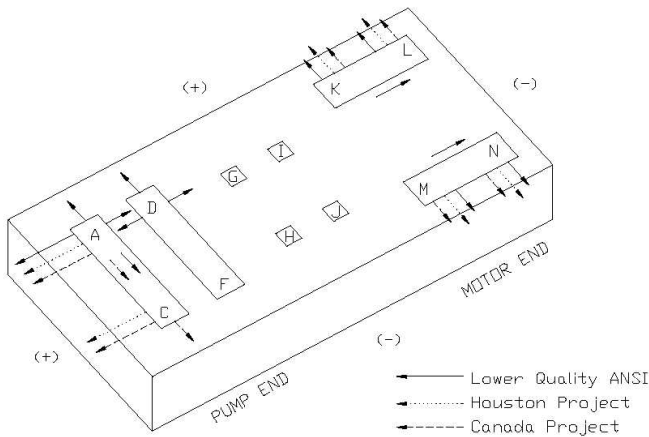
Figure 1. Pattern of Level Measurements. (Arrows point to high side.)

The baseplate distortion varied in amount but invariably followed the same pattern. The center of the baseplate "sank" causing all the mounting surfaces to be out of level with the mounting surface edge closest to the nearest side of the baseplate to be high. This pattern is represented in Figures 1 and 2. Field machining was felt to be necessary because typical values of level after cure for the ASME pumps were .010 to 0.012 inch/ft both axially and transversely. This condition is essentially impossible to shim out because the shims must taper in two directions to correct the condition. The baseplate distortion issue was further complicated by National Electrical Manufacturers Association (NEMA) frame motors failing soft foot tests.

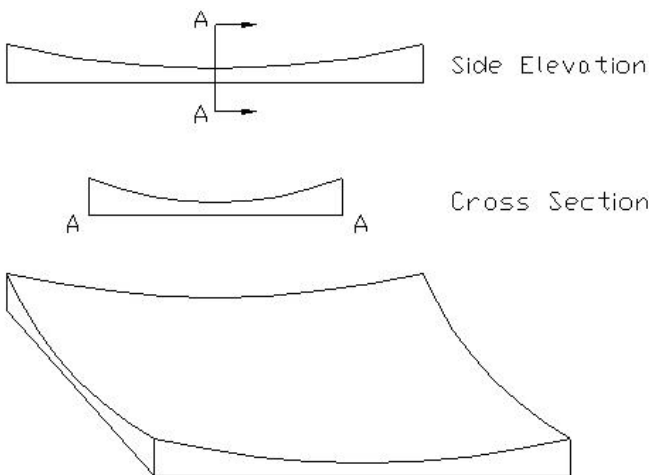
Figure 2. Typical Pattern of Baseplate Distortion.

grout under this type of baseplate. The ASTM data given by grout manufacturers investigated was factual and correct. Figure 2 was developed from the actual tests completed.

The tests conducted to investigate shrinkage showed that the center of the baseplate sank straight down. This caused the machined surfaces, which were stiffer, to slope upward toward the edges of the baseplate. This pattern of distortion suggested that placing a stiffening member across the baseplate under the motor pads where the majority of the deflection was found and an additional member under the pump might solve the problem. Twelve modified baseplates were manufactured in time to be used on the Houston project. Ten of the 12 stayed with tolerance and two were marginally out of tolerance after the grout cured. Clearly there are very large forces at work here. Also note that these baseplates were primed with inorganic zinc silicate. Prior to grouting, the baseplate was wiped down with solvent until there was no visible contamination. If the authors ever had any concern about bond strength with a properly applied primer, they thought they had it no longer.

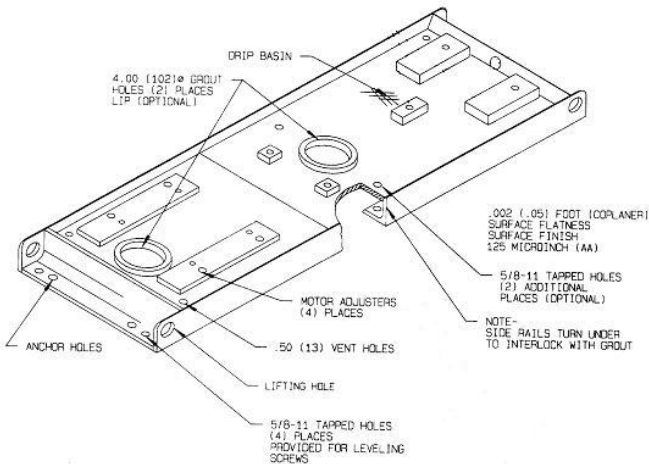
Figure 3. PIP Type Baseplate.

The ASME baseplates in question comply with PIP RESP002. The most numerous of the pumps used the design shown in Figure 3. This baseplate had been on the market with no changes in design for seven years. The manufacturer had very few complaints and had no plans to improve it. The two projects the authors have referred to were the first to report significant numbers of problems with the baseplate. Subsequently several other major projects detected the same distortion.

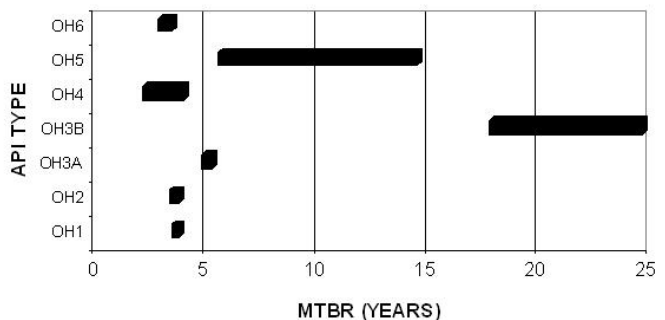
In Figure 4, the length of the bar is reflective of the 95 percent confidence limits given the size of the sample. OH1 through OH6 are the API pump types identified in API 610 (1995) (ISO 13709). The longer bars indicate smaller sample sizes. The results of this analysis were initially somewhat surprising to the authors. However, discussion of their surprise is outside the scope of this paper. Suffice to say, their data say that single-stage overhung vertical inline pumps are at least as reliable as SSOH horizontal pumps.

Figure 4. Single-Stage Overhung Pump Reliability in U.S. Chemical Plants.

In order to consider wider application of vertical pumps (including close coupled units) the authors investigated relative reliability within their chemical plant sites. The authors were completely appalled to find that they had (in violation of their selection guidelines) purchased significant numbers of OH4 and OH5 pumps. OH4 pumps are rigidly coupled vertical inlines and OH5 pumps are close coupled vertical inlines. The reliability of all single-stage overhung pumps installed in chemical facilities from 1991 to 2001 is shown in Figure 4.

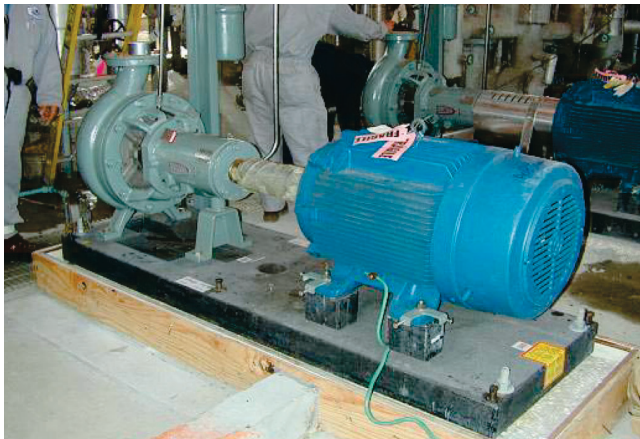
Figure 5. Polymer Concrete Baseplate During Installation.

Polymer concrete baseplates eliminate equipment removal, primer, grout distortion, and void concerns. In addition, the polymer concrete baseplates are corrosion resistant and have a lower installation cost than traditionally grouted baseplates (Figure 5).

Installation cost is lower because the baseplate itself is less expensive than a comparable metal baseplate, less grout is required (only a seal pour between the baseplate and the foundation), and the leveling and installation process is faster. Refer to estimates later in this paper.

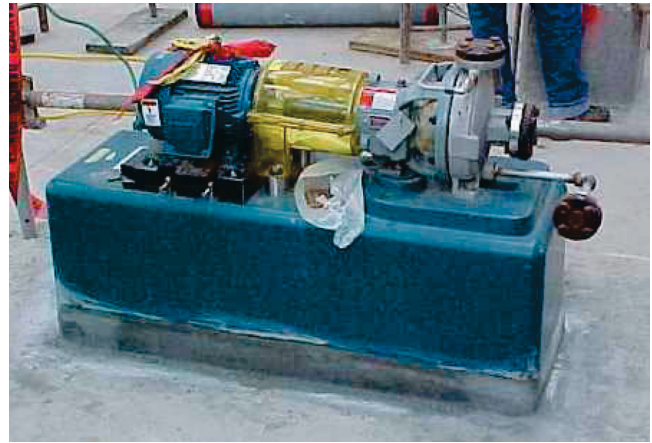
Figure 6. Polymer Concrete Foundation During Installation.

Polymer concrete foundation systems combine a baseplate with a foundation in a hollow shell configuration. These systems are installed by placing the shell over a rebar cage and filling the shell with concrete or cementitious grout (Figure 6).

These baseplates have been available for quite a long time but have been marketed for their corrosion resistance. However in addition to having all the benefits described above for a polymer concrete baseplate, the installation costs of a polymer concrete foundation system are lowered even further by eliminating the time and cost of constructing a separate concrete foundation.

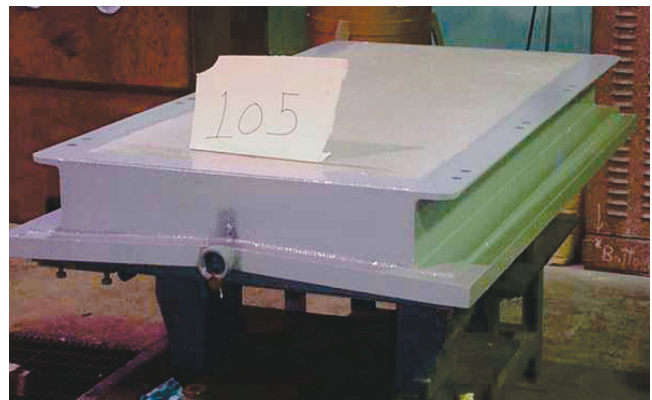
Figure 7. Pregouted Baseplate Bottom.

The pregouted baseplate has been gaining popularity in recent years. This type of baseplate system is produced by turning a conventional metallic baseplate upside down and filling the cavity with epoxy grout while still at the manufacturer (Figure 7). This strategy saves cost in the fabrication of the baseplate because grout placement holes, vent holes, and other features are not required.

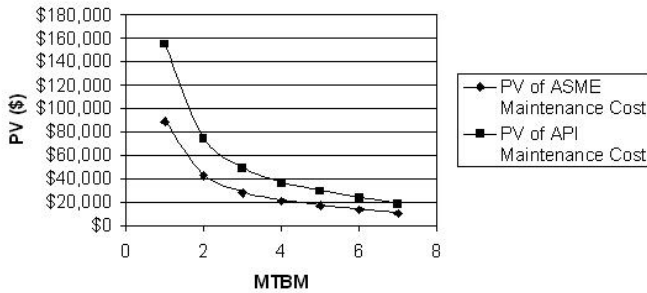
Figure 8 Present Values of Pump Maintenance Costs.

Figure 8 shows the present value of pump maintenance costs for an ASME and an API pump. If one assumes that one has a one year MTBM and increase it to two years, the MTBM changes by a present value of \$46,000. If one allows present value to be the investment criterion, this is the investment justified to obtain this improvement. On the other hand if the investment must compete for capital with the kind of criteria most companies use today it is more likely one must be in the neighborhood of a three year simple payout. Both techniques have been used to generate Figure 9.

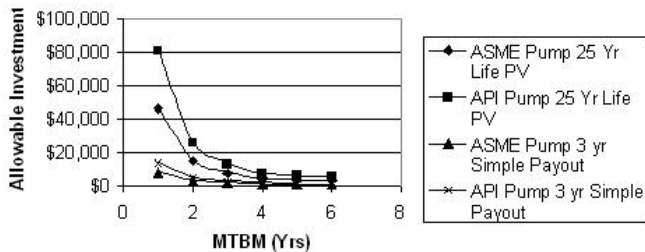
Figure 9. Investment Justified to Obtain One Year Improvement in MTBM.

It appears that if a plant has less than about a three year MTBM and if all of the one year improvement can be attributed to the traditional approach to pump installation and if the investment criterion is present value for a 25 year life maybe one can justify applying conventional baseplates grouted in with epoxy. If one uses an investment criterion of a simple three year payout, then the least expensive method will be used that the authors think will work.
