BONE-DRY RUNNING TESTS UTILIZING DIAMOND LIKE CARBON COATED SILICON CARBIDE BEARINGS AND POLYMER LUBRICATING STRIPS IN AN ANSI MAGNETIC DRIVE PUMP

Anthony E. Stavale

ITT A-C Pump Company

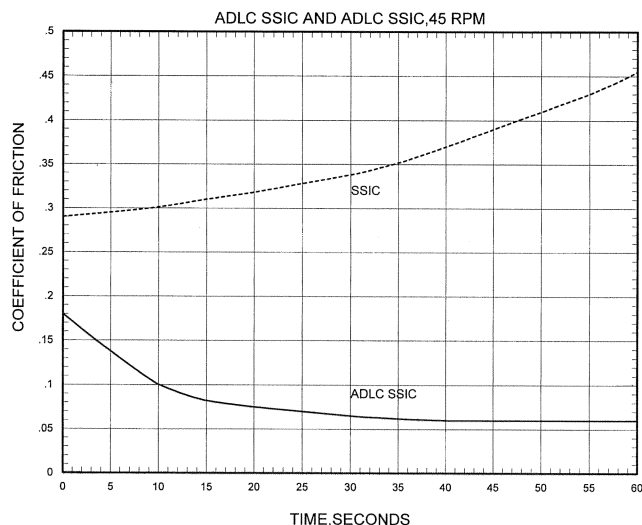
As shown in Figure 1, the dry friction coefficient of this coating is as low as 0.05 (ADLC vs ADLC) compared to 0.5 and higher for sintered silicon carbide. The friction coefficient under normal lubricated operation is typically less than 0.01.

Figure 1. Dry Coefficient of Friction Vs Time.

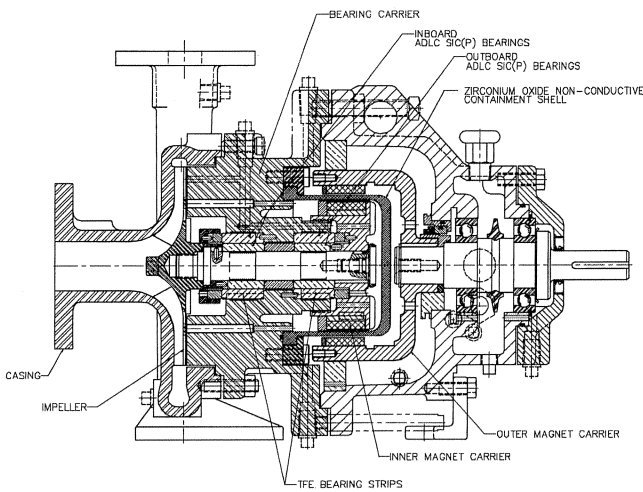
The test pump was a $1.5 \times 1 \times 6$ horizontal end suction ANSI magnetic drive pump fitted with a nonconductive containment shell as shown in Figure 2. The magnet drive was rated for 7.5 hp at 3600 rpm and was built using standard production parts. The threaded-on impeller was fastened with adhesive, as a precaution, to prevent possible loosening under dry running operation. The impeller front clearance was increased, for test purposes, to allow for any unexpected thermal growth of the shaft. The pump was coupled to a five hp 3600 rpm motor. Type J thermocouple wires were fitted to the OD of the stationary inboard and outboard bearings at approximately the midpoint of the bearing, since it was impractical to monitor temperature at the interface of the rotating and stationary bearings. Prior to testing, the thermocouple wires were calibrated for accuracy. During testing, ambient, inboard, and outboard bearing temperatures were recorded on a data acquisition system as a function of time. Observations were noted for any unusual noise, excessive vibration, or burning odors. Upon shutdown, the outer shaft was observed for a smooth, gradual coastdown.

Figure 2. Test Model 1.5 x 1 x 6 ANSI Magnetic Drive Pump—7.5 HP/3600 RPM.

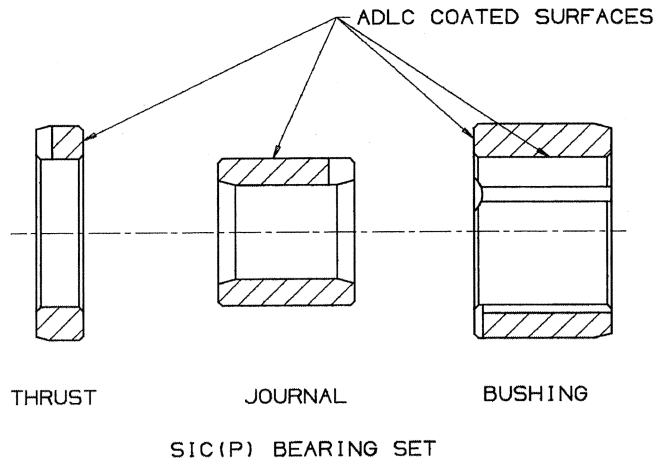
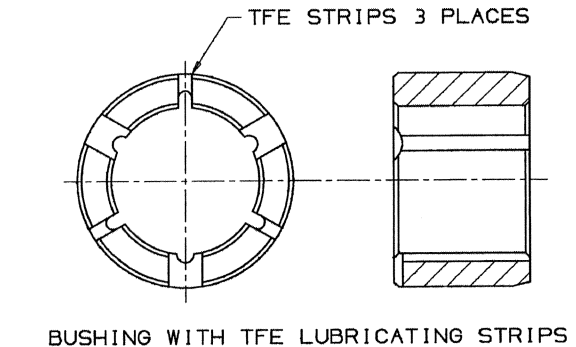
The ADLC coated surfaces are shown in Figure 3 for the stationary bushing, rotating journals, and thrust bearings. The bearing substrate material was controlled porosity sintered silicon carbide. The three grooves shown in the stationary bushing were

filled with Teflon® strips in Tests 5 and 10, and omitted in all other tests. The Teflon® strips are L-shaped in order to provide dry lubricant to both radial and thrust faces of the silicon carbide bearings. As heat is generated at the rotating and stationary bearing interface during dry running, these polymer strips expand outward due to their greater thermal expansion coefficient and wipe both the radial and thrust surfaces of the bearing. Once normal pumping is established, and excessive heat is no longer generated, the strips would retreat back into their grooves and remain inactive.

Figure 3. Bearing Test Configurations.

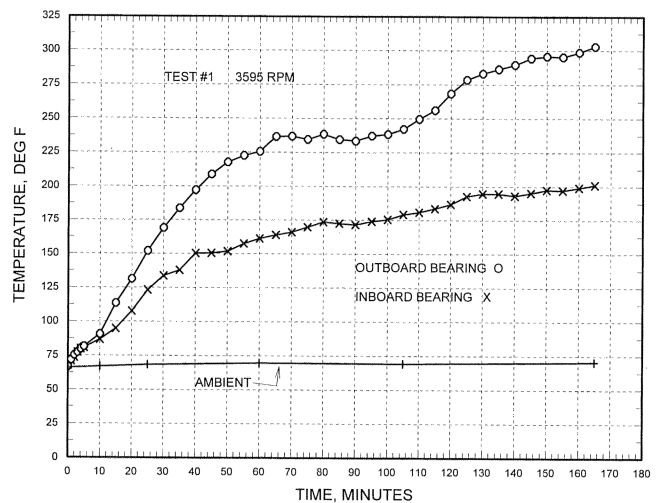
A time vs temperature plot of inboard and outboard bearing temperatures for Test Configuration 1, which consisted of ADLC SiC(P) rotating and stationary bearings, is shown in Figure 4. This arrangement successfully ran bone-dry for 161 min prior to reaching the 300°F temperature limit previously set for terminating the test. During the test, it was observed that the pump ran quietly and smoothly and there were no burning odors emanating from the pump. Upon shutdown, the coastdown of the outer shaft was smooth. A slight squeak was heard when rotating the shaft by hand; however, the noise disappeared after a few minutes of cooling. After dismantling the unit for inspection, light to moderate scoring was observed between the stationary and rotating bearings as shown in Table 5. Bearing wear was not measured during this test. Two additional repeat tests were performed using new bearing sets of the same test configuration (Tests 8 and 9). As shown in Table 6, nearly all wear occurred in the stationary bushings for these tests and ranged between 0.0004 in to 0.0008 in. This wear was evidenced by approximately ¼ tsp of black SiC powder that was found between the bearing running surfaces. A photograph of the SiC powder is shown in Figure 5. It is apparent that the ADLC coating has been worn away, at least in the stationary bushing, considering the degree of wear involved. However, despite this wear, the bearing set was still able to maintain its dry run performance. This may be attributed to the parts having lapped themselves together while operating, thereby eliminating any high spots and any minor amounts of edge loading present. The arrangement also shows that it has the ability to run dry even in the presence of solid particles, in this case, very abrasive SiC powder. Although bearing temperature will increase in the presence of solids due to the added friction involved, operating temperatures are still low enough to virtually eliminate the risk of thermal shock should liquid suddenly enter the pump. In addition, a reduced amount of axial bearing float, such as used in an open impeller design, would be highly desirable to reduce the risk of mechanical shock due to “slamming” of the rotor once liquid is admitted to the pump.

Figure 4. Bone-Dry Run Test—SiC(P) ADLC Stationary and Rotating Bearings.

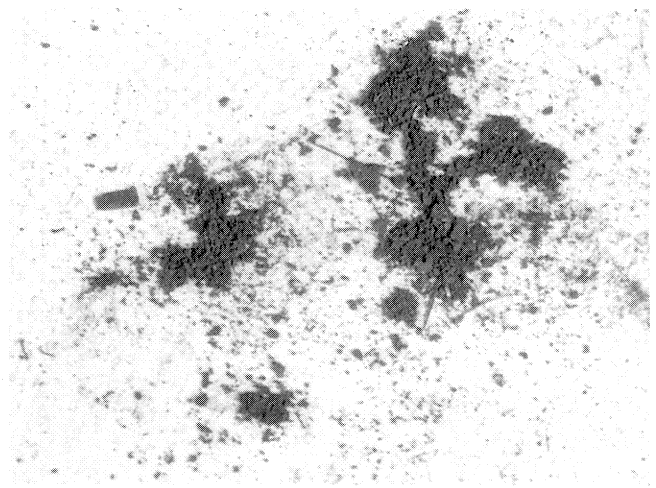
Figure 5. SiC Powder Observed After Testing.

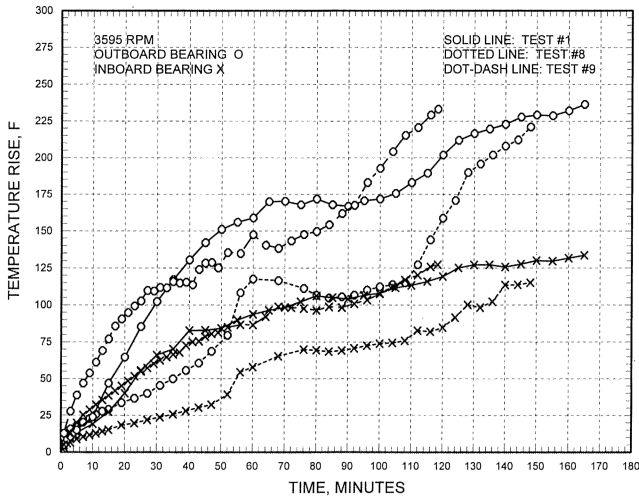
for the ADLC SiC(P) vs ADLC SiC(P) bearing arrangement. It was found that the repeatability between these tests was reasonably consistent as shown in Figure 6. The bone-dry run times to reach 300°F were 161, 147, and 117 min, respectively, for Tests 1, 8, and

9. The average dry running time for this configuration was 142 min. As shown in Table 5, an inspection of the bearings after all three test trials found their condition to be very similar. The bearings were judged to be in good condition and it would be expected that they could be put into service without problem. It should be noted that the outboard bearing ran consistently hotter than the inboard bearing. This is attributed to the following:

Figure 6. Bone-Dry Run Repeatability Tests—SiC(P) ADLC Stationary and Rotating Bearings.

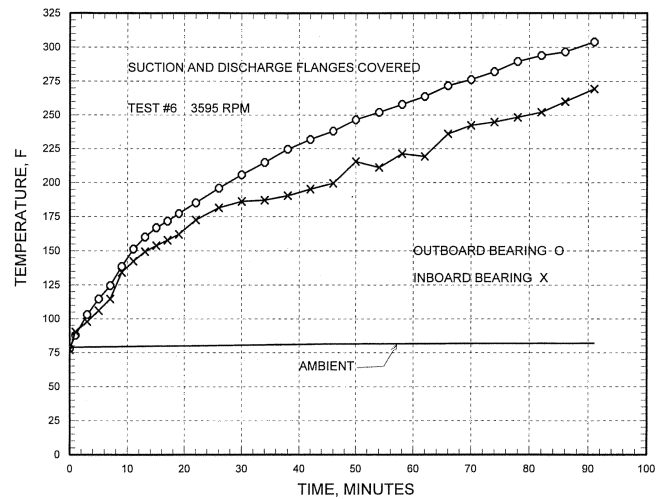
In an actual field installation, the degree of cooling attainable will depend on the volume of piping in the system and whether or not the discharge valve is open. Accordingly, a configuration was tested (Test 6) with the suction and discharge flanges covered with blind flanges to simulate a worse case condition, thereby greatly diminishing the cooling effect of the air flow. The results of this test are shown in Figure 7. The dry run time to reach 300°F was nearly 1.5 hr, which is very significant dry run protection under these unfavorable conditions. After dismantling the unit for inspection, the bearing condition was found to be very similar to Tests 1, 8, and 9 (with air flow). The bearing wear for Test 6 was a maximum of 0.0008 in.

Figure 7. Bone-Dry Run Test with Flanges Covered—SiC(P) ADLC Stationary and Rotating Bearings.

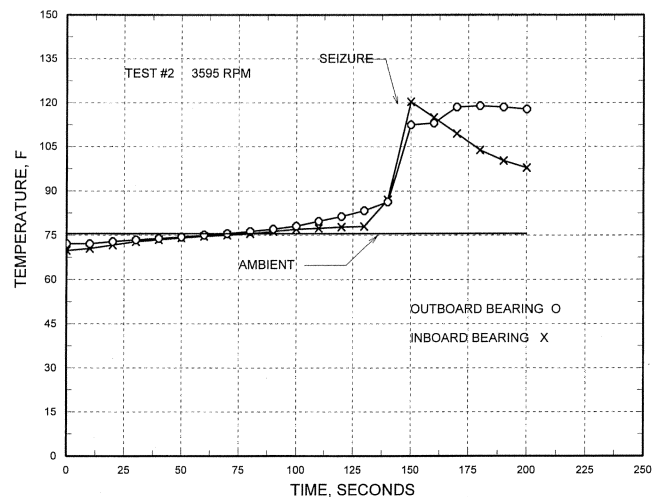
rotating bearing, while using uncoated silicon carbide on the other running surface. This would be advantageous from a cost standpoint. Test 2 utilized the ADLC on the stationary bearings only, while Test 3 incorporated the ADLC coating only on the rotating bearings. Both of these configurations seized prematurely; however, there was no internal contact with the containment shell. As shown in Figure 8, the ADLC coating on the stationary bearing only (Test 2) seized in under 2.5 min. The ADLC coating on the rotating bearings only, fared much better. As shown in Figure 9, Test 3 ran bone-dry for 32 min prior to seizing. In both of these configurations (Test 2 and 3), the outboard sleeve bearing cracked as detailed in Table 5. Although the 32 min dry run time of Test 3 was much shorter than that achieved in Test 1 (161 min), an argument can be made that if monitoring is not provided, the unit will eventually fail in either case without manual intervention. Therefore, the configuration with ADLC coating on the rotating surface only may still have some merit, based on cost considerations, and would serve to reduce the cost per bearing set by at least half.

Figure 8. Bone-Dry Run Test—SiC(P) ADLC Coated Stationary vs SiC(P) Uncoated Rotating Bearings.

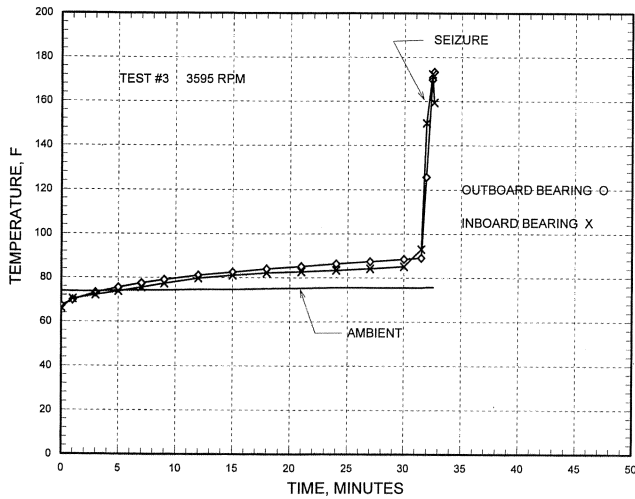
Figure 9. Bone-Dry Run Test-SiC(P) Uncoated Stationary vs SiC(P) ADLC Coated Rotating Bearings.

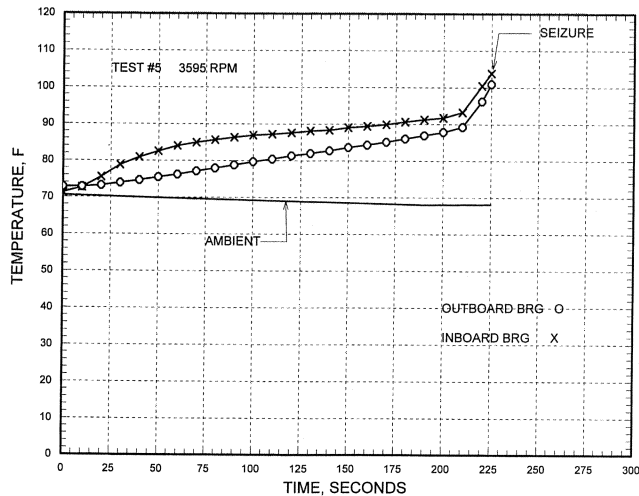
A bone-dry baseline test (Test 4) was performed on the test pump at 3595 rpm with SiC(P) rotating and stationary bearings without the ADLC coating or Teflon® strips, in order to determine the extent of dry running possible with plain silicon carbide. Not surprisingly, this configuration seized in under five sec operation. It should be noted that the failure was too sudden to develop a meaningful data curve. An inspection of the parts showed this failure to be the most severe of all test configurations; however, no internal rubbing of the containment shell occurred. It was found that both sleeve bearings were shattered and both stationary bushings were cracked. The addition of Teflon® strips in the stationary bushing showed a remarkable improvement in bone-dry run performance (Test 5). As shown in Figure 10, this low cost configuration incorporating Teflon® strips with SiC(P) vs SiC(P) bearings without the ADLC coating, extended dry run operation prior to seizure from just under five sec to nearly four min.

Figure 10. Bone-Dry Run Test-SiC(P) Uncoated Stationary and Uncoated Rotating Bearings with TFE Strips.

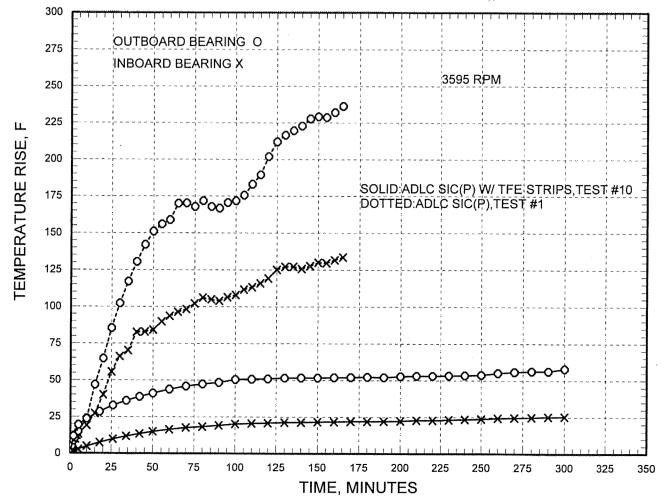
bearings; the result offered a major advance in dry run technology. As shown in Figure 11, the outboard bearing temperature leveled off at only 139°F ($\Delta T = 58^\circ F$) after five hr of bone-dry run operation. The inboard bearing stabilized at 107°F ($\Delta T = 26^\circ F$). The test was stopped after five hours due to time constraints, but it was expected that this configuration would have continued to run bone-dry successfully for many more hours. It was noted that there was no squeak audible when turning the shaft by hand after the unit was shutdown, as was detected in previous tests. In comparison, the best performing ADLC SiC(P) vs ADLC SiC(P) test experienced an outboard bearing temperature which peaked at 300°F ($\Delta T = 233^\circ F$) and an inboard bearing which reached 198°F ($\Delta T = 131^\circ F$) after 161 min of operation (Test 1). As shown in Table 5, the bearings from Test 10 were found to be free from scoring and judged to be in very good to excellent condition (the best of all configurations tested), despite having been in dry run operation nearly twice as long as the longest lasting previous test (Test 1). A comparison of outboard sleeve bearings between Tests 1 and 10 is shown in Figure 12. As shown in Table 6, the amount of bearing wear for Test 10 after five hr of bone-dry run operation ranged from 0.0001 in to 0.0002 in. This is an eight-fold improvement in wear resistance over Test Configuration 8. One interesting observation that should be noted is that, during the dismantling inspection, there was barely any silicon carbide powder found between the bearing running surfaces as was so evident during previous tests. This explains why the bearing temperatures and wear were so low. The SiC powder, which gets trapped between bearing running surfaces, will increase friction and consequently operating temperature. Additionally, the very abrasive nature of the SiC powder will only tend to exacerbate wear further. Based on these test results, the introduction of the Teflon® strips appears to maintain a low friction and soft running surface even in areas where the ADLC coating has been abraded away. This helps to reduce the abrasion and grinding action of SiC against SiC, which lessens the formation of SiC powder; consequently reducing friction and heat buildup.

Figure 11. Test Comparison of ADLC SiC(P) and ADLC SiC(P) Coated Bearings with TFE Strips.

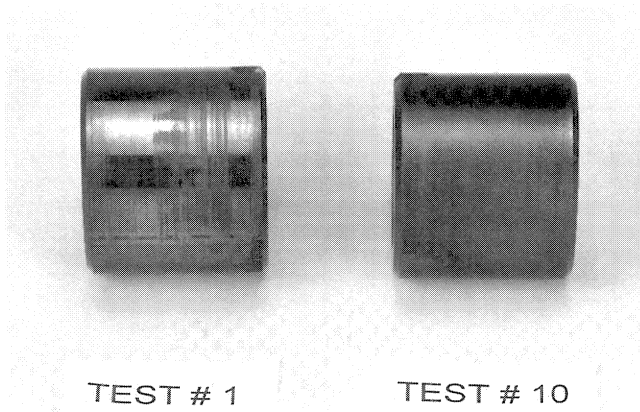
Figure 12. Comparison of Outboard Sleeve Bearing Condition-Tests 1 and 10.

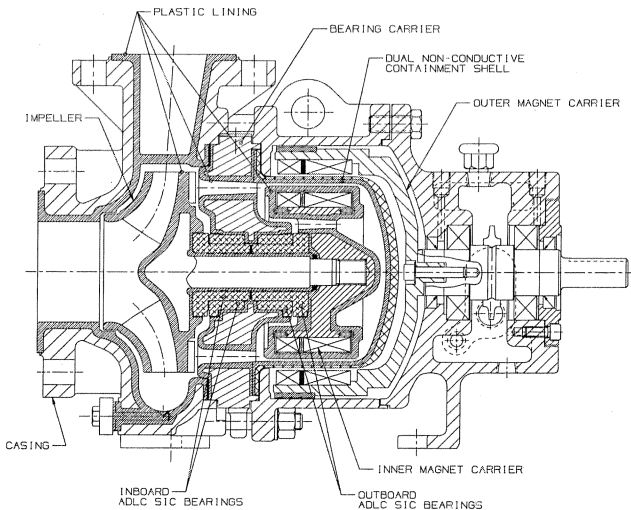
Bone-dry run tests conducted with plastic lined magnetic drive pumps, such as shown in Figure 13, indicate that the plastic lining, normally 1/8 in to 3/16 in, has an insulating effect on the efficient transfer of heat away from the SiC bearings. The large difference in dry run performance between a lined and metal bearing carrier is shown in Figure 14. These plastic lined magnetic drive pumps

Figure 13. Plastic Lined ANSI Magnetic Drive Pump.

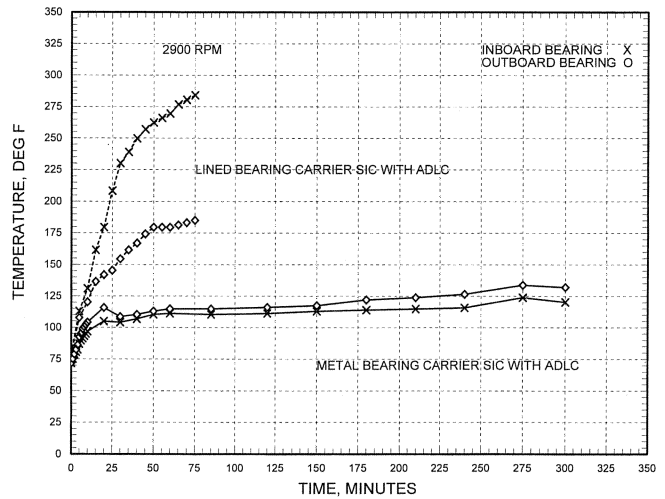
Figure 14. Bone-Dry Run Test Comparison with Lined and Metal Bearing Carrier.

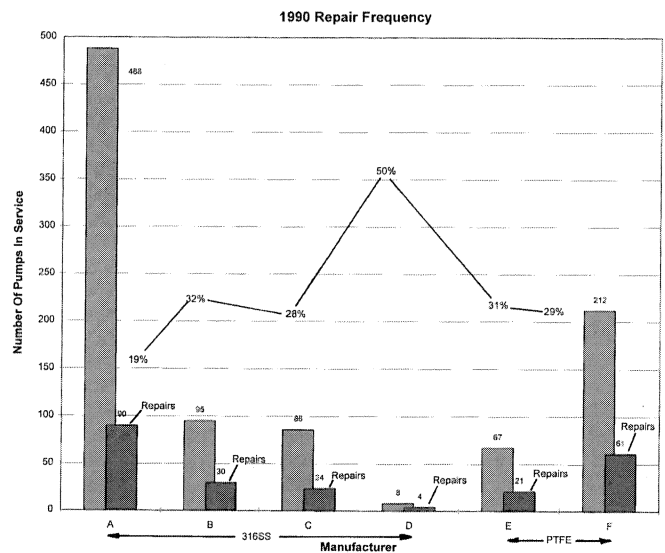
The 1990 and 1992 repair trends of magnetic drive pumps at a large German chemical plant [5] are shown in Figures 15 and 16. Manufacturer F, of plastic lined magnetic drive pumps, began to introduce the ADLC coating on SiC bearings during late 1990 and it was found that the repair frequency had fallen dramatically. During 1990, the repair frequency at this plant for Manufacturer F was 29 percent and had fallen to 11 percent during 1992, which represents a 62 percent reduction in failure rate. Although it is uncertain exactly what percentage of this reduction can be attributed to the ADLC coating and/or improvements in operating procedures and maintenance practices by plant personnel, it is

Figure 15. 1990 Repair Trends of Magnetic Drive Pumps at a Large German Chemical Plant.

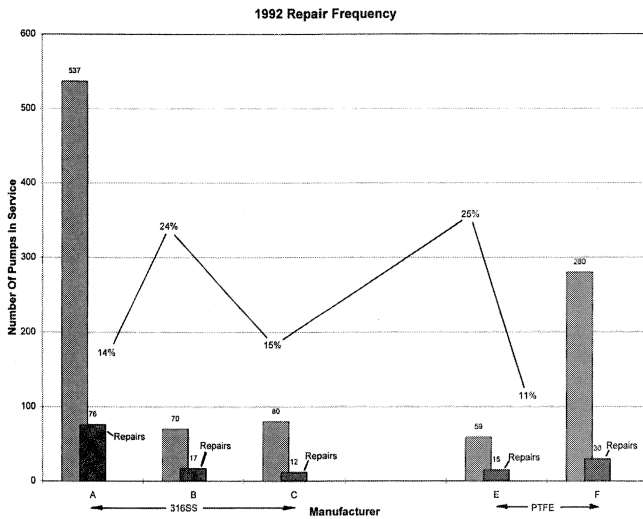
Figure 16. 1992 Repair Trends of Magnetic Drive Pumps at a Large German Chemical Plant.
