JUSTIFYING THE REINSTALLATION AND UPGRADING OF PROBLEM ANSI PUMPS AT AN OPERATING CHEMICAL PLANT

Joseph F. Dolniak
Maintenance Engineer
Reilly Industries
Indianapolis, Indiana

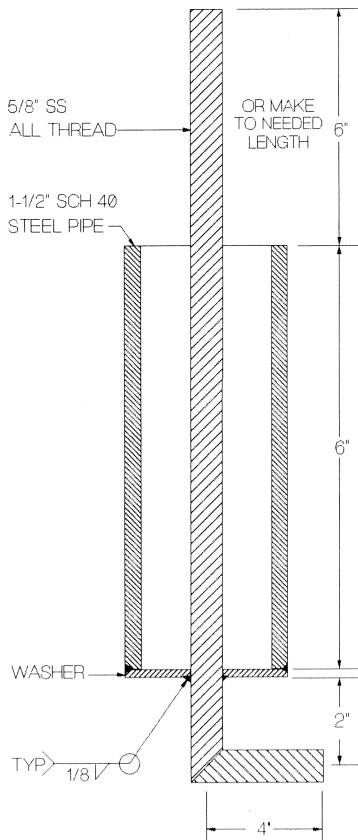
Figure A-1. Typical Hold Down Bolt.

6.1.1.6 Hold down bolts must be constructed of 316 stainless steel in an "L" fashion and be 14 in in length. Bolts must be installed in a 1 1/2 in Sch 40 pipe as per Figure A-1. Nuts should be carbon steel to prevent galling.

7.1 Figure A-1. Typical Pump Hold Down Bolts.

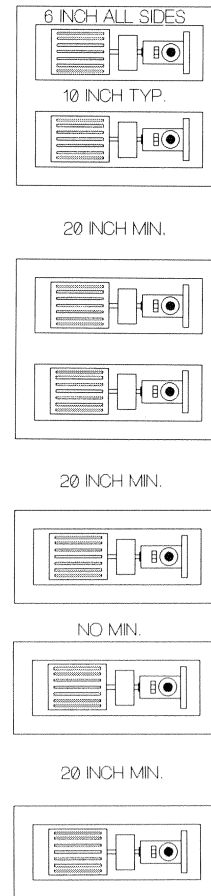
Figure A-2. Typical Pump Pad Spacing.

6.1.1.7 The maximum number of pumps per pump pads is two, and the minimum distance between pump baseplates on pump pads supporting two pumps should be 10 in (Figure A-2).

6.1.1.9 Pump pads in a common row should be separated by a minimum of 20 in (Figure A-2).

6.1.1.11 Pump hold down bolts on pads supporting two pumps should be aligned. (Figure A-2)

7.2 Figure A-2. Pump Row Pad Spacing.

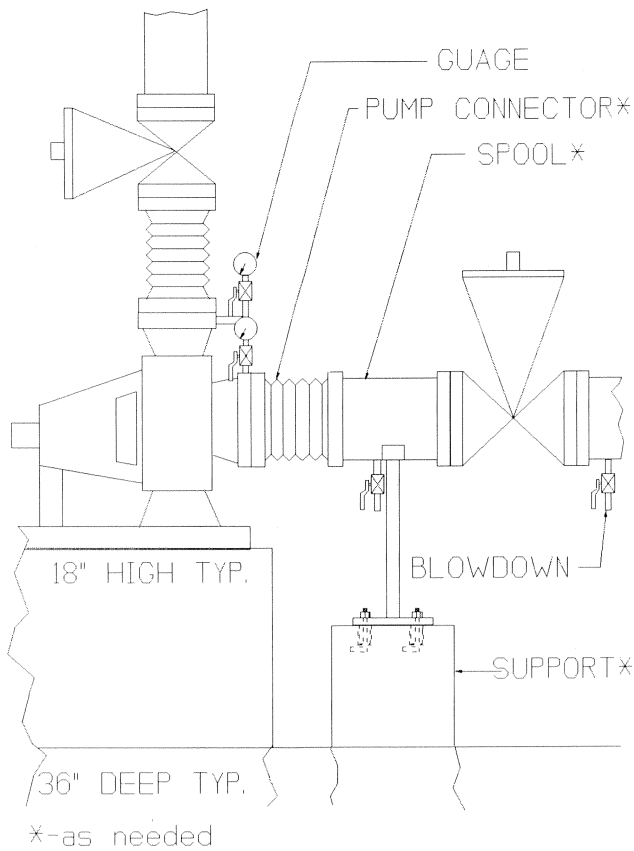
Figure A-3. Typical Piping Arrangement to Pump.

6.3.3 All pumps should be equipped with suction and discharge valves as shown in Figure A-3.

6.4.1 All pumps must have gauges installed on the suction piping and discharge piping (Figure A-3).

7.3 Figure 3. Typical Piping Arrangement at Pump.
