**SEDIMENT PROFILES AND HYDROLOGICAL IMPLICATIONS  
FOLLOWING HURRICANE HARVEY FOR MISSION RIVER IN TEXAS**

An Undergraduate Research Scholars Thesis

Sediment Profiles and Hydrological Implications Following Hurricane Harvey for Mission River  
in Texas

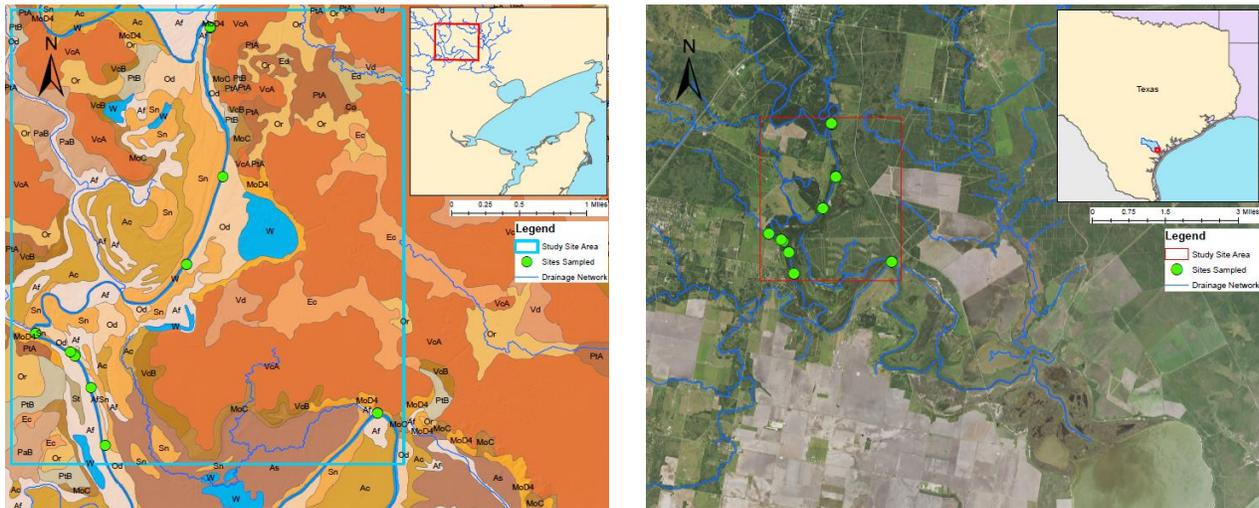
Figure 1. Study site and sampled sediment locations of Mission River, Texas and distribution of soil types within the study area (NRCS). The riparian zone within the study site is predominantly

comprised of a highly variable distribution of Aransas Clay, Sinton Sandy Clay Loam, Odem Fine Sandy Loam, Victoria Clay, and Papalote Fine Sandy Loam.

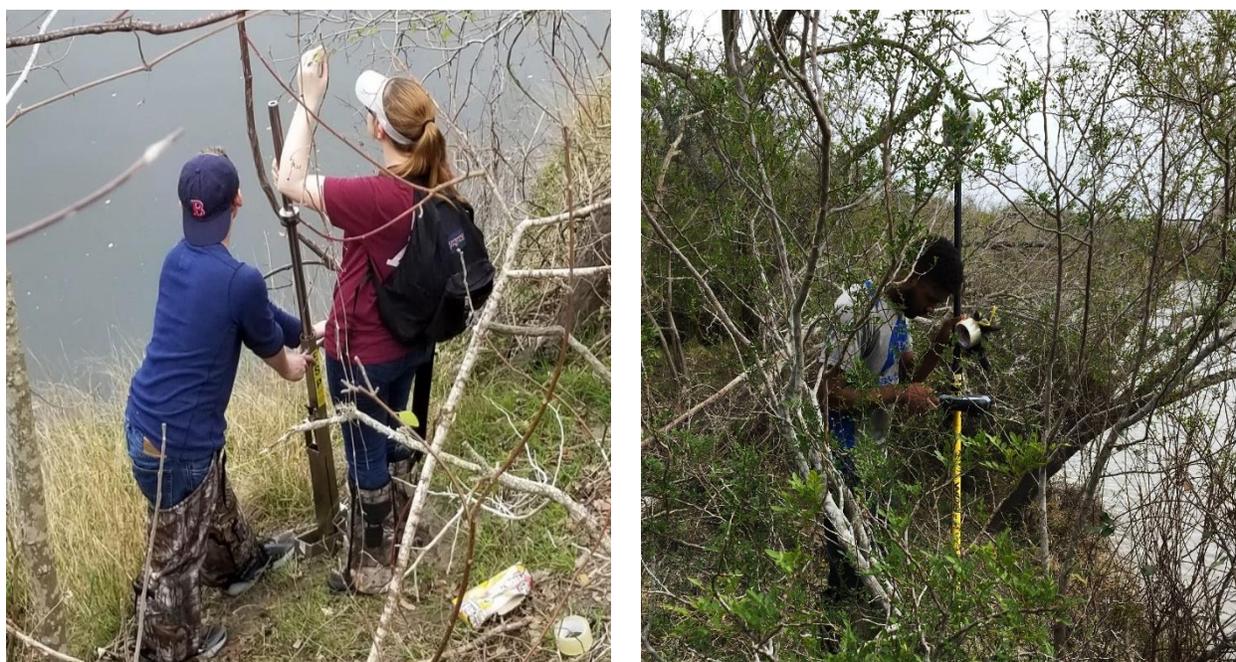
Figure 2. Photos taken on February 20, 2018. Fieldwork use of the sub-soil probe (PN150 JMC Environmentalist’s Sub-Soil Probe) and Trimble GPS point equipment.

Collection of sediment samples from various locations within the Mission River riparian zone entailed the use of a PN150 JMC Environmentalist's Sub-Soil Probe (ESP) to collect sediment samples from the surface and sub-surface. Sampling locations were selected based on previously-sampled vegetation transects measured at identified locations as follows: FR-0, FR-9, FR-11, FR-12, FR-13, FR-19, FR-21, and FR-25 (Davis, Smith 2013). Soils were gathered and distributed based on length from the surface; 0-0.3 meters characterized as surface sediments, and 0.3 meters-below as sub-surface sediments. Preserved horizon samples were then extracted using the PN150 JMC ESP for visual analysis for its respective sampled location in order to integrate depth and boundary variability (Schoenberger, 2012).

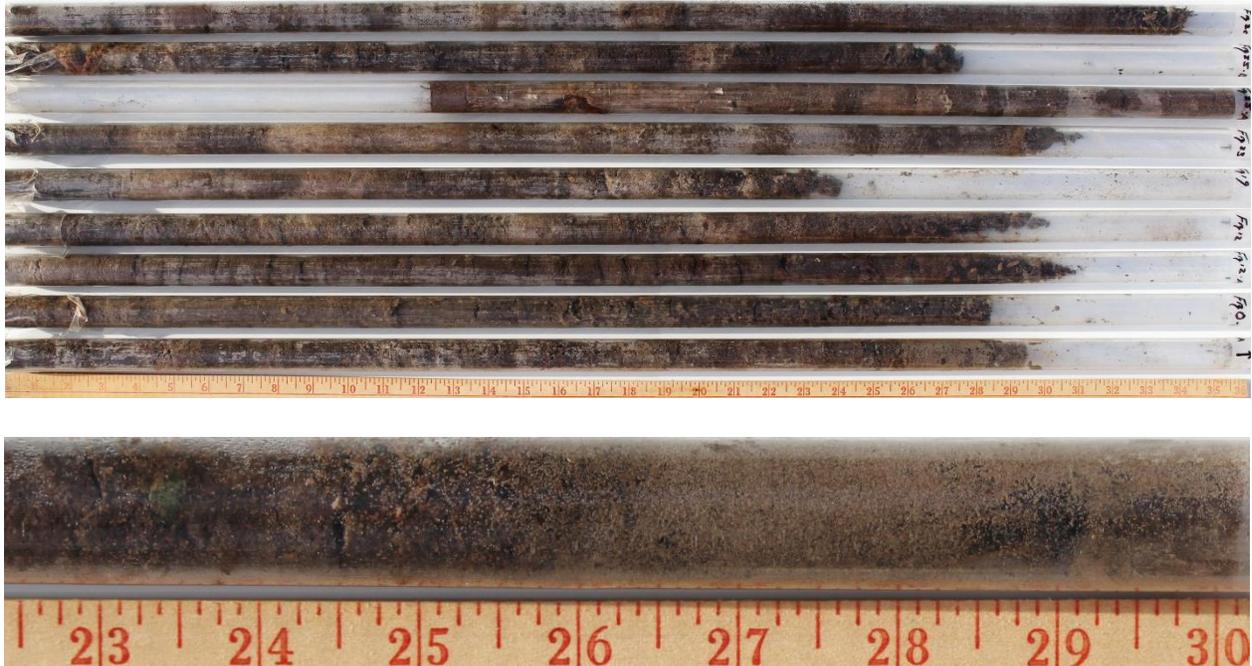
Figure 3. Preserved horizon sediment cores, upstream to downstream. Samples display variability in layers of clays, silty loams, and fine sands in addition to organic matter content and vegetation roots. Zoomed to FR-0 displaying surface-layer sandy flood deposit above clay and silty loam layers.

Preserved horizon cores were visually analyzed to identify horizon layers and sedimentary formations, as well as stratification of organic matter content and soil texture variability. Identified surface and sub-surface layers were then appended to results from laboratory analyses.

Sediment profiles collected displayed homogeneity among layers, ranging from clays to medium sands. Fine and medium sand layers overlaying clay and silty loam layers, characteristic of flooding events, were evident in many of the cores taken. Some sites displayed recent sand deposits in surface layers: FR-0, FR-13, FR-19, FR-23, FR-25, and FR-26.

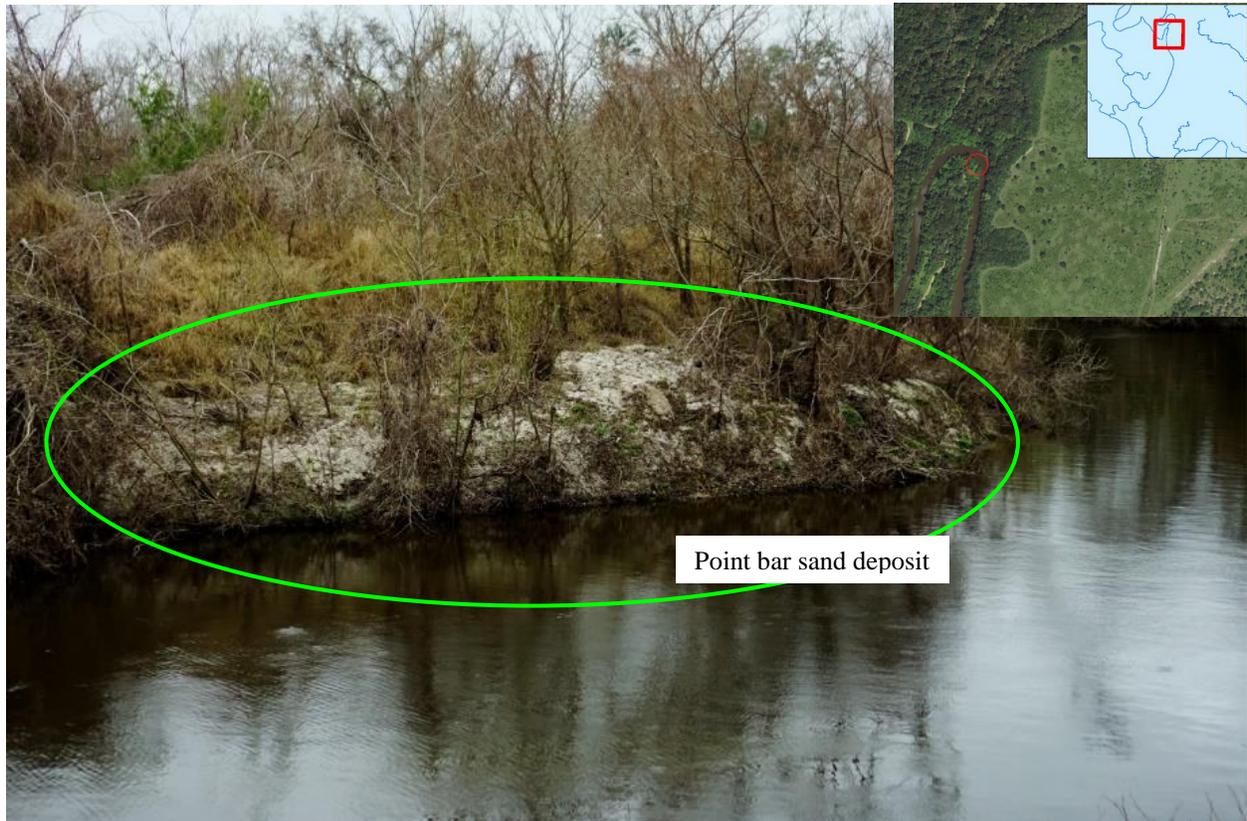
Figure 4. Photo taken on February 19, 2018. A point bar sand deposit along a meander near FR-25 in the northernmost region of the study site. This flooding formation, approximately 14 km from the river outlet at Mission Bay, is distinctly composed of coastal sands.

Observations based on aerial imagery and fieldwork were also indicative of changes to the riparian sedimentology. Recent sandy flood deposits were identified at locations along the riparian zone's study site, indicating changes to the Mission River's morphology.

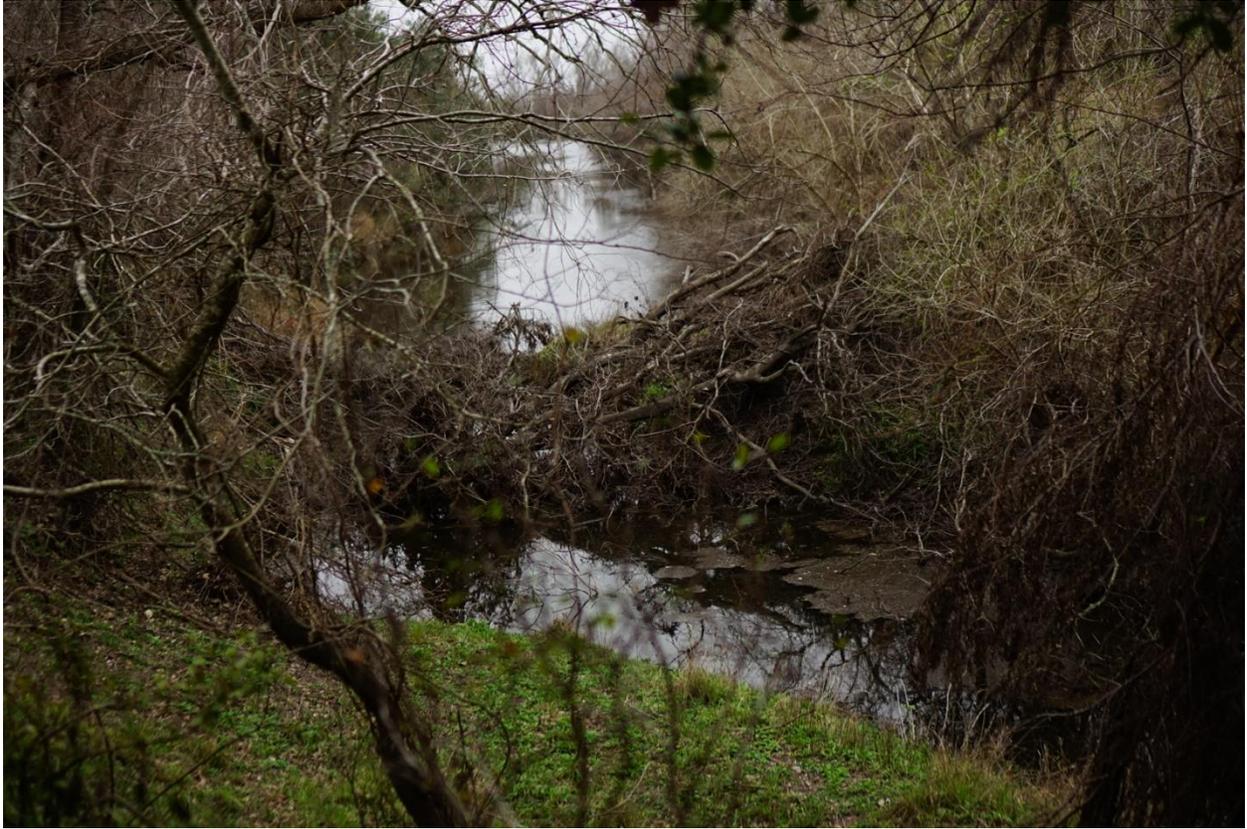
Figure 5. Dead and downed vegetation dam Dry Creek at its confluence with Mission River, nearby the northernmost sampled site FR-25.

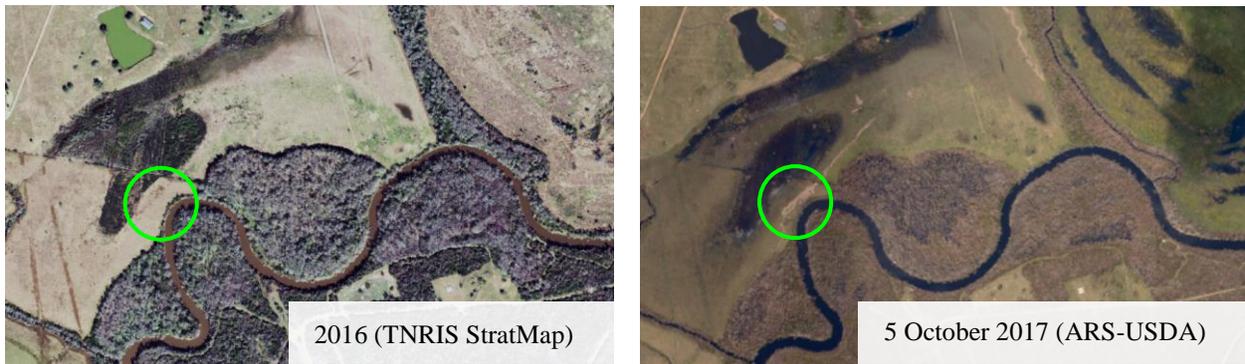
Figure 5. Aerial imagery taken before and after Hurricane Harvey's landfall. The identified feature shown is an early flood deposit formation of a levee after this event, located near a cut bank of a meander of the Mission River near site FR-12.

Analysis of aerial imagery input into a GIS environment also displayed changes to the Mission River's hydrological regime resulting from flooding events. Dead and downed vegetation following Hurricane Harvey's landfall was prominent in the study area, including the initiation of what might evolve into a natural levee.
