46<sup>TH</sup> TURBOMACHINERY & 33<sup>RD</sup> PUMP SYMPOSIA  
HOUSTON, TEXAS | DECEMBER 11-14, 2017  
GEORGE R. BROWN CONVENTION CENTER

# Pelletizer Motor Bearing Damage Detection Based on Vibration Data

This presentation provides a case study that pelletizer motor bearing damage on an extruder was detected from on-line remote monitoring vibration data. Though vibration level was well below the acceptable limit, its abnormal signatures warranted a shutdown action. It was then observed that for each bearing, the whole outer raceway was spalled circumferentially into a “washboard” pattern. This was caused by electrical corrosion or fluting due to poor insulation resulted from damaged insulating washers. After replacing the bearings with insulated ones , vibration level and signatures have then become normal ever since its restart.

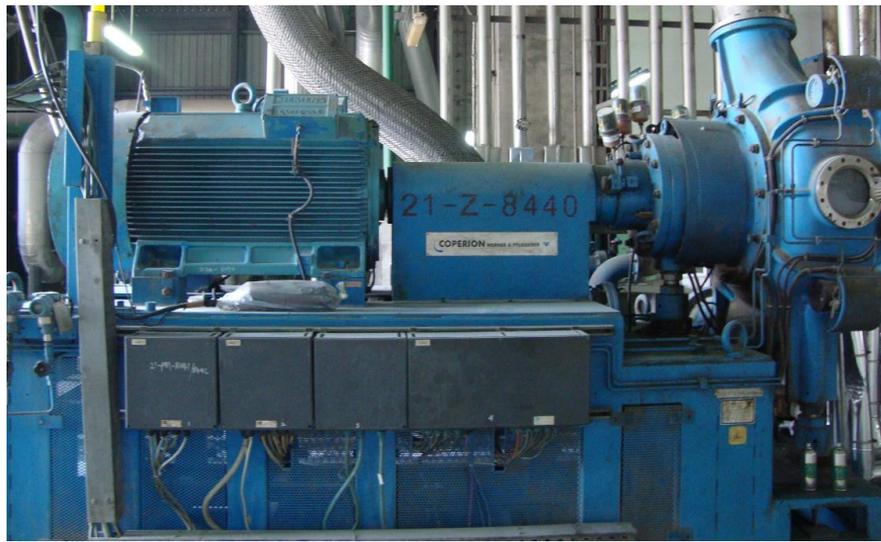
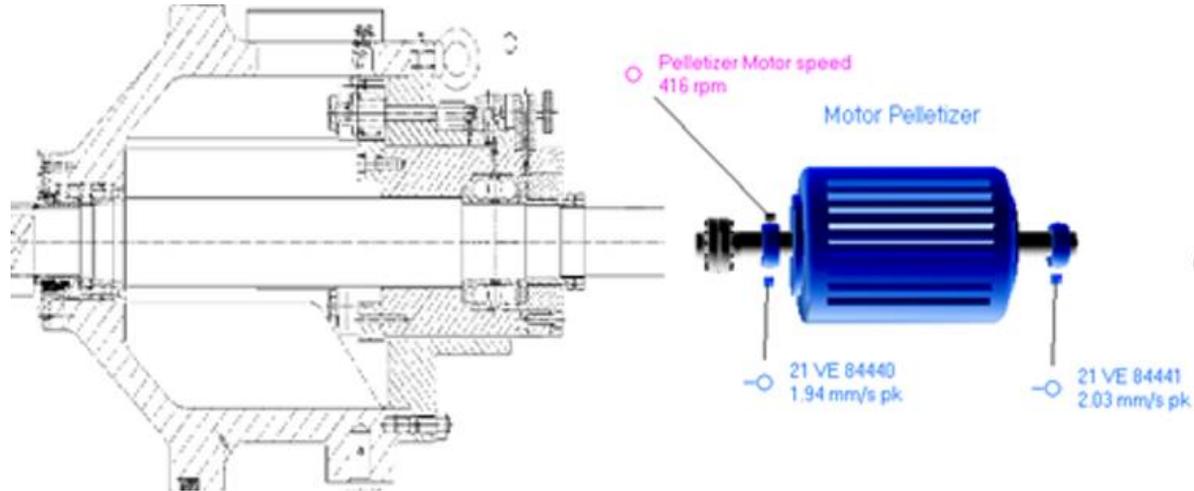
# 1. Introduction

- Pelletizer motor on an extruder
- Supported by two deep groove ball bearings
- Motor running at 350 ~ 390 rpm
- Vibration monitored by velocity transducers at each end of bearing housing

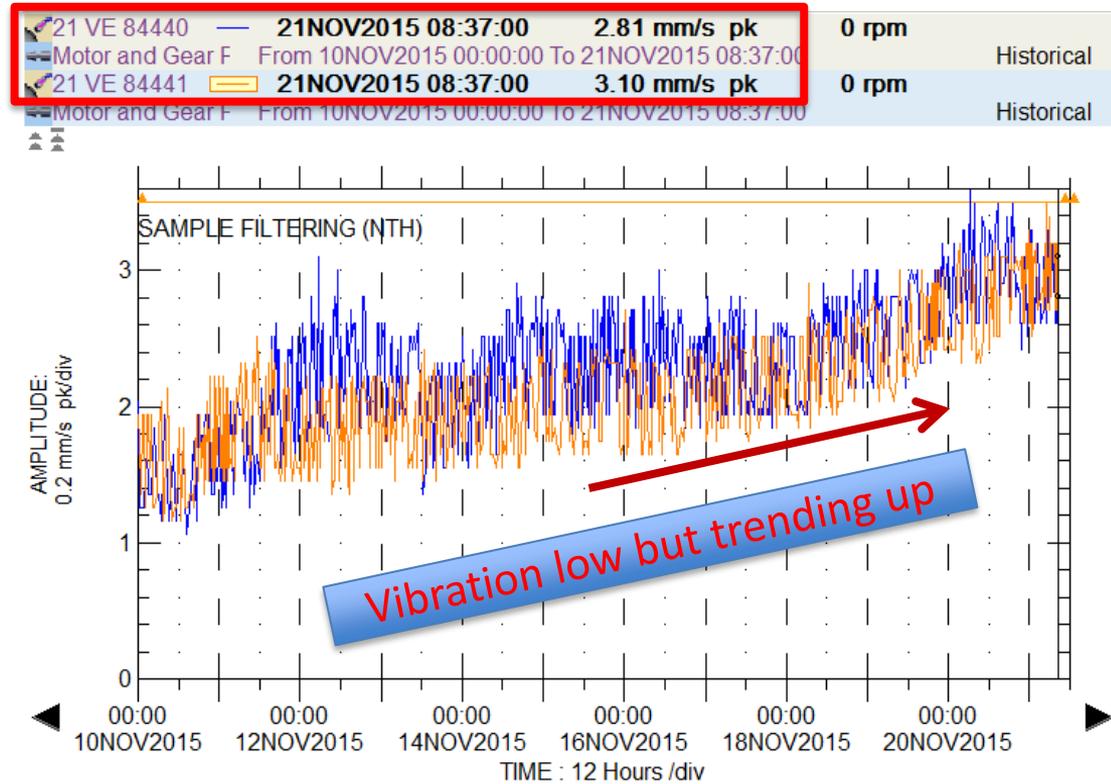
## 2. Problem Statement

- While reviewing high vibration data at other locations, vibration readings on motor bearings was found trending up.
- The motor vibration level was still within the acceptable limit, despite of trending up. Was there any problem?

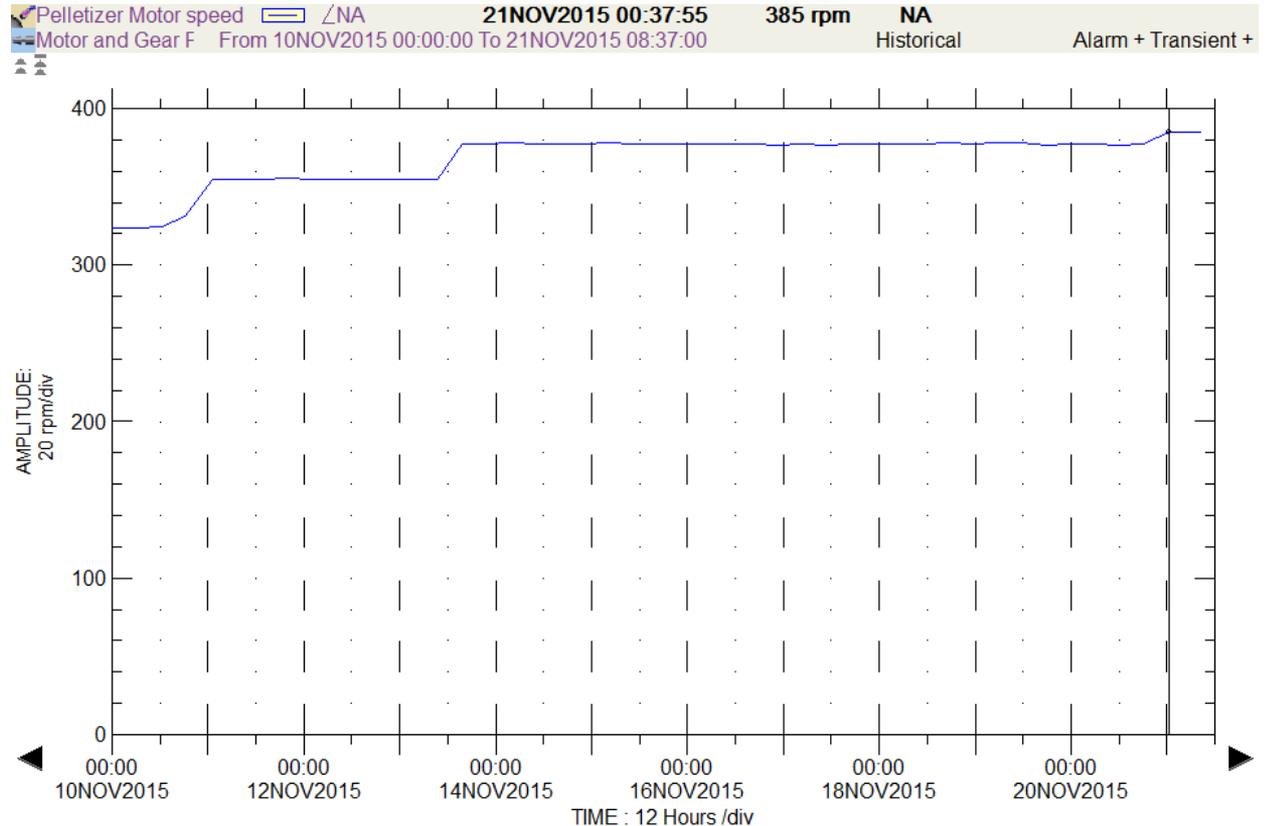
# 3.1 Data Review – Speed trend

- Stable in general, only varied with slight step changes
- 385 rpm used for bearing frequency calculation

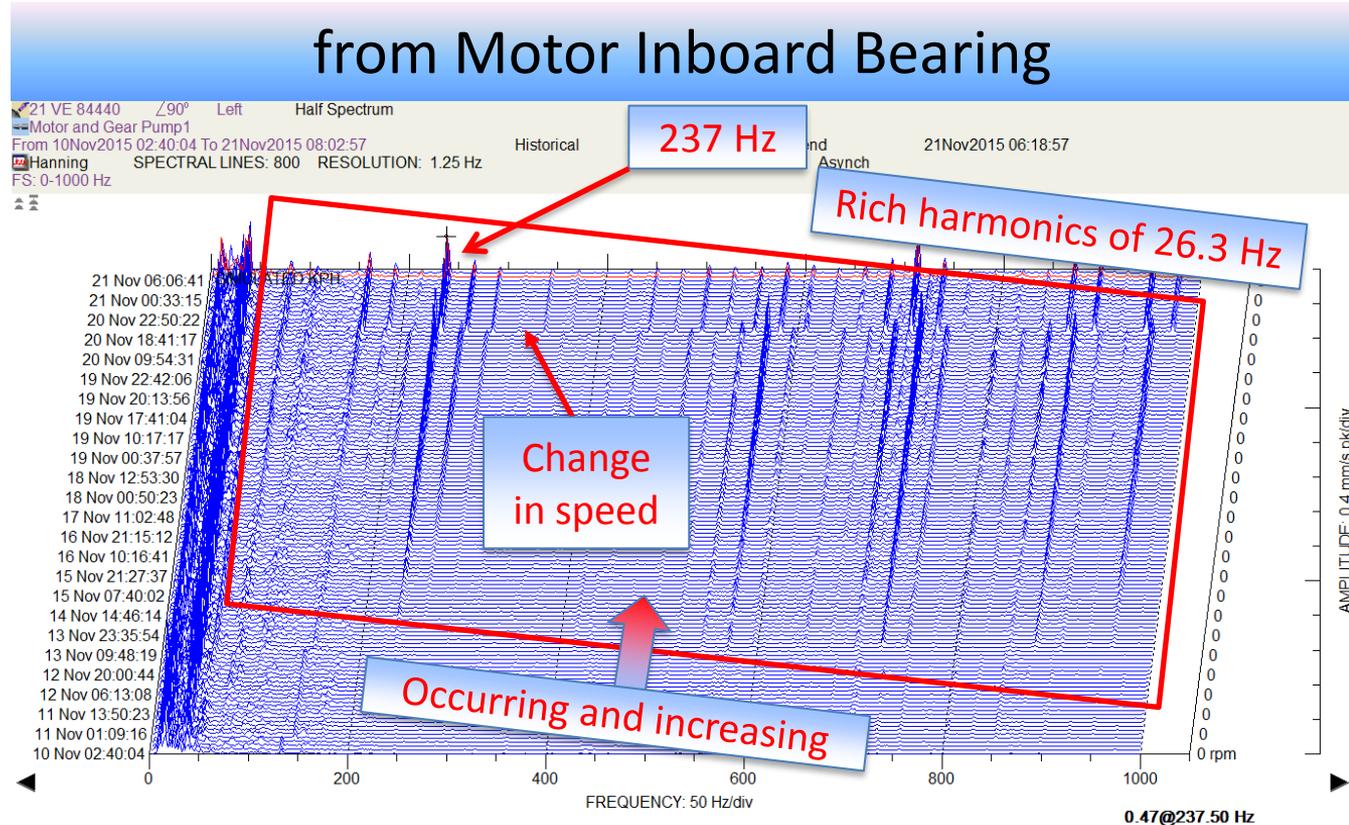
# 3.2 Data Review – Waterfall plot at Motor IB

- Harmonics or side bands appeared and significantly increased – abnormal.
- Highest peak at 237 Hz (~ 9 X 26.3 Hz), and rich harmonics of 26.3 Hz.

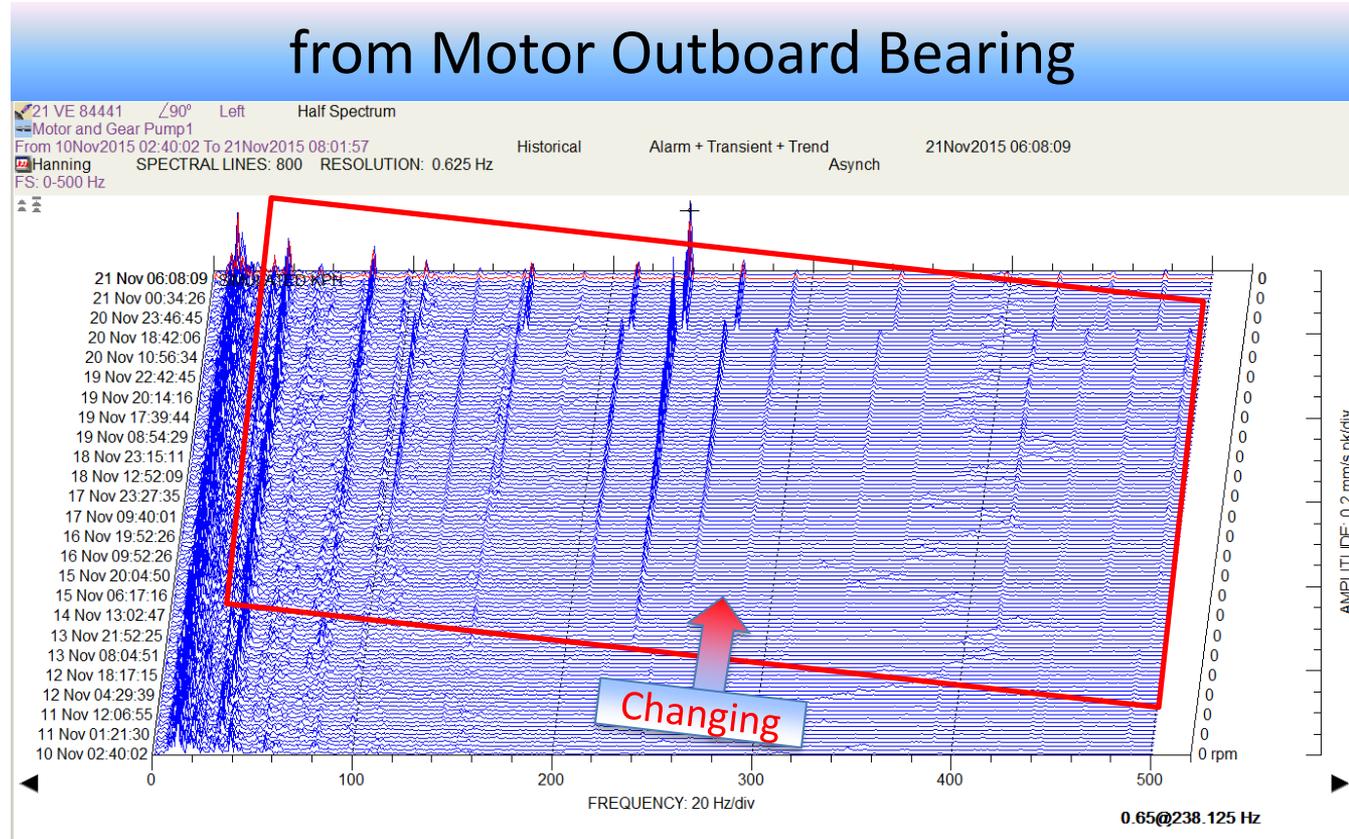
# 3.3 Data Review – Waterfall plot

Same signatures as those from inboard bearing

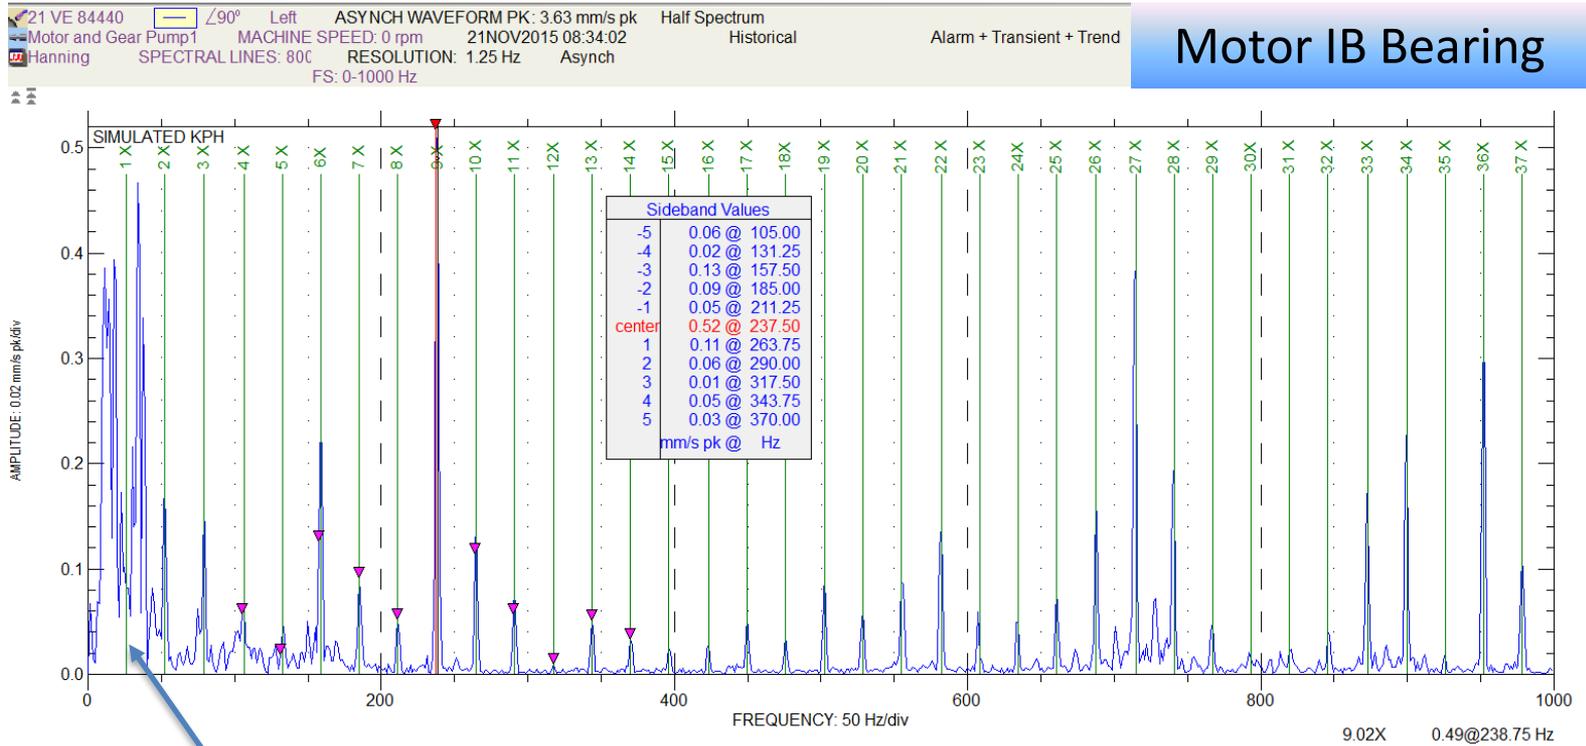
# 3.4 Data Review – Spectrum plot at 385 rpm

## Confirmation of rising vibration due to 26.3 Hz harmonics

Note: 1X=26.3 Hz = 4.1 x Shaft Speed

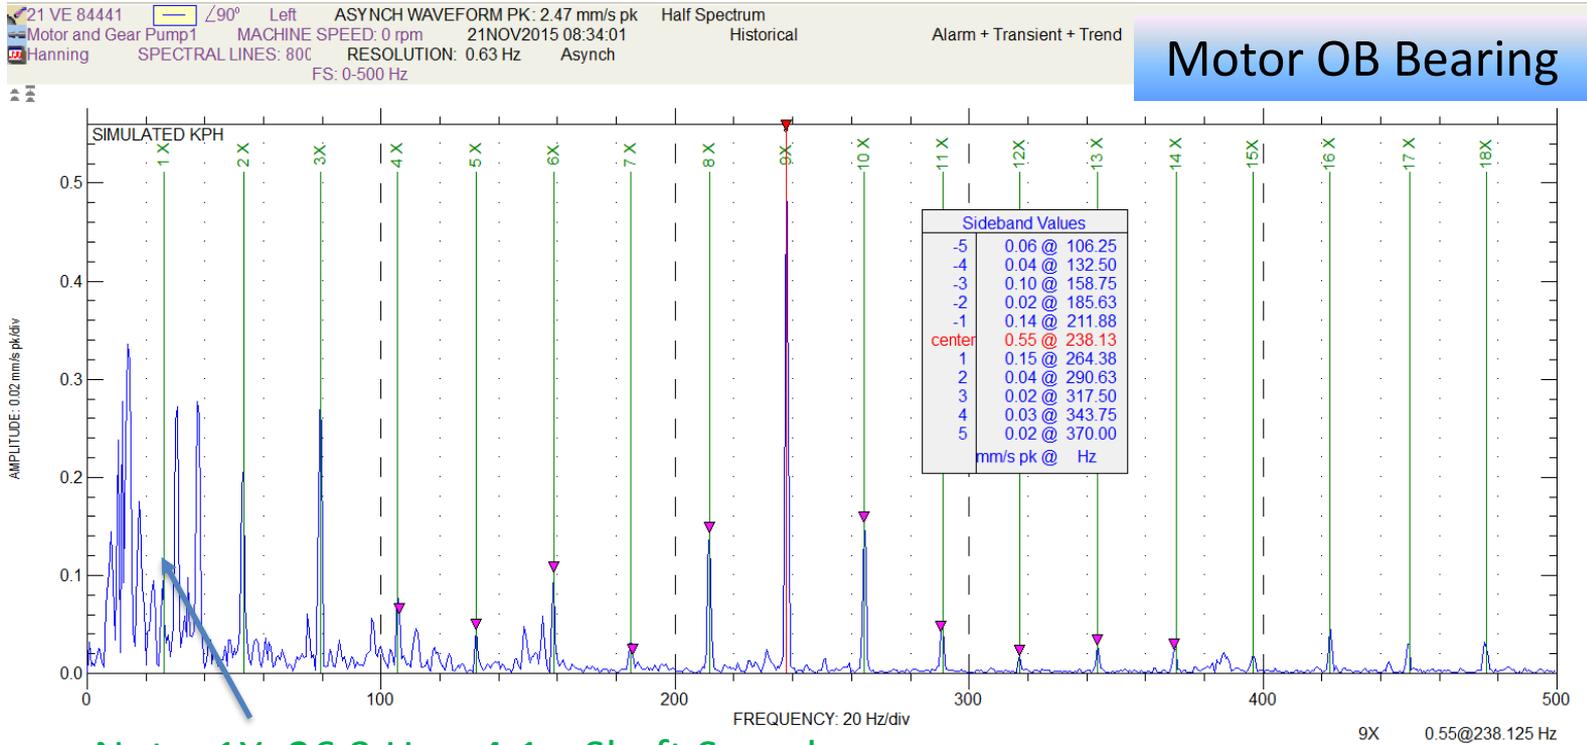
# 3.5 Data Review – Spectrum plot at 385 rpm

## Confirmation of rising vibration due to 26.3 Hz harmonics

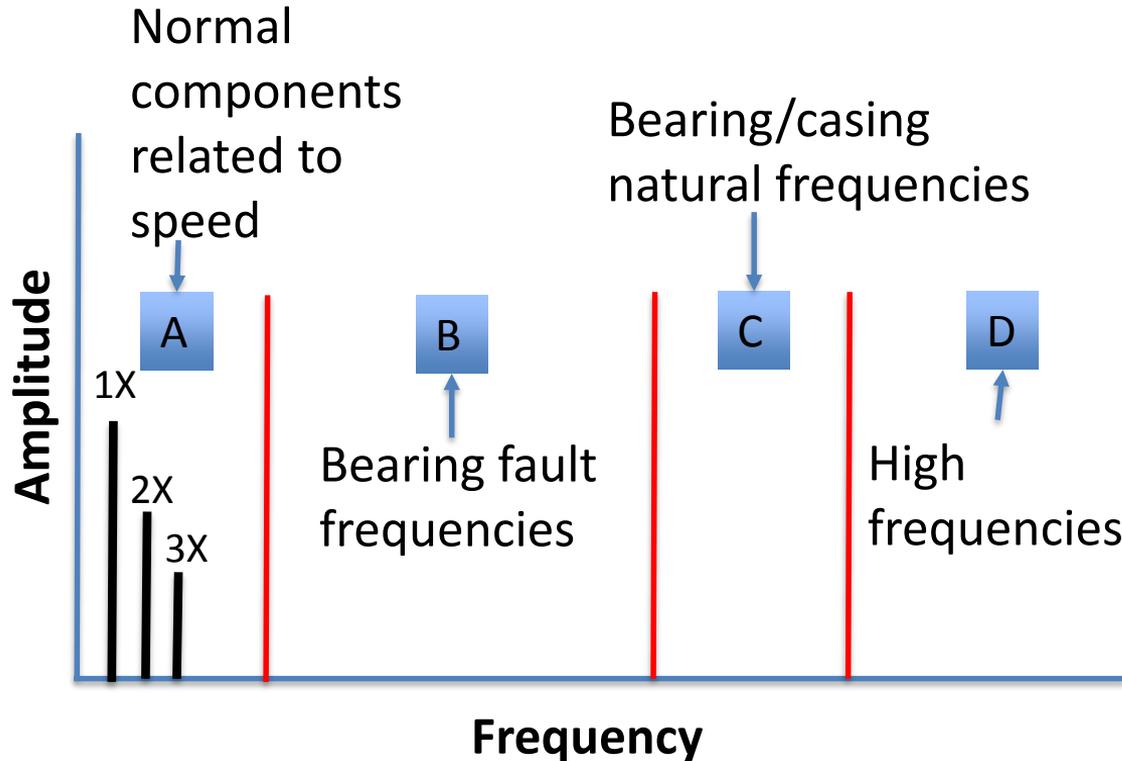
Four Stages of bearing life

- **Stage 1:** 10-20% life left, frequencies in Zone “A” & “D”
- **Stage 2:** 5-10% life left, frequencies in Zone “A” , “C” & “D”
- **Stage 3:** <5% life left, plus additional Zone “B” with bearing frequencies
- **Stage 4:** <1% life left, Zone “B” & “C” replaced with random noise.

- Conclusions:
  - Outer race damage occurred on motor bearings.
  - Became severe in a fast progression.
  - Bearing life in later Stage 3, towards Stage 4.
- Recommendations
  - Stop the machine within a few days
  - Inspect the two bearings to confirm the damage
  - Find the root-cause of the damage
  - Install the new bearings

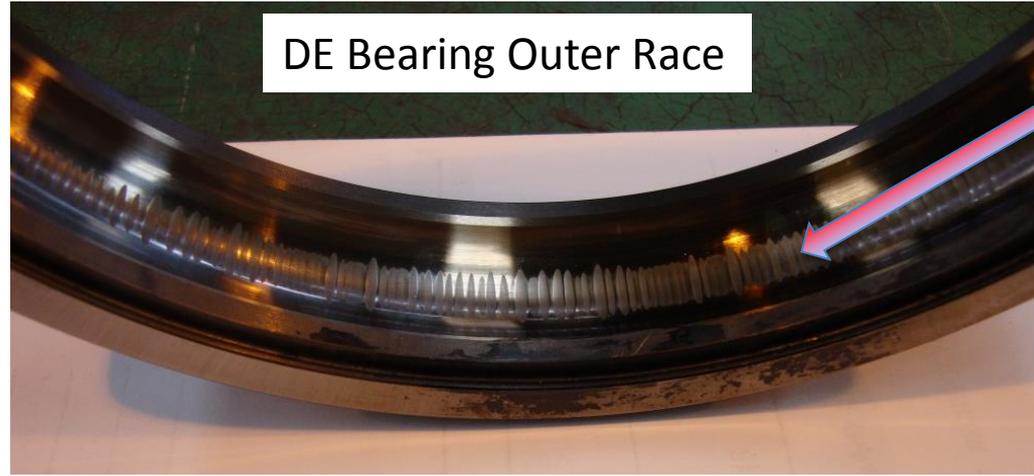
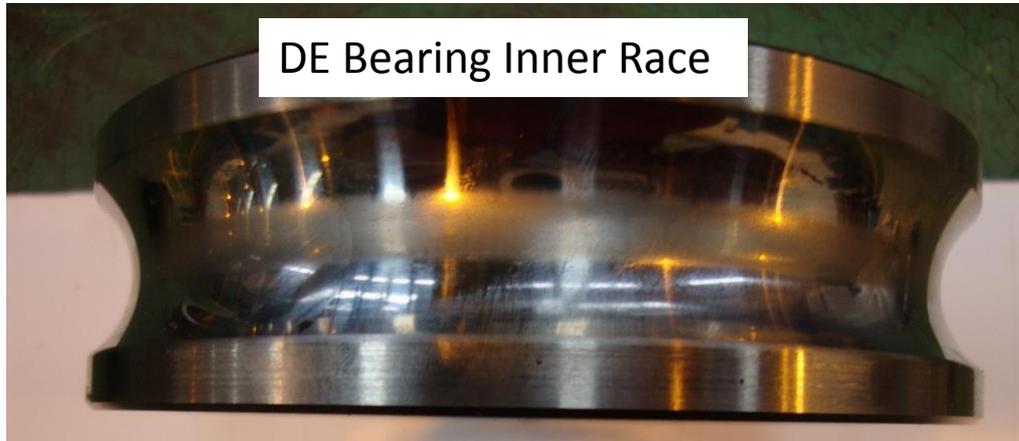
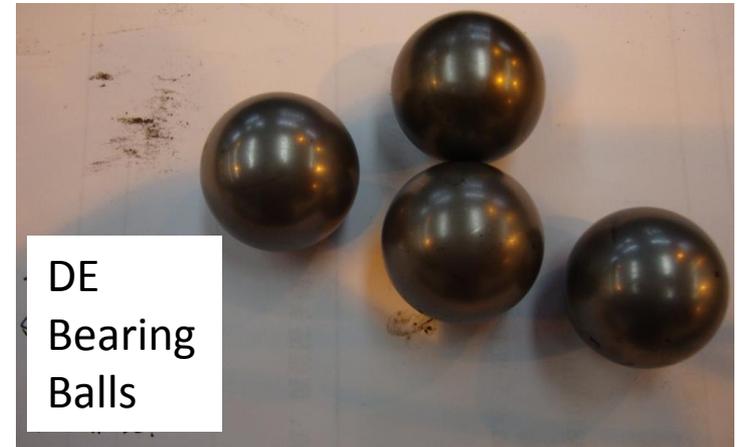
# 5.1 Inspection and Findings

**“Washboard”** pattern across the entire outer race circumferentially, plus wear on inner race and dark discoloration on balls

**Electrical Corrosion/Fluting**

The stator and rotor generate charge accumulation, which passes through the motor shaft to the bearings and discharges from the balls with enough energy to pit the race.

Damaged bearings

Replaced by

Insulated bearings

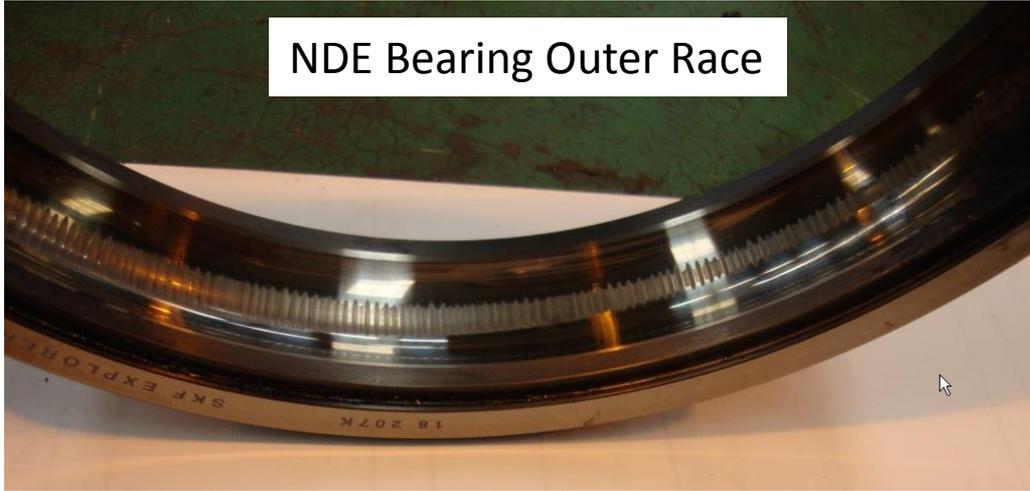
NDE Bearing Outer Race

Similar damages on  
NDE bearing

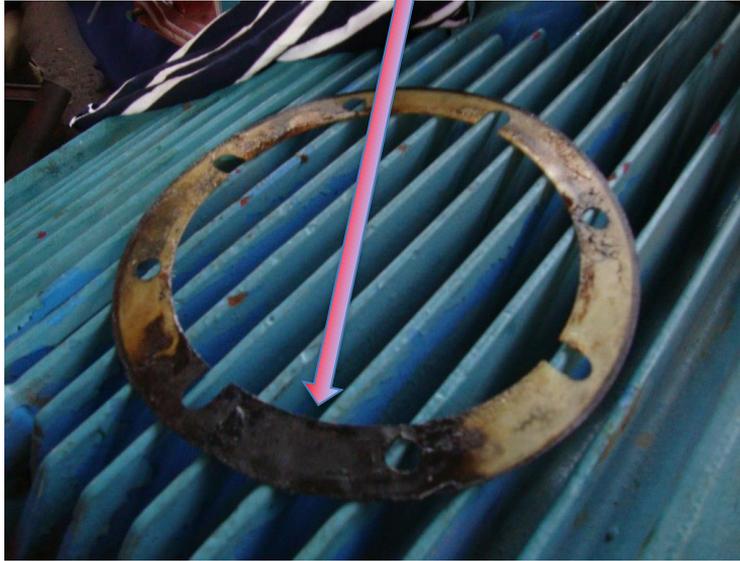
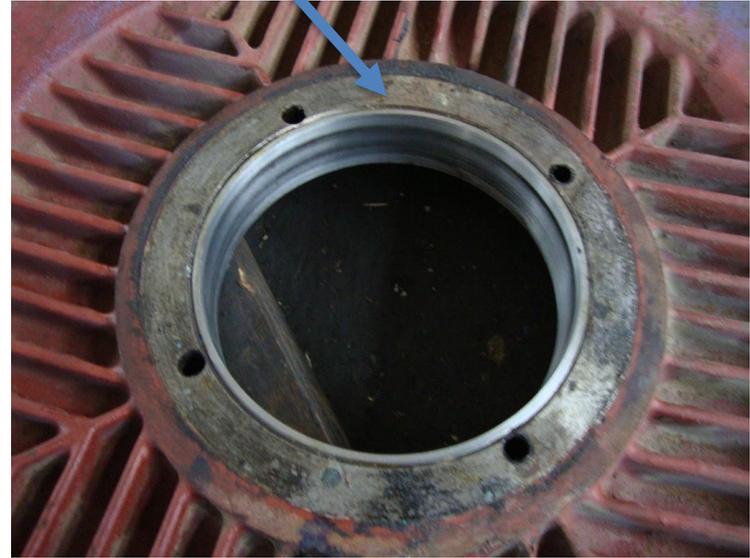
## 5.3 Inspection and Findings

**Insulated washers** damaged on **end cover** of NDE bearing

**Presumed insulation broken due to damaged insulation washers**

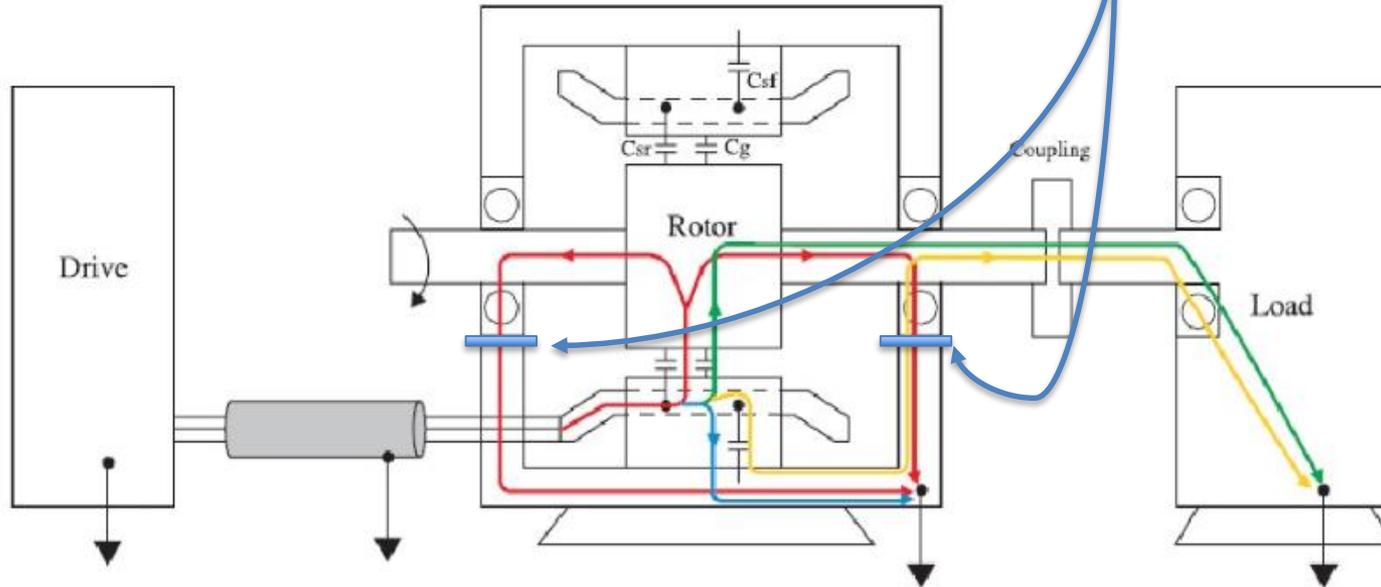
# 6.1 Resolution and Final Vibration Results

Aluminum  
oxide  
coated  
external  
surface of  
outer ring  
for  
electrical  
resistance

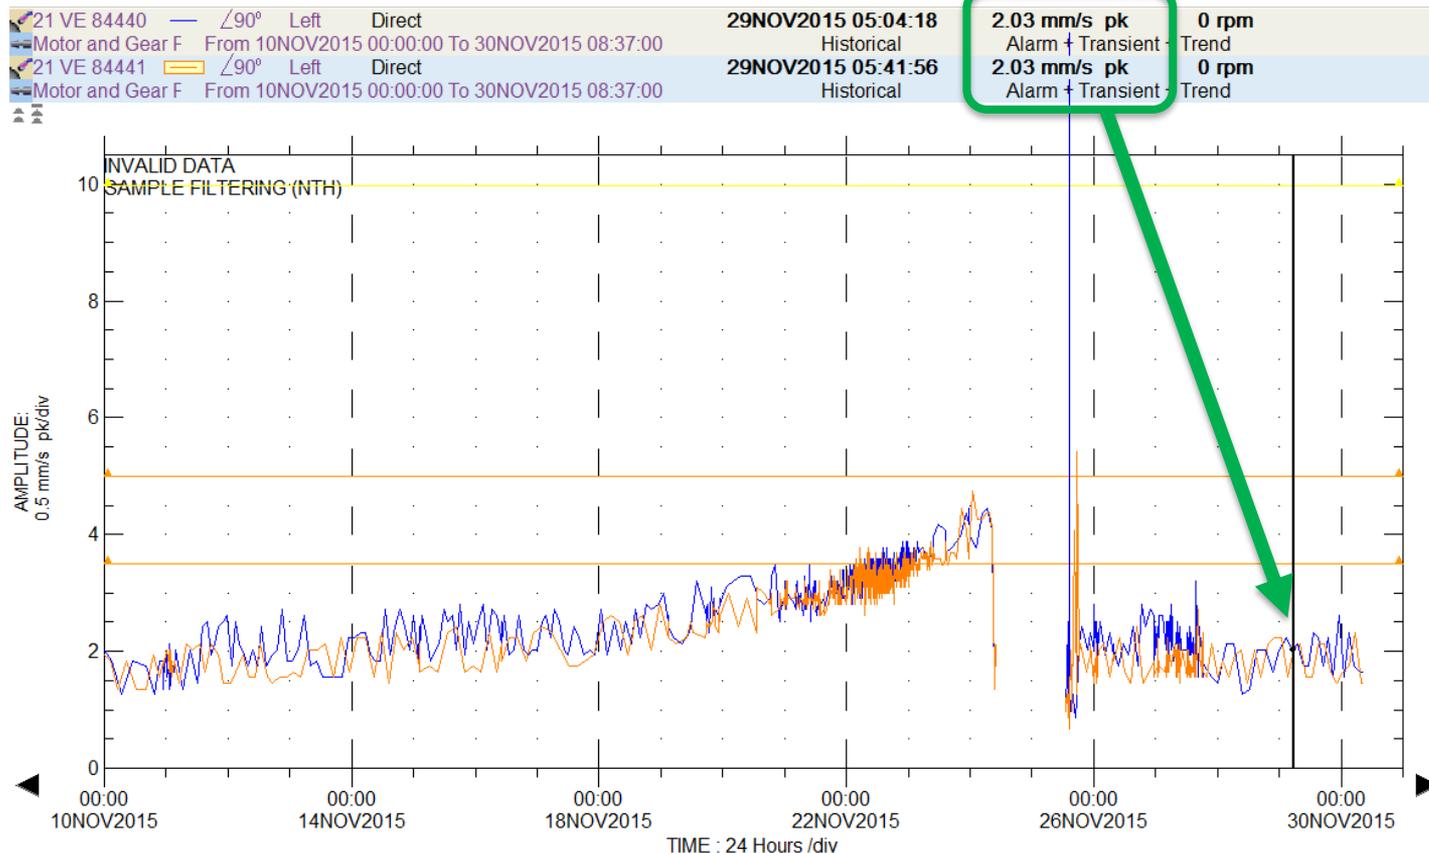
# 6.2 Resolution and Final Vibration Results

Vibration readings became low and stable.

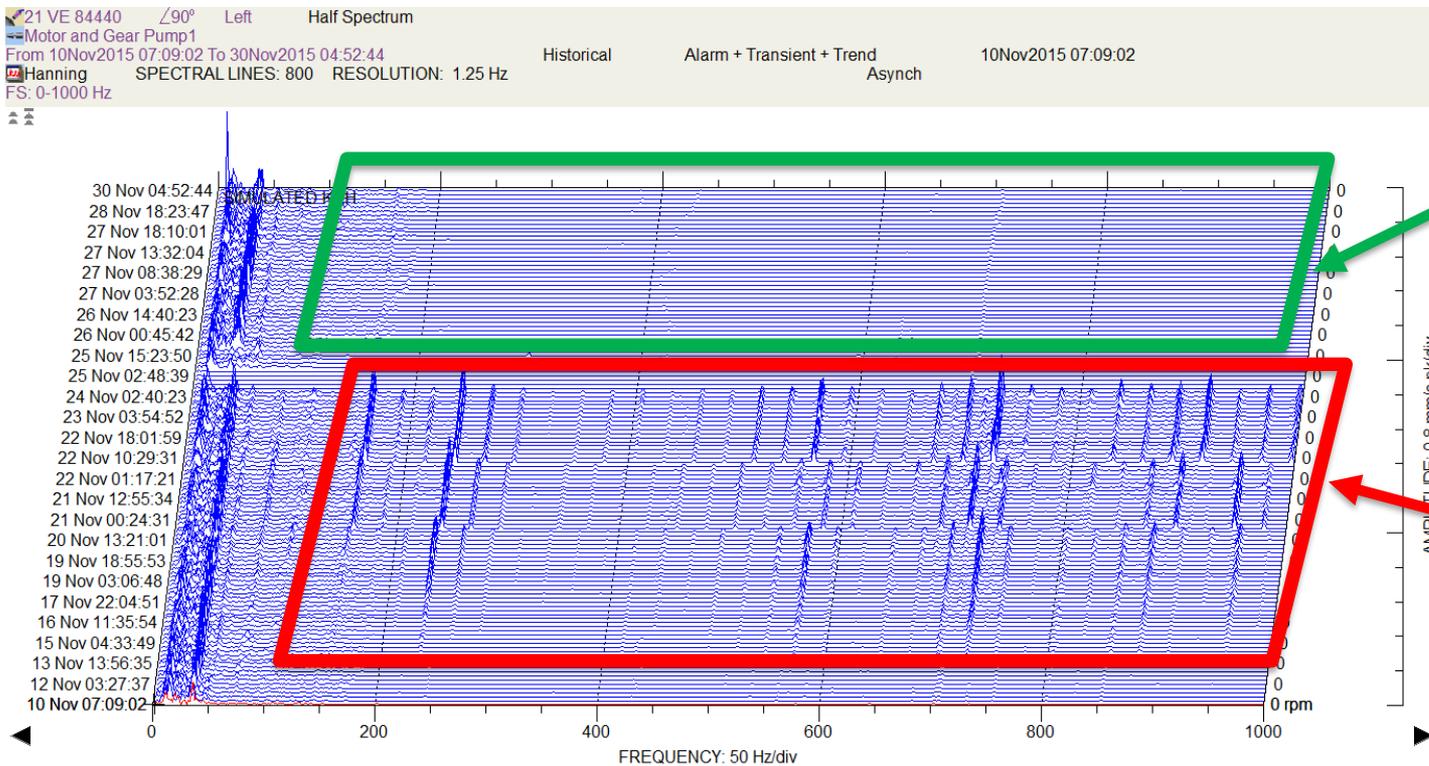
# 6.3 Resolution and Final Vibration Results

Abnormal harmonics disappeared!

after

before
