ASIA TURBOMACHINERY & PUMP SYMPOSIUM
MARCH 2018 | SUNTEC SINGAPORE

Unsteady vibration due to cavitation in mixed flow pumps

Torishima Pump Mfg. Co., Ltd.

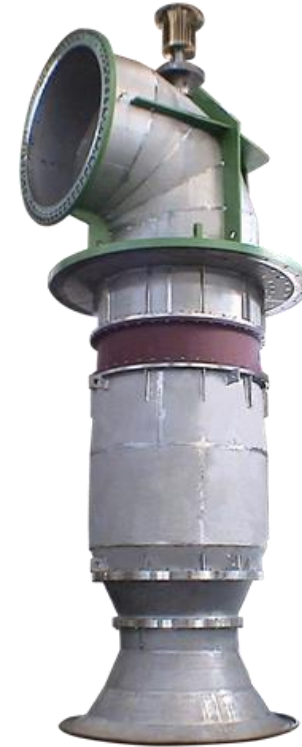
Figure Actual pump structure

Type & Size	2,200mm
Rotational Speed: N	295min ⁻¹
Rated Capacity: Qr	53,600m ³ /h
Rated Head: Hr	27.0m
Motor output	5000kW
NPSHA	15m
NPSH3	9.5m at Qr(nss=1630)
ns (min ⁻¹ , m ³ /min, m)	745

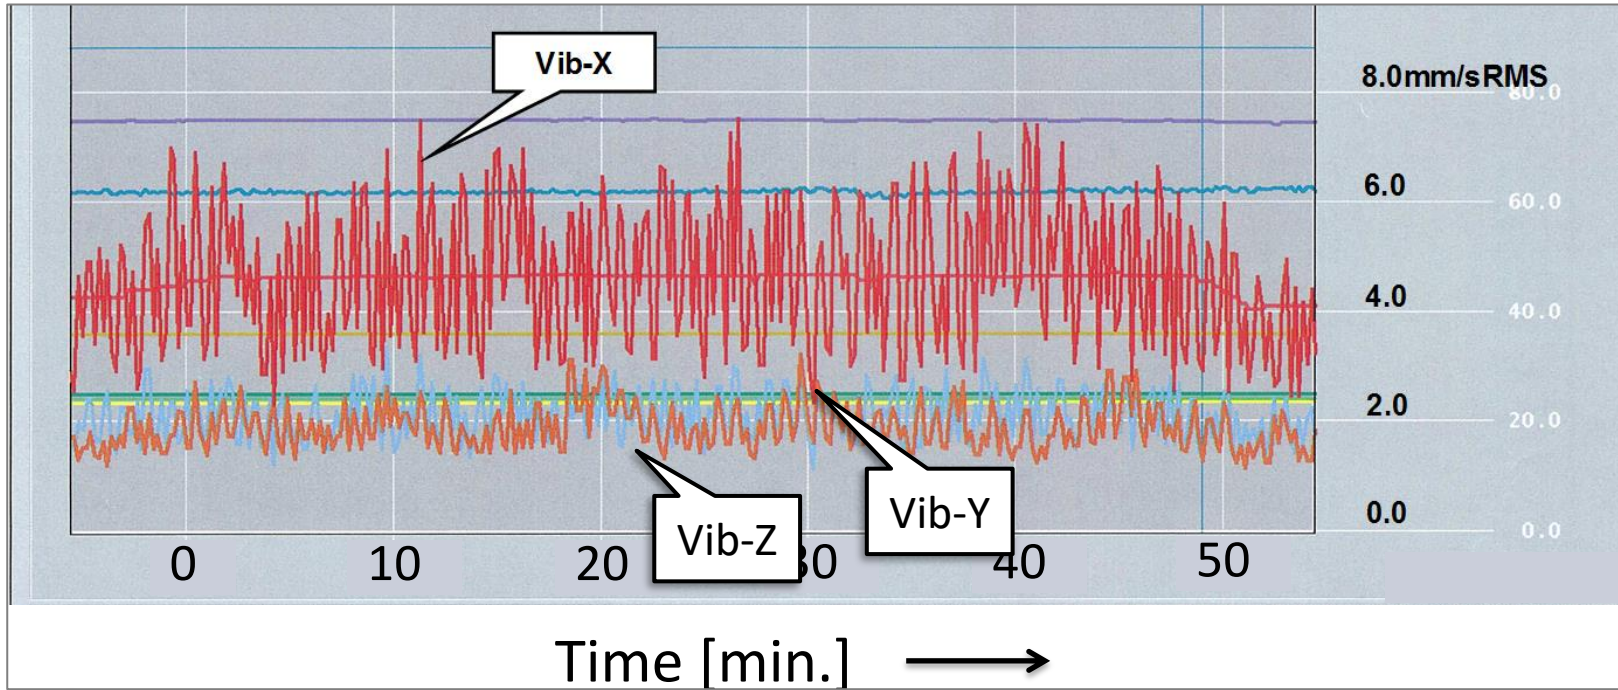
As shown in the below, the vibration level was high and intermittent.

POSITION: Pump's thrust BRG,
X: 90deg from Dis. direction, Y: Dis. direction, Z: Axial

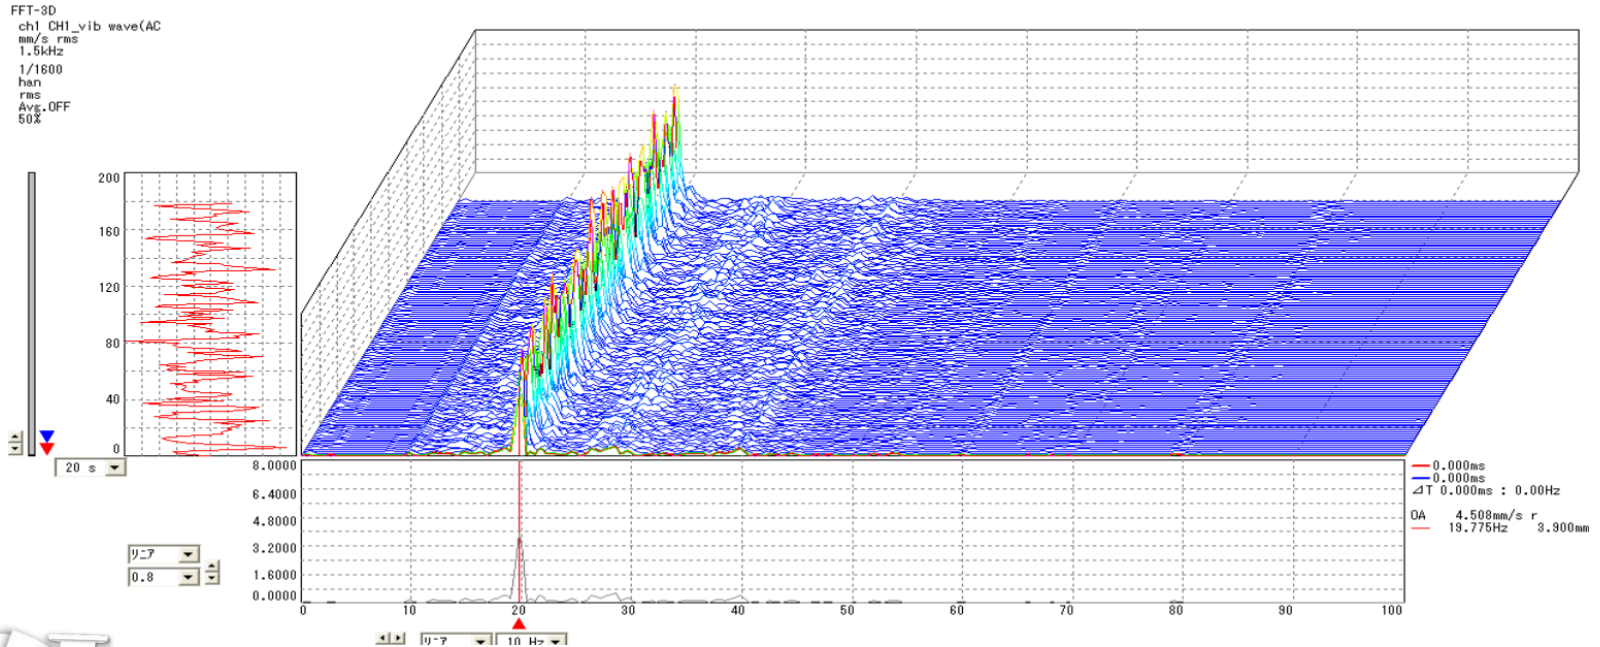
Figure Water fall diagram for vibration at pump thrust bearing and discharge direction

The site investigation was carried out and it was found that the dominant frequency was blade pass frequency: Blade number $Zr=4$ x Rotational frequency : $N=4.9\text{Hz} \doteq 20\text{Hz}$).

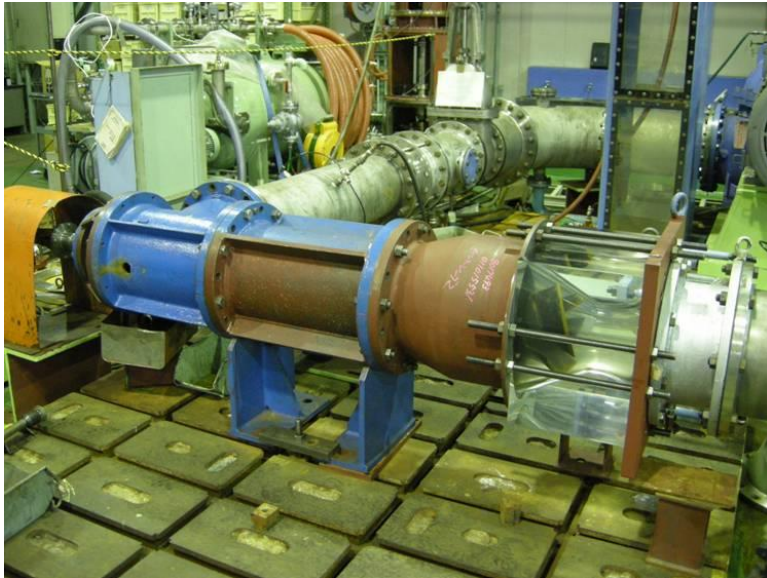
Photo. Schematic view of model pump

Physical model test was performed to find the real cause of the vibration by investigating the internal flow of the pump.

Design conditions	
Suction and discharge diameter (mm)	300
Design flow rate: Q_d (m^3/min)	18.86
Design total head of pump: H_d (m)	25.3
Rotational speed: n (min^{-1})	2088
Specific speed: ns ($min^{-1}, m^3/min, m$)	760
Cavitation number: σ_3 (NPSHA)	0.53(15.0m)

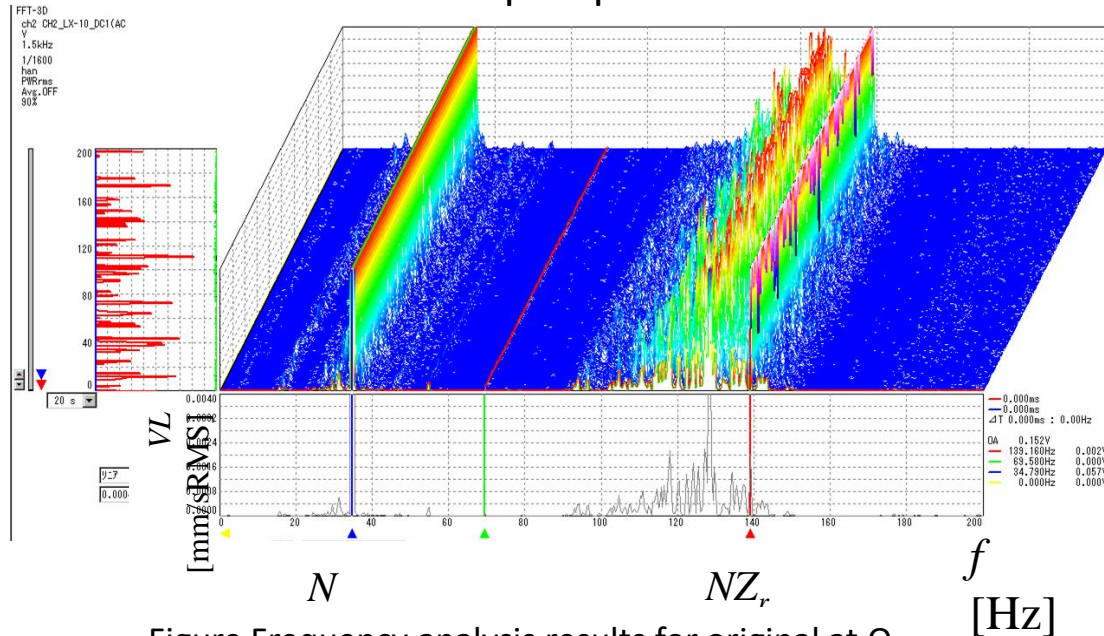
Figure Frequency analysis results for original at Q_{BEP}

Vibration : The below figure shows the frequency analysis result of vibration at discharge direction and Q_{BEP} in the case of original impeller. It is evident from this that the dominant frequency is the shaft rotating and the blade passing frequencies. Additionally, the level of blade passing frequency changes intermittently. Therefore, the same phenomenon was confirmed in the actual pump.

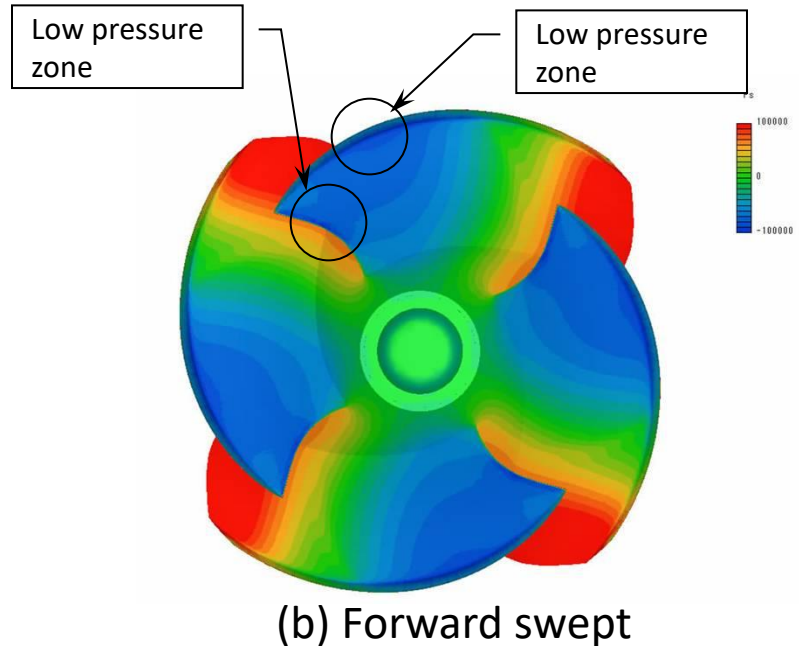
CFD analysis was performed to estimate the effect of new impeller design on suppressing the cavitation intensity. The summary of the results is as follows:

- Low pressure zone moved inlet tip side to the middle of the leading edge
- The secondary flow at radial direction is suppressed by the forward sweep.
- Consequently, the blade loading decreases around the leading edge at the tip.

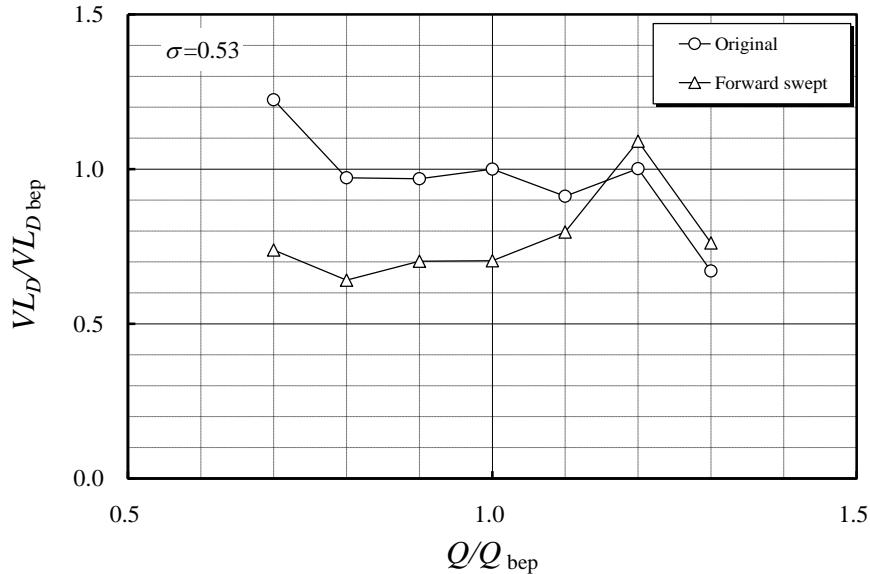
Figure Comparison of vibration level between original and forward swept impellers

Vibration: Below figures show the comparison of the vibration level between the original and the forward swept impellers. From this figure, the vibration level in the forward swept impeller decreases at both directions compared with the original.

(a) Discharge

(b) axial

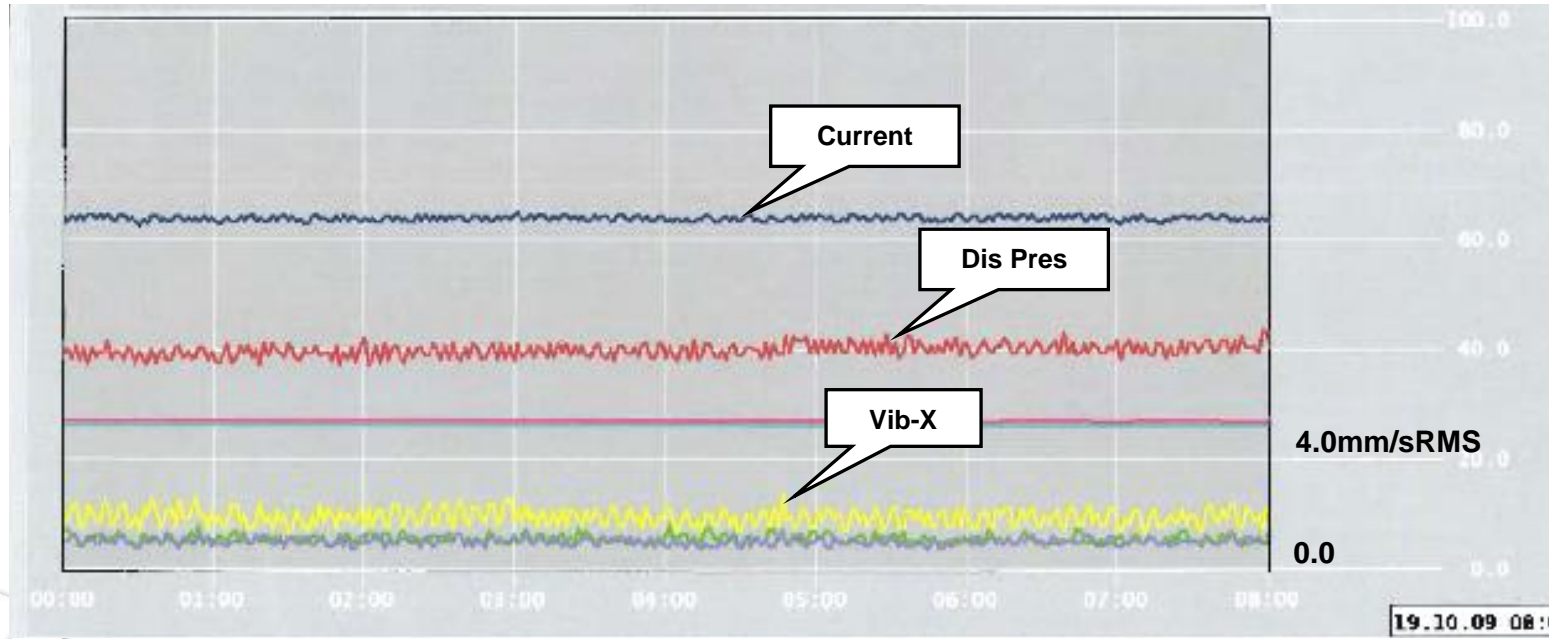
Figure Site test results by new impeller

SWSP with new impeller was operated and the vibration level in all of directions had drastically decreased up to 2.0mm/sRMS. This confirmed that the RCA and impeller design improvement was the correct solution for this vibration problem.
