ASIA TURBOMACHINERY & PUMP SYMPOSIUM  
12 - 15 MARCH 2018  
SUNTEC SINGAPORE

## ATYPICAL RESULTS FROM IMPROPERLY SIZED & CHARGED PULSATION DAMPENERS

At a facility with four quintuplex pumps, pulsation dampeners were being used to control pulsations in the discharge line. However, the initial dampeners were both undersized and undercharged for the application. As a result, in addition to some typically expected results, including high pulsations and frequent failures of the internal bladders, the effective volumes of the dampeners and lengths of piping in the system set up an acoustic natural frequency that caused significant safety concern and limited system operability. This natural frequency was in a range that could be excited by the pumps such that the presence of the dampeners in the system was actually causing even higher pulsation levels. This paper will look at the troubleshooting efforts including field testing and acoustic simulations. Results from the modified system will also be discussed.

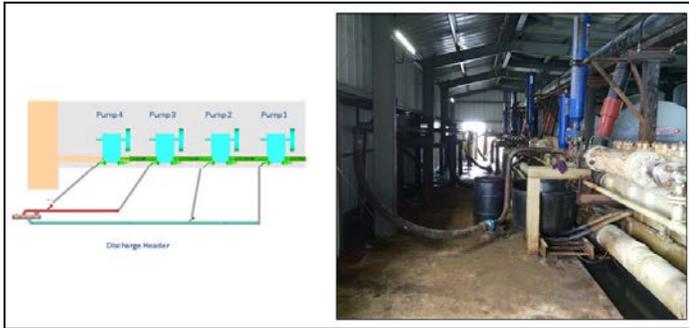
**Figure 1: Facility Layout**

A discharge piping system, as shown in Figure 1, being supplied by four (4) positive displacement (PD) quintuplex pumps operating in parallel at Liberty Resources', end-user, site was experiencing excessively high vibrations and numerous failures.

The facility, as illustrated earlier in Figure 1, consists of four pumps connected to a split discharge header before running underground to two well locations.

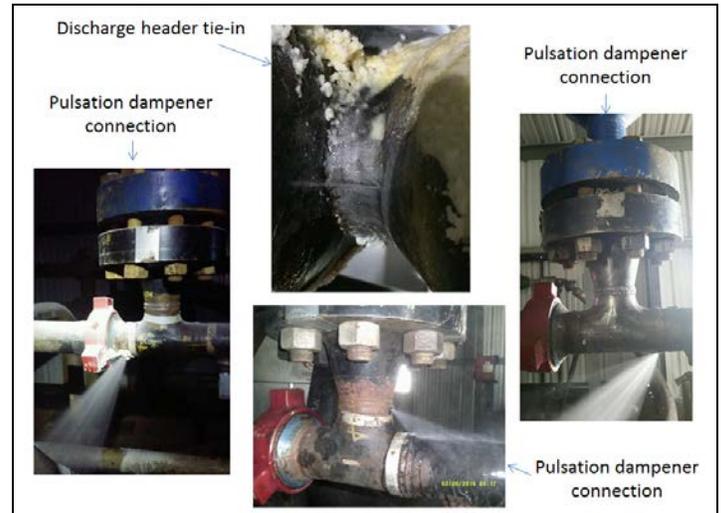
**Figure 2: Examples of Recent Failures in Piping**

The discharge header was also redesigned in an attempt to better control the fluid introduction from each pump into the piping. The discharge header was built by a well-known and reputable fabrication firm. A material change was made to more ductile steel as well as increasing the piping wall thickness. A large emphasis on quality control and inspection was placed on the welding and fabrication of the discharge header as the end-user was first told that improper welding was a contributing factor to the original failures. The constraint points of the discharge header were also modified and the running speeds of the pumps were adjusted to offset the running frequencies. All attempts failed in reducing the vibrations on the discharge piping, and as such failures still occurred, as shown in the examples of Figure 2.

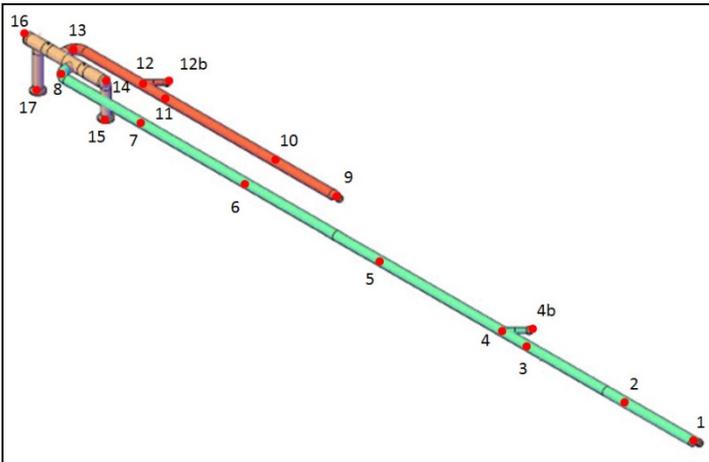
**Figure 3: Header Test Points**

Dynamic pressure transducers were installed near the pump on the discharge line of each pump, and on the suction line of pump 1. The velocity probes, as previously mentioned, were roved around the entire facility. Test points on the header are shown in Figure 3. Where possible, vibrations in all three directions were recorded for these points. However, in most locations, vibration measurements were limited to horizontal (perpendicular to the piping run) and vertical measurements.

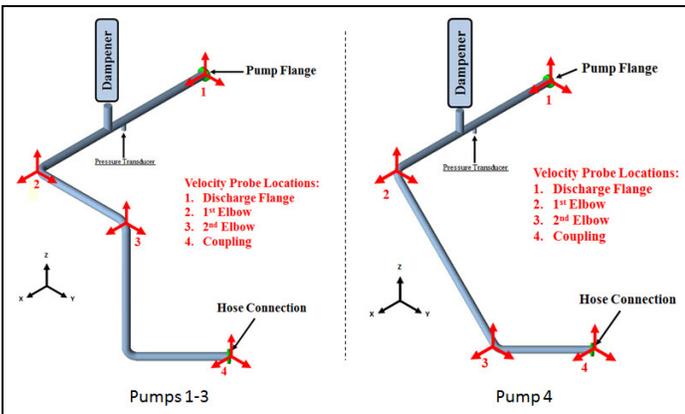
**Figure 4: McGregor Pump Discharge Test Points**

Vibrations were also measured on each of the pump discharge lines. Given the similarity between pumps 1-3, the test points were identical whereas the points on the pump 4 discharge line are similar but ultimately unique given the different geometry. The test points for all four discharge lines are illustrated in Figure 4.

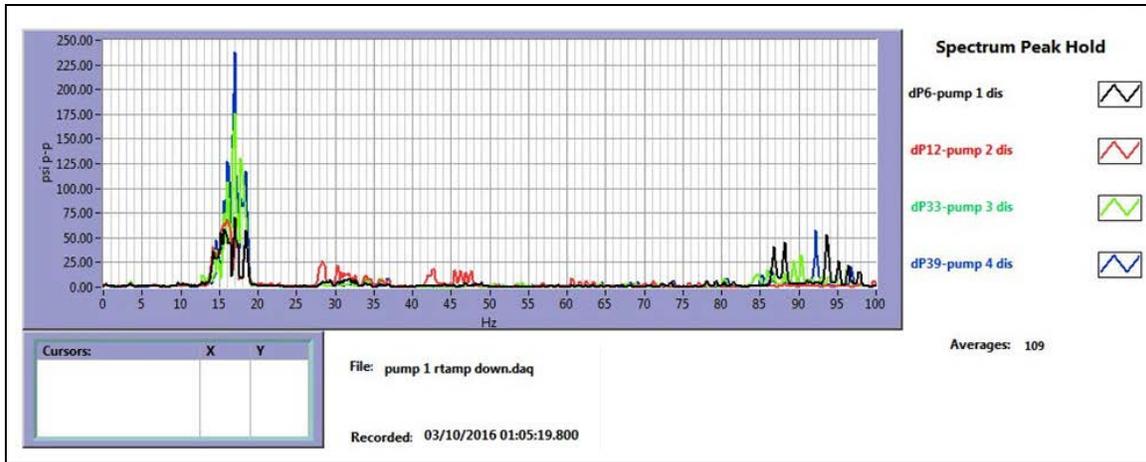
Figure 5: Ramp-Down Pulsations

Measurements at the facility showed strong dynamic responses in both vibrations and pressure pulsations of the discharge system near the fifth order of running speed for the individual pumps. Measurements for pulsations on the discharge lines for the four units are shown in Figure 5 below for the period of time when the units were changed in speed from the normal operating speed to a lower operating speed.

The high peak of the Pump 4 discharge pulsations (blue curve) is indicative of an acoustic resonance in the piping system.

Initially, the unit speeds were dropped by 5 percentage points; however, this resulted in elevated pressure pulsations and vibrations. Therefore, speeds were dropped an additional 5 percentage points.

The peak seen in the ramp-down data (Figure 5) occurs at approximately 17 Hz. Given the speed of the units, the 3<sup>rd</sup> and 4<sup>th</sup> pumps were providing excitation nearly exactly at this frequency during their period of running at the medium speed; hence, the large amplitude of measured pulsations. Pulsation measurements made during the period when the pumps were at their medium speeds are shown in Figure 7 below. Pulsations measured on the 1<sup>st</sup> and 2<sup>nd</sup> pump discharges do not show amplitudes of those seen by the 3<sup>rd</sup> and 4<sup>th</sup> pump because they are running well below this frequency in the low and medium speed cases, and do not run close enough to the acoustic resonant frequency in the high speed case.

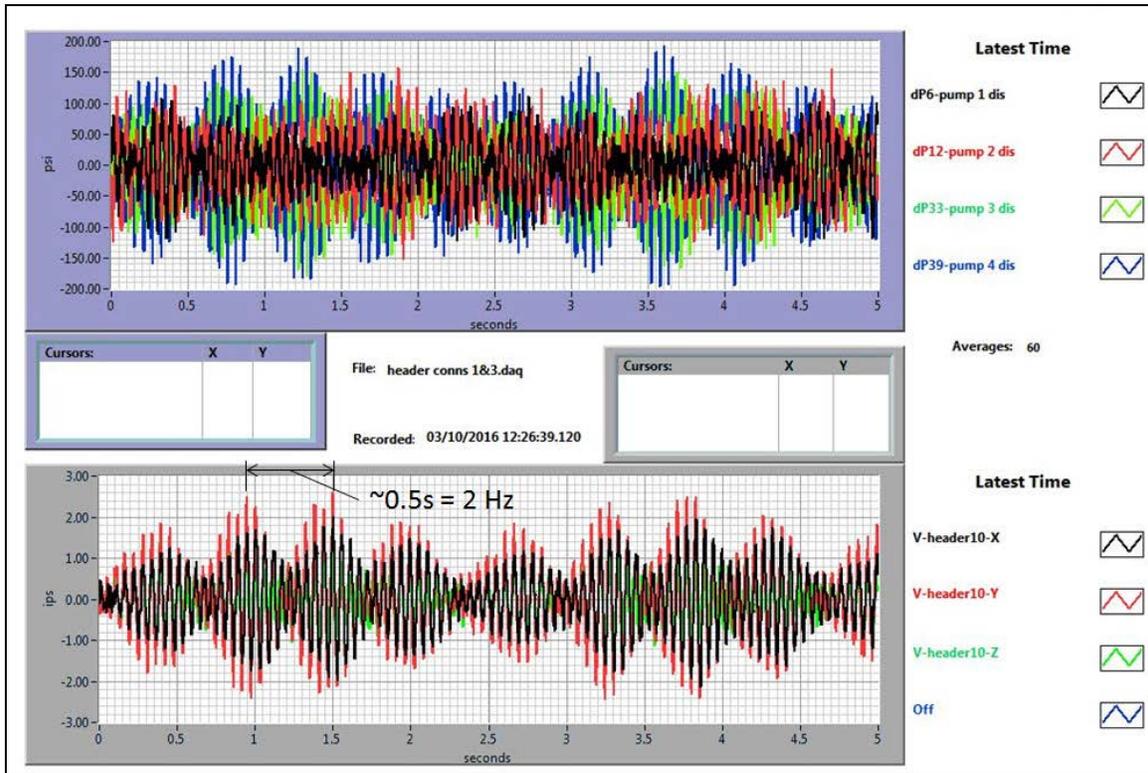
Figure 6: Beating Response in Raw Time Wave Signals

Analysis of the pressure pulsation spectra during the various speed changes indicates that the speeds of the various pumps ranged from 2.8 Hz to 3.7 Hz, or 168 rpm to 222 rpm. The running speeds for the various pumps are shown in Table 2 below, along with the resulting plunger frequencies (or 5x running speeds). In general, the pumps can be grouped into two sets: pumps 1 and 2, which run at speeds roughly 0.4 Hz lower than pumps 3 and 4. This difference of 0.4 Hz running speed generates a difference of about 2 Hz at the plunger frequency. And it was this difference in the primary pulsation response of the units that was the source behind the “beating” responses that are audibly and visually apparent to on-site personnel. The beating was also apparent in the raw time waves of measured data, as shown in Figure 6, where the time difference between peaks of the vibration data measured on the header (lower graph) was equivalent to a 2 Hz signal.

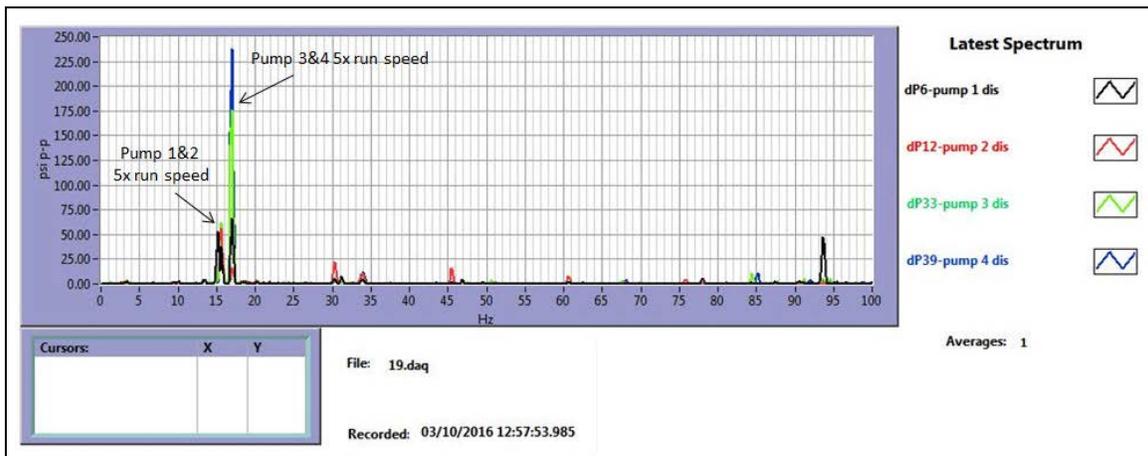
Figure 7: Middle Speed Pulsations

The pulsation measurements also showed that the two sets of pumps (1 & 2 and 3 & 4) were not isolated from each other. As such, there were pulsations that traveled between the two sets so that frequencies of vibrations were present on all pumps at both running speeds. However, the pulsations associated with Pumps 3 & 4 were more prevalent simply due to the higher amplitudes that were being generated.

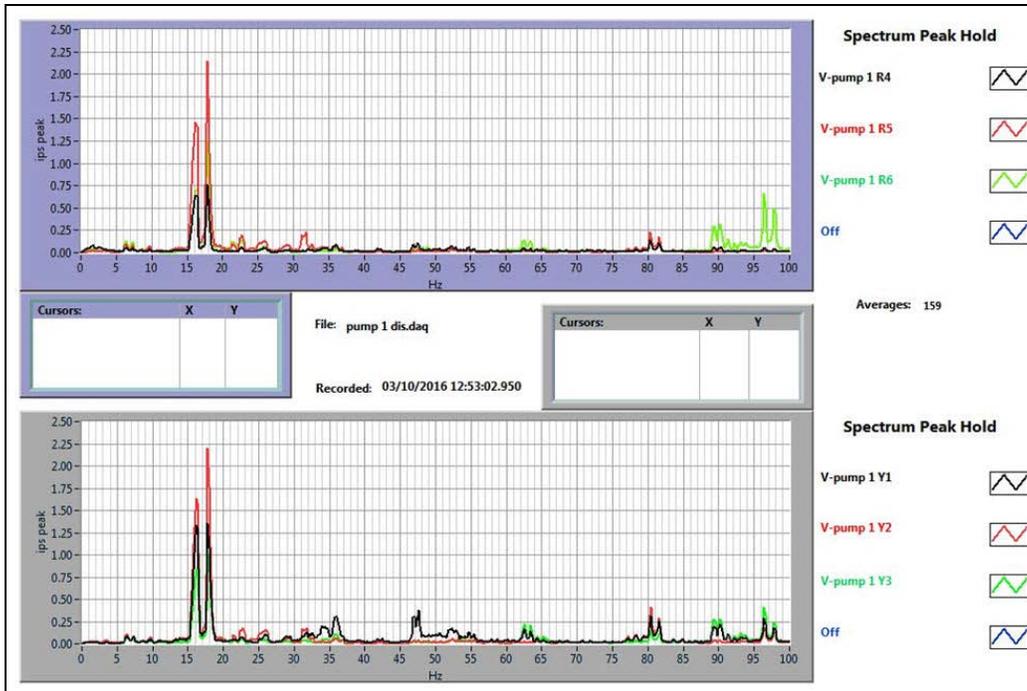
Figure 8: Pump 1 Discharge Piping Vibrations @ High Speed Operation

In terms of vibrations, amplitudes were generally greater at the high-speed case than the low-speed case due to the amount of energy required to go into running at higher speed. The middle speed case picks up due to the coincidence with the acoustic resonance, but in terms of evaluating the vibrations under normal operating conditions, the following figures are shown for the high speed operating case. Figure 8 through Figure 12 below show vibrations on the first and second elbows of the discharge piping of Pumps 1 through 4 respectively. The highest vibrations recorded were actually on Pump 1, with a peak at 17.8 Hz of 2.2 ips 0-p (inches per second zero-to-peak). Based on the contractor's general piping severity screening chart, this level of vibration fell into what was considered highly likely to fail. Given the limited restraints on this piping, some flexibility can be taken into account, but there was enough restraint and stress concentration along this piping (also considering the large mass of the pulsation dampener), that these vibration levels were considered excessive. And given the history of these units, there was no doubt that these vibrations should be corrected.

The coincidence with frequencies of internal pressure pulsations means the vibrations were likely a result of the pulsation energy coupling to the mechanical piping. In addition, operating deflection shape (ODS) modeling of the vibrations was used, and showed that the major points of motion were at the elbows of the discharge piping; which were ideal locations for pulsation energy to couple to the mechanical system. Therefore, the ideal resolution focused on the removal of the pulsation energy to avoid excitation of the mechanical system altogether. This was actually the primary focus of the second part of this project, the acoustic modeling, which is discussed in later sections.

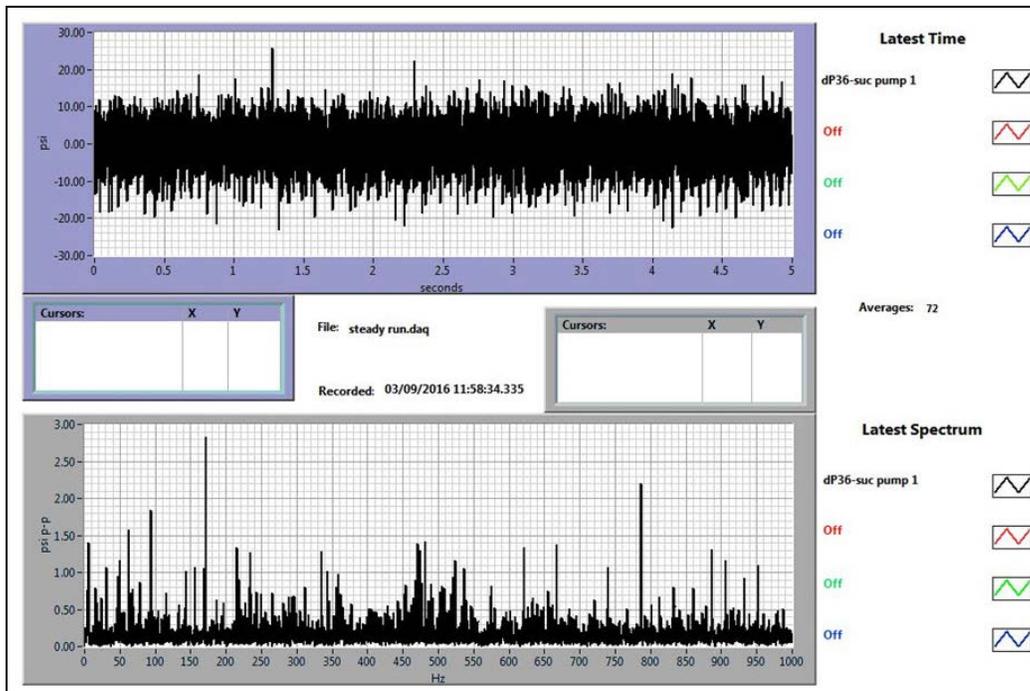
Figure 9: Suction Line Pulsations

Pulsations were also measured on the suction side of Pump 1, example shown in Figure 9, to determine the possibility of cavitation occurring on the suction side of the pumps. Overall and spectral pulsation levels in these signals were significantly less than what was seen on the discharge side. The overall timewave pulsations generally ranged from about  $\pm 20$  psi. Given a static pressure of 39 psi, this meant pressure on the suction side dropped to no more than about 19

psi. This pressure would be sufficiently above vapor pressure for the water that the chance of cavitation occurring in the pumps was not considered significant. Additionally, the low levels and overall appearance of spectral pulsation did not indicate the likelihood of cavitation either.

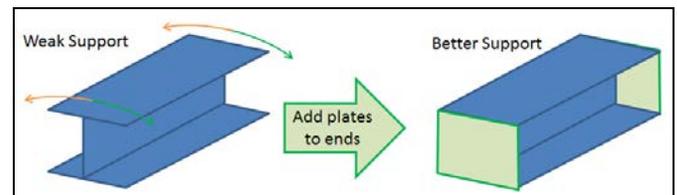
**Figure 13: Supports for Small Elevated Piping**

Locations and attached support structures for these clamps were also critical to proper performance of the system. Ideal routing of piping would place large headers and long runs of pipes close to grade for easy support. Frames built up to support piping would also be stiff in all three directions. For example, the small supports made from I-beams for some of the discharge pipes with added plates on the ends were much better supports than the I-beams by themselves (see Figure 13); some locations already had this modification, but this modification should be applied to all instances.

In general, contractor recommended that any restraints added to the system be of sufficient size and stiffness to provide adequate restraint and damping. Part of these clamp designs call for damping material between the piping and the clamp as well as between the piping and the support under the piping. This material would provide not only good contact between the piping and restraint, but would also provide wear resistance and vibration damping.

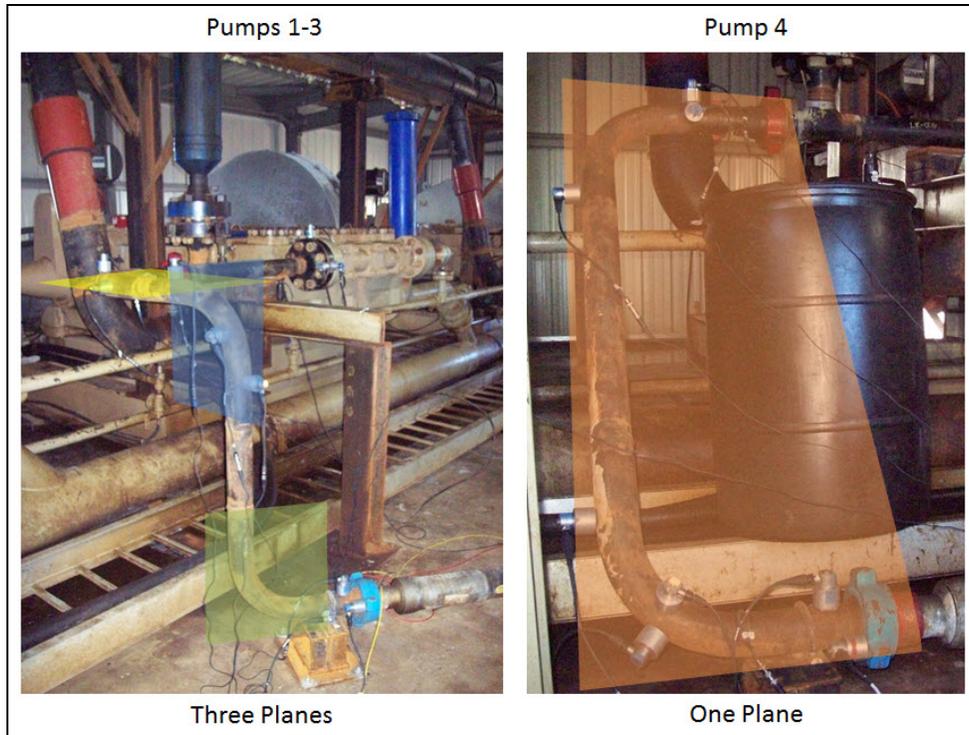
Figure 14: Planes of Excitation

Some specific locations that might benefit from added supports were the various pump discharge pipes. Especially those on Pumps 1 through 3; the number of elbows and lack of supports mad this run of piping very loose with numerous mechanical resonance modes that could be excited. In comparison, the discharge piping on Pump 4 is shorter, with one fewer elbow, so the piping would be stiffer and less prone to excitation at lower frequencies. In addition, the orientation of the elbows on Pump 4 meant there were fewer planes of excitation (see Figure 14 for an illustration of this concept), so there was less chance of exciting multiple modes.

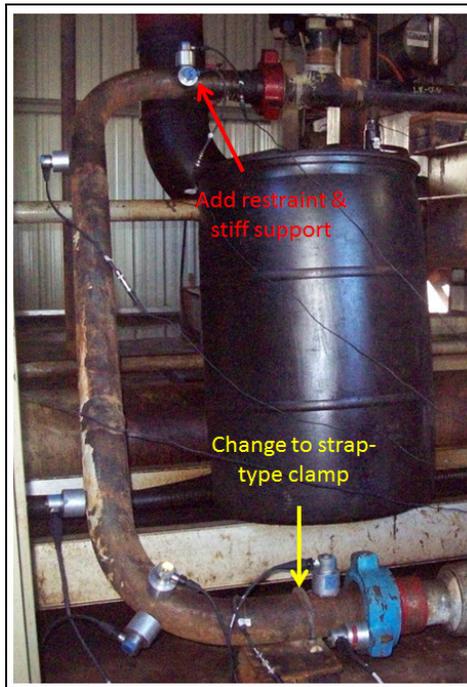
Figure 15: Restraint Recommendation for Pump 4 Discharge Piping

The ideal installation would place the header near the ground using strap-type clamps with adjustable wedge blocks to restrain header motion, and using well-supported lateral piping (or possibly flexible hosing) from the pumps with limited use of elbows. In lieu of this type of major modifications to the header design, it would be desirable to replace all discharge pipes with a design similar to Pump 4, with some added restraints, as shown in Figure 15. Alternatively, if the piping design is kept the same for Pumps 1-3, restraints should be added as indicated in Figure 16.

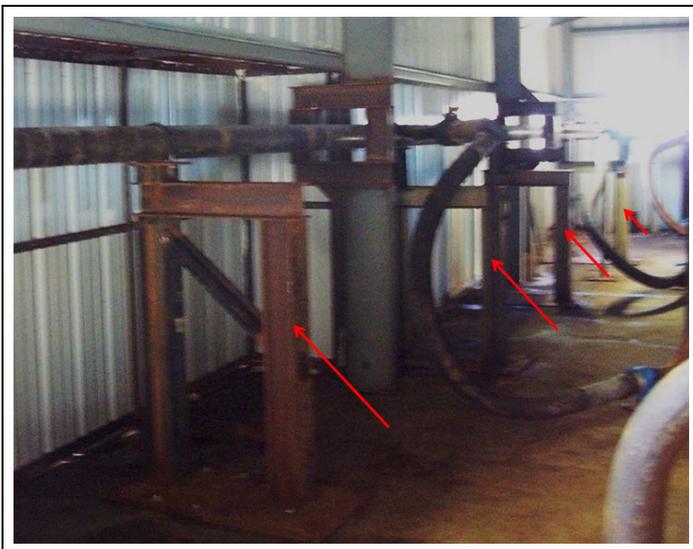
**Figure 17: Supports on Header**

Besides the discharge piping, a number of supports on the header could also be altered to improve vibration response. In particular, there are four supports (identified in Figure 17) on the header with similar designs that are prone to mechanical resonance excitation. The very first one in this image was particularly susceptible to vibration, with a resonance at 17 Hz and mode shape as indicated in Figure 18.

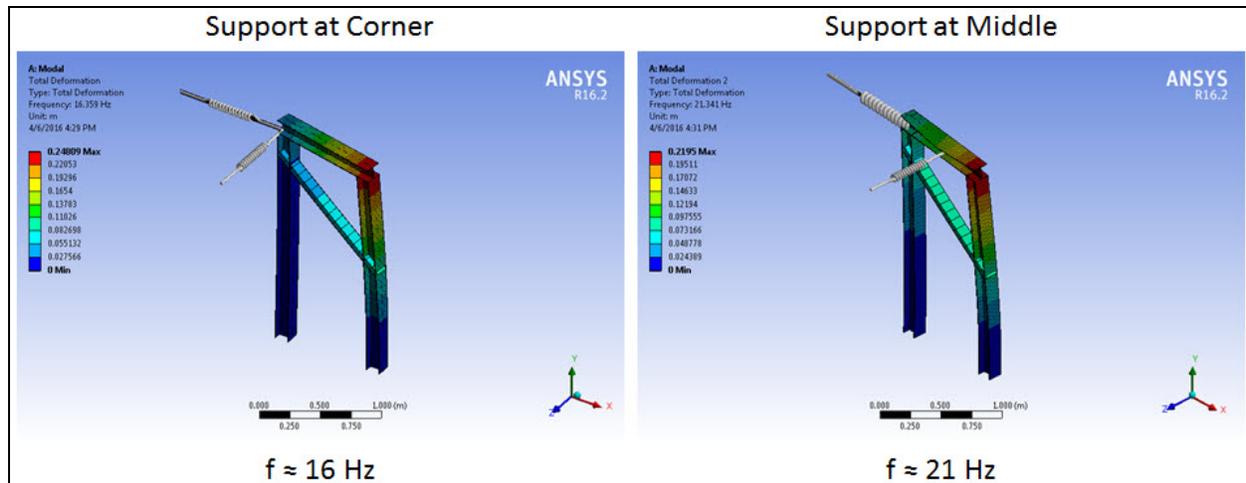
**Figure 19: FEA Results for Support Location**

Ideally, as previously mentioned, the header would be lowered closer to grade so that it could have shorter supports. Given the necessity of remaining at this elevation, however, the next best option is to provide additional bracing to stiffen the support in the direction of the pipe axial direction. At the very least, a rough FEA model of this support shows that by simply moving the support over, so that the pipe is supported in the middle of the cross-beam instead of at the corner, the first natural frequency could be increased as illustrated in Figure 19. (Note: this is not an exact model of the support, but only a conceptual illustration of the possible support; therefore, natural frequencies were not expected to be an exact match to field data.)

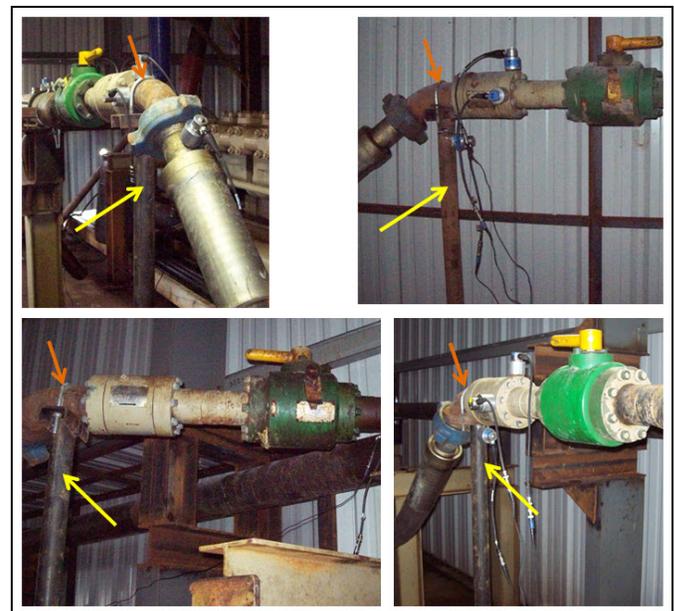
**Figure 20: Weight Supports on Header**

As with the supports on the discharge piping, changing the simple U-bolt restraints for strap-type clamps was also recommended wherever the pipe was restrained. Other restraints also existed on the header, as shown in Figure 20, that were in essence only weight supports given the high length-to-diameter ratio of the supporting pipes (yellow arrows). As such, the U-bolt restraints would do little more than possibly wear on the pipe. Replacing the U-bolt restraints with a pair of supporting wedge blocks with proper low friction material would be more adequate. This would also allow for adjustments so that the header piping would be supported given any thermal expansion that could lift the pipe off the support. It was noticed while on-site that the support for the connection of Pump #1 (shown in the upper right image of Figure 20) was only providing limited, if any, weight support as the pipe was lifted off its ground support and could be moved by hand.

If these supports were, however, meant to provide more than just weight support, the piping should be replaced with an appropriate framed structure using a strap-type clamp restraint as discussed earlier.

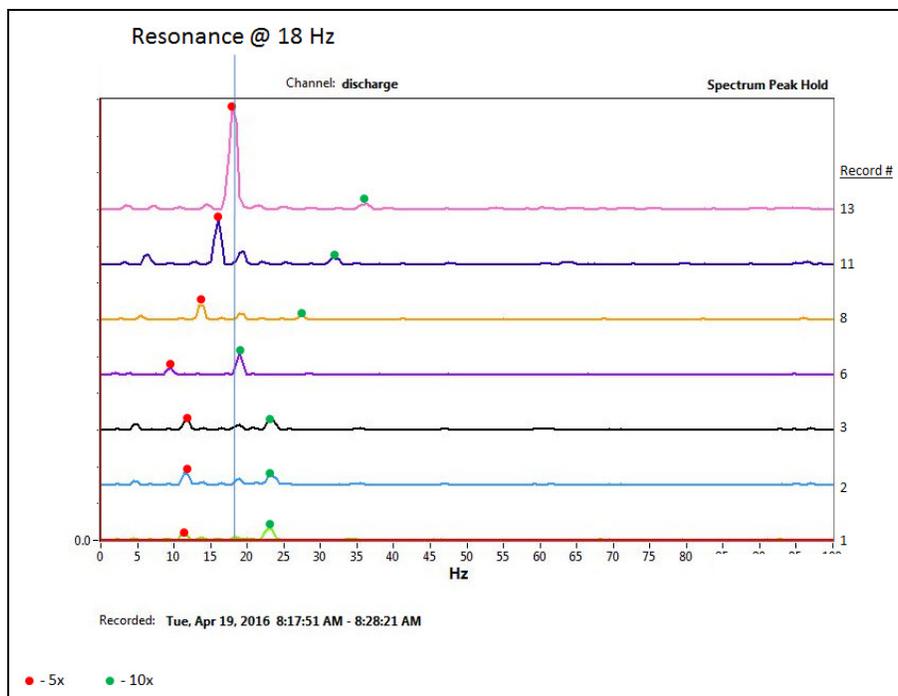
**Figure 21: Oil Pulsation Data - Set 1 Discharge Spectra**

Based on the first set of data collected by this means, it was determined that a resonance in the system with oil as the working fluid existed at about 18 Hz, as shown in Figure 21. This resonance was seen as the 5x order of running speed neared the resonance (especially during the 13<sup>th</sup> record), and also when the 10x order of running speed was near the resonance (as seen during the 6<sup>th</sup> record).

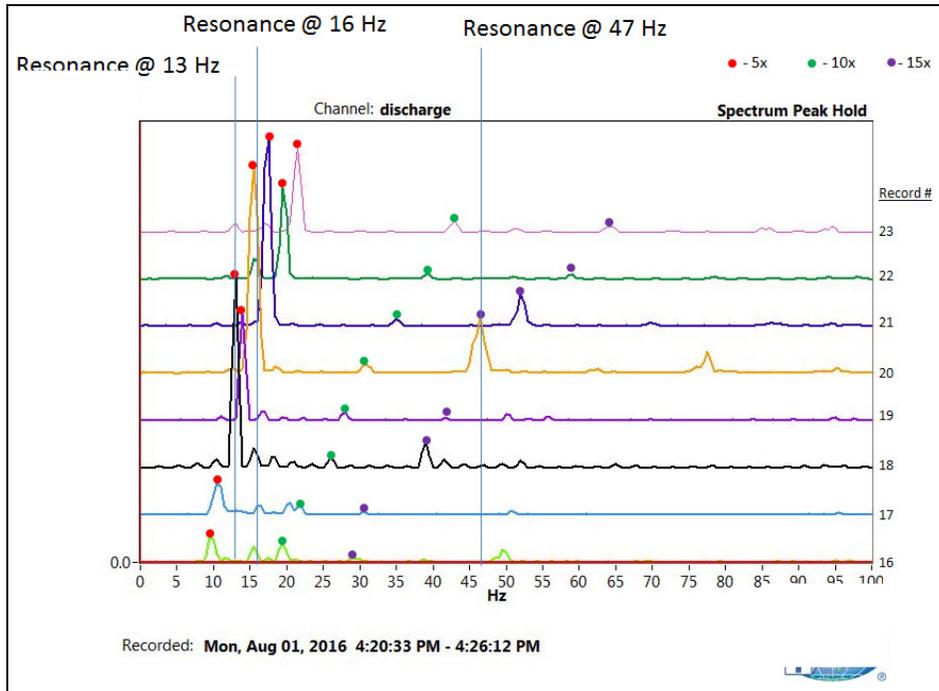
Figure 22: Oil Pulsation Data - Second Set with Blown Bladders

Data in the second set of post-field data indicated additional possible responses. Initially, with the bladders blown and the dampeners fully deactivated, possible acoustic resonances existed at 13 Hz and 16 Hz as shown in Figure 22. There was also the chance of higher frequency modes being

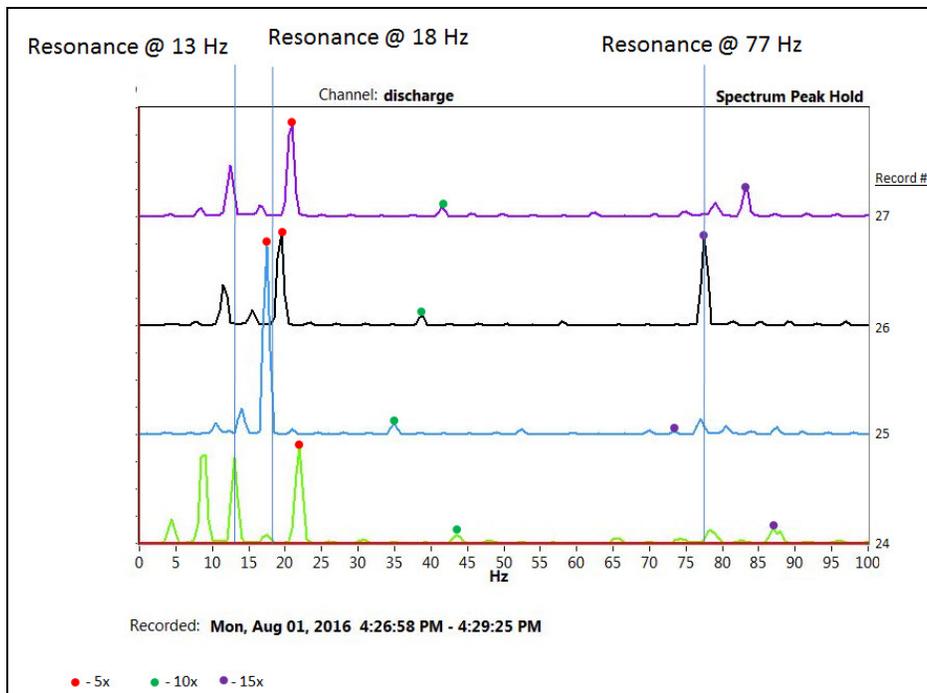
Figure 23: Oil Pulsation Data - Second Set with Replaced Bladders

excited by higher orders of running speed (in particular the 15x response seemed to be elevated in the 40-55 Hz range). After the bladders were replaced the 13 Hz mode appeared unaffected, but the 16 Hz mode increased to approximately 18 Hz. Additionally, the higher order mode seemed to be more prominent near 77 Hz. These are shown in Figure 23. Also, besides the shift in possible acoustic resonance frequency with the bladders being replaced, a noticeable decrease in the amplitudes of pulsations was visible as shown in Figure 24.

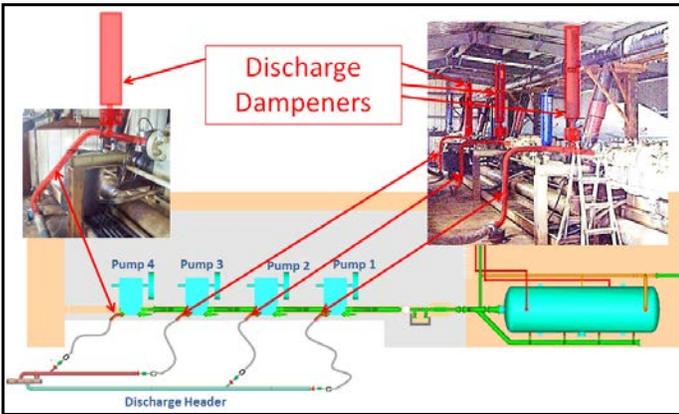
**Figure 25: Schematic of Discharge Piping Layout during Field Testing – “Existing System”**

The acoustic piping model was constructed using the dampener and pump manifold piping drawings provided by the end-user. A schematic showing a representation of the piping system under investigation is included in Figure 25. Acoustical data was recorded for the operating conditions described in Table 3.

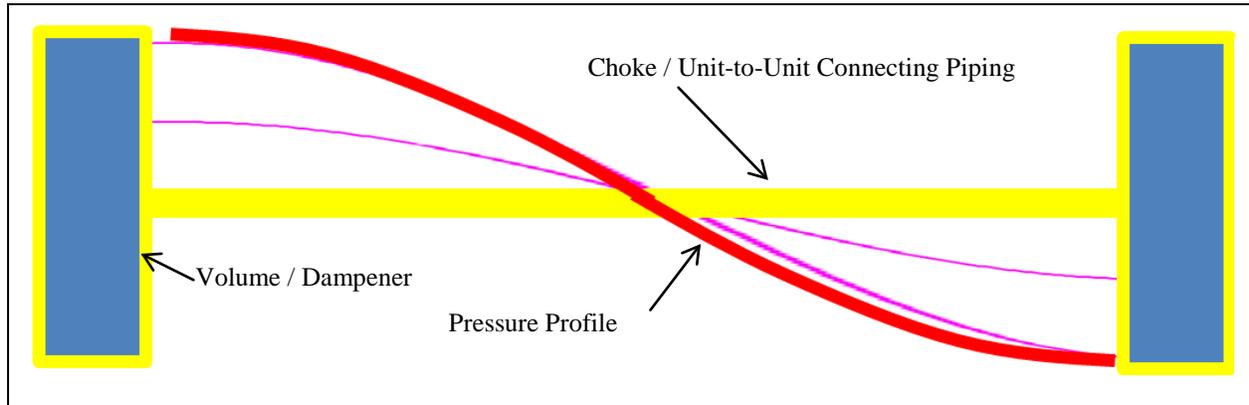
**Figure 26: Pressure Profile Plot for a Volume-Choke-Volume Piping Configuration**

It was determined by analytical calculations and confirmed with software modeling predictions that a piping system acoustic resonance existed in the original piping system. The acoustic resonance went from unit-to-unit. A Helmholtz-type resonance between the units was being excited by the pump pulsations that were inherently generated at 5 times pump running speed because of the quintuplex arrangement of the pumps. A pressure profile, as noted in red and fuchsia sinusoidal-shaped lines in Figure 26, for a Helmholtz-type response has high amplitude pressure fluctuations at and near the volumes, which was what was observed and predicted for the facility. The frequency of the resonance was set by the effective volume of the dampeners, diameter of the connecting piping, and length of the connecting piping. Altering the connecting piping diameter and/or lengths could be implemented to shift the resonant frequency. However, to minimize piping changes, the dampener volumes were modified. By increasing the effective volume of the dampeners, the acoustic resonance could be shifted to a much lower frequency at which the system acoustic response would not be excited or amplified to unacceptable levels.

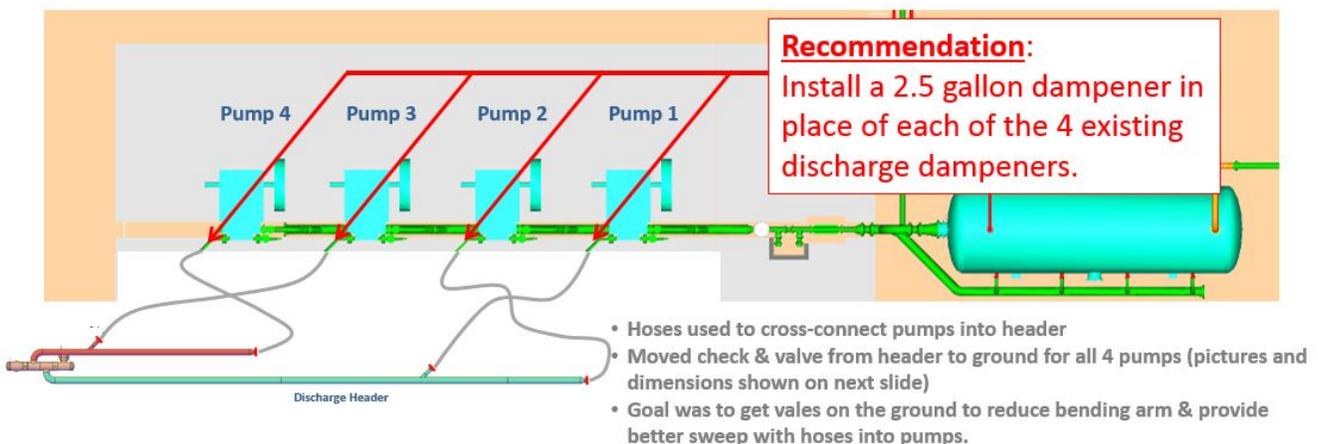
**Figure 27: Schematic of Discharge Piping Layout Shortly After Field Testing**

Several piping modifications and layout changes for shifting the acoustic resonance were discussed with end-user, and the system that provided the best balance between their needs, cost, and vibration reduction is presented in Figure 27. It was not necessary that the Pumps 1 and 2 and Pumps 3 and 4 lines cross each other. That was a piping layout modification that end-user chose to implement as an early field attempt to mitigate piping vibrations prior to the final recommended system modifications. The final system included the already crossed flex hoses and the recommended 9.5L dampener installed in place of each of the four existing/original discharge dampeners.

Based on the results of the pulsation analysis, it was recommended that 2.5 gallon gas-liquid dampeners be installed in place of the existing dampeners as noted on Figure 27, and that the pre-charge on these new dampeners be set to about 80% of line pressure per standard recommendations for gas-liquid dampeners.

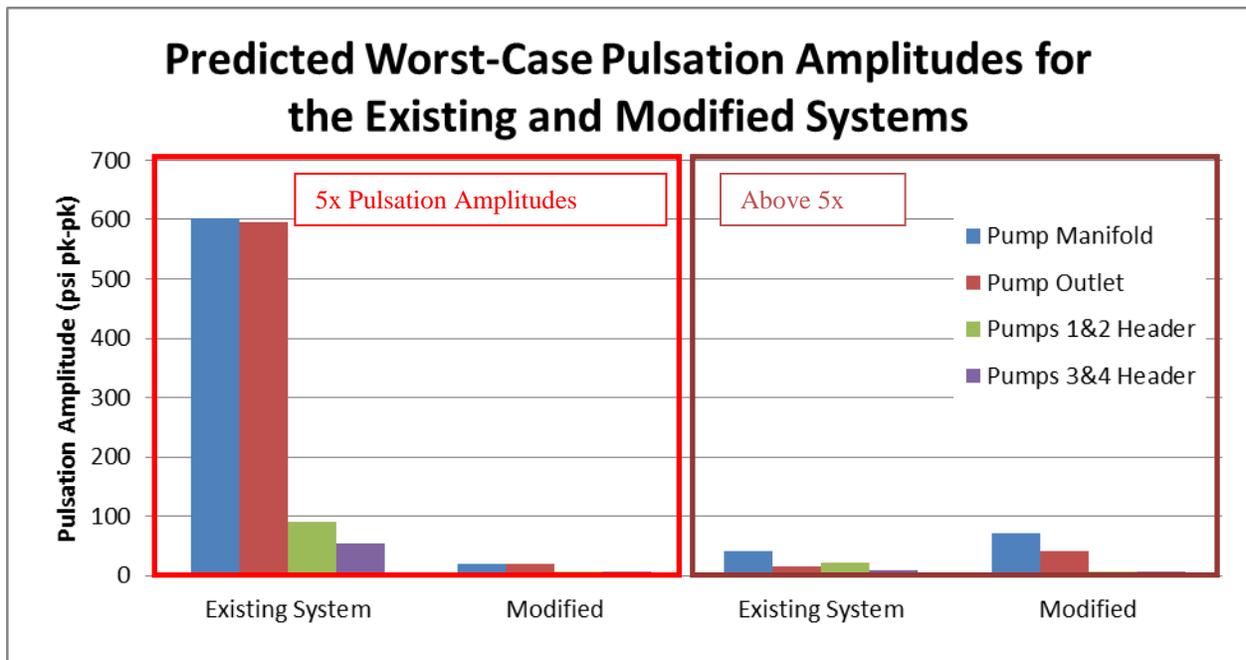
**Figure 28: Summary Graph of Worst-Case Predicted Pulsation Amplitudes**

The worst-case (assuming worst case phasing between units) predicted pulsations for the existing/original system and modified system, while pumping oil, are summarized in Table 5 and Figure 28. It was predicted that a pulsation amplitude reduction of 97% would be achieved for the worst case 5x pulsations. A pulsation amplitude increase was predicted at

orders above 5x; however, the overall reduction in the piping system pulsation amplitudes was considered significant and acceptable. It was predicted that shifting the piping system acoustic resonance to a frequency well below the primary pump excitation order (5x) would result in significantly reduced piping system pulsation amplitudes.

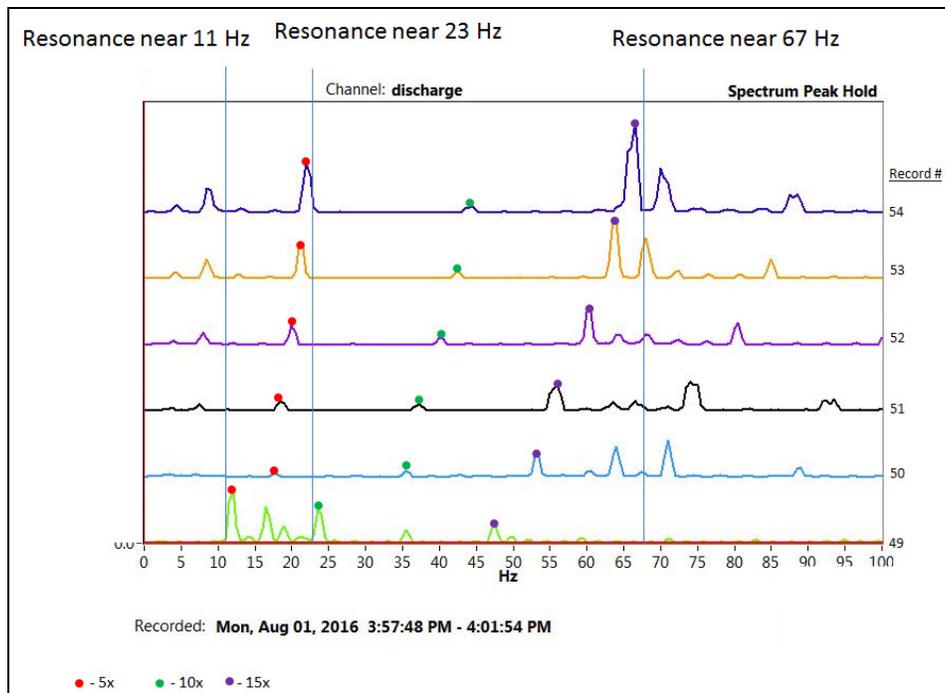
Figure 29: Post-Data – Third Set with Modified System

Final measurements made at the facility after the modifications recommended by contractor were implemented still show some characteristics of possible acoustic resonances, as shown in Figure 29. However, the overall pulsation amplitudes indicate these responses are well controlled and as such result in significantly reduced pulsations, as shown in Figure 30. Based on these results, it was evident that the modifications to the facility were
