ASIA TURBOMACHINERY & PUMP SYMPOSIUM
12 - 15 MARCH 2018
SUNTEC SINGAPORE

NOVEL FIBER OPTIC TECHNOLOGY MONITORS IN-SLOT VIBRATION AND HOT SPOTS IN AN AIR-COOLED GAS GENERATOR

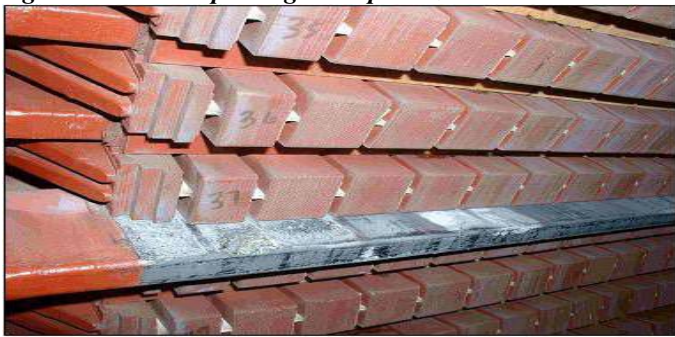
Fig. 3 – Complete winding insulation became destroyed at another power plant suspected to have similar problem.

It is hypothesized these were related hot spots developed in the stator, caused by Eddy current loops, formed when damage occurs between the insulation and the neighboring laminated steel plate. The hot spots reduced the performance of the insulation and PD subsequently occurred, eroding further the carbon paint. Furthermore, mica insulation also suffered from damage. PD activities would not have sufficient energy to puncture the mica. Therefore, another failure mechanism might be at work: vibration sparking. Such process is defined by excessive vibration occurring in the slot so that the carbon paint – normally maintaining ground contact to the stator – failed and high voltage appears at some of those disturbed locations and the air breaks down to form a plasma. Fig. 2 illustrates the concept. For the other side of the vibrating part, the plasma lost contact with its current source. This is a powerful source of electro-etching, an industrial process used to etch hard material like ceramics. If this process continues undetected, soon it would destroy completely mica insulation, leading to an unplanned outage (see Fig 3).

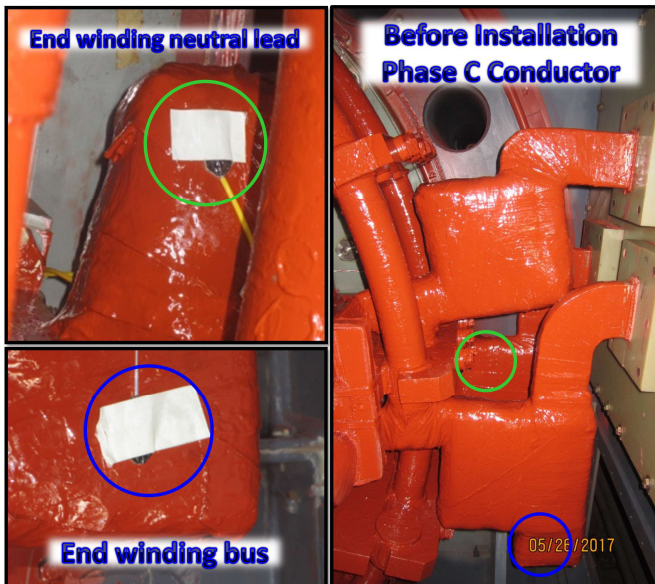
Fig. 10 – Two discrete sensors coupled at two different locations of the neutral bus of the phase C conductor.

One single point vibration sensor was installed at the end winding of the neutral lead as depicted in Fig. 10. The photograph at the right shows the end winding conductor before the sensor installation where the colored circles pinpoint where the two additional discrete sensors would end up coupled with.

A third vibration sensor was mounted on the neutral end winding bus (see Fig. 10). Once again, the vibration observed here is also consistent as depicted below in Fig. 12.

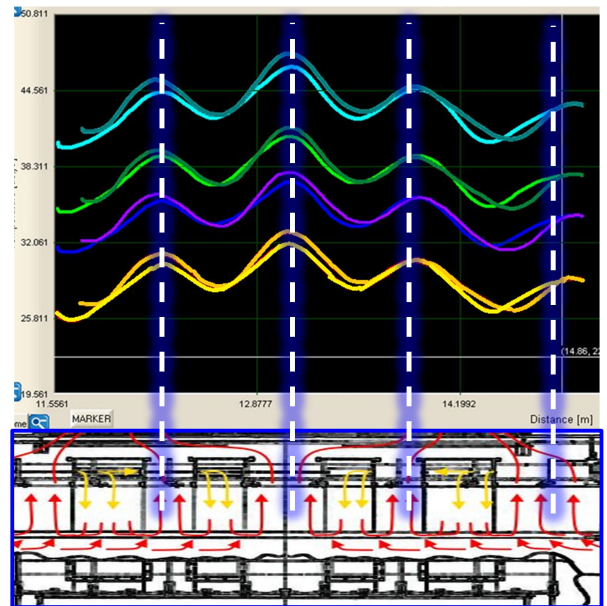
Fig. 15 – Temperature profile line-ups with the air duct locations.

We tried to line up the temperature profile with the layout of the air ducts by wrapping over at the middle. Valleys coincide very well with the air duct exhaust and the top peak always occurs in the middle between two air ducts where there are minimum cooling airflow (see Fig. 15). The difference between peak and valley is consistent at different loading levels.

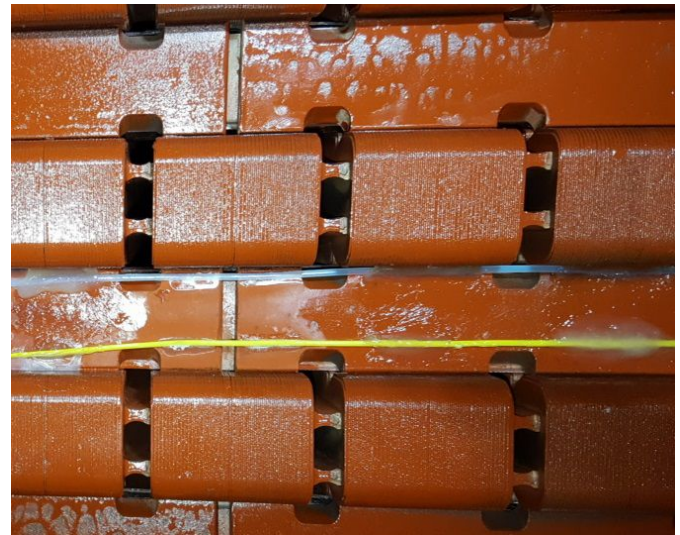
Fig. 19 - Top view of the core slot where the two Brillouin sensing arms are laid onto the wedge.

The temperature sensing fiber optic loop was deliberately placed asymmetrically. Referring to Fig. 19, the top sensing arm was set right at the foot of the wall where it would be affected by a shadowing effect. The cooling air would flow slightly outward in contrast to the other arm of the loop, which was placed close to the center of the slot, free from the shadow effect. The top represents the worst case.

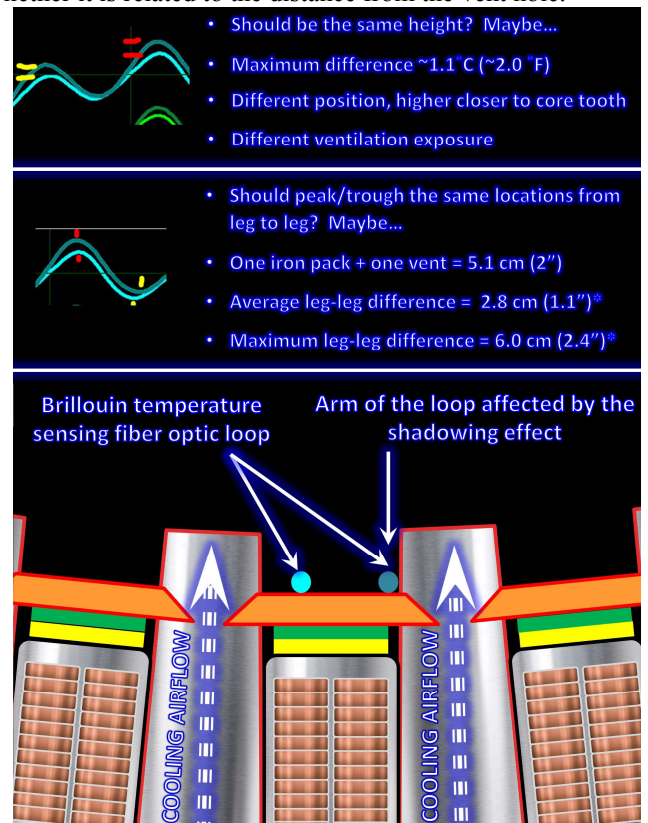
Fig. 20 - Diagram of a section of the stator core with slots filled with coils, ripple springs, wedges, etc.

The temperature difference between the two arms was found to be less than 1.1 degrees C (see Fig. 20). It is uncertain whether it is related to the distance from the vent hole.

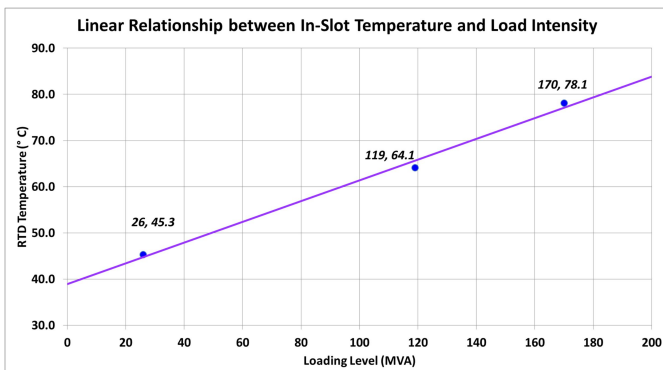
Fig. 21 – Temperature linear relationship between in-slot and load applied to the generator.

The temperature experimental data shows a linear correlation with the load applied on the generator
