ANALYSIS OF EXPERIMENTAL BEHAVIOR OF PRETENSIONED
CONCRETE BENT CAPS USING MOTION CAPTURE SYSTEMS

A Thesis

CODI DAVID MCKEE

Major Subject: Civil Engineering

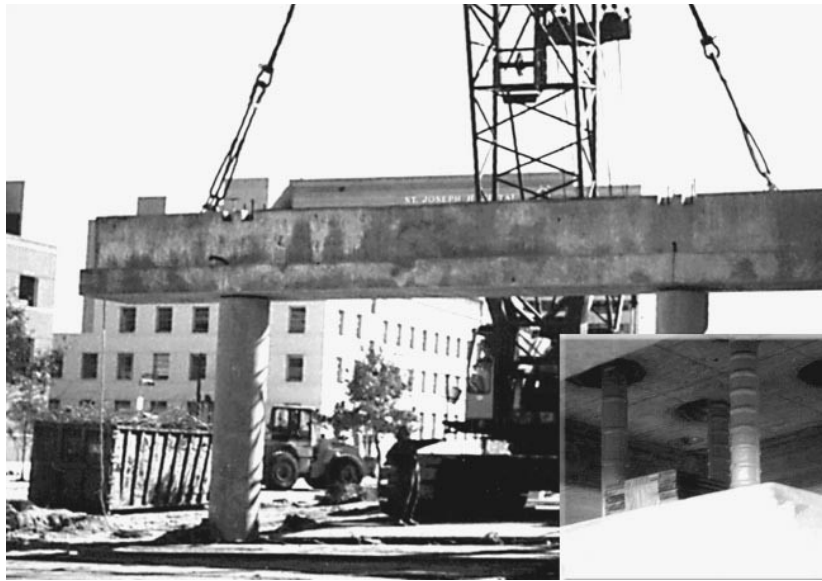
Figure 2.1. Pierce Elevated Precast Concrete Bent Cap and Beam-Column Connection (Jones and Vogel 2001).

To take advantage of the economic benefits of utilizing precast bridge elements TxDOT began the use of precast substructure elements in replacement of the Pierce

Elevated section of Interstate Highway 45 in Houston, Texas in 1996 (Jones and Vogel 2001). The project required the replacement of 113 spans of the elevated highway structure, with an estimated user daily delay cost of \$100,000. Using conventional TxDOT bridge construction techniques, the replacement project was estimated to take more than a year and half to complete. The final design for the structure replacement included the use of precast reinforced concrete bent caps to minimize the overall project length and the economic impact on commuters. The TxDOT engineers incorporated a beam-to-column connection (shown in Figure 2.1) that allowed for the minimal deviation from conventional reinforcement layout of the bent caps. The success of the Pierce Elevated project, and input from industry, lead to a push by TxDOT for research and development of precast reinforced concrete bent caps (Jones and Vogel 2001).

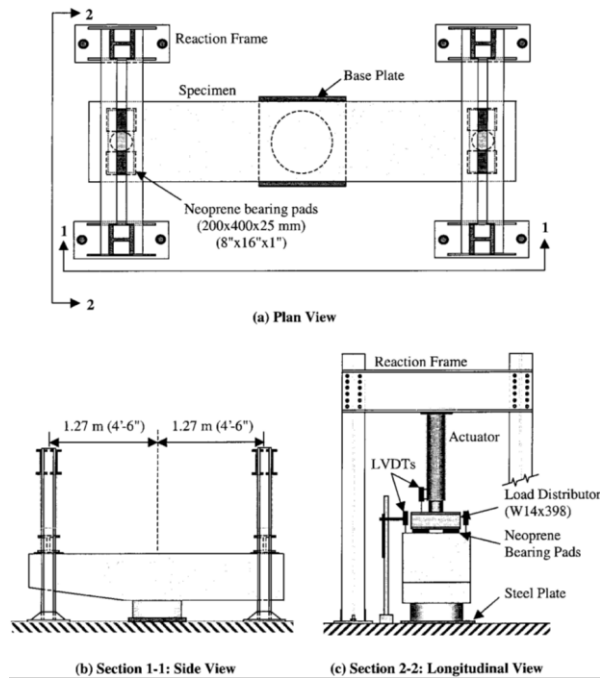
Figure 2.3. Experimental Test Setup (Young et al. 2002).

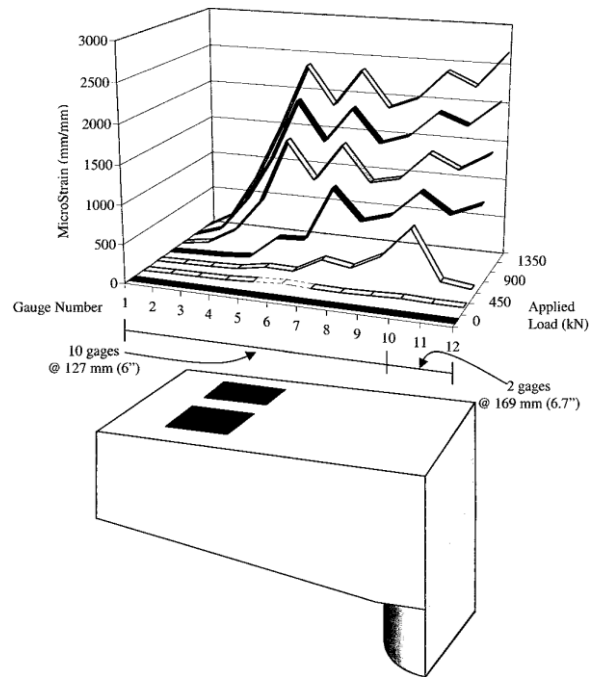
Figure 2.5. Longitudinal Reinforcement Strain Profile for Specimen 1A (Young et al. 2002).

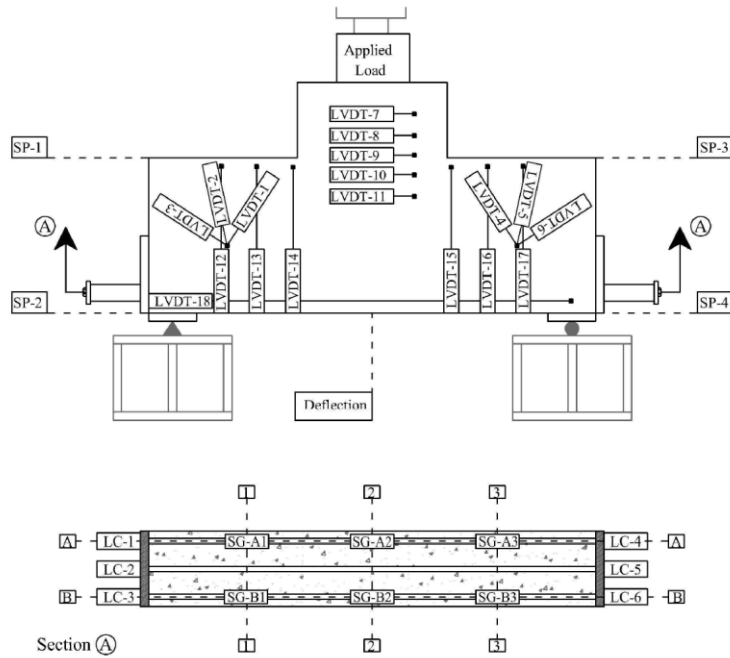
Figure 2.6. Instrumentation of Pier Cap Specimens (Bechtel 2011).

A finite element model (FEM) was created to determine the maximum shear force that could be applied to the pier cap under normal loading conditions. Both full-scale and half-scale specimens were tested to understand how size effects influence the behavior of the beams. Specimens were instrumented, as seen in Figure 2.6, with strain gauges attached to reinforcing bars, linear variable differential transformers (LVDT), string

potentiometers, and load cells. From testing the specimens, strain gauge and LVDT data was used to calibrate the FEM. The calibrated FEM aided in. During the tests, the deflection of the beam under the loading point was measured and correlated with the applied load, shown in Figure 2.7. The loads at which significant shear cracks formed were marked on the plots; an obvious change in the behavior of the cracked beams is noted by the researchers.

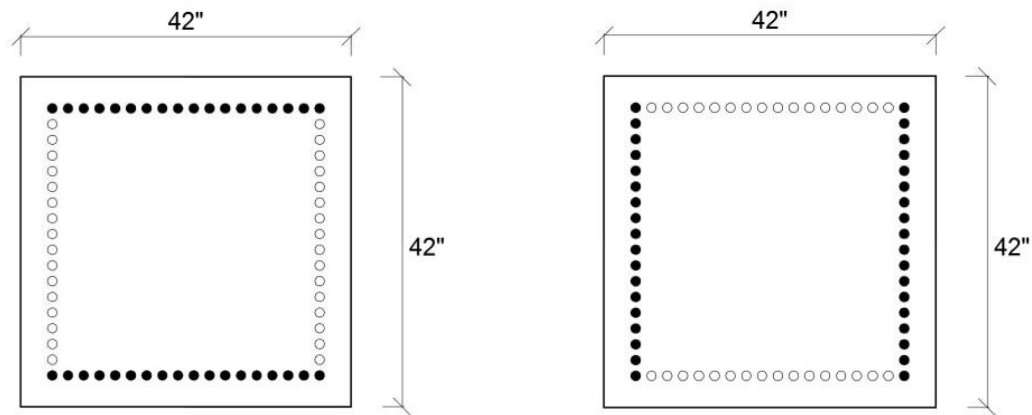
Figure 2.8. Top/Bottom Strand Configuration (left) and Side Strand Configuration (right) (Barooah 2016).

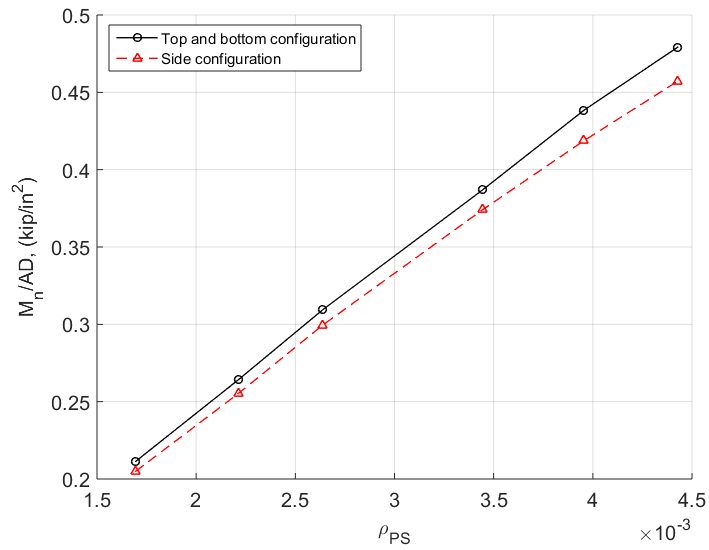
Figure 2.9. Nominal Strength vs. Area of Prestressing for Top/bottom and Side Strand Configurations (Barooh 2016).

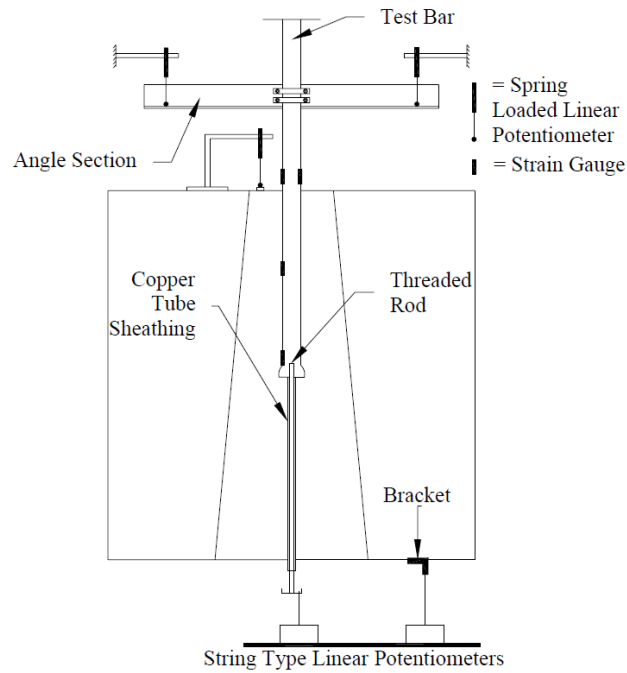
Figure 2.12. Pullout Test Setup (Matsumoto et al. 2001).

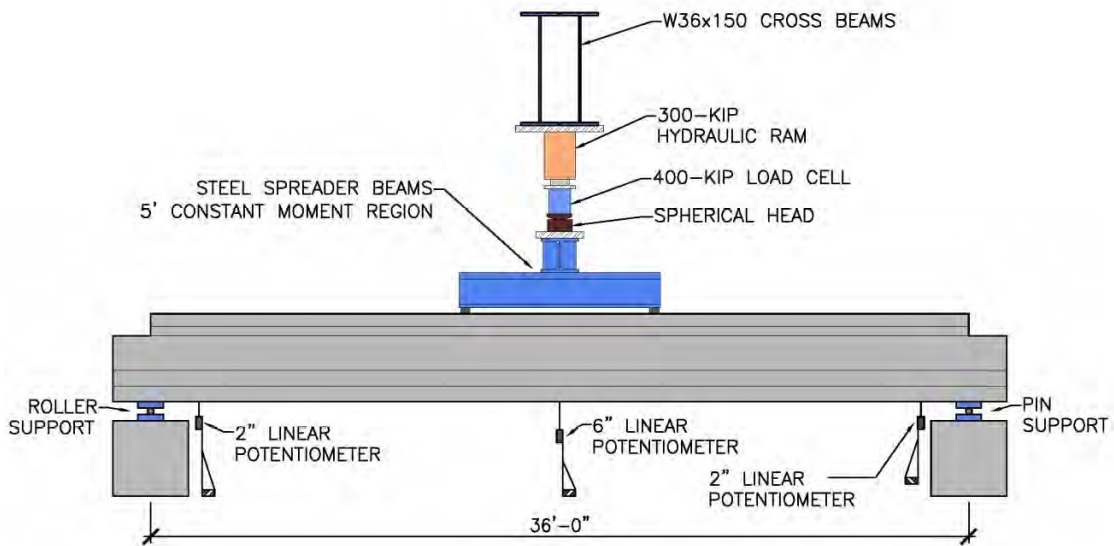
Figure 2.17. Experimental Test Setup (Schnittker and Bayrak 2008).

The girder specimens were tested in flexure in the test setup shown in Figure 2.17. Girders were instrumented with linear potentiometers to measure the displacement at the ends and mid-span. Box beam specimens were loaded incrementally to 20% beyond the observed cracking load. Loading was paused to mark and measure cracking. Using the collected data, load-deflection relationships were plotted and used to determine the apparent cracking moment capacity. It was recommended by the researchers that the allowable compressive stress at release be increased no more than 5% from the current limit.

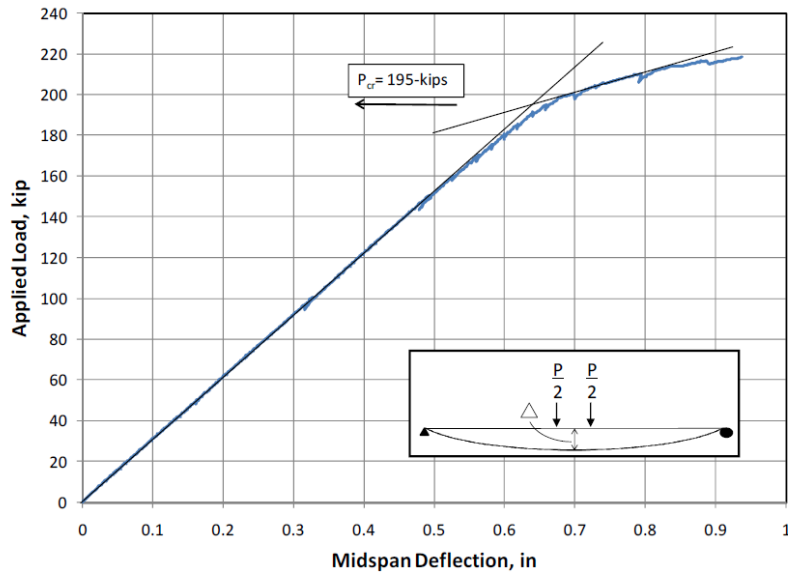
Figure 2.18. Load-Deflection Plot Example (Schnittker and Bayrak 2008).

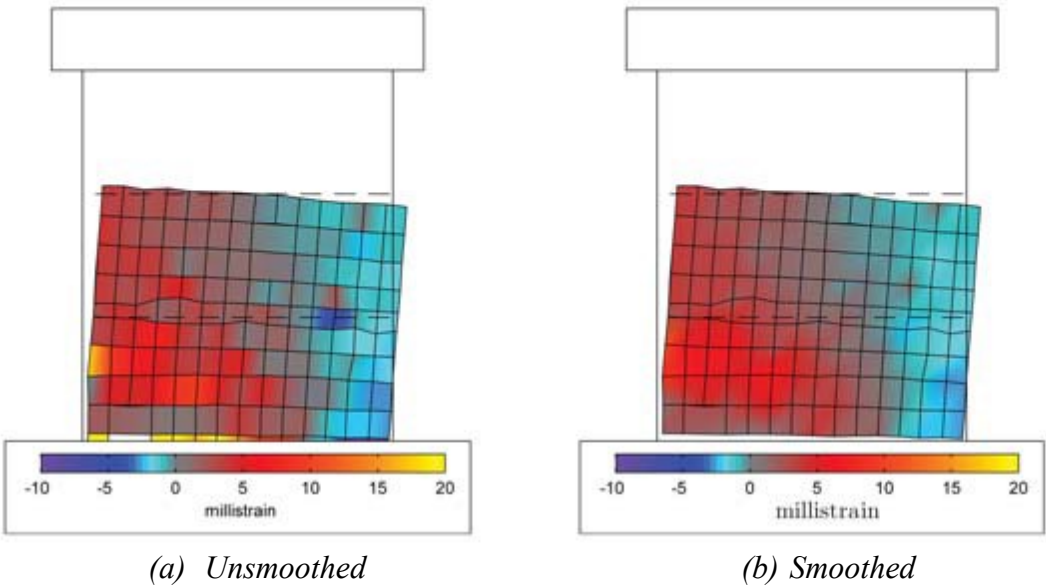
Figure 2.28. Unsmoothed and Smoothed Strain Field Plot Example (Birely 2012).

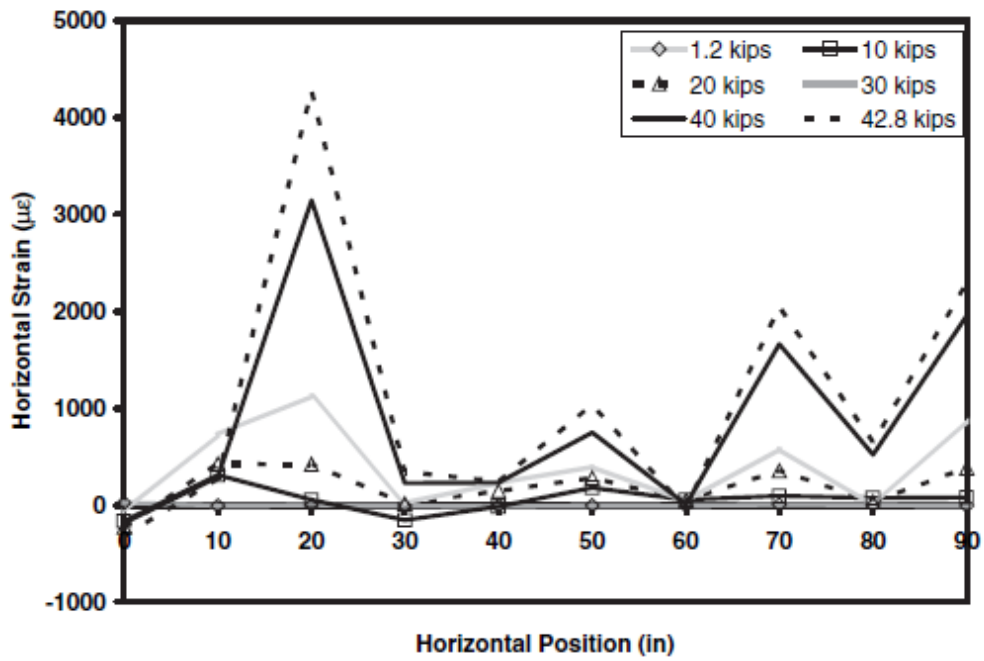
Figure 2.31. Horizontal Strain Profile Example (Hawkins and Kuchma 2007).

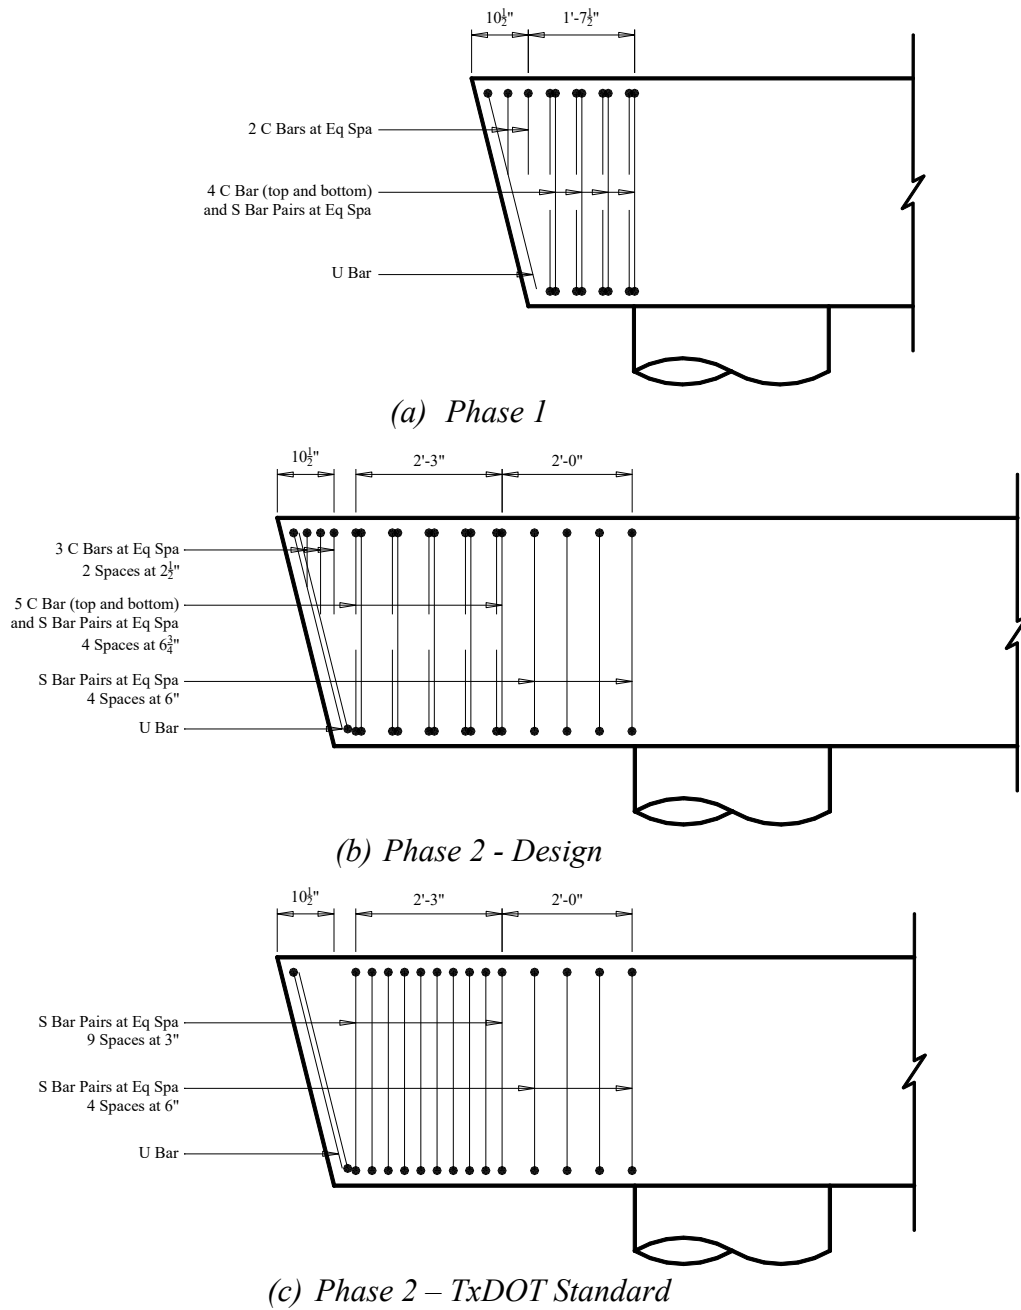
Figure 3.5. End Region Detailing.
 (Adapted with permission from Birely et al. 2018a)

The end region detailing took into consideration the spalling reinforcement from the AASHTO LRFD 5.10.10.1 and included bursting reinforcement immediately after spalling reinforcement from $D/4$ to the transfer length. Details of this design are discussed in [Birely et al. \(2018a\)](#). Individual C-Bars (#5 bars) were used at $D/4$ for the spalling reinforcement. C-Bar and S-Bar pairs were used for the bursting reinforcement up to the transfer length. During Phase 2, one specimen used end region detailing from standard drawings released by TxDOT during the completion of Phase 1. The end region detailing of the square ends was the same as the battered ends, except modified to account for the non-sloped face. Figure 3.5 shows the end region reinforcement for Phase 1 and Phase 2.

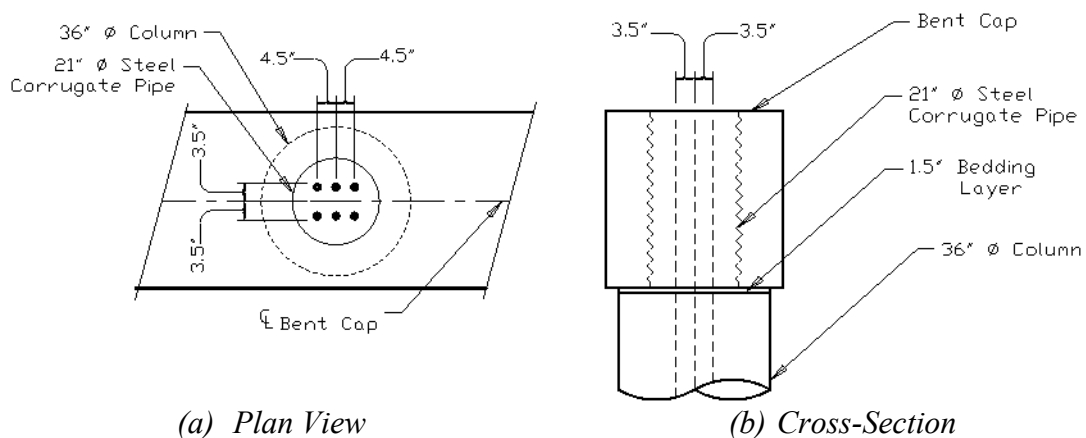
Figure 3.6. Pocket Connection Details.
(Adapted with permission from Birely et al. 2018a)

A pocket connection was chosen to connect the precast bent caps to the columns. The pocket connection emulates a monolithic connection by utilizing a single large pocket that encloses the dowel bars extending from the column. This connection replaced the 4-in. diameter vertical ducts in the current TxDOT Precast Bent Cap Option for Round Columns standard sheet. Following the recommendations of [Barooah \(2016\)](#), the spacing of 6-#11 bars detailed in the current connection standard was decreased to maximize the ease of constructability. A 21-in. diameter 12 gage corrugated steel pipe was selected to form the pocket. Figure 3.6 shows details of the pocket connection.

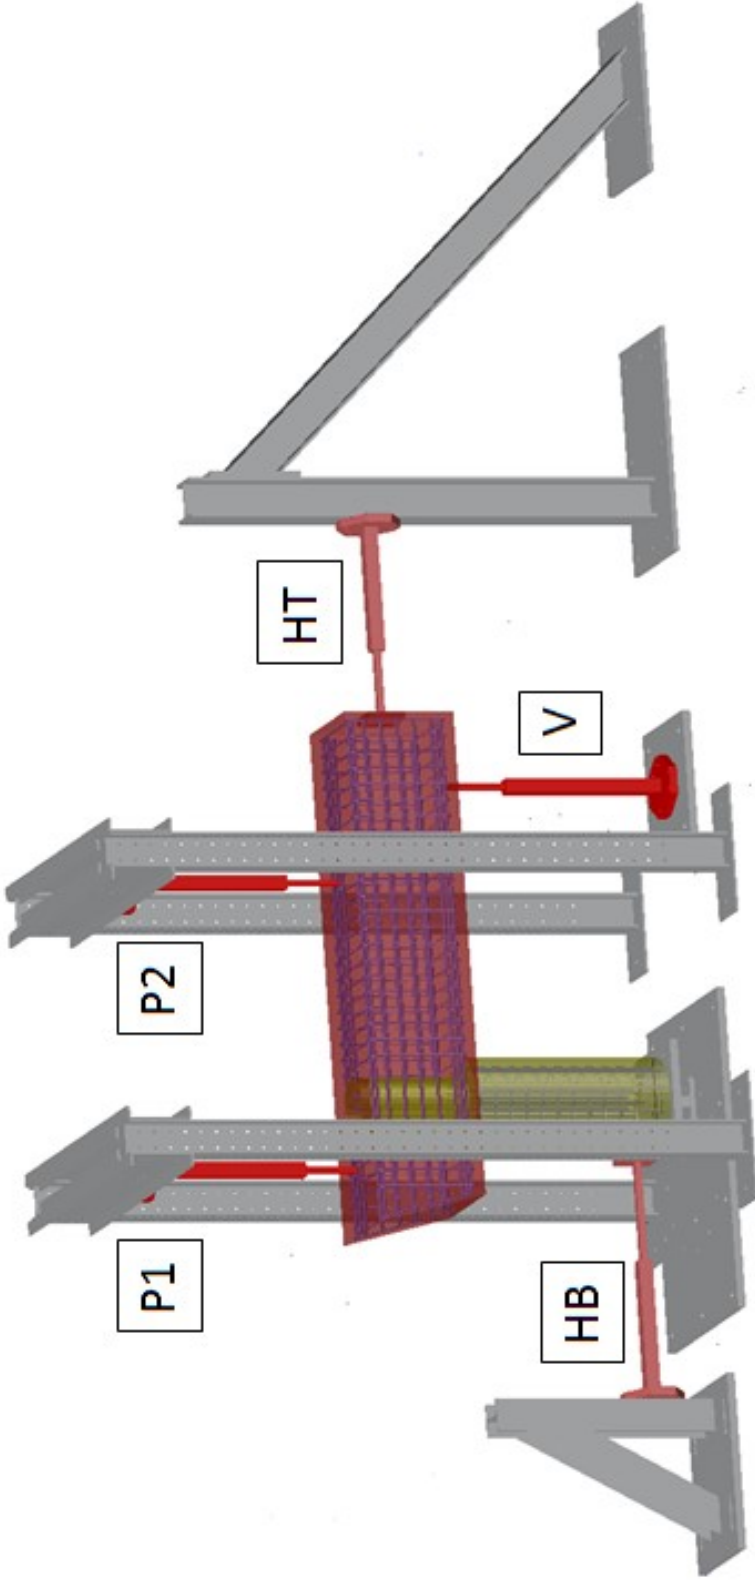
Figure 3.7. General Experimental Test Setup 3D Rendering. (Adapted with permission from Birely et al. 2018a)

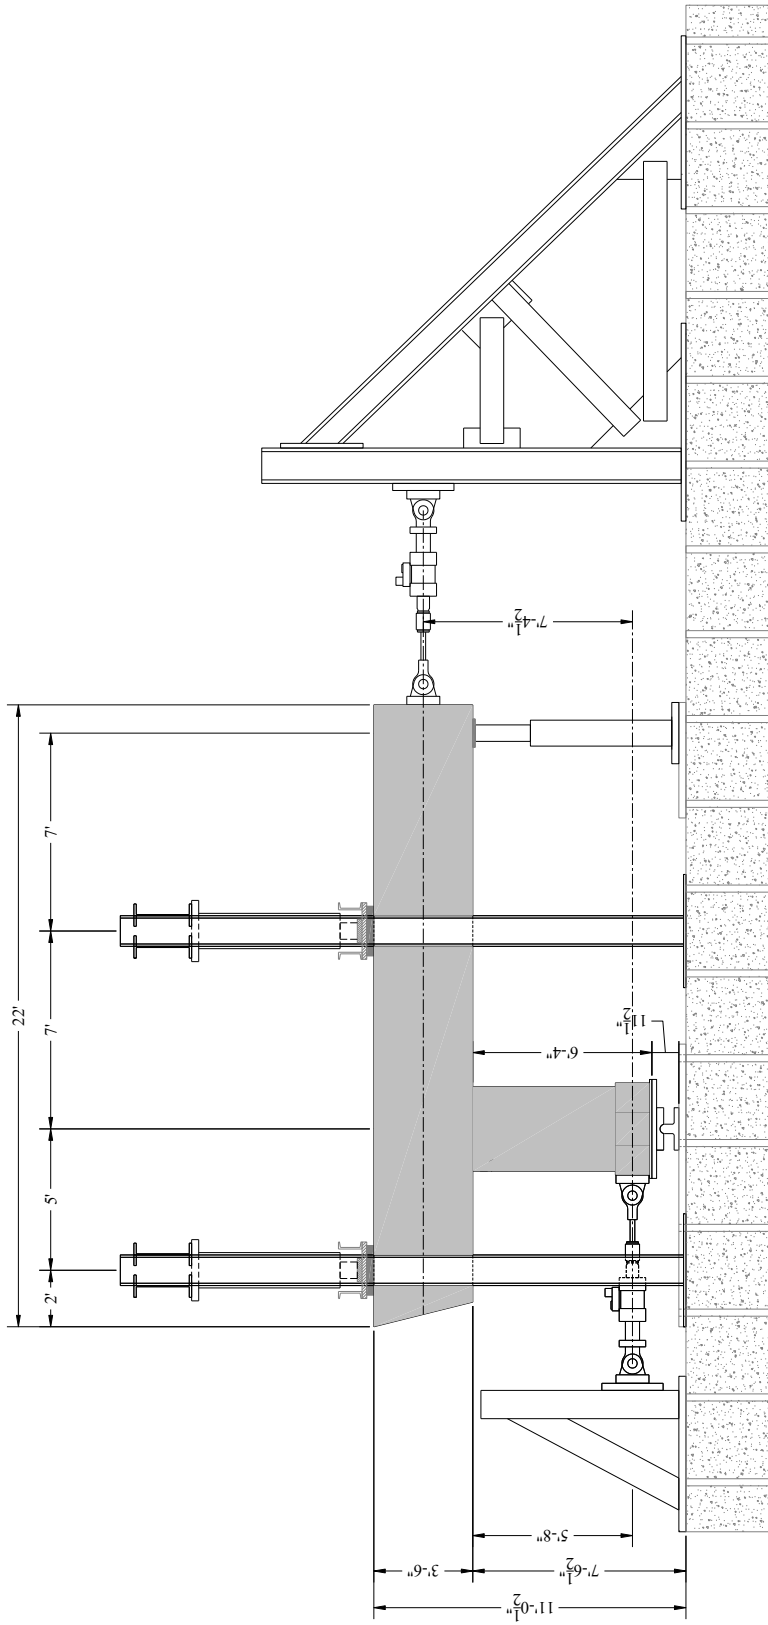
Figure 3.9. Phase 2 Experimental Test Setup. (Adapted with permission from Birely et al. 2018a)

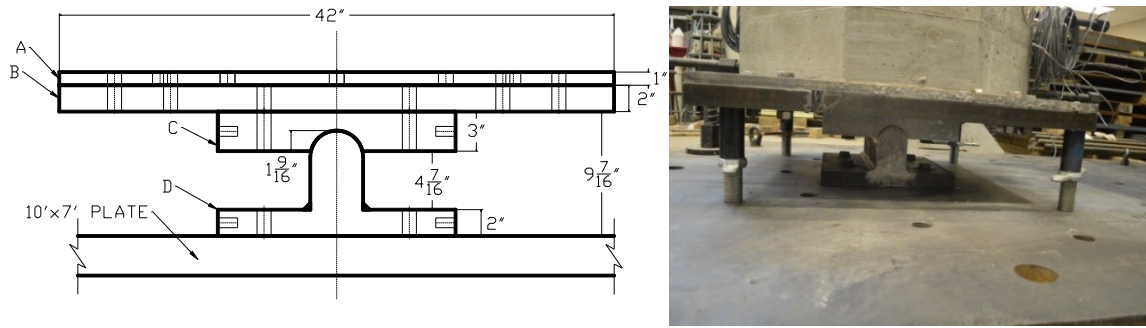
**Figure 3.10. Rocker Foundation (stability pegs were removed prior to testing).
(Adapted with permission from Birely et al. 2018a)**

The column rested on a rocker foundation, shown in Figure 3.10, bolted to a 10-ft x 7-ft steel foundation plate. Two top vertical actuators (P1, P2) supported on 9-ft headers between the vertical reaction towers, shown in Figure 3.11, simulated the girder loads. The bottom vertical actuator (V) acted as the shear at the bent cap inflection point and connected to the strong floor by a 4-ft x 4-ft steel foundation plate. Horizontal

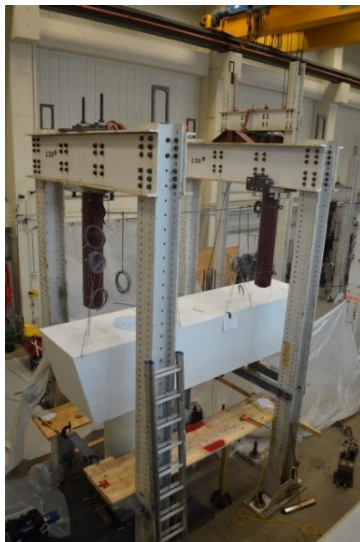
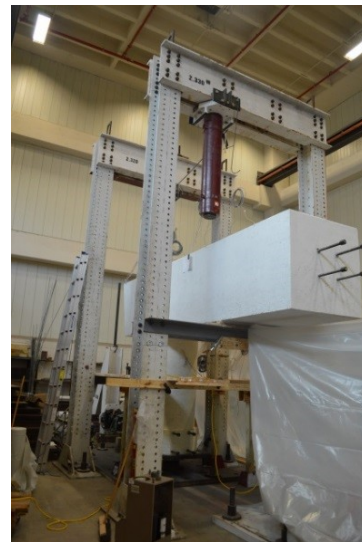
**Figure 3.11. Vertical Reaction Frame.
(Adapted with permission from Birely et al. 2018a)**

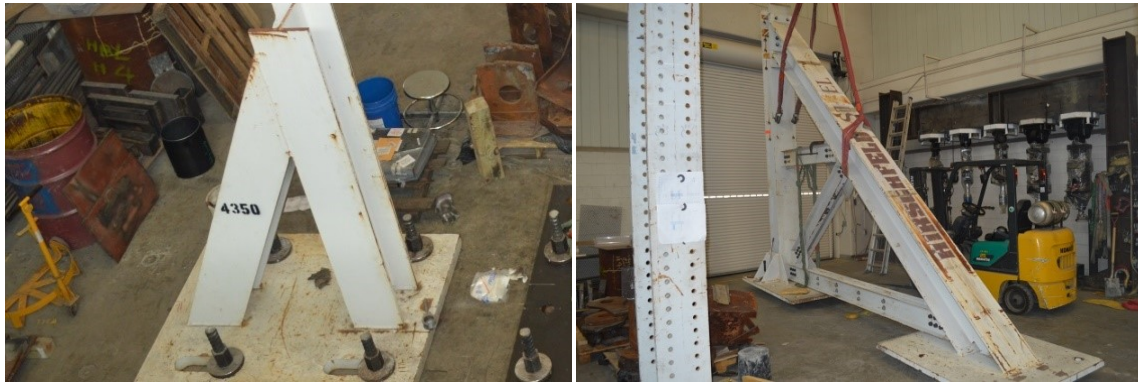
Figure 3.12. Horizontal Reaction Frames. (Adapted with permission from Birely et al. 2018a)

(a) *Bottom Horizontal Actuator (HB)
Reaction Frame*

(b) *Top Horizontal Actuator (HT)
Reaction Frame*

actuators (HT, HB) attached to horizontal load reaction frames, shown in Figure 3.12, provided stability.

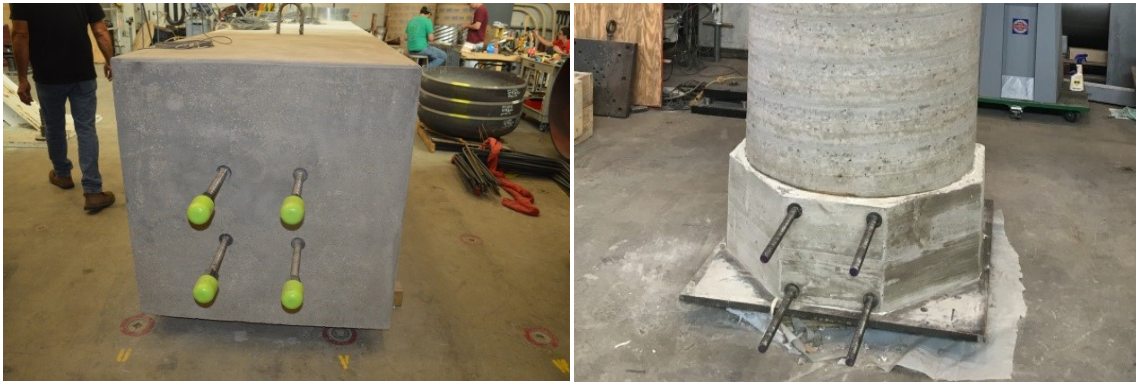
Figure 3.13. Horizontal Actuator Connections.
 (Adapted with permission from Birely et al. 2018a)

The top and bottom horizontal 110-kip actuators (HT and HB) were attached to the specimens with threaded rods that were installed during casting, shown in Figure 3.13. The actuators were installed on the horizontal reaction frames. The two vertical 600-kip actuators, simulating girder loads, were mounted to the 9-ft headers between the vertical reaction towers. Load was applied to the bent cap through TxDOT approved bearing pads placed as shown in Figure 3.14. Actuator load assemblies were designed to distribute the load from the single vertical actuator ram to the two bearing pads representing the individual girders, shown in Figure 3.15. Additional 2-in. steel plates were added to stiffen the assembly.

(a) HT Actuator Connection Rods

(b) HB Actuator Connection Rods

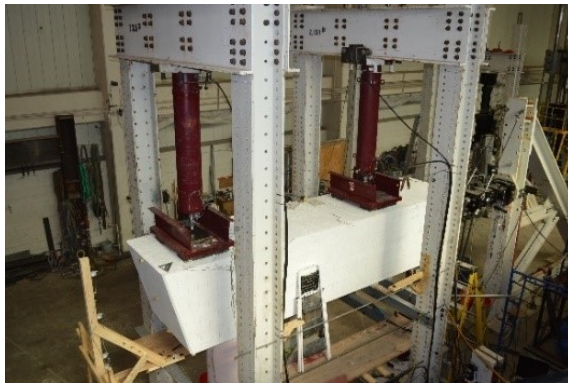
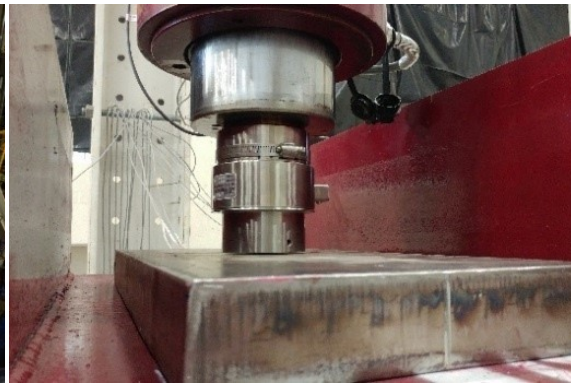
Figure 3.15. Vertical Actuator Load Assembly.
 (Adapted with permission from Birely et al. 2018a)

(b) Vertical Actuators Installed

(c) Additional 2-in. Plate

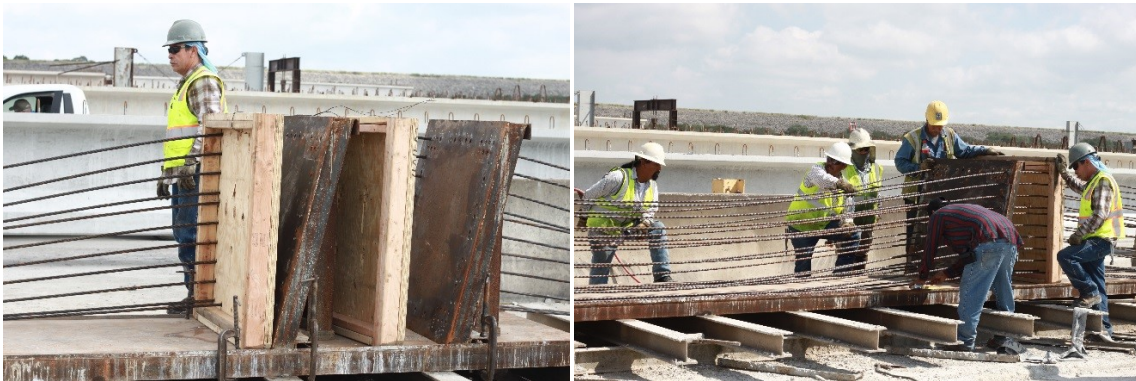
(a) Prior to spreading headers

(b) Prior to stressing first group of strands

Prestressing strands were fed through the wooden square end formwork and metal battered end formwork. Due to the geometry of the bent caps, details of the pocket connection, and size/location of the polystyrene voids, only 22 of the 28 strands were stressed at the start of fabrication. All prestressing strands were stressed to a force equivalent to $0.75f_{pu}$ of the 0.6-in. diameter Grade 270 7-wire strands (44 kips). The six strands located at the top of the strand pattern (B 38, F 38, and H 38 in Figure 3.17) were placed after pocket and interior void placement. After the initial strands were pulled through the header plates, the headers were spread to the correct positions along the prestressing bed. The headers were secured with metal plates welded to the base of the prestressing bed to prevent any movement.

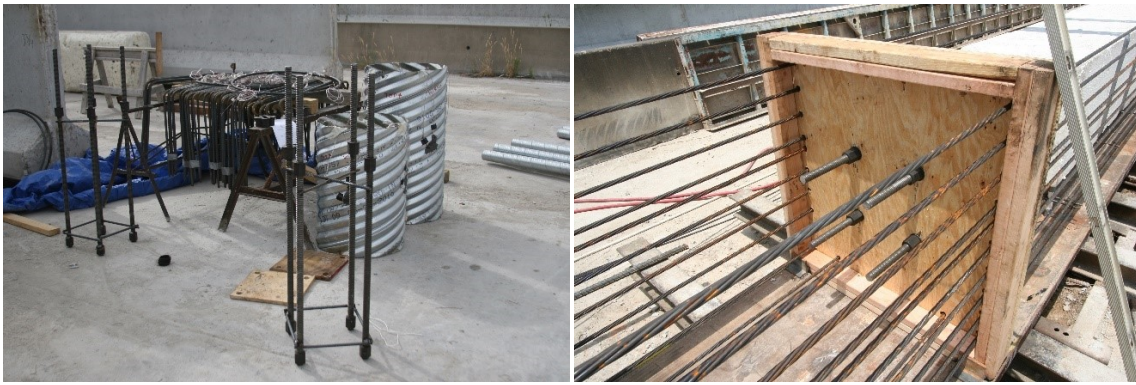
**Figure 3.19. Actuator Load Assembly.
(Reprinted with permission from Birely et al. 2018a)**

(a) All-thread Actuator Load Assembly

(b) Actuator Load Assembly Installed

Following the stressing of the initial 22 strands, workers placed the interior components of the bent caps. The all-thread actuator load assemblies (Figure 3.19) were

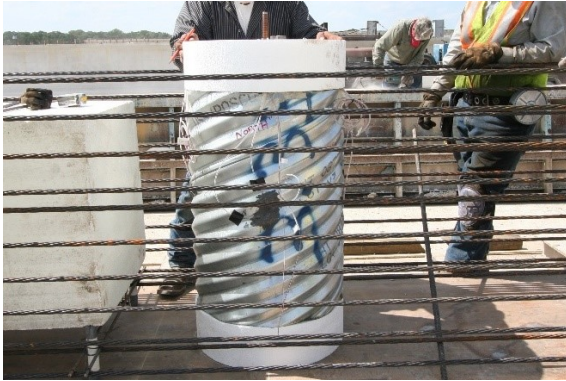
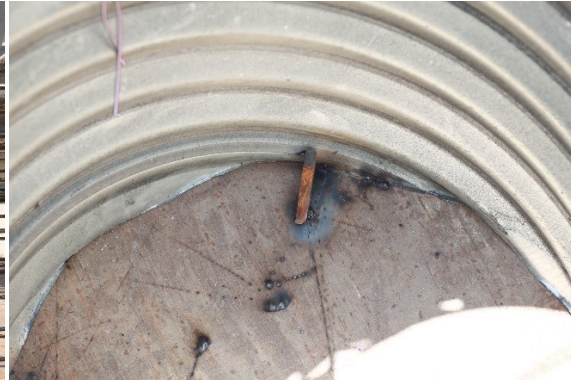
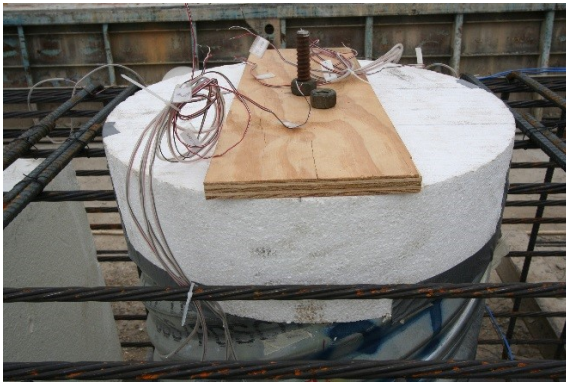
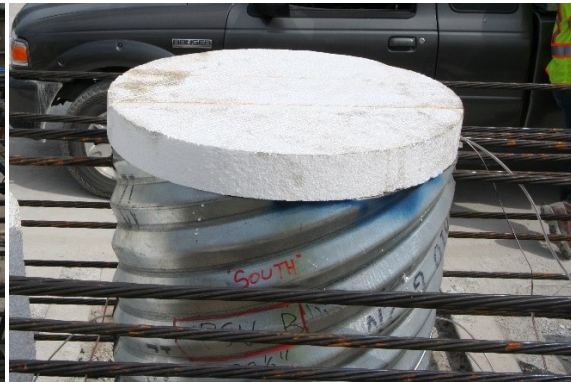
Figure 3.20. Corrugated Steel Pipe Installation.
(Reprinted with permission from Birely et al. 2018a)

(a) PSV-28A Corrugated Pipe Secured to Prestressing Bed

(b) PSV-28B Welded Metal Tabs Securing Corrugated Pipe

(c) PSV-28A Polystyrene Plug Secured with All-Thread Rod

(d) PSV-28B Top Polystyrene Plug

The corrugated steel pipes were installed into the formwork. Due to the differences in pocket connection details, different methods of securing the corrugated steel pipe were used for each specimen. The corrugated steel pipe for specimen PSV-28A was secured on top of a 6-in. polystyrene forming plug using a threaded rod (Figure 3.20a). For specimen PSV-28B, the corrugated steel pipe extended to the bottom of the formwork and welded metal tabs were used to prevent movement of the corrugated steel pipe during concrete placement (Figure 3.20b). A polystyrene forming plug was placed at the top of each corrugated steel pipe to seal the pocket connection during concrete placement.

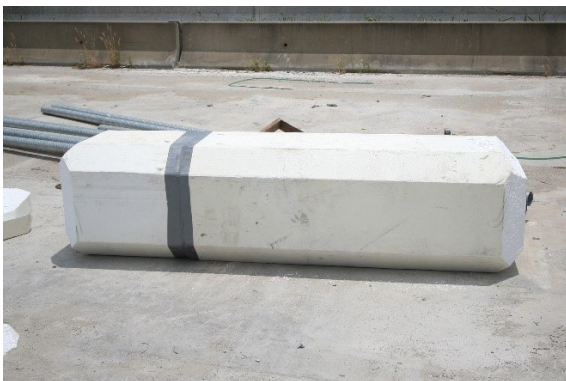
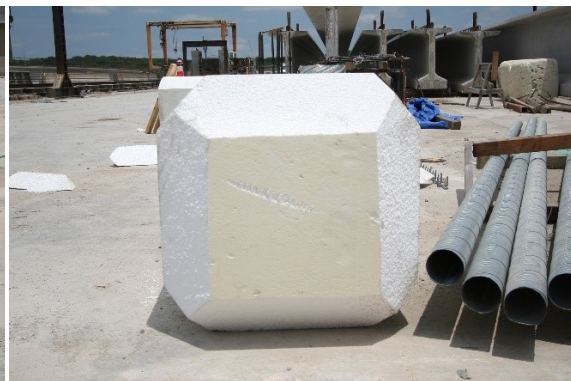
Figure 3.21. PSV-28B Polystyrene Forming Block.
(Reprinted with permission from Birely et al. 2018a)

(a) PSV-28B Interior Void Polystyrene Block (span) - Elevation

(b) PSV-28B Interior Void Polystyrene Block (span) - Side

The geometry, size, and quantity of the interior voids differed between PSV-28A and PSV-28B. The interior voids were formed with polystyrene blocks. The longitudinal 5-in. chamfer on the polystyrene blocks for PSV-28B were precut at the time of manufacturing, while the transverse 5-in. chamfer was field cut after the block was cut to the appropriate length (Figure 3.21 and Figure 3.22). The polystyrene blocks were held in place with #3 rebar tied to the prestressing strands. PVC drain pipes were installed at the bottom corners of the polystyrene blocks (Figure 3.23). Polystyrene blocks were restrained from floating during concrete placement with rectangular plywood held down with threaded rods secured to the transverse formwork bracing. Due to the geometry of interior void in specimen PSV-28B, adjustments were made to the hold down mechanism. Instead of a single piece of plywood held with two threaded rods, two pieces of plywood

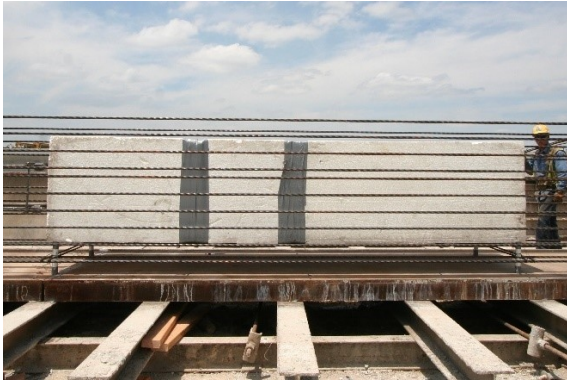
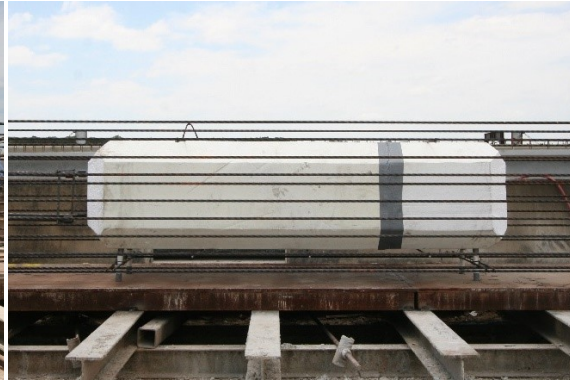
Figure 3.22. Polystyrene Forming Blocks Installed.
(Reprinted with permission from Birely et al. 2018a)

(a) PSV-28A Interior Void Polystyrene Block – In Place

(b) PSV-28B Interior Void Polystyrene Block – In Place

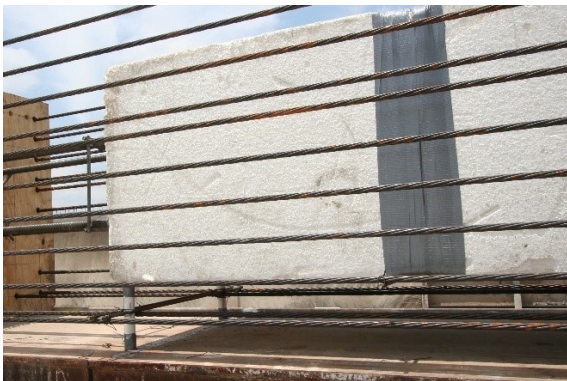
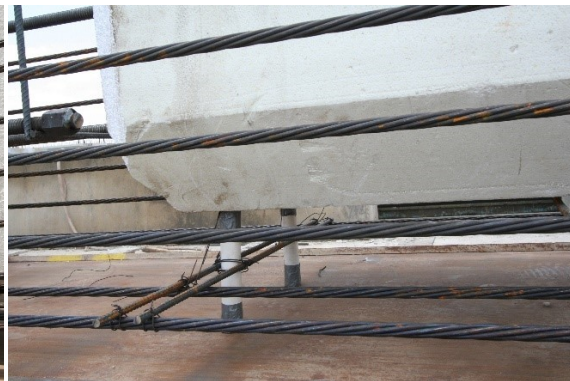
Figure 3.23. PVC Drain Pipe Installation.
(Reprinted with permission from Birely et al. 2018a)

(a) PSV-28A PVC Drain Pipes

(b) PSV-28B PVC Drain Pipes

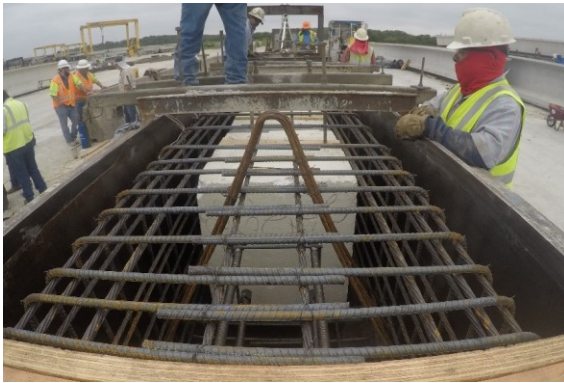
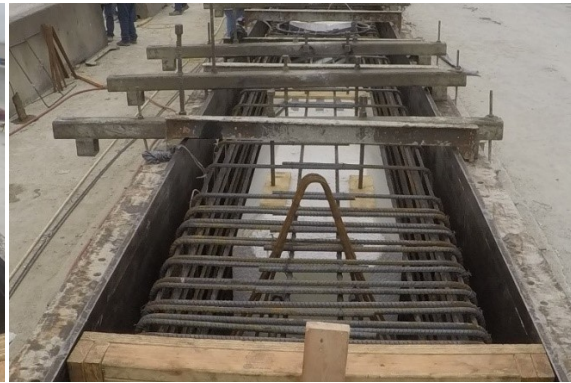
Figure 3.24. Interior Void Polystyrene Forming Block Hold Downs.
(Reprinted with permission from Birely et al. 2018a)

(a) PSV-28A

(b) PSV-28B

were held in place with individual threaded rods. These differences can be seen in Figure 3.24.

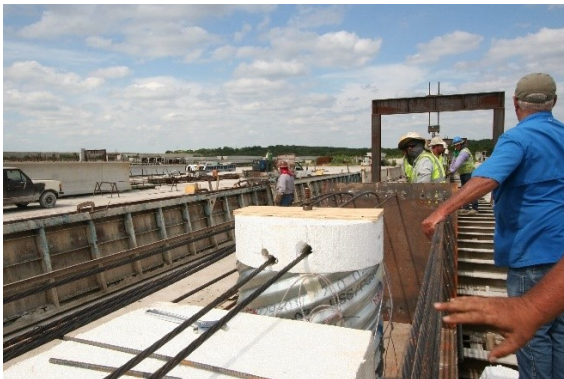
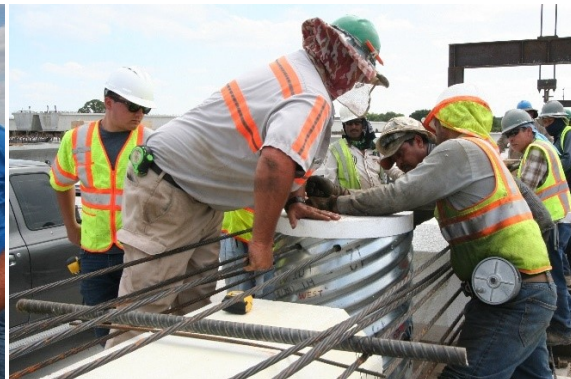
Figure 3.25. Strands through Pocket Connection.
(Reprinted with permission from Birely et al. 2018a)

(a) Strands Placed Through PSV-28A
Forming Plug

(b) Workers Feeding Strands Through
PSV-28B Pipe

After the interior void forming blocks and corrugated steel pipes were installed, the last six strands were fed through the formwork and the pocket connection (Figure 3.25). The prestressing strands were passed through holes in the corrugated steel pipe in specimen PSV-28B (Figure 3.25b). In both specimens, the strands were passed through the polystyrene plugs at the top of the corrugated steel pipes; holes were formed in the polystyrene using a heated piece of strand (Figure 3.25a).

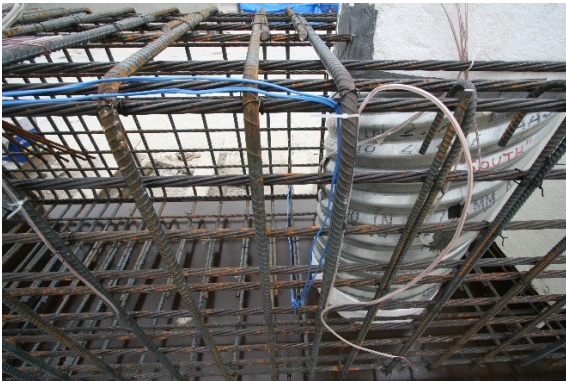
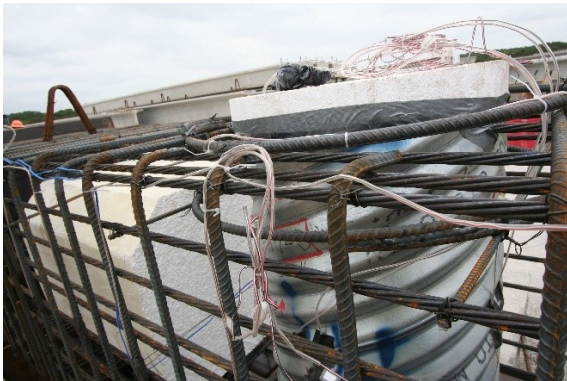
Figure 3.26. Strain Gauged Reinforcement.
(Reprinted with permission from Birely et al. 2018a)

(a) PSV-28A Strain Gauged Mild Steel Shear Reinforcement and Corrugated Steel Pipe

(b) PSV-28B Strain Gauged Mild Steel Shear reinforcement, Mild Steel Hoops, and Corrugated Steel Pipe

Mild steel reinforcement was placed after all strands had been stressed. Transverse shear reinforcing bars gauged for monitoring during experimental testing were provided by the research team (Figure 3.26). Two #5 mild steel hoops were placed around the top of the corrugated steel pipe in PSV-28B (Figure 3.27). The hoops were secured to the reinforcing cage using tie wire and #3 reinforcing bars where necessary to maintain the correct position. Thermocouples were installed in both specimens, as seen in the

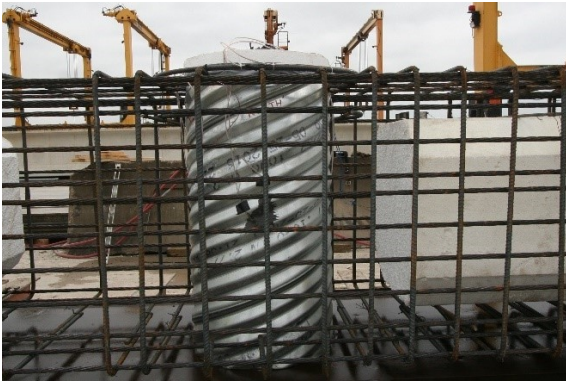
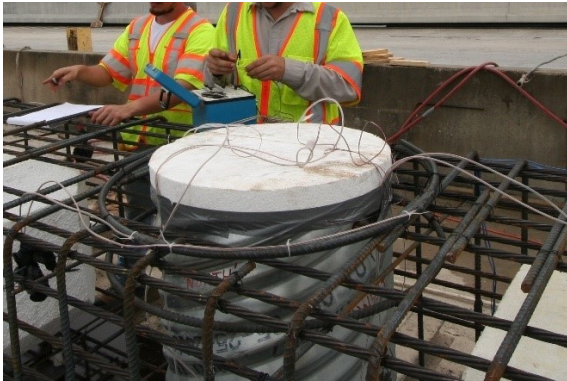
Figure 3.27. PSV-28B Mild Steel Hoop Installation.
(Reprinted with permission from Birely et al. 2018a)

(a) Elevation View

(b) Hoops at Top of Steel Pipe

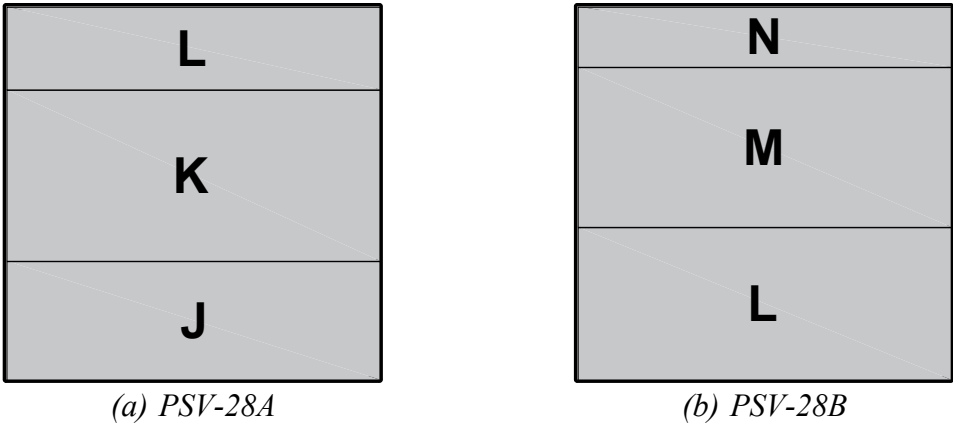
Figure 3.29. Concrete Batch Distribution.
(Reprinted with permission from Birely et al. 2018a)

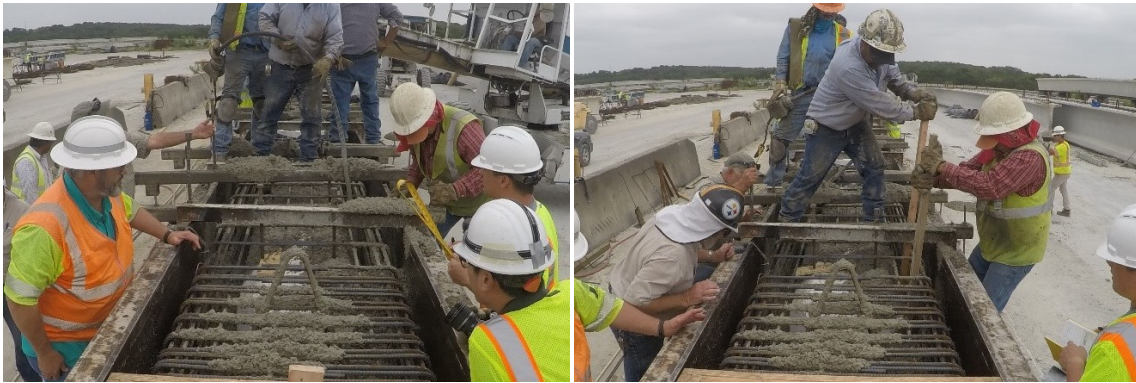
Figure 3.31. PSV-28B Polystyrene Block Shifting.
(Reprinted with permission from Birely et al. 2018a)

(a) Shifted

(b) Correcting the Shift

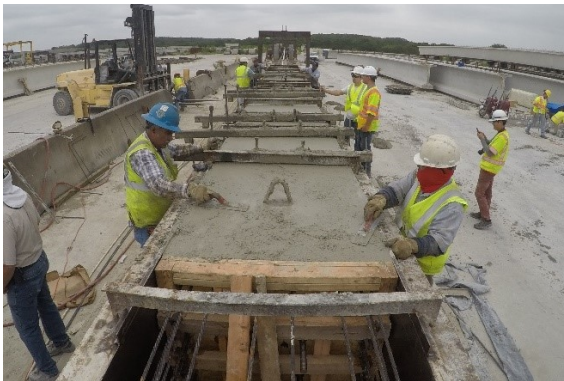
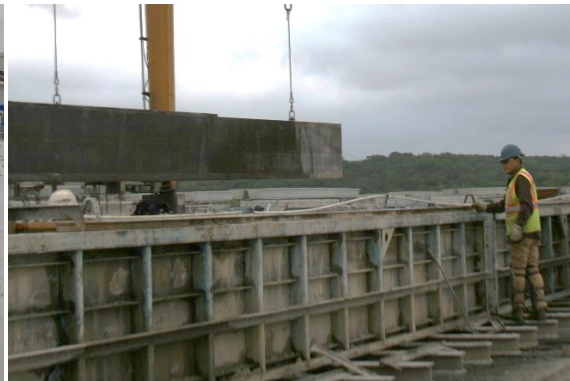
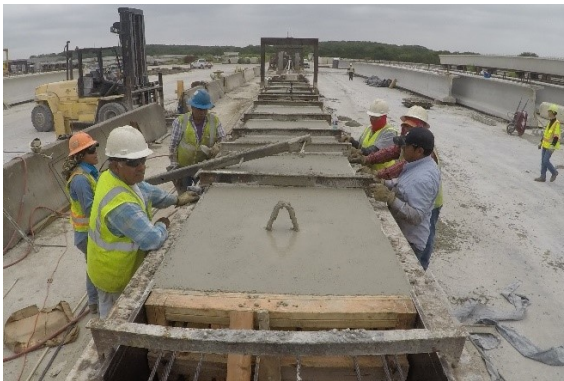
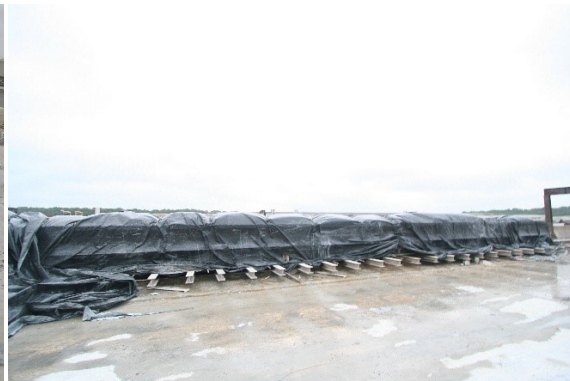
Figure 3.32. Concrete Finishing and Curing.
(Adapted with permission from Birely et al. 2018a)

(a) Trowel Finishing

(b) Irrigation System

*(c) Removing All-Thread Rods
 Securing Polystyrene Voids*

(d) Black Plastic Covering

Concrete was placed in 4 cubic yard batches from the onsite plant. Five batches were used to cast the Phase 2 specimens. These batches are referred to as batches J, K, L, M, and N. For each concrete batch, slump was recorded and test cylinders were made. Each concrete batch had a slump ranging between 7 to 7-1/2 inches. Batch L was used in both specimens, so additional material testing specimens (cylinders and beams) were made. PSV-28A consisted of batches J, K, and L, while PSV-28B consisted of batches L, M, and N. The approximate distribution of the concrete (by batch) in each of the specimens is shown in Figure 3.29. The concrete was placed in approximately equal lifts in each specimen. Workers used vibrators to consolidate the concrete (Figure 3.30). During the placement of concrete near the square end of PSV-28B, the interior void was shifted out of place. Workers adjusted the polystyrene block back to within 3/8-inches from the correct position and resumed the concrete placement (Figure 3.31). After completing the concrete placement, workers removed the threaded rods holding down interior void forming blocks, finished the surface with metal and wooden trowels, and installed a water irrigation system. The specimens were covered with black plastic to retain heat and moisture during the initial curing process (Figure 3.32).
