ANALYSIS OF EXPERIMENTAL BEHAVIOR OF PRETENSIONED
CONCRETE BENT CAPS USING MOTION CAPTURE SYSTEMS

A Thesis

CODI DAVID MCKEE

Major Subject: Civil Engineering

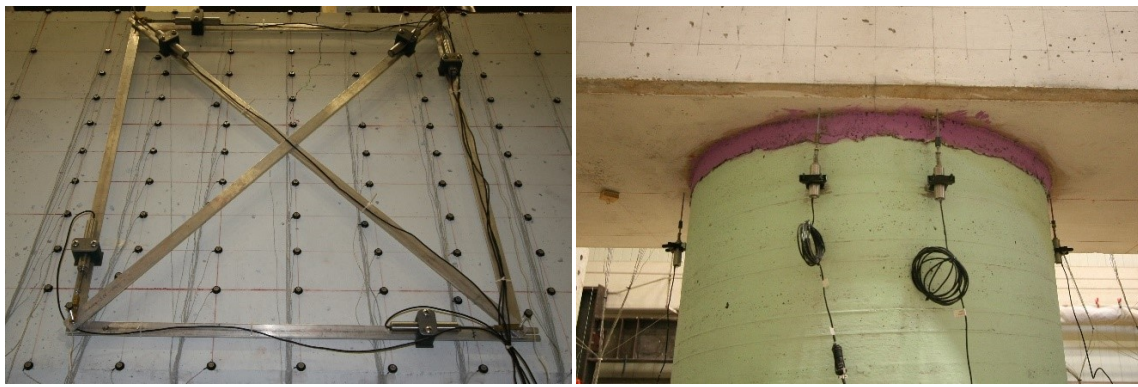
Figure 3.34. LVDT Locations. (Reprinted with permission from Birely et al. 2018a)

(a) Phase I Joint Region LVDTs

(b) Dowel Bar (PSV-28B only) and Bedding Layer LVDTs

During Phase 1, a total of six of LVDTs were installed in horizontal, vertical, and diagonal directions in the joint region to measure relative vertical, horizontal, and diagonal

displacement to monitor joint shear deformations (Figure 3.34a). In all tests, two LVDTs were placed vertically under the bent cap adjacent to column to measure opening of the bedding layer. On PSV-28B, two additional LVDTs (Figure 3.34b) were placed vertically under the bent cap adjacent to the column in the location of the outer dowel bars to determine the strain in the dowel bars during loading. LVDTs within bent cap-column connection measured relative vertical, horizontal, and diagonal displacement to monitor joint shear deformations. Two vertical LVDTs under the bent cap adjacent to the column measured opening at the bedding layer.

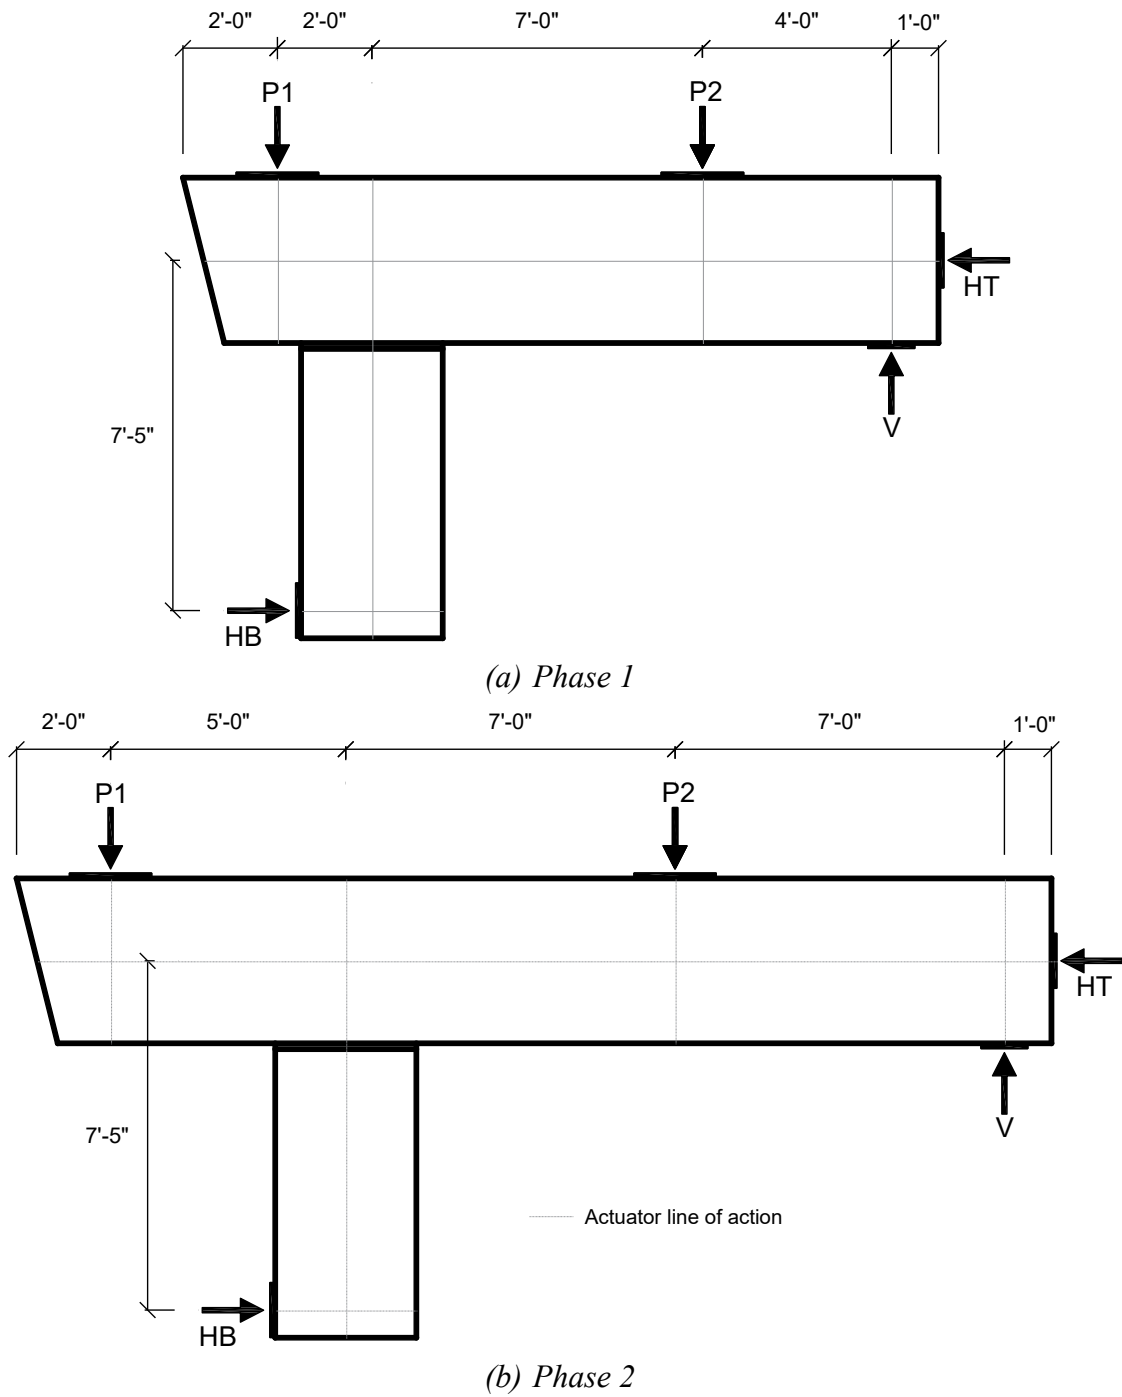
Figure 3.38. Location of Actuator Forces.
 (Reprinted with permission from Birely et al. 2018a)

All specimens were tested under multiple load patterns. The main pattern (Pattern A) generated shear and moment demands characteristic of multi-column bridge bents. Joint opening and closing were conducted to test the cap-column connection performance in Pattern C and D. Pattern B and E were selected to generate the largest moment demands permitted by the experimental test setup. Finally, Pattern F was used to fail the specimens by using large axial forces in the bent caps. Figure 3.39 shows the general moment diagrams for each load pattern. To achieve each load pattern, P1, P2, V, and HT/HB actuators were controlled through a mix of force and displacement control settings. Table 3.7 summarizes the actuator controls for each load pattern. Table 3.10 and Table 3.11 summarize actuator forces for Patterns A, B, E, and F. Patterns C and D are not included.

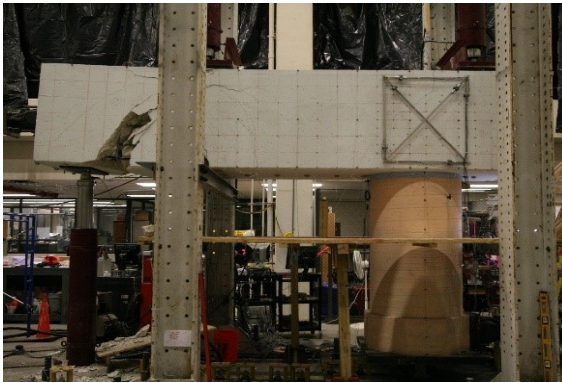
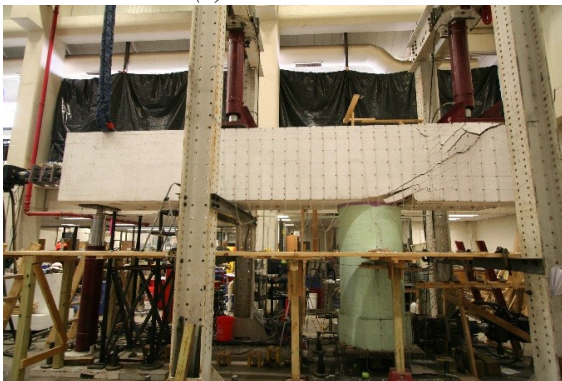
**Figure 3.40. Visual Observation at Failure (Back Face).
(Reprinted with permission from Birely et al. 2018a)**

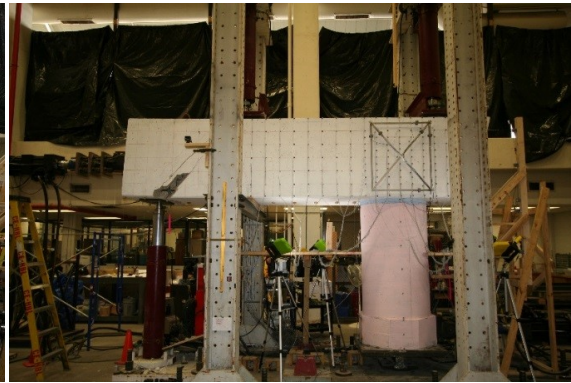
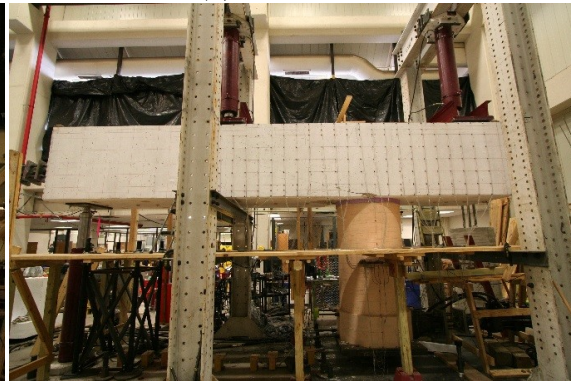
(b) PSS-16-24

(d) PSV-28A

During testing, the specimens were observed for signs of damage at different load stages. The outline of cracks was marked with colored permanent marker to correspond the damage with a load pattern. The cracks were measured with a metric crack comparator, and the maximum width of the cracks were recorded. Reported crack measurements have been converted from mm to inches. Photos were taken during testing to document damage. Figure 3.40 and Figure 3.41 shows the extent of the damage after the failure load case for each specimen.

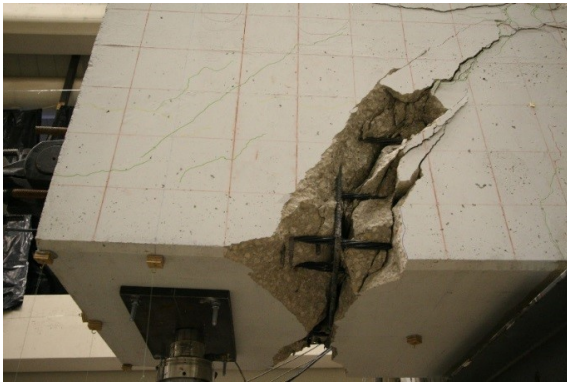
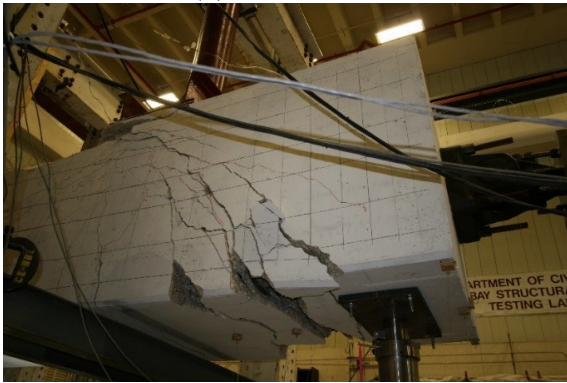
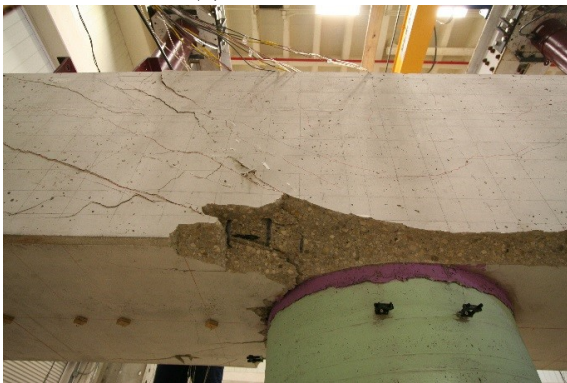
**Figure 3.41. Visual Observation at Failure (Failed region).
(Reprinted with permission from Birely et al. 2018a)**

(a) PSS-16-12

(c) PSV-16-12

(e) PSV-28B

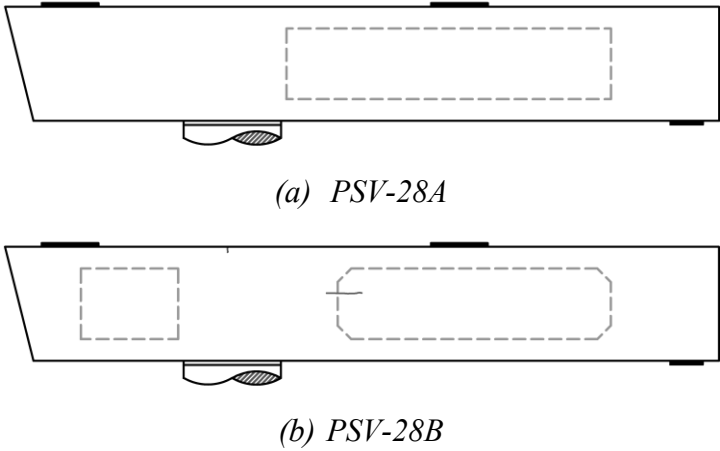
Figure 3.46. Cracking of Phase 2 Specimens under Pattern A SLS.

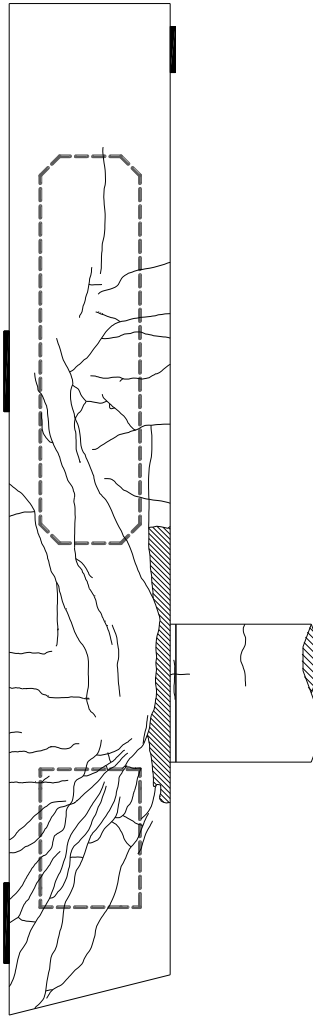
(b) PSV-28B

$P1 = 595 \text{ kips}$ $P2 = 395 \text{ kips}$ $V = 0 \text{ kips}$ $H = 0 \text{ kips}$

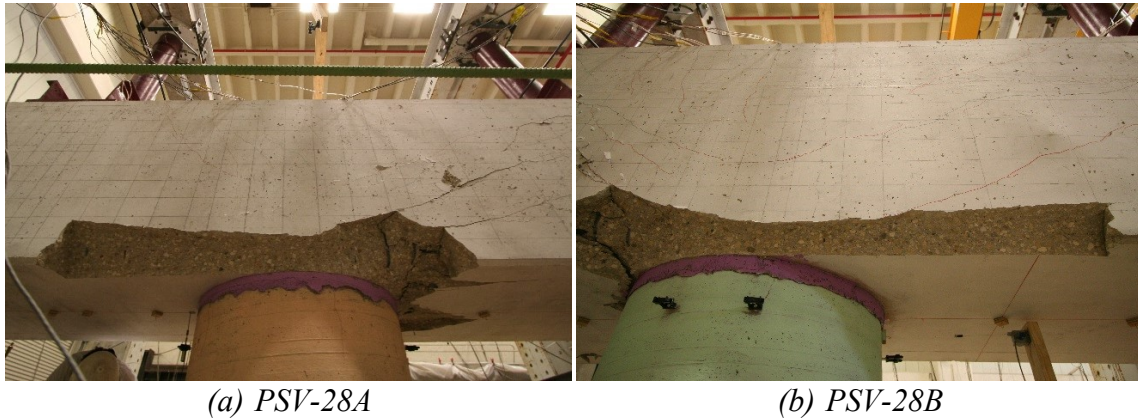
Figure 3.52. Loss of Concrete in Negative Moment Region of Phase 2 Specimens during Maximum Negative Moment Demands. (Reprinted with permission from Birely et al. 2018a)

Both specimens failed in the negative moment region during Pattern E (maximum negative moment). Shown in Figure 3.51, the loss of concrete appears to be associated with the concentration of compressive stress at the corner of the interior void in both specimens. Differences in the loading conditions are noted. Although PSV-28B also had extensive shear damage in the overhang, the spalling of the concrete on the interior (span) side of the column happened first similar to the failure of PSV-28A.

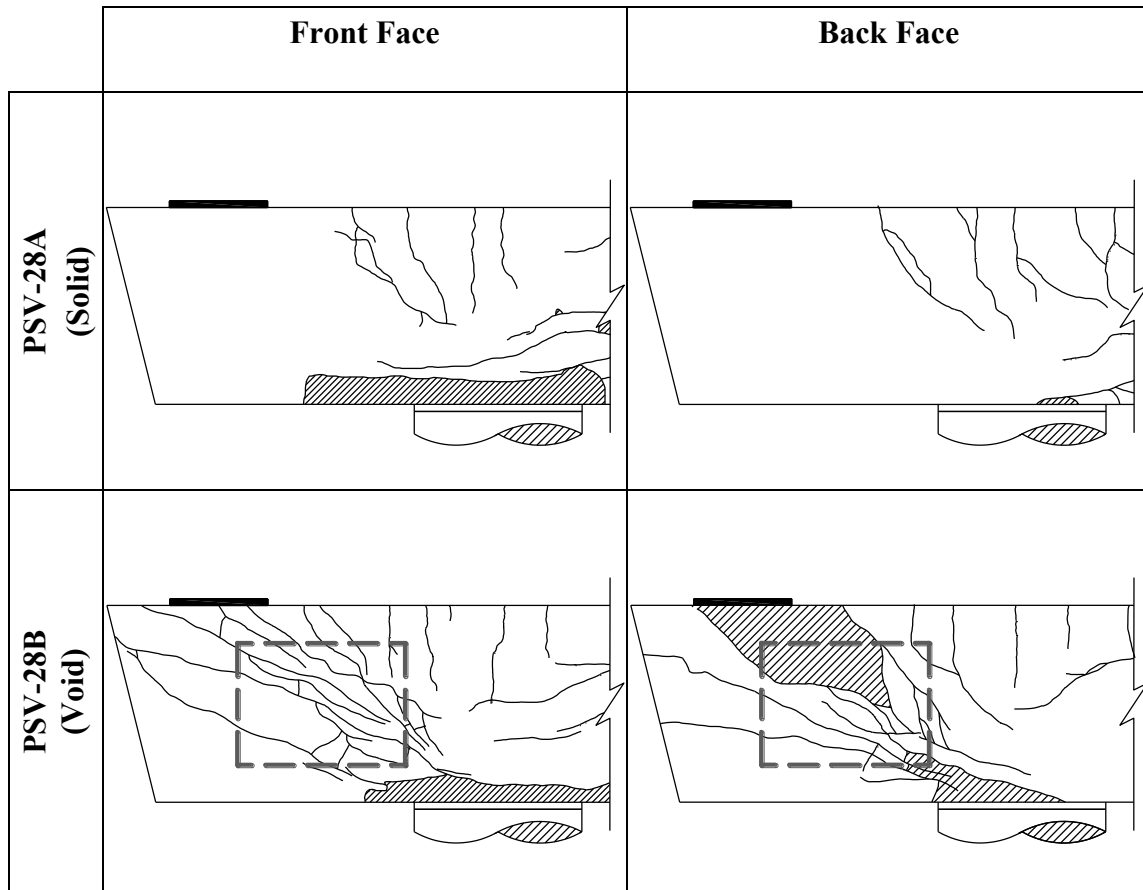
Figure 3.55. Comparison of Overhang Damage of Solid (PSV-28A) and Voided (PSV-28B) Overhang at Negative Moment Region Failure.
(Reprinted with permission from Birely et al. 2018a)

Figure 3.55 compares the damage in the solid and voided longer overhangs of PSV-28A and PSV-28B at the time of failure in the negative moment region. While failure in both specimens occurred in the compression zone of the negative moment region, PSV-28B also crushed along the compression strut from the $P1$ actuator to the exterior face of the column.

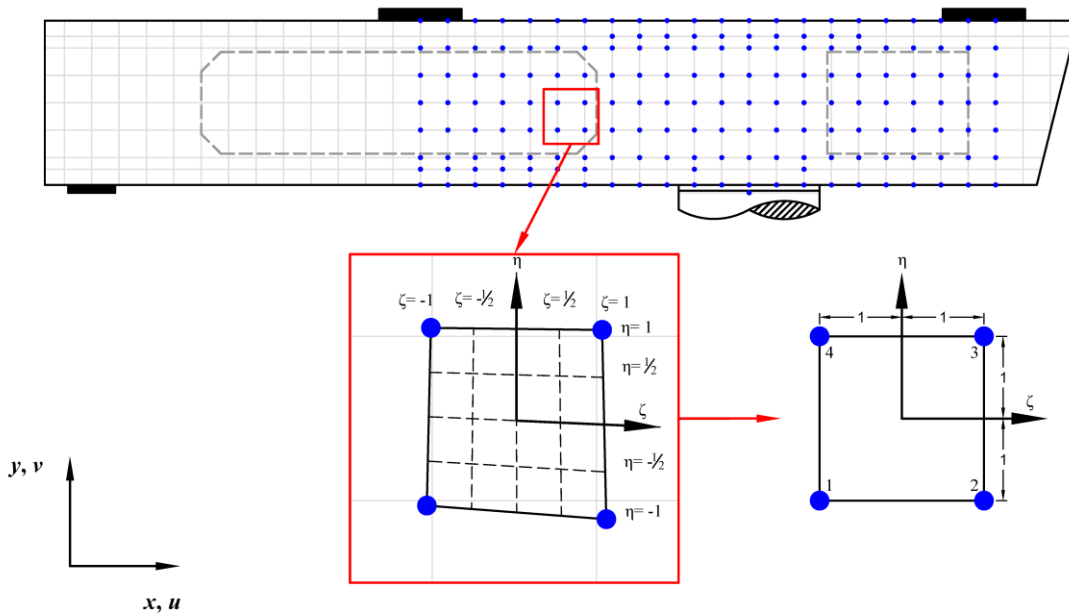
Figure 4.13. General Transformation for Mapping LED Markers from Physical Space to ζ - η Space for Isoparametric Quadrilateral (Q4) Formulation.

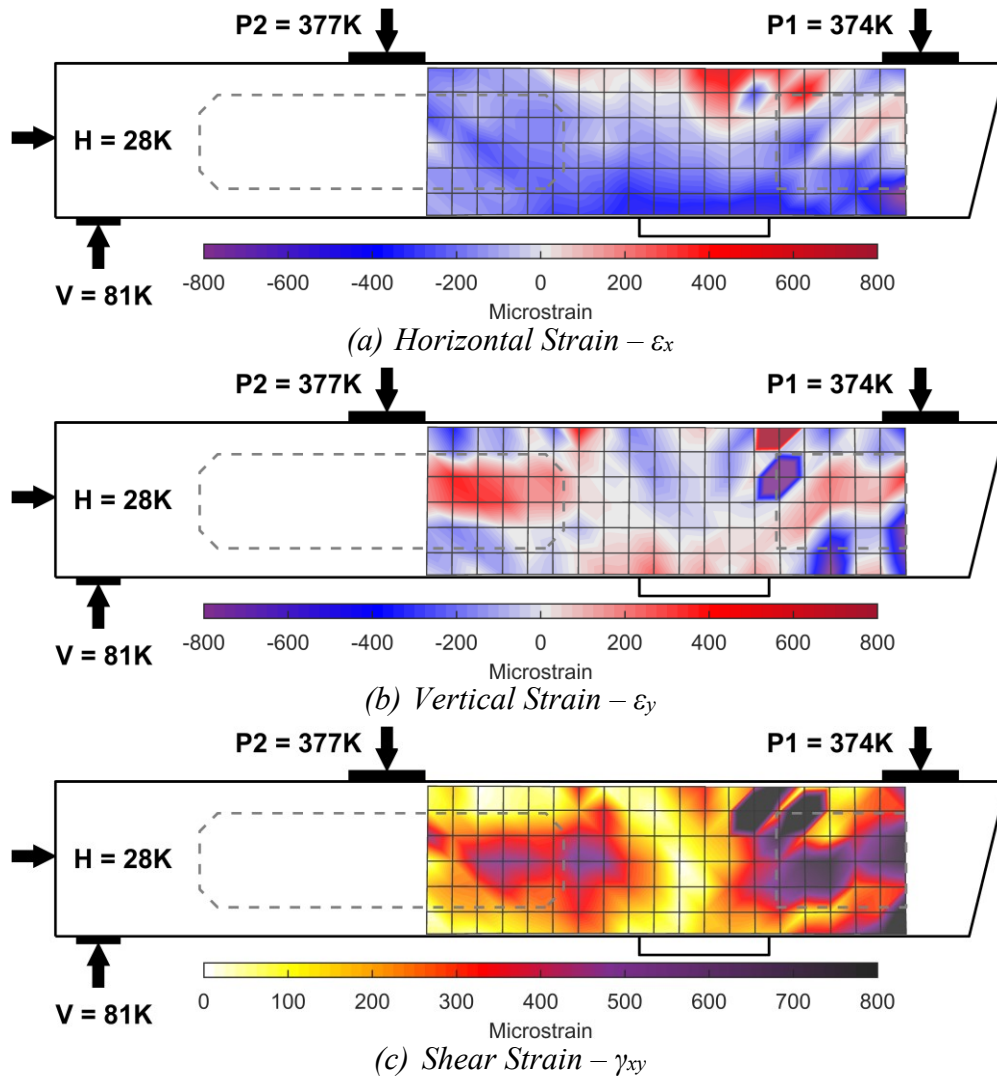
Figure 4.17. Horizontal, Vertical, & Shear Strain Fields (ϵ_x , ϵ_y , & γ_{xy}) under Pattern A ULS Demands for PSV-28B.

These figures show that the strain fields correspond with the expected response of the bent caps. In the negative bending are, the horizontal strain fields show tensile strain at the top of the beam and compressive strain at the bottom of the beam. The transition from tensile (red) to compressive (blue) strain is indicated with a white fill color and relates to the location of the neutral axis. The horizontal strain fields show that for the design ULS demands, the neutral axis of the bent caps remains at just below $D/2$ through the negative bending joint region.

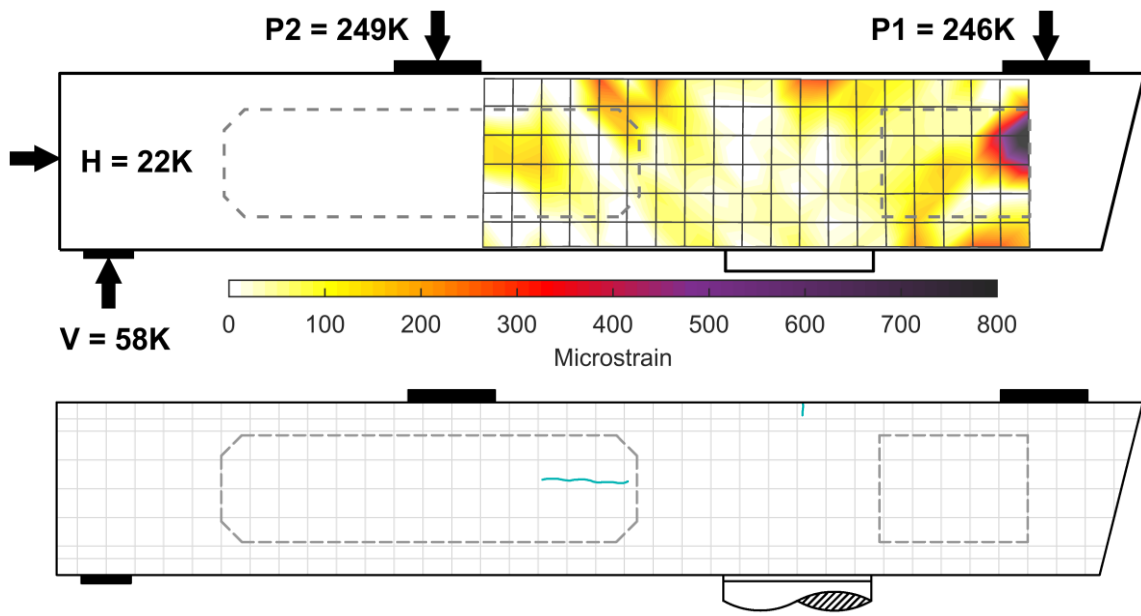
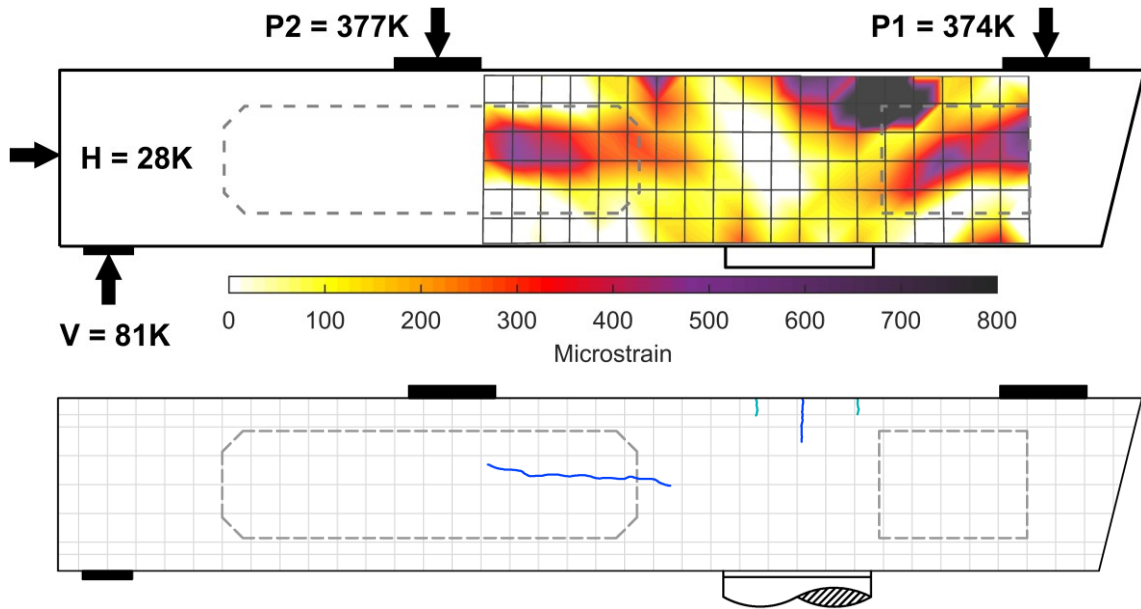
(a) Pattern A – SLS

(b) Pattern A – ULS

Figure 4.21. Comparison of Principal Tensile Strains and Observed Damage under Pattern A Demands for PSV-28B.

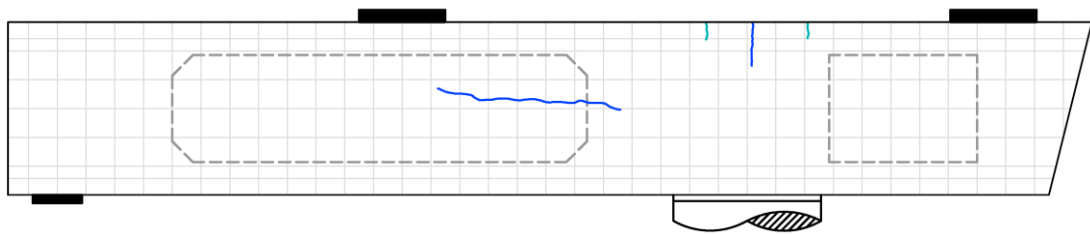
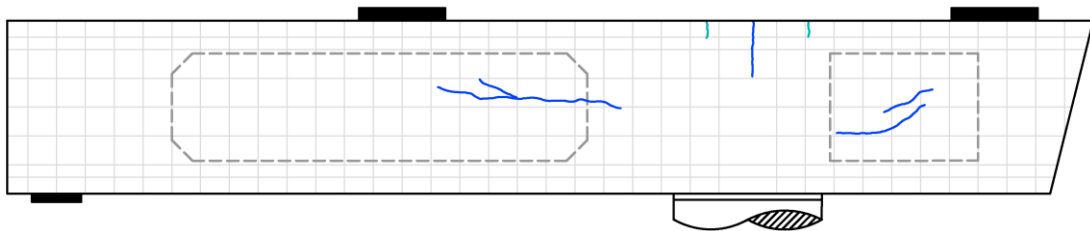
(a) 1st Instance of ULS Demands – Principal Tensile Strain Fields

(b) 1st Instance of ULS Demands – Observed Damage

(c) 2nd Instance of ULS Demands – Observed Damage

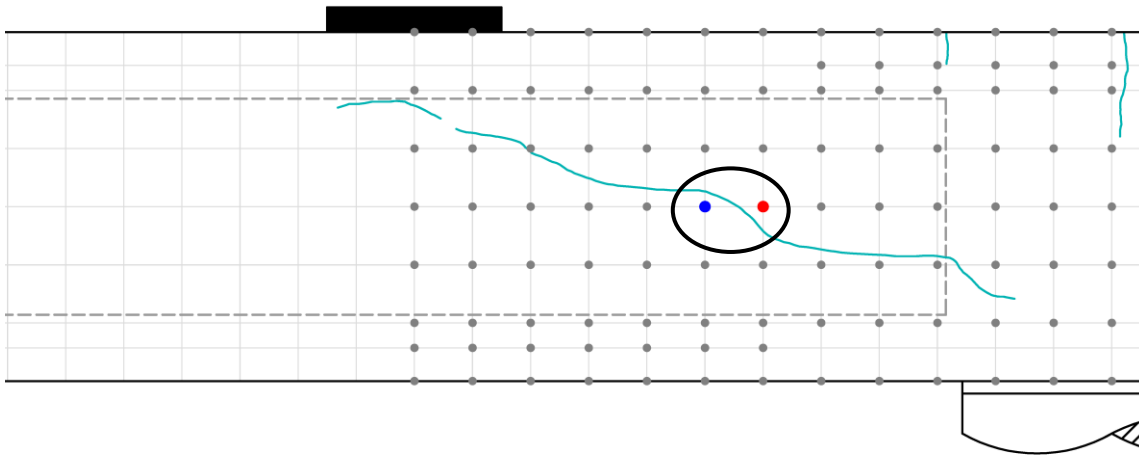
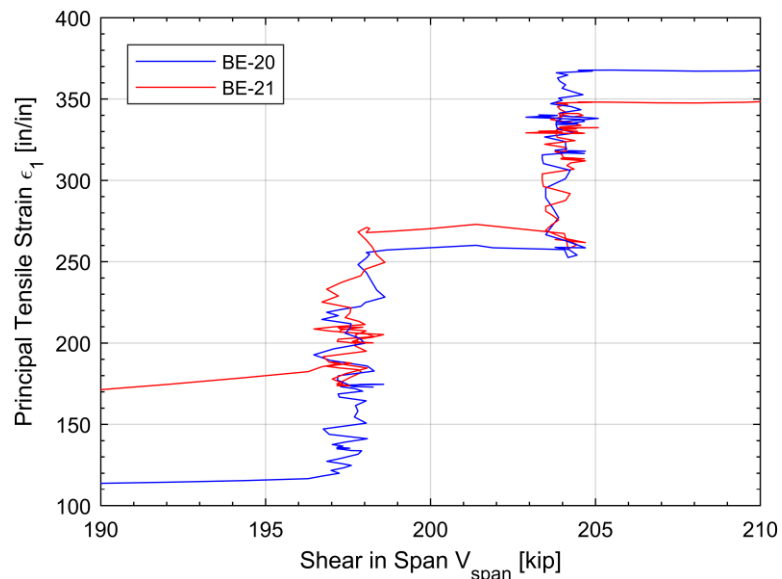
(a) Location of LED Markers in Relation to the Shear Crack Observed Between SLS and ULS Demands

(b) Principal Tensile Strain vs Applied Shear V_{span}
