EFFECT OF POLYPROPYLENE FIBER REINFORCEMENT  
IN CEMENT SHEATHS EXPOSED TO CYCLIC FATIGUE LOADING

A Thesis

Major Subject: Petroleum Engineering

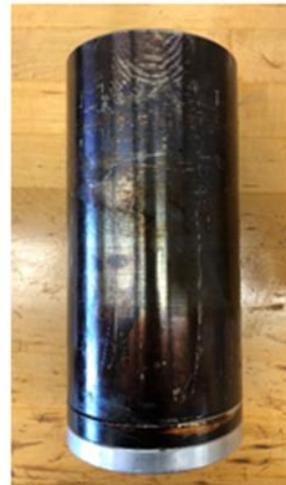
**Small vessel and sample**

**Vessel head**

**Large vessel**

**Figure 7:** Schematic of pressure vessels

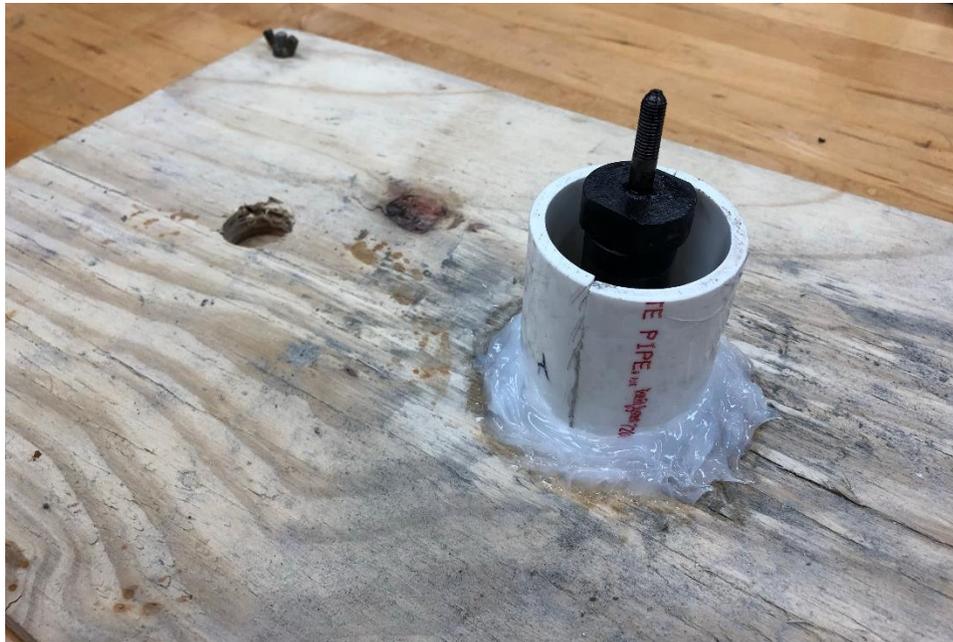
molding board. Some silicone typically squeezed out of the hole and was then removed to prevent contamination with the cement slurry. PVC pipe was cut into two inch long pieces and sawed in half to provide seams for easy demolding. The two halves were taped together, centered around the small vessel, and glued onto the molding board using silicone. The mold was allowed to dry for several hours to ensure cement would not leak from the mold during the placement or curing process. **Figure 7** shows a sheath mold ready for cement placement.

**Figure 10:** Molding board, PVC pipe, and small vessel

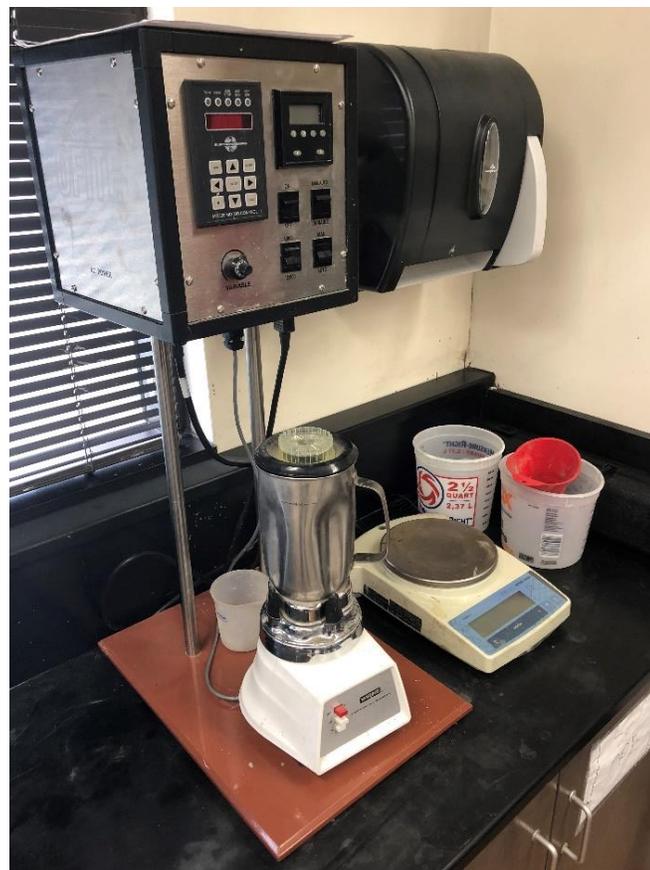
material additives were weighed individually, then thoroughly blended in a large container. The mix water was poured into the 1-liter capacity blender container and placed on the blender base. The blender motor was turned on high at  $4,000 \pm 250$  rpm for 15 seconds. During the 15 second period, all dry materials were added to the mix water. Then, the container lid was attached and the blender motor was turned up to  $12,000 \pm 250$  rpm for an additional 35 seconds of mixing. Once this period was over, it was often observed that a layer of dry material would float on top of the cement batch. A spatula or similar instrument was used for hand mixing until the batch reached a satisfactory uniform composition.

**Figure 12:** Cement mixing equipment

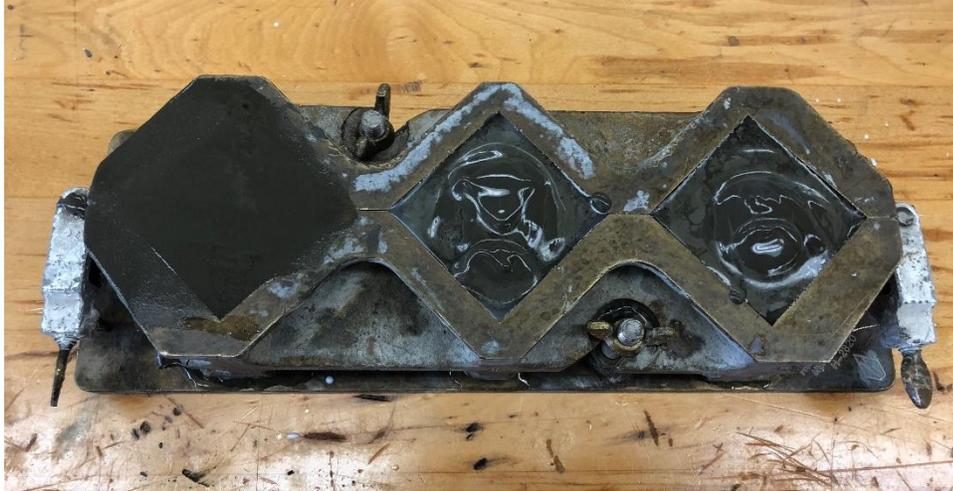
Throughout the placement process, cement slurry was continuously hand mixed in the blending container. It is also important to mention the order for pouring cement into the molds. The first layer of all cube molds was poured first, then the first layer of the cement sheath mold. A second layer was added to one cube mold, then the cement sheath mold, and finally the remaining two cube molds. The intricate order, combined with continuous hand mixing, provides a good distribution of different parts of the slurry batch into the molds.

**Figure 13:** Cement placement into cube mold

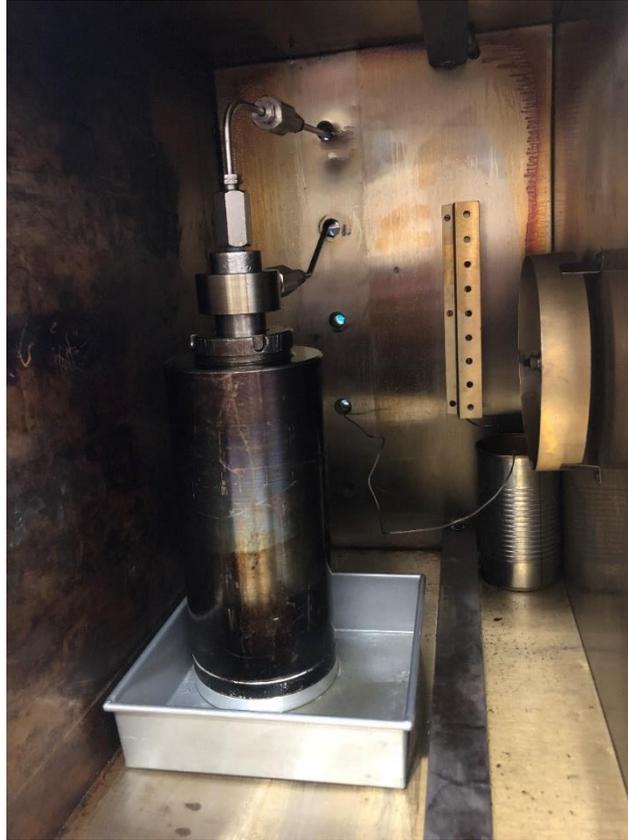
**Figure 15:** Large vessel arrangement inside the oven

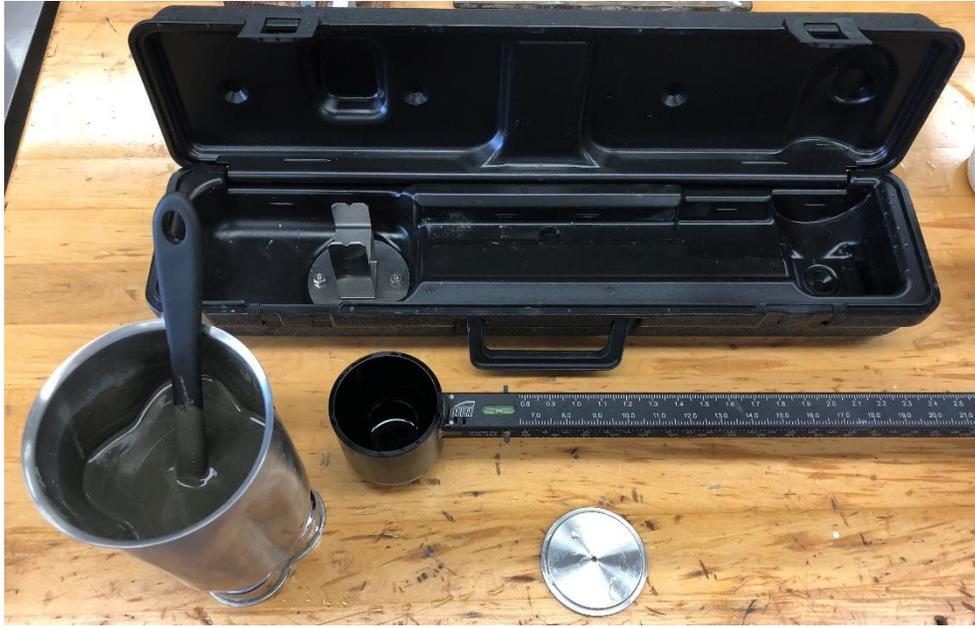
Once tested, the slurry was poured from the cup back into the blender container and thoroughly mixed. The measured density was then compared with the acceptable range. If the slurry passed the density test, it was placed into the molds. If it failed, the density was measured a second time. A second failed density test meant the batch failed specifications and the entire batch was discarded.

**Figure 16:** Mud balance and cement slurry for density testing

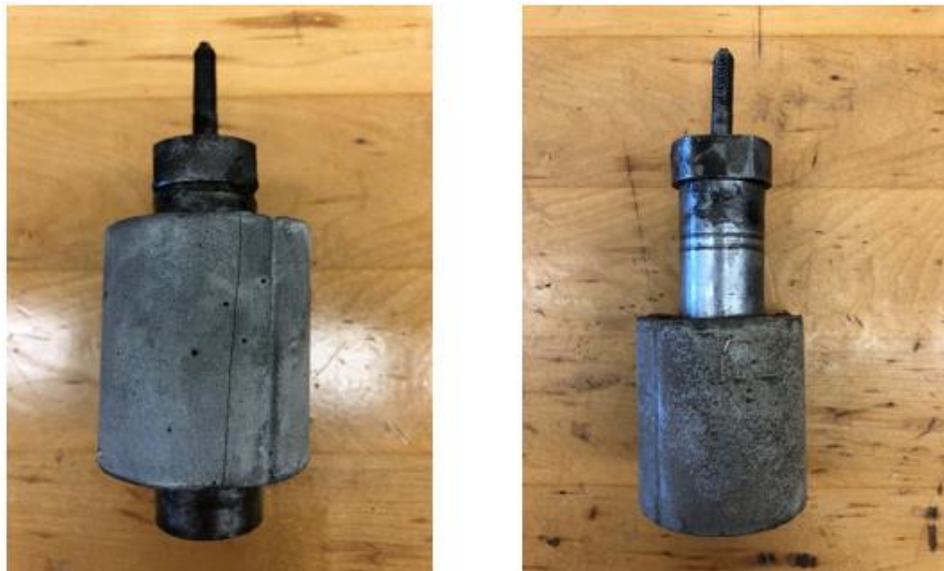
After a predetermined number of pressure cycles, the test was stopped to remove the cement sheath sample. The sample was checked for cracks or debonding failure, as shown in **Figure 23**. If the sample had failed by severe debonding, the test was immediately stopped. Otherwise, the test continued with more pressure cycles until the sample did fail in this manner. Later, the test's voltage data was exported into a spreadsheet and converted to psi.

**Figure 23:** Radial cracking (left) vs. debonding (right)

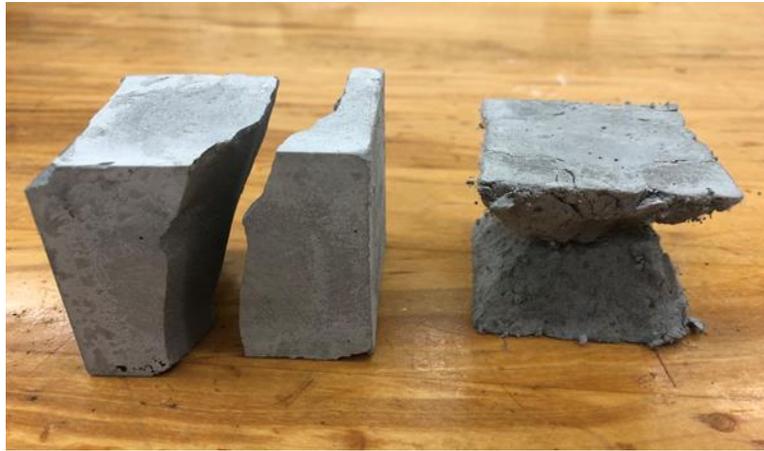
This section contains the results from compressive strength testing. In general, there were two types of failure observed, as shown in **Figure 28**. High compressive strength cubes failed catastrophically with a single large crack while the lower compressive strength cubes failed gradually in an hourglass shape. This behavior is attributed to the relative level of ductility from one slurry design to another.

**Figure 28:** Brittle failure (left) vs. ductile failure (right) of cement cubes

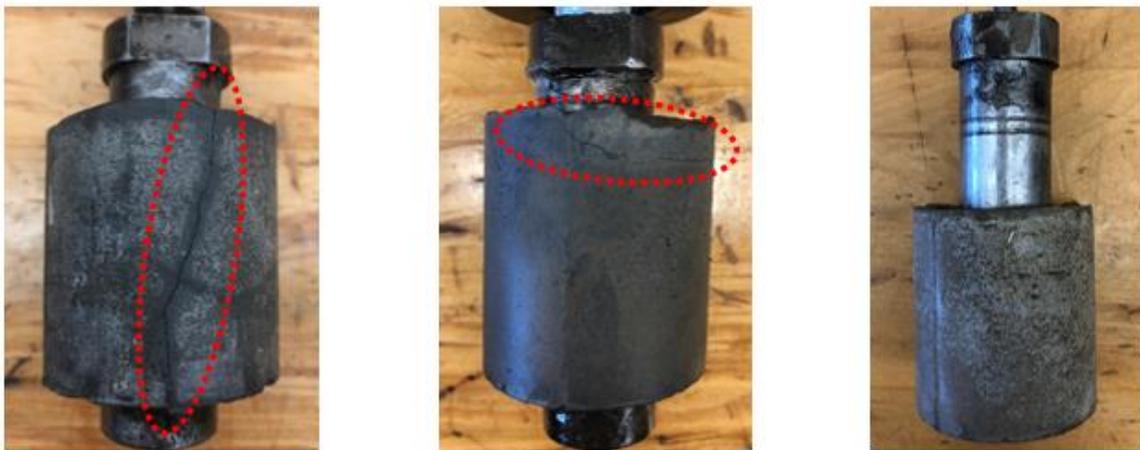
Cement sheath samples underwent cyclic fatigue loading at wellbore conditions. Results from those tests are presented in this section. Samples exhibited three types of failure including radial cracks, disk cracks, and debonding from the small pressure vessel, as shown in **Figure 35**. The methods of failure were termed minor or severe according to the level of propagation which is shown in **Figure 36**.

**Figure 35:** Types of failure – radial crack (left), disk crack (center), debonding (right)

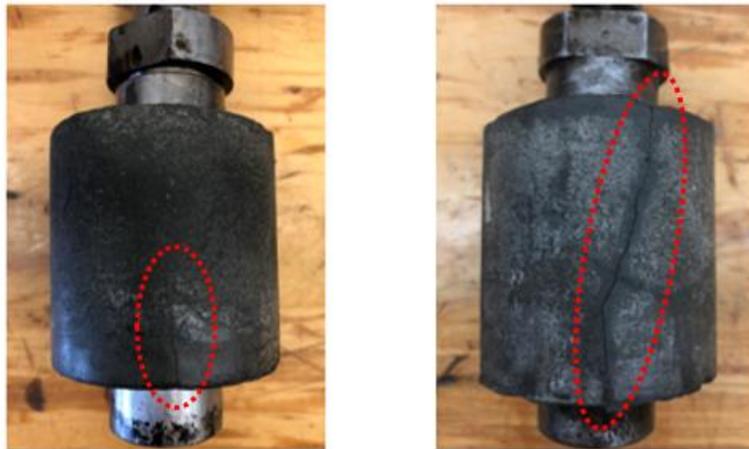
**Figure 36:** Radial cracks – minor (left) vs. severe radial (right)

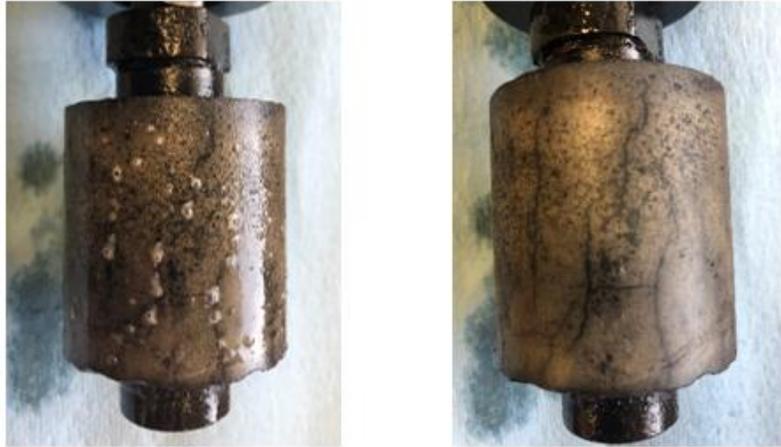
**Figure 40:** NS samples after wellbore curing

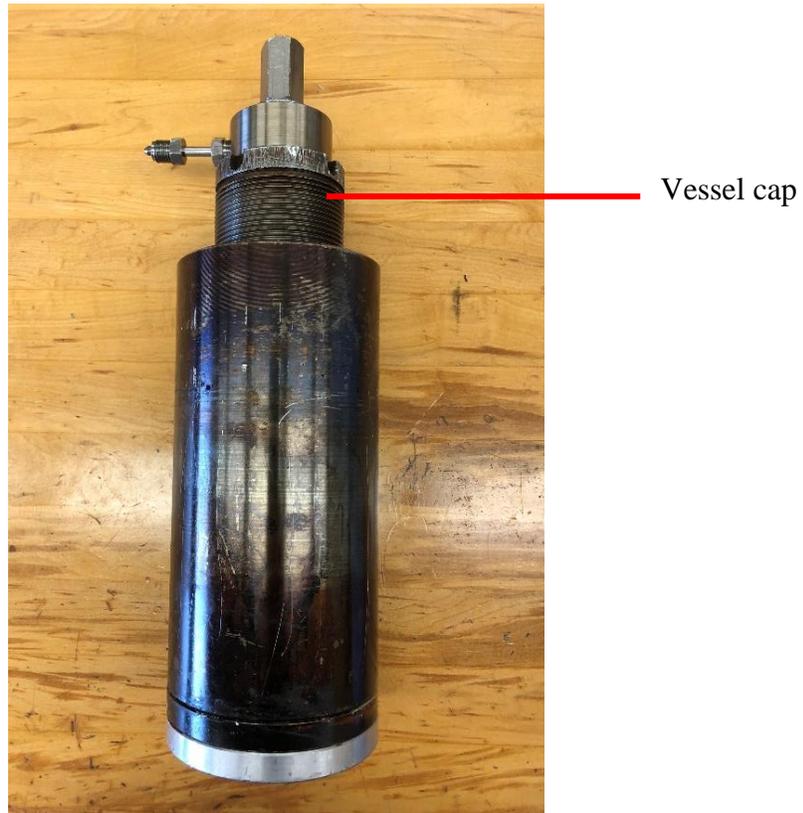
**Figure 42:** Pressure cap stuck in large pressure vessel

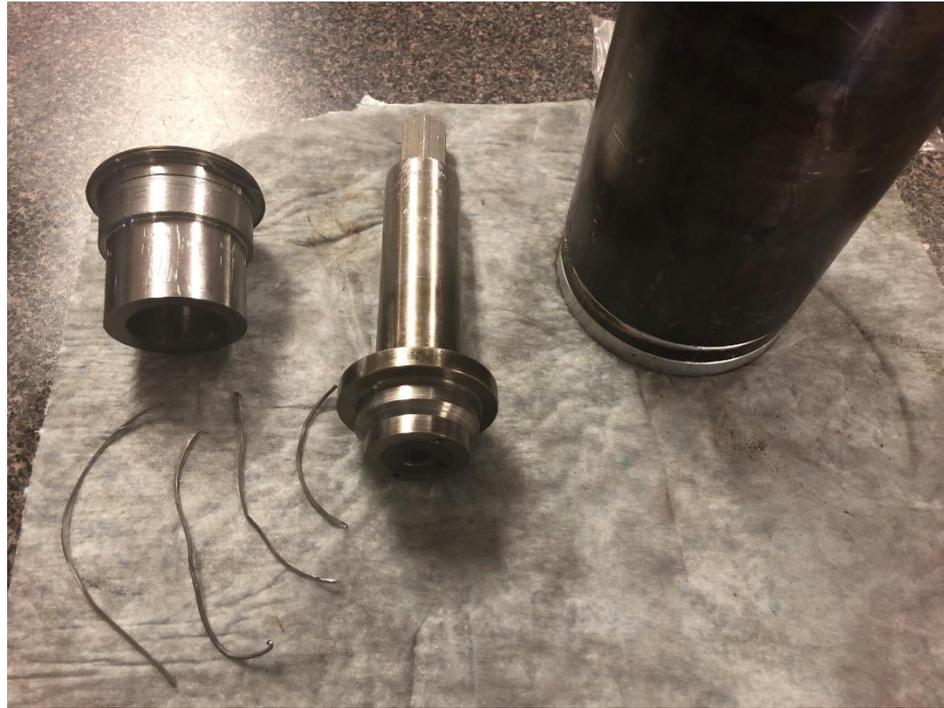
**Figure 43:** Pressure cap without its threads after being machined out

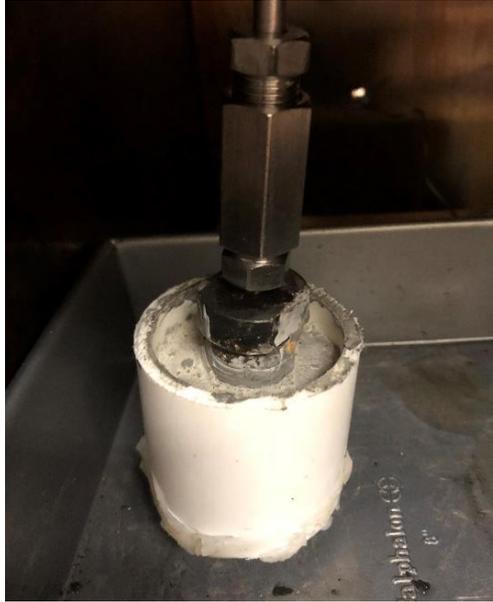
**Figure 44:** Sch. 40 PVC pipe confining pressure

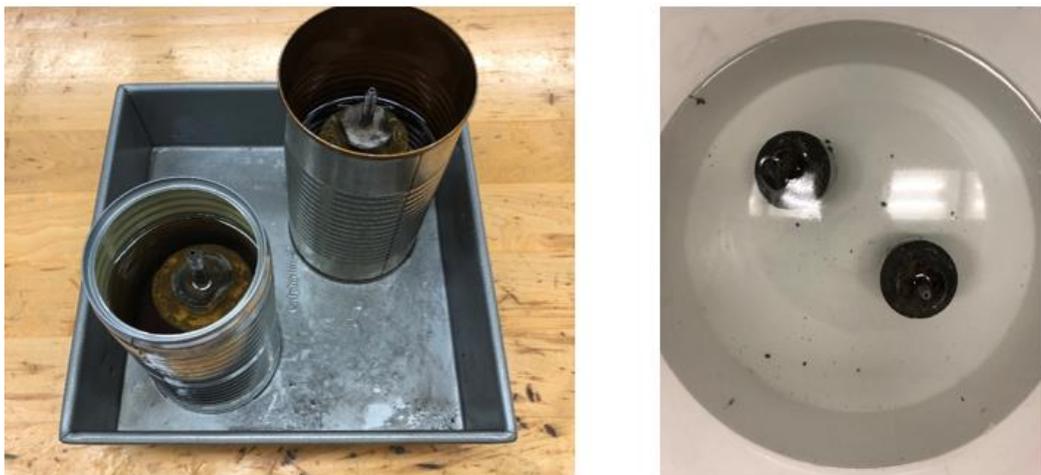
**Figure 45:** Samples immersed in oil and water for temperature cycles

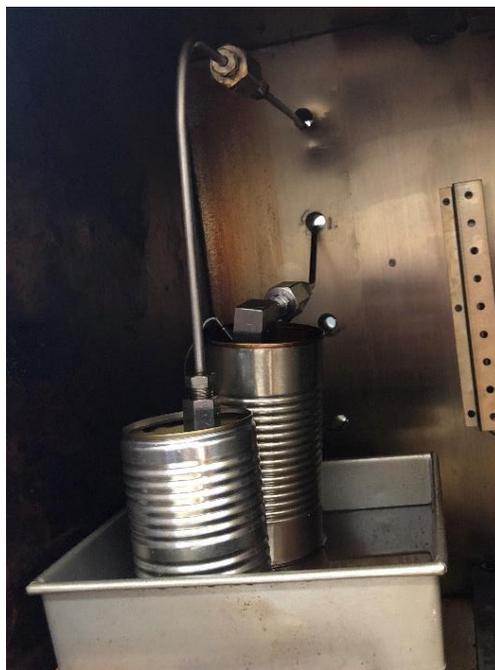
**Figure 46:** Samples connected to flow lines for S-cycles

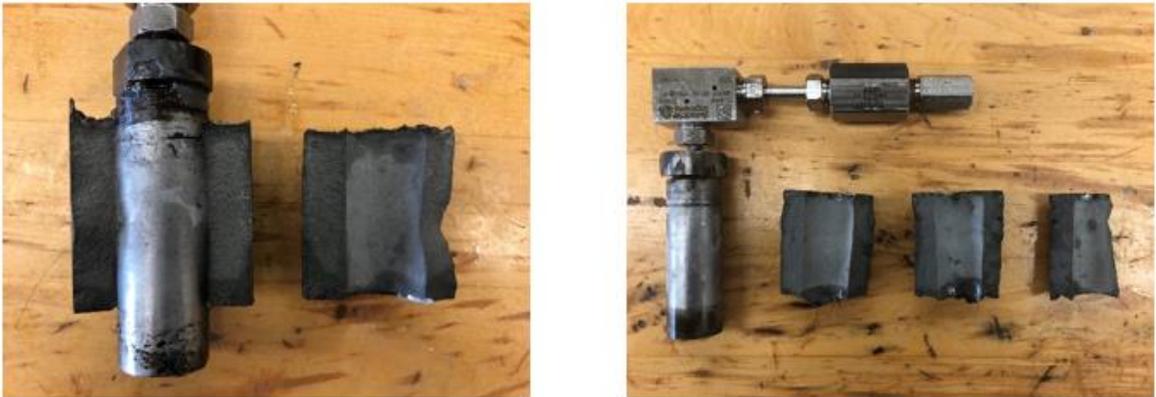
**Figure 50:** 1 plane, 2 point failure (left) and 2 plane, 3 point failure (right)

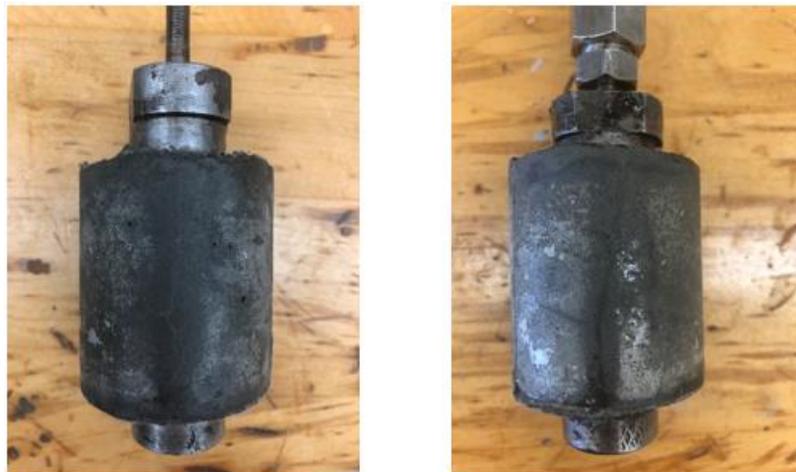
**Figure 53:** Radial cracking in PP cement sheaths

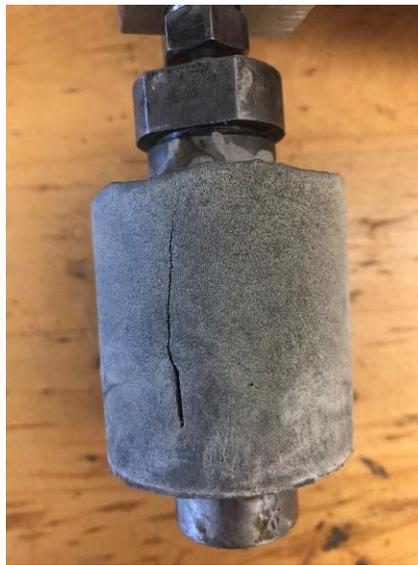
**Figure 56:** Bad sample, BEN 9-4

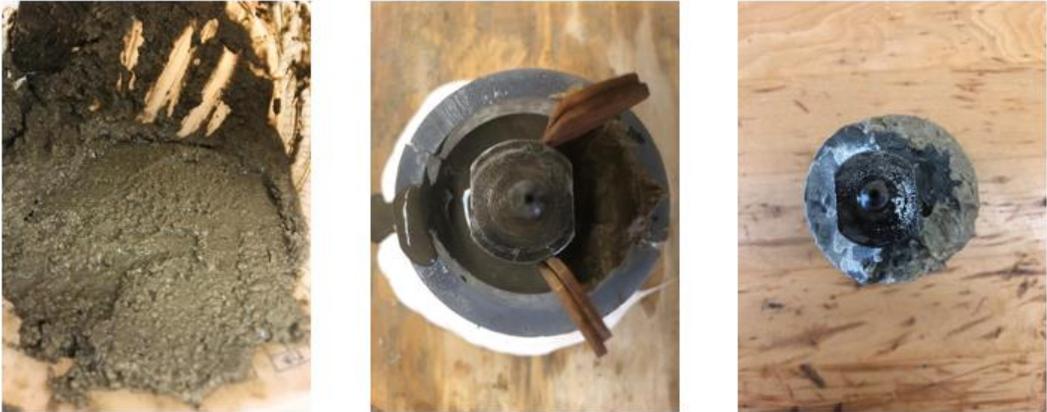
**Figure 60:** Mixing and placing OBM into BEN cement molds

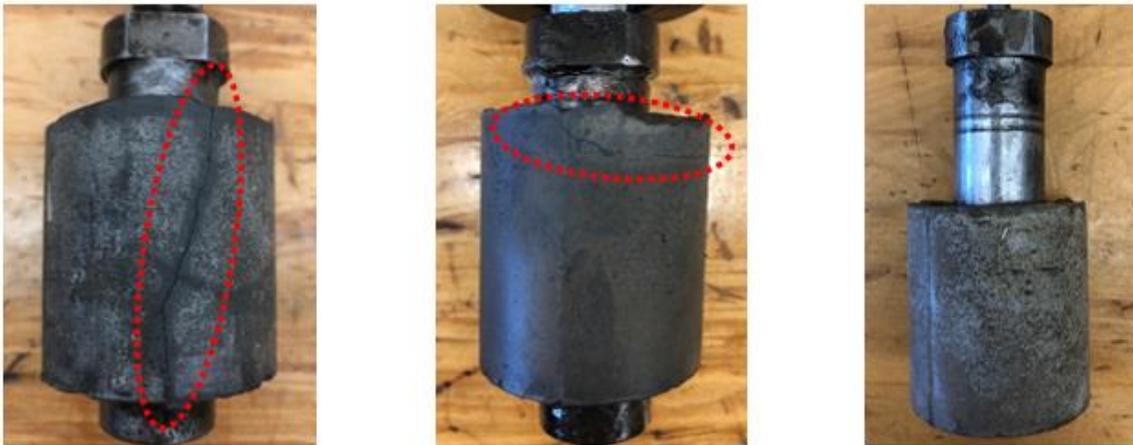
**Figure 64:** Types of failure - radial crack (left), disk crack (center), debonding (right)

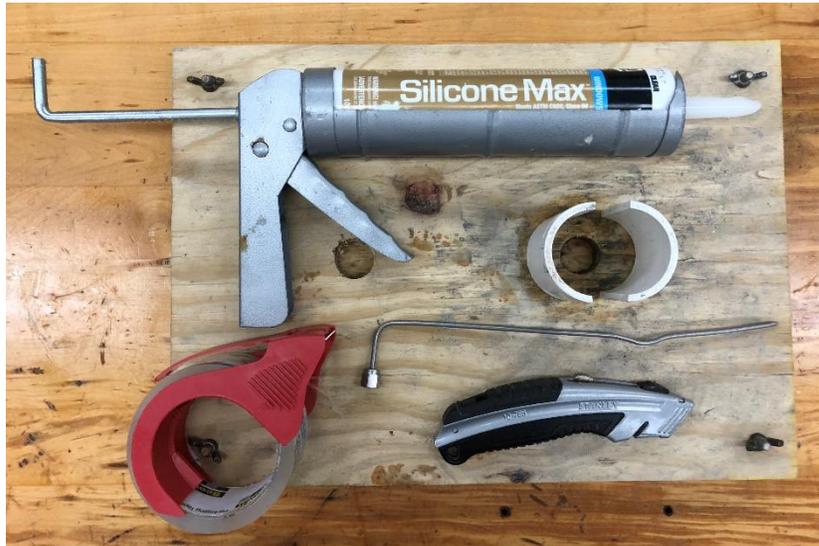
**Figure A.1:** Cement sheath sample preparation

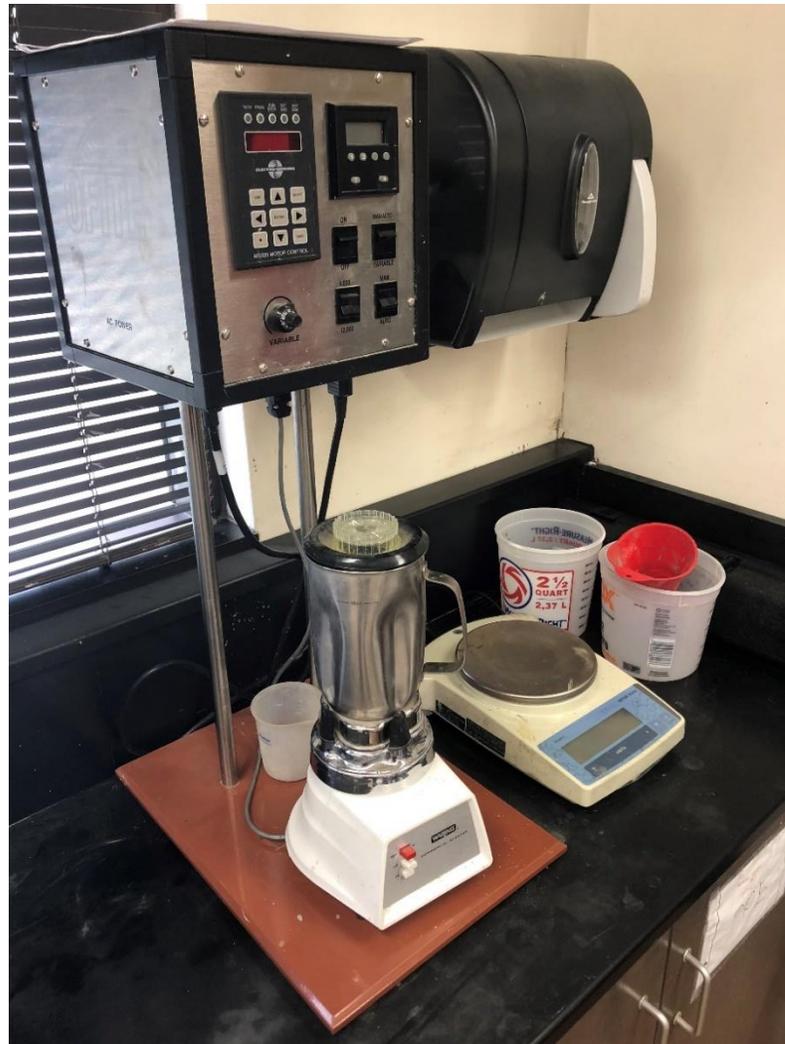
**Figure A.3:** Cement mixing set-up

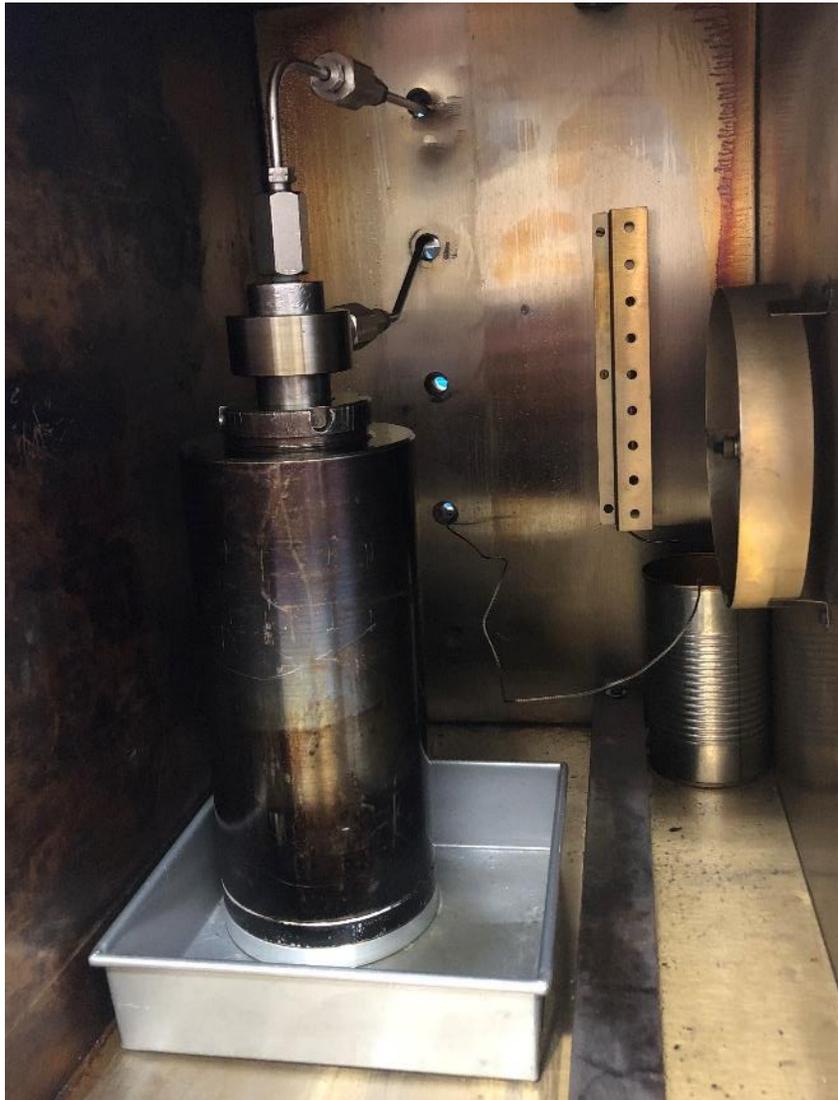
**Figure A.12:** Wellbore curing

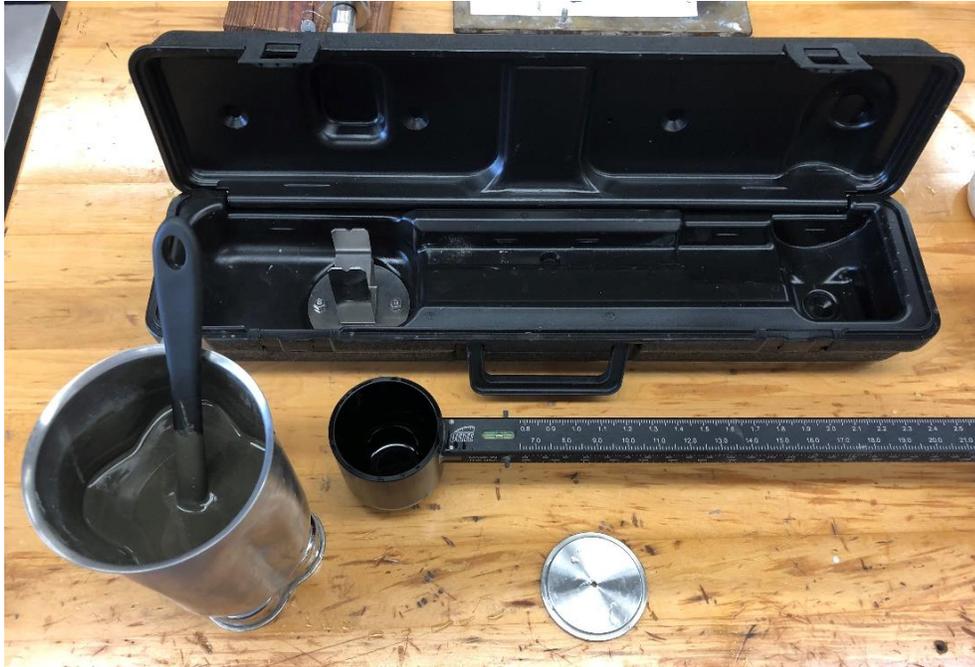
**Figure A.13:** Mud balance for density testing

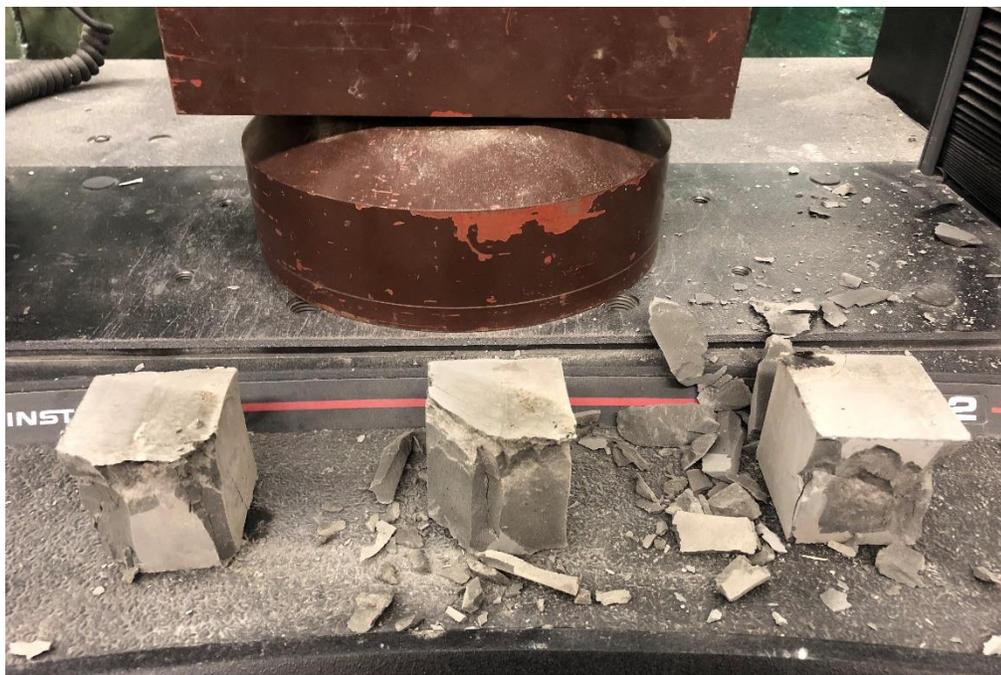
**Figure A.19:** Broken samples

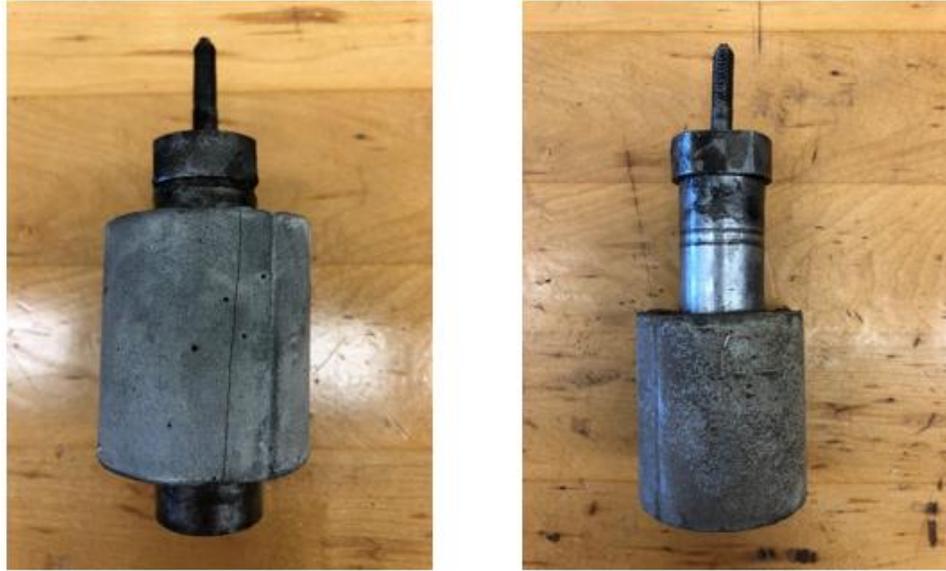
**Figure A.26:** Radial cracking failure (left) and debonding failure (right)
