UAS BASED PHOTOGRAMMETRY: A NEW TOOL FOR MONITORING BEACH
NOURISHMENT PROJECTS: A GALVESTON, TX TEST CASE

A Thesis

In December of 2016 the “Phase III Beach Nourishment: Seawall East” project started laying down approximately 920,000 m³ of sand dredged from the Big Reef area on the East end of Galveston Island, TX across 6.2 km of Seawall beaches from 10th Street to 61st Street. This project offered a unique opportunity to collect data on a pre-nourished beach area and monitor that same area monthly post-nourishment over the course of a year. Information on the health and life span of beach nourishment projects is valuable to coastal managing agencies, who require detailed data to back up the investment they have made, as well as for planning future projects. A low cost, easy to use, and quick survey method is required so that such agencies can better monitor their beaches for these purposes. For this thesis a deployment protocol was developed for Unmanned Aircraft System (UAS) based photogrammetric modeling methods which were used to generate photorealistic LiDAR quality point clouds to create profiles and sand volume calculations of this beach area for 14 months. Analysis of the

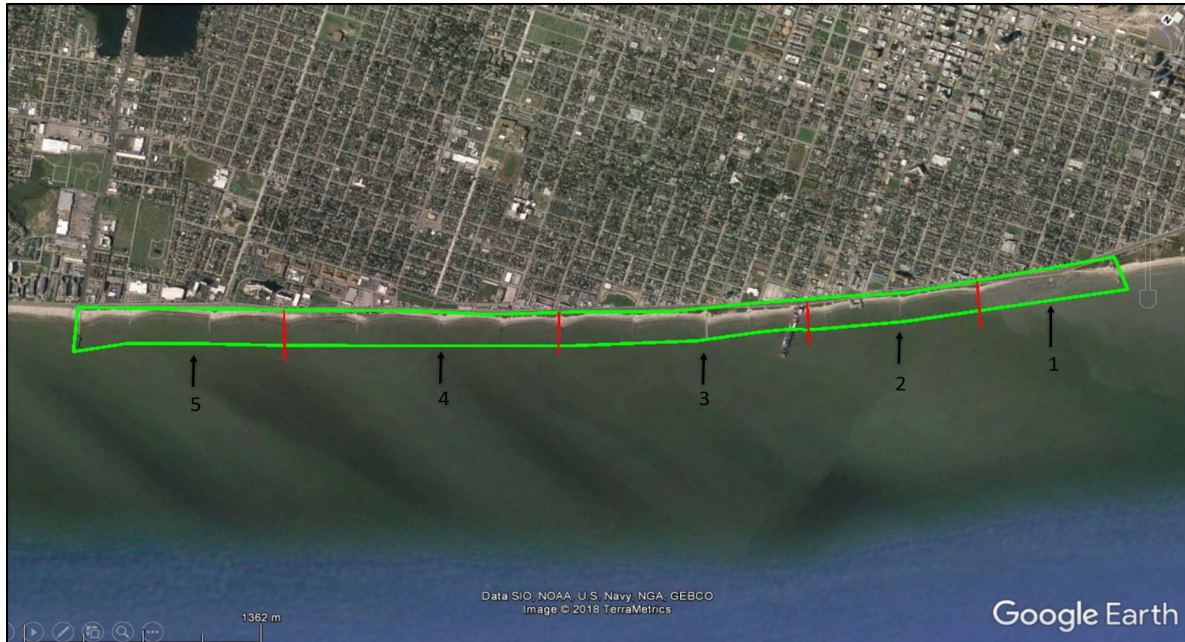
Figure 3 The 5 sections of Phase III Beach Nourishment: Seawall East study area. Modified from (Google Earth, 2018).

Elevational Measurements of a UAS-Based Beach Survey” found in **Appendix A**. Due to the size of the study area and flight time per battery limitation of the DJI Phantom 4 Pro UAS used in the study, the study area was divided into 5 sections in which each had its own flight plan (Figures 3 & 4).

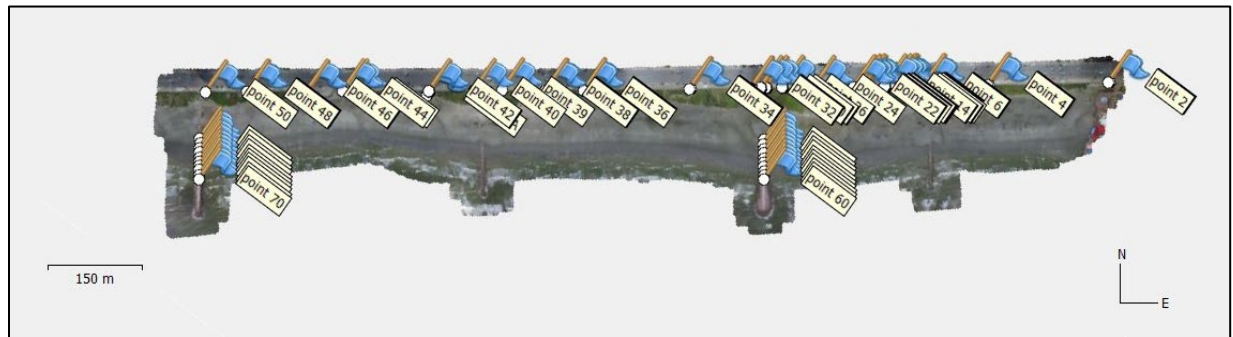
Figure 6 GCP placement along the seawall and groins of section 3. *Produced using Agisoft Photoscan Pro

only required 40 GCPs whereas the areas with 3 or more groins (Sections 2-5) were benefitted from more GCPs evenly placed across their surface, to ensure that the beach segments being surveyed had closely associated ground control. To this end Sections 2-5 had a total of 70 GCPs placed in them to provide adequate coverage. Due to uncontrollable variables such as tourists visiting the beach, beach maintenance personnel, and animals, it was decided to forgo the use of traditional target plates used for GCPs. It was observed that people and animals were often attracted to the target plates during the deployment protocol testing. Since any interference with the plate would invalidate the use of the GCP and the RTK GPS measurement taken at it, static features in the hard structure of the seawall and groin field were chosen to be used as reference points to create GCPs (Figure 6).

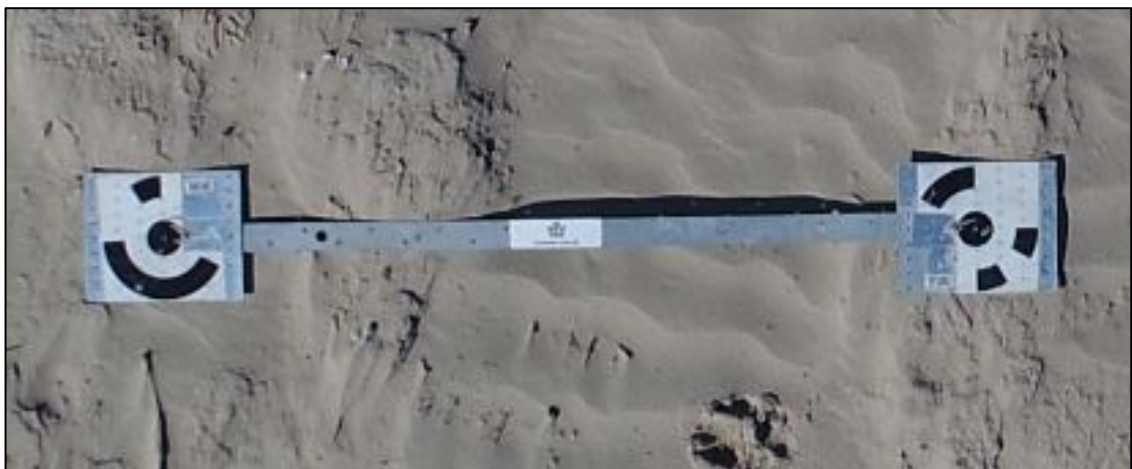
Figure 7 Example of a 0.914 m scale bar with coded targets.

In addition to GCPs, 2 scale bars were placed in a “T” pattern on the beach of each section when it was being imaged as a means of quality control. These scale bars measuring 0.914 m in length have a coded target plate at each end. These targets are generated by Agisoft Photoscan Pro and can be automatically detected by the software (Figure 7). At the end of the imaging of a section the UAS would be flown to the location of these scale bars and they would be imaged at a height of 36m then 20m then 5m. This process allowed these images to be aligned in Agisoft Photoscan Pro with the rest of the images taken for the section while ensuring that the coded targets would be clearly visible.

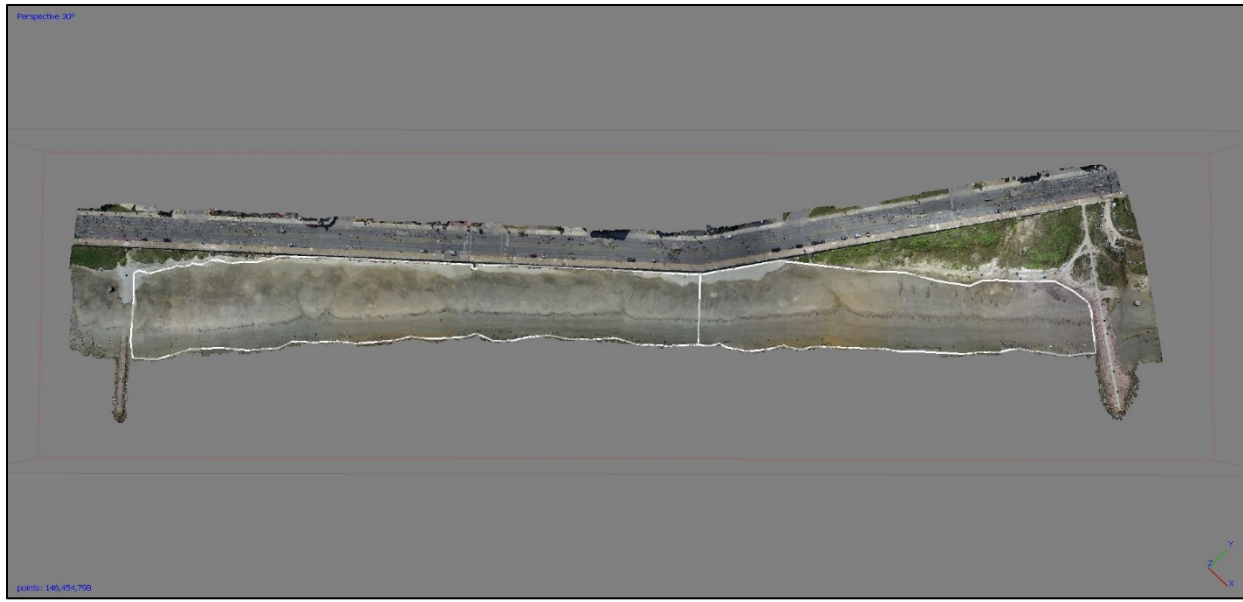
Figure 8 Section 1 Beach segment 1 dense point cloud with volume polygon and profile polyline. *Produced using Agisoft Photoscan Pro

The images captured using the UAS were aligned, and dense point clouds, meshes, georeferencing, and production of DEMs, and orthomosaics were produced in Agisoft Photoscan Pro using the workflow detailed in **Appendix B**. This same software package contains a suite of tools that allows for analysis of the products it produces. These include a tool for measuring profiles based off drawn polylines and volumes using drawn polygons. These shapefiles were drawn on the dense clouds of each monthly iteration of the models so as to only measure the visible sand and not interpolate data beyond the scope of the know beach area (Figure 8).

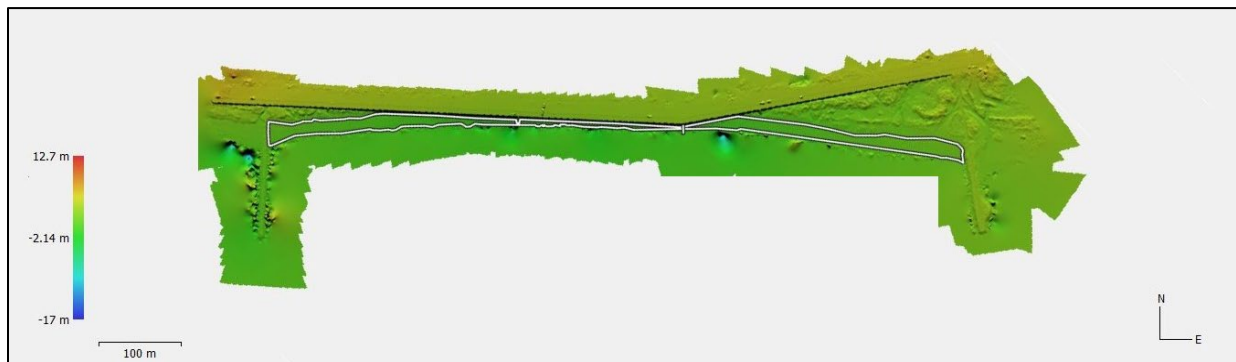
Figure 9 December 2016 digital elevation model (DEM) of Section 1 Beach segment 1 with volume polygon and profile polyline. *Produced using Agisoft Photoscan Pro

Once the shape files had been imported and resized to follow the change in shoreline, the altitude for each shapefile was updated to “clamp it to ground”. This procedure takes the edited shapefile and pairs it to the altitude values of the terrain it overlays. This ensures that measurements using the shapefile correspond with the terrain data and provide accurate volume and profile measurements.

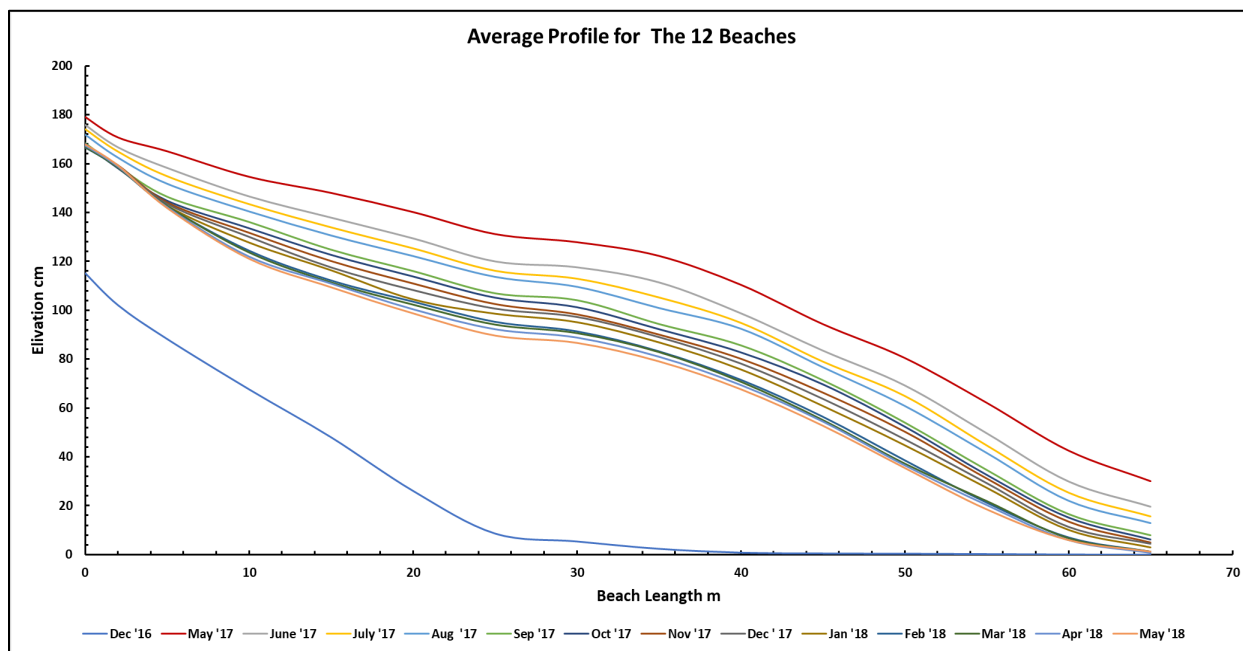
Figure 13 Average beach profile change for the 14 months of the study.

compiled so that the changes in volume and profile could be compared to SWH data to quantify the relationship between monthly SWH and sand volume loss (Figures 13 & 14).

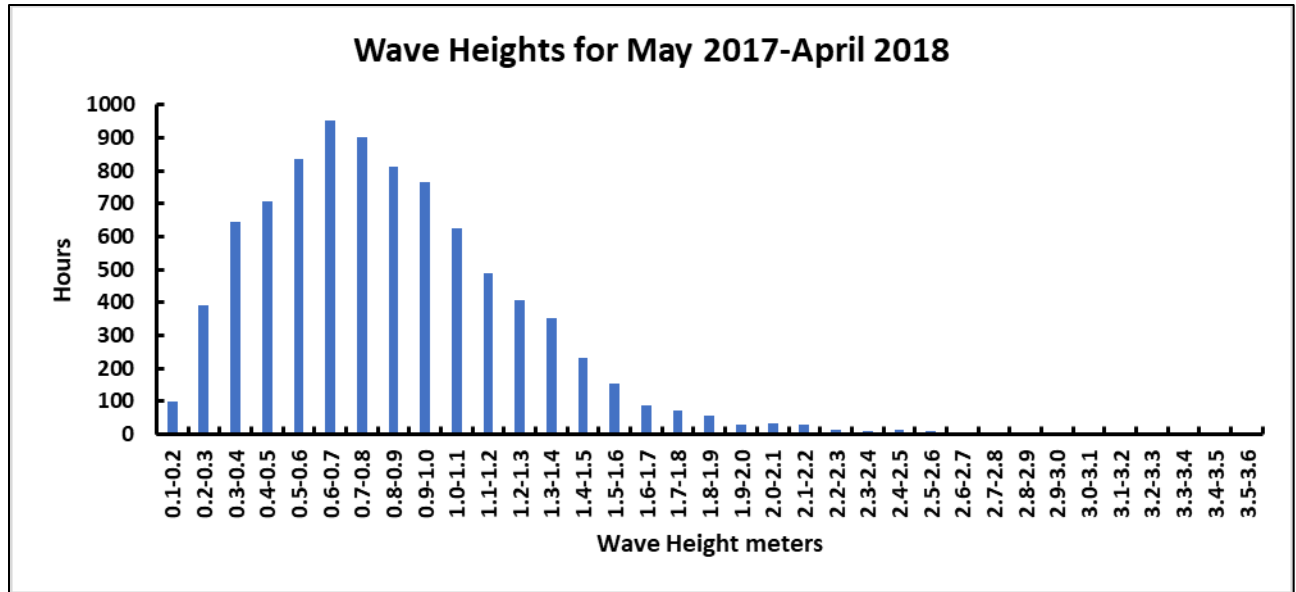
Figure 15 Histogram of SWH per hour for May 2017 through April 2018. Range 0.1-0.2 m to 3.5-3.6 m. Skewness 1.018.

This data was then normalized using the “Standardize” function in Excel so that each monthly data set contained 730 data points. This was done so that each month’s distribution of significant wave height per hour could be compared to the other monthly SWHs and the volume and profile data from the UAS surveys to quantify the relationship between SWH and the change in the beach volume over the 12 months of the study to see if significant erosional events found in the beach fill volume data correlated with a greater number of large waves (Figures 15 & 16).

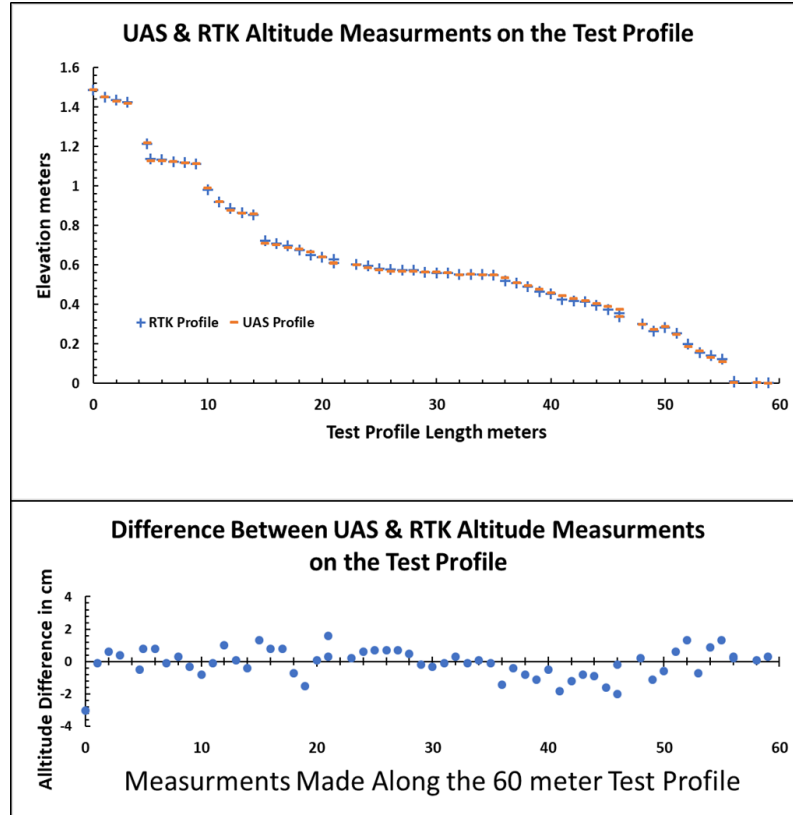
Figure 18 Difference in altitude measurements taken by RTK and UAS along the profile line used for ground truth testing. Note: Measurements were made at 1 meter intervals along a single profile extending from the base of the Seawall (0 m) to the water line (60 m).

In order to assess the accuracy of measurements being made using the UAS, a test was devised in which a single beach segment would be imaged with the UAS using optimal flight and measurement parameters (see **Appendix A**) and compared with an RTK GPS profile measured right after the UAS flight. A survey tape was laid out on the beach from the base of the Seawall to the waterline to use so that RTK and UAS-based measurements could be made along the same profile and at an equal 1 m spacing along the tape. Sixty RTK measurements were recorded along the profile, points were then drawn in the UAS data for the survey along the base line to match the 1 m portions taken with the RTK, measurements of the position and elevation were then made for each point in the UAS data using the Measure Shape tool in Agisoft Photoscan Pro. This test showed that there was a maximum difference of +/- 2 cm between UAS and RTK measurements made along the profile with <1 cm being the most common (Figure 18 & **Appendix C**).

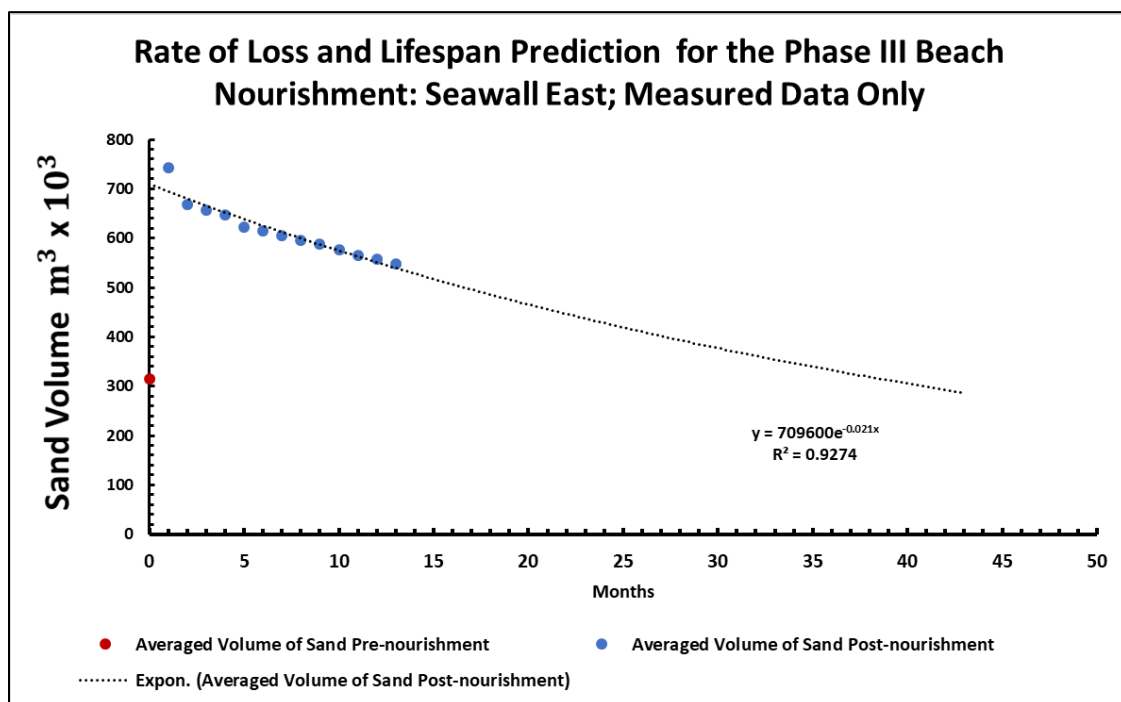
Figure 19 Rate of loss and lifespan prediction for the Phase III Beach Nourishment Project.
Note: Percentage of fill lost thru May 2018 was 26.2%

Averaging this data into a single volume and profile change for the entire 6.2 km allowed for the calculation of the month-by-month percentage of fill lost post-nourishment. This rate of loss curve can be extrapolated to estimate the expected time (in months) before the beach would return to its pre-nourishment volume (Figures 19 & 20).

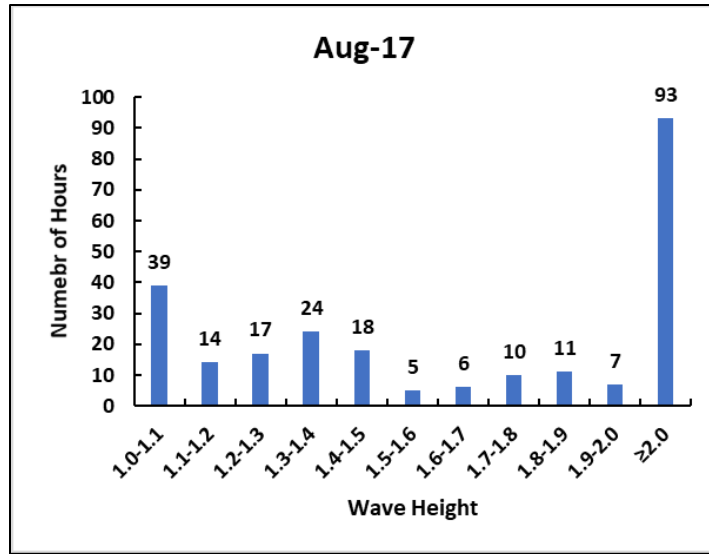
Figure 21 Hourly significant wave height for the month of August 2017 when Hurricane Harvey occurred. Compare with the other months shown in figures 15 & 16.

The month of highest volume loss (August 2017) was correlated with the month of greatest number of hours (93) of SWH >2.0 m. This was significantly above average for wave conditions found for the other 11 post-nourishment months (Figure 21).

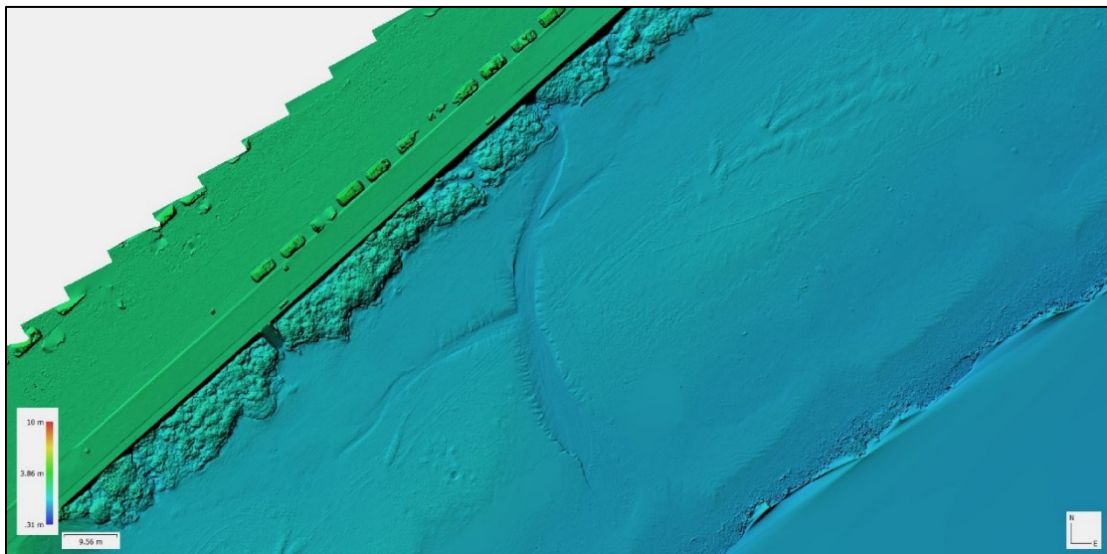
Figure 23 Example of an erosional cut in Section 2, Beach segment 2 July 2017. *Produced using Agisoft Photoscan Pro

DEMs and orthomosaics allowed for the identification of features in the beach and their creation or change over the study period. Seawall Boulevard sheds rain over Galveston's Seawall and several associated features of the Seawall such as stairs, ramps, and drains funnel this water onto the beach. This action creates erosional cuts in the beach, carrying away beach material and exacerbating subaerial erosion (Figure 23). Events of heavy rain followed by dry periods where wind and pedestrian traffic on the beach had a chance to fill these erosional cuts can be seen. While some of these cuts are quite wide and deep and will remain for some time, smaller cuts were easily filled and little evidence of them remains today. By recording and measuring this type of feature with UAS allows for more accurate and precise beach volumes than with standard RTK GPS surveys which do not have the areal coverage to resolve these features.

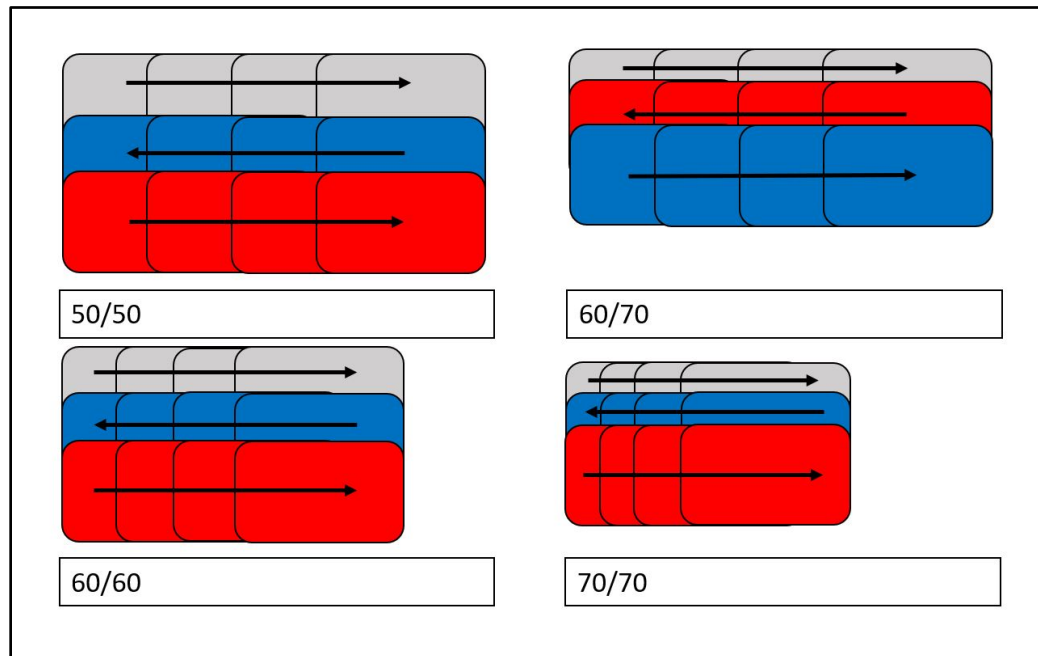
Figure 4 Examples of the difference in camera overlap and side-lap used.

also an indicator of elevational measurement accuracy. Excellent pixel resolution aided in the accurate placement of GCPs in the models. Ratios of overlap and side-lap were chosen to represent a range from the minimum required for the programmatic process to work (50/50) and what was determined to be a maximum of 70/70 as ratios over this increased flight times past an acceptable limit. In addition, a 60/70 ratio was added to determine if this was the optimal ratio for UAS based photogrammetric surveying per one of the DroneDeploy software defaults.

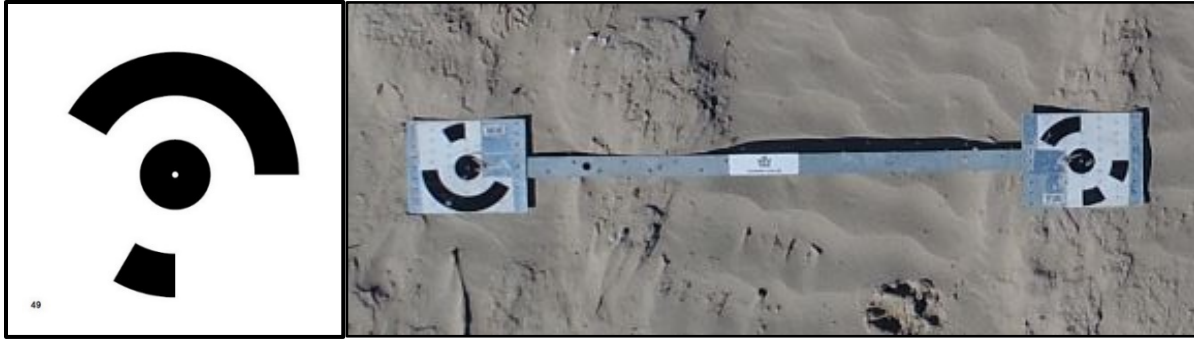
Figure 5 Examples of Agisoft Photoscan coded target pattern and pattern printed out in 26cm² used for ground control points Attached to the 0.914 m long scale bars for quality assurance in measurements.

Once flight planning was completed, testing with the three UAS platforms was conducted at the test area. In order to geo-reference the produced programmatic models and products, 40 GCPs were placed across the test area. These consisted of thirty-six 26cm² coded targets (Figure 6) created by Agisoft Photoscan Pro affixed to 0.914m long scale bars with the remaining 4 GCPs being chosen from easily recognized points in the hard structure of Galveston's Seawall. The use of the 0.914m scale bars with coded targets attached was chosen to ensure that GCP targets would be evenly placed and allowed for a quality control measurement in the models produced. If the measurement between coded targets were much greater or smaller (+/- 2cm) than the 0.914m known length of the scale bar steps were taken to correct the underlying issue that caused this error ensuring the greatest possible accuracy in measurements. All points were measured using a Leica Viva GS10 RTK system monumented to a National Geodetic Survey Benchmark for GPS and Vertical control set in the top of the Seawall. Geo-referencing the models produced in Photoscan Pro using RTK derived GCPs ensures the produced data is accurate and allows for the creation of accurate DEMs for use in profile and volumetric calculations (Ruzgienė et al, 2015). Coded target GCPs offer the ability to place GCPs on any surface being surveyed and have Photoscan Pro detect the targets in the imagery taken. GCPs can also be created using points on hard structures that are easily identifiable.

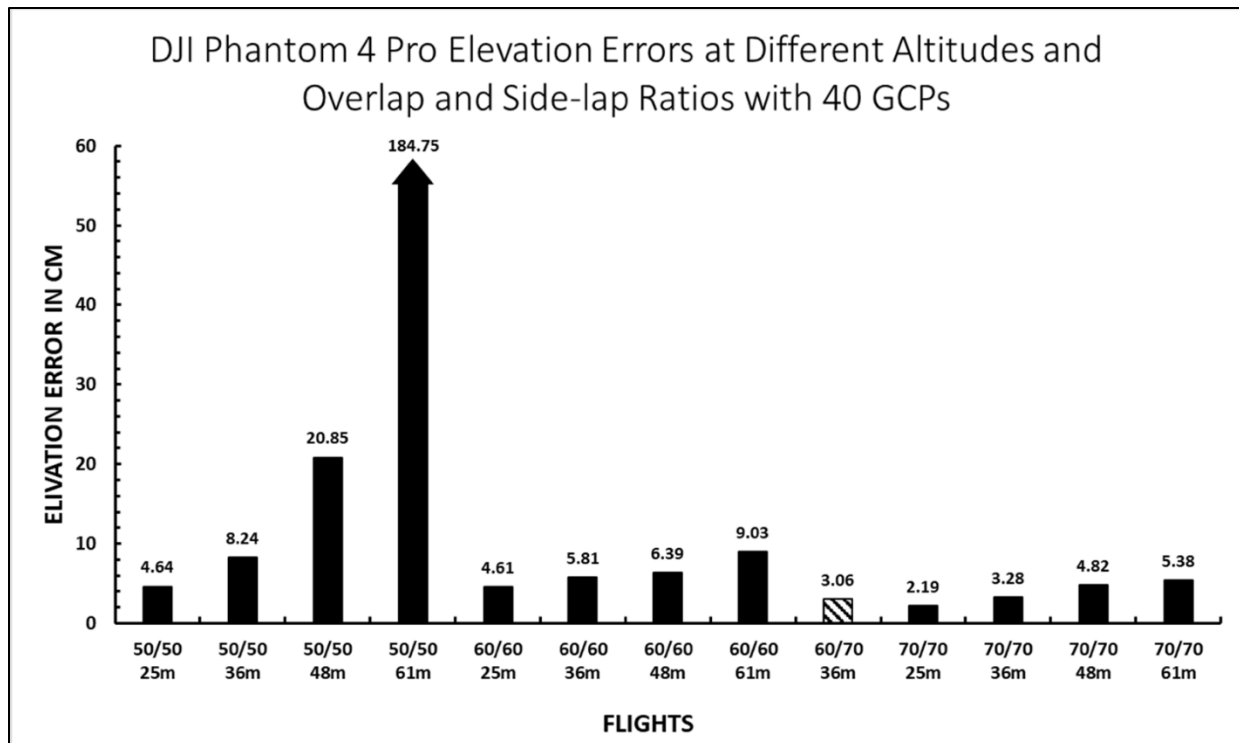
Figure 25: Elevation error data in centimeters for 13 flights using the Phantom 4 Pro over the 3.23-hectare test area using 40 GCPs.

Analysis of the post processing data from Agisoft Photoscan Pro for the thirteen testing flights with the Phantom 4 Pro produced a range of data (Figures 9&10) that was used to help determine which altitude and overlap to side-lap ration produced the best accuracy in elevational measurements for volumetric calculations of sand while being the most time and resource efficient. Elevational errors were calculated by deducting values from the DEM value at the same point as GCPs by drawing a point on the GCP in the DEM and measuring its position and elevation (Uysal et al, 2015).

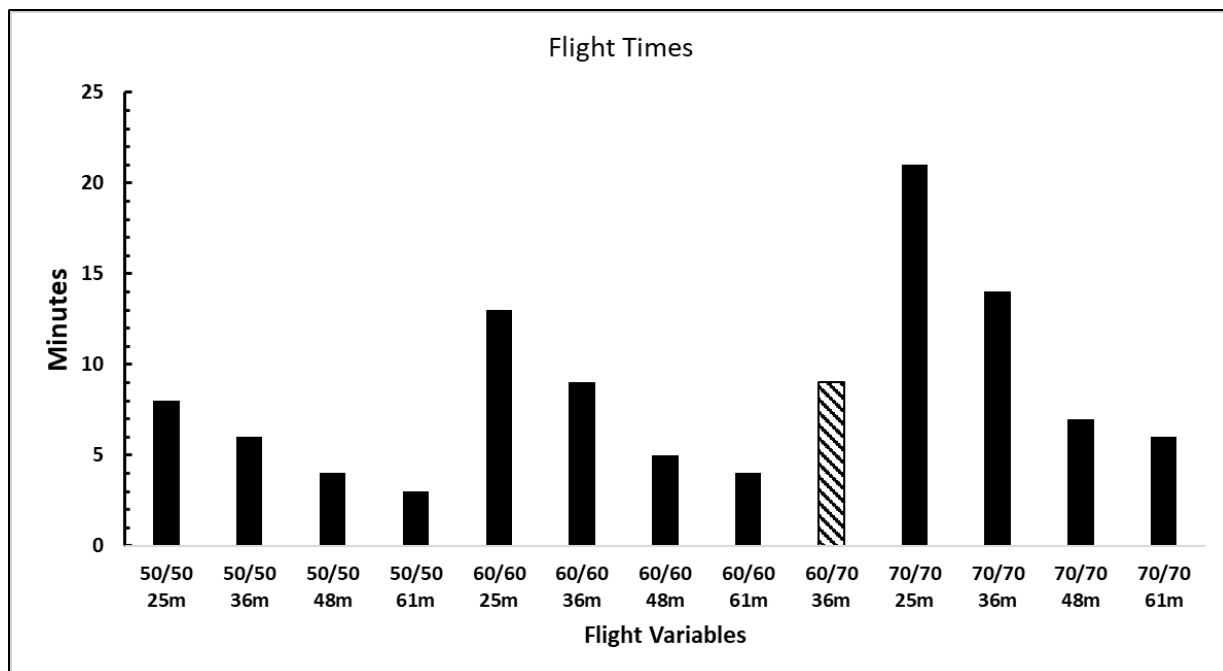
Figure 8: Flight time data for 13 flights using the Phantom 4 Pro over the 3.23-hectare test area.

hectares was multiplied to account for the entire area of the beach nourishment study area with its 121.40 plus hectares area an approximate need flight time of 787 minutes (13hrs) was calculated to complete the study. Using the recommended Drone Deploy settings of 60 /70 at an altitude of 36m produced the next smallest error in elevational measurements (3.1cm) and with a significantly reduced flight time at 8:52 minutes required to cover the test area and the subsequently the beach nourishment study area with a calculated required flight time of 337 minutes (5.5hrs). Since the objective of the beach nourishment study is to complete monthly surveys in as little time as possible while retaining the highest accuracy in elevational measurements the 60/70 overlap/side-lap at 36m altitude was decided upon.

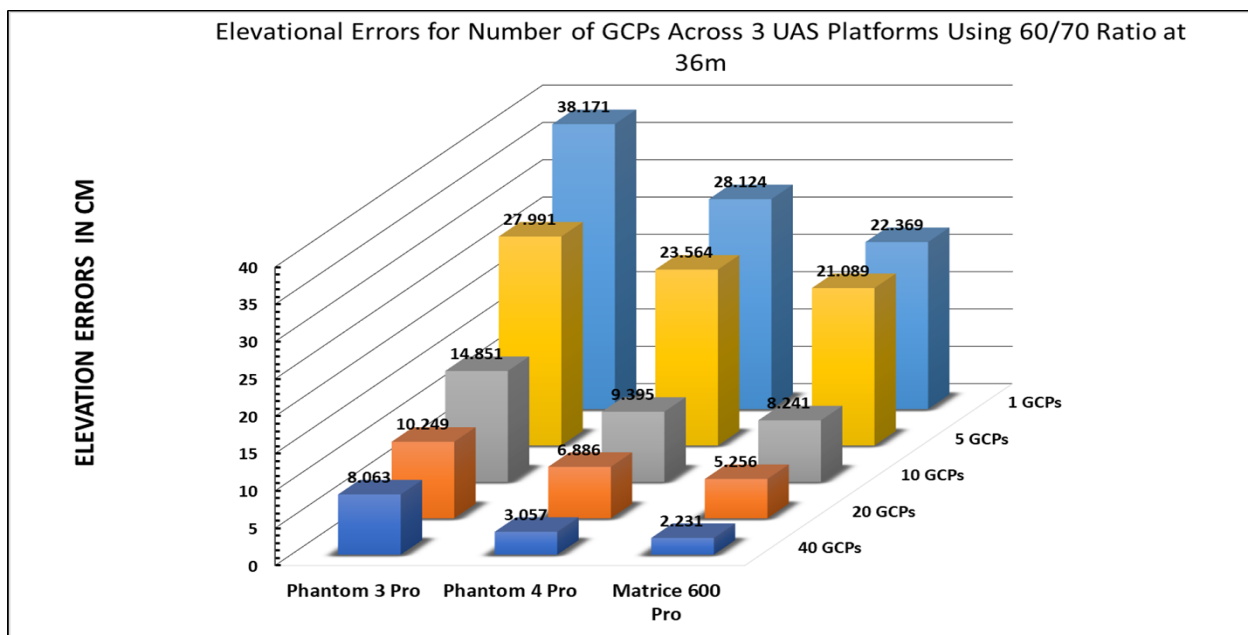
Figure 9 Comparison of elevational errors between Phantom 3 Pro, Phantom 4 Pro, & Matrice 600 Pro at 60 /70 overlap at 36m

Data sets for the Phantom 3 Pro using this protocol produced elevational errors of 8.0 cm at 36m and the 2.2cm at 36m with the RTK enabled Matrice 600 Pro UAS. While results with the Phantom 3 Pro were not as desirable as the Phantom 4 Pro or the Matrice 600 Pro they fall below the 10cm mark. The Phantom 3 Pro was used in these tests to represent the low end of the consumer UAS available which can still be used for studies like the one being conducted in Galveston. The RTK enabled Matrice 600 Pro Produced the best(smallest) elevational errors due to its precision guidance, and the ability to accurately geotag images using RTK-derived geodetic data.

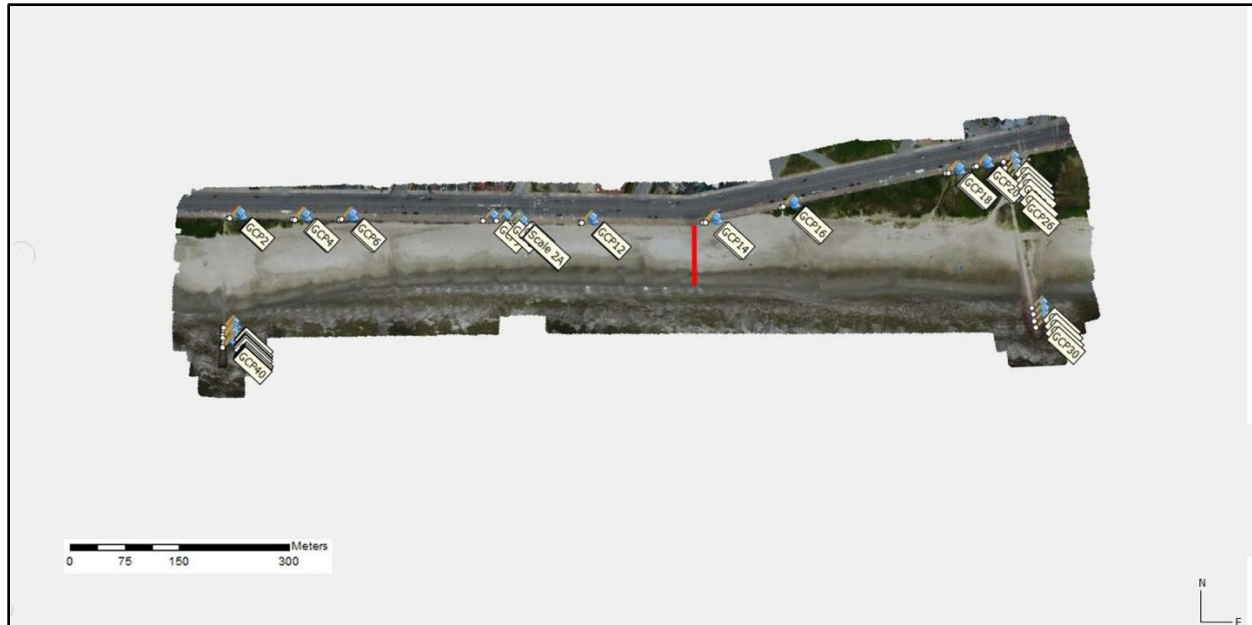
Figure 26 Section1 of the Beach Nourishment study area with distribution of GCPs and scale bars and the location of the profile taken in the center (red).

Twelvemonths of data have been collected with this initial monitoring study (Ritt and Jones, in prep). Using the methodology established in this paper; models, DEMs, and other products were produced for Section 1 which represents the longest distance between any two groins (850m) in the beach nourishment area along the Galveston seawall as an example for this paper. Forty GCPs were chosen along the Seawall's hard structure and that of the groins that bookend the section. The placement of the GCPs as such allows for their reuse for every survey of that section reducing required field time and simplifying the process (Casella et al, 2014). Two scale bars with coded targets (Figure 6) were placed in the middle of the section for quality assurance measurements as well.

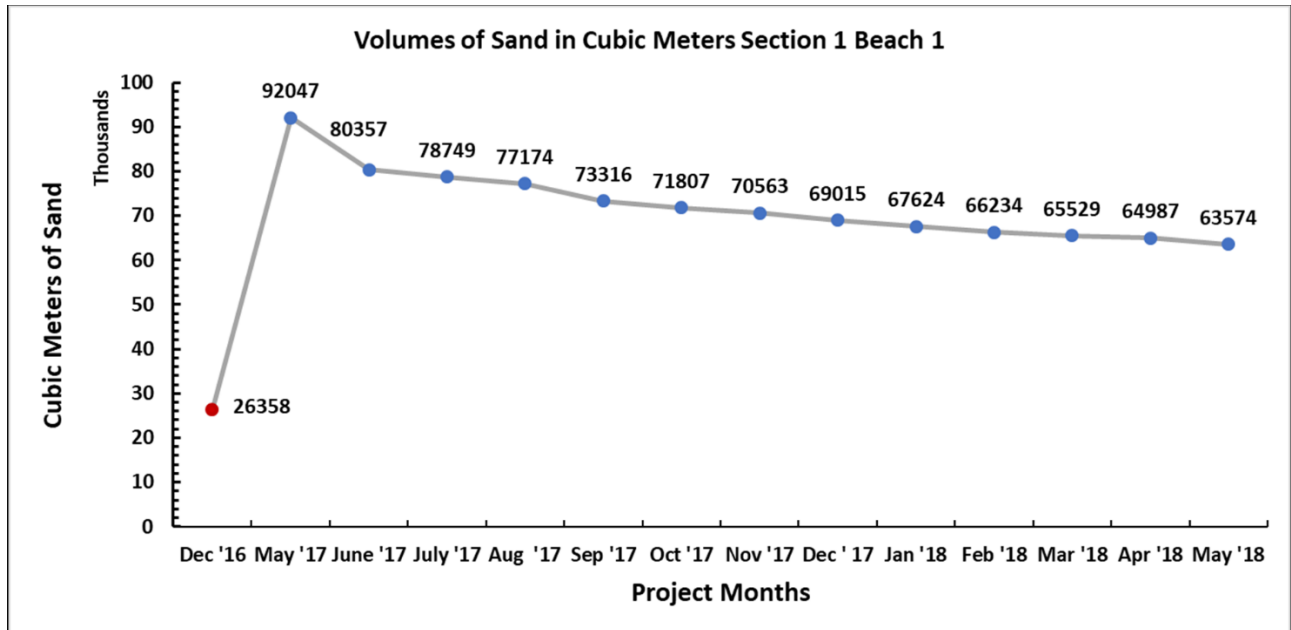
Figure 27 Volume calculations of Beach sand for Section 1 Beach 1 of the Beach Nourishment monitoring project.

The above the waterline volumetric measurements of beach sand in the section allowed for the creation of a trend model that depicts the average loss of sand for the beach section over a 10-month period. This volume trend showed that after an initial high-volume loss in the first 2 months directly after the nourishment project concluded the beach maintained a much smaller steadier rate of sand loss. The initial loss during the first 2 months is most likely due to the formation of a more natural beach profile from that which was created during the process of adding the sand (Figure 15).

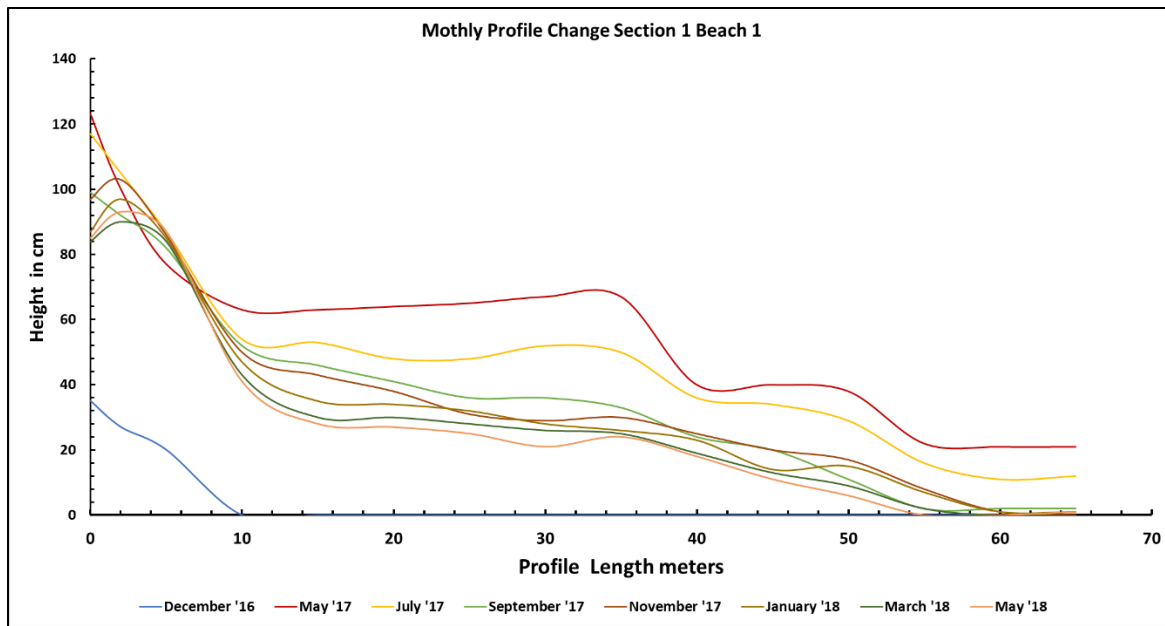
Figure 29 Alternating Monthly Beach Profiles for Section 1 Beach 1

In addition to volume calculations a profile was created for each month (Figure 14) from the middle of the section (Figure 12) to help better explain the nature of the change to the newly nourished beach and to see if the profile would help explain the trends in sand volume loss from above the waterline. These profiles show the change that the beach has experienced over the last ten months of the study. Of particular note is the shape of the beach in May 2017 and June 2017 right after the nourishment project was completed. These profiles show how the addition of sand during the nourishment created a beach surface that had a flat structure with a lip close to 40 meters from the seawall. This structure was created during nourishment to help retain sand during beach building and its erosion along with the grading of the beach through natural processes helps explain the high amount of loss in the initial 2 months after the nourishment was finished. After that time the beach more gradually hit a point of homeostasis and volume loss decreased with time.
