47<sup>TH</sup> TURBOMACHINERY & 34<sup>TH</sup> PUMP SYMPOSIA  
HOUSTON, TEXAS | SEPTEMBER 17-20, 2018  
GEORGE R. BROWN CONVENTION CENTER

# Structural Natural Frequency Tuning on a Vertical Pump

Several pumps were experiencing high vibration in the field. They are VFD driven, VS1 style pumps. Vibration evaluation indicated an above grade natural frequency within the VFD operating range. Design changes to the discharge head and foundation were analyzed and predicted to raise the natural frequency above operating speed. The proposed changes were made to one unit and successfully reduced the vibration amplitudes to within acceptable levels.

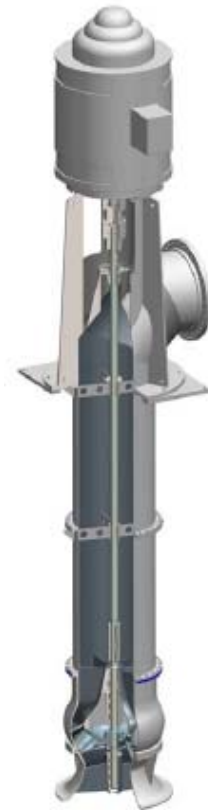
- Existing VS1 style in condensate water service
- Rated for 148 feet at 9000 GPM running at 900 rpm
- 400 HP VSS motor
- VFD operated at 65%-100% speed (585-900 rpm)

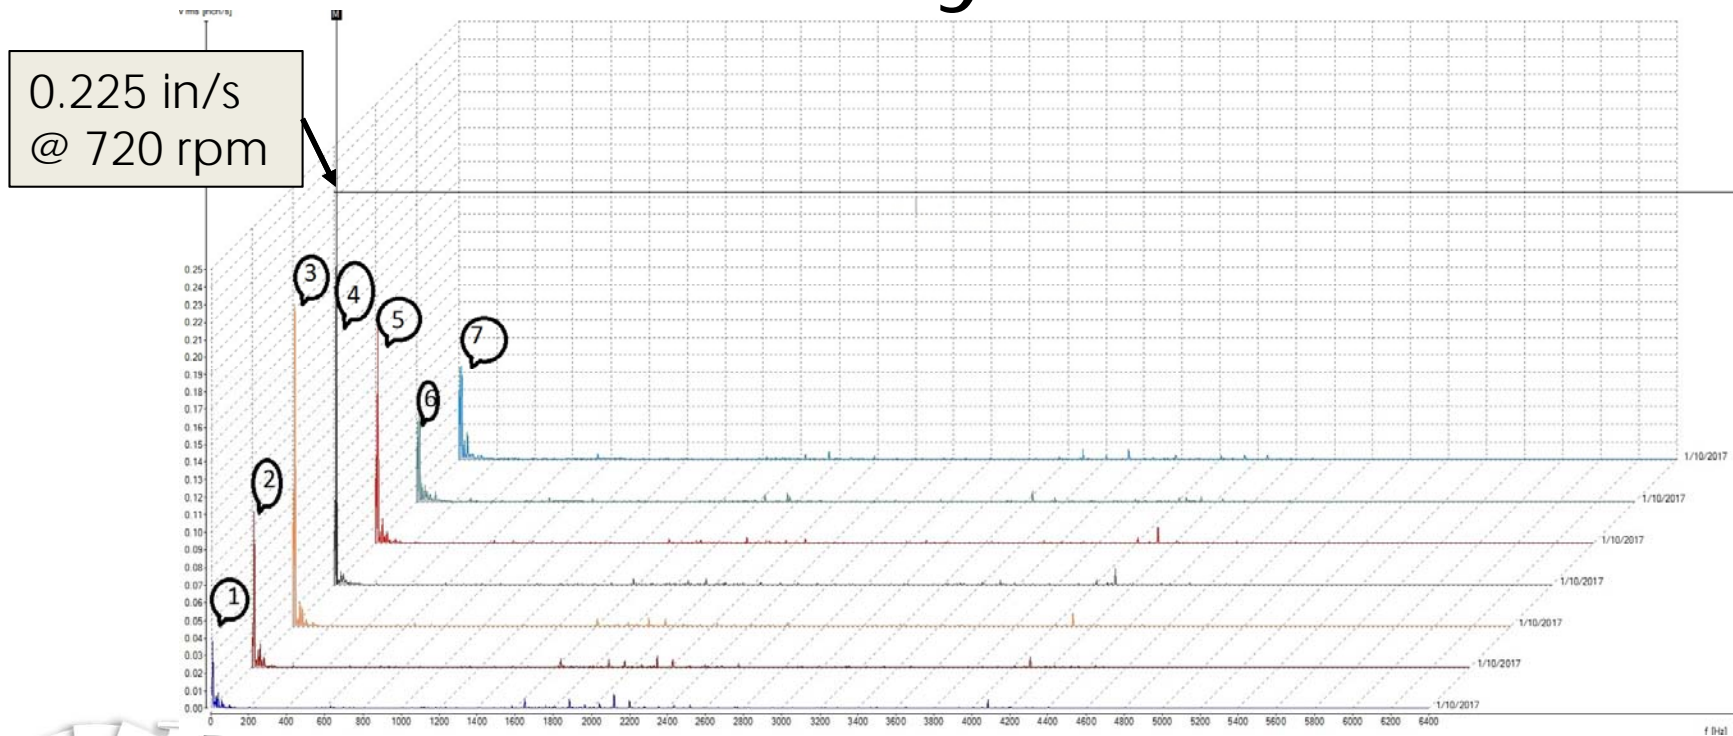
- Waterfall plot showed high vibration amplitude in the horizontal plane (0.22 in/s) at approximately 12 Hz when running at 80% speed.
- Bump testing indicated a natural frequency at 12 Hz, which correlated with operational vibration data.

WATERFALL PLOT FROM INITIAL VIBRATION EVALUATION

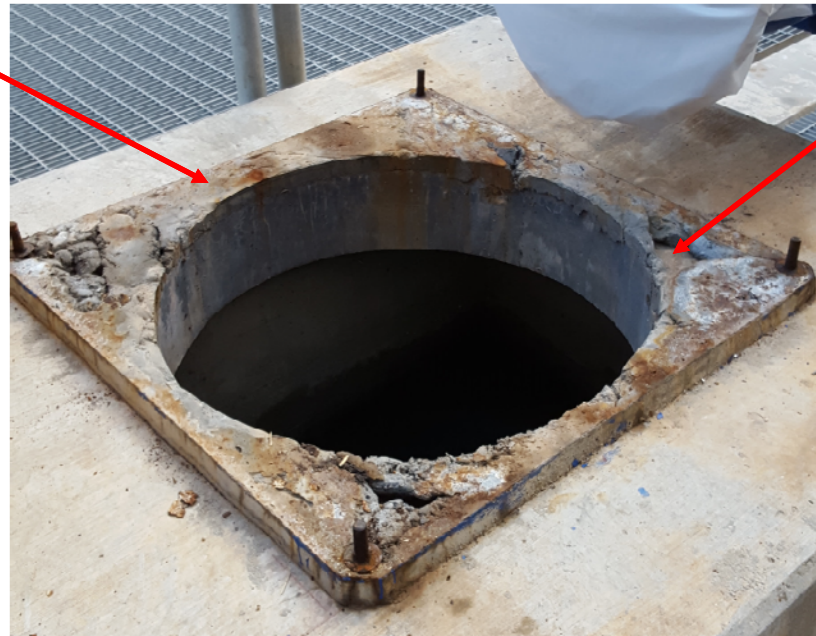
- Pump foundation showed poor grout conditions, with excessive voids and 100% delamination.
- Pump mounting plate was resting on nuts installed on the anchor bolts between the grout and mounting plate.

100% Grout delamination

Grout voids

- Anchor bolt pattern modified from four to six bolts, with reduced bolt circle.
- Recommended re-grouting on the pump foundation.
- Removed nuts on anchor bolts under the mounting plate.
