47TH TURBOMACHINERY & 34TH PUMP SYMPOSIA
HOUSTON, TEXAS | SEPTEMBER 17-20, 2018
GEORGE R. BROWN CONVENTION CENTER

KNOW YOUR TURBOMACHINERY'S OPERATING ENVIRONMENT!

David Linden

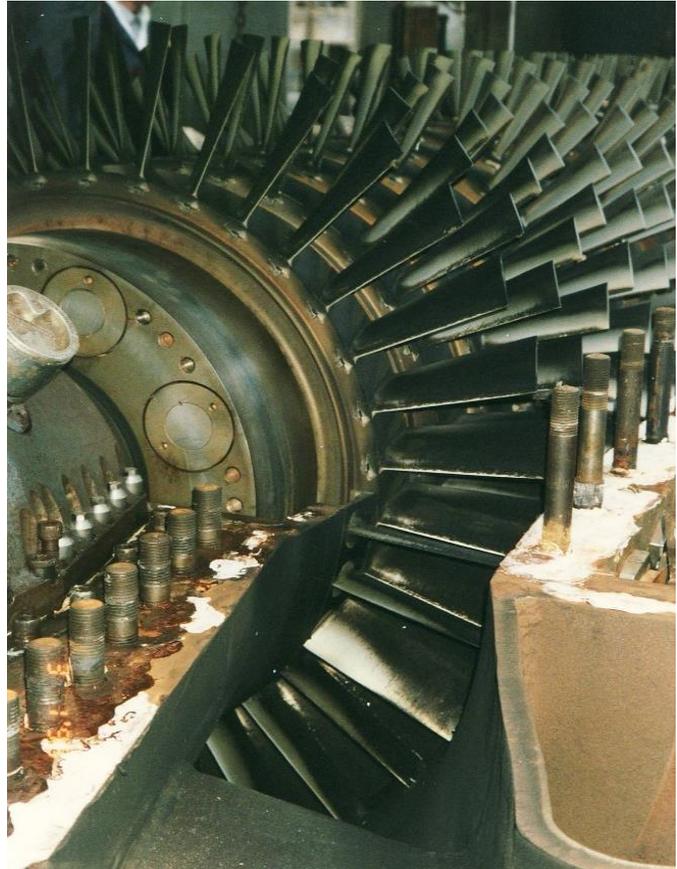
An example of a heavily fouled axial air compressor can be seen in Figure 1. Compressor performance losses of more than 5 percent in efficiency and capacity occurred from this fouling in only several months of operation. While it was initially concluded that the slippery, oil like substance on the blading was bearing housing oil leakage into the compressor, detailed deposit analysis revealed the black substance to be fine particulate (process catalyst) bound to the blading by Ammonia Sulfate that formed from gaseous ammonia and air borne salts. The deposits were found to occur mainly in the first four stages of the fifteen-stage compressor.

Figure 1- Axial Compressor Flow Path Fouling

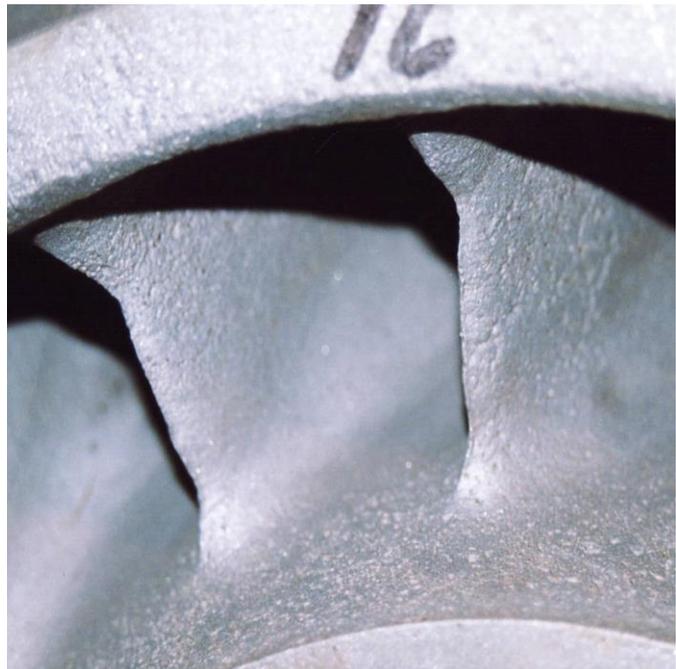
Unlike flow path deposition where fine particles adhere to the flow path surfaces, larger particles ingested into Turbomachinery can be very abrasive and cause erosion damage to the machinery flow paths. Erosion is the result of gas entrained particles or moisture droplets being accelerated to high velocity in the Turbomachinery flow path and impacting the surfaces of the flow path. Figure #3 is an example of heavily eroded inlet edges of centrifugal compressor impeller vanes. The vanes have been worn from the ingestion of air borne particulate in a steel mill environment. Some corrosion pitting can also be noted on the vanes. The source of the erosive particulate was a nearby slag pit that quickly overloaded from the compressor inlet filter system. Impeller failures have occurred due to the vane thinning and corrosion damage similar to that shown.

Figure 3 - Centrifugal Compressor Solid Particle Erosion

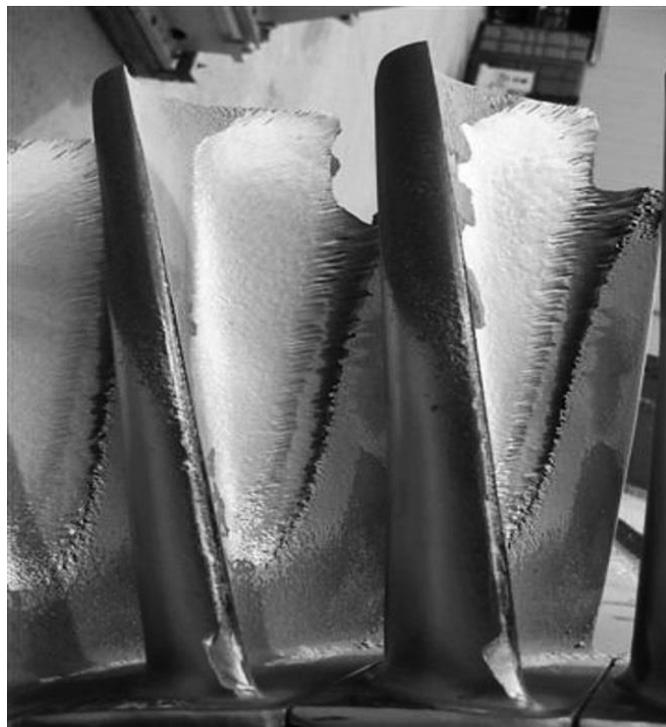
Solid particle erosion is the loss of base material that results from the repeated impact of solid particles. Erosion can occur as the result of the particle machining away the base material, an impaction of the surface with consequential deformation and a shattering and/or spalling of the base material surface. Particle size, shape, impact angle and velocity all have strong influences in the base material erosion rates. Two examples of solid particle erosion can be seen in Figures 4 and 5. Figure 4 is an example of very heavy solid particle erosion of the rotor blades in a FCC hot gas expander. Hard and abrasive process catalyst is carried over from the process and can be very erosive to the expander flow path. With proper process operation and the use of properly designed and operating particle separators, the FCC expander can operate for more than 40,000 hours continuously with only minor erosion damage. This is despite the expander ingesting more than 100 lbs. (45 kg) per hour of the particulate throughout the entire operating period. Process upsets or problems with the separation equipment can increase the amount and sizes of catalyst carryover. In the case shown in Figure 4, a problematic particle separator has allowed the catalyst carryover to increase in particle size from less than 10 microns to more than 80 microns. The aluminum silica-based catalyst is very abrasive and eroded the expander blades in only a few weeks of operation. Erosion of this magnitude greatly reduces the power produced by the expander and the blade structural integrity becomes questionable. The heavy erosive wear changed the geometric shape of the blades, which in turn changed the flow path aerodynamics, the resulting stress distributions, created stress risers in critical regions of the airfoil and changed the blade natural frequencies.

Figure 4 – Expander Rotor Blade Erosion - Process Catalyst

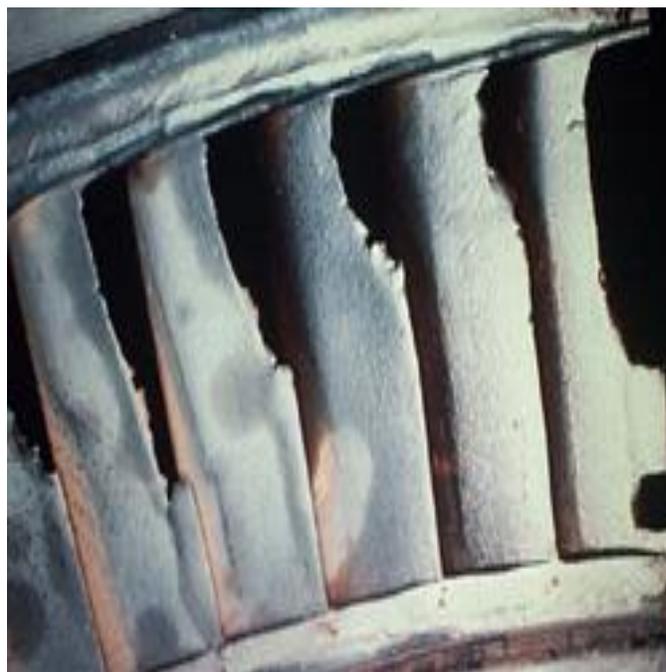
Figure 5 is an example of steam turbine flow path solid particle erosion. Feed water contaminants and scale from the exfoliation of boiler tubes are common sources of solid particles in steam systems and are very erosive to the nozzle block and impulse stages of the turbine. Solid particle

Figure 5 - Steam Turbine Flow Path Solid Particle Erosion

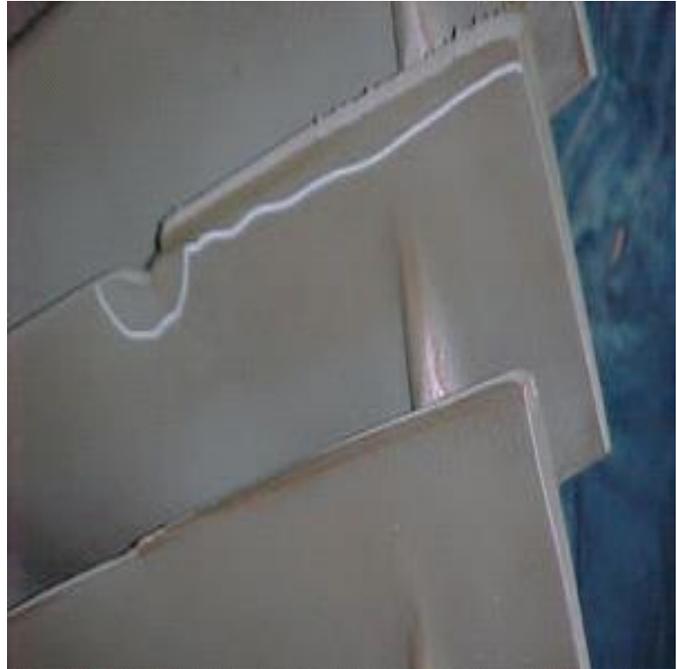
As the working gases change pressure and temperature throughout turbine and compressor flow paths, condensation can occur, and liquid droplets form. The impaction of the droplets can be very erosive to the flow path components. Figure 6 shows an example of leading edge, water droplet erosion on low pressure steam turbine blading. Unlike solid particle erosion, water droplet erosion is often the result of the rotor blade impacting the slower moving liquid droplet. The erosion is most commonly found on the low-pressure blades that operate with saturated or wet steam. Liquid droplet erosion can also be the result of intentional injection of a liquid into a flow path to clean flow path foulants. The liquid droplets often remove small amounts of the base material and create pits, voids and microcracks in the surfaces. In corrosive environments, the microcracks can be initiation sites for fatigue cracking.

Figure 6- Steam Turbine LP Blade liquid droplet erosion

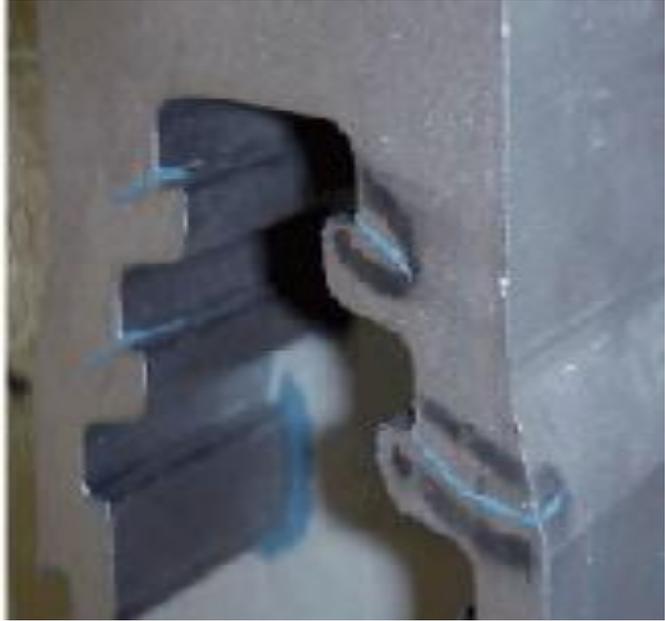
One of the most common modes of Turbomachinery component failures is Stress Corrosion Cracking (SCC). Stress Corrosion Cracking is the initiation and propagation of cracks in steels subject to the combination of high mean surface stresses, a susceptible material and operation in a specific corrosive environment. Figure 9 shows an example of Stress Corrosion Cracking in a 12 percent Chromium Stainless Steel steam turbine blade attachment. While the environment is a major contributor, the designed related causes are very important and controllable by the machinery designer. Design related causes include high steady and/or vibratory stresses, the use of materials susceptible to SCC, the use, manufacturing method and heat treatment of high strength materials, the material composition, quality and the surface treatments.

Figure 9- Stress Corrosion Cracking of Steam Turbine Blade Attachment

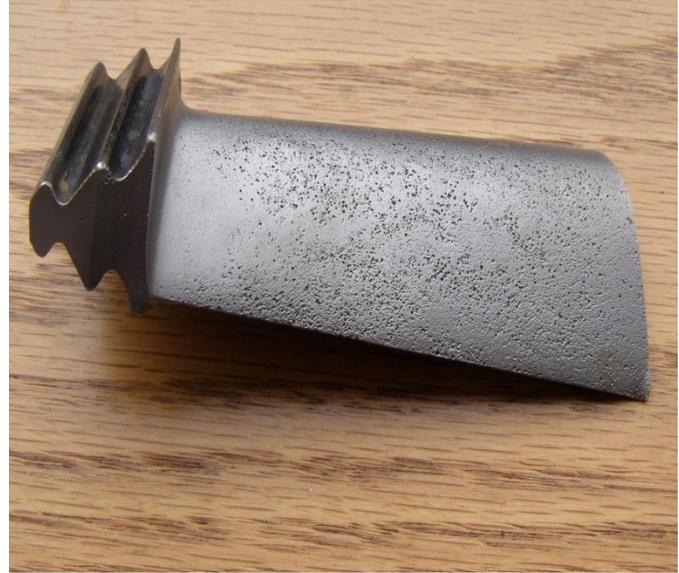
down periods, contiguous shutdown and start up periods and even during the storage of used rotors after removal from the unit. Shut down corrosion is generally the result of contaminants and deposits remaining on the flow path components after the unit has been removed from service. During these shut down periods, the deposits hydrate from process gas condensation, steam condensation or even local environmental humidity. Once hydrated, the local environment in and around the deposits experience the formation of very aggressive acids. Significant local corrosion damage can occur very rapidly. Figure 12 shows extensive corrosion pitting on a rotor blade from residual nitrous oxide deposits hydrating and forming aggressive acids during a Nitric Acid Gas Expander shut down.

Figure 12 – Shut Down Corrosion Pitting on a Nitric Acid Expander Rotor Blading

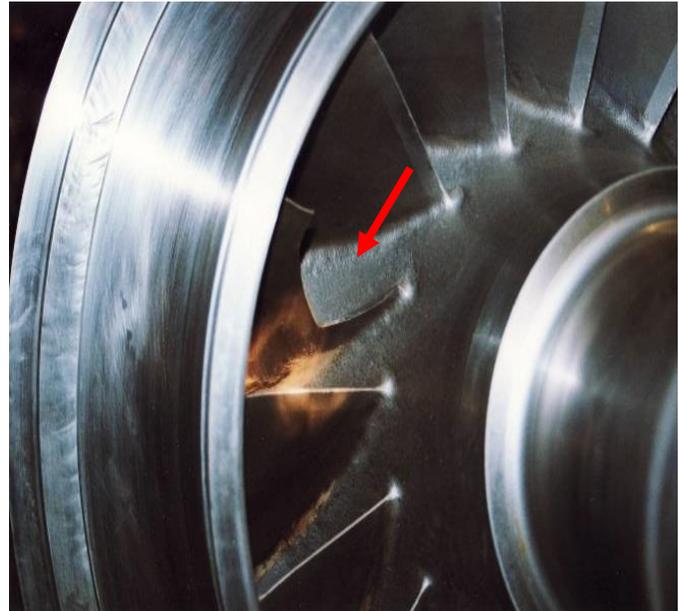
After many years of successful operation, a multistage industrial centrifugal compressor began to experience multiple impeller vane failures. Three impeller failures occurred in both new and existing used spare rotors in less than 10,000 hours of operation. These failures resulted in compressor flow path damage, high rotor vibrations, unscheduled plant shut downs, costly repairs and extended plant down time. The failures occurred in both high strength alloy steel and 12% chromium impellers. Figure 16 shows one of the damaged impellers with a large section of missing vane. The failure analysis team performed extensive:

Figure 16 - Centrifugal Compressor Impeller Vane Failure

Findings of the analytical investigations revealed that the first stage impeller was operating with moderately high stresses. While no evidence of impeller resonant conditions were found, the vane dynamic stress levels were also moderately high.

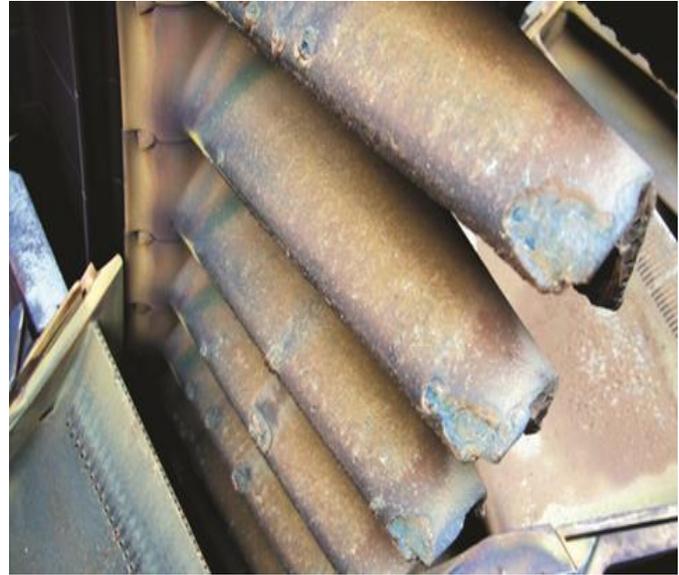
Foreign materials enter the gas turbine from the inlet air, combustion fuel and water or steam injection sources. Common contaminants in gas turbines include sodium and potassium chloride salts, sulfur and heavy metals such as vanadium and lead. The lines of defense against most types of hot corrosion are similar: Reduce the contaminants, reduce the component operating temperature, use corrosion resistant materials and apply corrosion and deposit resistant coatings.

Figure 17 – Gas Turbine Salt deposits and Hot corrosion damage (Courtesy of Sulzer)
