**OVERDISCHARGE AND EXTERNAL SHORT BEHAVIOR  
OF LITHIUM-ION BATTERIES**

An Undergraduate Research Scholars Thesis

Major: Mechanical Engineering

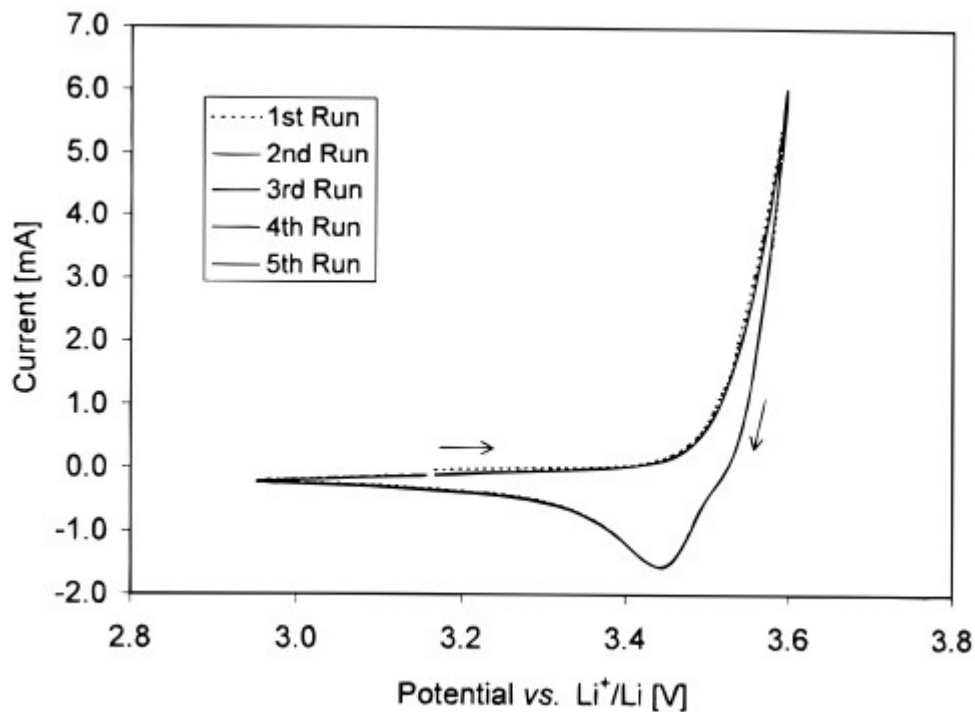
**Figure 4.** Five consecutive CV cycles of a Cu foil electrode in 1M LiPF<sub>6</sub>/PC:EC:DMC (1:1:3) electrolyte [10].

The voltage change at the end of discharge in a full cell is primarily driven by the rise in voltage of the anode [8]. When the anode voltage reaches 3.5 V (vs Li/Li<sup>+</sup>) or higher, the copper current collector of the anode can begin to oxidize to Cu<sup>2+</sup> and dissolve into the electrolyte [9]. The results of a cyclic voltammetry test on copper foil in an organic electrolyte are shown in Figure 4, which shows that the rate of copper dissolution increases rapidly around 3.5 V [10]. The dissolved copper from the anodic current collector will be redeposited on the anode surface, which can form an electric shunt and increase the internal resistance of the cell [9]. At the same time, over-deintercalation of lithium at the anode causes decomposition of the solid-electrolyte interface (SEI), which generates gases, including carbon dioxide. The formation of new SEI films while recharging the cell then consumes some lithium ions, reducing the cell capacity.

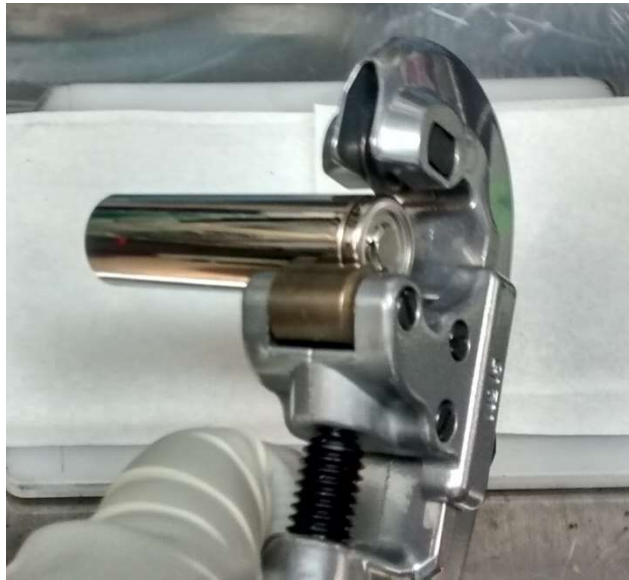
***Figure 7.*** Cell is opened by breaking the seam with a pipe cutter.

1. Remove plastic wrapping to expose aluminum casing.
2. Insert pipe cutter blade at seam of cell, as shown in Figure 7. Tighten until seal is broken and rotate cell until the whole cap is detached. Do not tighten pipe cutter too much, or the gasket separating the cap from the case may be punctured and the cell may short.

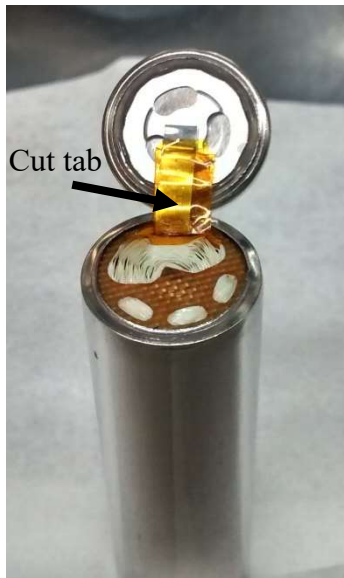
*Figure 8. Cap is removed. Metal tab is cut to separate cap from case.*

3. Remove cap of cell and cut connecting metal tab with scissors, as shown in Figure 8.

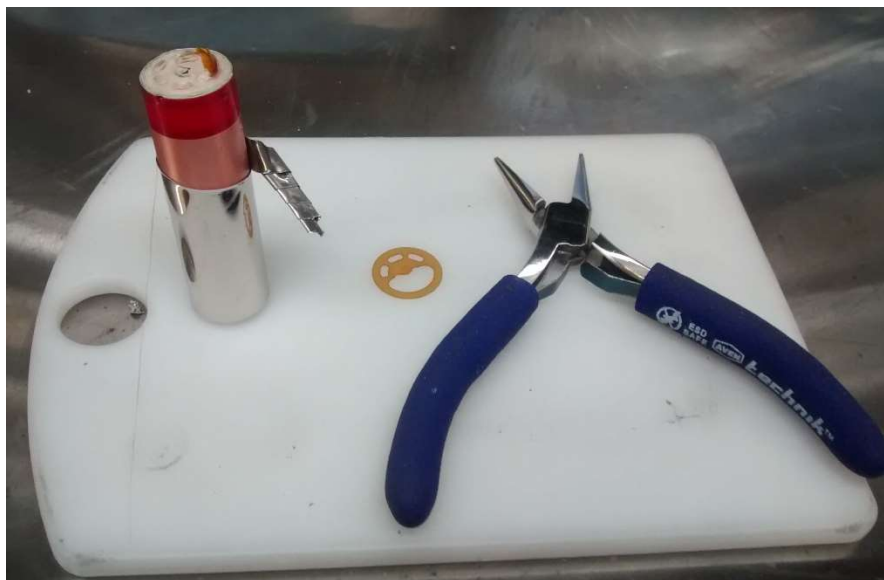
*Figure 9. Aluminum case is removed by peeling it diagonally with pliers.*

4. Use pliers to pry back aluminum casing, starting at the top lip. Peel the material at a downward angle so that case can be removed in one continuous strip. A cell with the case partially peeled is shown in Figure 9.

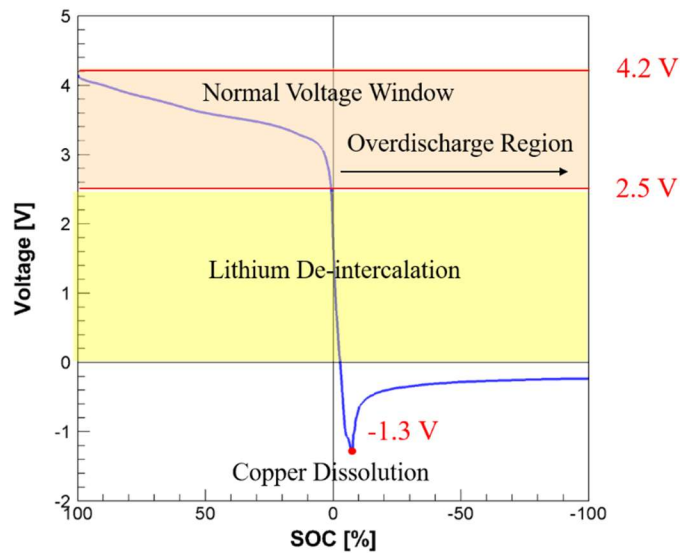
**Figure 14.** Full voltage profile of overdischarge test, performed at 1C.

The full voltage profile of the overdischarge test is shown in Figure 14. When the SOC is between 100% and 0%, the voltage resides in the normal voltage window specified by the manufacturer (2.5-4.2 V). Beyond 0% SOC lies the overdischarge region, where the cell voltage plummets to a minimum value of -1.3 V before rebounding asymptotically to 0 V. The rapid decline in cell voltage near 0% SOC can be attributed to the onset of concentration polarization, causing the anode voltage to rise and the cathode voltage to fall.

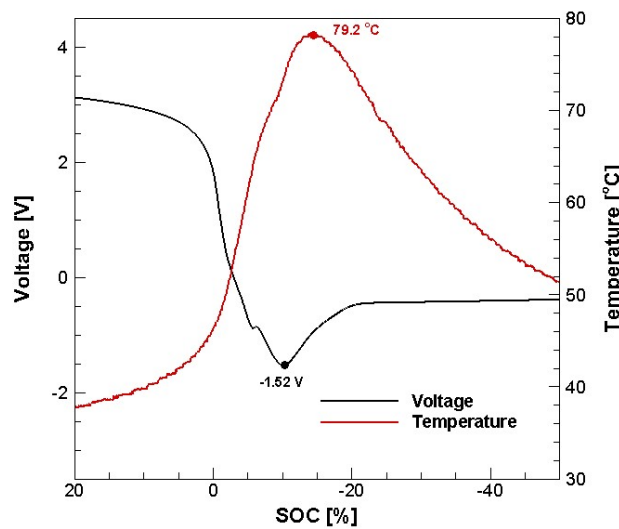
**Figure 16.** Voltage and Temperature vs. SOC plot for overdischarge at 1C.

The surface temperature of the cell is compared to the cell's voltage profile throughout the overdischarge test at 1C in Figure 16. Temperature begins to increase drastically around 0% SOC as concentration polarization sets in. The initiation of copper dissolution aligns with an inflection point in the temperature profile, showing that it further increased the heat generation rate. The temperature reached a maximum at 79.2°C and declines as the voltage begins to approach 0 V. The cell that was overdischarged at C/10 experienced a temperature change of less than 20°C, indicating that the temperatures achieved during overdischarge are rate-dependent. Although 79.2°C is not a high enough temperature response to imply significant damage, a test performed at a higher discharge rate could result in higher temperatures as well.

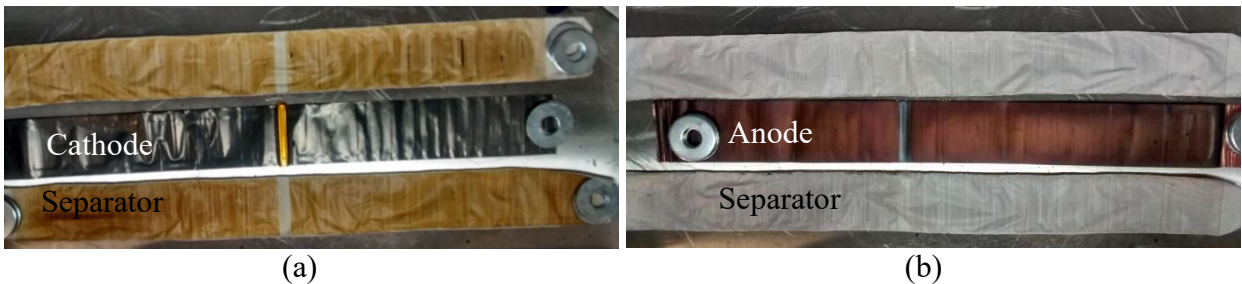
**Figure 18.** Electrode and separator surfaces of (a) cathode and (b) anode of externally shorted 18650 cell after performing DPA.

The results of DPA on a cell that had been repeatedly externally shorted are shown in Figure 18. The bronze anode color seen in Figure 20b indicates that this cell was deconstructed in a partial state of charge. The main difference is the darkening of the separator material on both sides. This can possibly be attributed to the fracturing of electrode materials at the anode and cathode due to the high mechanical stresses induced during high-current operation. The loss of electrode material suggests that the external shorting caused a decrease in cell capacity. Nevertheless, it is important to note that this cell suffered repeated external shorting and could still be charged to full at 4.2 V.

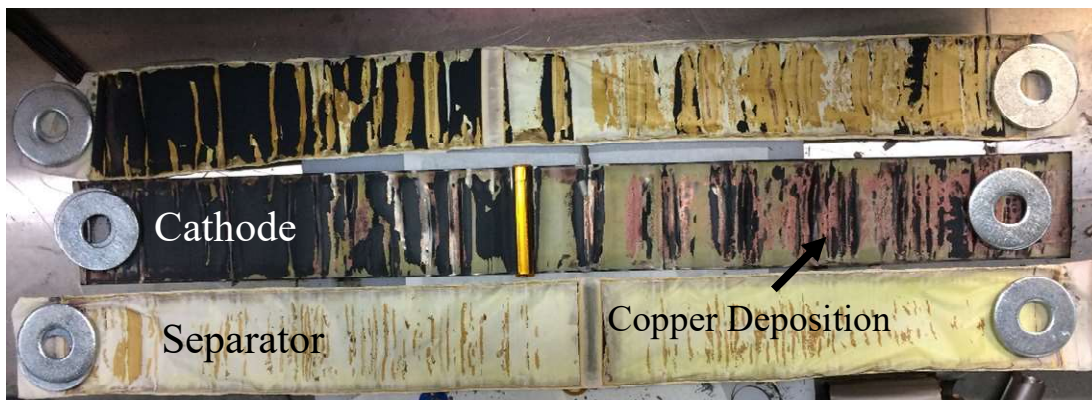
*Figure 20. Center-facing cathode surface and cathode-facing separators.*

The center-facing side of the fully unraveled cathode roll and the corresponding separator are shown in Figures 20 and 21. The cathode can be divided into three zones, as labeled in Figure 21. In Zone A, the ceramic coating on the separator detached and stuck to the cathode. The coloring of Zone A suggests that a layer of copper below the ceramic is providing the adhesion. In Zone B, a layer of cathode material adhered to the separator, tearing away from the electrode. Zone C

represents a region where no material was ripped from either the electrode or separator surface, but a layer of copper deposition is visible. Samples from this region were taken for SEM post-mortem analysis to prove the presence of copper.
