EXPERIMENTAL PERFORMANCE OF REINFORCED AND PRETENSIONED
PRECAST CONCRETE BENT CAPS

A Thesis

KEVIN JACK YOLE

August 2017

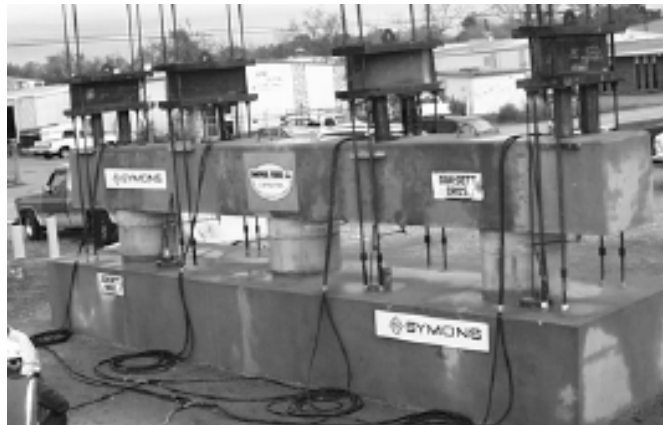
Figure 2.11. Experimental Setup Column Bent Cap (Matsumoto et al., 2001).

Loads were applied at four locations with rams on either side of the connections for a total of eight points loads (Figure 2.11). The first load combination created service and factored demands. The second load combination provided the maximum realistic longitudinal moment demands by applying a larger load on the rams on one edge while the third load combination consisted of removing the loads from the rams one edge; both created longitudinal eccentricities to provide a larger moment transfer to the connection. The fourth and final load combination provided a transverse moment by applying the loads at the overhang.

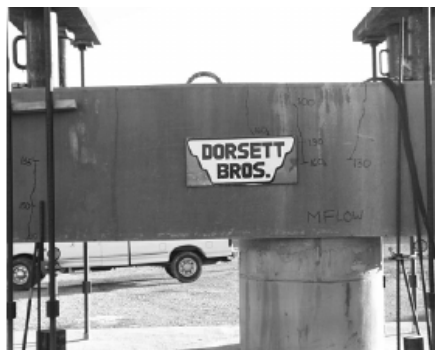
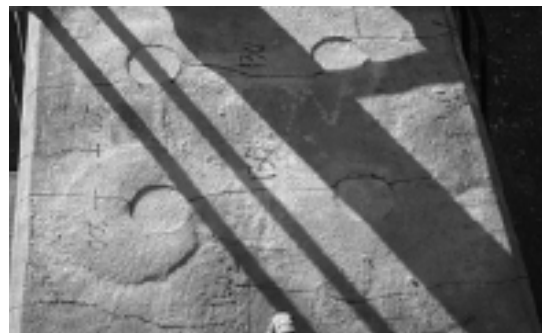
Figure 2.12. Column Bent Cap Performance (Matsumoto et al., 2001).

Under the application of service and factored loads, maximum cracks widths of 0.007-in developed in the positive and negative moment regions of the bent cap (Figure 2.12.a). The grouted vertical duct connection showed no cracks in the grout surface at the top and no opening or cracks in the bedding layer. Subsequent loads combinations produced a maximum bedding layer opening of 0.013-in and cracks at the top of the connection region of 0.007-in wide (Figure 2.12.b). Due to the limitation of the test setup and specimen configuration, it was determined that no significant damage was produced in the connection region and only minor deflections and cracks were recorded on the bent cap.

(a) Flexure Cracks on Sidewall at Factored Loads

(b) Flexure Cracks at Top of Connection at Max. Realistic Longitudinal Moment

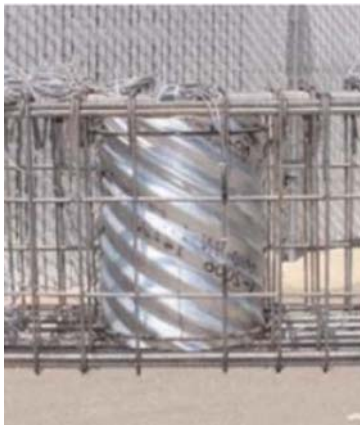
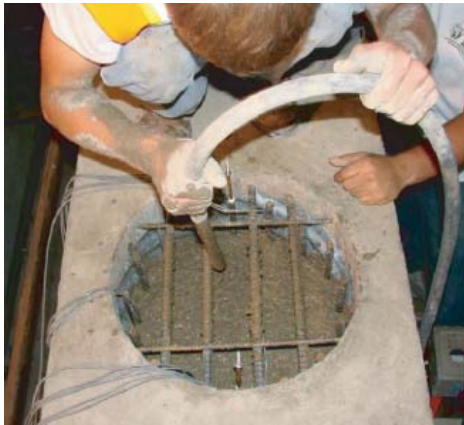
Figure 2.13. Pocket Connection Construction (Restrepo et al., 2001).

A pocket connection was designed using the same full-ductility design basis as the cast-in-place specimen to provide a direct comparison. This pocket connection incorporated the use of a single 18-in diameter, 16-gage steel corrugated pipe installed during the construction of the precast bent cap reinforcement cage with additional hoops placed at each end of the pocket to reinforce the pipe. The corrugated pipe acted as stay-in-place formwork housing the 16-#5 longitudinal column bars that extended above the column connecting into to the bent cap during placement and also served as the equivalent joint hoop reinforcement provided in the cast-in-place connection. A 1.5-in bedding layer was constructed using a steel collar with air vents and high-strength plastic shims to support the bent cap and attain the required thickness of the bedding layer. After the bent cap was placed on the column, normal-weight concrete with maximum nominal aggregates sizes limited to 1/3 the thickness of the bedding layer was used to cast the bedding layer and the pocket to complete the connection (Figure 2.13).

(a) Corrugated Pipe

(b) Casting

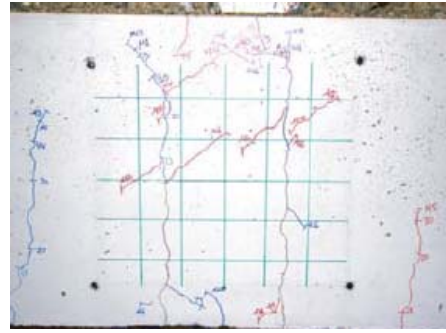
Figure 2.15. Joint Region Post Test Damage Patterns (Restrepo et al., 2001).

Inspections after testing showed the specimen with the corrugated pipe developed fewer diagonal cracks in the joint region with smaller maximum cracks widths (0.009-in) compared to the cast-in-place specimen (0.025-in). Different crack patterns were noticed between the two specimens, with the corrugated pipe connection only developing cracks through the center of the of the joint region at 3.2% drift. The cast-in-place specimen developed more widespread diagonal cracks throughout the joint region. The different crack pattern and widths in the corrugated pipe specimen were evidence of a different loads path as a result of the corrugated pipes (Figure 2.15). Smaller strains at 25% yield were recorded in the stirrups in the joint for the corrugated pipe specimen compared to the full yield strains in the cast-in-place specimen. The supplementary hoops used at the ends of the corrugated pipe reached 52% of yield showing their contribution to the joint performance, and pipe strains were limited to 37% of yield. Both specimens showed failure due to buckling and fracture of columns bars with no signs of failure in the joint.

(a) *Cast-in-Place Specimen – East Side* (b) *Corrugated Pipe Specimen – East Side*

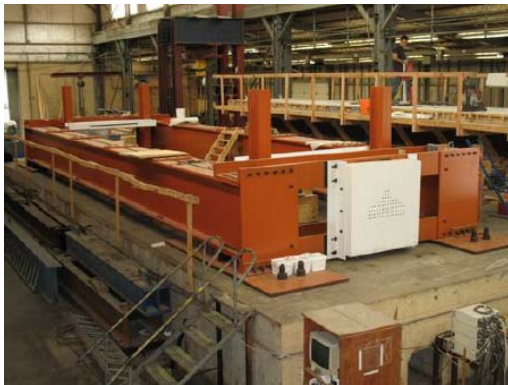
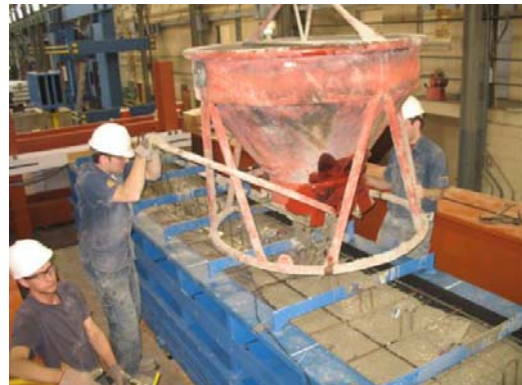
Figure 2.17. Specimen Construction (O'Callaghan and Bayrak, 2008).

(a) *Prestressing Bed*

(b) *Casting*

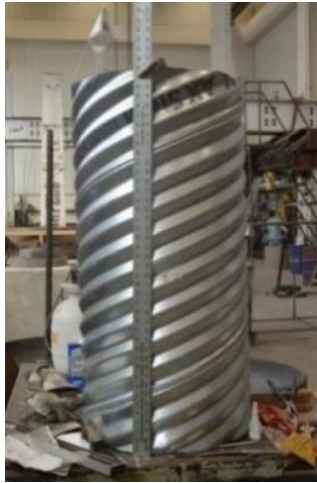
The layout of pocket and dowel bars is shown in Figure 3.10. A single 21-in nominal diameter corrugated pipe (Figure 3.11) serves as a stay-in-place form along the full depth of the bent cap. The chosen pipe thickness was based on the ensuring uniform distributions of prestressing forces during the release of strands using the following equation:

Figure 3.11. 21-in Nominal Diameter, 12-gage Steel Corrugated Pipe.

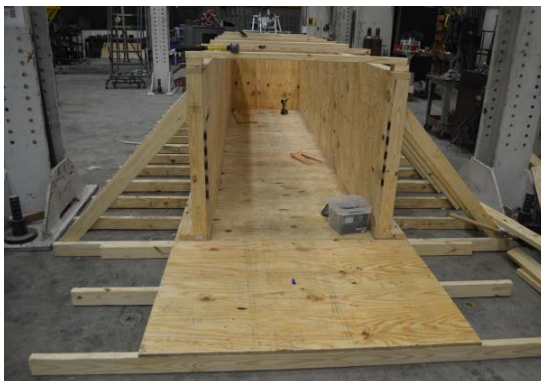
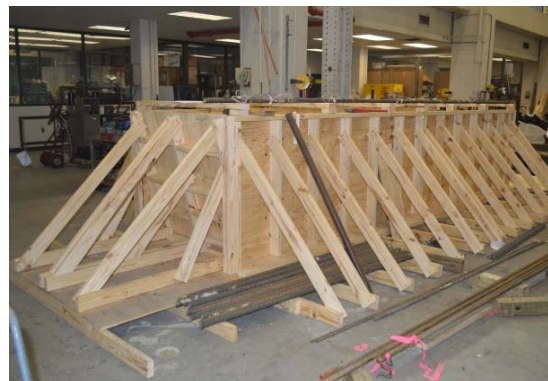
Figure 3.16. Bent Cap Formwork.

Wood formwork was constructed for RCS-16-12. Figure 3.16 shows completed formwork. Appendix B shows the front, plan and sides views of the formwork drawings. Star flat head screws were used to ease formwork demolition. To secure the formwork walls, additional braces were incorporated with scrap cuts of lumber. Details of lumber materials are provided in Appendix B.

(a) Square End

(b) Battered End

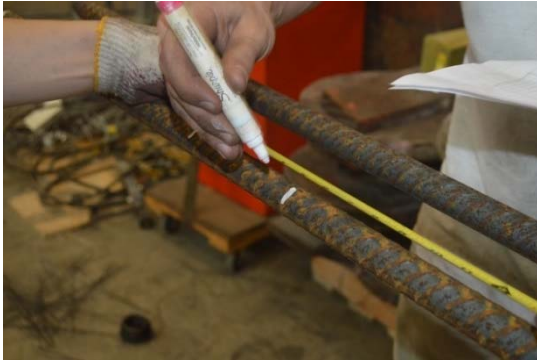
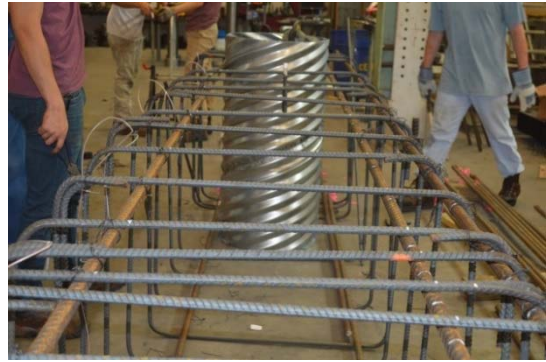
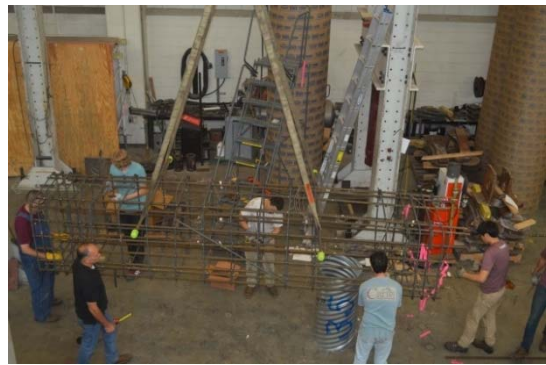
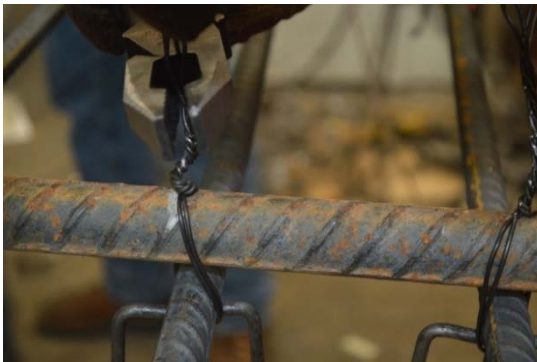
Figure 3.17. Bent Cap Steel Reinforcement.

The construction of the bent cap steel reinforcement cage followed strict guidelines to ensure the proper locations of all parts. The first step was to mark all flexural reinforcement (A-bars) with the location of the shear reinforcement (S-bars) and vice versa. The overhead crane was used to hoist the top corner A-bars while the S-bars and corrugated pipe (pocket) were placed in their corresponding locations. The bottom A-bars were then installed to provide the initial stability of the steel cage. The S-bars were tied to the top and bottom A-bars with 16-gage tie wire double ties. Two 4-ft #6 bars were temporarily installed on the outside vertical faces of the steel cage at opposite angles to brace the steel cage against sway during construction and installation; bars were removed prior to casting concrete. The remaining A-bars were tied to the S-bars in their corresponding locations. A second pair of #6 bars was fed through perpendicular to the longitudinal orientation of the steel cage in order for the crane to lift the steel and installed the bottom cover chairs. Once all the steel reinforcement was tied in place, the locations of all S-bars and A-bars were verified to match the RCS-16-12 plans (Figure 3.17). The overhead crane was used to place the steel cage in the formwork. The corrugated steel pipe for the pocket connection was also installed using the overhead crane and fastened into its proper location with compressed wood stumps. Once the steel cage and corrugated pipe were installed, the square end wall of the formwork was constructed to completely enclose and seal the cap formwork. Finally, two lifting hooks at equal distances from the center of gravity of the bent cap were installed for lifting the bent cap (Figure 3.18).

(a) Marking Location of S-bars

(b) Installed Bottom A-bars

(d) Hoist Steel Cage to Install Chairs

(e) Chair Ties

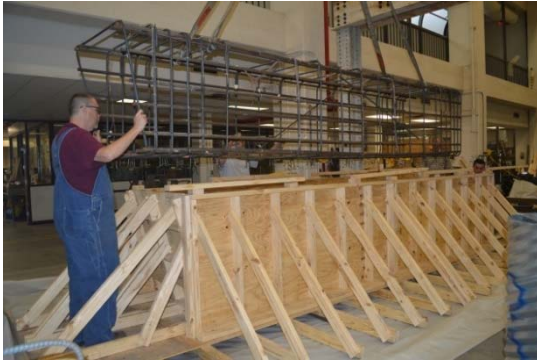
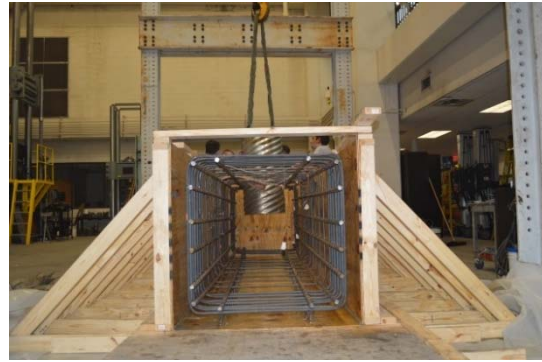
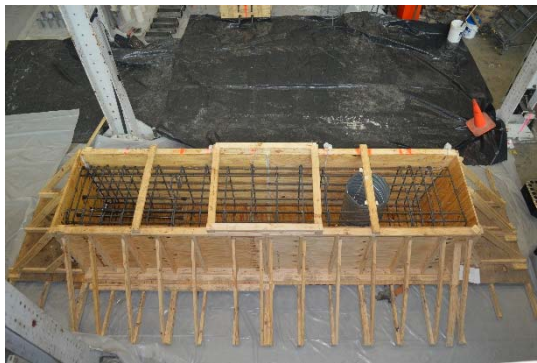
(a) Placing Steel Cage in Formwork

(b) Placing Corrugated Pipe

(c) Final Inspection

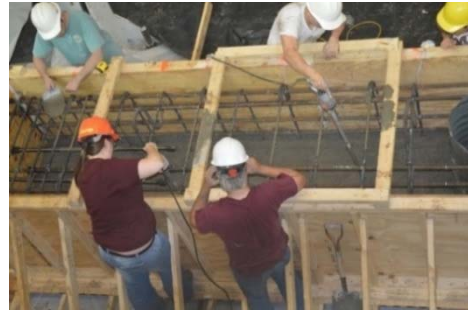
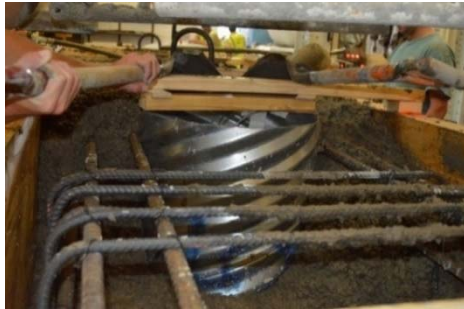
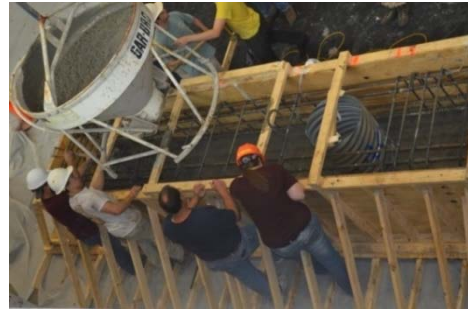
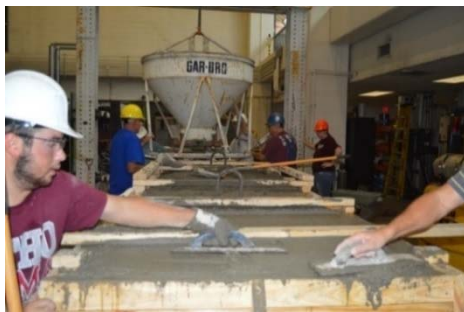
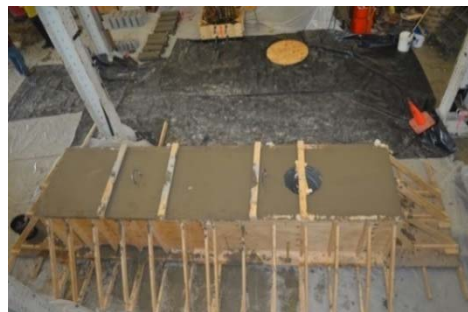
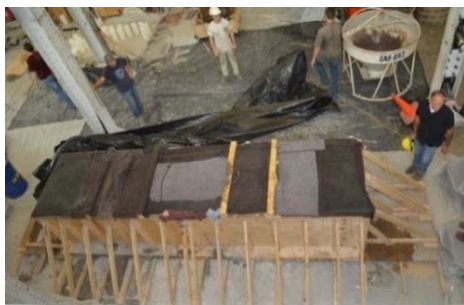
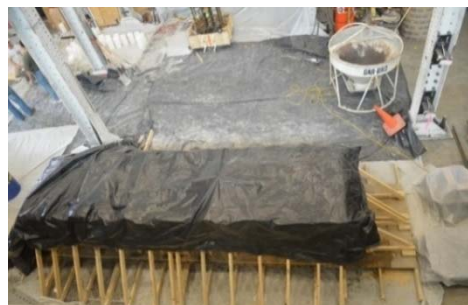
Figure 3.19. Casting the Reinforced Concrete Bent Cap.

by compression with lumber and thin plywood. During the first lift of concrete, a shift in the position of the pocket occurred from placing the concrete at a high rate into the battered end of the bent cap. The pocket was reset to its original location by spreading the concrete around and away from the corrugated pipe and pushing it back into position. After all concrete lifts were complete, the bent cap top surface was finished with smooth trowels and floated. Filleted trowels were used approximately an hour after the last concrete lift to provide smooth round edges at the top surface of the bent cap. Once the concrete had set (5 hours), the top surface of the bent cap was watered, covered with soaked towels and covered again with a black tarp for 4 days of moist curing (Figure 3.19).

(b) Consolidation

(c) Pocket Anchorage Side View

(d) Pocket Anchorage Top View

(e) Surface Finishing

(f) Finished Surface

(g) Wet Curing Towels

(h) Impermeable Curing Tarp

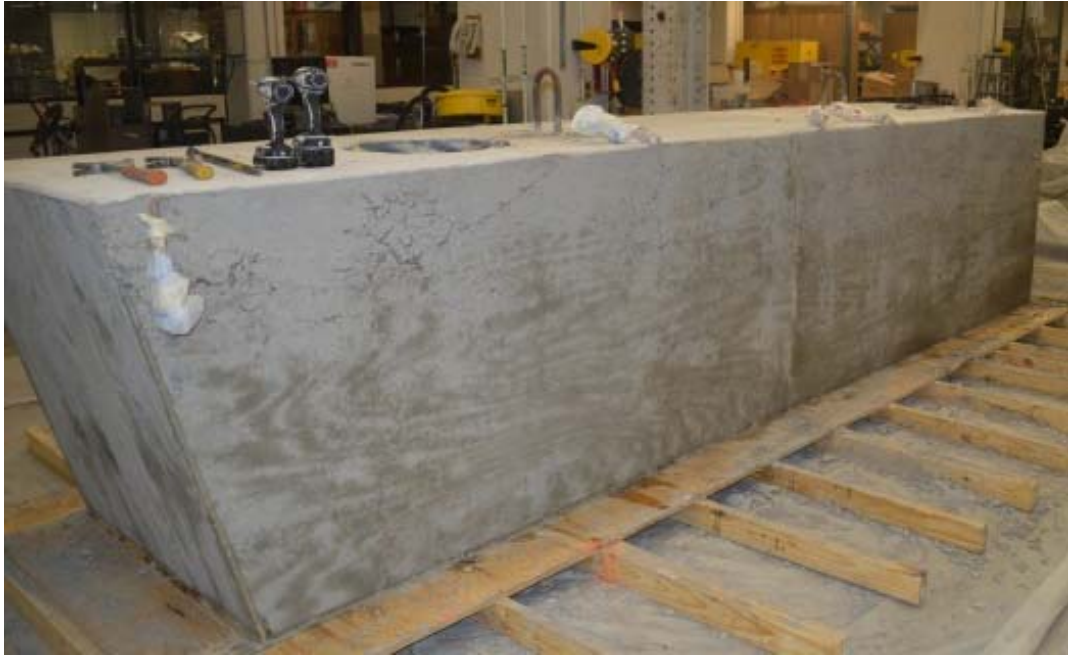
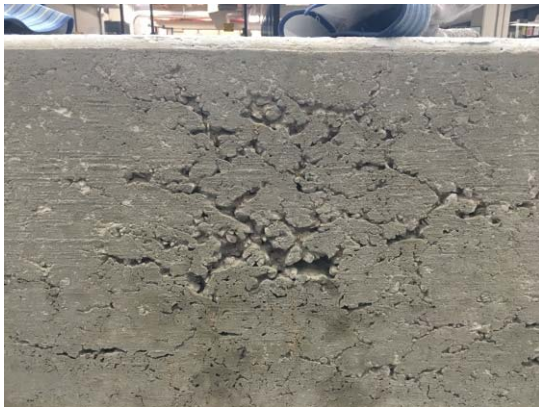
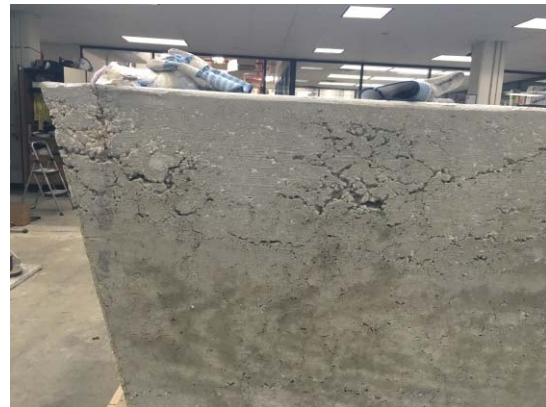
Figure 3.20. Honeycombing (RCS-16-12).

In an effort to protect the strain gages during the casting of the bent cap, improper vibrating resulted in honeycombing in certain areas of the bent cap after releasing the formwork as seen in Figure 3.20. According to the Chapter 2 - Damage Assessment and Repair Types of the TxDOT Concrete Repair Manual ([Freeby, 2015](#)), the honeycombing was determined to be minor with no effects to the structural integrity of the specimen. The average depths of the honeycombs were less than 7/8-in. The only two areas of largest honeycombs were 1-1/8-in and 1-1/2-in deep (depth of cover concrete 2-7/8-in). No rebar was exposed. Repair guidelines were followed and the areas were cleaned and filled with cement grout. The surface of the specimen was finished with a diamond concrete surface grinder. After all the honeycombing was repaired, the specimen was placed on support blocks (Figure 3.21).

(a) Honeycombing– Front Face of Bent Cap

(b) Span

(c) Battered End

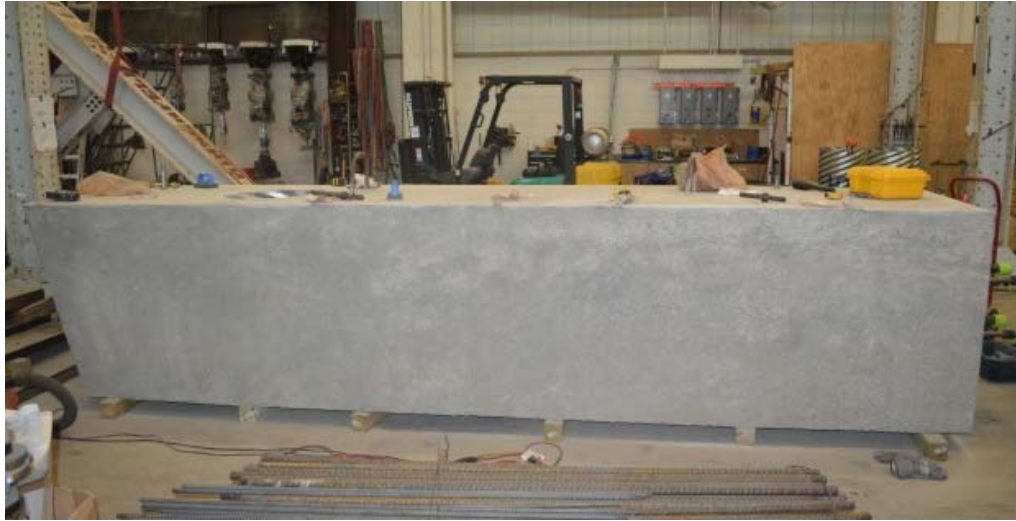
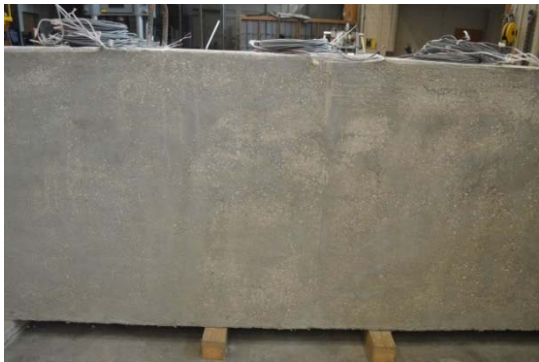
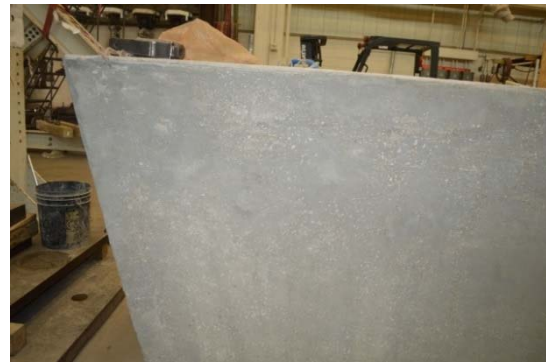
Figure 3.21. Honeycomb Repairs (RCS-16-12).

(a) Honeycombing Repairs – Front Face of Bent Cap

(b) Span

(c) Battered End

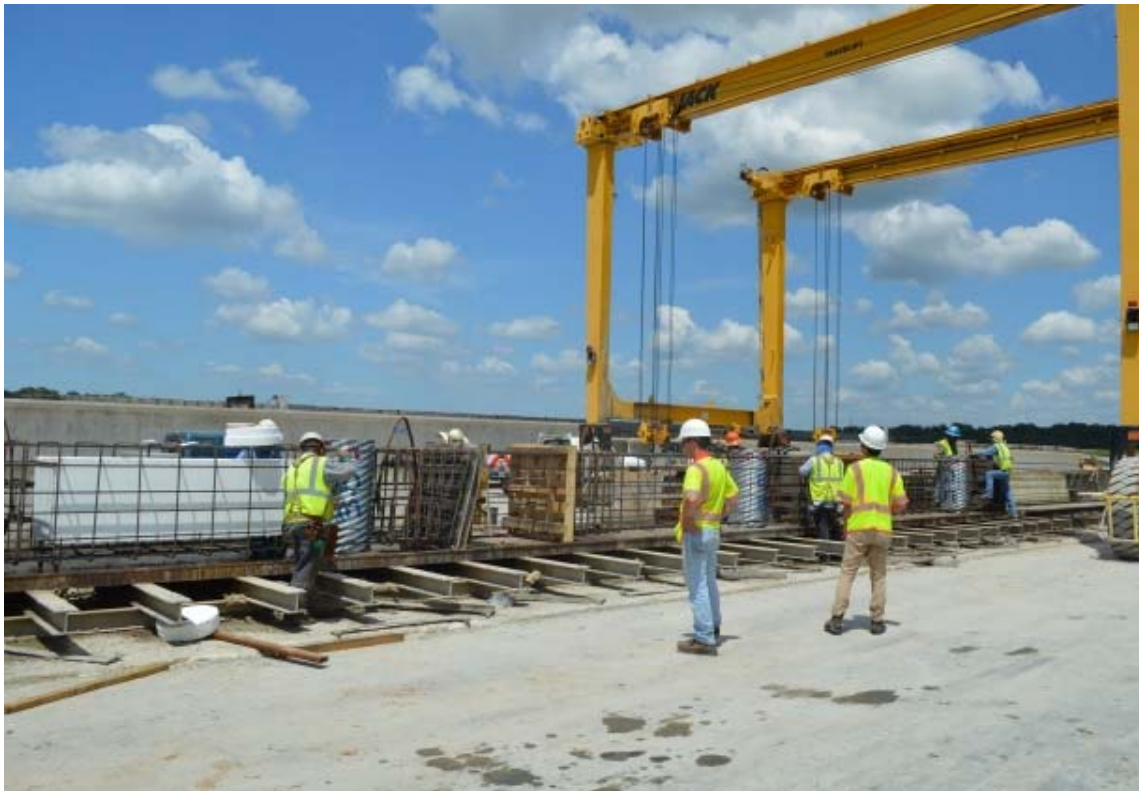
Figure 3.23. Prestressing Bed.

The construction of pretensioned bent caps PSS-16-12, PSS-16-24 and PSV-16-12 took place at Bexar Concrete Works in San Antonio, Texas under the close supervision of both TxDOT and Texas A&M Transportation Institute (TTI) personnel. All three pretensioned bent caps were constructed along the same prestressing bed (Figure 3.22 and Figure 3.23). The first steps consisted of placing the formwork for each end of the specimen. Metal

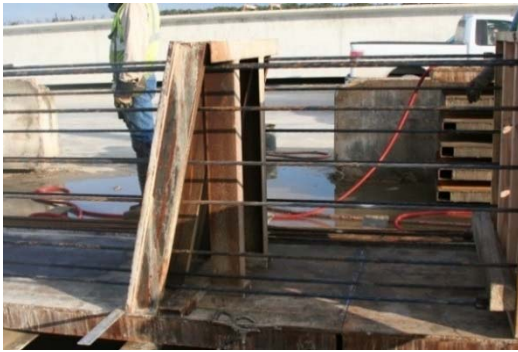
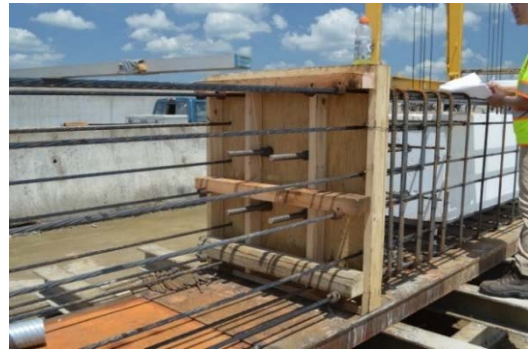
Figure 3.24. End Formwork.

formwork was used for the battered end and wood formwork was used for the square end (Figure 3.24). The strands were placed in the specified locations according to plans and anchored at one end of the prestressing bed and stressed at the opposite end (Figure 3.25). Four metal stumps were welded to the prestressing bed to secure the steel corrugated pipes (Figure 3.26). The styrofoam void and drains were installed and secured at the bottom with No. 3 rebar and to prevent floating, three 3/4-in plywood sheet cuts were installed at the top of the styrofoam and held in place with threaded bars that fed through the side wall formwork braces (Figure 3.27). Six additional C-bars were placed vertically and horizontally (twelve total) at the battered and square end of PSV-16-12 and at the square end of PSS-16-12 to prevent cracking from the releasing of the strands based on recommendations from the precaster. To validate the effectiveness of additional C-bars at the end region of bent caps, no additional bars were provided in PSS-16-24 (Figure 3.28). Two additional transverse reinforcement bars were provided 2-in from each of the corrugated pipe faces in both the east and west directions for PSS-16-12 and PSV-16-12. To allow comparison, no additional transverse reinforcement was placed in PSS-16-24. The additional end region and transverse reinforcement followed the details previously presented in Figure 3.9 and Table 3.5.

(a) Metal Formwork – Battered End

(b) Wood Formwork – Square End

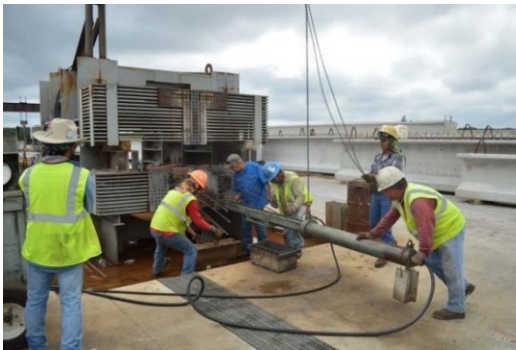
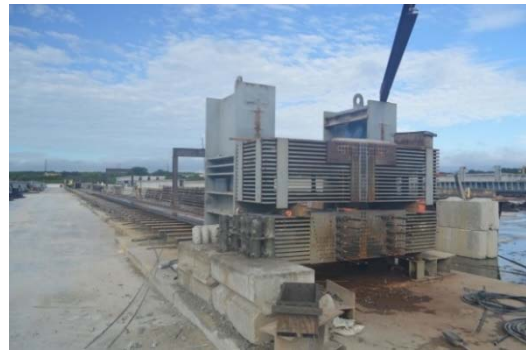
Figure 3.25. Stressing of Strands.

(a) Stressing End

(b) Anchorage End

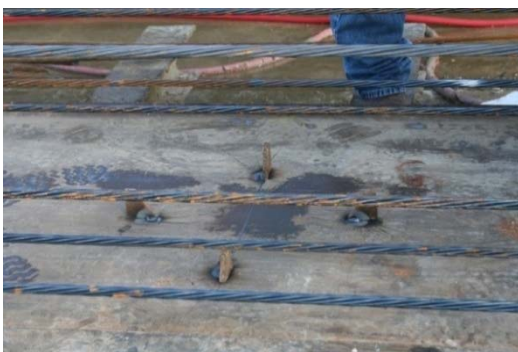
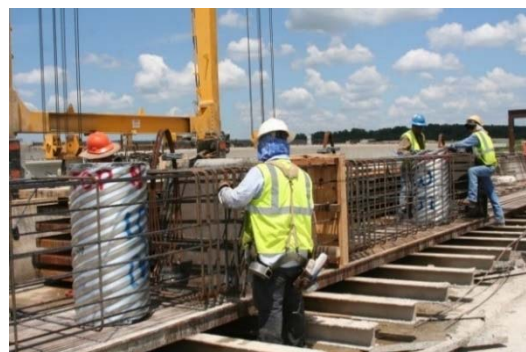
Figure 3.26. Installation of Steel Corrugated Pipe.

(a) Corrugated Pipe Stumps

(b) Steel Corrugated Pipe

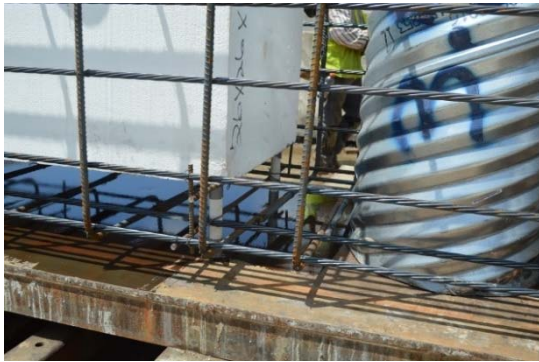
(a) Bottom Cover and Drain Pipes

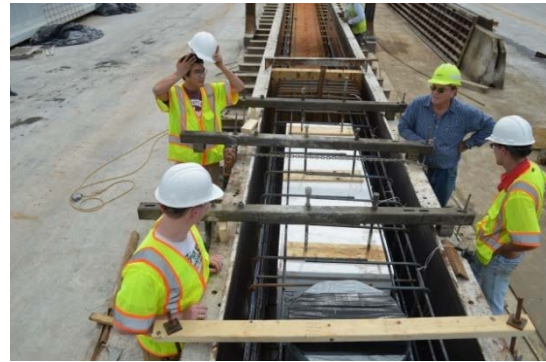
(b) Top Cover Plywood Cuts

Figure 3.27. Void Installation.

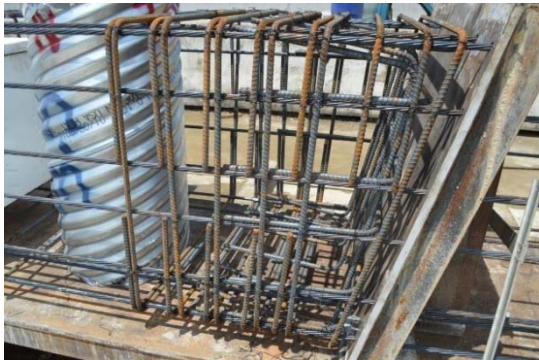
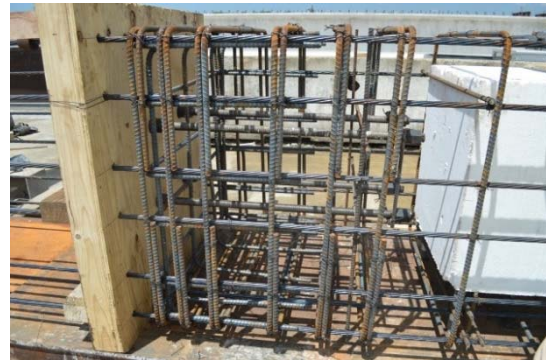
Figure 3.28. Additional End Region Reinforcement.

(a) Battered End

(b) Square End

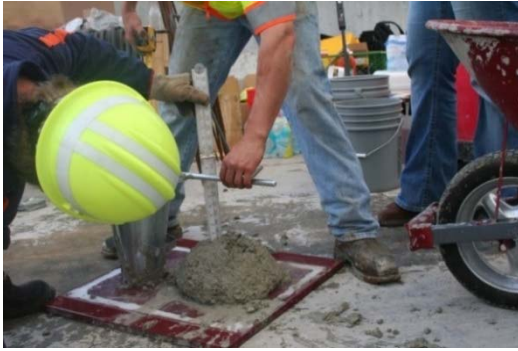
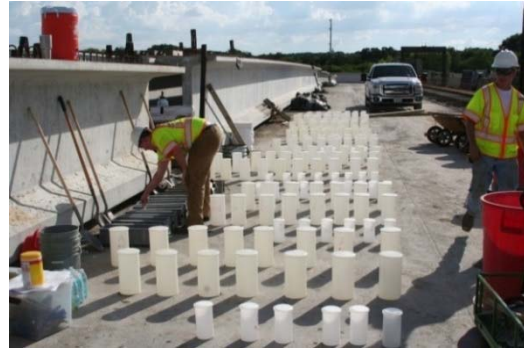
Figure 3.30. Concrete Material Samples.

(a) Slump Test

(b) Cylinder and Beam Molds

The initial target compression strength was 4-ksi for strand release and a target value for 28-day strength was between 6-ksi and 7-ksi. Figure 3.29 shows the distribution of batches in the three specimens. An initial slump of 7-in was recorded, and molded cylinders and beam specimens were made for each concrete batch (Figure 3.30). The first concrete batch (A) filled approximately two-thirds of PSS-16-12, and the second concrete batch (B) filled the remaining portion of PSS-16-12 and the bottom third of PSS-16-24. The third (C) and fourth (D) concrete batches filled the remaining of PSS-16-24. The

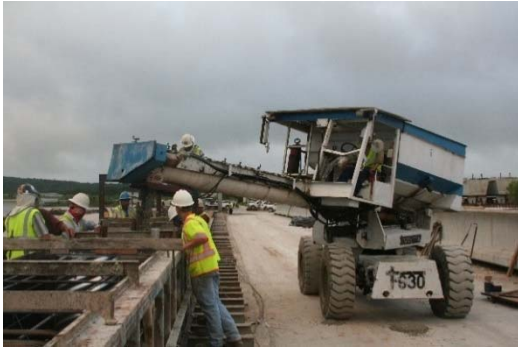
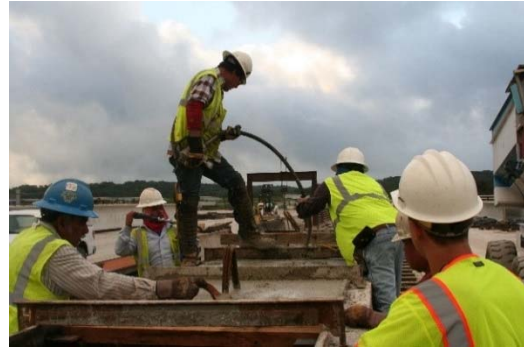
Figure 3.31. Casting Pretensioned Specimens

(a) Concrete Pour

(b) Consolidation

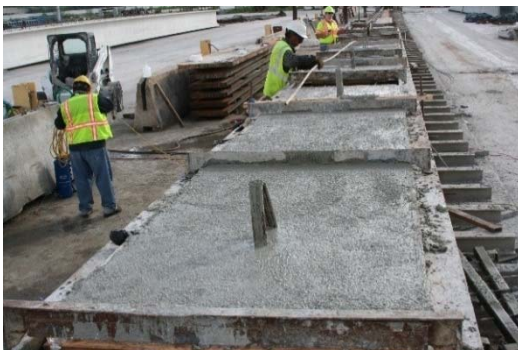
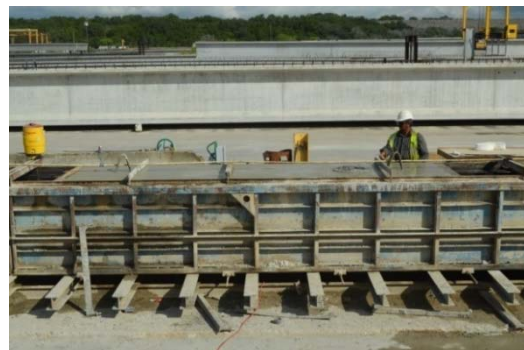
Figure 3.32. Finishing and Curing of Concrete.

(a) Wood Trowel Finish

(b) Curing

remainder of the fourth batch (D) was discarded after topping off PSS-16-24 because of an interruption in the pour due to a displacement in the pocket, which was partially corrected and less than 1/4-in of rotation at the base remained. The fifth batch (E) filled over two-thirds of PSV-16-12. The sixth and final batch (F) of concrete filled the remainder of PSV-16-12 (Figure 3.29). Extra material testing samples were made with the remaining concrete from the final batch. After the concrete pours were completed and vibrated for proper consolidation, the tops of the specimens were finished with wood trowels. A water irrigation system was installed above the specimens to provide the proper curing of the top concrete surface and maintain humid conditions (Figure 3.31 and Figure 3.32).

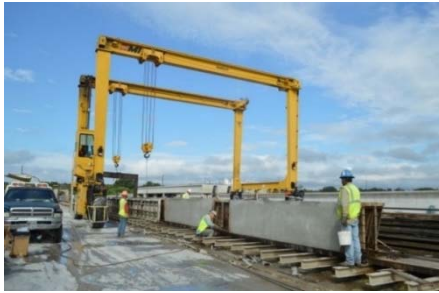
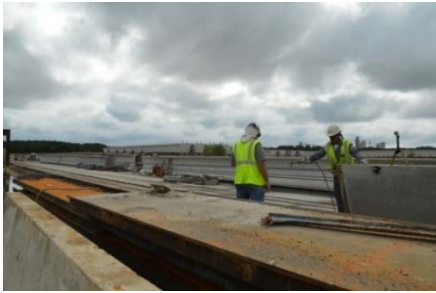
Figure 3.35. Formwork Removal and Strand Release.

(a) Formwork Removal

(b) Flame Torch Strand Release

The formwork for all specimens was removed and the strands were released on the third day after the concrete was poured. During the release of the strands, a jack was used to lower the tension of the strands at the stressing end and flame torching techniques were used to release the strands at the anchorage end and in between each specimen (Figure 3.35). Strands were released individually in a symmetrical pattern. Compressive strengths of the collected cylinder samples averaged close to 4.5-ksi. No cracks were present in the specimens before or after the release of the strands (Figure 3.36). The ends of the strands were prepared by melting approximately 2-in into the cover concrete and patching with grout to prevent corrosion of the strands (Figure 3.37).

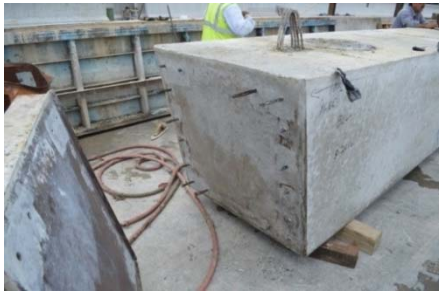
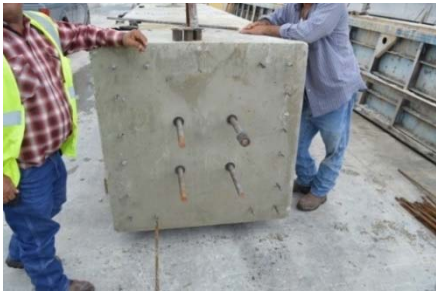
Figure 3.36. Post Strand Release Crack Inspections.

(a) Battered End

(b) Square End

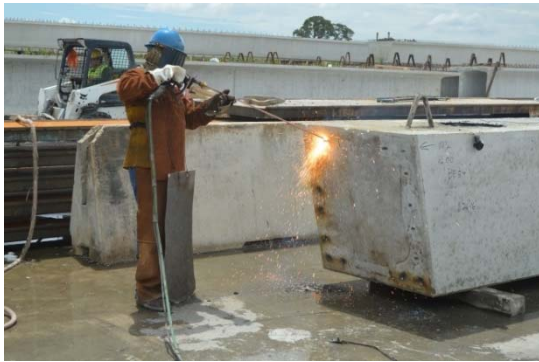
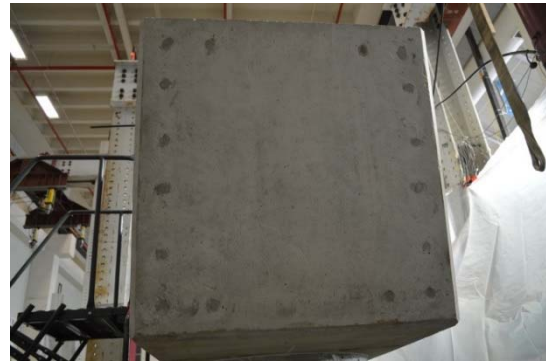
Figure 3.37. Strand End Preparation.

(a) Melting Strand Ends

(b) Grout Strand Patches

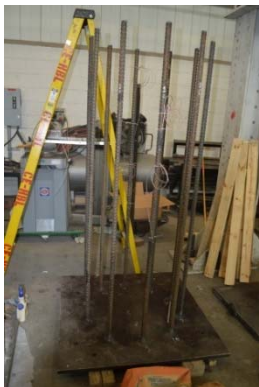
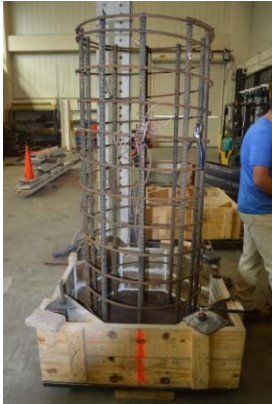
Figure 3.41. Column Reinforcement.

(a) Threaded Longitudinal Bars

(b) Deformed Spiral

The construction of the reinforcement cage for the column began by threading the bottom of the column longitudinal bars into a 1-in steel plate (Figure 3.41(a)).

The construction of the column steel cage followed a similar procedure as the bent cap, by marking the 6-in pitch of the spiral reinforcement on the column longitudinal bars. The overhead crane lifted the spiral reinforcement to the marked locations on the longitudinal reinforcement. One complete loop of spiral reinforcement was tied to the bottom of the longitudinal reinforcement and the 6-in pitch was continued thereafter. An extra full loop of spiral reinforcement was tied at the top of the longitudinal reinforcement (Figure 3.41(b)). The spiral reinforcement was tied at every column longitudinal reinforcement bar.

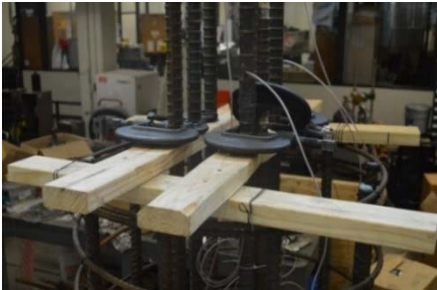
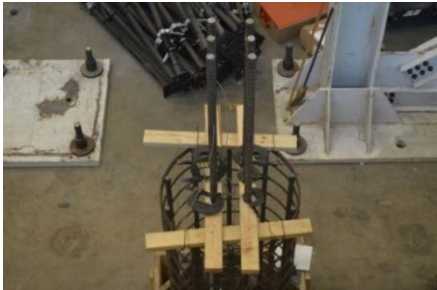
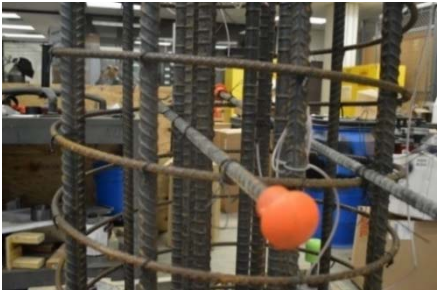
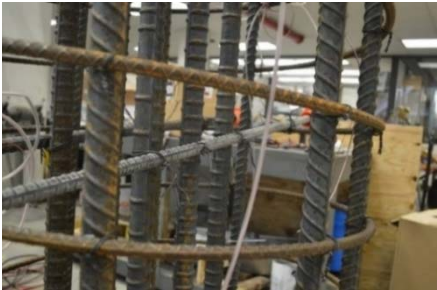
Figure 3.42. Temporary Dowel Formwork.

(a) Top of Column

(b) Column Midheight

The dowel bars for the connection between the bent cap and the column extended 5-ft 6-in into the column and 3-ft 2-3/4-in into the bent cap. To install the dowel bars in the correct position, formwork made of 2 x 4 cuts of lumber with holes matching the spacing of the dowel bars were placed at the top of the column steel reinforcement cage. Clamps were used to secure the dowels bars at the correct alignment and elevation. A second point of alignment was created by installing temporary spare rebar inserted through the spiral reinforcement perpendicular to the length of the column longitudinal bars near the base of the column. This additional point of alignment secured the dowel bars into a level position and fixed the dowel bars against any rotation or misalignment during the casting of the column base. The dowel formwork was temporarily removed to place the

sonotube over the column steel reinforcement cage after the casting of the column base concrete (Figure 3.42).

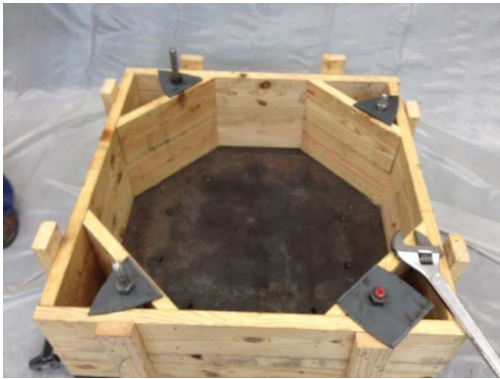
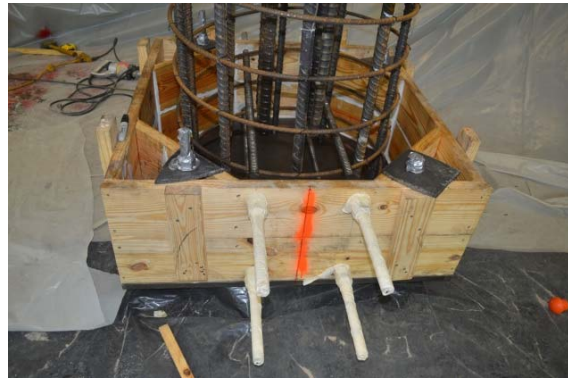
Figure 3.44. Octagonal Base Formwork.

(a) Column Base Formwork Installation

(b) Column Base Cage

Three components were used for the construction of the column formwork. The first component was the steel plate mentioned with the column reinforcement cage. The second consisted of an octagonal base necessary for a flat contact surface for the connection of the bottom horizontal actuator. The third and final component was the remaining circular column on which the bent cap would be installed. Figure 3.43 shows plans for the 14.5-in high octagonal base that was constructed using 2 x 8 cuts of lumber. The formwork for the octagonal base was secured to the plate with all-thread rods fastened by custom cut steel plates as seen in Figure 3.44. Concrete for the column base was poured prior to casting the main portion column to provide a solid foundation for the column formwork.

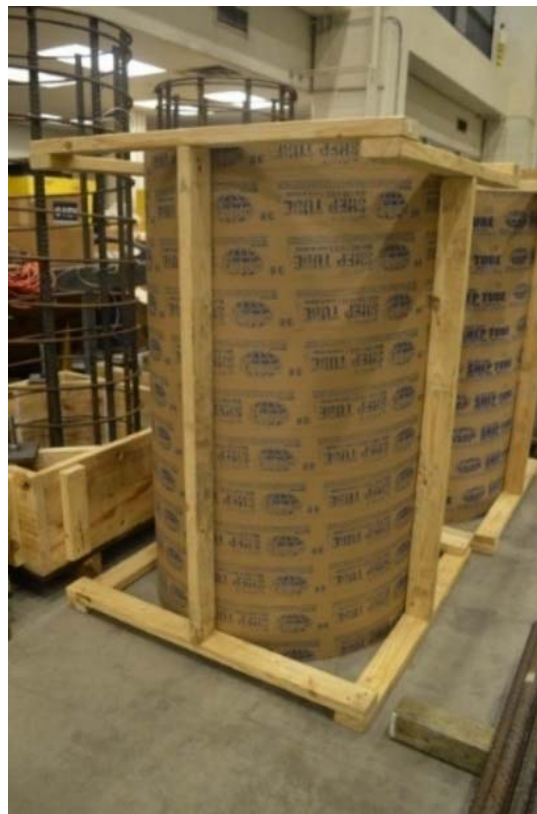
Figure 3.45. Column Sonotube Formwork.

The column formwork consisted of a 36-in diameter cardboard sonotube. Shipping and storage prior to delivery caused the sonotubes to deform into an oval shape. Bracing was added to the top and bottom (Figure 3.45) to provide support for the sonotube and to maintain the 36-in diameter. The correct alignment and floating prevention of the sonotube during casting were ensured by screwing the bottom braces of the sonotube to the column base formwork.

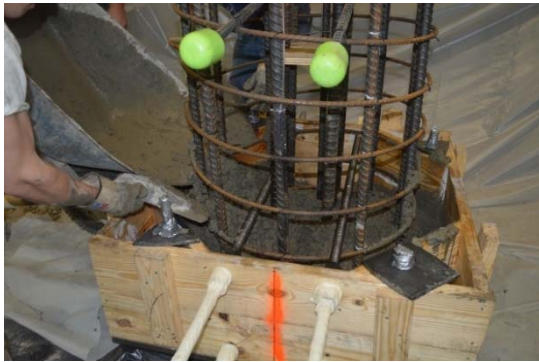
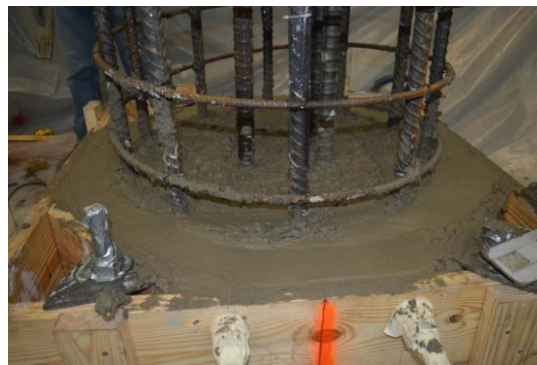
Figure 3.46. Casting Column Base.

(a) Placement of Concrete with Wheel Barrels

(c) Rough Finish

The formwork from the octagonal base was left in place during the casting of the column allowing the bottom lumber formwork of the sonotube to attach to the column base formwork (Figure 3.46). The formwork at the top of the dowel bars was reinstalled onto the top of the sonotube to secure the dowel bars during concrete casting (Figure 3.47). The column base concrete was transported from the concrete mixer truck to the formwork by wheel barrels filled with concrete, then vibrated for consolidation. The top surface of the octagonal column base was left with a rough finish to increase the bond between the two separate pours. The outer edges were finished with trowels to provide a smooth

contact surface for the sonotube. The octagonal column base was cast at a minimum of 24 hours prior to the column.

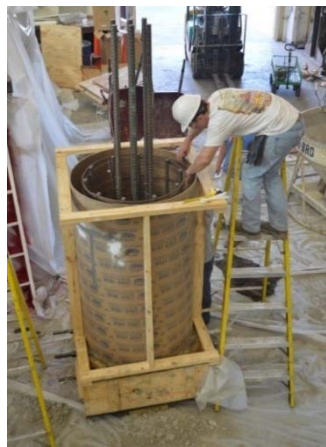
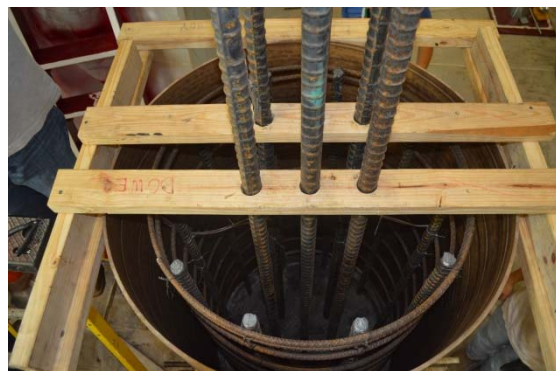
Figure 3.47. Column Concrete Pour Preparation.

(a) Sonotube Installation

(b) Dowel Bars Supports

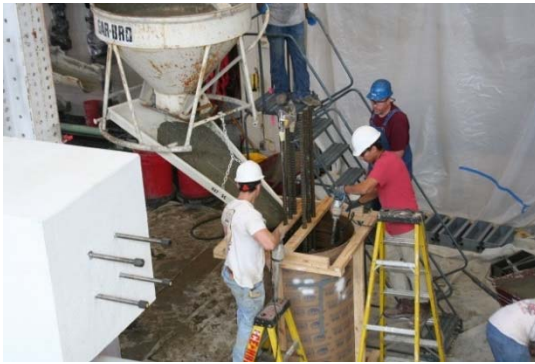
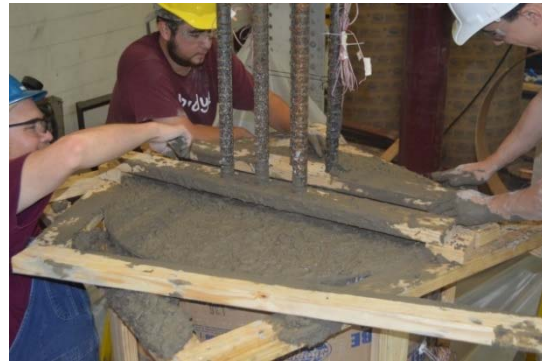
Figure 3.48. Casting Column.

(a) Hopper and Side Shoot

(b) Rough Finish

A hopper with a side shoot was used to place the concrete in the column. The column was cast in three lifts, with each vibrated for consolidation. The top surface was left with a rough finish to provide a stronger bond with the bedding layer (Figure 3.48).

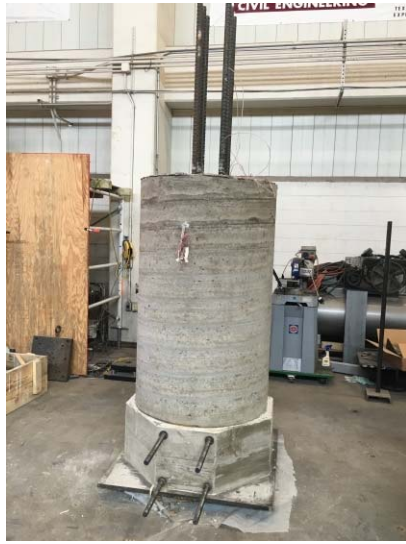
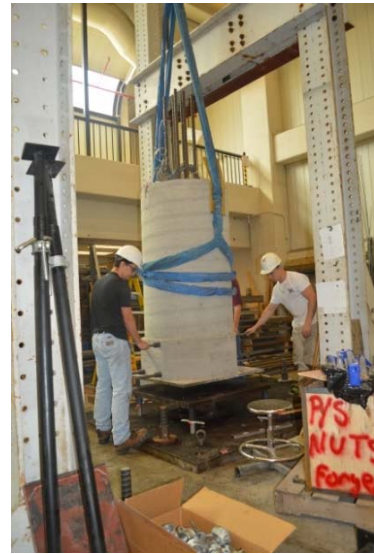
Figure 3.49. Column Installation.

(a) Cured Concrete

(b) Installing onto Test Setup

The next step in the construction of the experimental test specimen consisted of assembling the components. The column was placed onto a roller foundation simulating a pin connection at the moment inflection of the prototype bridge column (described in Section 3.1) by attaching lifting straps with a double-choke to the overhead laboratory crane. Screw jacks on each corner of the 2-in plate were used to fix the roller foundation in position and ensure the specimen maintained a level position prior to testing (Figure 3.49).

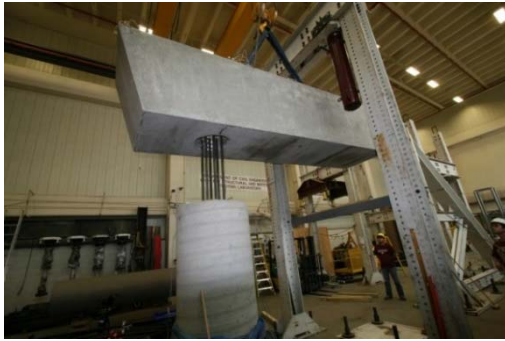
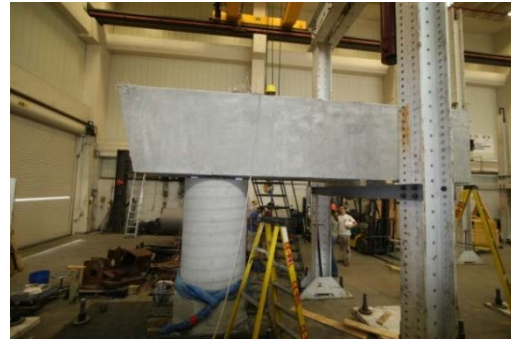
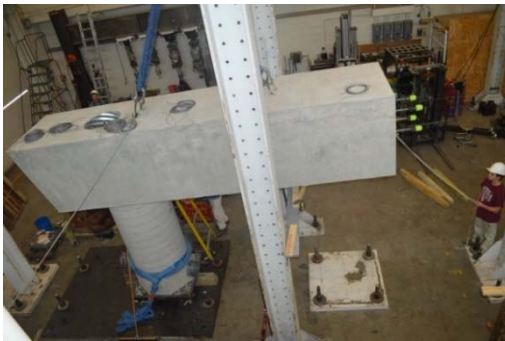
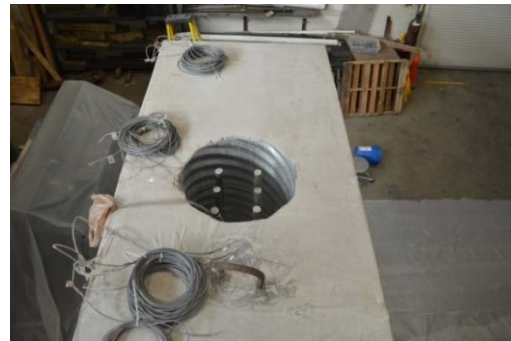
Figure 3.50. Installation of Bent Cap onto Column.

(a) Placing Bent Cap

(b) Bedding Layer and Shims

(c) Placed Bent Cap Top View

(d) Dowel in Pocket Connection

After the column was secured onto the roller, the bent cap was placed on top of the column which took place by attaching the overhead crane to the lifting hooks. The ease of installment of the bent cap onto the column with the use of the larger single pocket connection allowed for a quick assembly of the specimen in the laboratory (Figure 3.50). Temporary shoring for the east end of the bent cap was provided by two angle iron headers attached to the reaction towers. Wood shims were used to obtain the correct height and level installation of the bent cap resting on the angle iron headers.

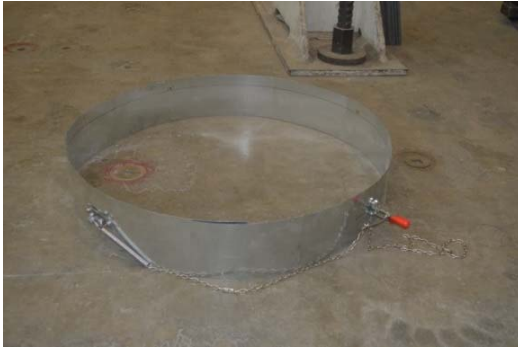
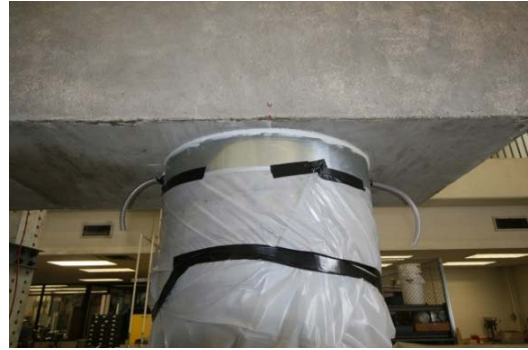
Figure 3.52. Bedding Layer Formwork and Air Vents.

(a) Formwork

(b) Air Vents

The pocket connection consisted of a 21-in diameter corrugated pipe. A sleeve made of sheet metal with a spring-loaded chain and latch was constructed to provide the formwork for the bedding layer. The latch and the spring provided the necessary stiffness in the sleeve to remain in place during casting and consolidation of the pocket concrete. For the construction of RCS-16-12, two 1/2-in inner diameter clear tube vents were installed behind each of the two shims placed along the centerline of the bent cap to allow any entrapped air to exit the interface between the edge of the column and pocket during the casting of the bedding layer (Figure 3.52). Although a 3/4-in aggregate was used for the pocket, the concrete flow through the clear tubes was minimal. Making use of just the

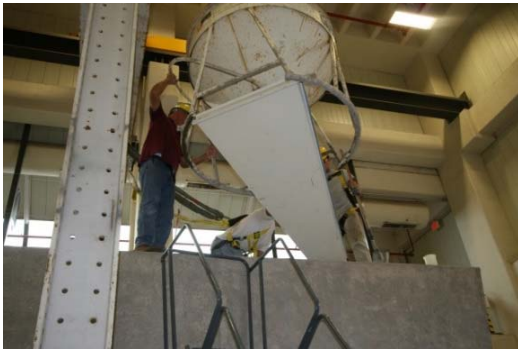
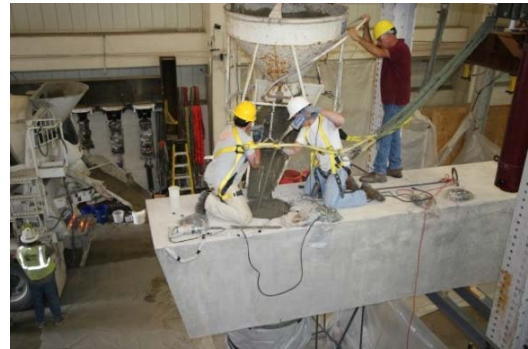
Figure 3.53. Casting of the Bedding Layer.

(a) Bottom View

(b) Top View

Prior to casting the bedding layer, the concrete at the top of the column inside the pocket connection was hydrated to ensure the bond of the bedding layer to the top of the column. Soaking with water immediately prior to the concrete pour was implemented for RCS-16-12, while PSS-16-12 used overnight soaked towels to hydrate the concrete at the top of the column; no significant impact between either technique was observed. Concrete slumps of 4.5-in and 5.5-in were recorded for RCS-16-12 and PSS-16-12, respectively. The overhead crane and a side shoot on the concrete bucket were used to cast the concrete into the corrugated pipe connection (Figure 3.53). The pockets were cast in three equal layers and consolidated at each level. Additional vibration was applied to the first layer around the bottom circumference of the corrugated pipe to ensure the concrete filled the bedding layer and spread around the plastic shims.

The difficult access to the bedding layer from the top of the pocket connection made spreading and consolidating of concrete challenging. During the construction of RCS-16-12, two small areas of honeycombing were present in the bedding layer as a result of the constructability problems encountered while casting the pocket connection and the lower slump (Figure 3.54). The level of honeycombing in the bedding layer was determined to be minor and showed to have no negative effects on performance during testing. The honeycombing areas were cleaned and repaired using cement grout.

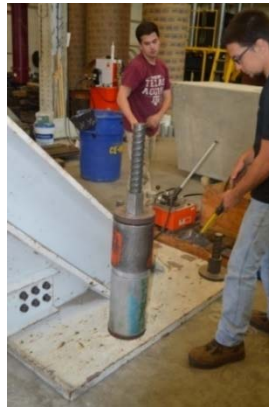
Figure 3.56. Post-tensioned Dywidag Connection to Strong Floor.

The strong floor consists of 3-in diameter holes spaced at 3-ft. The vertical reaction towers, reaction plate and horizontal reaction frames for the specimens were attached to the laboratory strong floor by 2.5-in Dywidag threaded bars and each tensioned to 3,000 psi (Figure 3.56). The specimen was aligned above a strong floor foundation wall to accommodate the large forces acting on the specimen (See Figure 3.57 and Figure 3.58).
