EXPERIMENTAL PERFORMANCE OF REINFORCED AND PRETENSIONED
PRECAST CONCRETE BENT CAPS

A Thesis

KEVIN JACK YOLE

August 2017

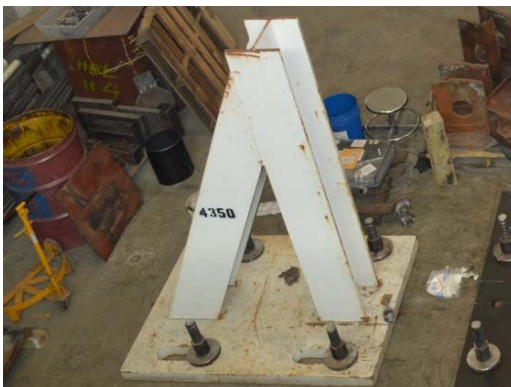
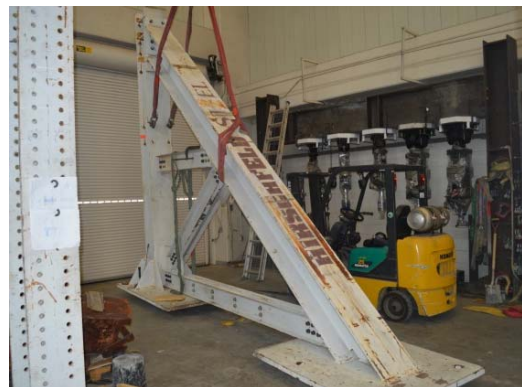
(a) Bottom Horizontal Reaction Frame

(b) Top Horizontal Reaction Frame

Figure 3.57. Horizontal Reaction Frames.

The strong floor consists of 3-in diameter holes spaced at 3-ft. The vertical reaction towers, reaction plate and horizontal reaction frames for the specimens were attached to the laboratory strong floor by 2.5-in Dywidag threaded bars and each tensioned to 3,000 psi (Figure 3.56). The specimen was aligned above a strong floor foundation wall to accommodate the large forces acting on the specimen (See Figure 3.57 and Figure 3.58).

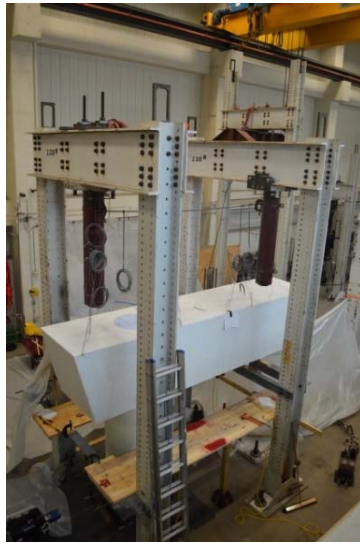
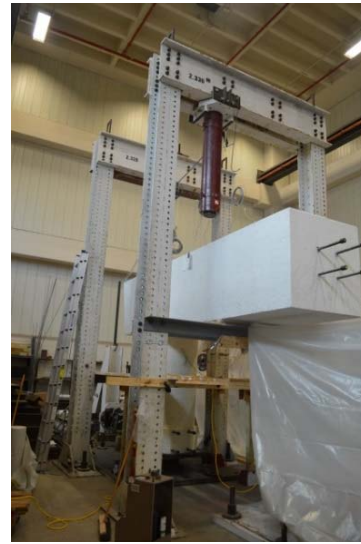
(a) Top View

(b) Bottom View

Figure 3.58. Vertical Reaction Towers.

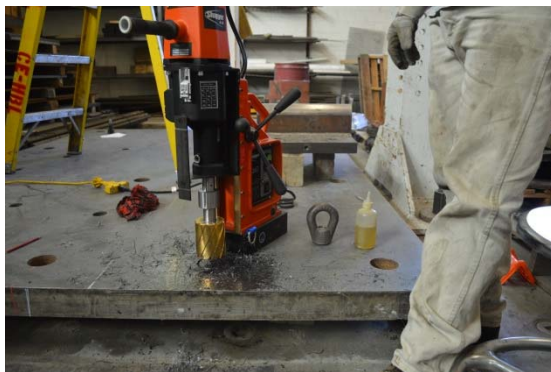
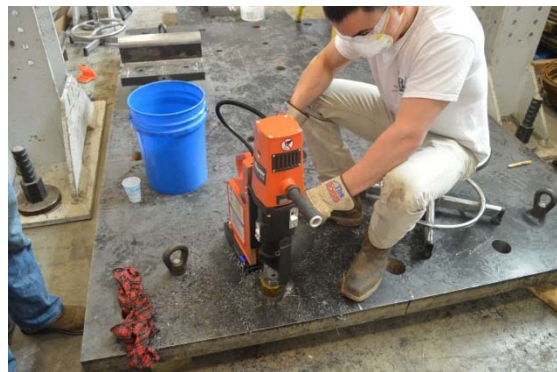
(a) Magnetic Drill

(b) Drilling 3-in Holes

Figure 3.60. Drilling 3-in Holes for Dywidag Bars.

The Texas A&M University High Bay Structural and Materials Testing Laboratory had in its inventory a 10-ft x 7-ft x 3-in plate that served as the base plate for the column to attach securely to the laboratory floor. The roller foundation was attached to the 10-ft x 7-ft base plate using 1-in diameter tap and drilled bolts connections. Additional 3-in diameter holes for the Dywidag were necessary for the base plate as seen in Figure 3.59. The additional Dywidag holes required the use of a magnetic drill press kit with a 3-in diameter and 3-in cutting depth titanium coated high-speed Weldon 1-1/4-in shank annular cutter (Figure 3.60). The roller foundation plate was attached to the 10-ft x 7-ft plate in a similar fashion. The magnetic drill was used to drill 7/8-in holes and tapped for a 1-in 8 UNC (Figure 3.61 and Figure 3.62).

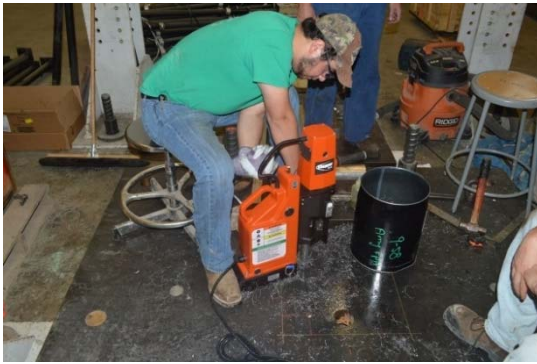
(a) Drilling 7/8-in holes

Figure 3.61. Drilling and Tapping 1-in Roller Foundation Threads.

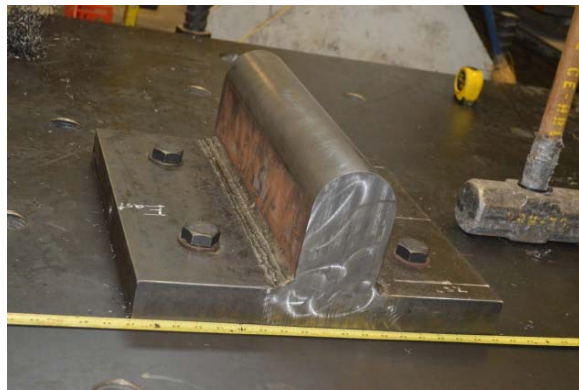
Figure 3.62. Installation of Roller onto 10-ft x 7-ft Base Plate.

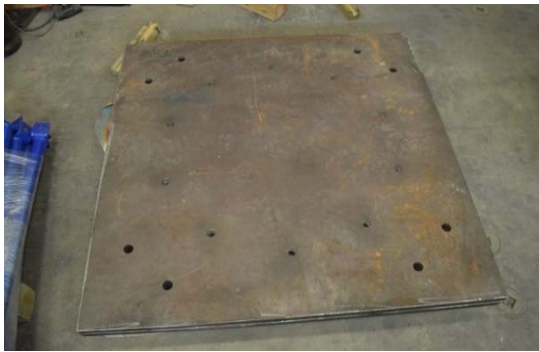
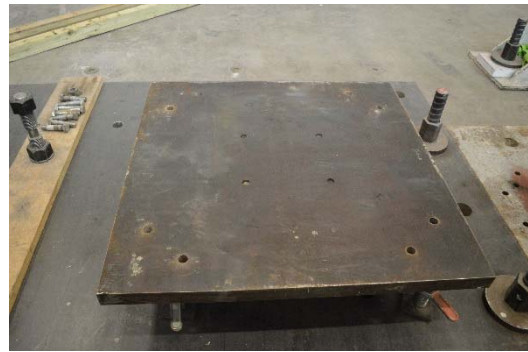
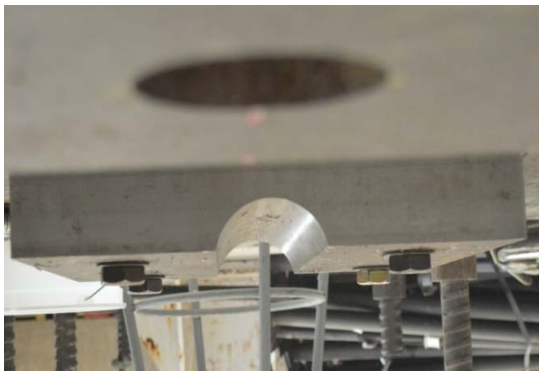
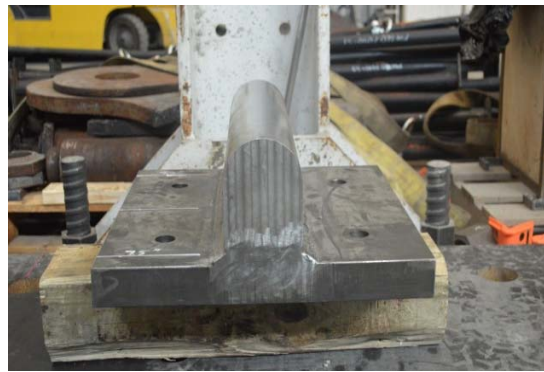
(a) Plate A - 1-in

(b) Plate B - 2-in

(c) Part C – Top Half Circle

(d) Part D - Roller

Figure 3.64. Roller Foundation Assembly.

Part A consisted of a 42-in x 42-in x 1-in steel plate that incorporated the drilled and tapped 1-in 8-UNC holes for the column longitudinal bars which were threaded into the 2-in plate connecting the column base to the roller foundation (Part B). Two 1-1/16-in through-holes at each corner were also included in Part A for 1-in bolts that would attach to Part B. Part A was designed to be disposed of after each test. Part B had dimensions of 42-in x 42-in x 2-in with the 1-1/16-in through-holes at each corner to connect to the Part A. Four additional holes were tapped and drilled near the center of Part B for 1 in – 8 UNC to attach to Part C. Part C consisted of an 18-in x 18-in x 3-in steel plate that was machined to have a 4-in diameter “half circle” void matching the top of the roller of Part D. Part C also had four holes tapped and drilled for 1-in -8 UNC to attach to Part B. Part D acted as the main component of the roller foundation representing the pin at the moment inflection point at the exterior column of the prototype bridge and consisted of two pieces of steel. The top vertical piece was a 6-in x 4-in block of steel machined to

have a 4-in diameter half circular surface at the top and was then welded with 1/2-in E70XX electrodes on both sides to the 18-in x 18-in x 2-in horizontal plate. The horizontal plate also had 1-1/8-in through-holes to attach 1-in threaded bolts to the 10-ft x 7-ft base plate (Figure 3.64 and Figure 3.65).

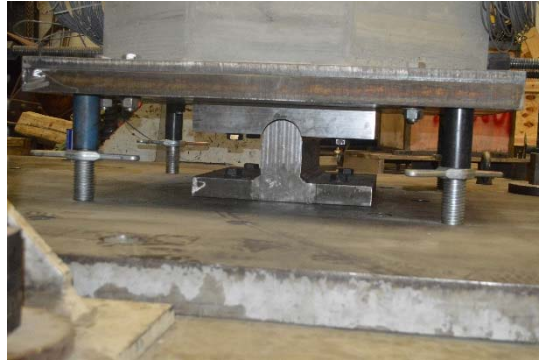
Figure 3.65. Installed Roller Foundation Assembly onto Test Setup.

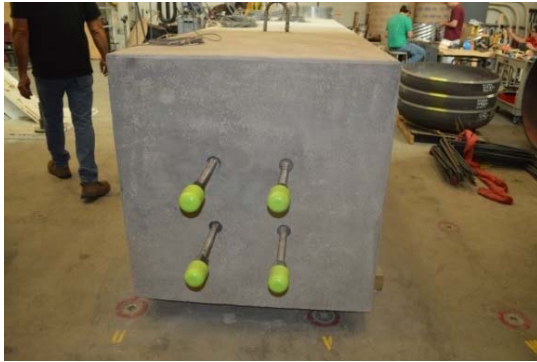
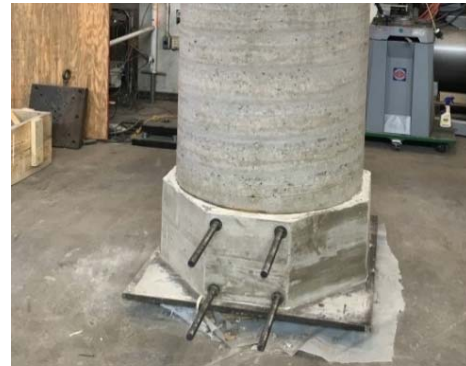
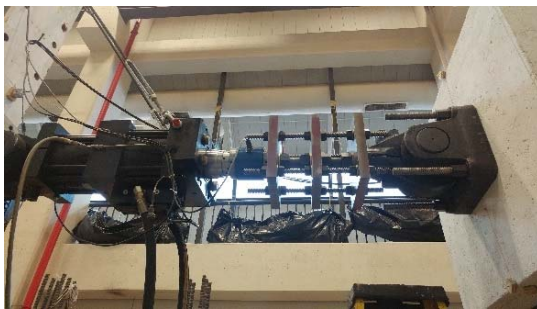
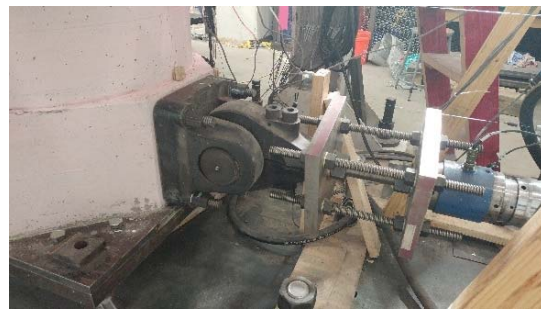
(a) HT Actuator Connection

(b) HB Actuator Connection

(c) Installed HT Actuator

(d) Installed HB Actuator

Figure 3.66. Horizontal Actuator Connections.

The 110 kip actuators providing the horizontal stability (HT and HB) for the specimens required the installation of rods cast into the specimens as seen in Figure 3.66. The cleats of the 110 kips actuators had four 1-1/4-in holes located 11-in apart. Williams Form Engineering 150-ksi 1-in all-thread rods were cast into the column base and the square end of the bent cap to provide the attachment of the 110 kip actuators to the specimen. The horizontal actuators were mounted to the horizontal reaction frames.

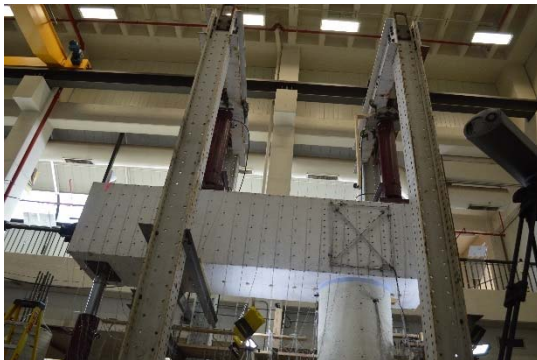
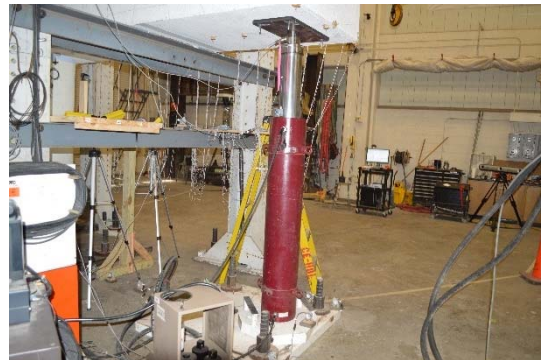
(a) P1 and P2 Actuators

(b) V Actuator

Figure 3.67. Vertical Actuator Connections.

The two top vertical actuators acting as the girder loads (P1 and P2) were attached to 9-ft headers at the top of the steel towers (Figure 3.67.a). The bottom vertical actuator (V) rested on a 3-in thick base plate attached to the laboratory floor (Figure 3.67.b).

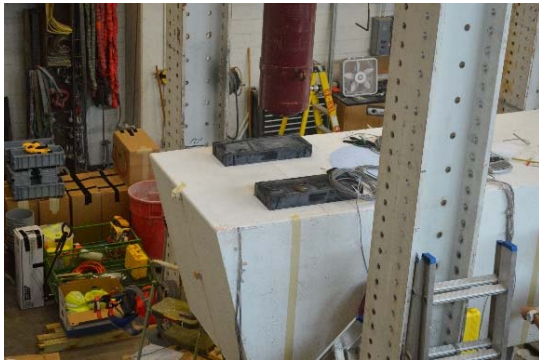
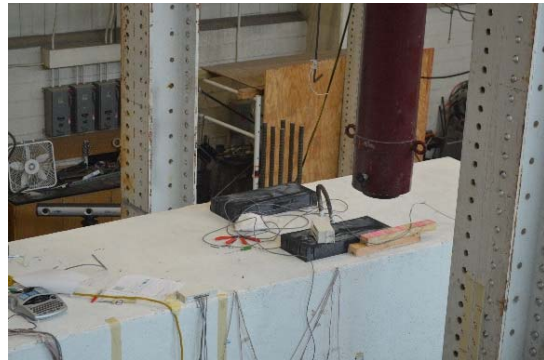
(a) P1 Actuator Bearing Pad

(b) P2 Actuator Bearing Pad

Figure 3.69. Elastomeric Bearing Pads.

The bearing pads were purchased from TxDOT approved producer Dynamic Rubber Inc. The two bearing pads simulated the ends of two girders as they rest on the bent cap. The dimensions and locations of the bearing pads followed the guidelines from elastomeric bearing and girder end details (Figure 3.68 and Figure 3.69).

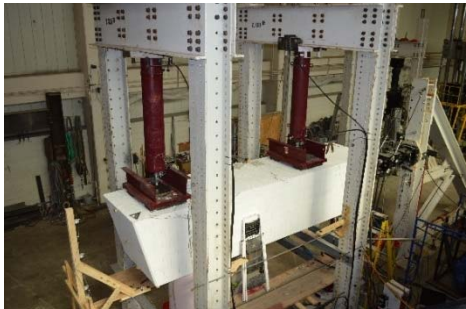
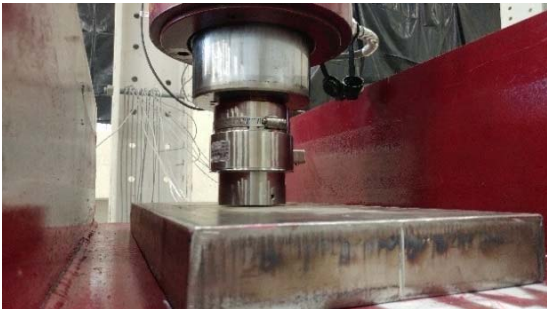
(b) Installation

(c) Additional 2-in Plate

Figure 3.70. Actuator Load Assembly.

Two actuator load assemblies were designed to evenly distribute the loads from the single actuator ram to the two bearing pads. Each actuator contact assembly consisted of two A-992 steel 10X30 C-channels welded to a 2-in plate and with an additional 2-in plate resting between the actuator load assembly and the actuator ram (Figure 3.70).

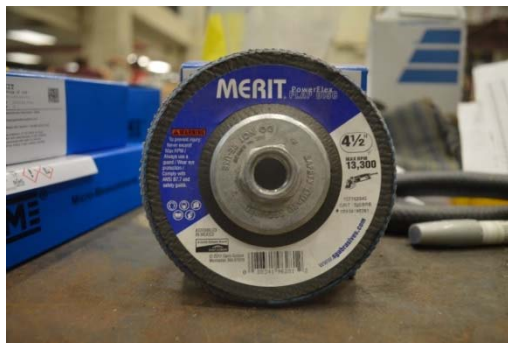
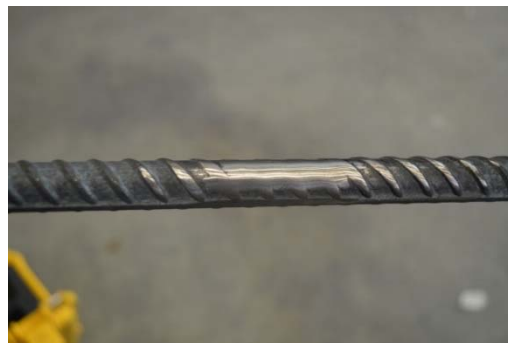
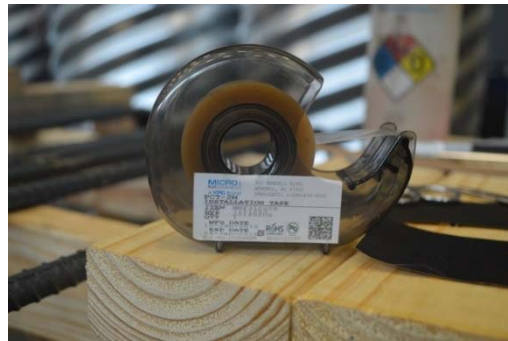
(a) Flap Sanding Disk

(b) Sanded Surface

(d) Installation Tape

Figure 3.72. Surface Preparation.

Strict guidelines were followed during the installation of strain gages. The first step was to prepare the rebar surfaces with flap sanding discs for nonmetals with a 320 grit to ensure the diameter of the bars was not reduced, followed by a cleaning with acetone and installation tape (Figure 3.72). A straight edge was then used to draw a lightly pressed marked line parallel to the length of the bar and another line perpendicular to the length of the bars to ensure the proper location of the strain gage. A second strip of installation tape was used to assist in the placement of the Vishay CEA-06-250UN-350 strain gauges and CPF-75C port. The tape was partially rolled back with the attached strain gage and port, and the M-Bond 200 was applied to the bottom of the strain gage and port then lightly pressed back onto the rebar for at least 30 seconds to allow the M-Bond 200 to cure; the tape was removed afterward (Figure 3.73). The strain gages and terminals were connected using lead based solder and copper wires, and the terminals were soldered to the 326-DFV wires with sufficient length to exit the bent cap formwork (Figure 3.74). The 326-DFV wires were then fed through 1/8-in clear heat shrink tube to for protection during the casting of concrete and coated with M-Coat B to increase the bond with the M-Coat JA. The final M-Coat JA and protective tape where applied to seal the strain gages against any moisture and chemicals from the concrete (Figure 3.75). The strain gage wires were then

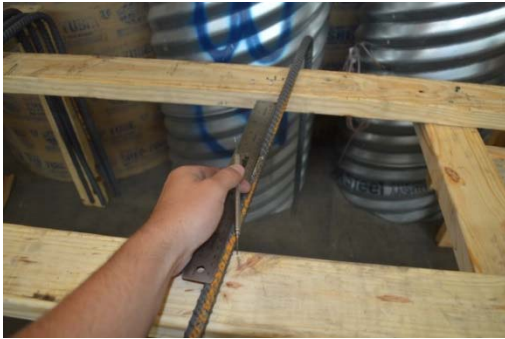
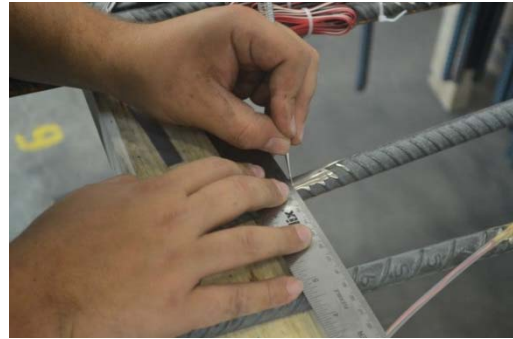
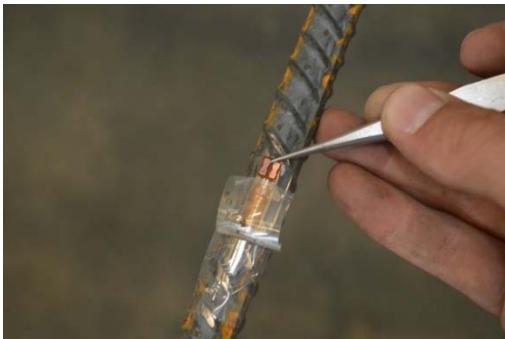
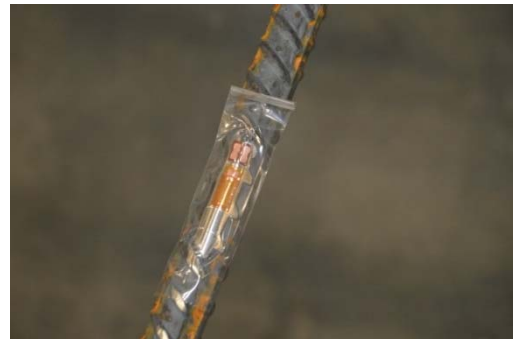
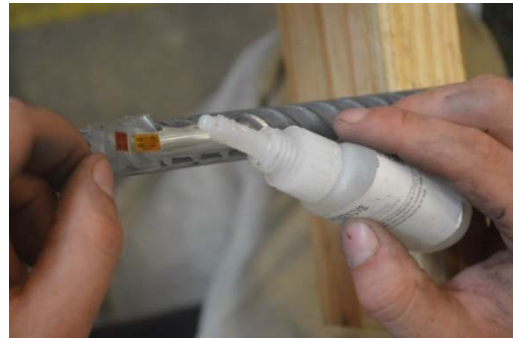
(a) Parallel Marking

(b) Perpendicular Mark

(c) Tape Strain Gage Installation

(d) Secure Placement of Strain Gage

(f) Application of M-Bond 200 Adhesive

Figure 3.73. Strain Gage Installation.

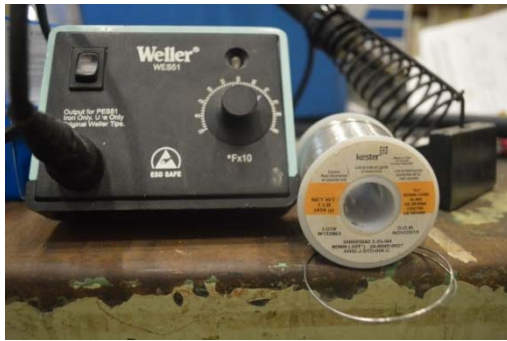
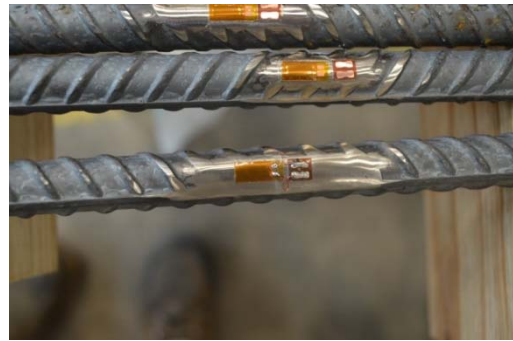
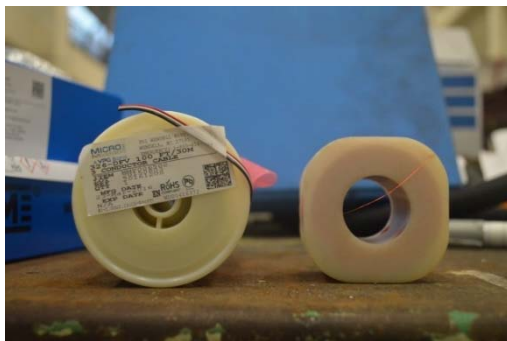
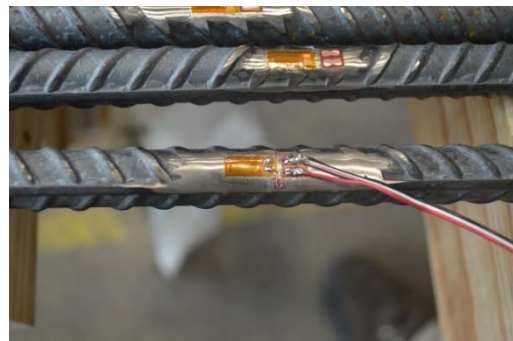
(a) Soldering Kit

(b) Soldered Ports

(c) 326-DFV and Copper Wire

(d) Soldered 326-DFV Wires

Figure 3.74. Soldering and Wiring of Strain Gages.

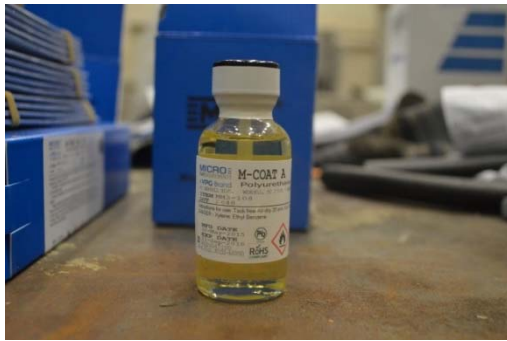
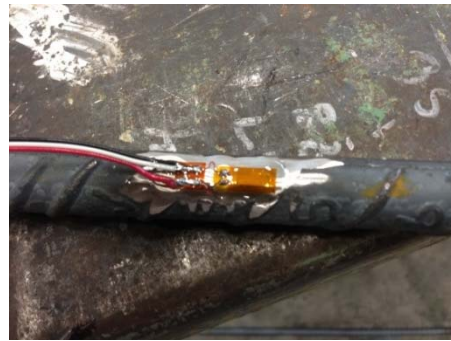
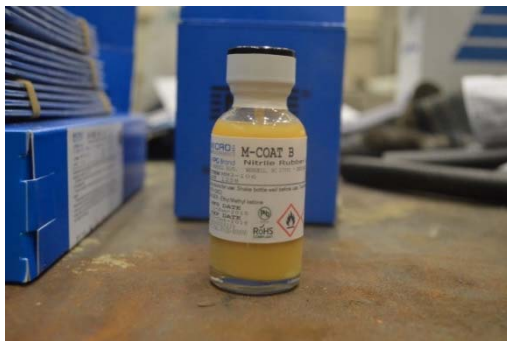
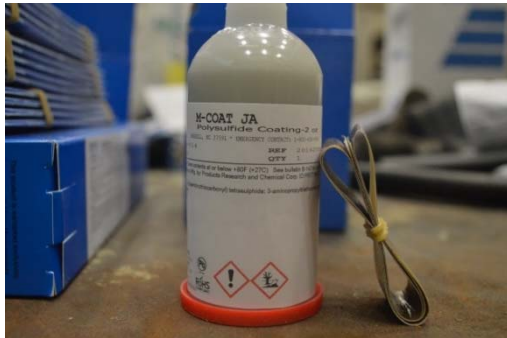
(a) *M-Coat A*

(b) *Application of M-Coat A*

(c) *M-Coat B*

(e) *M-Coat JA*

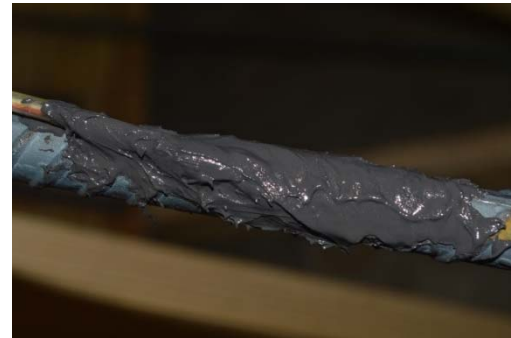
(f) *Application of M-Coat JA*

Figure 3.75. Application of Protective Coats.

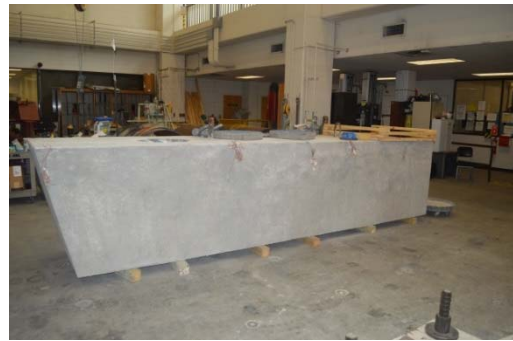
(b) After Casting Concrete

Figure 3.76. Strain Gage Wire Exit Locations.

fed to the chosen exit locations on the bent cap away from all loading points. Plastic bags were used to cover the name tags placed on each strain gage to protect from damage during concrete placement (Figure 3.76). The final step was to splice the ends of the 326-DFV wires exiting the specimen to the Belden shield twisted wire that connected to the laboratory data acquisition system.

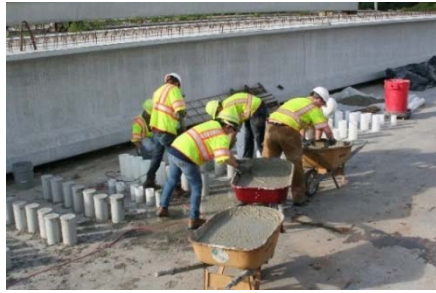
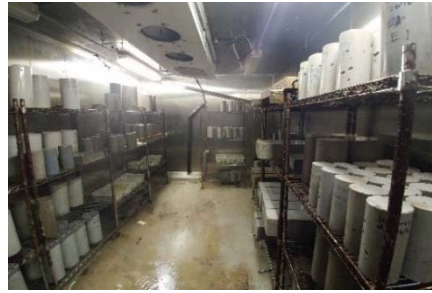
(a) Sample Collection

(b) Curing Room

Figure 3.81. Collecting and Curing Concrete Samples.

Concrete material properties tests were conducted for the slump, compression strength, modulus of elasticity, tensile strength, and modulus of rupture. Representative samples of fresh concrete were collected according to ASTM C172/C172M standards. All molded cylinders and beam specimens were collected according to the requirements of ASTM C31/C31M (Figure 3.81).

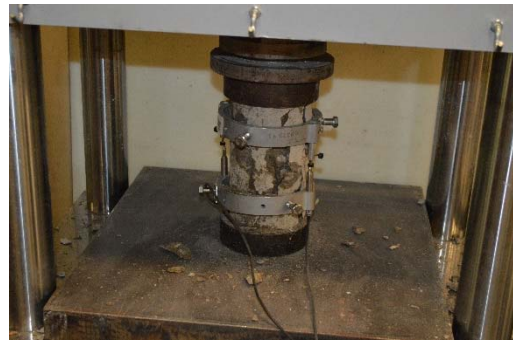
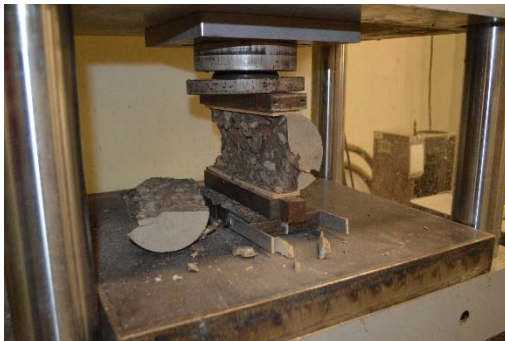
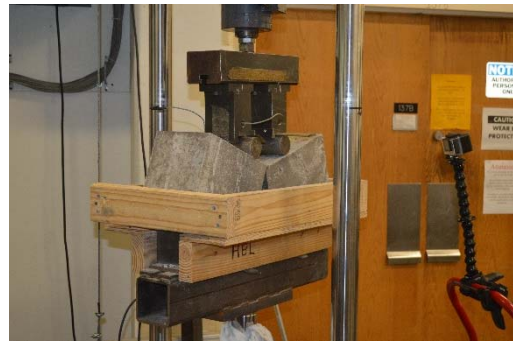
Figure 3.83. Material Properties Test Setups

(b) *Modulus of Elasticity*

(c) *Modulus of Elasticity*

(d) *Modulus of Rupture*

determined according to ASTM C78/C78M and used 6-in x 6-in x 21-in beams. Table 3.13 gives a summary of the E_c , f_{ct} and f_r tests results for all concrete deliveries. Figure 3.83 show material properties testing setups for the cylinder compression, modulus of elasticity, tensile strength, and modulus of rigidity material testing setups following their respective ASTM standard.

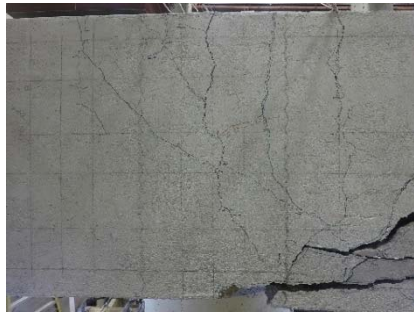
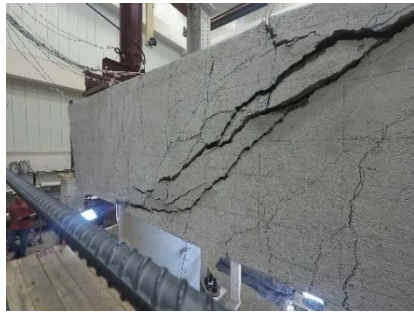
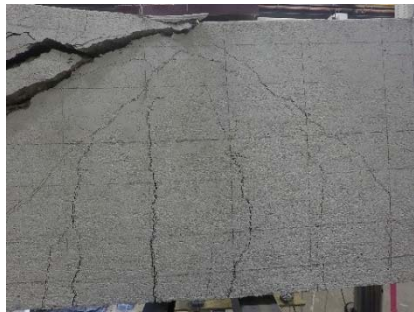
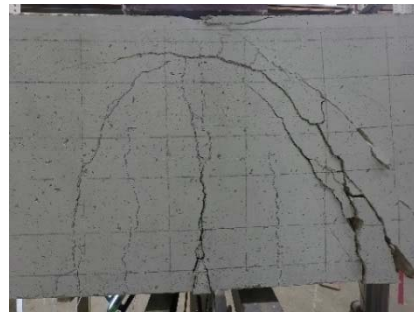
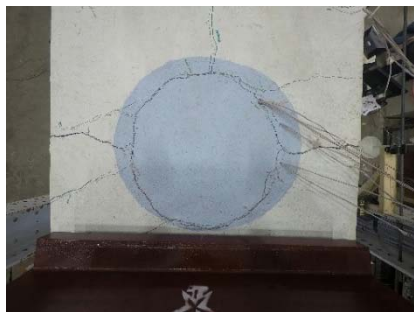
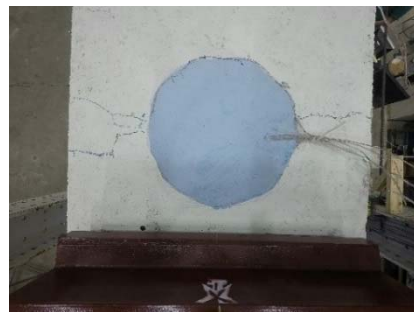
(a) Negative Moment Region

(b) Midspan

(c) Positive Moment Region

(d) Pocket Connection

Figure 4.3. Visual Observations at Failure; Blue paint extends beyond edge of pocket in RCS-16-12. (Left: RCS-16-12, Right: PSS-16-12)

During the experimental testing, it was possible to closely observe the specimens for the appearance of cracks. All longitudinal and transverse reinforcement and the corrugated pipe were drawn in pencil on the front face of each specimen. Cracks at each load pattern were marked in different colors to create a better perspective of their formation. Figure 4.3 shows the extent of cracking and damage seen at the failure load patterns on the front face and top of the pocket connection for the reinforced concrete specimen, RCS-16-12, and the pretensioned specimen, PSS-16-12. A description of the damage progression for each load pattern is presented in the following sections.

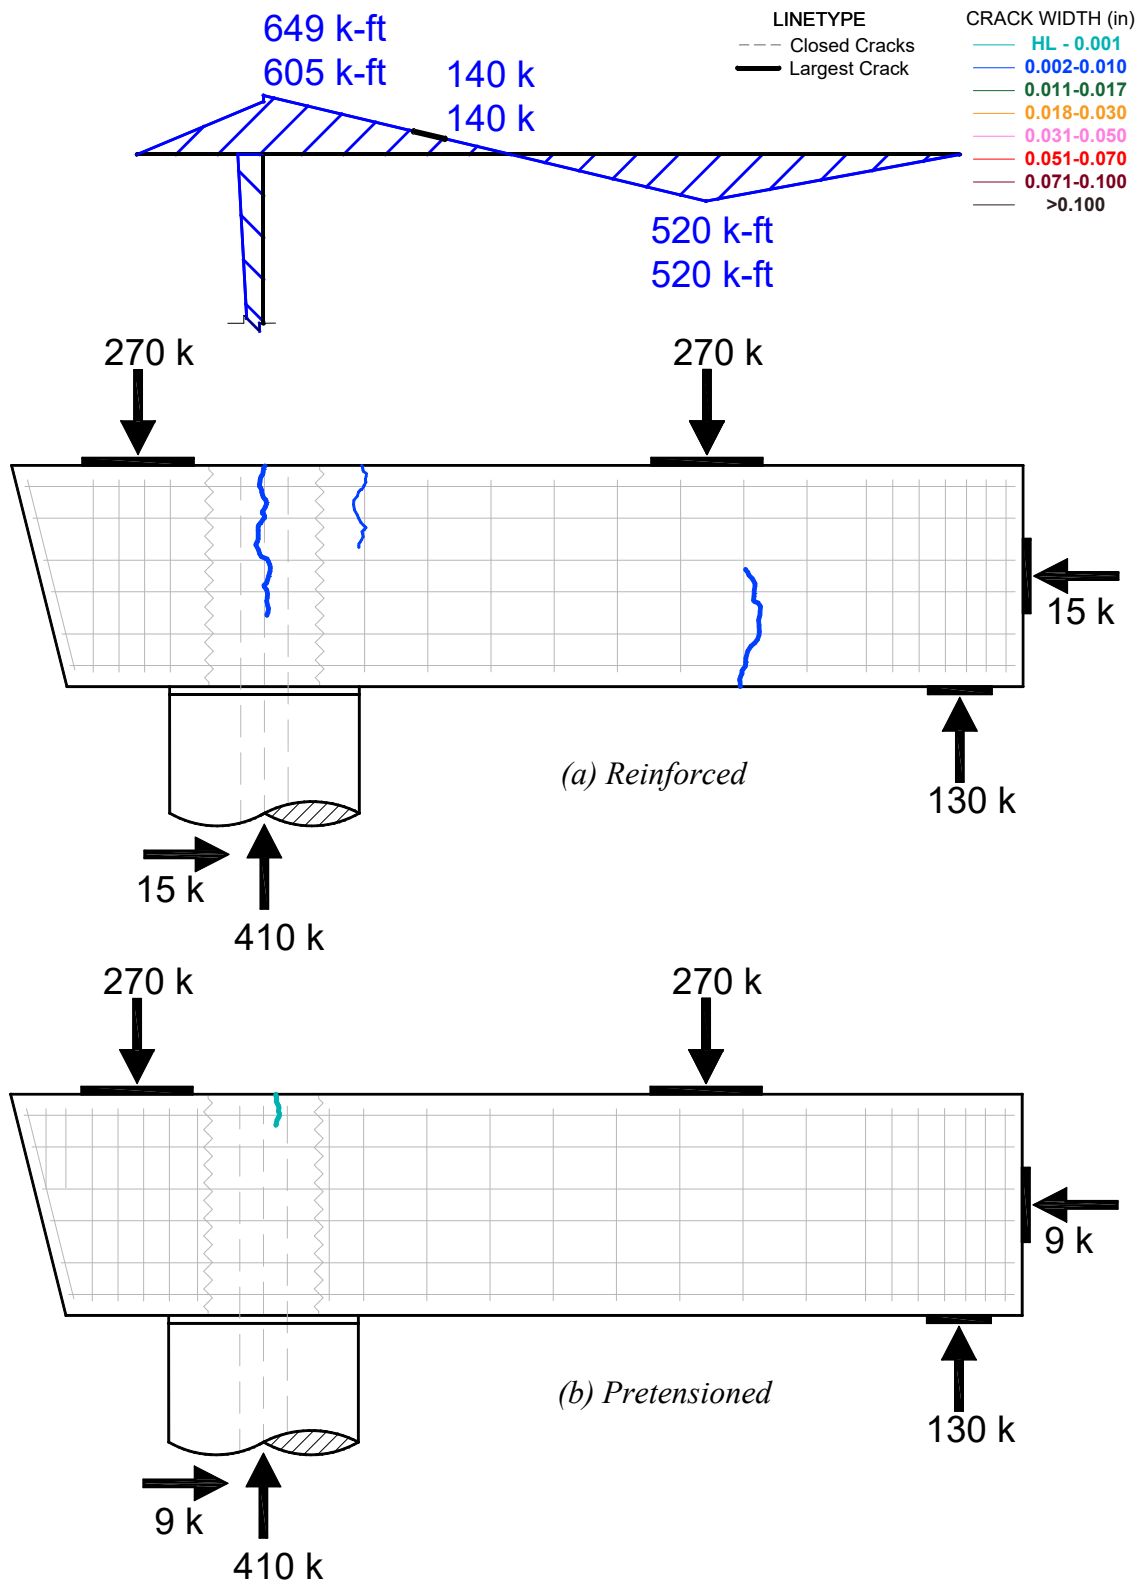
Figure 4.6. Crack Patterns – SLS Demands.

Figure 4.6 shows the demands and cracks at the SLS demands. SLS demands were all significantly below the expected yielding and nominal strengths for both specimens and all cracks were below the 0.017-in AASHTO crack width limit for Class 1 exposure. In RCS-16-12, the initial crack that appeared during 74% SLS demands in the negative moment region increased to approximately 0.008-in, and additional cracks appeared in both the positive and negative moment regions; all within the range of 0.002-in to 0.010-in. PSS-16-12 developed a single hairline crack above the center of the column.

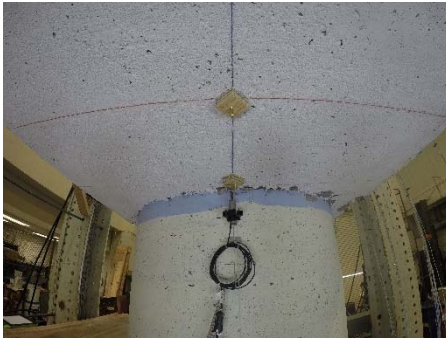
Figure 4.14. Crushing at Interior Face of Column – RCS-16-12.

RCS-16-12 experienced an increase from two to seven main cracks in the negative moment region. Cracks were very dispersed and extended along the entire front face of the bent cap. Crack widths also increased with two cracks measuring 0.198-in and four others measuring 0.157-in, 0.118-in, 0.177-in and 0.098-in. Shear cracks were present in both the overhang and span extending from both P1 and P2 to the interior face of the column. Crushing initiated at the bottom of the bent cap above the interior face of the column (Figure 4.14). Cracks in the positive moment region were not measured for RCS-16-12.

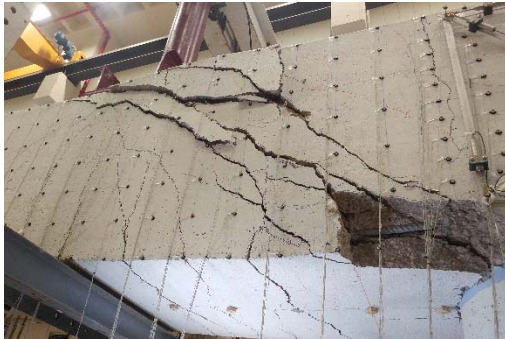
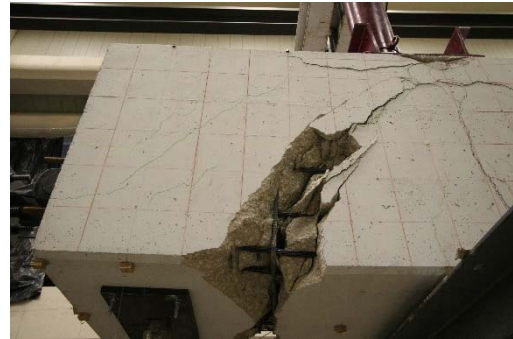
(a) RCS-16-12

(b) PSS-16-12

Figure 4.17. Failure Planes (Back Face).

RCS-16-12 developed significant damage along the span during Pattern B and Pattern E, and the failure of this specimen developed as a continuation from this previously seen damage. The actuators were set to the configuration of Pattern F discussed in Section 4.1. A compression strut formed along the span when the actuators were near their maximum capacity. The compression strut failure developed between the interior face of the column and actuator P2 at an angle of approximately 40°. Crushing of concrete under actuator P2 and above the inside face of the column was observed, and exposure of longitudinal and shear reinforcement was seen along the failure plane (Figure 4.17.a).

PSS-16-12 developed failure between actuators P2 and V. The location of failure for PSS-16-12 was damage not seen during any previous load patterns. A compression strut developed between actuators P2 and V with cracks first appearing during the initial stages of Pattern F. The failure of PSS-16-12 took place when all actuator loads were to their maximum capacity. Exposure of prestressing strands and shear reinforcement was observed along the failure plane and crushing developed at the top of the specimen near the load area of P2 (Figure 4.17.b).
