**VERIFICATION OF HANDHELD ULTRASONIC TOMOGRAPHY
FOR INTEGRATION INTO A BRIDGE MAINTENANCE DEVICE**

A Thesis

Major Subject: Civil Engineering

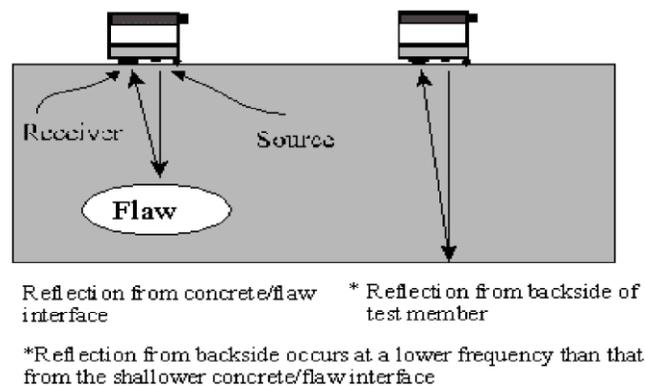
Impact-echo is useful for detecting delamination in concrete. With this technique stress waves are generated by striking the bridge deck surface. The response waves are recorded with contact or air-coupled sensors near the site of impact. From this test, the frequency and the depth of reflection can be determined. This depth could be the possible location of a change in material, which can be the source of delamination in a bridge deck. Delamination causes the steel and concrete to separate, causing air-voids. Once the location of the delamination is determined, there are various ways to determine the severity of the delamination and how it will affect the overall health of the structure. One way to analyze the condition of the delamination is by observing the frequency pattern. A delaminated point will shift the frequency to higher amplitudes because the reflections occur at more shallow depths (Cheng and Sansalone, 1995). Figure 2.1 shows a simple schematic of the impact-echo procedure.

Figure 2.1: Schematic of Impact-Echo Method (Tinkey et al., 2003)

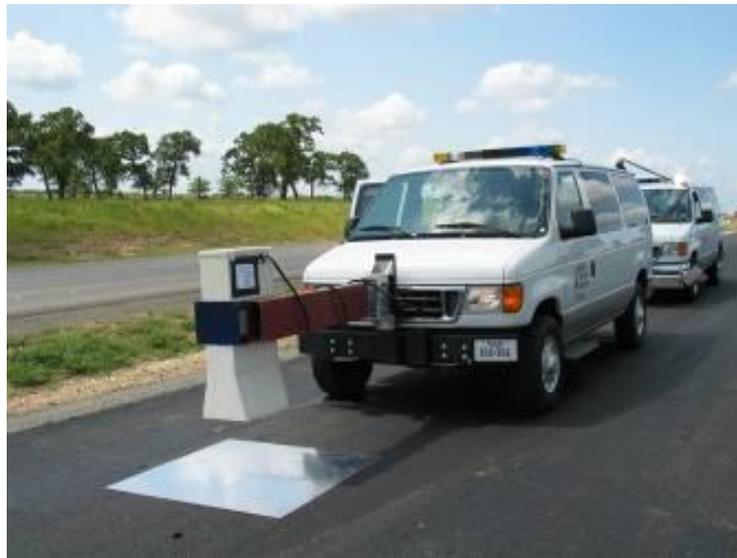
Figure 2.2 shows a picture of an air-coupled GPR system. The setup consists of a radar antenna attached with a fiberglass arm to the front of a moving vehicle. The antenna, which is directed to the ground, emits a high frequency electromagnetic wave and then captures the reflection in real-time. It is critical that the antenna be composed of fiberglass so it does not interfere with the emitted signal.

Figure 2.2: Air-Coupled GPR System (Wimsatt et al., 2008)

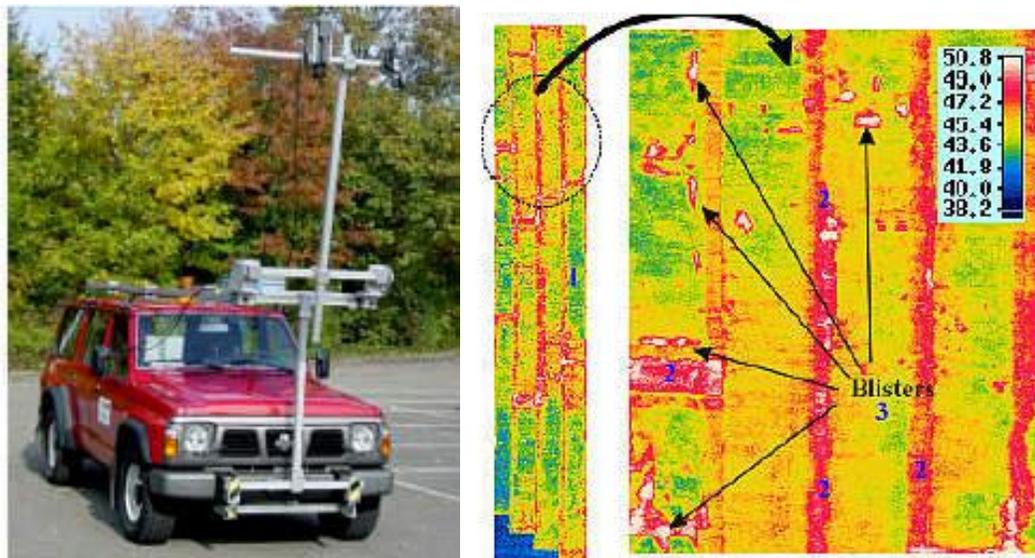
Though the infrared camera can detect where a delamination or void is present in reference to the surface, it cannot detect the depth location of the flaw (Gucunski et al., 2013). This technique is also affected by surface anomalies and boundary conditions. Figure 2.3 shows a typical mobile infrared thermography setup as well as a thermal map.

Figure 2.3: Mobile IR Measuring Equipment (Left) and Typical Thermal Map (Right)
(Stimolo, 2003)

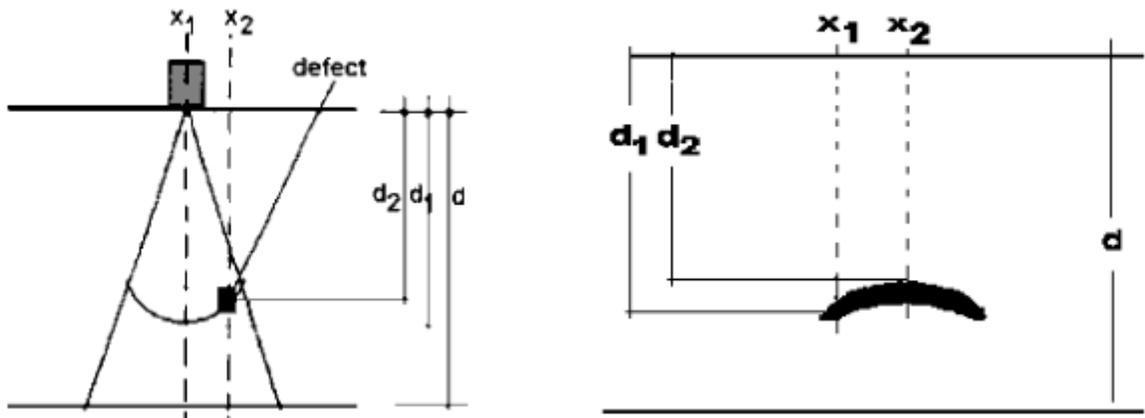
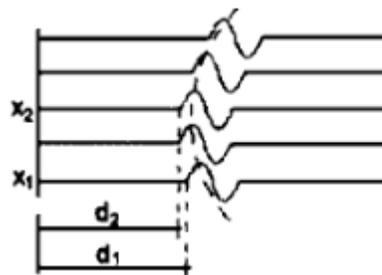
assists in the layering of the A and B scan. The aperture width of the transducer corresponds to the width of the cone and at what range it can be applied. The path length that the signal must travel corresponds to the phase shift seen in the signal. From these geometric properties, an engineer can construct images that simplify the detection of defects below the concrete surface (Kotoky and Shekar, 2013). This geometric interpretation can be seen in Figure 2.5.

(a) Display of the waves passing through the Defect Zone

(b) B- Scan of the Iron Defect

(c) Resulting Image Produced from the Waves Passing Through the Defect in 2.5(a).

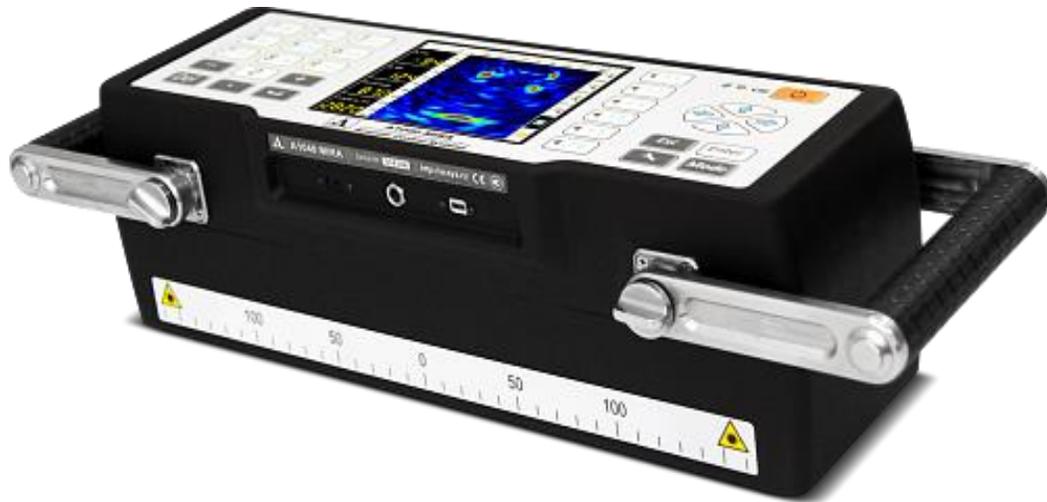
A1040 MIRA (MIRA) is an ultrasonic tomographic device developed by Acoustic Control Systems used to image the internal configuration of a concrete structure with access to only one side. This device can detect defects such as honeycombing, cracks, holes, and delamination. This is possible because MIRA produces high quality, informative images for engineers to assess quality of construction and detect critical flaws in structures. It uses dry contact, 50 kHz transducers, which eliminate the need for contact gels to maintain a clean surface. MIRA consists of a linear array of 48 transducers in a configuration of 4 by 12. MIRA emits shear waves and receives the reflected signal by various transducer pairs which allows for various incident angles. These varying incident angles are critical to analysis of non-homogeneous materials (Hoegh 2013). The transducers are equipped with wear resistant tips that minimize damage and allow MIRA to be used on rough surfaces (Acoustic Control Systems, 2015). MIRA can be seen in Figure 2.6.

Figure 2.6: A1040 MIRA Ultrasonic Tomographic Device (Acoustic Control Systems, 2015)

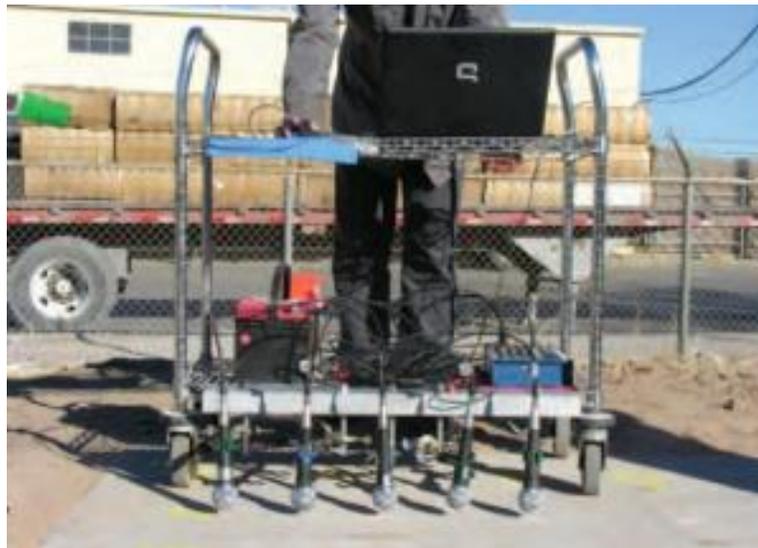
Strengths of this device include the automated data collection and processing systems in addition to ease of use. The weaknesses include collection time, which is a significant improvement in comparison to commercial products, but would still require construction to be halted or a completed structure to be closed. Figure 2.8 shows the configuration of the device.

Figure 2.8: Impact-Echo Device University of Illinois Urbana-Champaign (Gucunski et al., 2013)

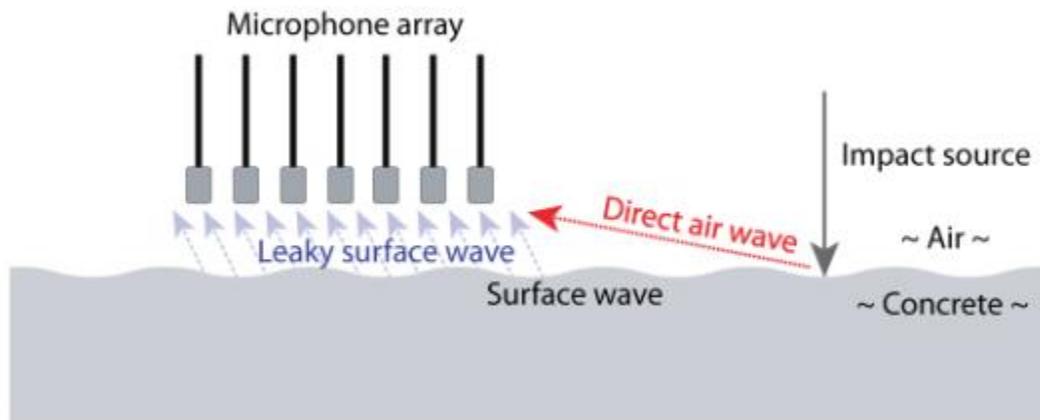
This very applicable for pavement testing and integrity, but may not be the best application for concrete bridge decks, since it doesn't directly acquire data for the desired characteristics. Another significant drawback is that the machine needs to be manually pushed at a slow rate in order to receive data properly, which is not feasible for high speed demands. Figure 2.9 from Ryden et al. (2008), depicts how the microphones receive the surface waves.

Figure 2.9: Description of Non- Contact Wave Testing (Ryden et al., 2008)

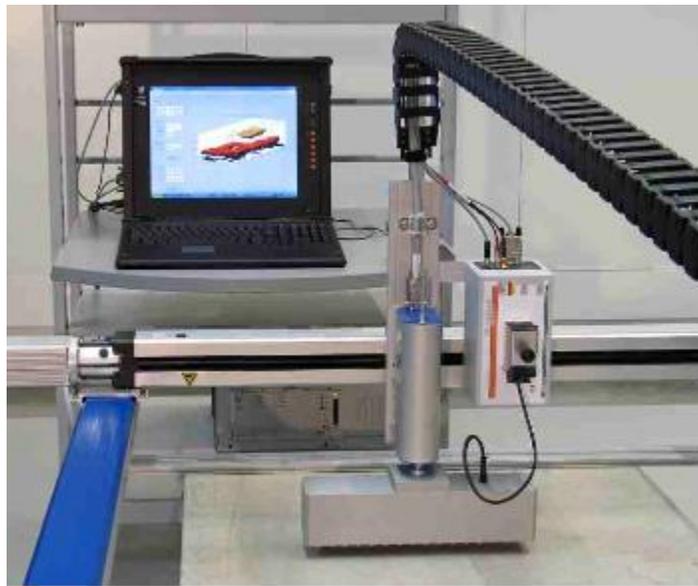
choose between SAFT to either produce high quality images or reduce scanning time to approximately 1 minute per a square foot (Schickert, 2015). Though this increases speed, it still takes a substantial amount of time to scan an entire concrete bridge deck. Additionally, FLEXUS is primarily used for walls and other vertical structures; a horizontal scanning system is desired for this project. Figure 2.10 displays the FLEXUS configuration.

Figure 2.10: FLEXUS Multipoint Scanner (Hillger et al., 2014)

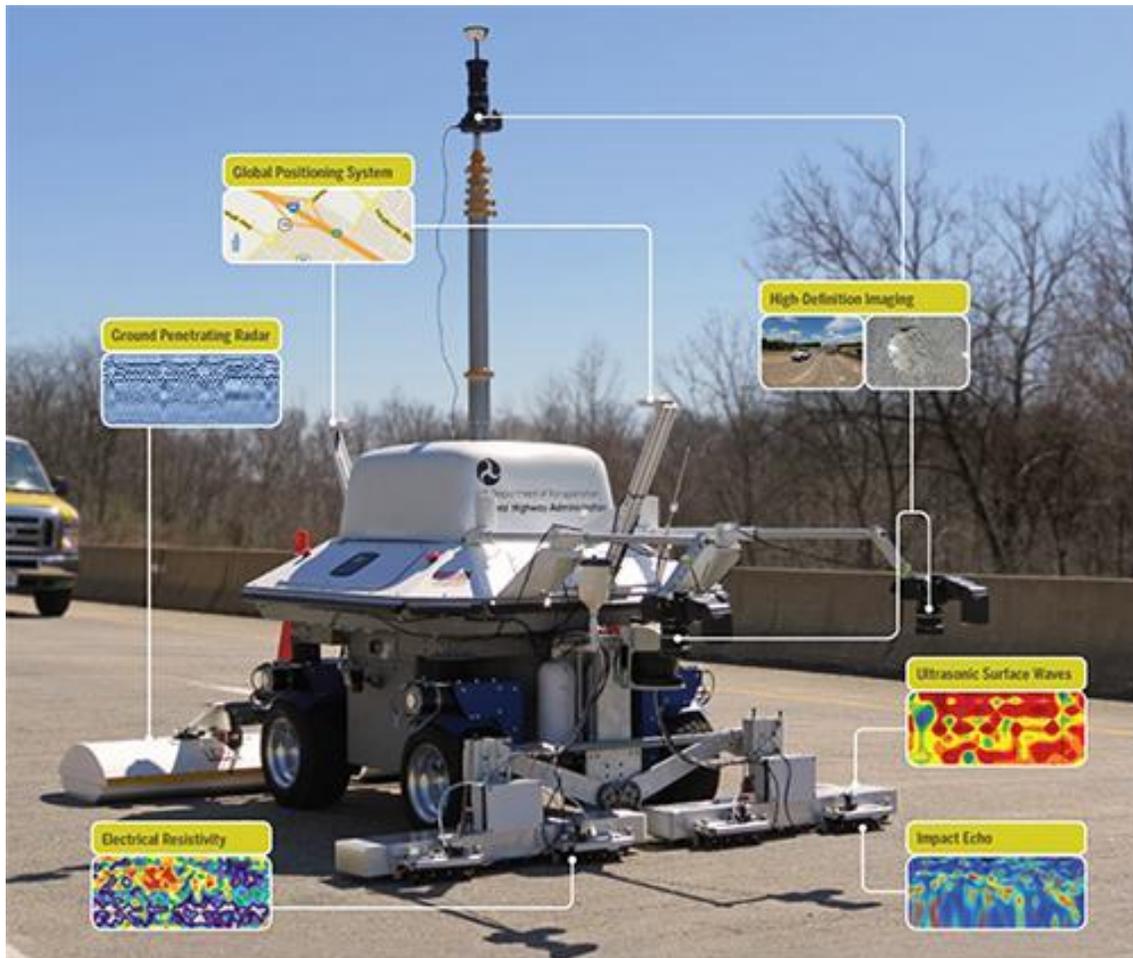
Transportation, 2014). It is a fully automated device, but with a large variety of NDT technology it requires a complex understanding to determine the best approach for various structures. Figure 2.11 depicts the RABIT configuration and shows all non-destructive technologies.

Figure 2.11: Image of RABIT (Center for Advanced Infrastructure and Transportation, 2014)

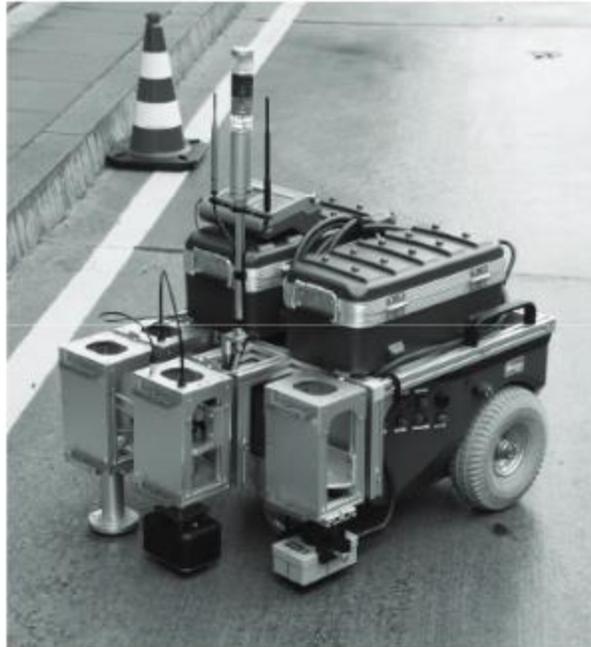
Figure 2.12: BetoScan Automated Robot (Reichling et al., 2009)

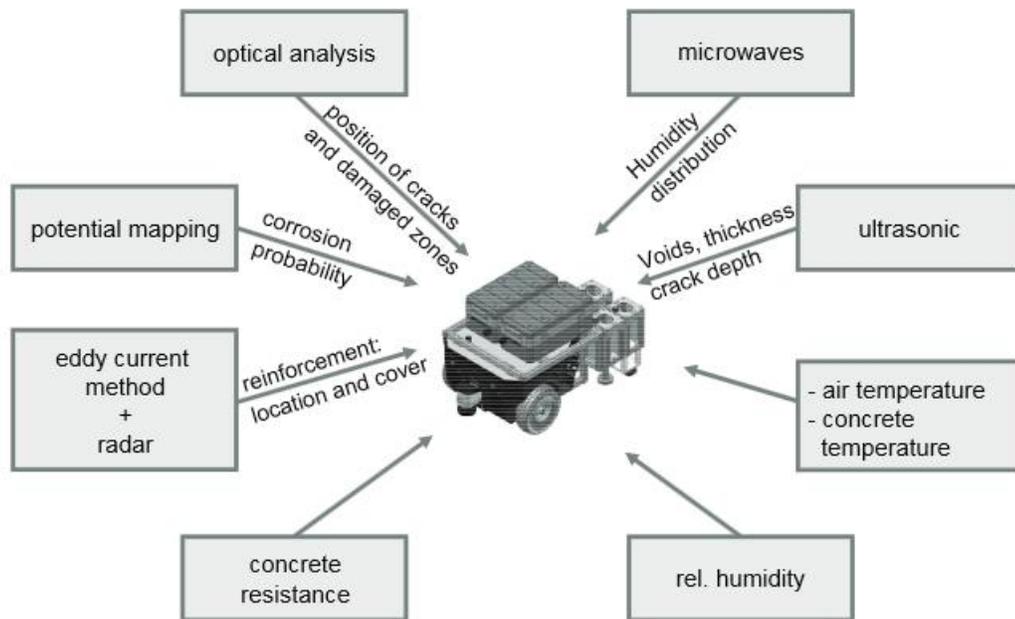
Figure 2.13: BetoScan Capabilities (Reichling et al., 2009)

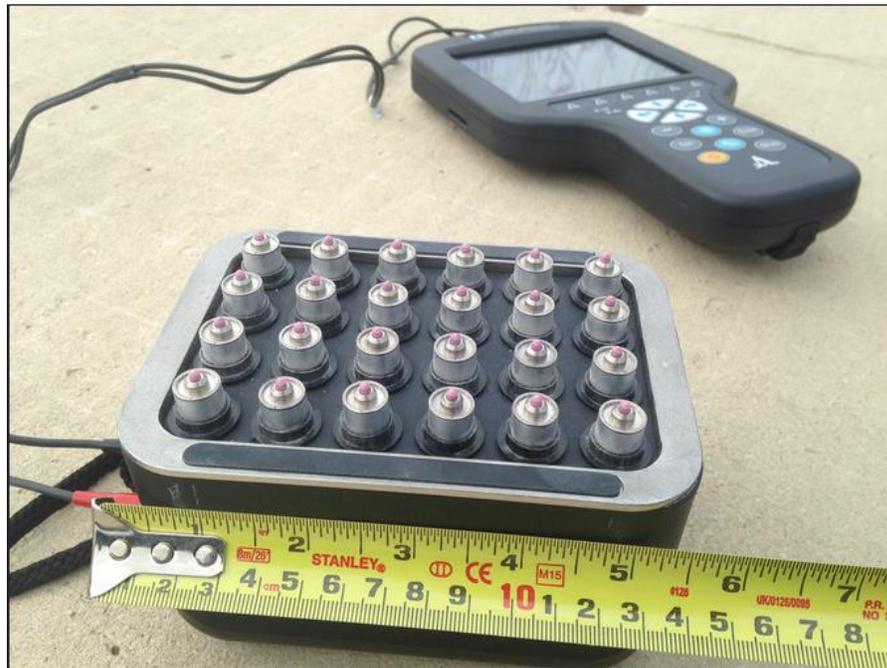
EYECON, also known as the A1120 Monolith, is a handheld ultrasonic tomography device. Like MIRA, EYECON is a portable device that can successfully determine concrete thickness, delamination, voids, honeycombing, and bond quality using the ultrasonic pitch-catch method in the time domain. Figure 2.14 shows the EYECON device and its included transducer array.

Figure 2.14: Transducer Array (Foreground) with EYECON Handheld Computer (Background)

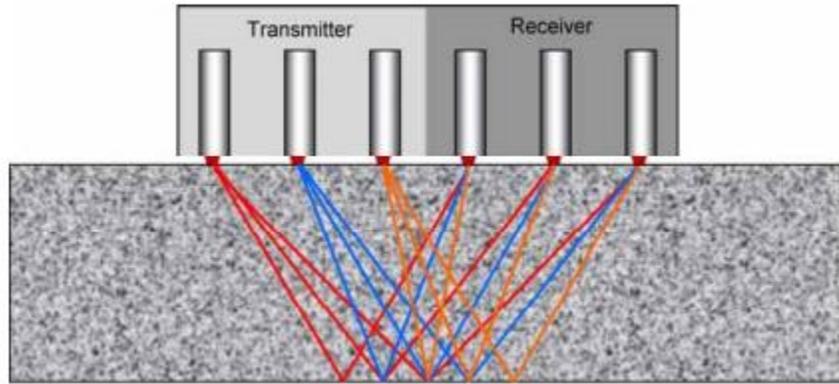
shear wave at 50 kHz, while the remaining 12, on the right, receive the reflected waves. A more detailed image depicting the signal emission and receiving process can be seen in Figure 2.15.

Figure 2.15: Transmitting and Receiving Configuration of EYECON (Germann Instruments, 2015)

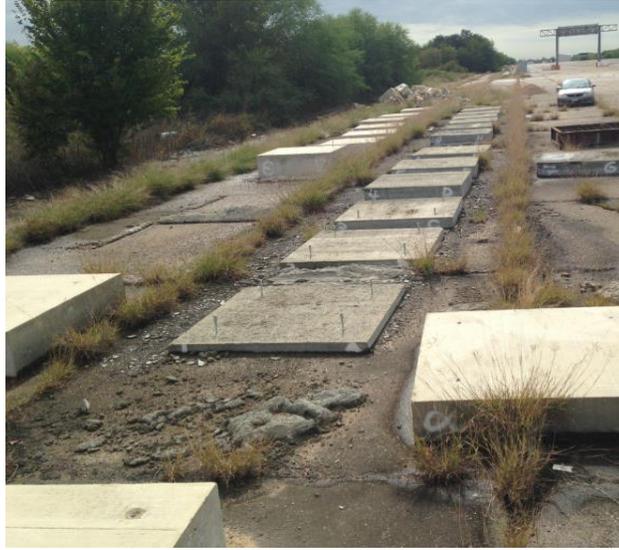
**Figure 3.1: Concrete and Shotcrete Specimens at Texas A&M University RELLIS
Campus, Bryan, TX**

A total of eleven concrete slabs with varying depth, reinforcement details, and known defects were available for conducting the experimental program. During construction of the slabs, a defect key was created that documented the exact location of the simulated defects within each slab. All slabs are nominally 1.83 m by 1.83 m (6 ft by 6 ft) in length and width, but vary in depth. Table 3.1 summarizes the slab depth, reinforcement details, defects, and the location of the defects located within each slab. Test results were compared to this documented defect key for validation. All slabs containing rebar have two mats of No. 5 rebar at depth, d , from the top and bottom of the slab, and at 203 mm (8.0 in.) o.c. All depths of the defects are from the top of the slab. Figure 3.1 summarizes the slabs used for testing.

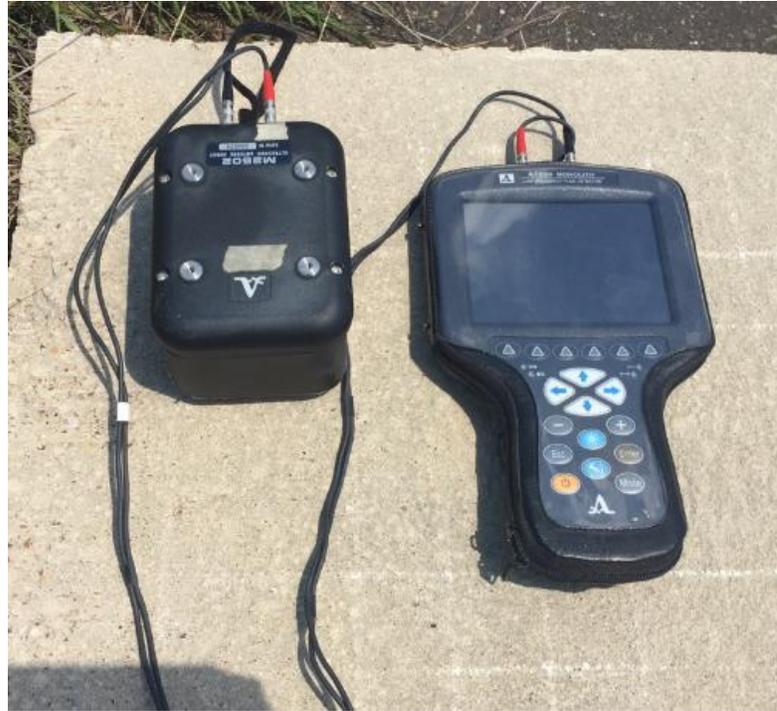
Figure 3.2 displays the experimental setup of the handheld ultrasonic device. The influence of the orientation of the device on the detection of flaws is also investigated for reliability purposes. Each slab was scanned with the transducer array in the vertical and horizontal orientations. The scans in the two orientations were recorded starting from the same origin, without any changes in the device settings. Figure 3.3 depicts where the origin of the grid is located, as well as the orientation of all slab images.

Figure 3.2: Experimental Setup

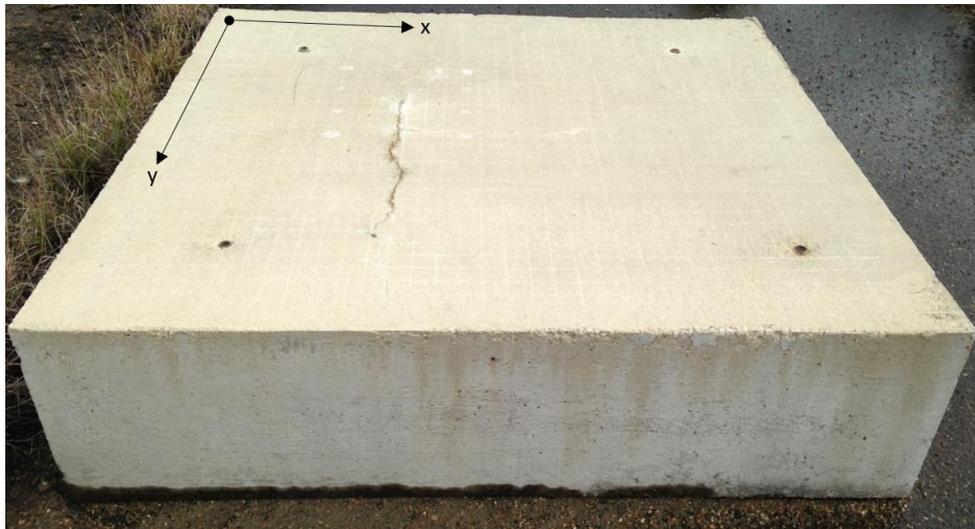
Figure 3.3: Origin of the Grid

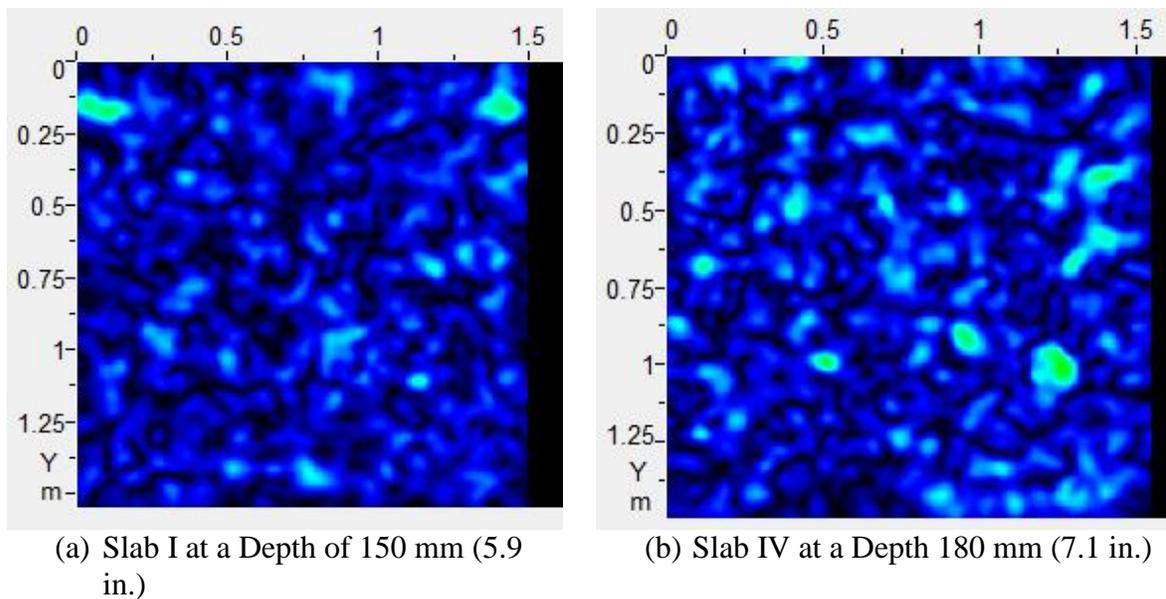
Scans from the vertical orientation and horizontal orientation of the device were also compared to each other. Irrespective of the orientation of the device, similar results were obtained in terms of the overall depth, and the absence of defects and reinforcement in the slab. The location of the lighter blue tones are similar, although not completely identical. There are no notable variations in contrast of the C-scans to indicate the possibility of defects within the slabs. From both transducer orientations, it is evident that the slab is clear of significant imperfections and both scans produce similar information. Additional C-scans at various depths of Slab I and IV can be found in Appendix A.

Figure 3.4: C-Scans of Plain Slabs

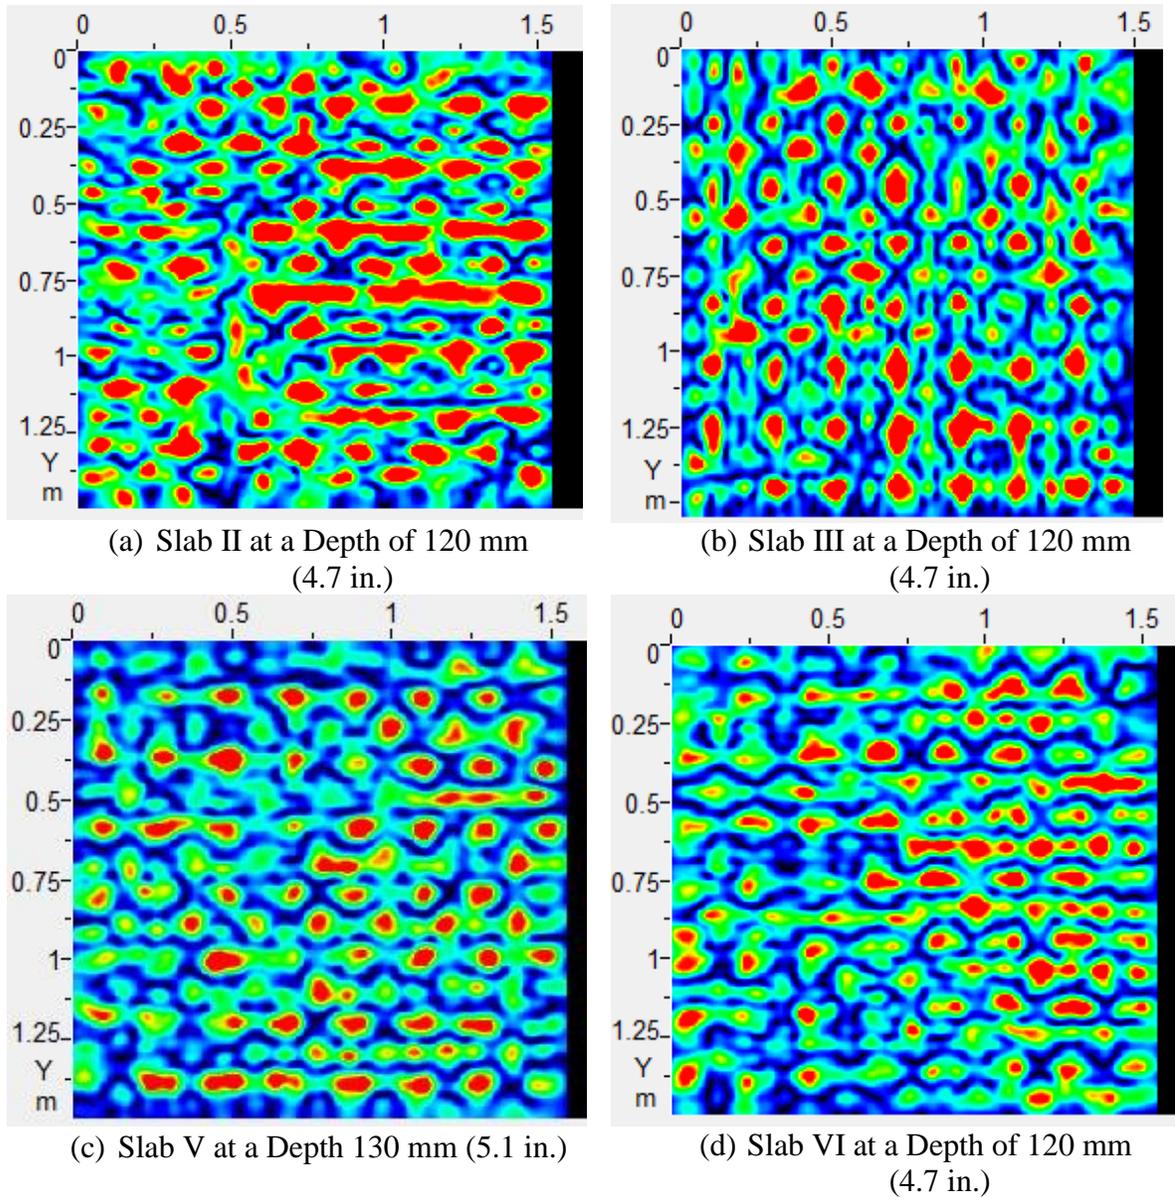
A review of the C-Scan images of the slabs does not reveal any features before a depth of 100 mm (3.9 in.). A grid develops at an approximate depth of 100 mm (3.9 in.) with the contrast becoming most apparent at depths of 120 mm (4.7 in.) and 130 mm (5.1 in.). Figure 3.5 shows the C-scans of all the reinforced slabs at a depth of 120 mm (4.7 in.) or 130 mm (5.1 in.). From these images, it is evident that the grid shape corresponds to the first layer of reinforcement. The image visualization program reads only to the nearest centimeter and the images shown in Figure 3.5 have the greatest contrast area between depths of 120 mm (4.7 in.) and 130 mm (5.1 in.). This corresponds to the actual depth of the rebar at 127 mm (5.0 in.) from the surface of the slab. The diameter of a No. 5 bar is 16 mm (0.63 in.), and at locations where the horizontal and vertical rebar overlap the overall diameter is 32 mm (1.3 in.). The images reflect the first indication of the rebar at a depth of 100 mm (3.9 in.), which is within 11 mm (0.43 in.) of the actual edge of the first layer of rebar at a depth of 111 mm (4.7 in.). A depth of 111 mm (4.7 in.) is where the layer should start to emerge at points where the horizontal and vertical rebar overlap. This difference is off by 2.4% of the total depth of the slab, which is well within the manufacturer's tolerance of 10% of the total depth of the specimen.

Figure 3.5: C-Scans of Reinforced Slabs without Defects

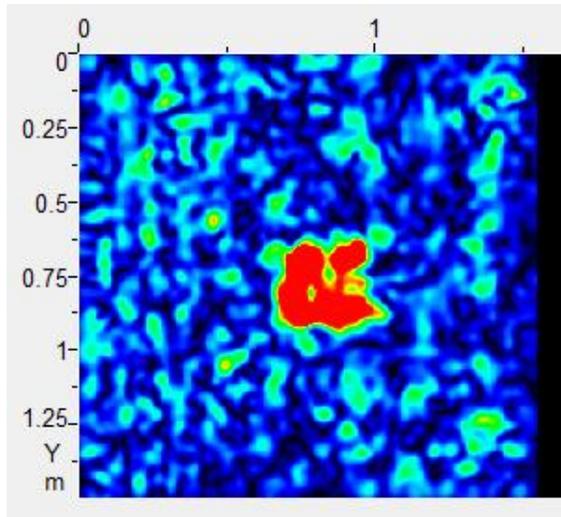
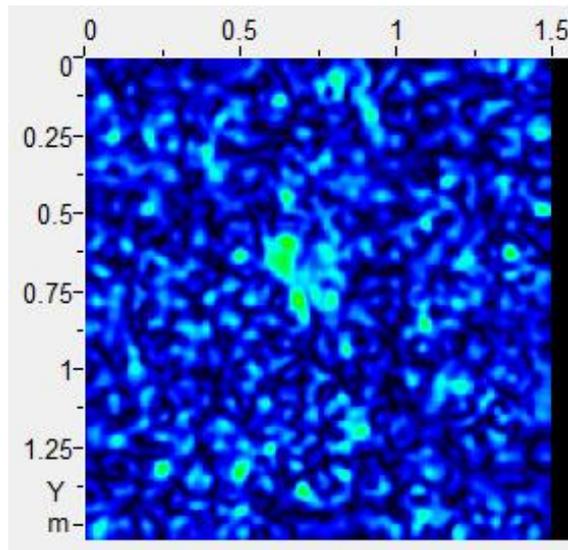
Similar to Slab VII, a square defect starts to emerge in Slab VIII at a depth of approximately 80 mm (3.2 in.) with it becoming more apparent at a depth of 90 mm (3.5 in.), as displayed in Figure 3.6(b). The first sign of the defect at a depth of 80 mm (3.2 in.), corresponds well with the actual location of the defect located at a depth of 76 mm (3.0 in.).

(a) C-Scan of Slab VII at a Depth of 80 mm (3.2 in.)

(b) C-Scan of Slab VIII at a Depth of 90 mm (3.54 in.)

(c) C-Scan of Slab IX at a Depth of 30 mm (1.2 in.)

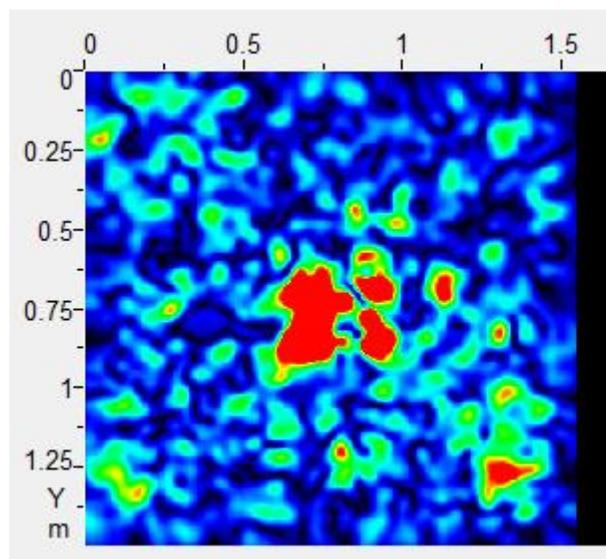
This section discusses reinforced slabs that contain air-filled voids. The overall depth of Slab X is 381 mm (15.0 in.), and it contains two layers of rebar at 127 mm (5.0 in.) and 254 mm (10.0 in.). The air-filled void is simulated using a 13 mm (0.51 in.) thick piece of foam and is located at a depth of 203 mm (8.0 in.). Slab X also has a noticeable crack on the surface of the slab, but it was not detected by the ultrasonic tomography device. Similar to the other slabs, a rebar grid emerges at a depth of approximately 100 mm (3.9 in.). The grid is most clearly visible at a depth of 130 mm (5.1 in.). This corresponds to the first layer of rebar. After the first layer of rebar, a defect starts to appear approximately in the center of the slab at a depth at 210 mm (8.3 in.). As shown in Figure 3.7, the defect becomes most apparent at a depth of 220 mm (8.7 in.).

Figure 3.7: C-Scan of Slab X at 220 mm (8.7 in.)

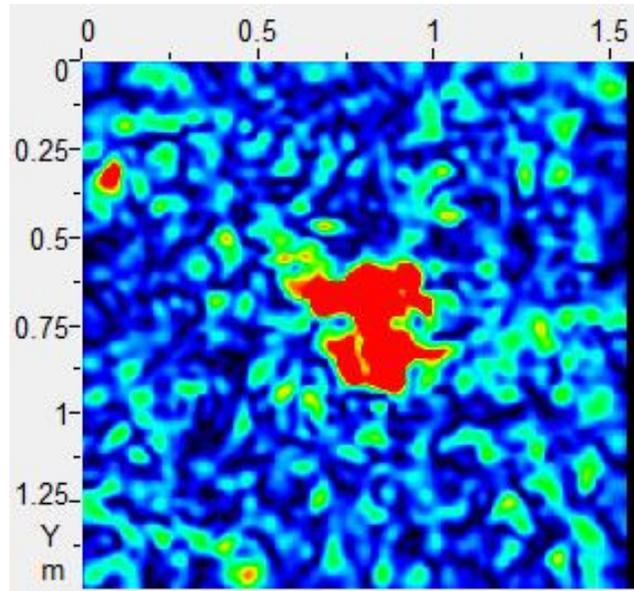
Slab XI is a reinforced concrete slab that is 381 mm (15.0 in.) thick. The slab has two layers of reinforcement at depths of 127 mm (5.0 in.) and 254 mm (10.0 in.). The water-filled void is simulated by embedding a Ziploc bag filled with water. The defect is located at a depth of 203 mm (8.0 in.) from the surface of the concrete slab. From the C-scans, it is evident that no defects are present up to a depth of 90 mm (3.5 in.). At approximately 90 mm (3.5 in.), a grid pattern emerges and is thickest at a depth of 120 mm (4.7 in.), indicating the presence of rebar. This corresponds well with the actual location of the rebar which is located at a depth of 127 mm (5.0 in.). In the C-scan images, at a depth of 200 mm (7.9 in.), a change in color begins to faintly appear in the center of the slab. However, as displayed in Figure 3.8, the contrast is highest at a depth of 210 mm (8.3 in.).

Figure 3.8: C-Scan of Slab XI at 210 mm (8.3 in.)

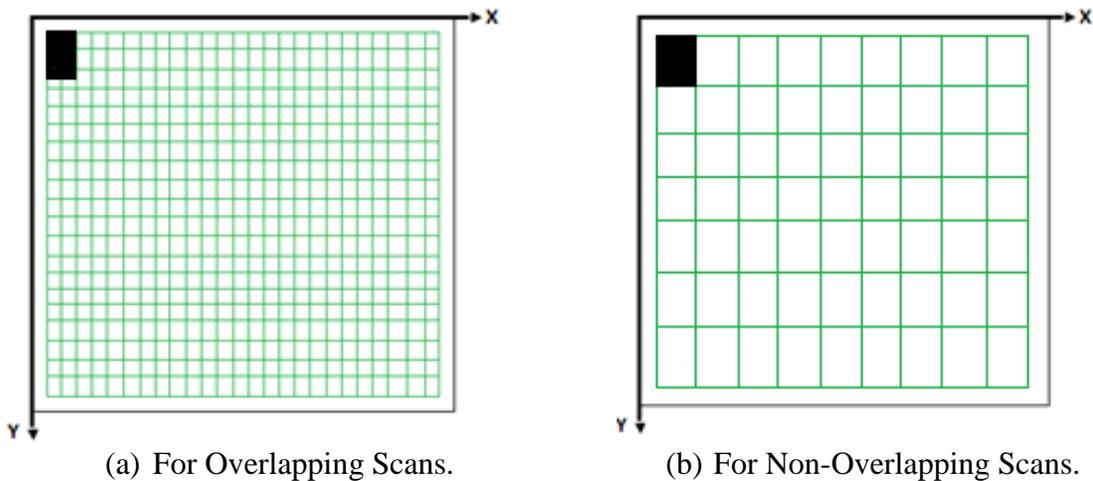
Ultrasonic tomography relies on the SAFT algorithm to construct complete 2-D or 3-D images from a compilation of individual pulse echo scans. The scans typically overlap one another in order to produce a higher resolution image. The clarity produced by using overlapping images can help when identifying defects within a concrete component. High resolution images come with a cost since more overlap requires a greater number of scans. This task aims to determine if defects can still be detected to a sufficient level of detail without the use of overlapping scans. Figure 3.9 shows the difference between the grids with overlap, and no overlap. The black rectangle represents the transducer with the vertical orientation in reference to the grid.

Figure 3.9: Grid with Overlapping vs without Overlapping Measurements

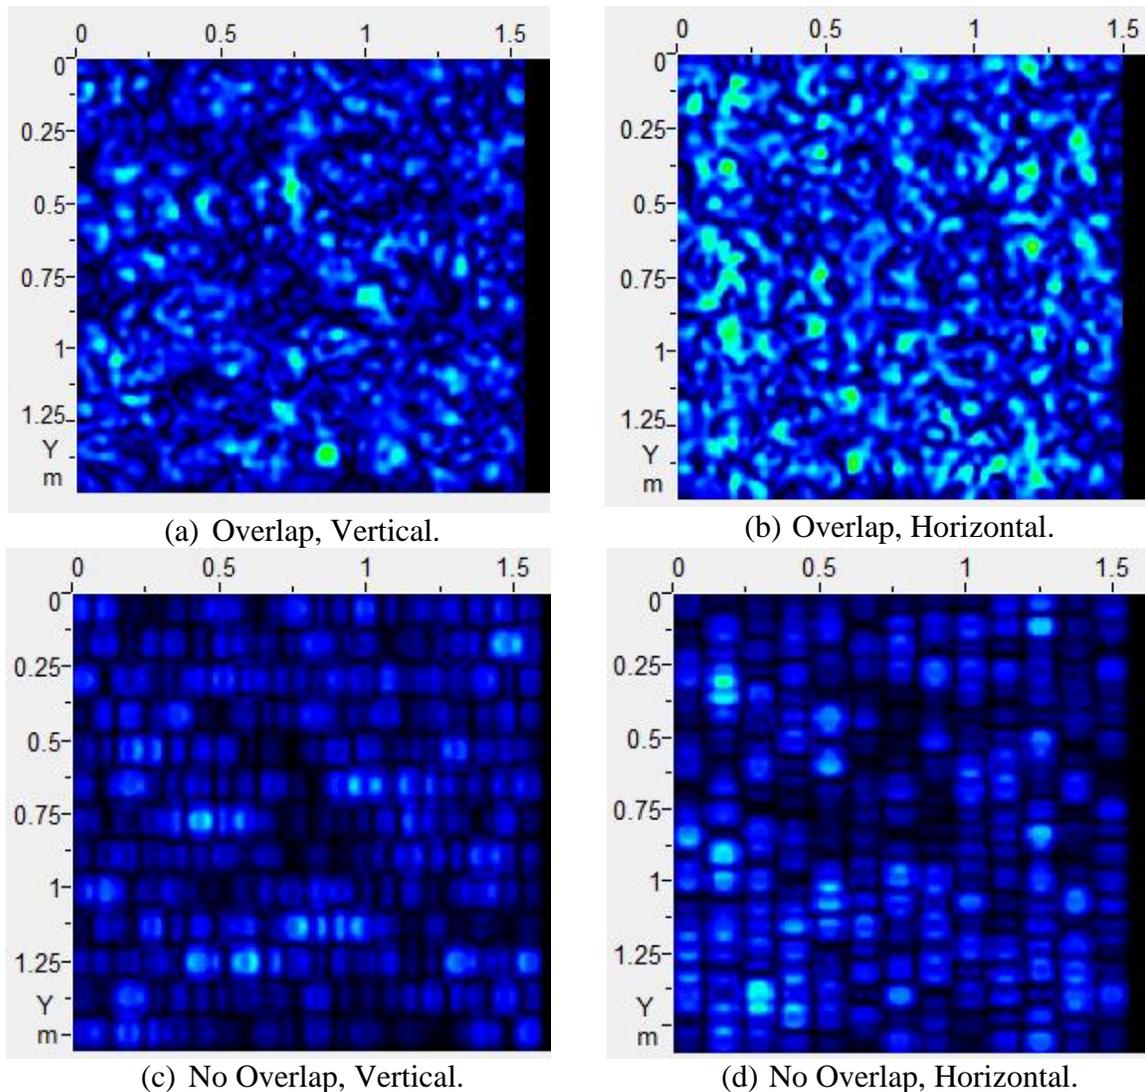
Figure 3.10 shows a comparison of the C-scans at a depth of 30 mm (1.2 in.), obtained with and without overlapping scans with the vertical and horizontal orientation of the transducer. No defects are revealed in any of the four C-scan images presented in Figure 3.10, which corresponds with the actual condition of Slab VIII. Figure 3.10(c) and (d) do not have the same resolution as the images in Figure 3.10 (a) and (b), but they are able to convey identical information to the user.

Figure 3.10: Comparison of C-Scans Obtained from Scan with and without Overlap – Slab VIII at a Depth of 30 mm

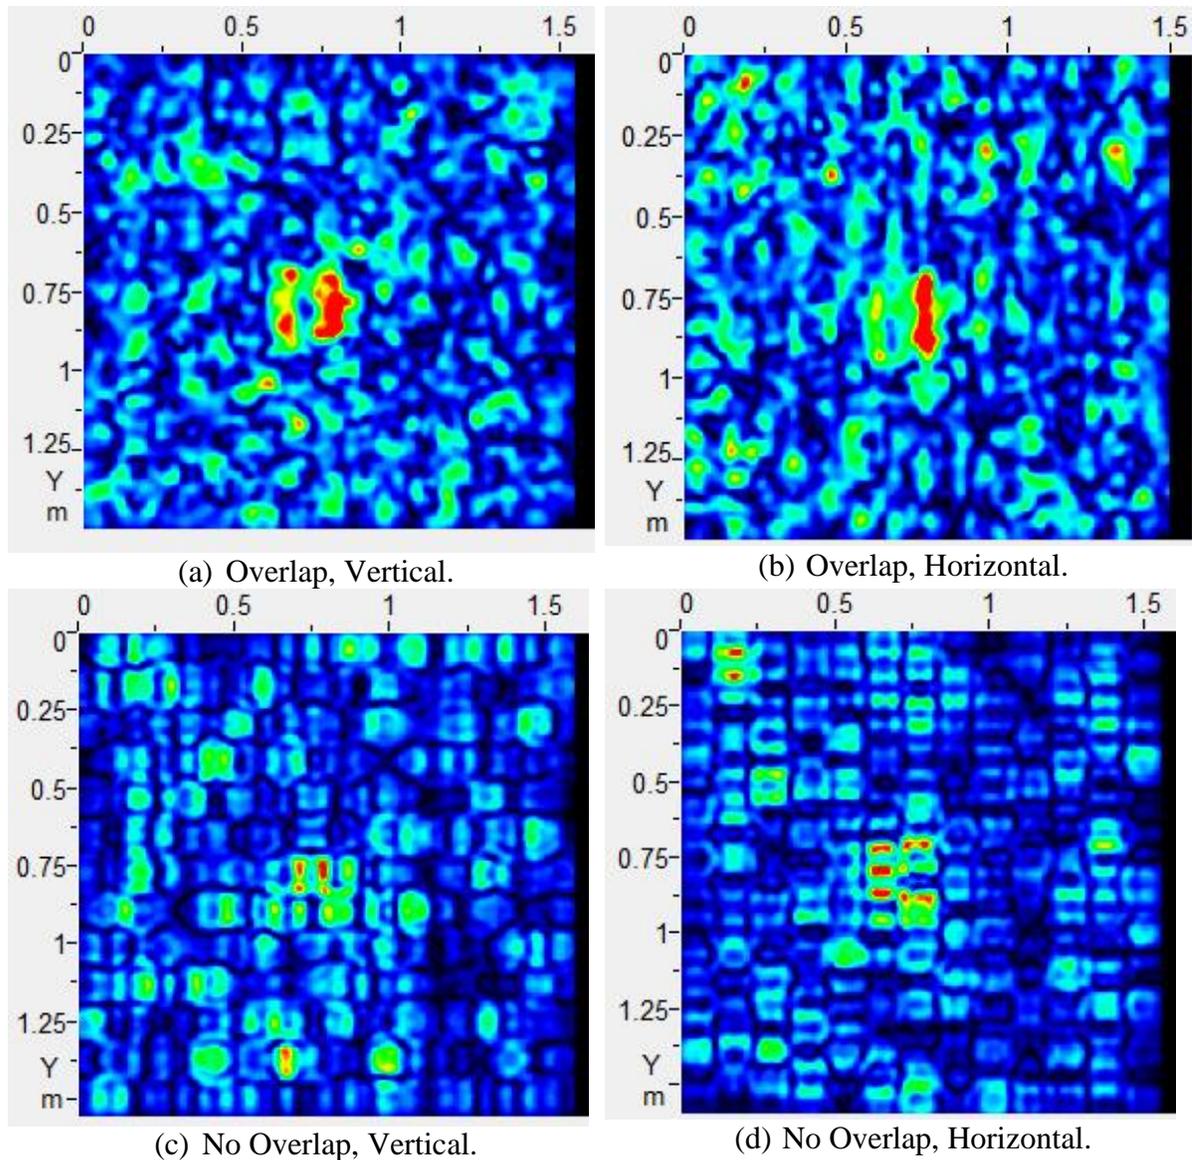
horizontal scan with no overlap, has a better clarity than Figure 3.11 (c), vertical no overlap, showing a slightly more defined square defect near the center of the slab.

Figure 3.11: Comparison of C-Scans Obtained from Scan with and without Overlap – Slab VIII at a Depth of 80 mm

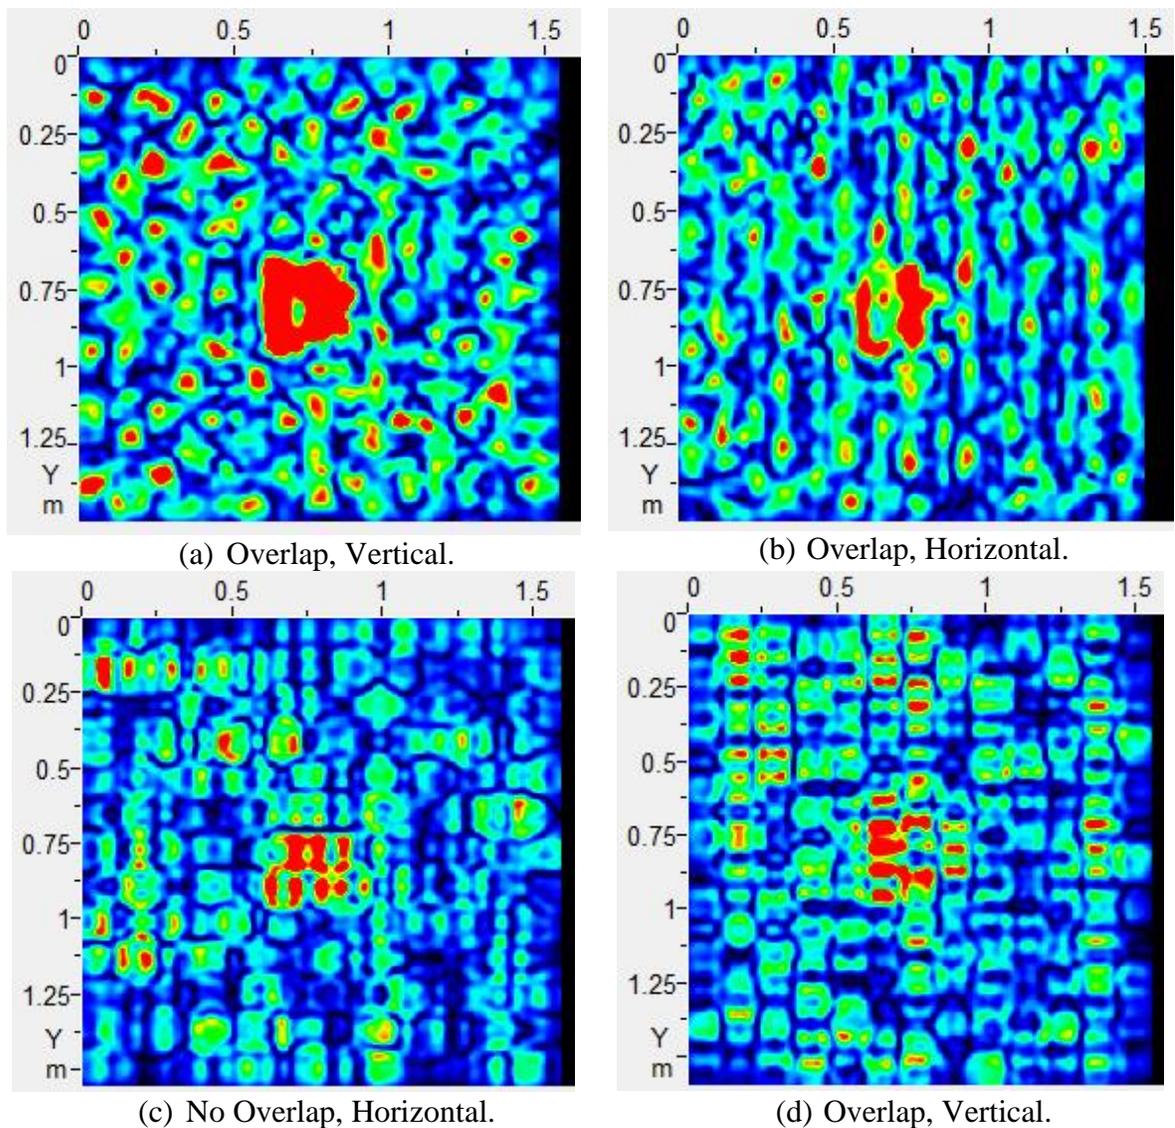
reinforcing steel grid surrounding it. With no overlapping measurements, the thin plastic defect can still be identified unmistakably near the center of the slab as shown in Figure 3.12(c) and (d), but the rebar is not as evident. It is more evident at 100 mm (3.9 in.) than at 80 mm (3.2 in.) for the scans taken with no overlapping measurements, indicating that the depth may not be as accurate but the device can still locate the defect within 10% of the total depth.

Figure 3.12: Comparison of C-Scans Obtained from Scan with and without Overlap – Slab VIII at a Depth of 100 mm

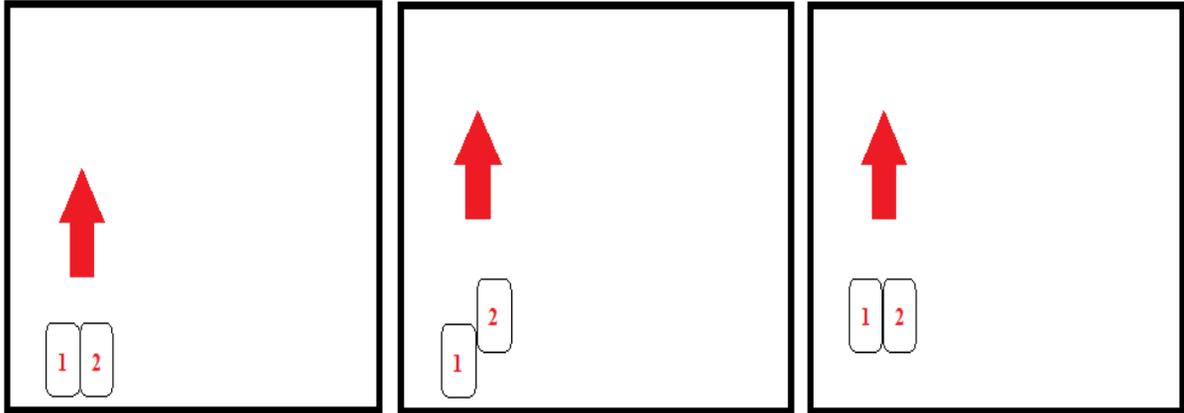
The device moves comparable to human legs. The transducers start off next to one another, transducer array 2 then moves forward the desired step size. Pressure is applied with the hydraulic system in the legs to ensure the transducer array is in proper contact with the specimen surface, capturing a single measurement in map mode. Then transducer array 1 moves up next to the first transducer array, it is then pressed down by the hydraulic system and a measurement is taken. The stepping process is described in detail in Figure 4.1. The red arrow indicates the direction of movement.

(a) Starting Position,
Transducers are
Aligned

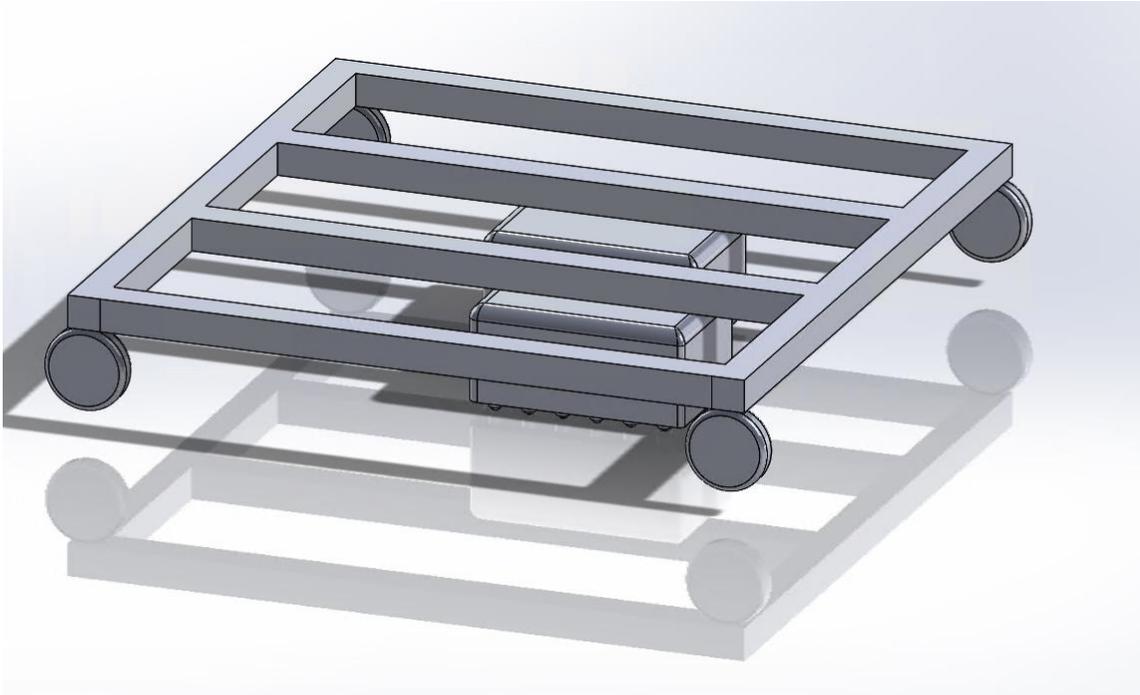
A second, more refined version of the stepping design is presented in Figures 4.2 and 4.3. This system constitutes a smaller frame with two transducers on sliding rails. This allows for measurements to be taken in a similar manner as the first stepping design, but also provides more freedoms.

Figure 4.2: Sliding Rail System

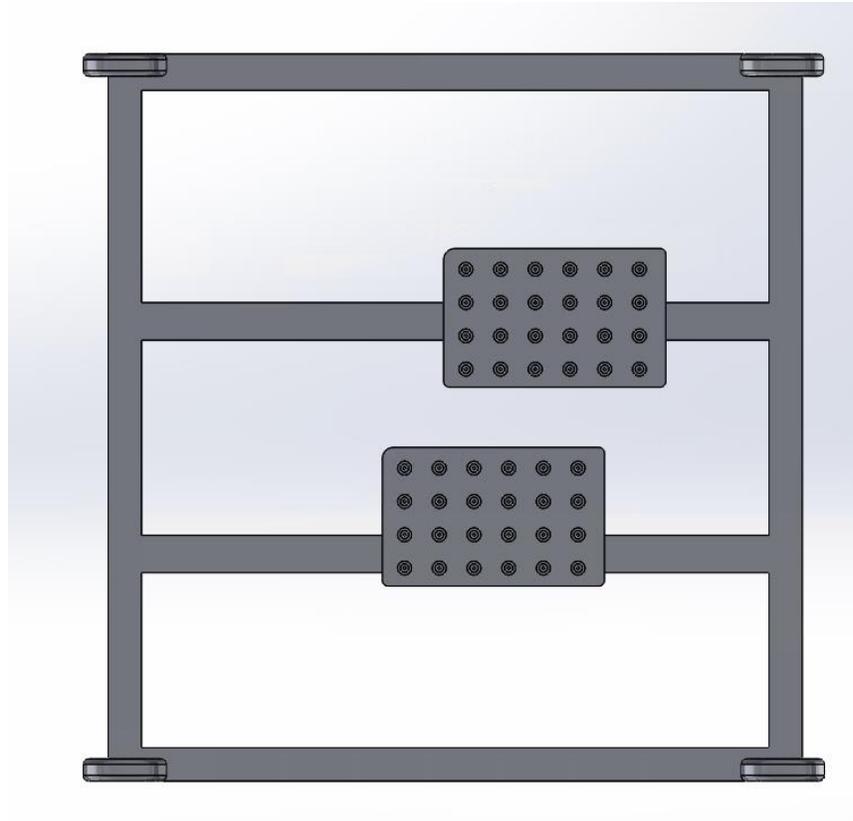
Figure 4.3: Sliding Rail System Bottom View
