**VERIFICATION OF HANDHELD ULTRASONIC TOMOGRAPHY
FOR INTEGRATION INTO A BRIDGE MAINTENANCE DEVICE**

A Thesis

Major Subject: Civil Engineering

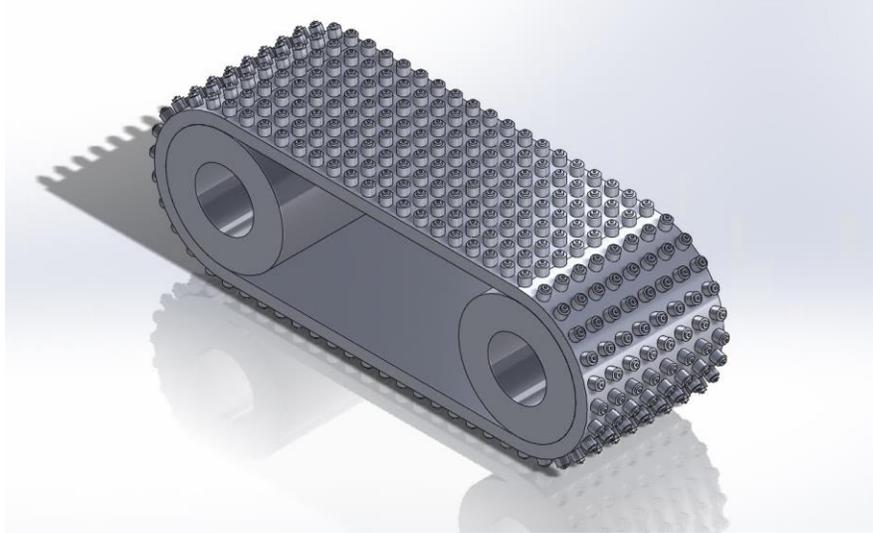
As brainstorming progresses, a continuous track system, resembling the track of a tank, is considered. The continuous track has transducers equally spaced around the rubber perimeter. Figure 4.4 provides an image of a general configuration. A final design would require more details regarding the motorized system.

Figure 4.4: Preliminary Continuous Track Design

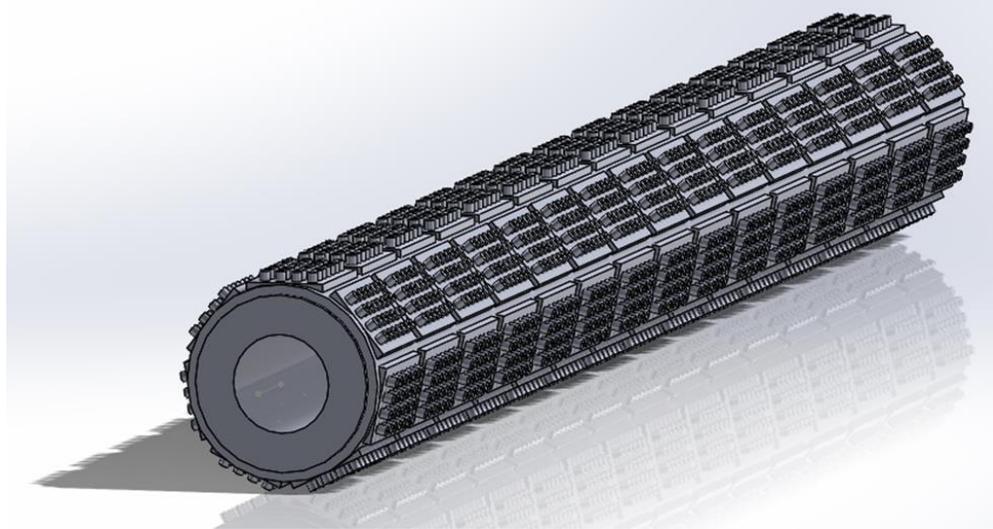
The continuous track design placed pressure on the transducers for a longer period of time than what is needed to acquire data. Due to this exposure and mechanical complexity the focus shifts to circular rolling designs. The initial rolling design relies on currently available transducer arrays for simplicity. Figure 4.5 presents the rolling design that incorporates existing transducer arrays.

Figure 4.5: Rolling Design with Existing Transducer Arrays

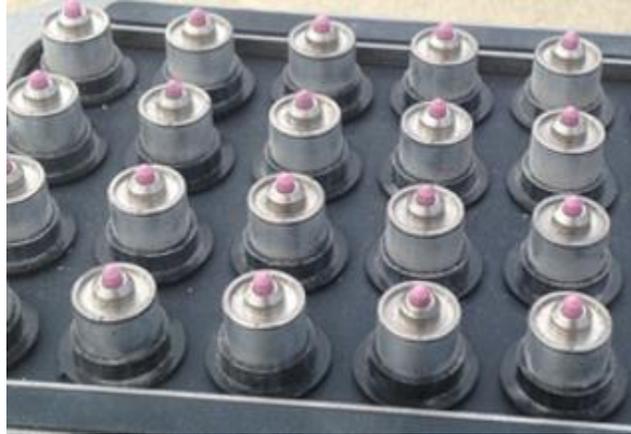
Figure 4.6: Rubber Securement In-between Transducers

To combat spacing issues and impact in Options 3 and 4, the transducers will be taken out of their current casing and curved along a circular path. The current plastic outer shell can be removed, leaving a rubber securement that spaces the transducers. The rubber securement can be seen in between the transducers in Figure 4.6.

The existing rubber between the transducers is flexible, meaning the transducers can be curved along a circular path while still maintaining current functionality and dependability. The challenge would be to determine how many 4 by 6 transducer arrays are needed in order to provide enough space for the portion of the transducer extending towards the center of the circle. Figure 4.7 shows the preliminary design option.

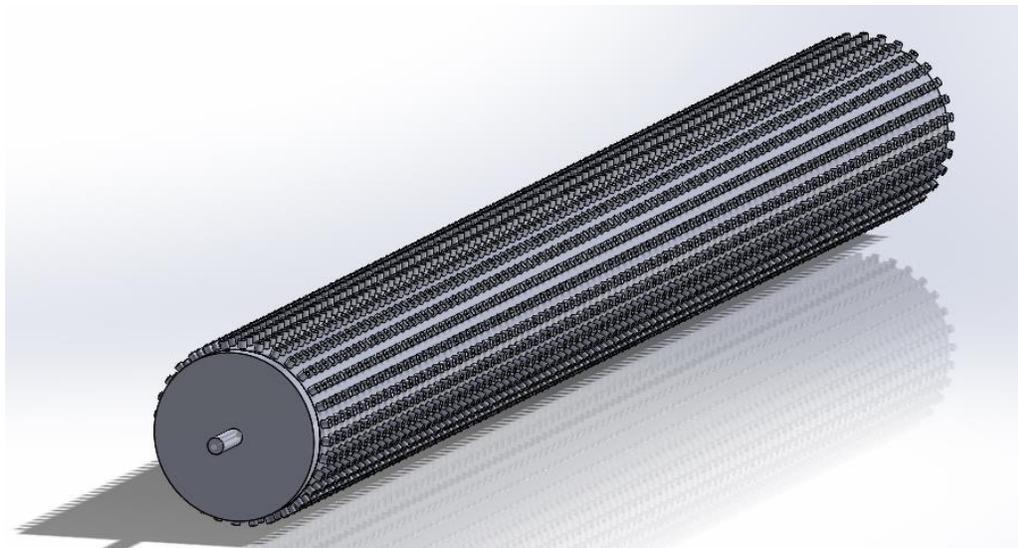
Figure 4.7: Rolling Design with Equally Spaced Transducers

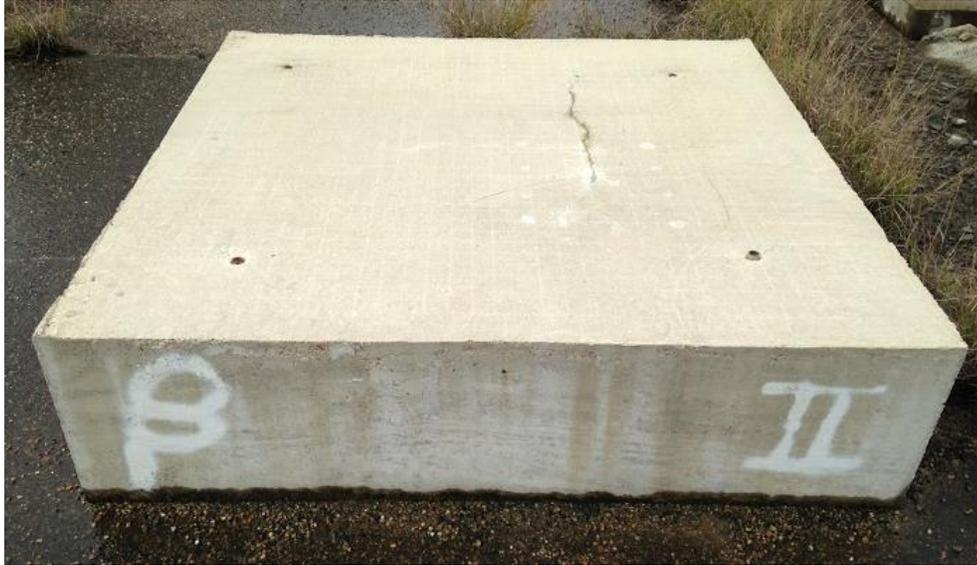
Figure 5.1: Hollow Rods Shown in the Four Corners of Slab II

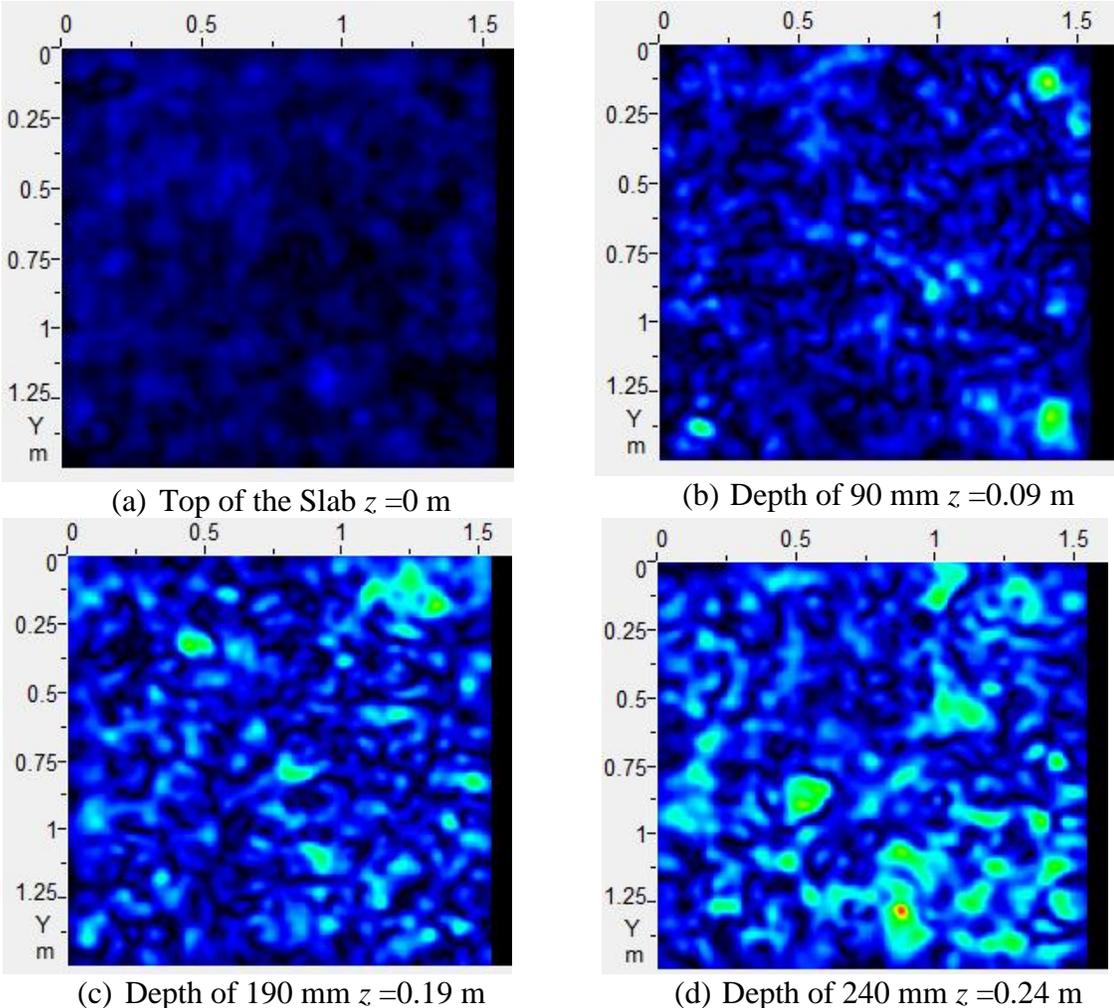
Figure A.1: C-Scans of Slab I at Various Depths using Vertical Transducer Orientation

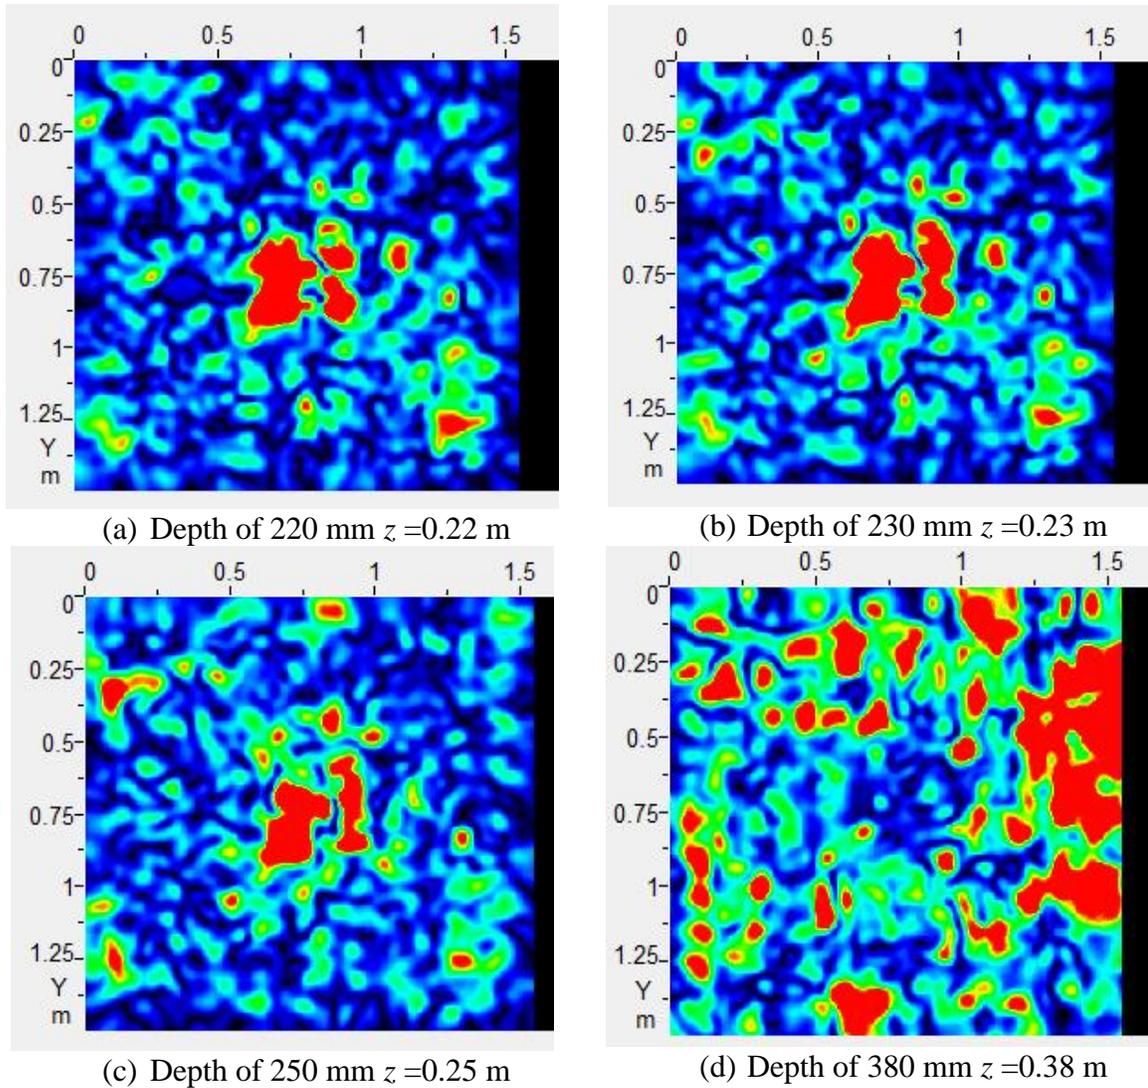
Figure A.34: C-Scans of Slab X at Various Depths from 220 mm to 380 mm

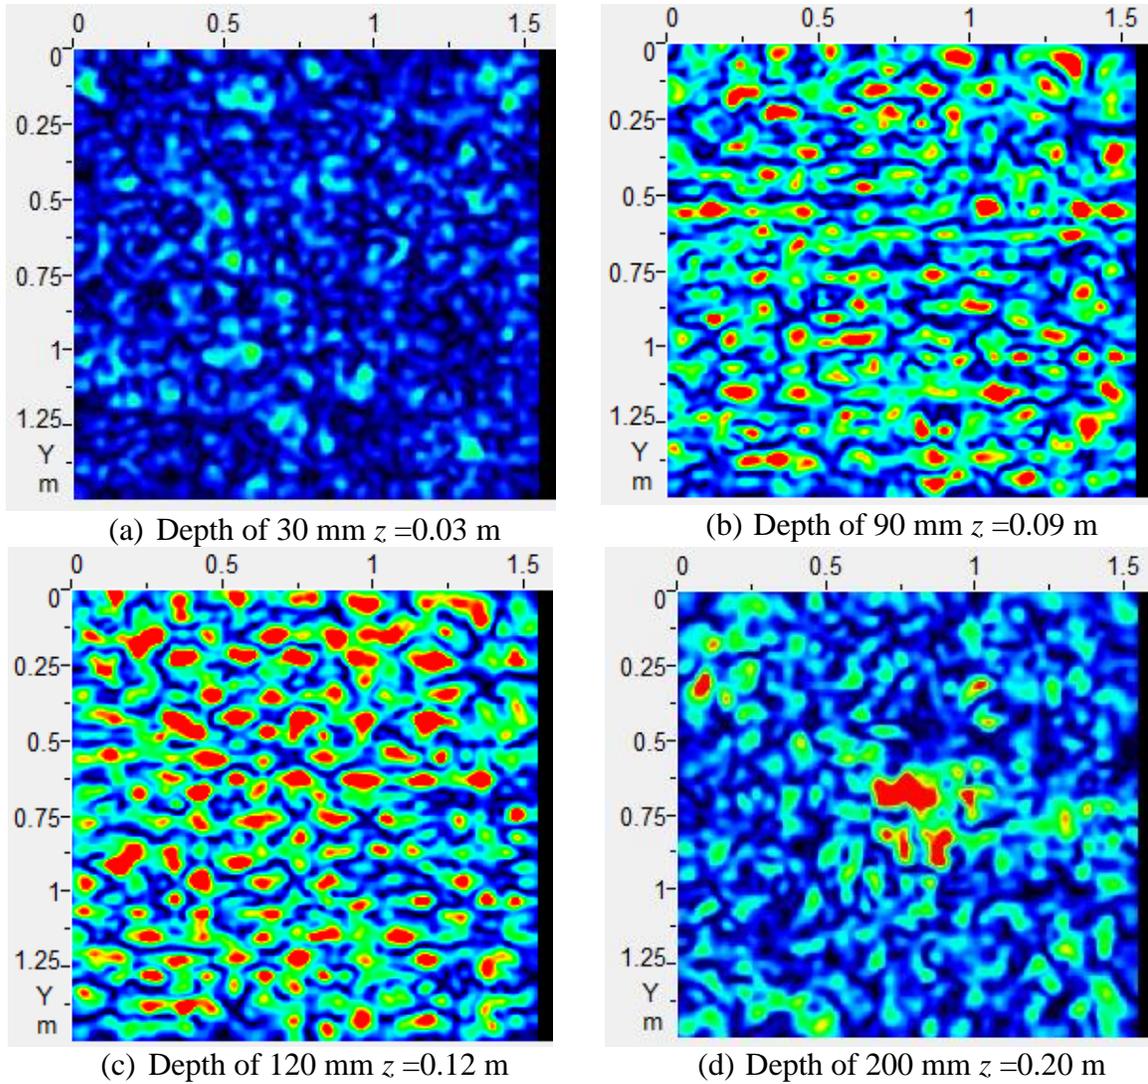
Figure A.37: C-Scans of Slab XI at Various Depths from 30 mm to 200 mm

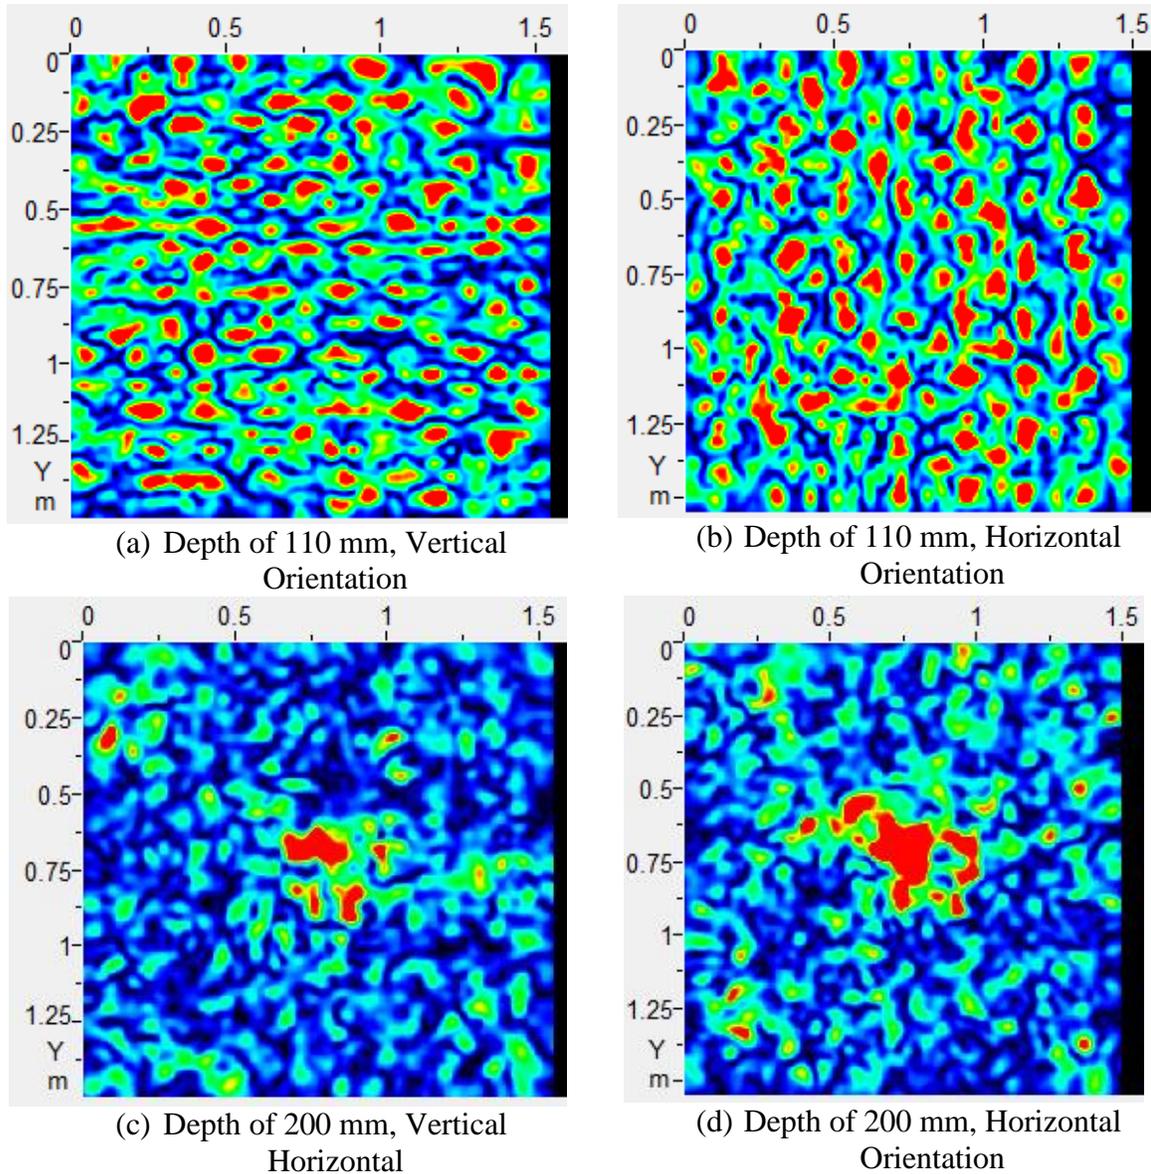
Figure A.39: C-Scans of Slab XI with the Vertical (left) and Horizontal (right) Orientations at 110 mm and 200 mm
