NON-DESTRUCTIVE EVALUATION OF STAY CABLE BRIDGE SYSTEMS

A Thesis

December 2015

Major Subject: Civil Engineering

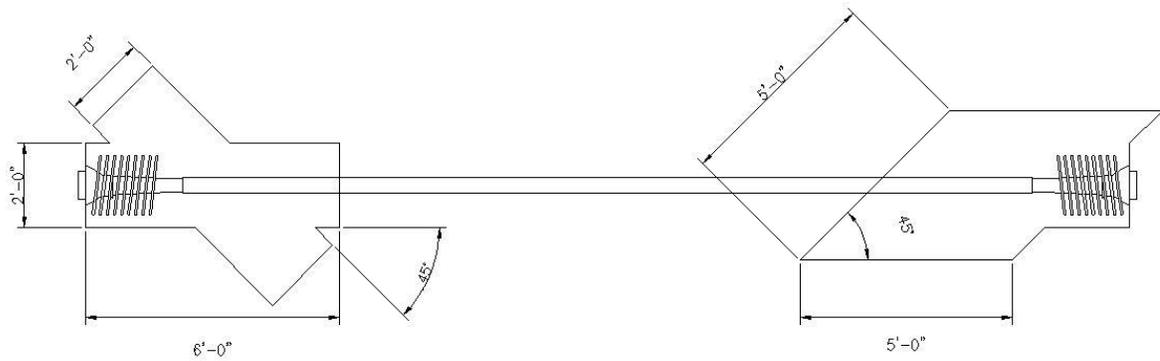
Figure 1-2: Plan View of Typical Stay-Cable Mock-Up Specimen Showing Anchorages in Representative Bridge Deck and Pylon

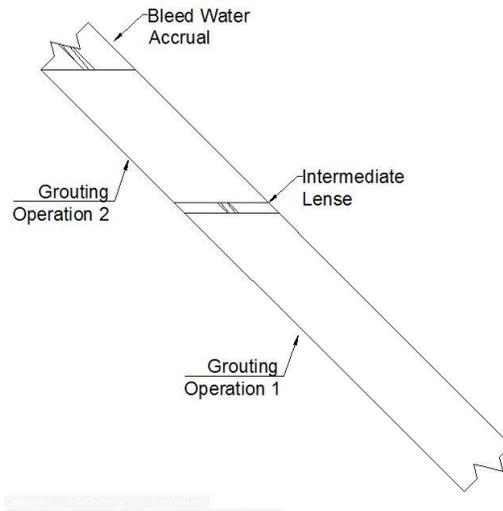
Water infiltration of a grouted tendon has similar consequences to grouting voids in that it can allow a corrosive environment to be created around the steel strand. One possible cause for water infiltration within a tendon includes the existence of a void allowing water to accumulate in the voided area through either an opening in the duct or an accrual of humidity. Another cause, which is more commonly an issue in vertically angled tendons, such as stay cable MTEs, is bleed water. Bleed water is typically caused by poor mixing, poor materials, or excessive water in the grout but is essentially the formation of a water pocket that forms at the highest point of the grout as the particles settle downwards and force the water upwards. Because of the vertical orientation of the tendons, the required pumping head cannot be obtained to pump the entire tendon full of grout in one operation but rather it is done segmentally from bottom to top. This means that not only could bleed water accumulate at the top of the tendon but also at the interfaces between grouting operations, which are referred to as intermediate lenses, both of which are shown in Figure 2-1 (Pielstick, 2014).

Figure 2-1: Bleed Water and Intermediate Lense Illustration

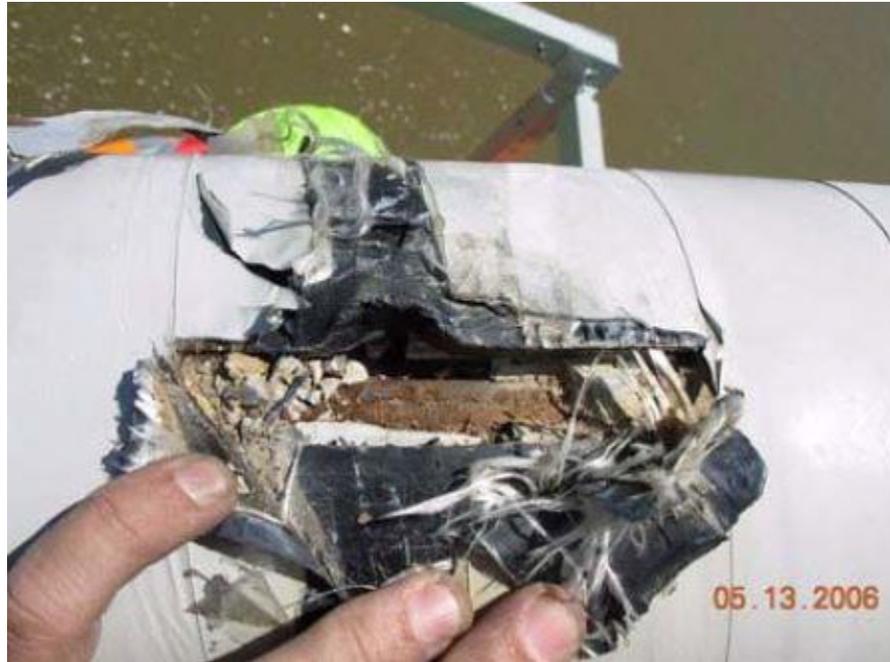
In 1985, the Louisiana Department of Transportation and Development (LADOTD) observed some of the HDPE sheathing encasing the cables had cracked, compromising the first layer of corrosion protection of the strand. Initially, this problem was solved by wrapping all seventy-two tendons with a PVF tape to protect the cracked ducts. But over a decade later, further investigation noticed more problems. In 1998, the LADOTD developed an inspection method using two trolleys to be used on the two different cable configurations. A four-cable trolley setup was used to inspect the cables on the side spans while a two-cable trolley setup was used to inspect the cables on the main span (Elliott & Heymsfield, 2003). Inspection of the free lengths of the cables found several detrimental conditions: corrosion of steel wires (Figure 2-3), damages to the PVF tape, and grouting voids to name a few. After the inspection, thirty-nine of the seventy-two cables were rated as critical and the rest were rated as poor, all a result of protective coating failure.

Figure 2-3: Corrosion of steel wires in Luling Bridge stay cable (Mehrabi, 2009)

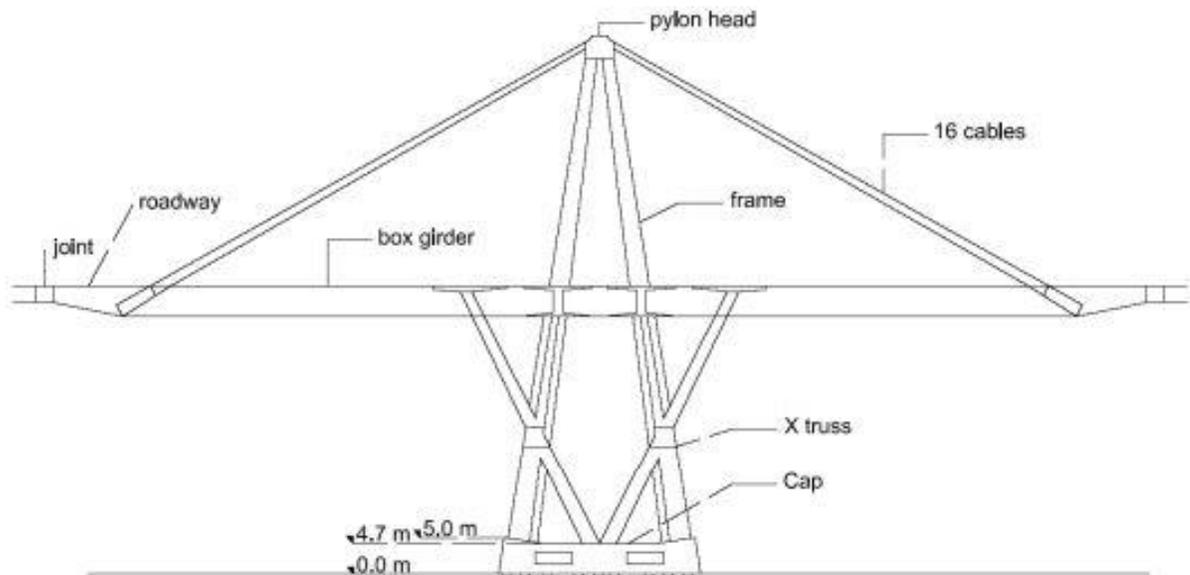
pylon, supported by the structural cables. Each main span is comprised of A-frame towers resting on X-frame supports, of which the deck extends from, as shown in Figure 2-5 (Pipinato, 2012).

Figure 2-5: Design scheme of Maracaibo Bridge (Pipinato, 2012)

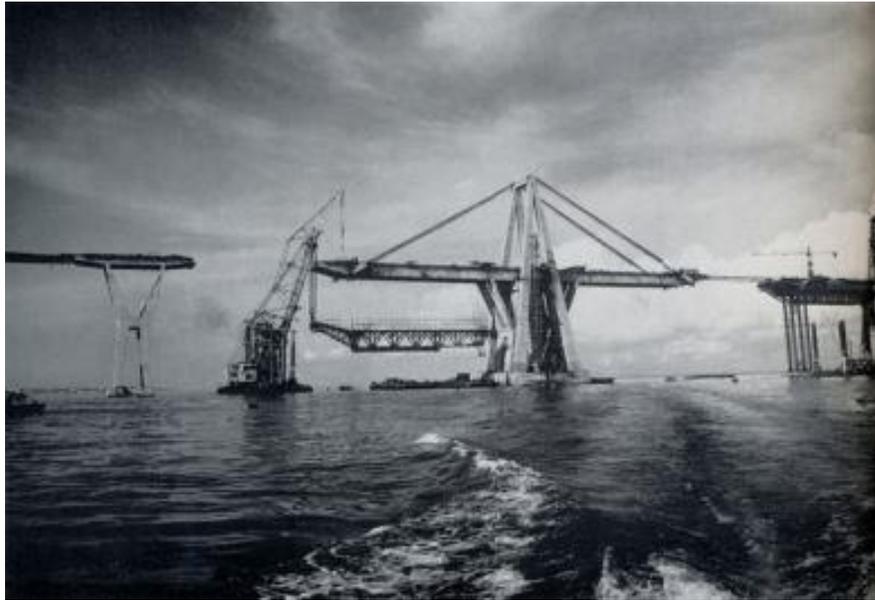
reassembled (Pipinato, 2012). Figure 2-6 shows construction operations during the replacement.

Figure 2-6: Construction operations during cable replacement (Pipinato, 2012)

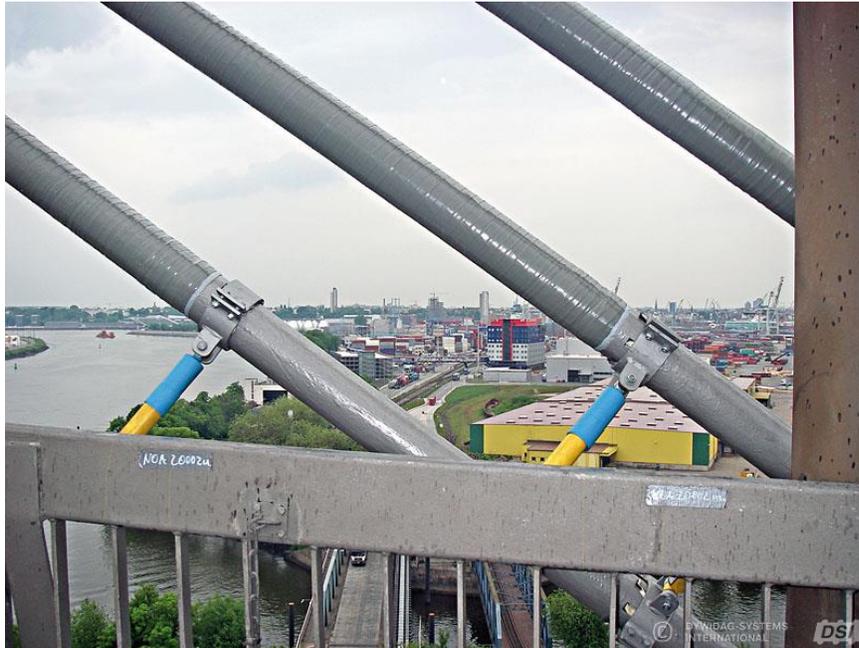
The corrosion protection system was updated from the corrosion coatings to use of a butyl rubber tape wrapping, which can be seen in Figure 2-10.

Figure 2-10: Repaired Corrosion Protection Coatings (DWIDAG-Systems International, 2014)

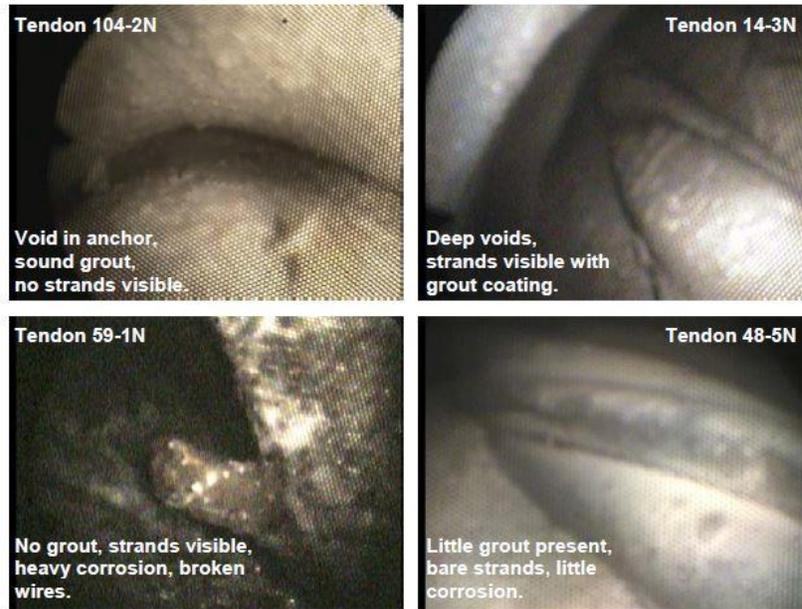
If entry of the imaging device into a tendon is available, borescoping can be an extremely useful NDE method for determining the actual conditions that exist within a stay cable MTE. Borescoping not only allows the inspector the ability to view strand or grouting conditions, but also to qualitatively evaluate the severity and shape of the defects in order to recommend remediation techniques. Corven (2001) inspected the Mid-Bay Bridge in Okaloosa County, Florida and used a borescope to inspect different anchorages, of which four still photos are shown in Figure 2-11, showing broken wires, corrosion, and grouting deficiencies.

Figure 2-11: Images from Borescope Inspection of Post-tensioned Bridge (Corven, 2001)

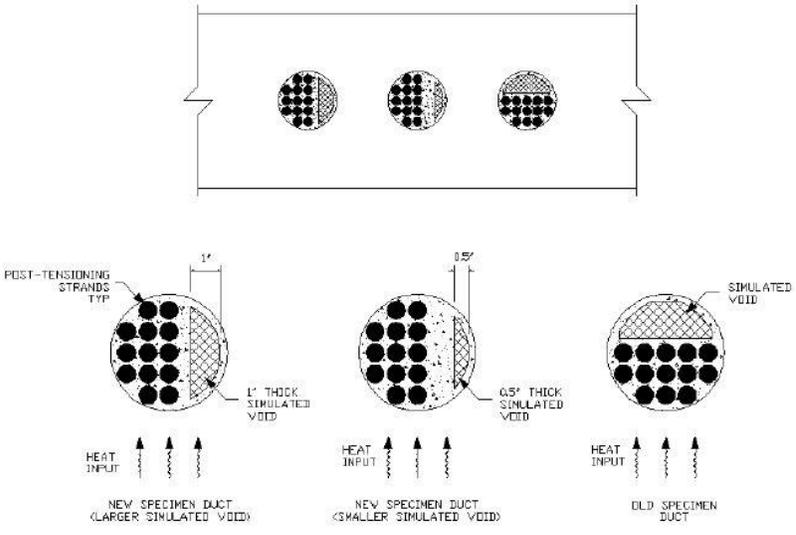
The thermal nature of IRT gives it the capability to locate detrimental conditions based on differences in the thermal properties of steel, concrete, air, water, or any other material present in a structure because abnormalities theoretically will affect the heat flow of the structure and be seen in the thermal image (Mehrabi, 2006). For instance, air has a much larger thermal conductivity than concrete, meaning that concrete containing an air void will produce observable surface temperature variation compared to that of a solid concrete region (Poulain et al., 1999). Pollock et al. (2008) attempted to study the feasibility of detecting voids within internal ducts. Their research team constructed a series of small, concrete specimens of different thicknesses with internal post-tensioning incorporating different sized and angled voids, with a typical specimen cross-section shown in Figure 2-12.

Figure 2-12: Typical Concrete Specimen Showing Various Voided Regions (Pollock et al., 2008)

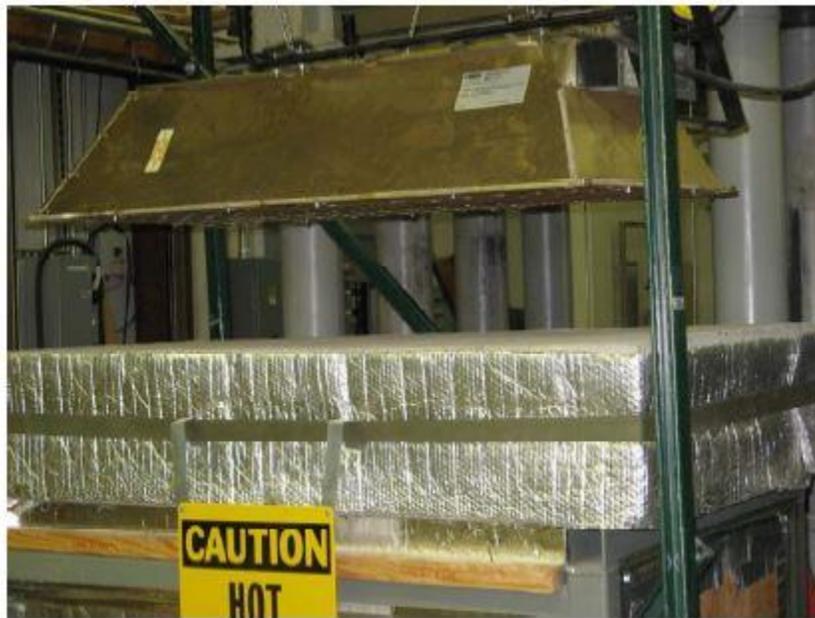
After all of the specimens were completed, the test setup was designed. Active IRT was used for this testing, meaning that the specimens were subjected to external thermal heating, along with a reflective insulation. The insulation used in this setup was reflectix with an R-value of 14.3 and 97% reflectivity. The heater used was a heater manufactured by Fostoria (Model #CH-1324-3A). The entire setup is shown in Figure 2-13.

Figure 2-13: IRT Testing Setup with Suspended Heater (Pollock et al., 2008)

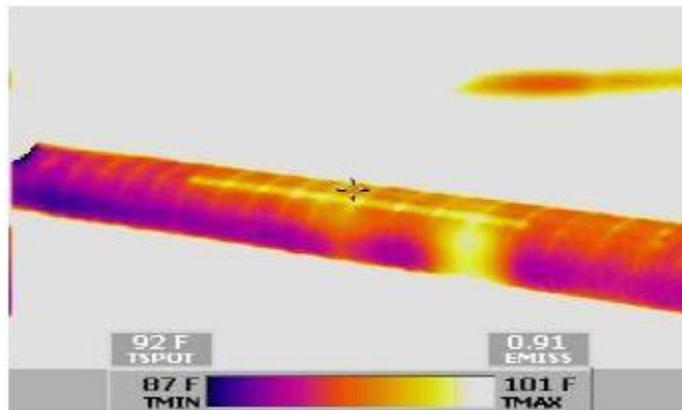
Similarly, IRT has been used for investigation of an external or stay cable ducts, including tape condition because it is a rapid, convenient, and contactless NDE technique. Figure 2-14 shows an example of an infrared thermographic image of a polyethylene external duct containing a split in the sheathing.

Figure 2-14: IRT Image Showing Splitting of Polyethylene Sheathing (Azizinamini & Gull, 2012)

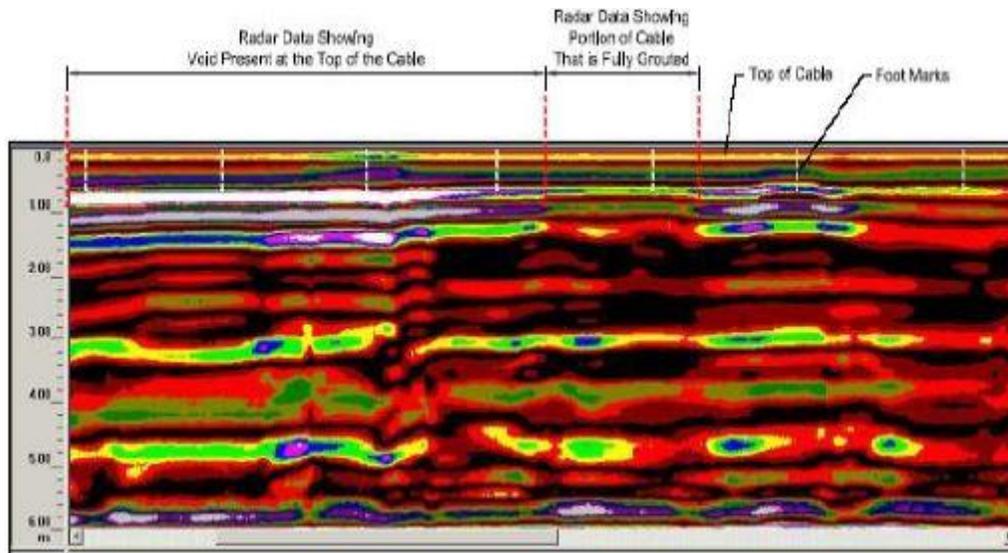
Azizinamini and Gull (2012) explored the potential to detect grout conditions, such as voids, soft grout, or water intrusion within a plastic duct due to the higher levels of moisture and electrolytes of the grout. The higher reflection levels of these conditions were able to be seen using GPR, as the presence of a void is shown by the white pattern in Figure 2-15.

Figure 2-15: Sample Radar Scan showing Voided Region in Grout (Azizinamini & Gull, 2012)

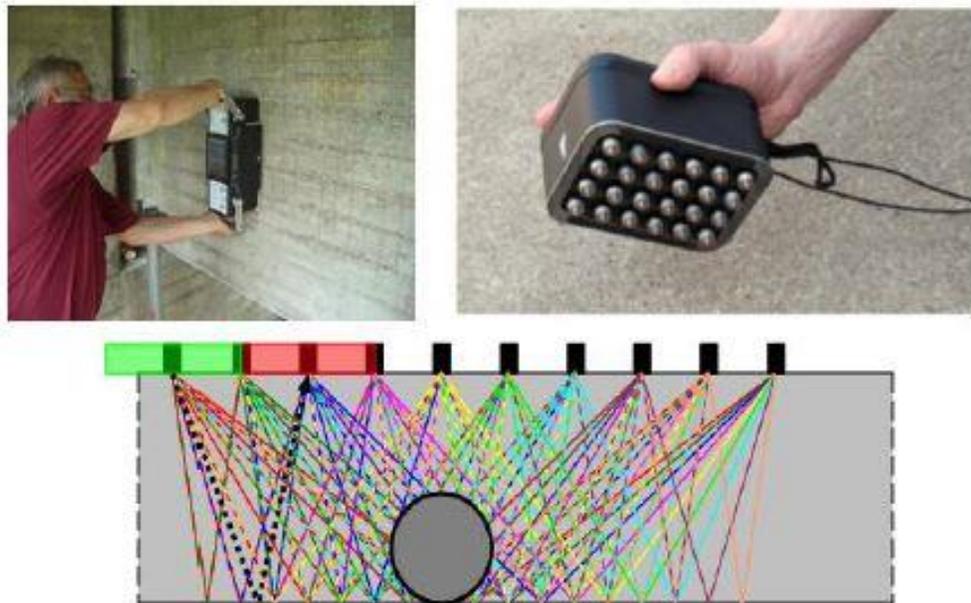
transducer emitting a linearly time-spaced shear wave into the structure, of which the wave reflects back to each of the adjacent transducers within the array (Azizinamini & Gull, 2012). Figure 2-16 shows typical shear wave transducer array equipment and a typical shear wave propagation arrangement.

Figure 2-16: Typical Ultrasonic Tomography Equipment (Top) and Wave Propagation Scheme (Bottom) (Azizinamini & Gull, 2012)

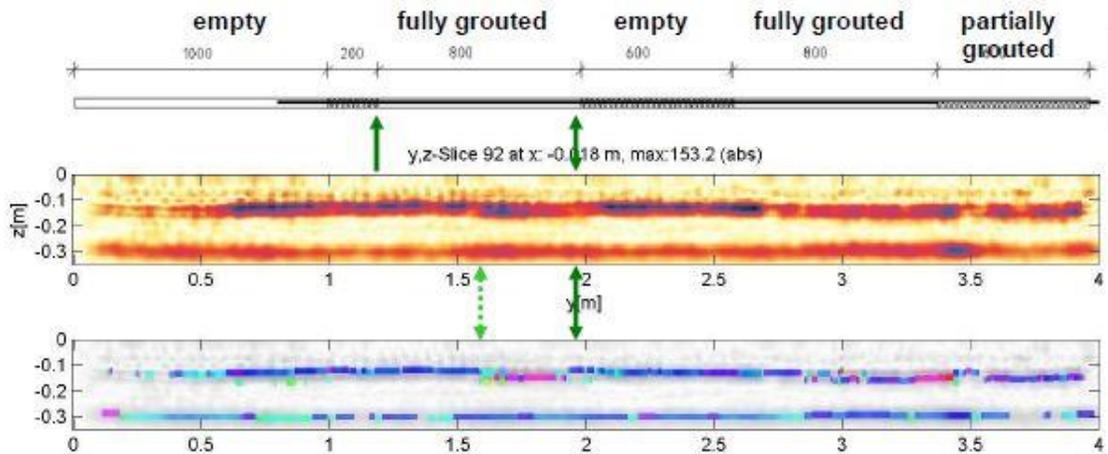
These intersecting shear wave paths and recorded phases of each reflected wave can be used to generate data. Recent developments have allowed this data to be transformed into a map of the structure using post-testing data processing softwares. An example of a scan image of an internal tendon can be seen in Figure 2-17, in which the colors indicate the phase of the reflected waves.

Figure 2-17: Ultrasonic Tomography Conventional (Top) and Modified (Bottom) Scans (Azizinamini & Gull, 2012)

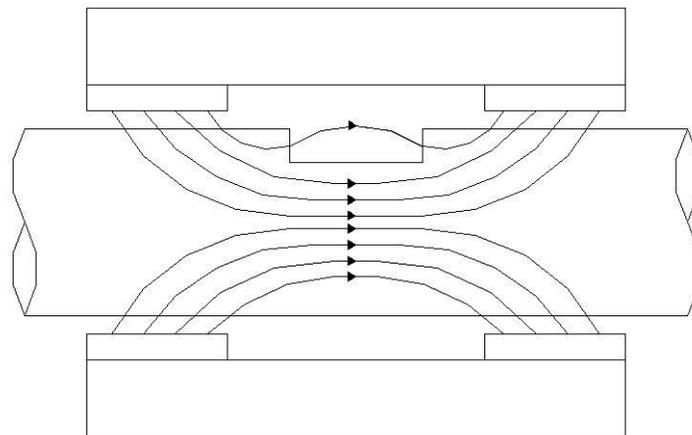
tendons, meaning that the flux will align with the steel strands and data can be measured as the device is moved along the length of the tendon. Because the flux density of iron is roughly 100 times that of air, the flux follows the low-resistance path of the metallic matter (Xi et al., 2012). This flux can become disrupted by a loss in cross-sectional area of the steel, causing some of the flux to escape, or “leak”, into the air (Weischedel, 2003). This leaking flux can be measured by a variety of different sensors and MFL technologies to determine cross-sectional area loss and is illustrated in Figure 2-18. As the machine is pushed along the cable, point measurements can be taken along the entire length, giving the inspector the ability to identify a loss metallic material that cannot be viewed by the naked eye from outside the tendon.

Figure 2-18: Representation of Flux Leakage due to Loss of Cross-Sectional Area

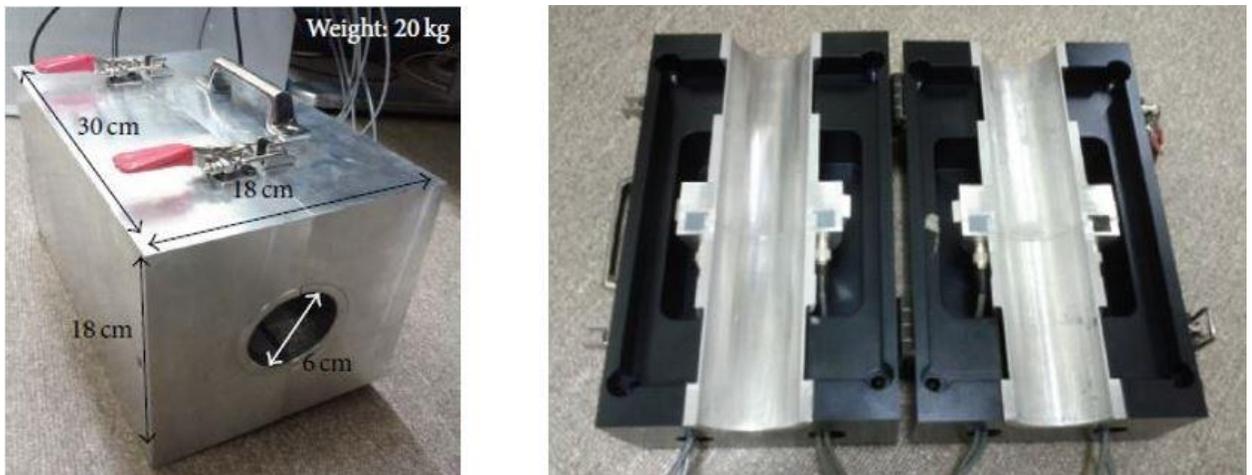
Park et al. (2014) fabricated a sensor head prototype using two high strength permanent magnets and 8 Hall sensors placed in equal intervals around the circumference of the sensor head, which is shown in Figure 2-19.

Figure 2-19: Proposed MFL Sensor Head (Park et al., 2014)

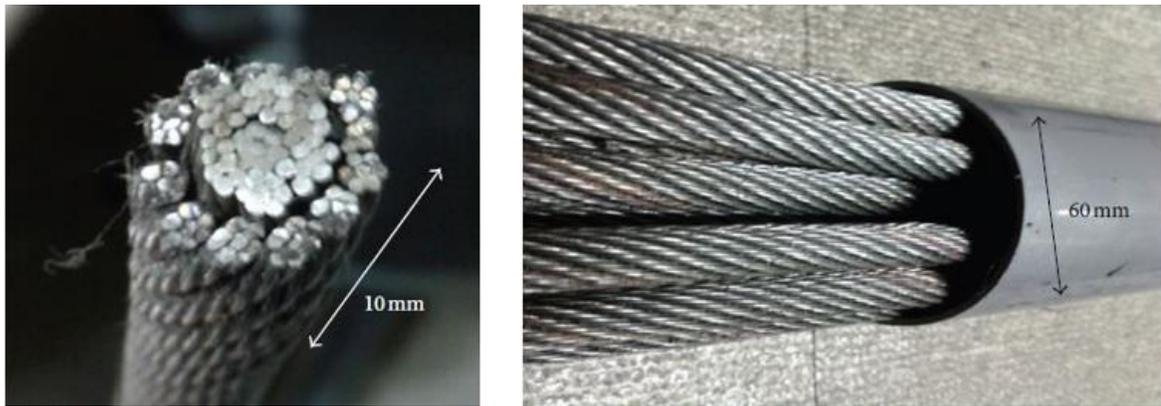
intervals along the length of the specimen but defected strands were also located in different cross-sectional locations within the tendon.

Figure 2-20: Testing Specimen Illustrations (Park et al., 2014)

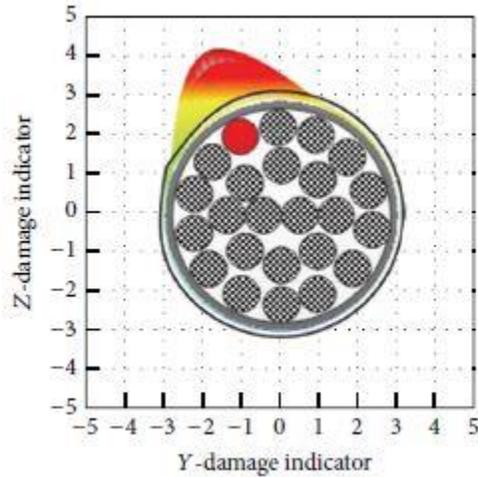
This study used a 99.99% confidence level threshold of the intact sections and a calculated damage threshold value was determined to be 0.1358 V (equaling 0.1358 Wb/s), meaning that all flux leakages measured over this value signals a flaw in the tendon. Results of this study found that not only were all LF damages detected, but the circumferential location of each defect was found based on which Hall sensor(s) measured the leaking flux and the data was three-dimensionally graphed. An example of one of the 3-D tendon damage models is shown in Figure 2-21.

Figure 2-21: Localized Damage Representation (Park et al., 2014)

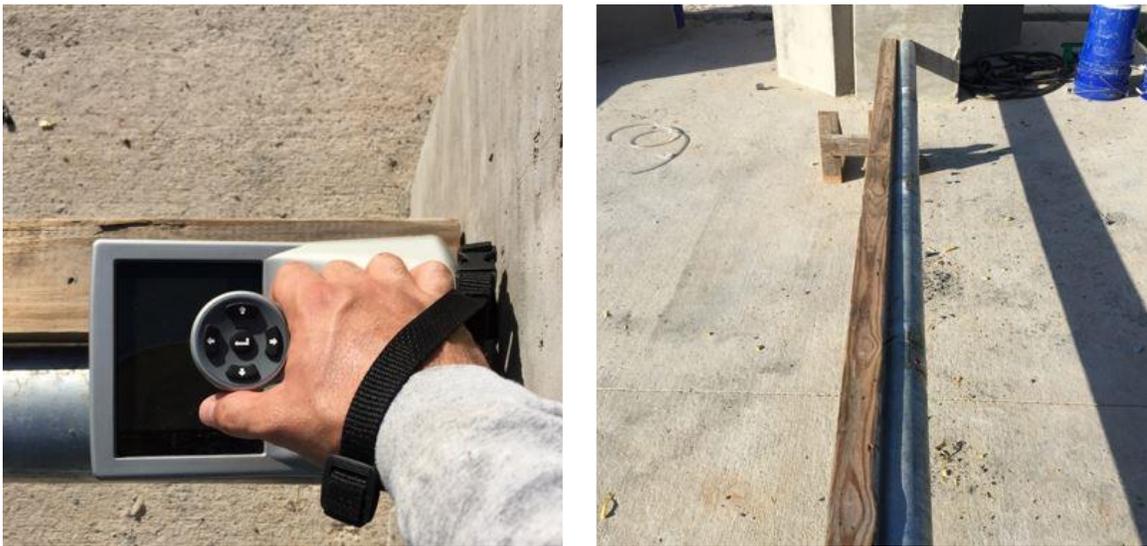
(a)

created. For inspection of the free spans, line scan data was acquired as the device moved along the free span of the specimens. Because of the circular shape of the tendons, temporary wooden support structures had to be constructed on each side of the duct to ensure that the wheels turned as the device was moving and data was being collected. An illustration of these temporary wooden supports can be seen in Figure 3-1.

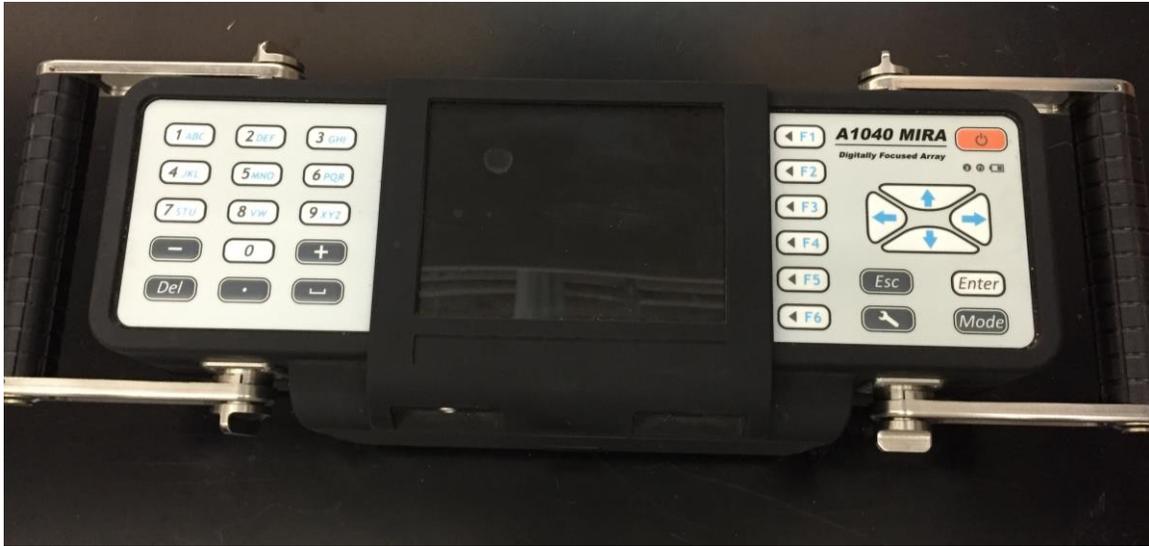
UST testing was performed using an A1040 MIRA unit, as shown in Figure 3-5. This is a dry acoustic contact device, meaning that the device can be placed directly against the concrete surface for testing and the surface didn't need prepared. All UST testing was performed at 50 kHz, which is the nominal operating frequency of the array (Acoustic Control Systems, n.d.).

Figure 3-5: A1040 MIRA

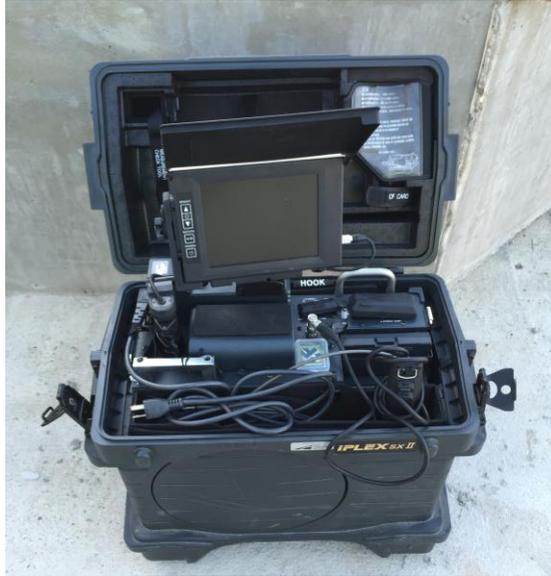
Borescope inspections were performed using an Olympus IPLEX SX II, shown in Figure 3-10.

Figure 3-10: Olympus IPLEX SX II

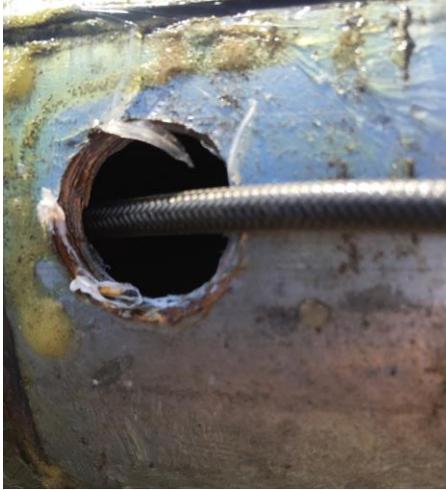
As referenced in the literature review, borescope inspection requires an entry point for the camera to extend into the duct. In this research, threaded entry holes were drilled into the duct and sealed with a screw-in plug when not in use in order to protect the integrity of the defects. Figure 3-11 shows an example of a borescope access hole with the borescope sticking in the hole for inspection. In addition to drilled holes, grout ports were used as entry points. Although holes were drilled at each defect location, entry access was not necessarily available in each section, as fully grouted sections did not allow access of the camera even after the plug was removed.

Figure 3-11: Drilled Borescope Inspection Hole

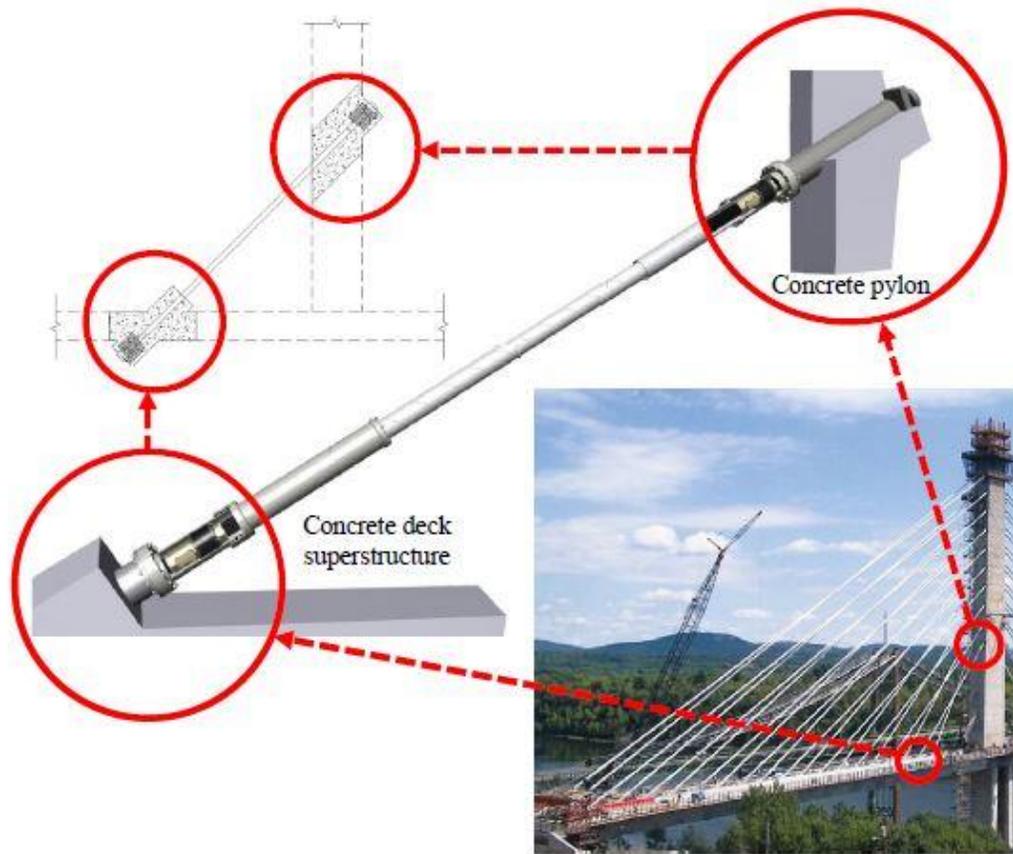
The primary goal of the stay cable mock-up specimens was to accurately mimic both the free span and end conditions of actual stay cable bridge systems, as shown in Figure 4-1. The end conditions that are intended to be represented by the specimens are the typical concrete deck superstructure and the typical concrete pylon, characterized geometrically by the mass concrete blocks shown in Figure 4-2. All four stay cable mock-up specimens consist of a 17-foot long free span restrained at both ends by the concrete blocks, which are 2 feet thick. The anchorage blocks for each specimen were dimensionally identical and contain typical steel reinforcement, as shown in Supplemental File A.

Figure 4-1: Stay Cable End Conditions Mimicked in Mock-Up Specimen (DYWIDAG-Systems International)

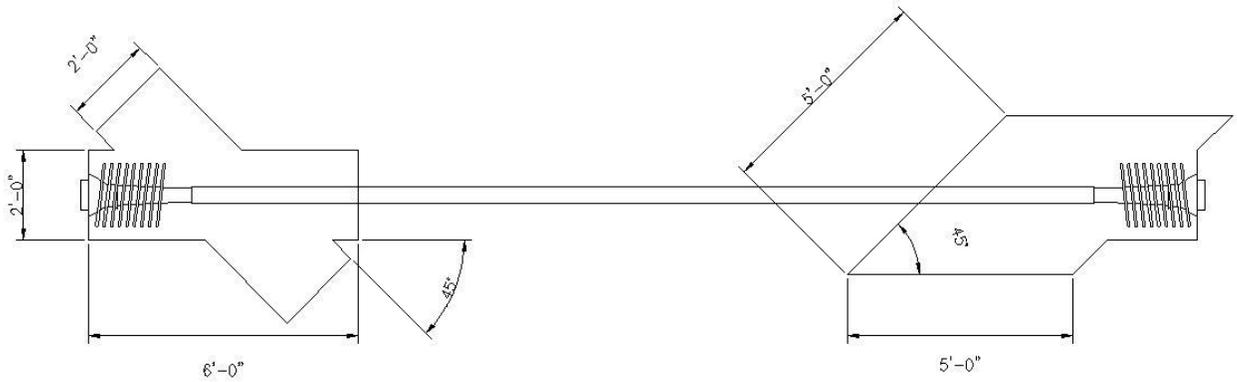
Figure 4-2: Stay Cable Mock-Up Specimen Plan View

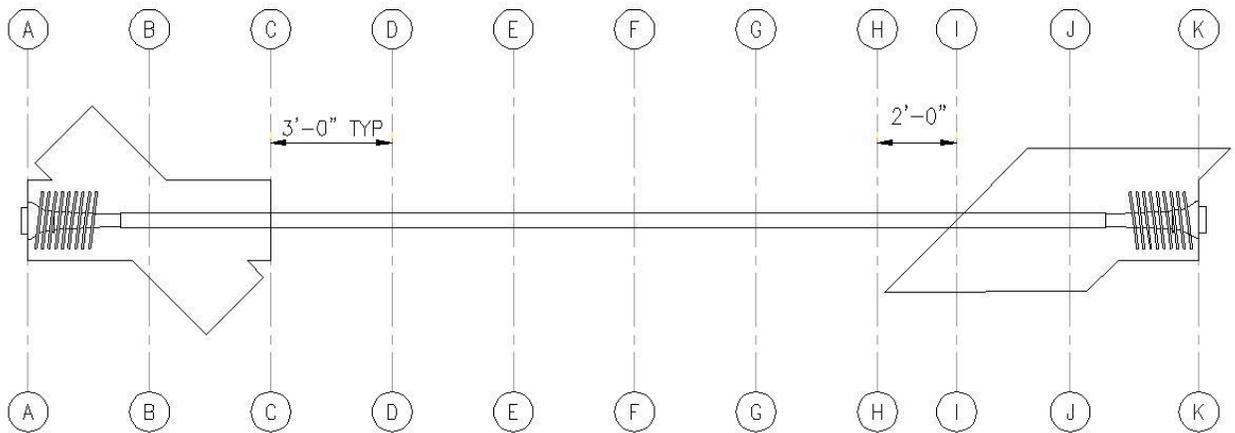
Figure 4-3: Typical Mock-Up Specimen Defect Grid

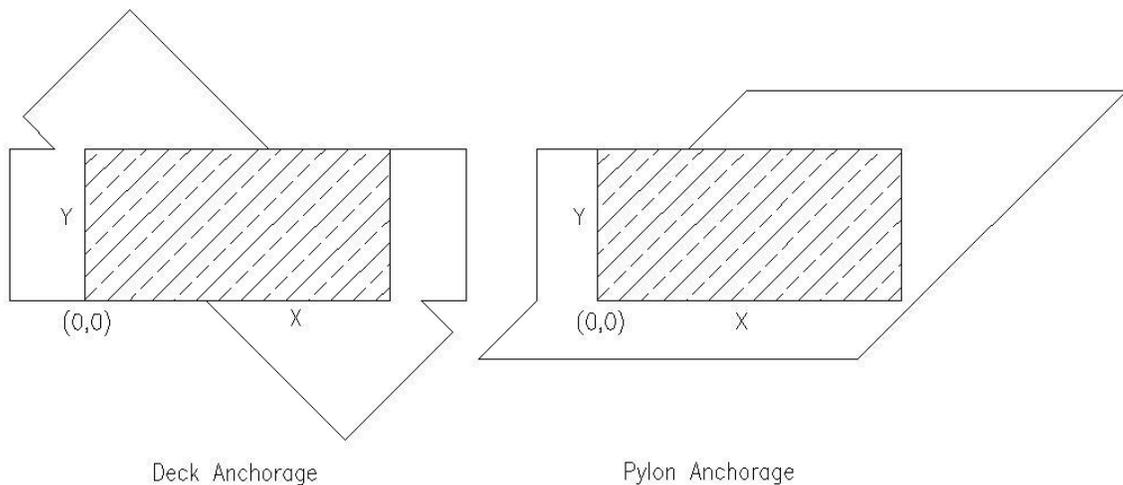
Figure 5-1: GPR 3-D Testing Coordinates and Labeling For Anchorage Zones

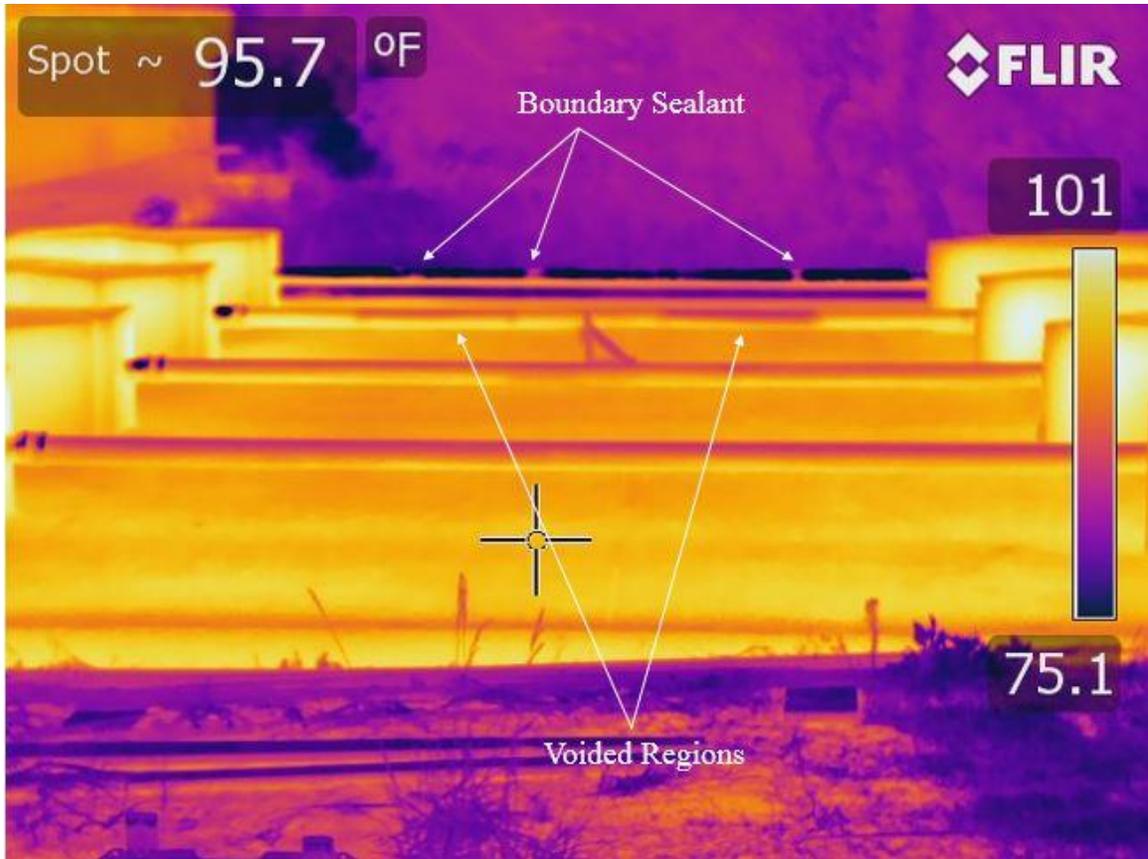
Figure 5-3: Enlarged Infrared Image of Mock-Up Specimens During Cooling Off Period

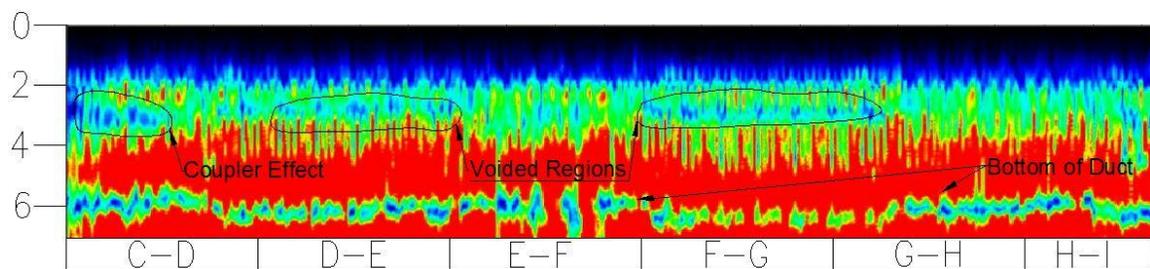
Figure 5-5: B-scan Results of Specimen 2 (Test 1)

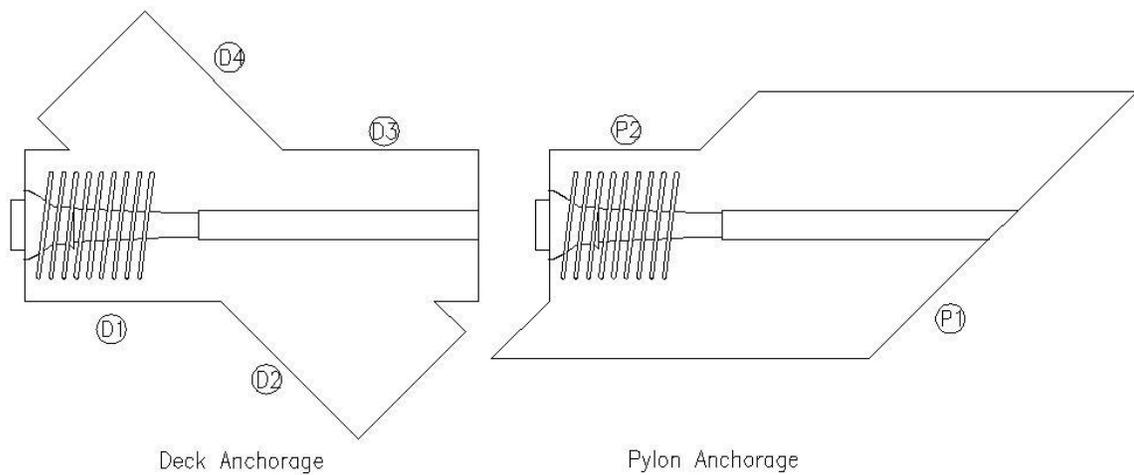
Figure 5-6: Testing Grid Labels for UST Testing of Anchorages

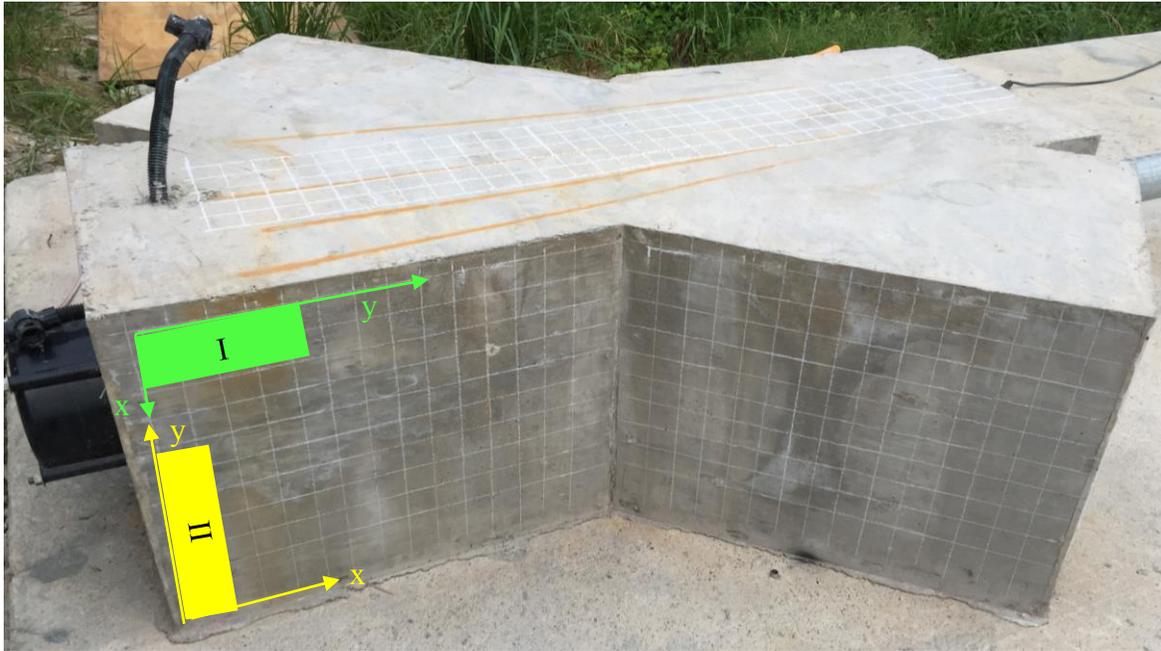
Figure 5-7: Device Orientation and Axes for UST Anchorage Testing

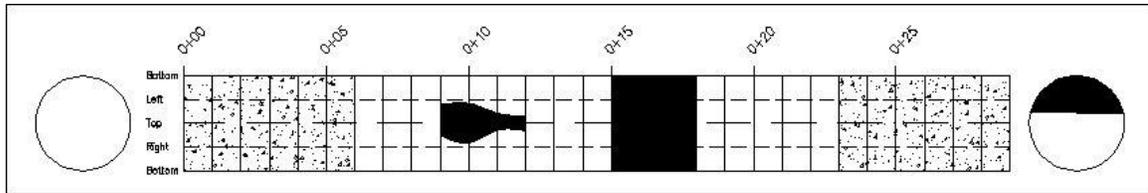
Figure 5-8: Sounding Map 1 of Specimen 1

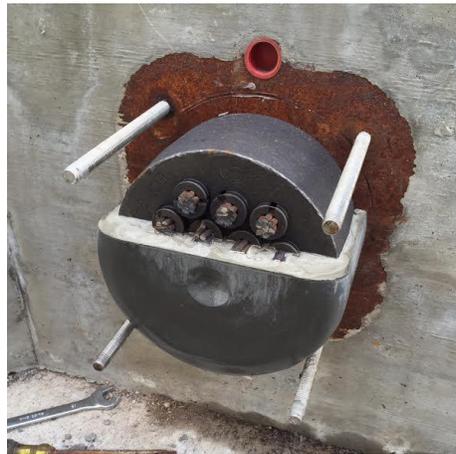
Figure 5-9: Partial Grouting of End Cap

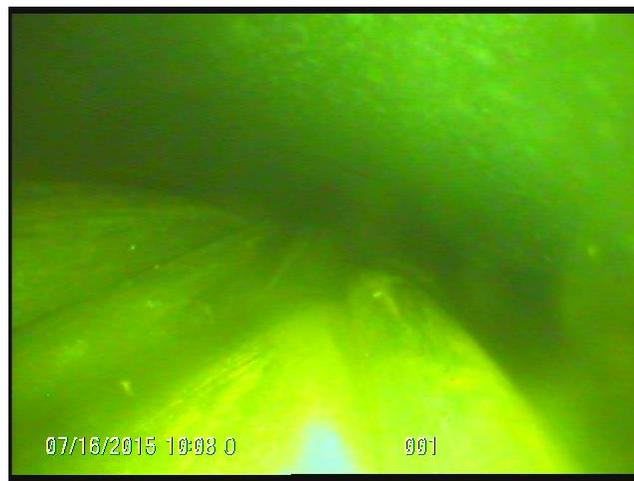
Figure 5-10: Borescope Photo of Voided Region in Specimen 1 Grid F-G

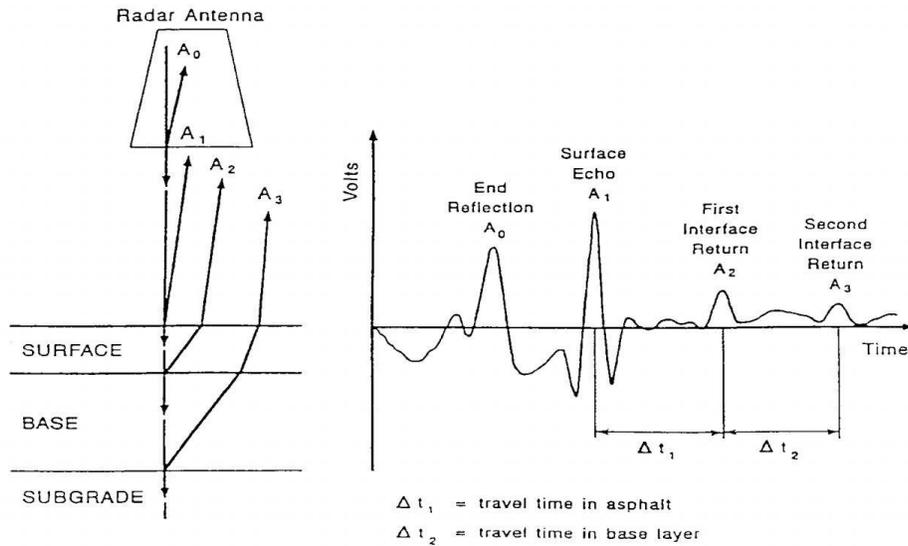
Figure A.1-1: GPR antenna sends and receives EM pulses after reflection from subsurface interfaces (left); GPR trace of signal amplitude vs time (right) (from FHWA)

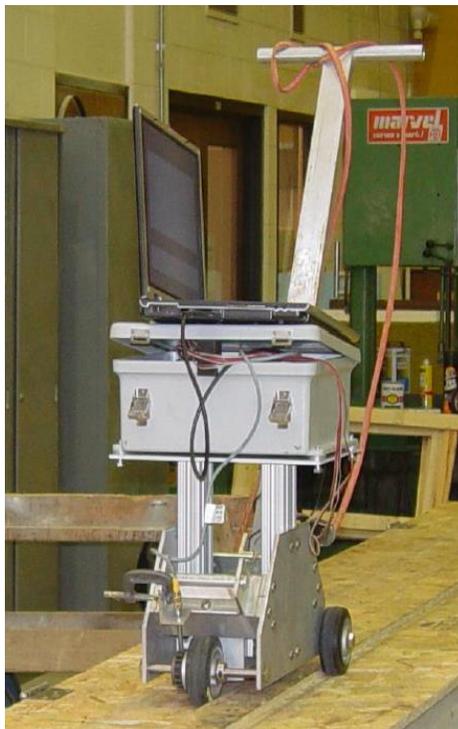
Figure A.2-1. MFL device for internal ducts (from DaSilva et al. 2009).

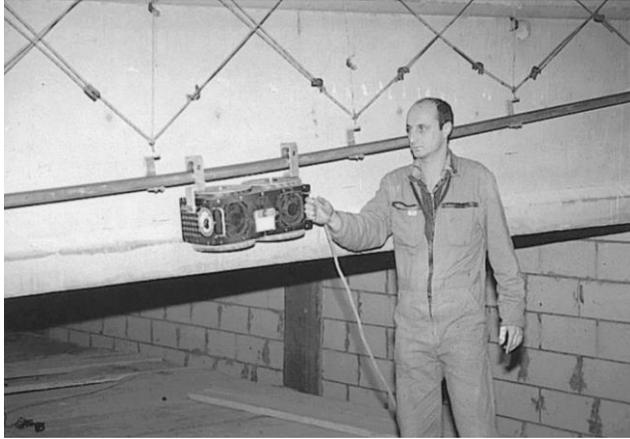
Figure A.2-2. Application of MFL on an external tendon specimen (from Sche et al. 2003).

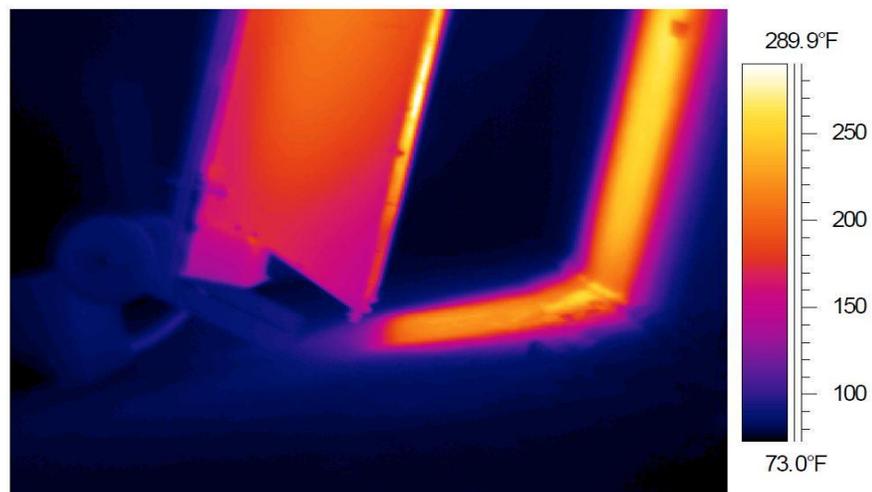
Figure A.3-1. Active IRT of a segmental box girder (from Pollock et al. 2008).

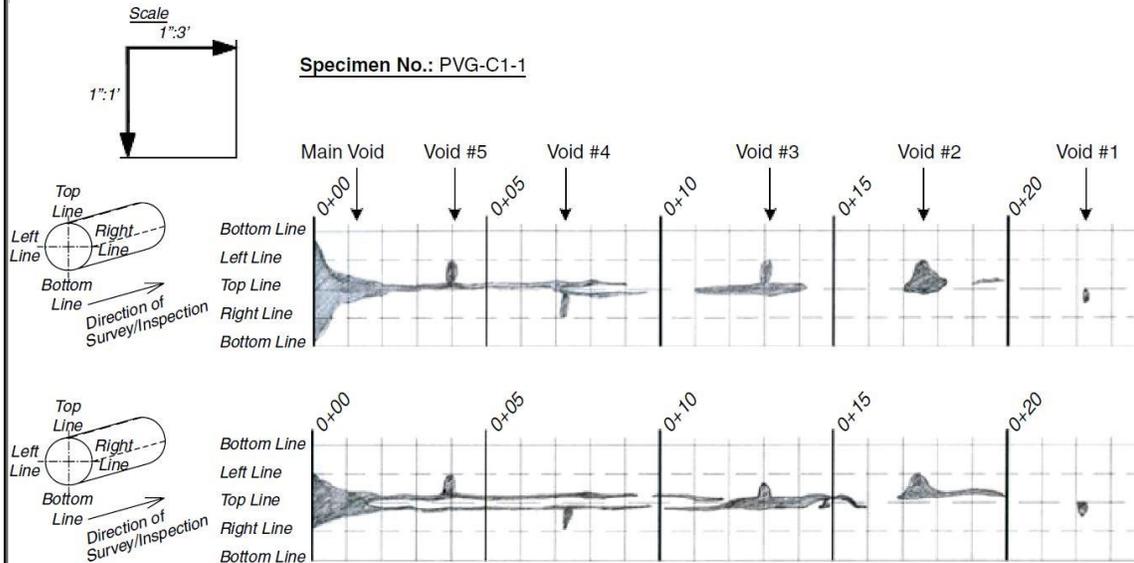
Figure A.5-1. Void image of specimen (from Im and Hurlebaus 2012).

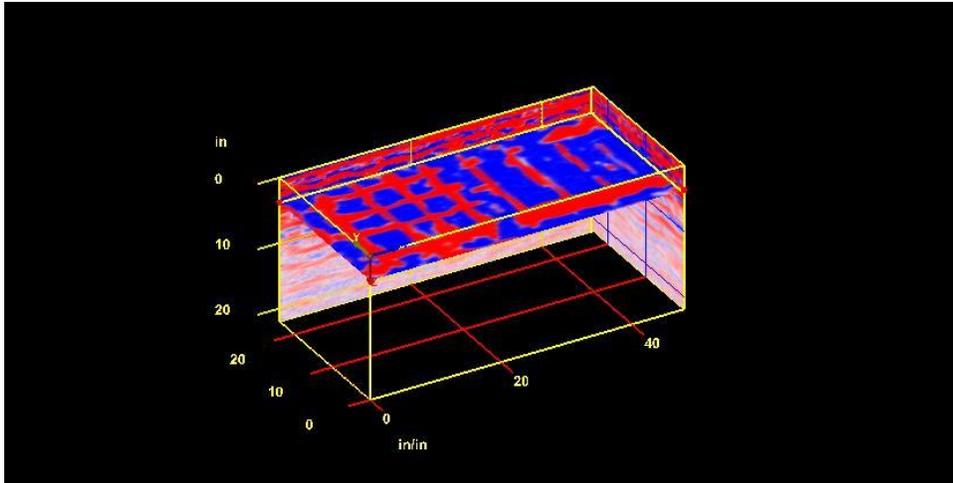
Figure B.1-7: GPR Map Showing Reinforcing Grid For Deck Anchorage

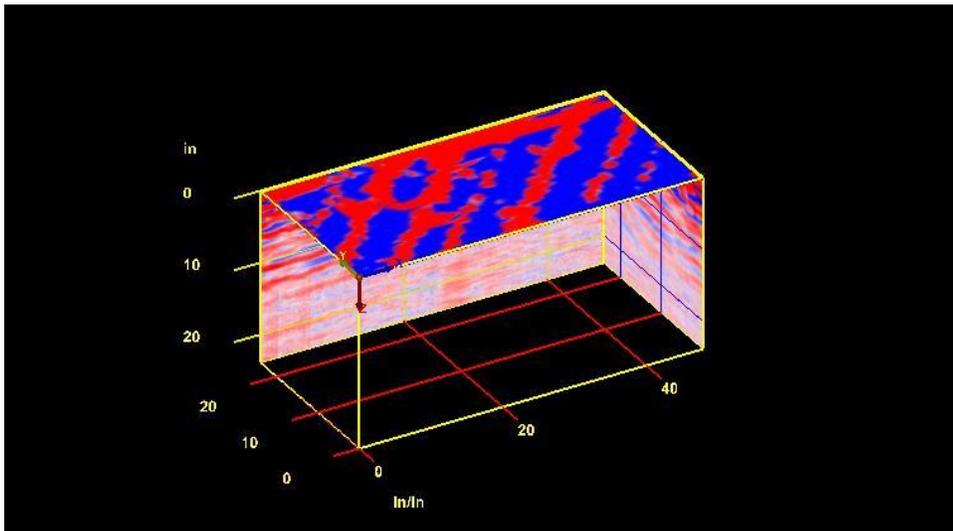
Figure B.1-8: GPR Map Showing Reinforcing Grid For Deck Anchorage

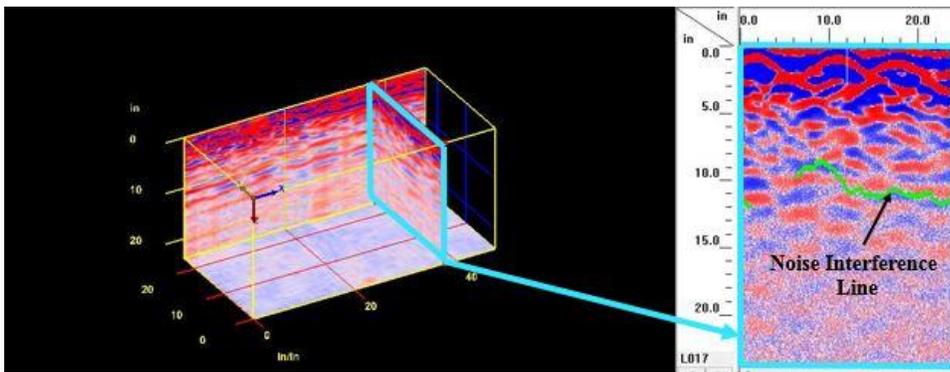
Figure B.1-10: GPR Map and D-Scan Showing Noise Interference Level For Pylon Anchorage
