NON-DESTRUCTIVE EVALUATION OF STAY CABLE BRIDGE SYSTEMS

A Thesis

December 2015

Major Subject: Civil Engineering

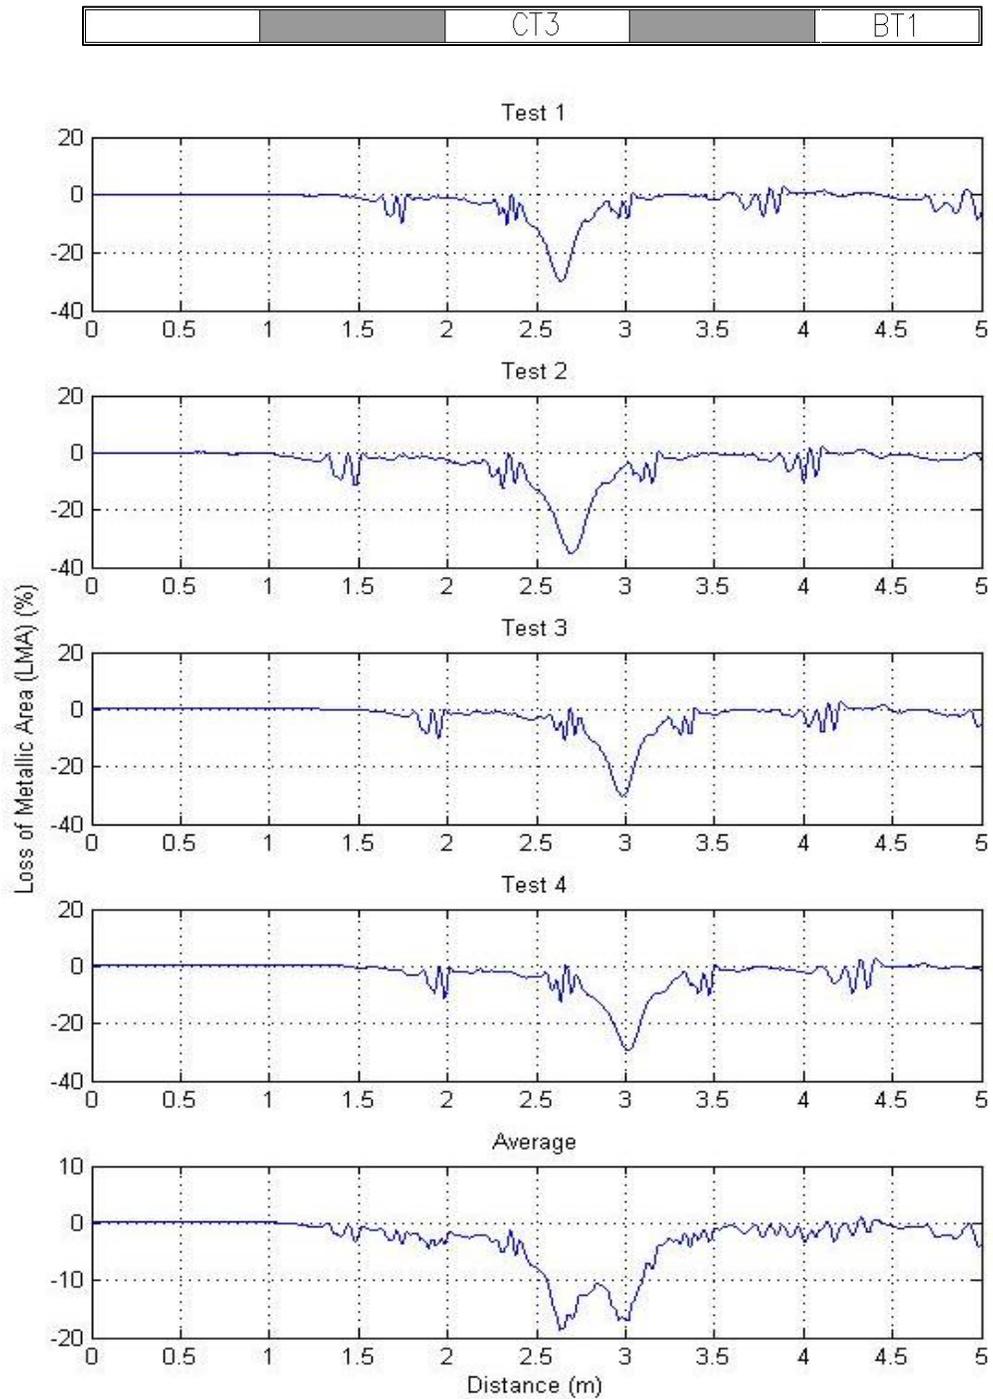
Figure B.2-1: Specimen 1 MFL Results

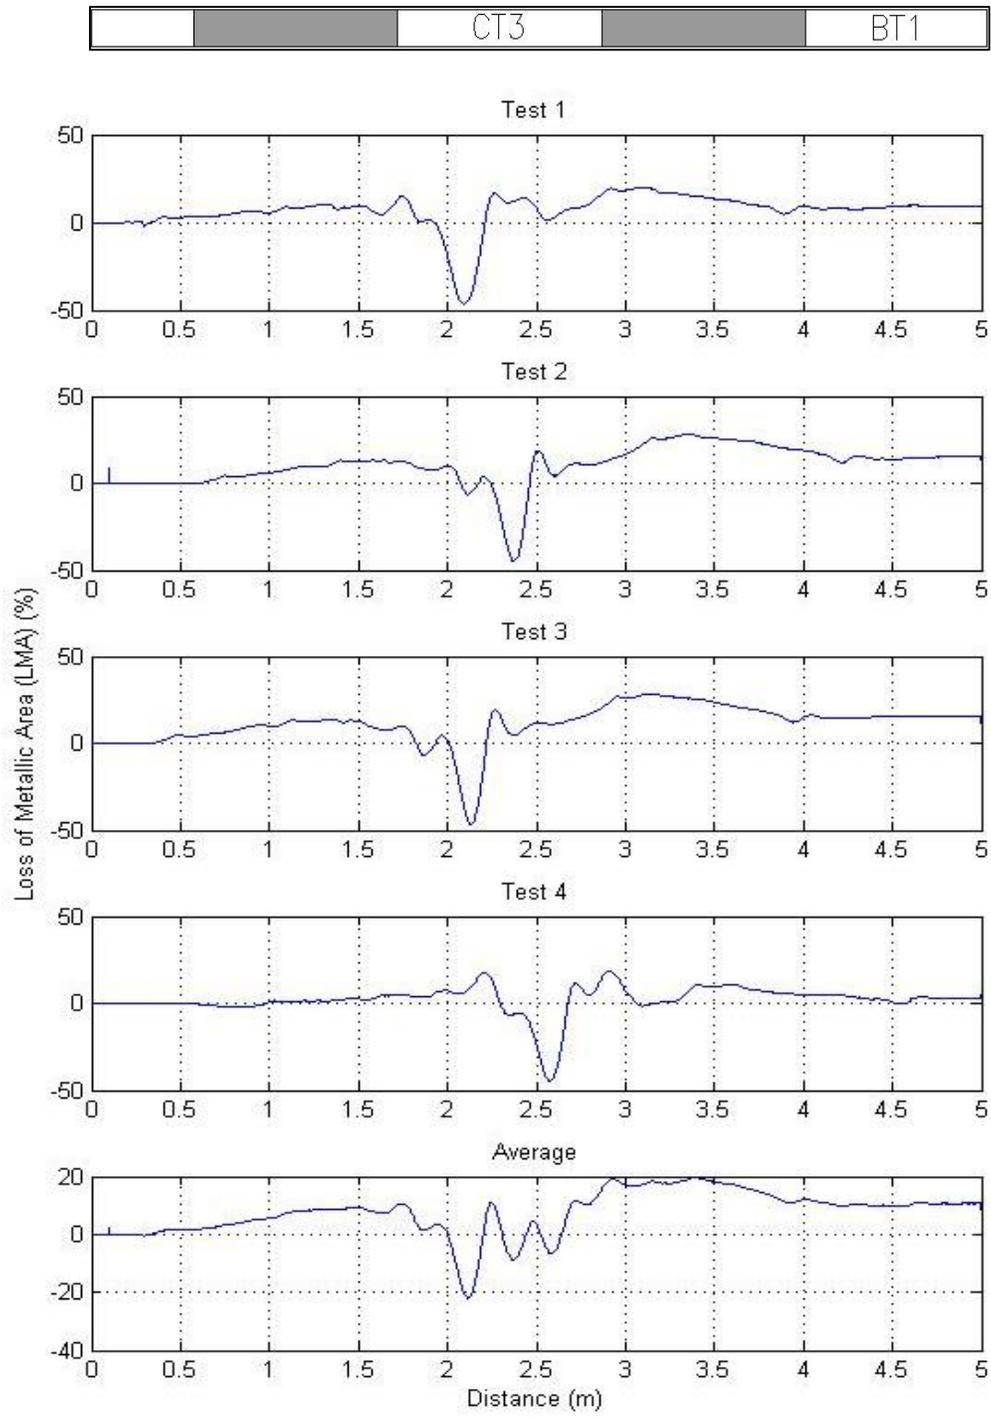
Figure B.2-2: Specimen 2 MFL Results

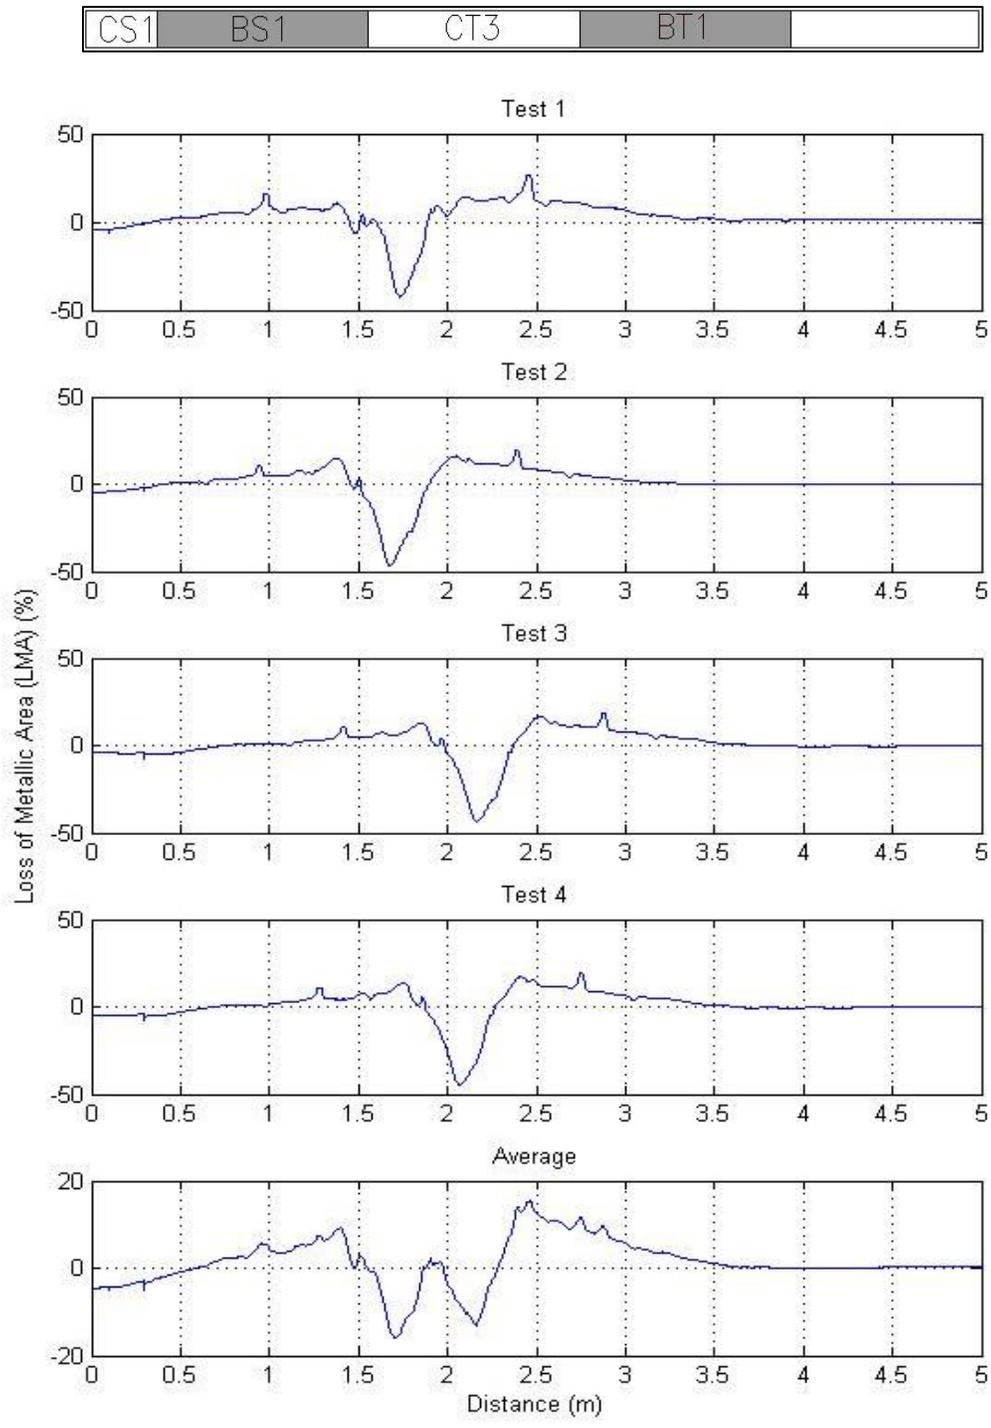
Figure B.2-3: Specimen 3 MFL Results

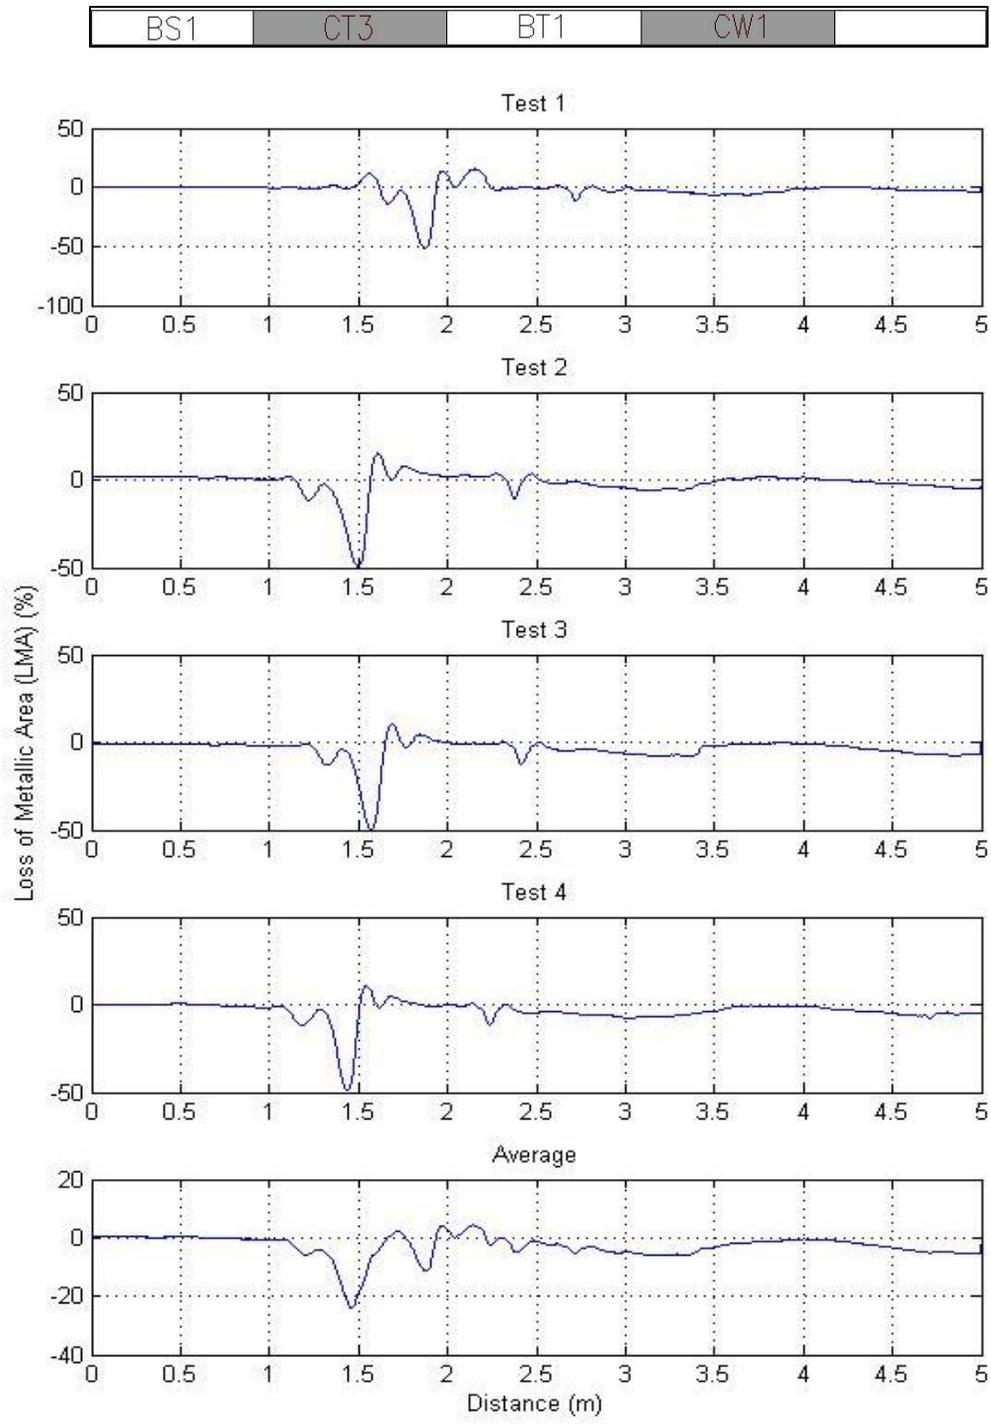
Figure B.2-4: Specimen 4 MFL Results

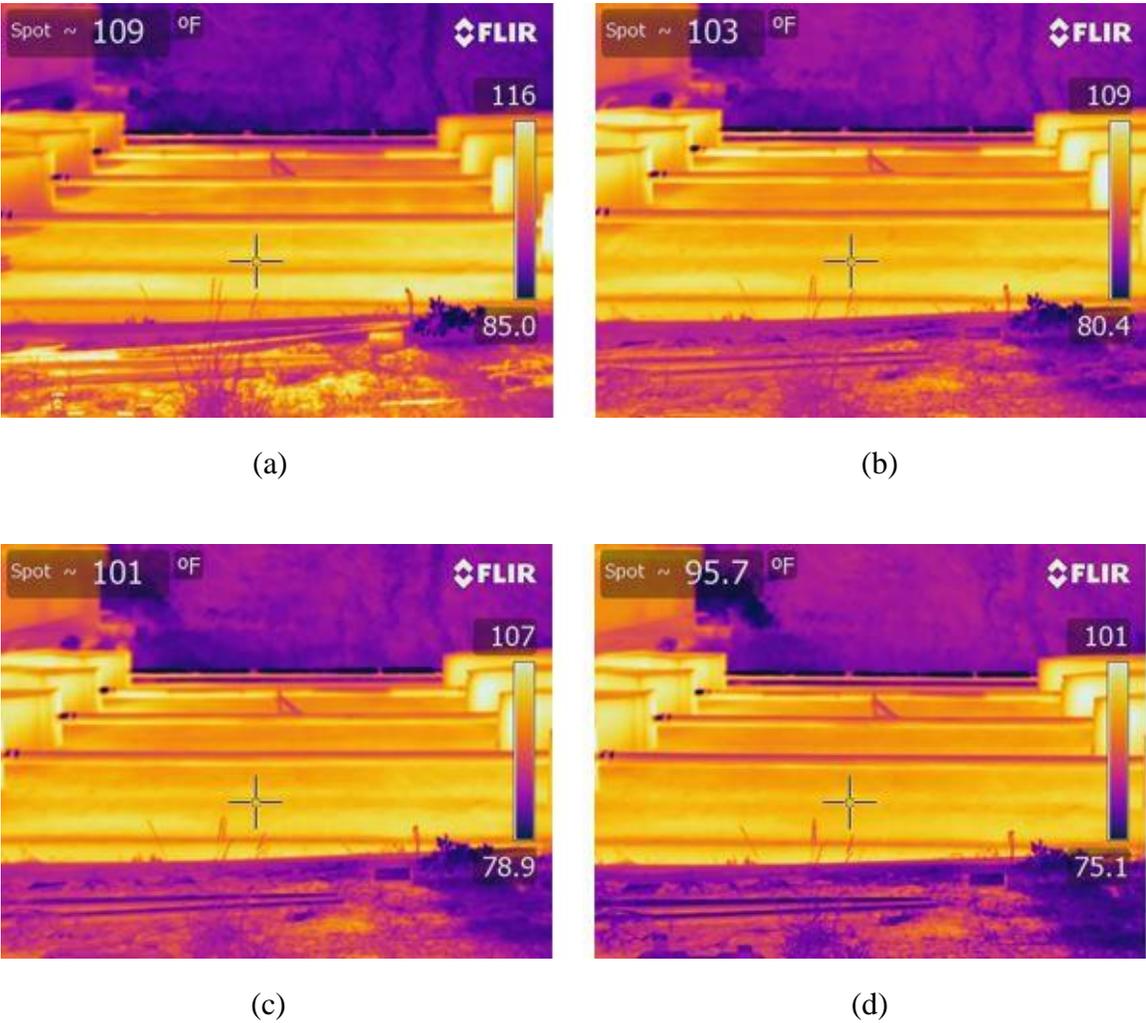
Figure B.3-1: Infrared Images of Mock-Up Specimens During Cooling Off Period

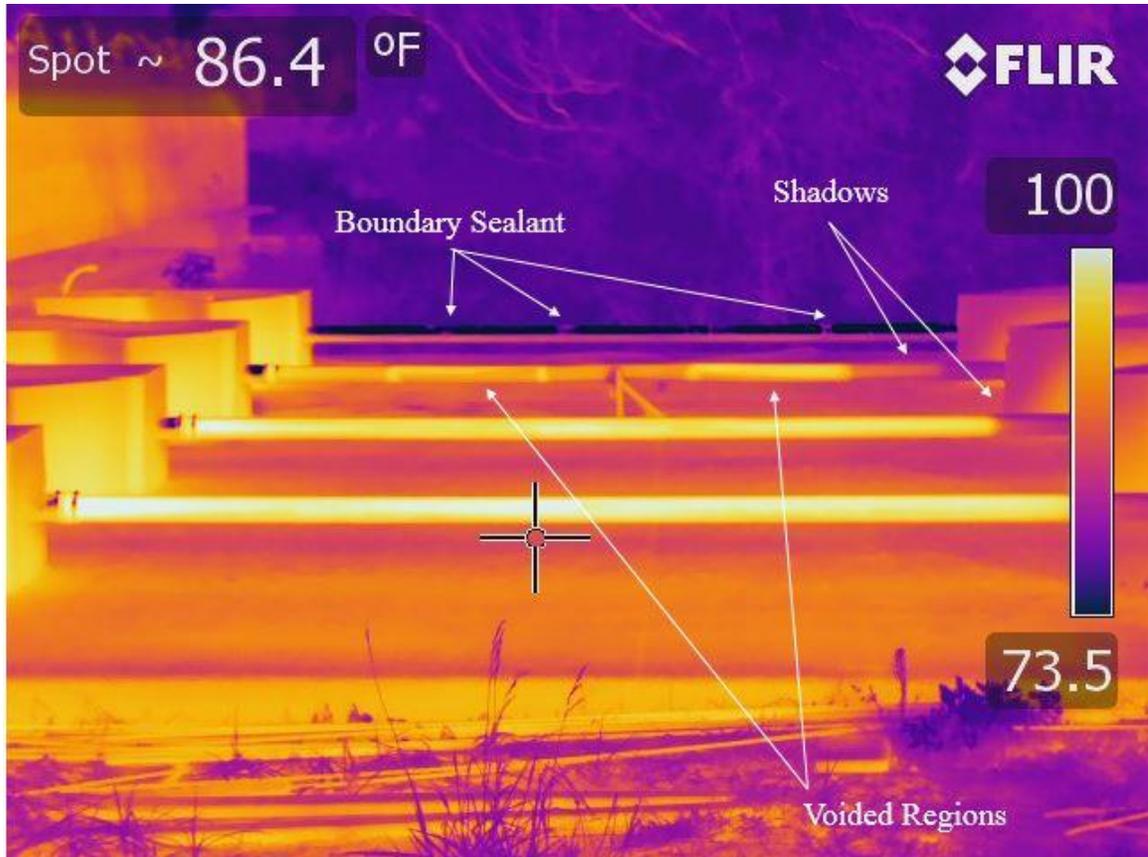
Figure B.3-3: Enlarged Infrared Images of Mock-Up Specimens During Heating Up Period

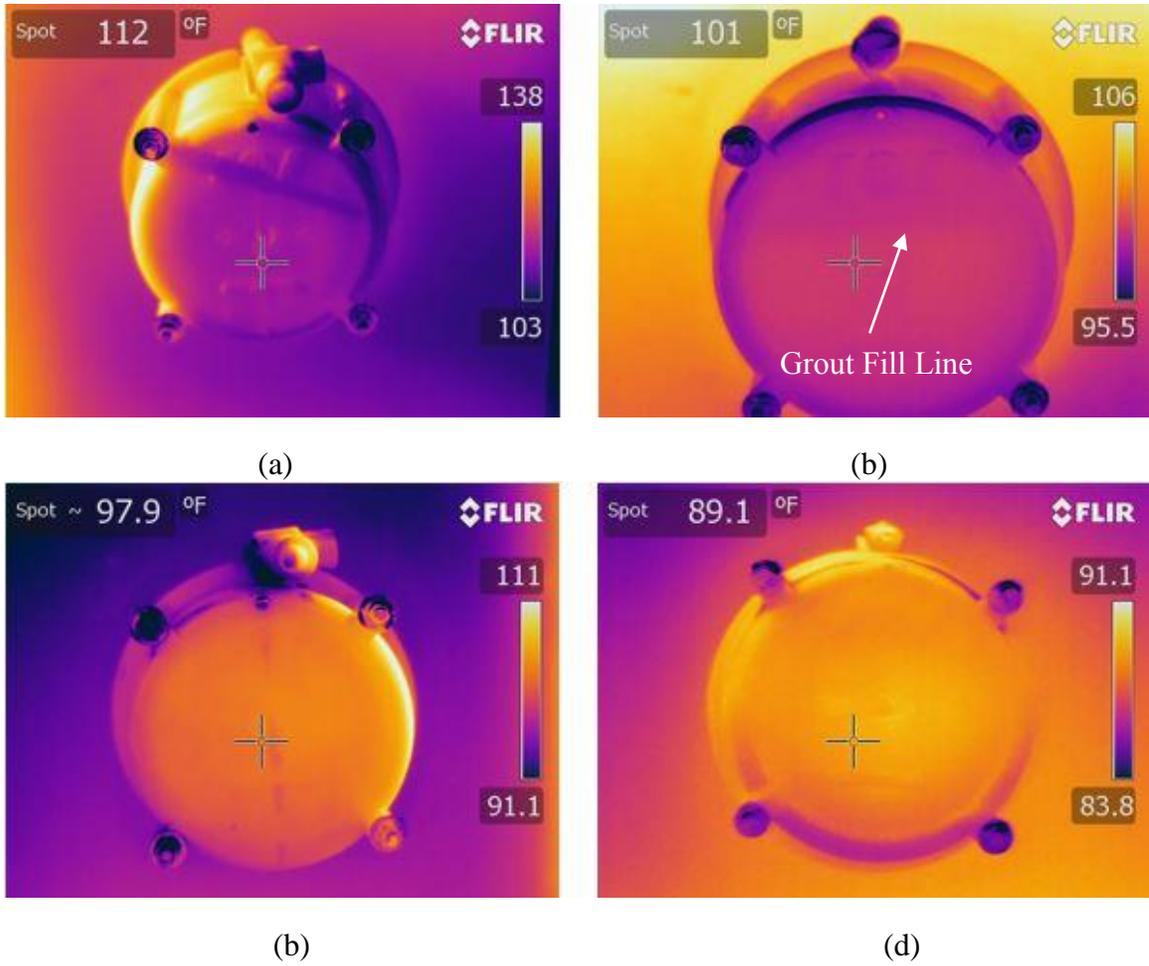
Figure B.3-4: Infrared Grout Cap Images of Specimen 1 (a) Gridline A During Cool Down (b) Gridline K During Cool Down (c) Gridline A During Heating Up (d) Gridline K During Heating Up

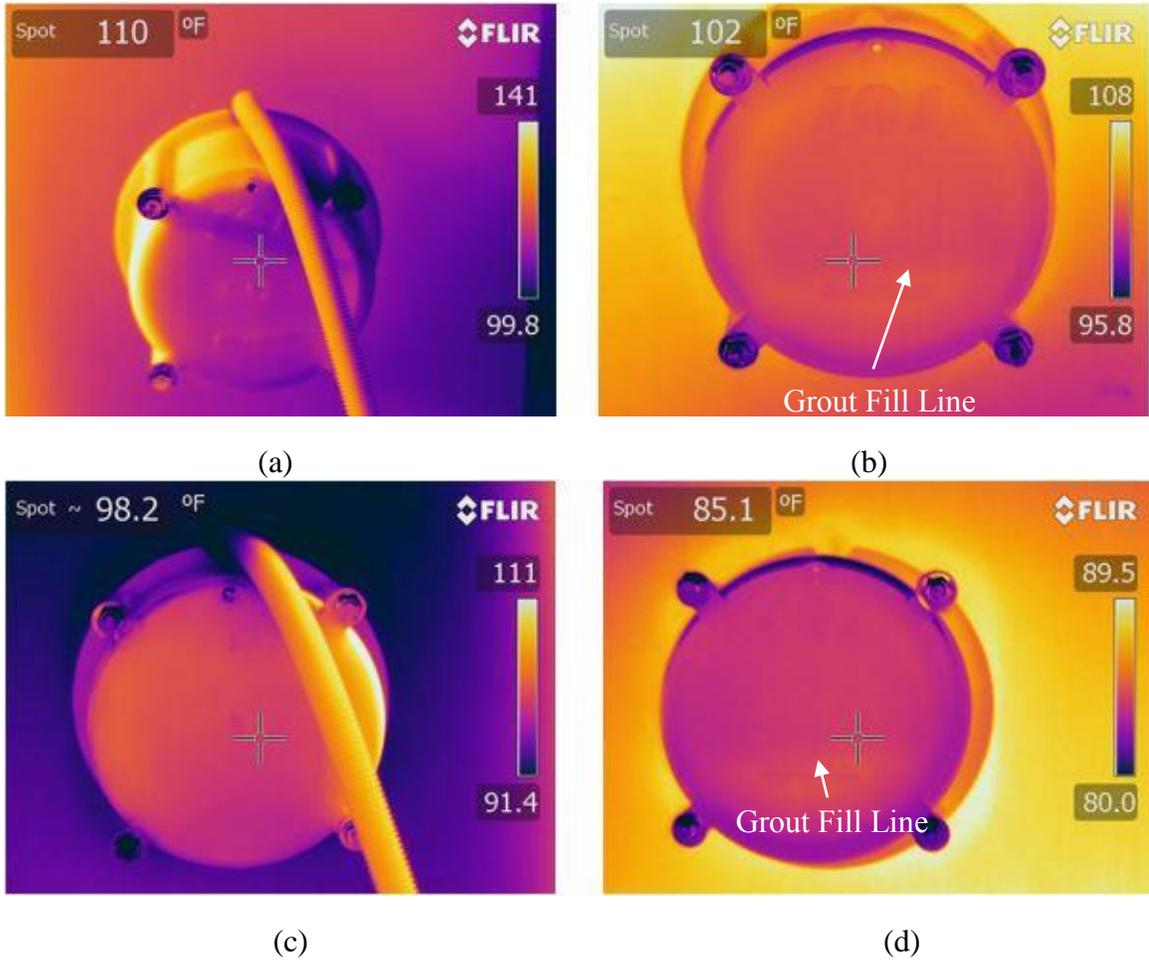
Figure B.3-5: Infrared Grout Cap Images of Specimen 2 (a) Gridline A During Cool Down (b) Gridline K During Cool Down (c) Gridline A During Heating Up (d) Gridline K During Heating Up

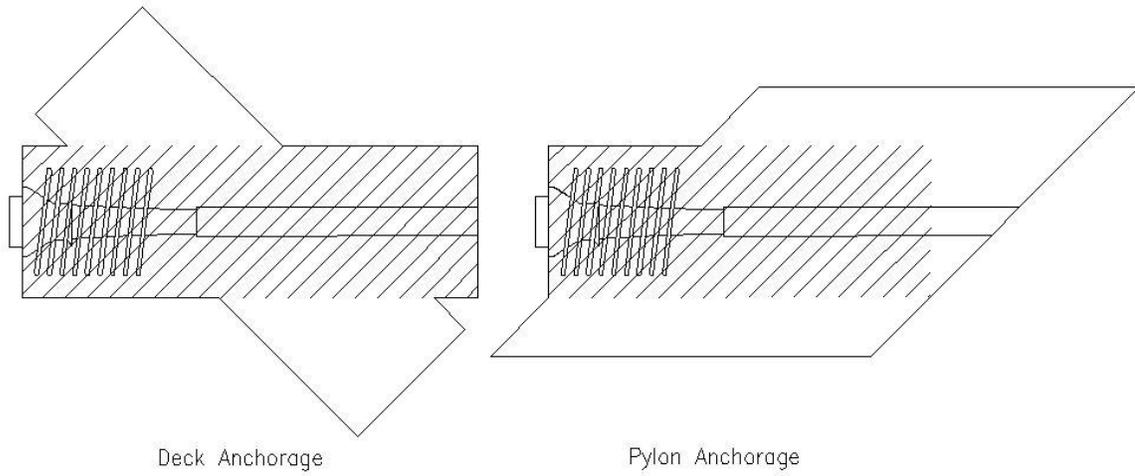
Figure B.4-4: UST Testing Areas for Top Scans

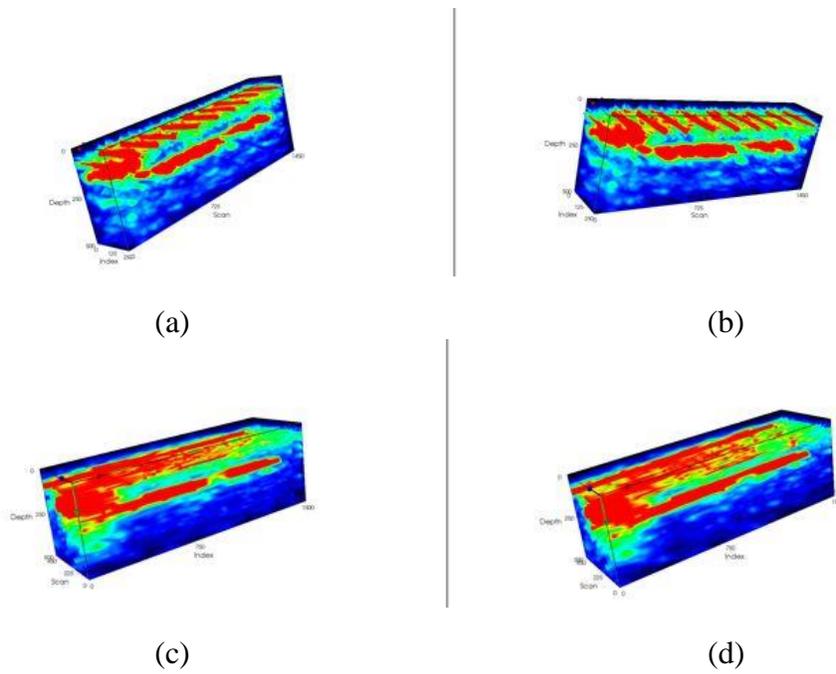
Figure B.4-5: UST 3-D Maps from Specimen 1 Deck Anchorage Top Scans (a) I (b) I (c) II (d) II

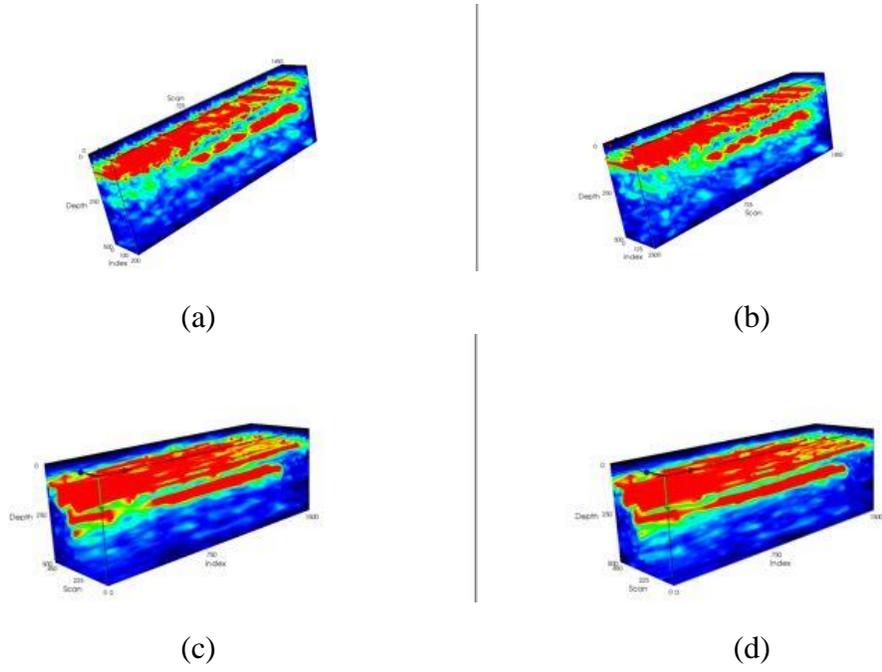
Figure B.4-8: UST 3-D Maps from Specimen 4 Deck Anchorage Top Scans (a) I (b) I (c) II (d) II

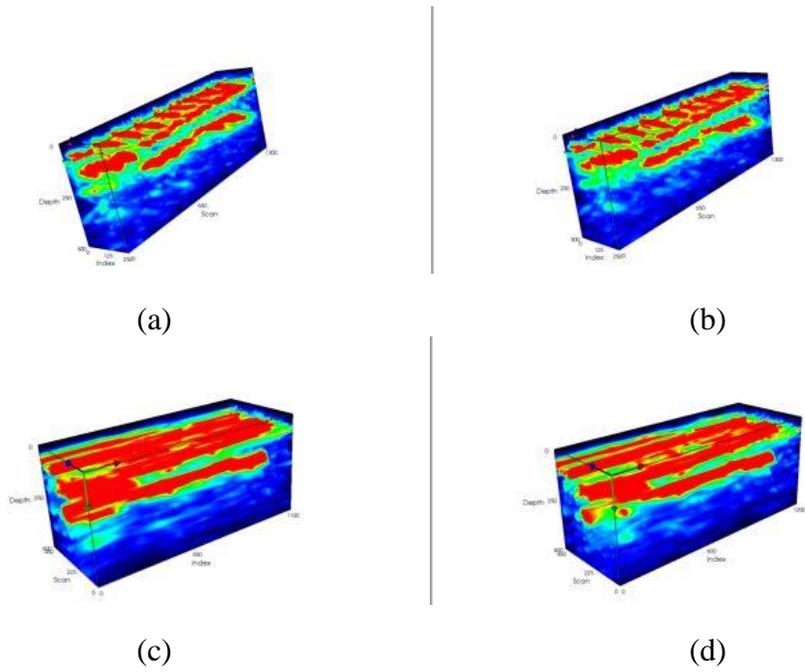
Figure B.4-9: UST 3-D Maps from Specimen 1 Pylon Anchorage Top Scans (a) I (b) I (c) II (d) II

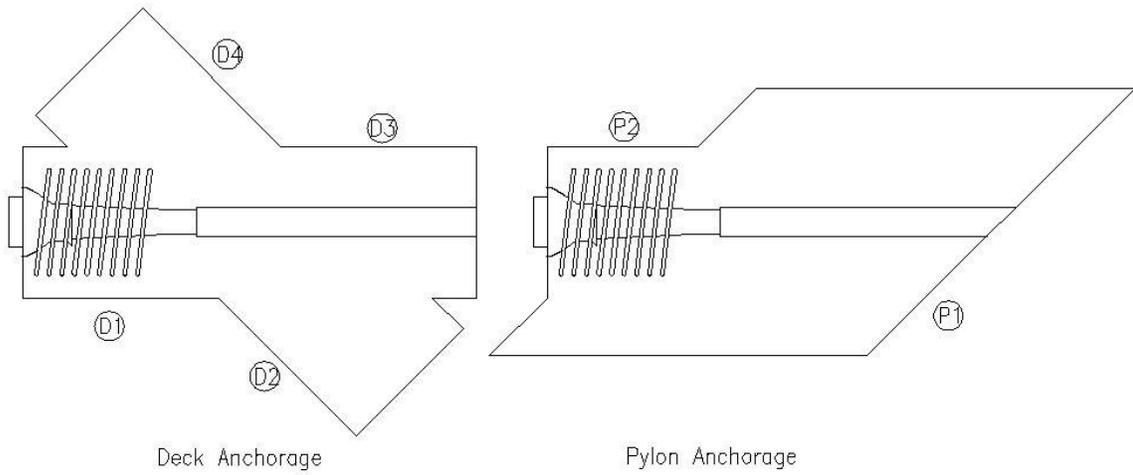
Figure B.4-21: Labels for UST Side Scans

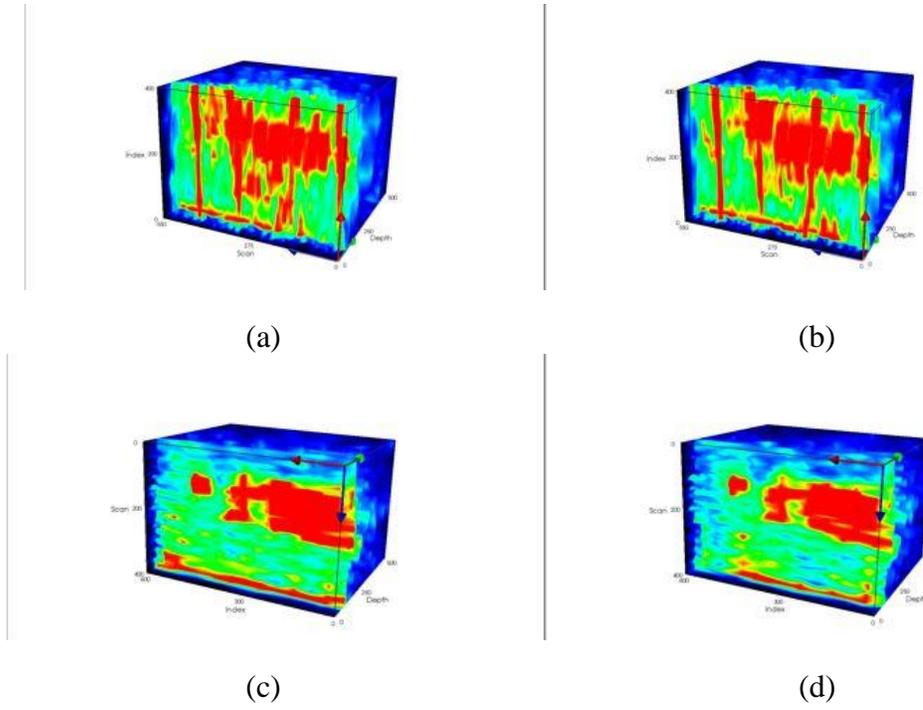
Figure B.4-22: UST 3-D Maps from Specimen 1 D1 Scans (a) I (b) I (c) II (d) II

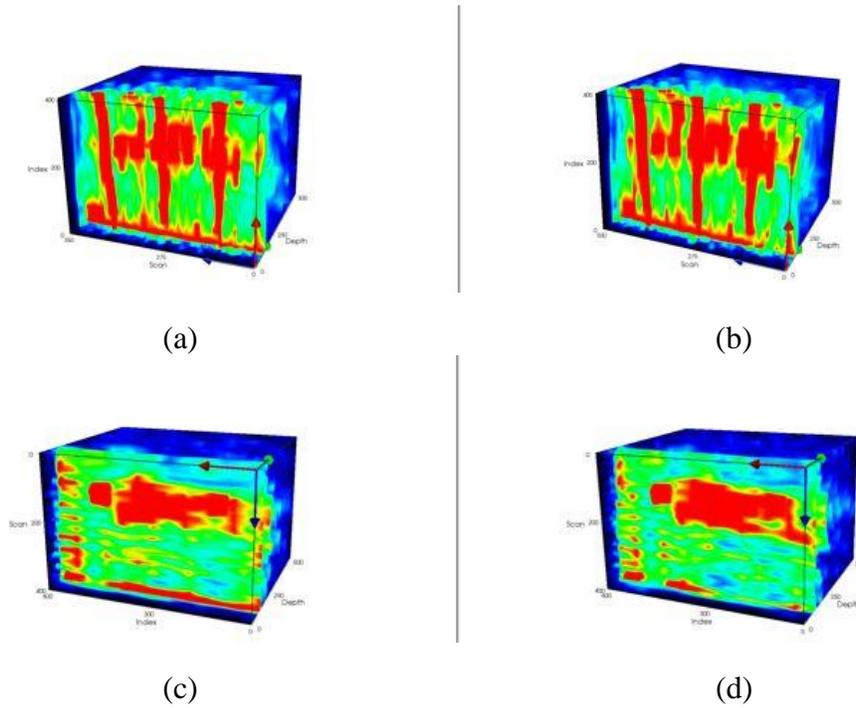
Figure B.4-23: UST 3-D Maps from Specimen 2 D1 Scans (a) I (b) I (c) II (d) II

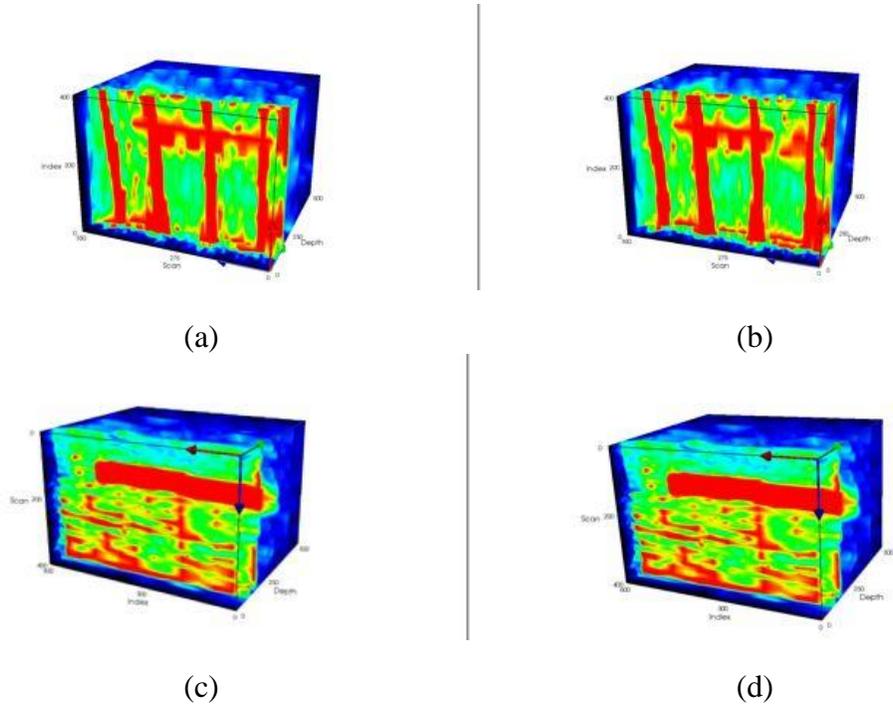
Figure B.4-37: UST 3-D Maps from Specimen 4 D3 Scans (a) I (b) I (c) II (d) II

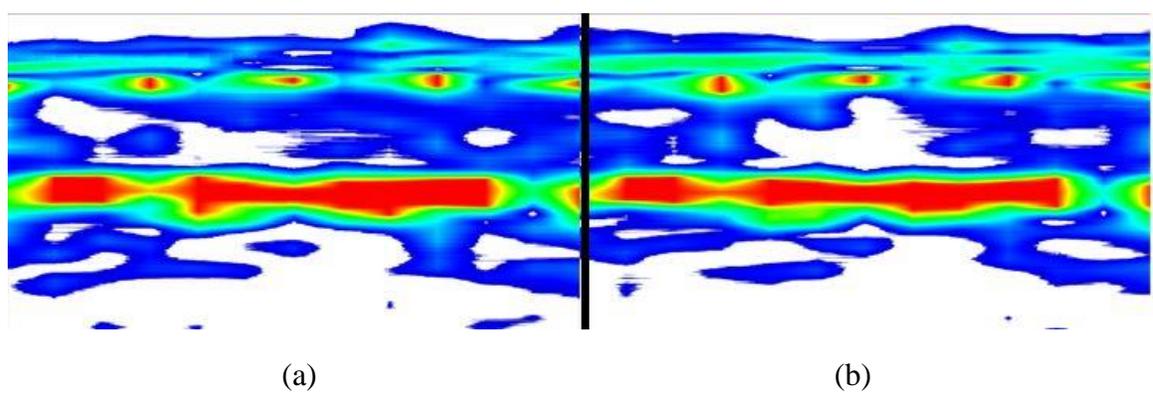
Figure B.4-38: UST C-scans Through Duct from Specimen 1 D3 Scans (a) II (b) II

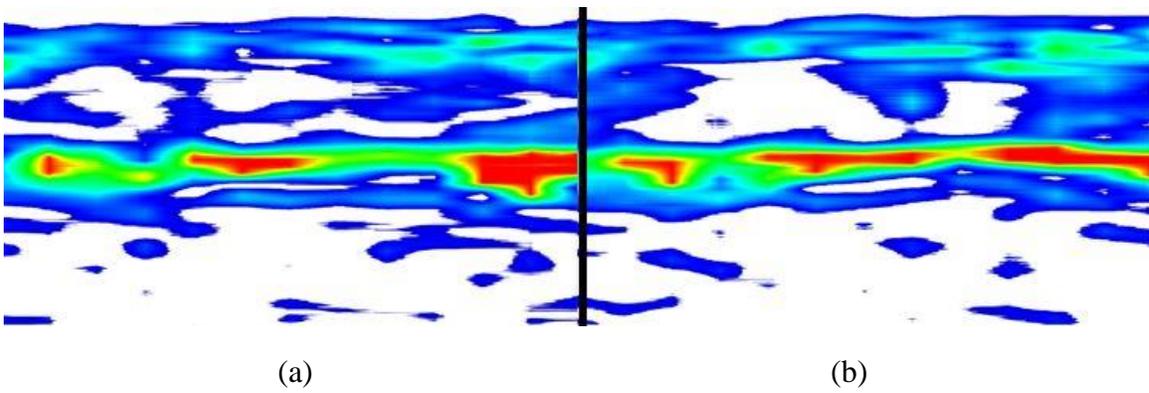
Figure B.4-40: UST C-scans Through Duct from Specimen 3 D3 Scans (a) II (b) II

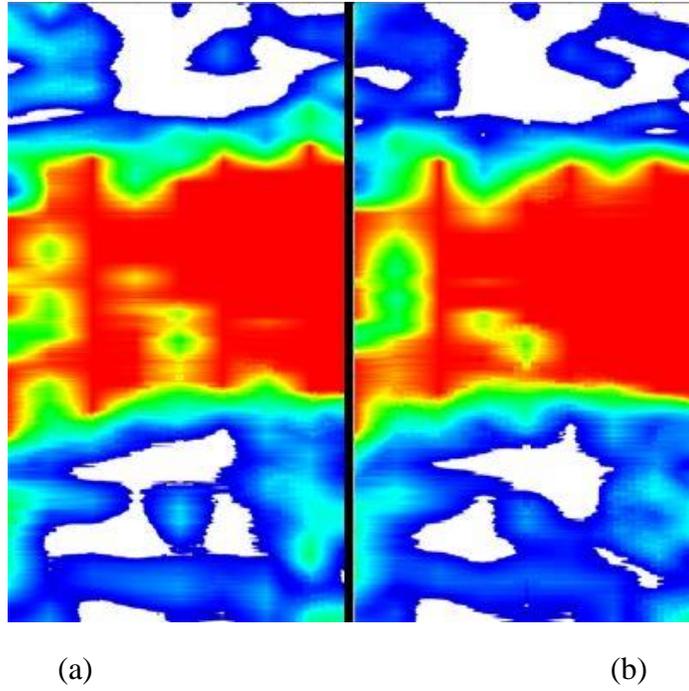
Figure B.4-54: UST D-scans Through Duct from Specimen 1 P2 Scans (a) II (b) II

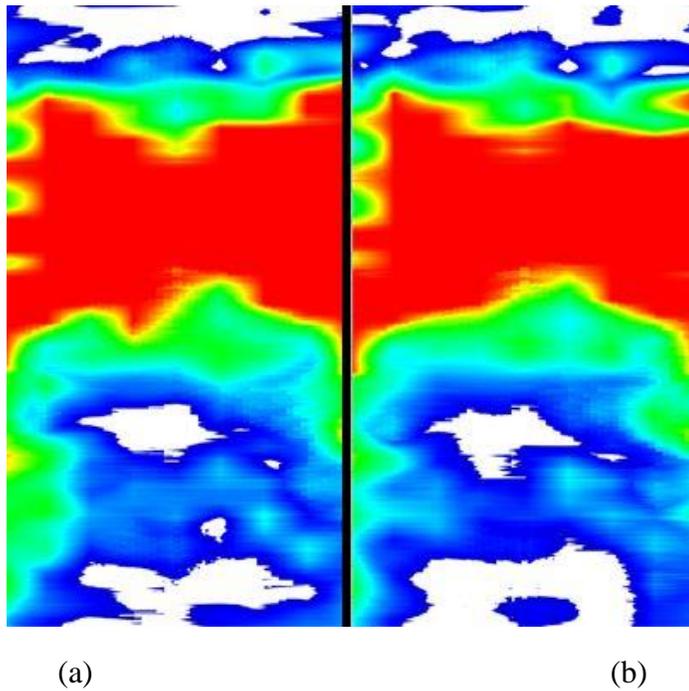
Figure B.4-55: UST D-scans Through Duct from Specimen 2 P2 Scans (a) II (b) II

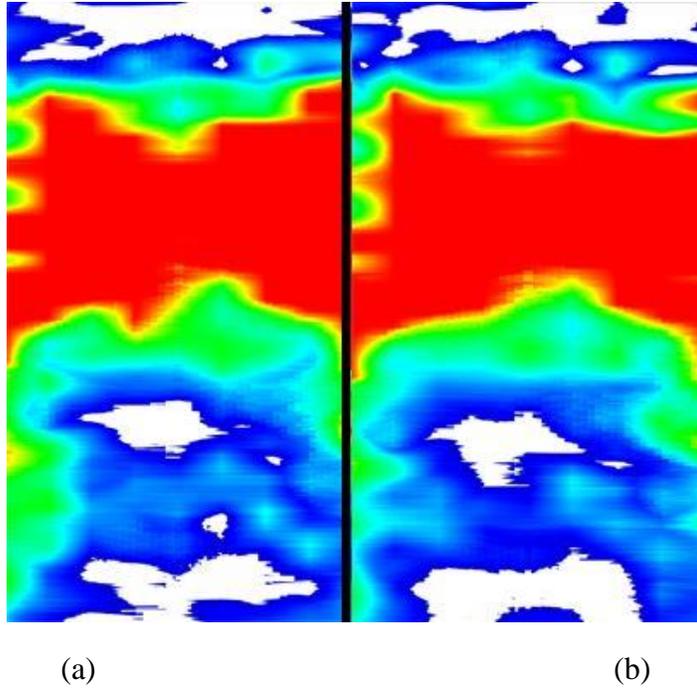
Figure B.4-56: UST D-scans Through Duct from Specimen 3 P2 Scans (a) II (b) II

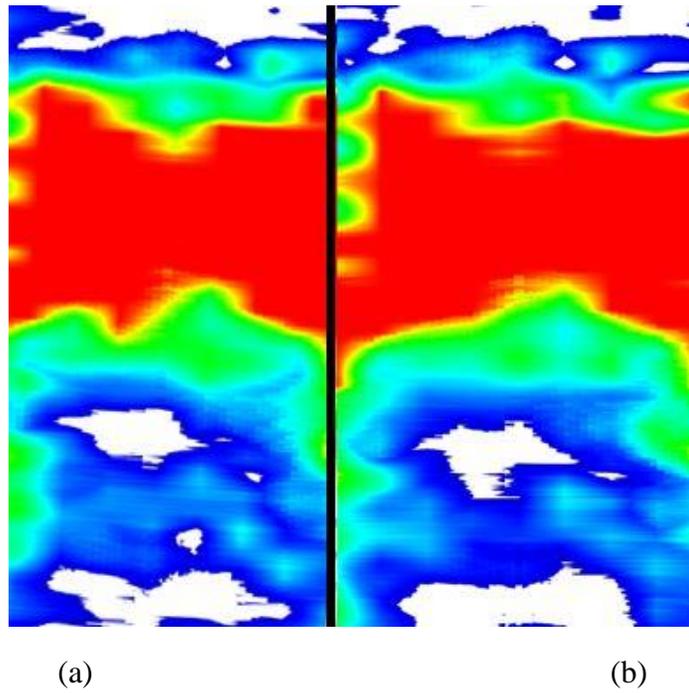
Figure B.4-57: UST D-scans Through Duct from Specimen 4 P2 Scans (a) II (b) II

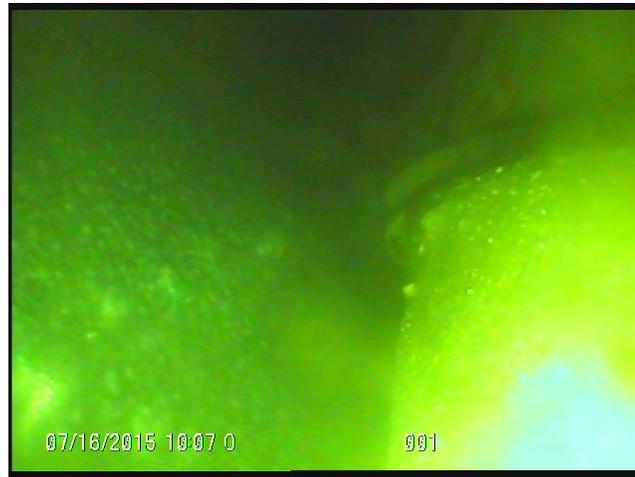
D-E:

Figure B.6-1: Borescope Photo of Water Infiltration in Specimen 1 Grid D-E

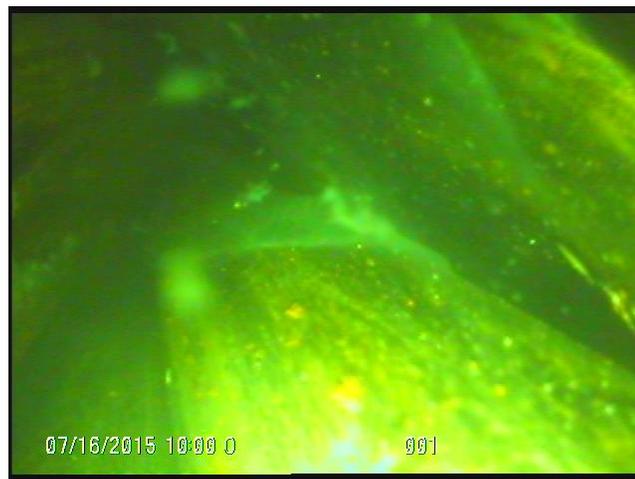
J-K:

Figure B.6-3: Borescope Photo of Water Infiltration in Specimen 1 Grid J-K
