# The Bhopal gas Tragedy: A safety case study

# The Tragedy

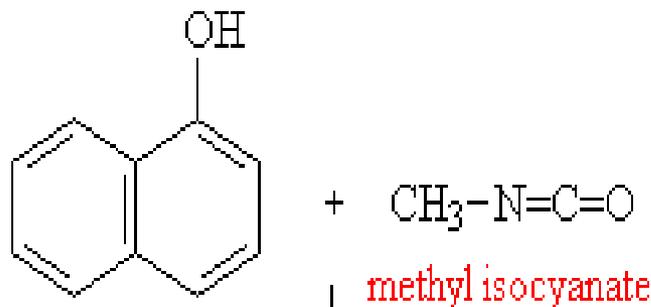
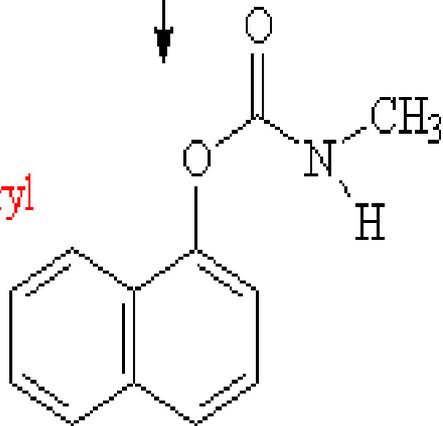
Ingredients:

Carbon Monoxide (CO)

Monomethylamine (MMA)

} imported by truck

Chlorine (Cl<sub>2</sub>)

Alpha-Naphthol (AN)

} made on site

Carbaryl

→ Process route

MIC stored in three 15,000 gal tanks

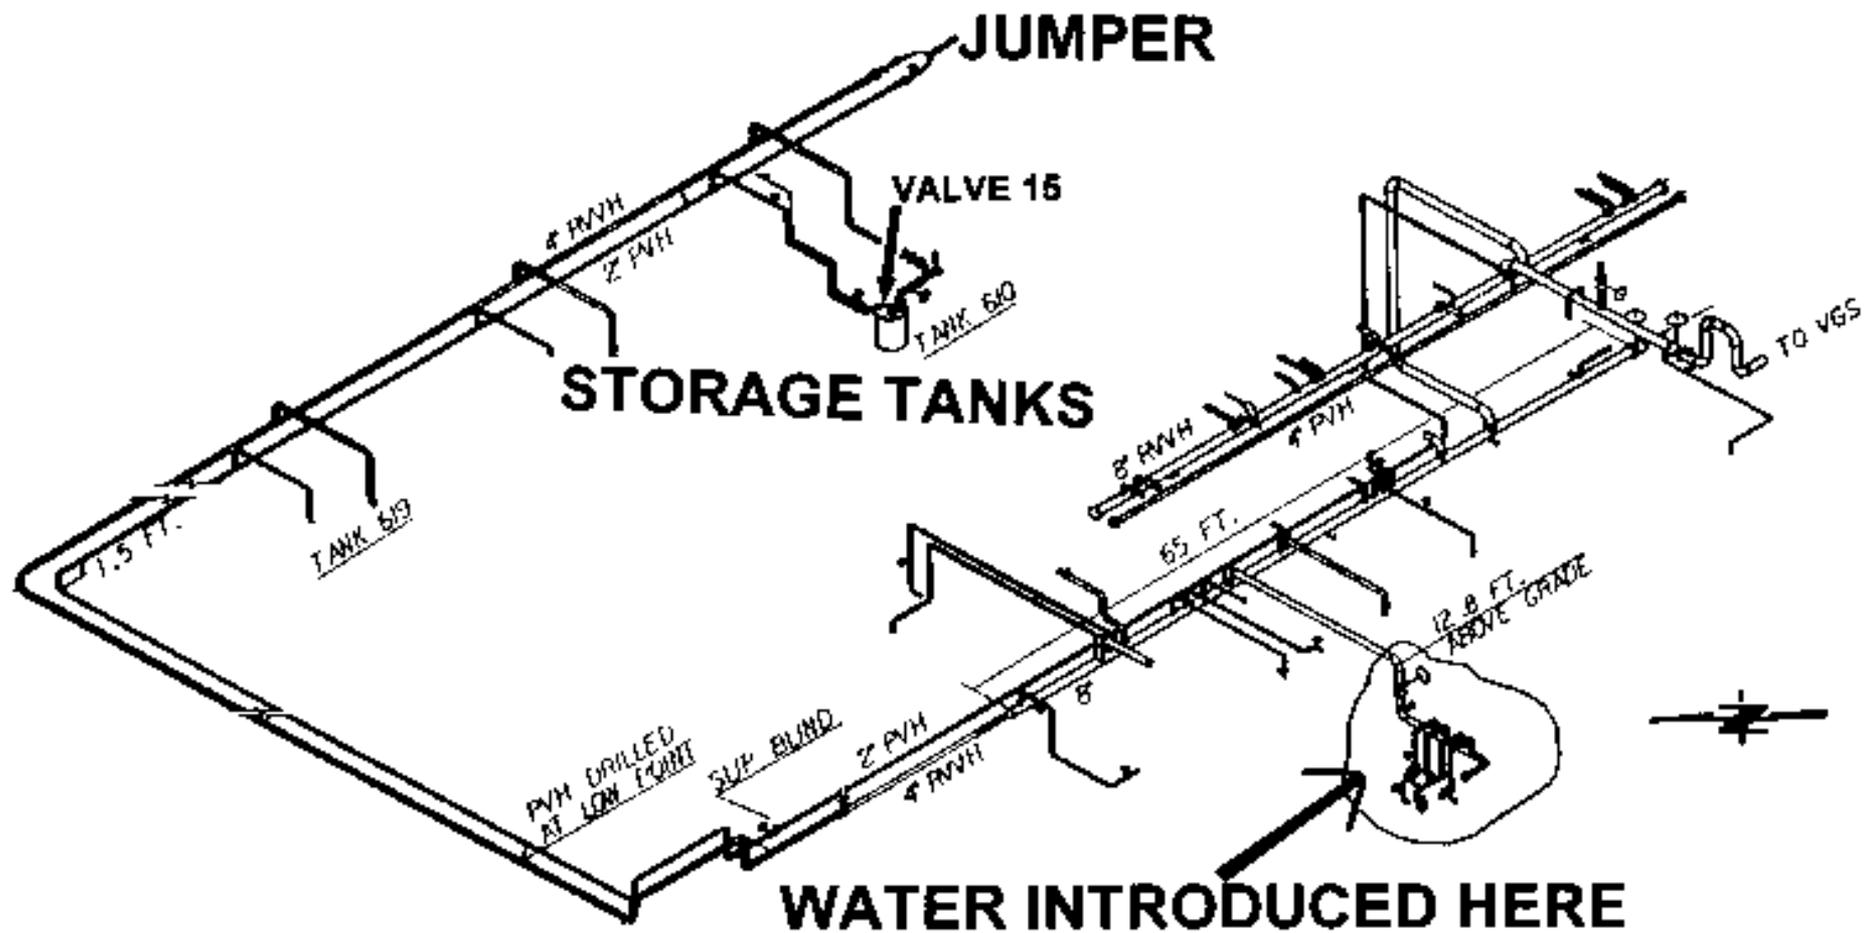
# The Water Washing Theory

- *New York Times* – large volume of water entered tank 610 causing the accident
  - “Water Washing Theory” - Employee violates policy and fails to use slip blind
- Union Carbide – large volume of water entered tank 610 causing the accident
  - Accident
  - Deliberate connection
  - Reveals several cover ups and possible sabotage by disgruntled employee
- Indian Government – similar to *New York Times*

8-9 pm: The MIC plant supervisor was ordered to wash out several pipes running from the phosgene system to the scrubber through the MIC storage tanks.

9:30 pm: The water washing begins. One of the bleeder valves (overflow device) was blocked.

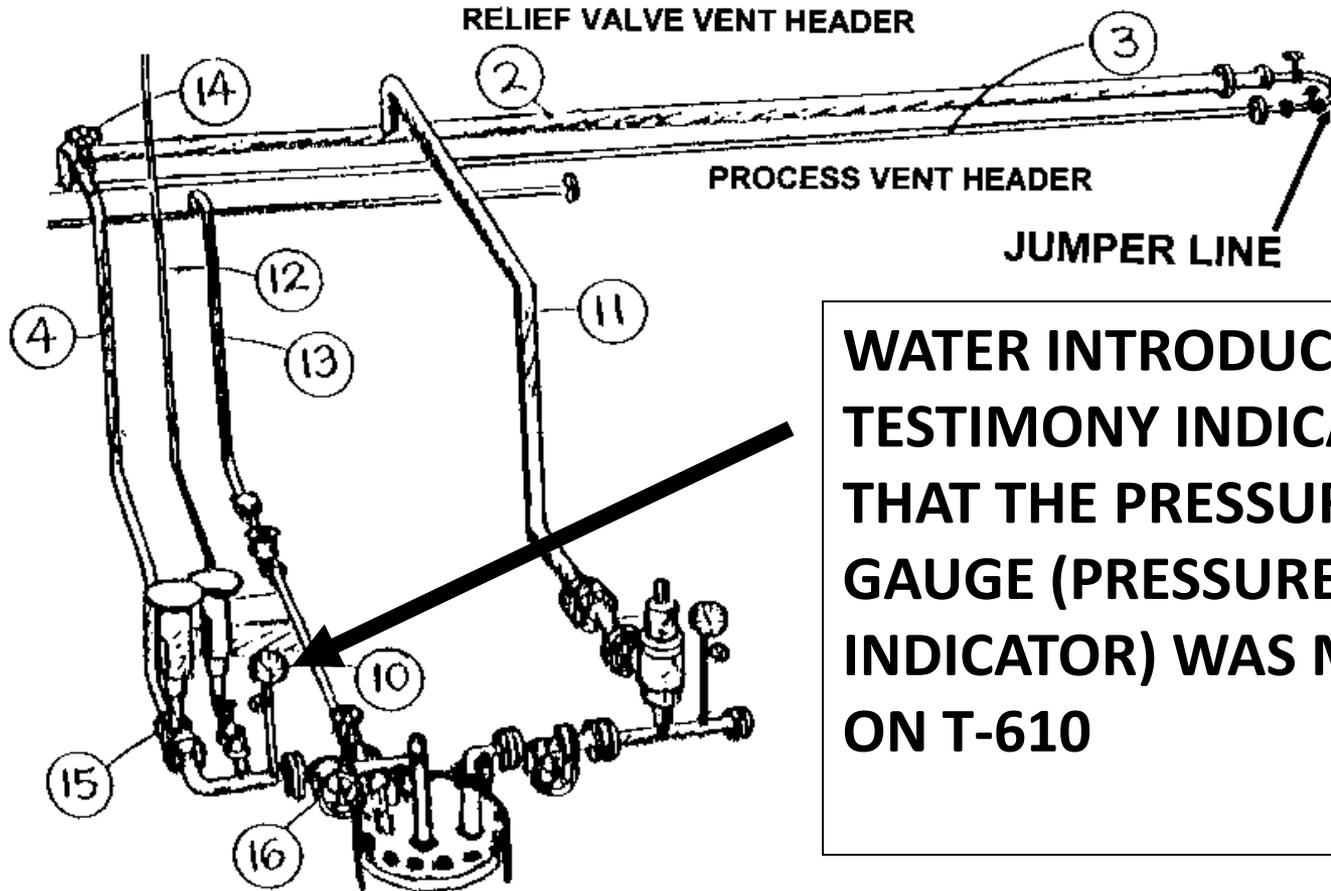
# Sabotage Theory

**WATER INTRODUCED  
TESTIMONY INDICATED  
THAT THE PRESSURE  
GAUGE (PRESSURE  
INDICATOR) WAS MISSING  
ON T-610**
