TURBOMACHINERY  
& PUMP SYMPOSIA

# Analysis and countermeasure for Sulfide Stress Cracking of Centrifugal compressor

Trouble Shooting Case 1

Trouble Shooting Case 2

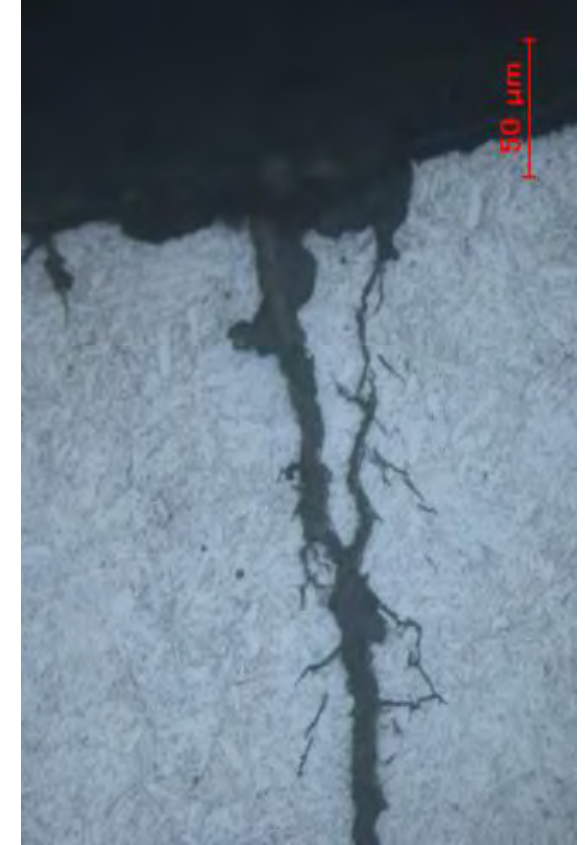
- Sulfide stress cracking (SSC) is a form of **hydrogen embrittlement** which is a cathodic cracking mechanism. Susceptible alloys, especially steels, react with hydrogen sulfide, forming metal sulfides and atomic hydrogen as corrosion byproducts. **Atomic hydrogen** either combines to form H<sub>2</sub> at the metal surface or **diffuses into the metal matrix**.
- Sulfide stress cracking has special importance in the gas and oil industry, as the materials being processed there (natural gas and crude oil) often contain considerable amounts of hydrogen sulfide.

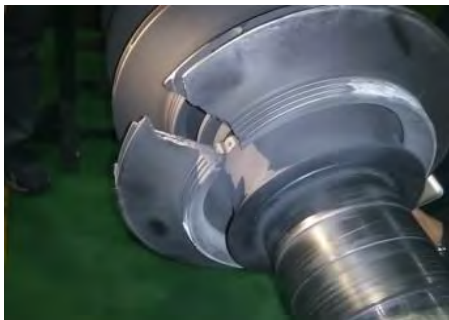
**1<sup>st</sup> Impeller**

- 1<sup>st</sup> impeller was cracked completely
- Wet contaminant on suction side
- Heavy fouling on labyrinth

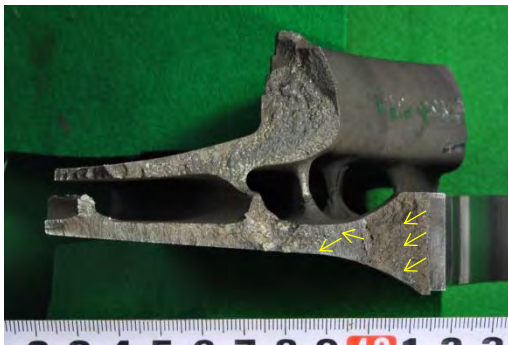
- 1** Crack initiated from Key groove of impeller

- High Hardness<sup>1)</sup> (HB 261)
- Stress Concentration on Key Groove

- Avoiding high stress concentration on rotor (Keyless type impeller)

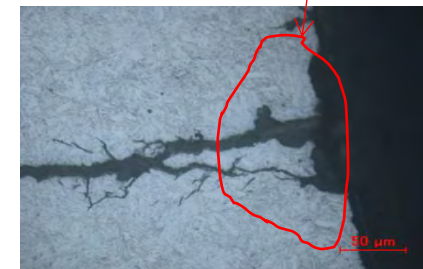
**Corrosion Pit**

- 6** Additional Cracks on Key Groove (w/Corrosion pit , 2<sup>nd</sup> Crack)

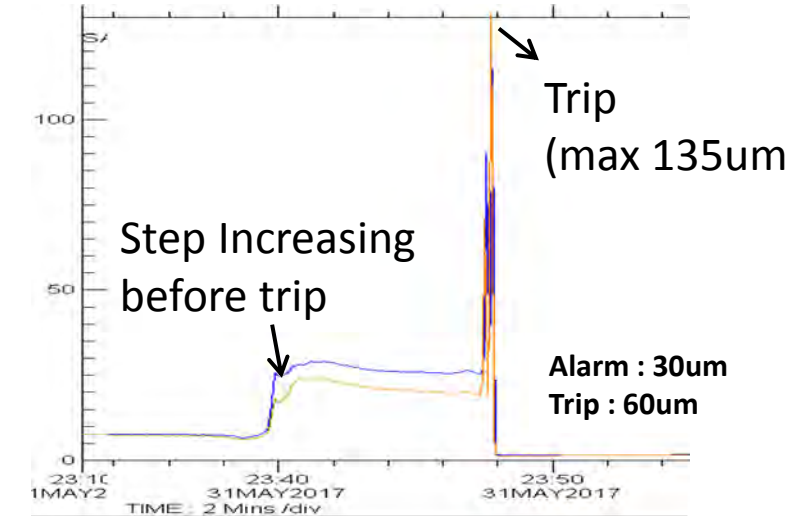
Vibration Trend : step changed and tripped in a few minutes

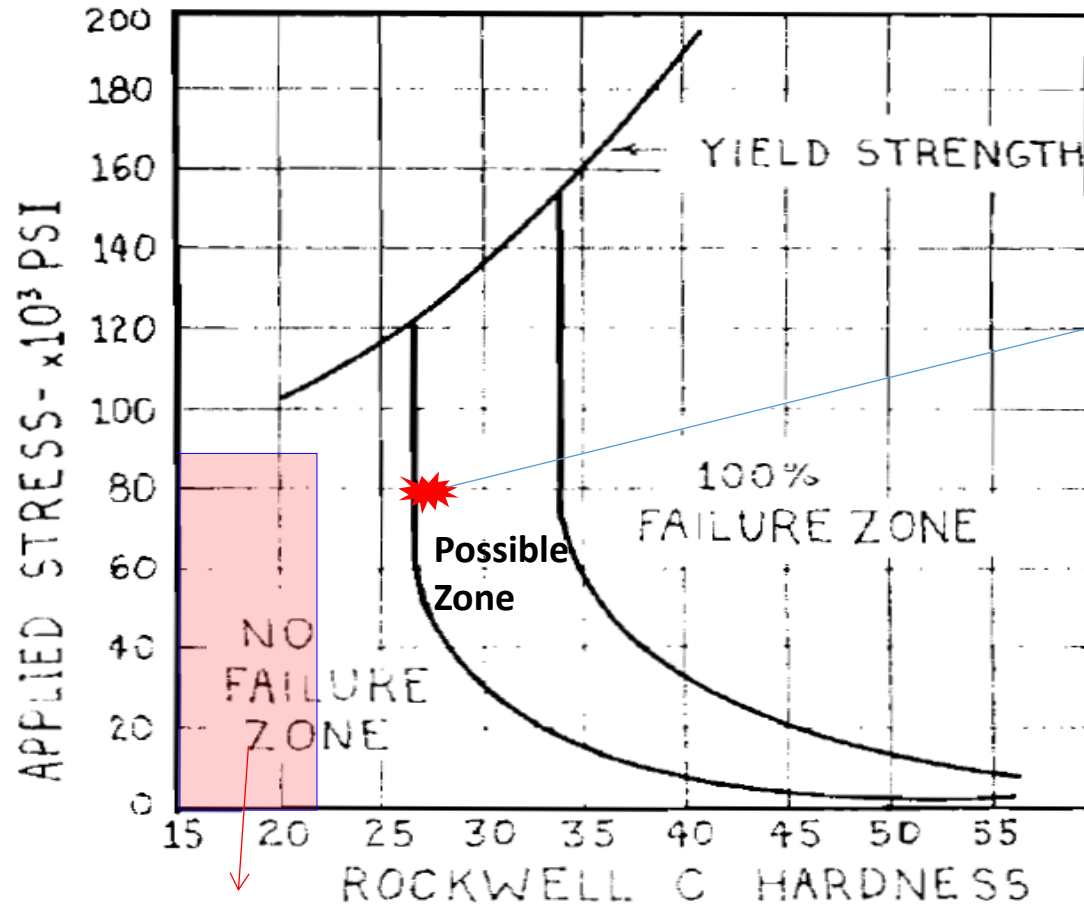
Case 1 material hardness

API Limit Zone  
(Failure Free Zone)

- For AISI4140
- Test result in the condition of H<sub>2</sub>O+H<sub>2</sub>S 40°C, 250 psi

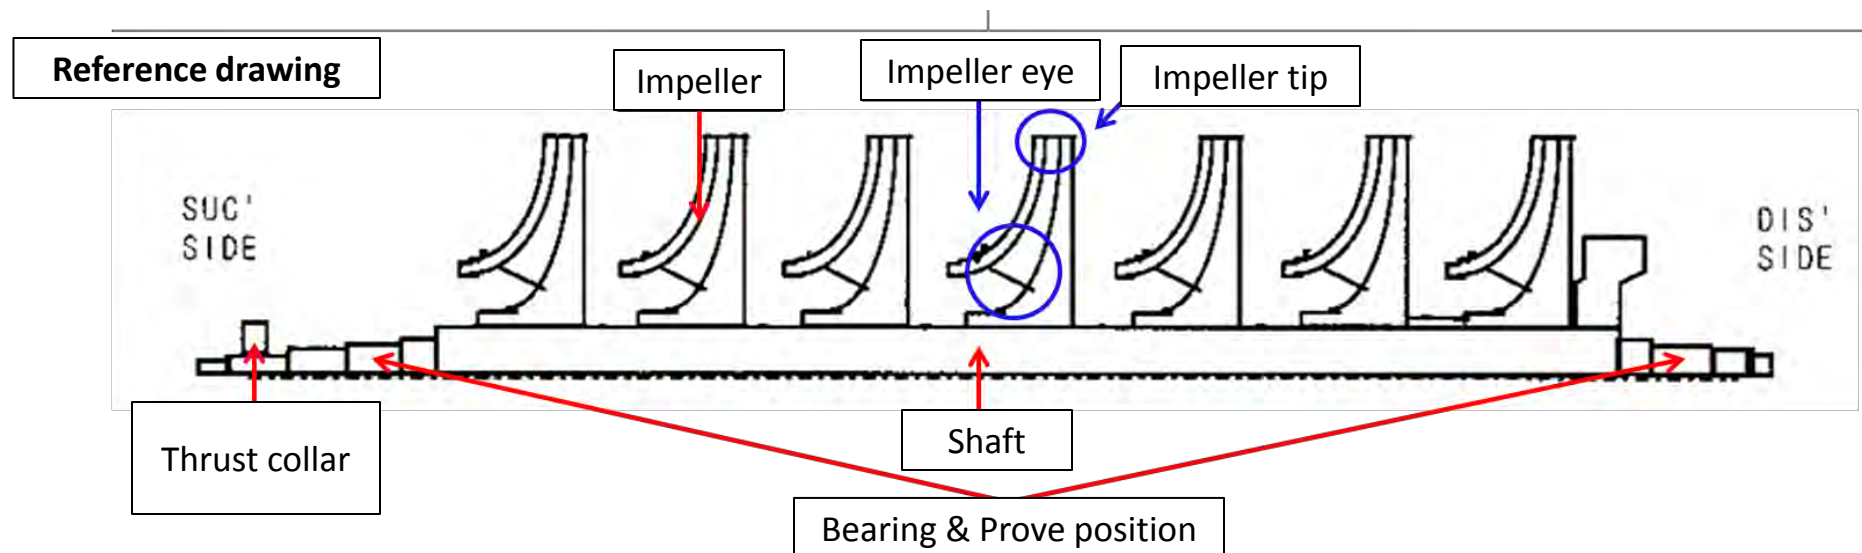
Parts	Surface crack inspection for rotor	
Inspection Point	Overall surface of rotor excluding the position of bearing, prove, thrust collar	
Method	Visual inspection	By mechanical division
	WFMT	By inspection division
	PT	By inspection division

Because it's impossible to inspect the internal surface of impeller in detail, impeller eye and tip applied the magnetic field are enough to inspect. If applied WFMT. Magnetic field have to be eliminated and residual magnetic field have to be under 3 Gauss after WFMT
