High Reliability Pistons for Reciprocating Compressors – Non Lube Piston for 5 Year Run-Time

Andreas Brandl, Cory Bulloch HOERBIGER Service Inc. Houston, TX

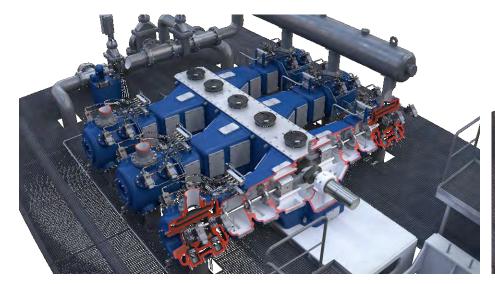
Cut through a two-throw compressor

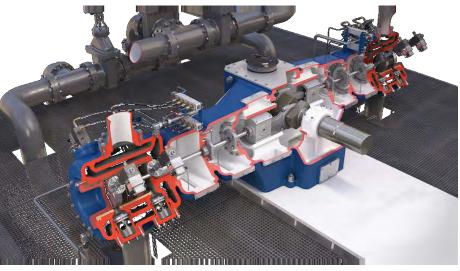
Six throw compressor

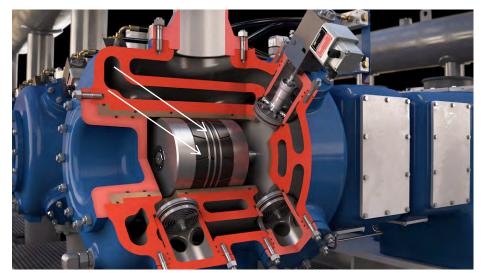
Piston rings: Sealing

Rider bands: Weight

Cut through compressor cylinder

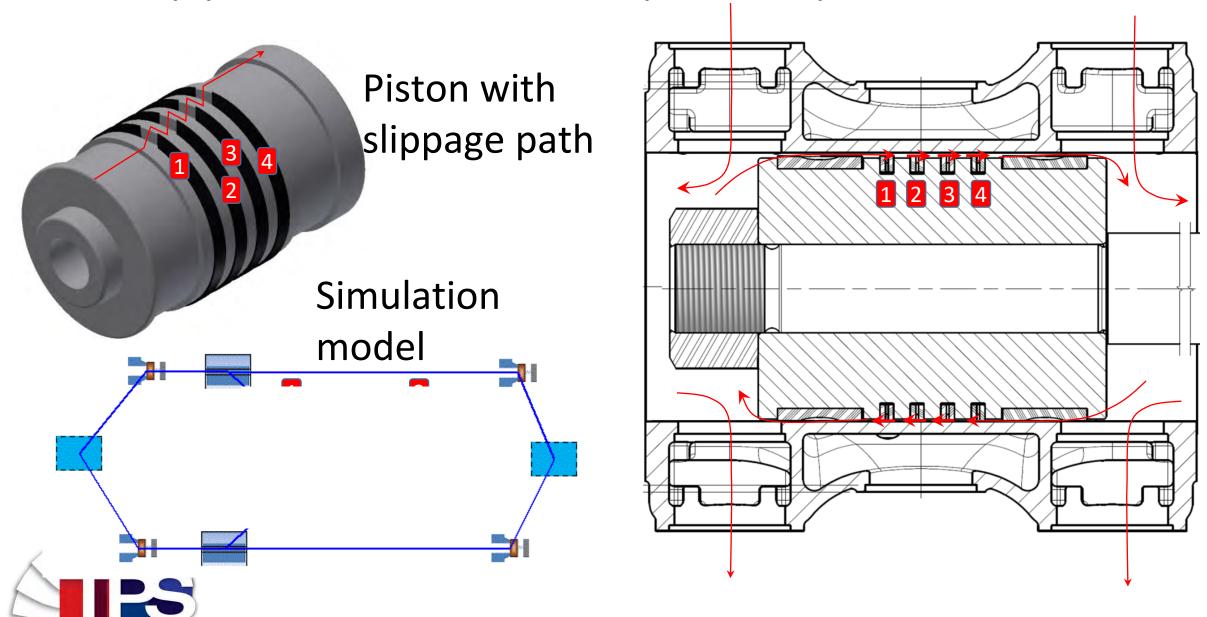
New approach to model piston performance

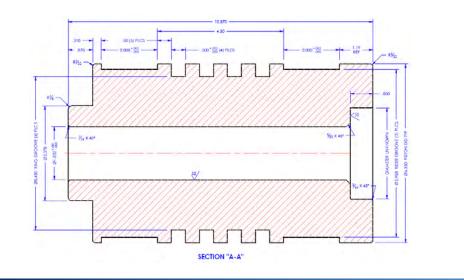
Non-Lube H2: Capacity losses due to blow-by

Compressor Data	
Cylinder dia [in]	6.5
Stroke [in]	9
Speed [rpm]	412
Driver Power [hp]	170
Suction Pressure [psig]	395
Discharge Pressure [psig]	810
Cylinder Lubrication	Non-Lube
Avg Piston Speed [ft/min]	618

Single Throw Unit	
H2	99%
CH4	1%
Molecular Mass [kg/mol]	2
Isentropic exponent	1.4

Predicted capacity losses 15% after one year

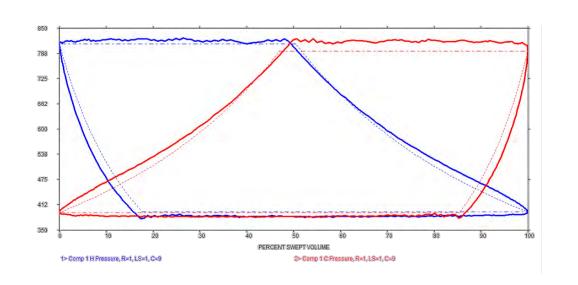
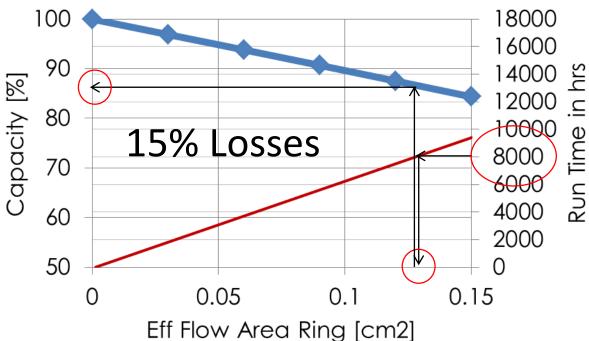
Measured pV diagrams confirm the capacity losses due to blow-by

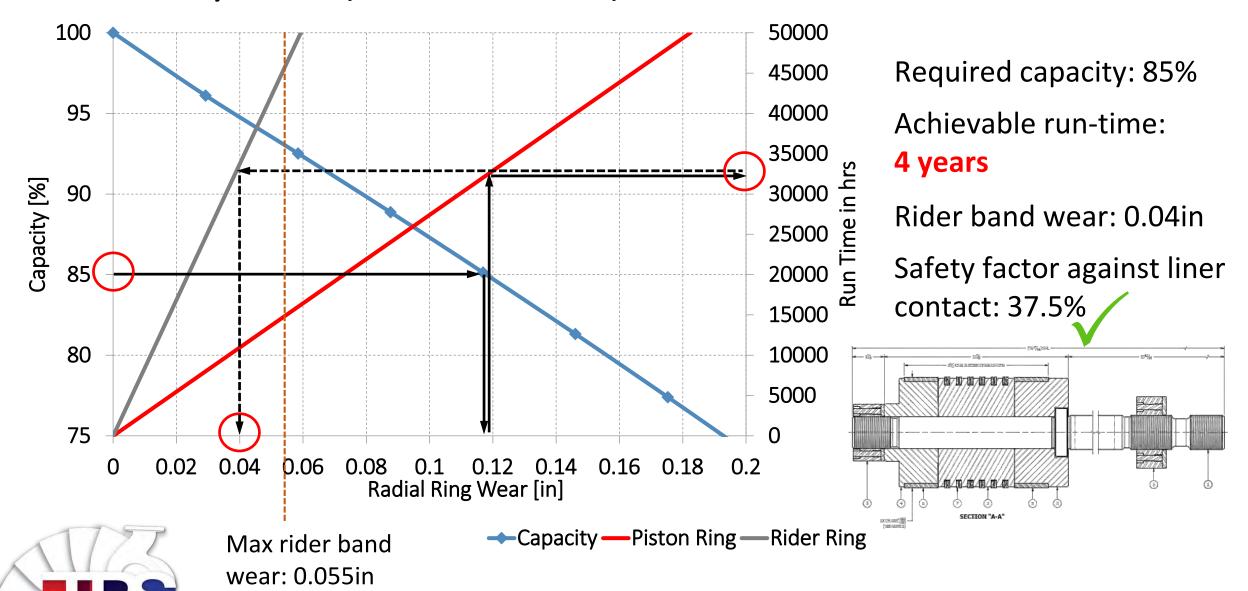
Piston layout (Non-Lube) for Max Run-Time

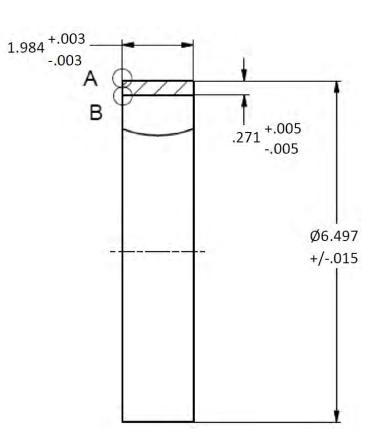
Drawing of Uncut Rider Band

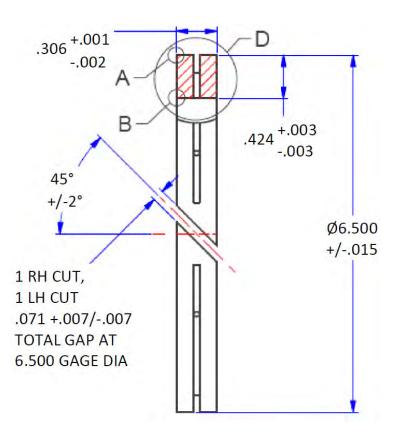
Drawing of Pressure Balanced Piston Rings

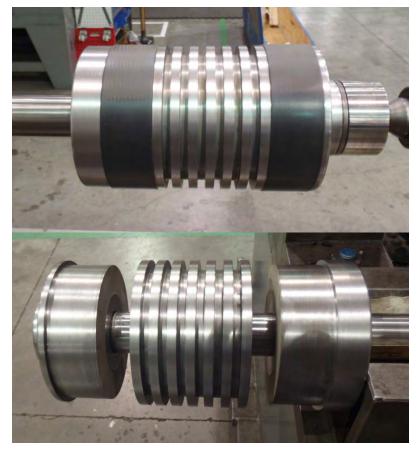
Piston after 20 months of run-time

Piston ring wear: 0.036in

Ring inspection after 20 months of run-time

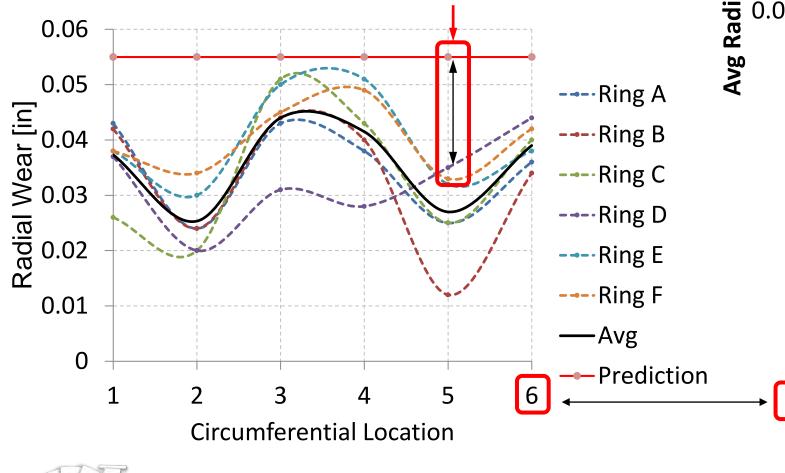
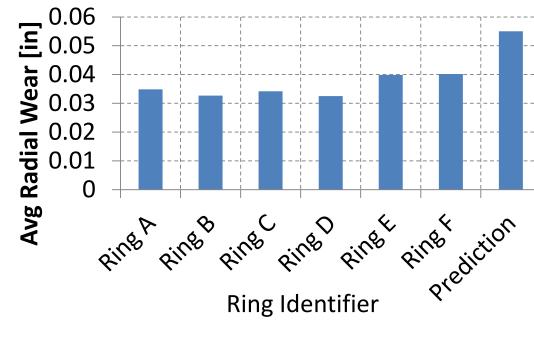
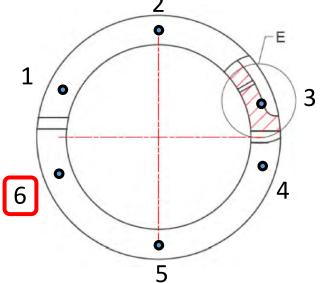
Difference: Predicted wear vs. measured wear

Rider band wear: < 0.01in

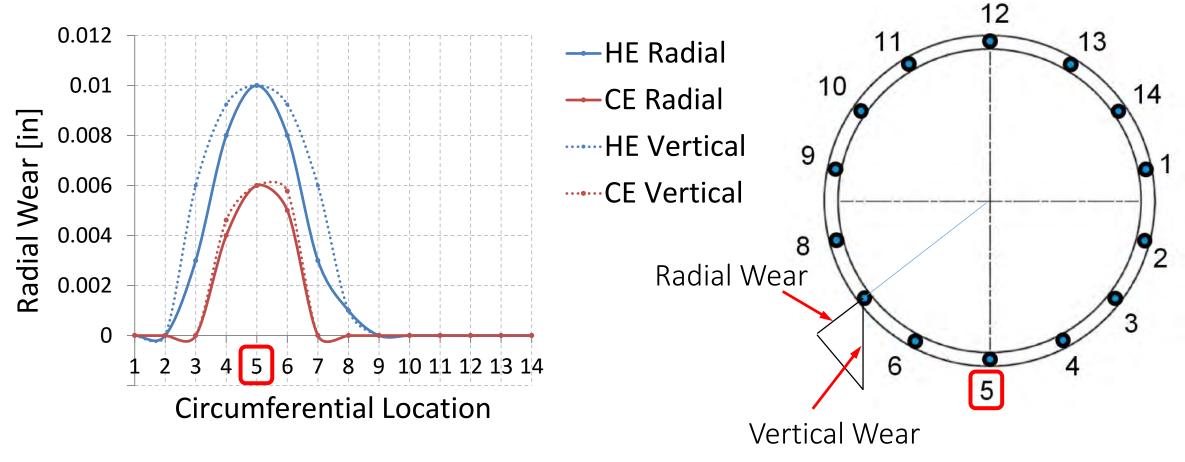
Avg. wear on HE rider: 0.0081in (Prediction: 0.018in)

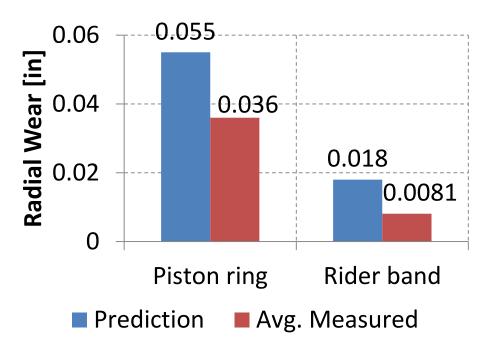
Inspection after 20 months run-time

Avg. contact pressure on piston rings [psi]	14.3
Avg. contact pressure on rider bands [psi]	4.5
Factor	3.18
Avg. wear on piston rings [in]	0.036
Avg. wear on rider band (HE) [in]	0.0081
Factor	4.44

- Wear is higher on tips of the rings
- Wear pattern and absolute wear is comparable on all piston rings
- Wear is lower than predicted (especially on rider bands)
- Non-Lube Piston design for 5 year run-time (prediction: 4 year run time)
