TURBOMACHINERY
& PUMP SYMPOSIA

RADIAL SUBSYNCHRONOUS VIBRATION CAUSED BY AXIAL VIBRATION

This case study depicts the cause of a radial subsynchronous vibration during mechanical running tests under vacuum of a High Pressure Compressor following API 617 requirement. During the tests it was investigated how the lateral vibration behaved while the rotor speed, oil pressure and flow to thrust bearing, load and torque were varied. After some tests, vibration analysis and literature revised, it was concluded that the main cause of radial subsynchronous vibration observed during mechanical running test (MRT) was due to axial vibration of the rotor.

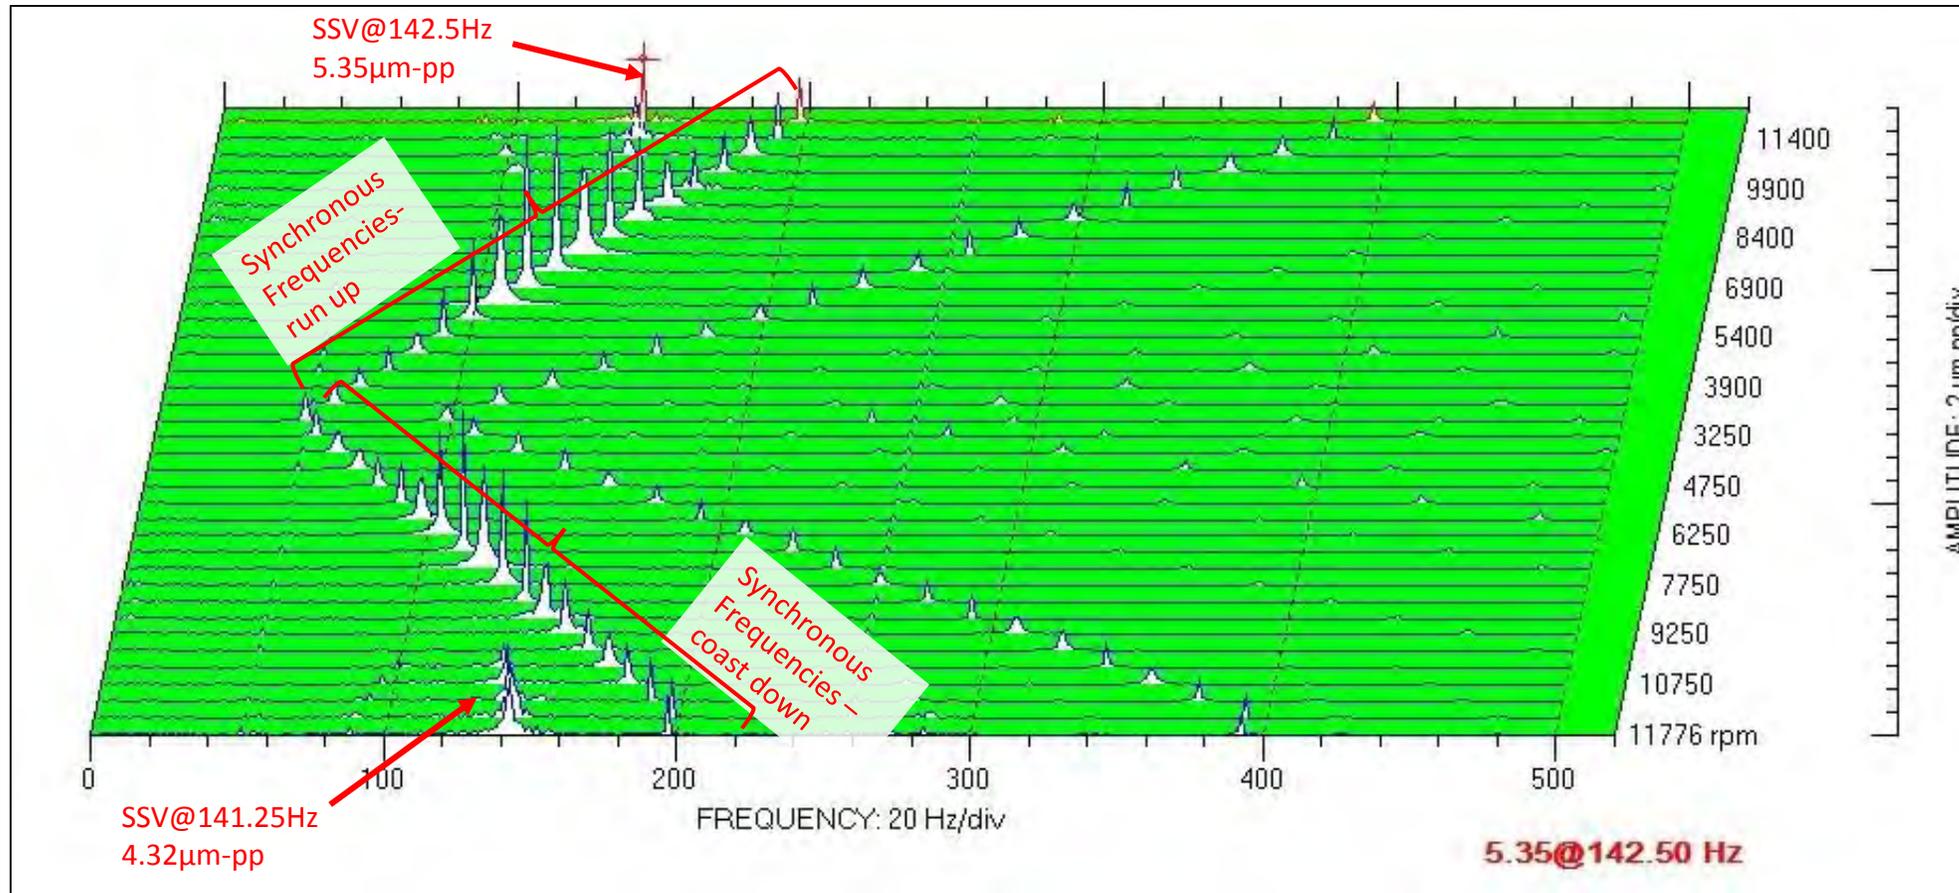
- When a subsynchronous vibration is found in a spectrum of a rotating machine, it may become a concern because of its potential to induce instability.
- During a mechanical running tests in vacuum of high pressure compressors, **subsynchronous vibrations (SSV)** were observed **in radial direction** using proximitors probes mounted in the non driven end as well as the driven end bearing. Therefore, the root cause of SSV was investigated in order to avoid future problem onsite.

- The tests were carried out as specified by API617 and **the limit of the amplitude** of any discrete, **nonsynchronous vibrations (limited to 5 microns according to used procedure)** were sometimes **exceeded by this SSV.**

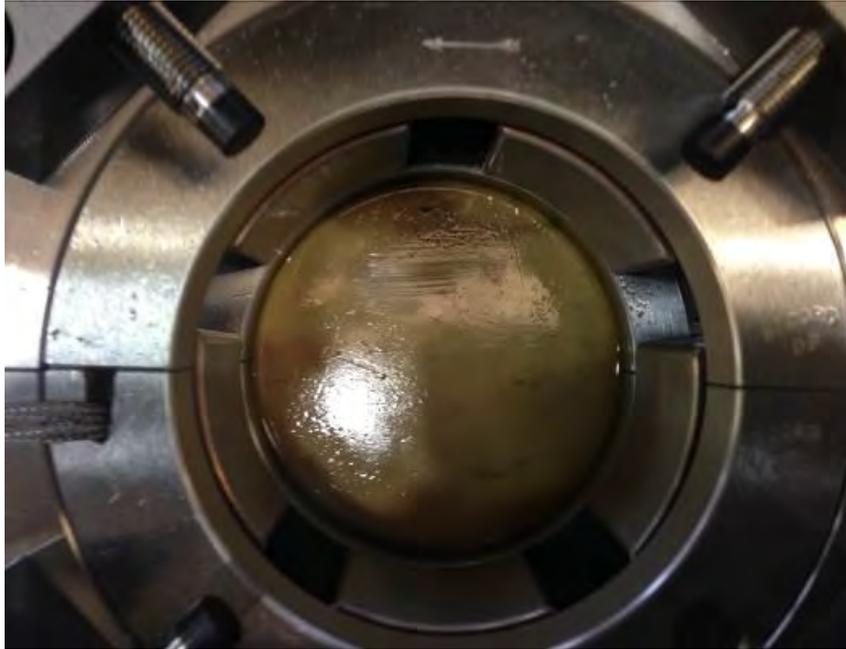
RADIAL TILTING PAD BEARING
Diametral Clearance (min/max):(0.12/0.138) μm
Load on pad
Offset 60%

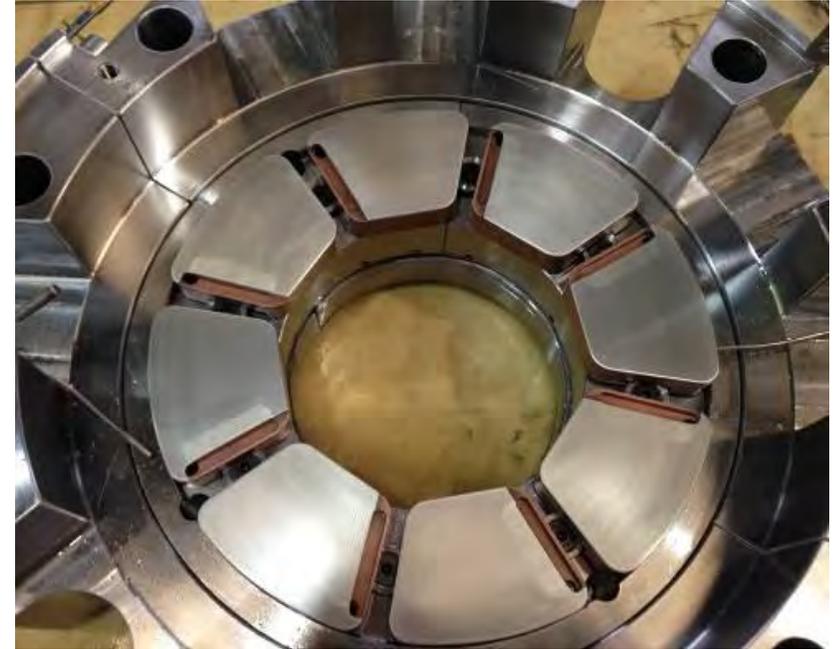
AXIAL TILTING PAD BEARING
Axial Clearance (min/max):(0.30/0.40) μm
Manufacturer: Kingsbury
Offset: 60%

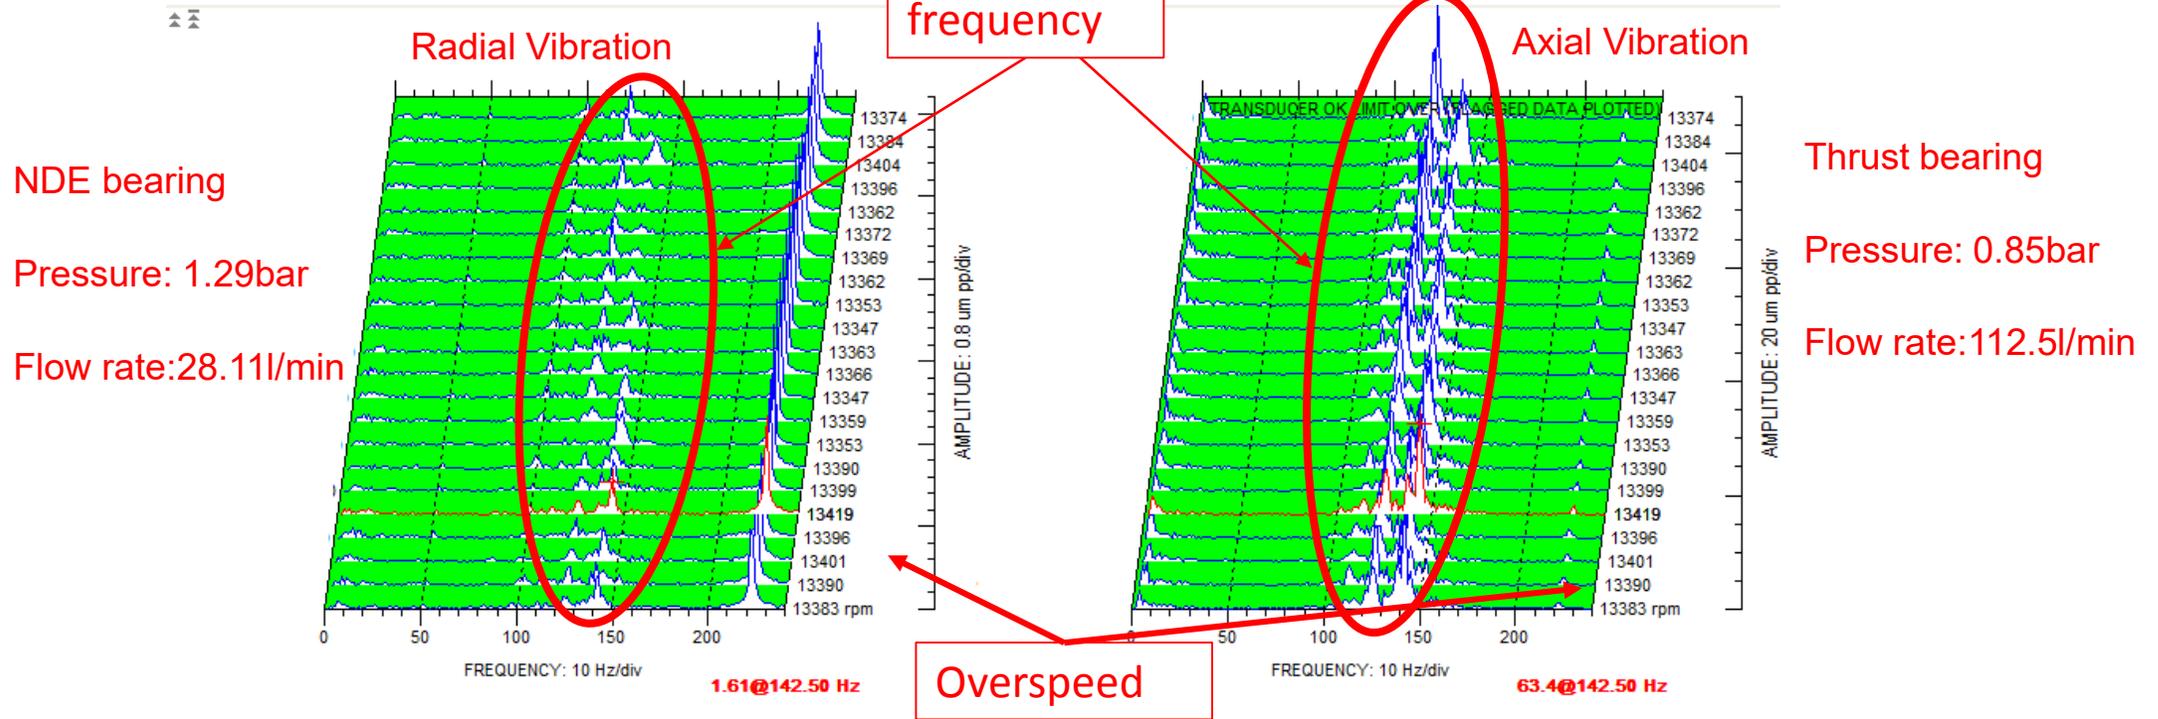
- Running at overspeed

- It is clearly seen that the two frequencies, 125 and 142.5Hz, that excite the rotor in axial direction led lateral vibration, although in lower amplitudes. The average radial subsynchronous amplitude was near of 30% of radial synchronous amplitude, in other words, these SSV are important since they have high amplitude and they should be studied.

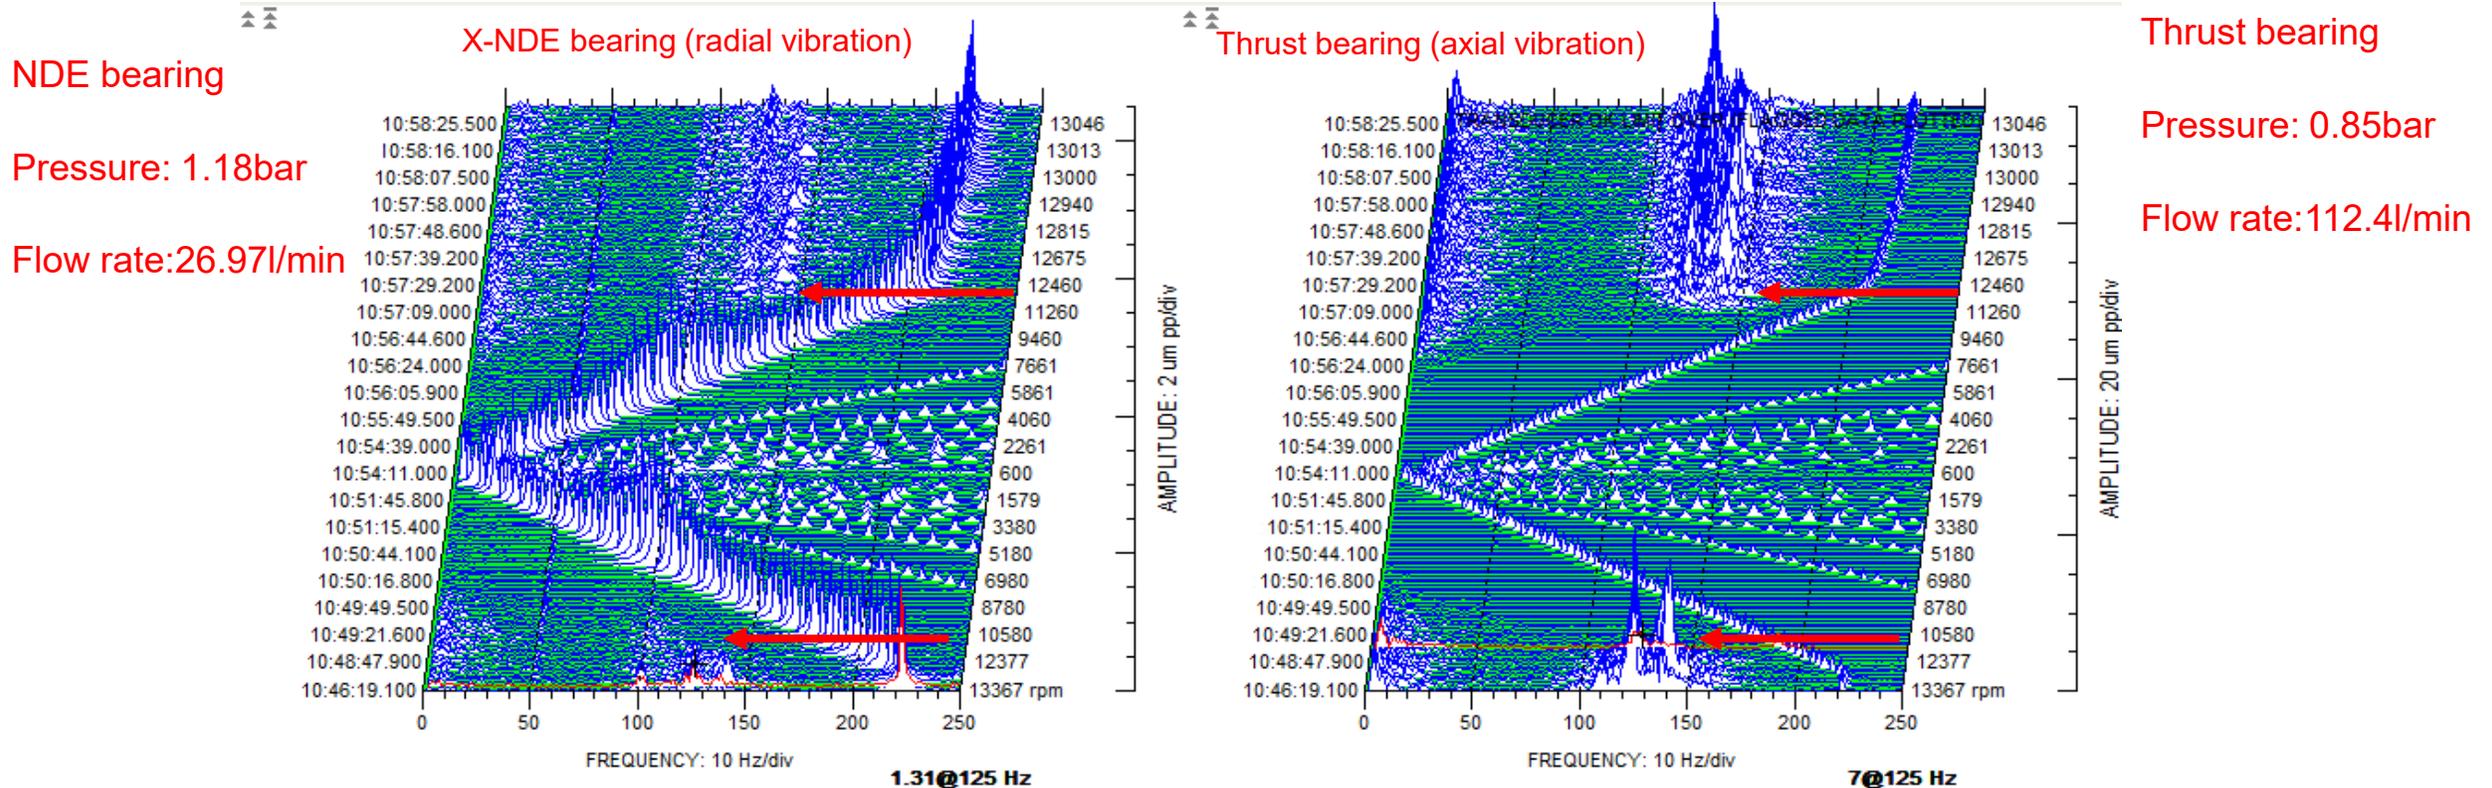
- Changing Torque and Speed

- The red arrows indicate when the SSV appear. It was noted that threshold of subsynchronous frequencies, 125 and 142.5Hz, is around 11.100rpm, without (run down) and with (run up) torque. Therefore, these SSV did not undergo influence from torque.

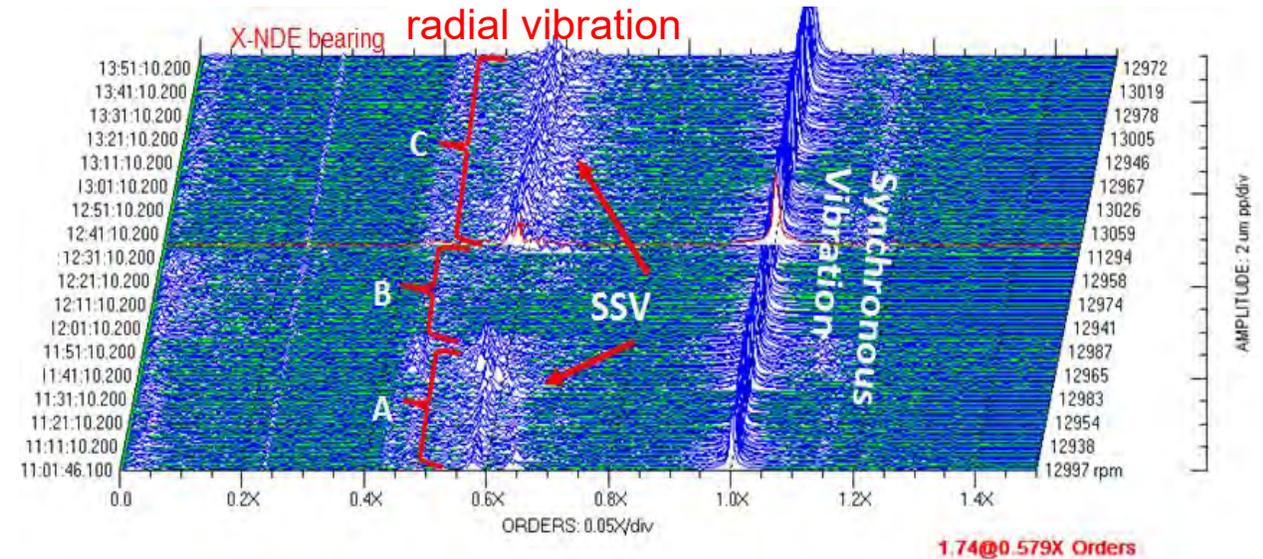
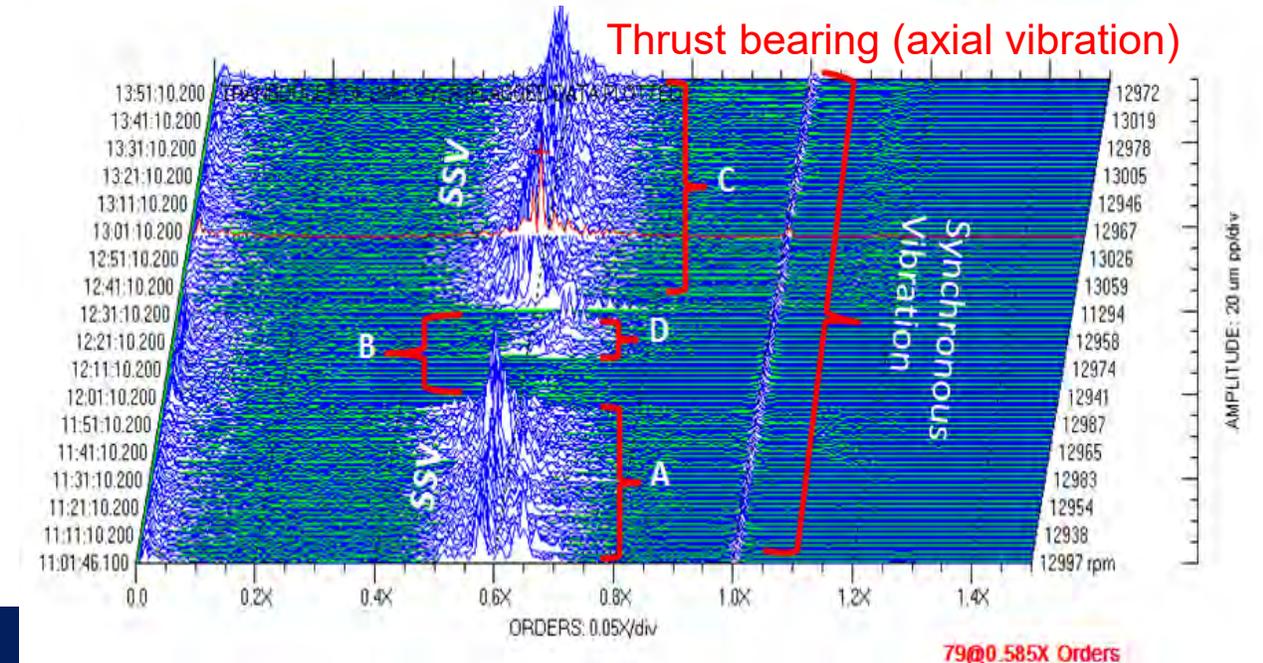
Period	Thrust Bearing			Radial Bearings		
		Lube Oil Flow (l/min)	Lube Oil Pressure (bar)	Axial Disp. (μm)	Lube Oil Flow (l/min)	Lube Oil Pressure (bar)	
A	11h01min46s - 12h01min10s	135	0.96	82	27.8	1.24	with SSV
B	12h01min10s - 12h41min10s	170	1.51	75.9	33.4	1.59	without SSV
C	12h41min46s - 13h51min10s	92.4	1.52	83	29.12	1.37	with SSV
D	12h21min10s - 12h31min10s	124.5	0.8	85.3	NA	NA	with SSV

- Changing lubricant oil pressure and flow
 - Analyzing the waterfall graphics on the previous slide, it can easily be seen that an increase of thrust bearing stiffness by increasing lube oil flow and pressure, the radial subsynchronous as well as axial vibration (@125 and 142.5Hz) disappeared. In other words, starved thrust bearing causes pad vibration that leads lateral SSV motions.

- Oil flow rate and pressure variables on thrust bearing play the key role on lateral subsynchronous vibration induced by axial vibration. One possible cause of SSV is that the insufficient oil on the pad film thickness may trigger pad flutter behavior on thrust bearing.
- In spite of not being a API 617 requirement and not usual monitored in industrial application, these tests showed the importance of set the axial probe to measure vibration instead of just checking rotor displacement during mechanical running test and operation onsite.

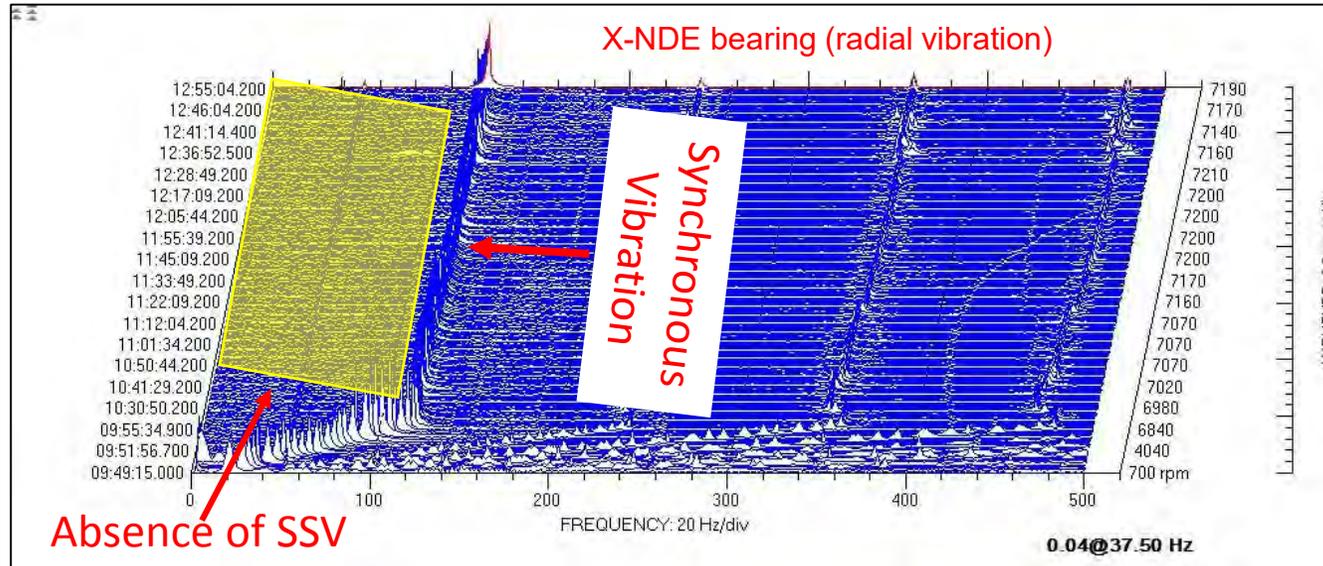
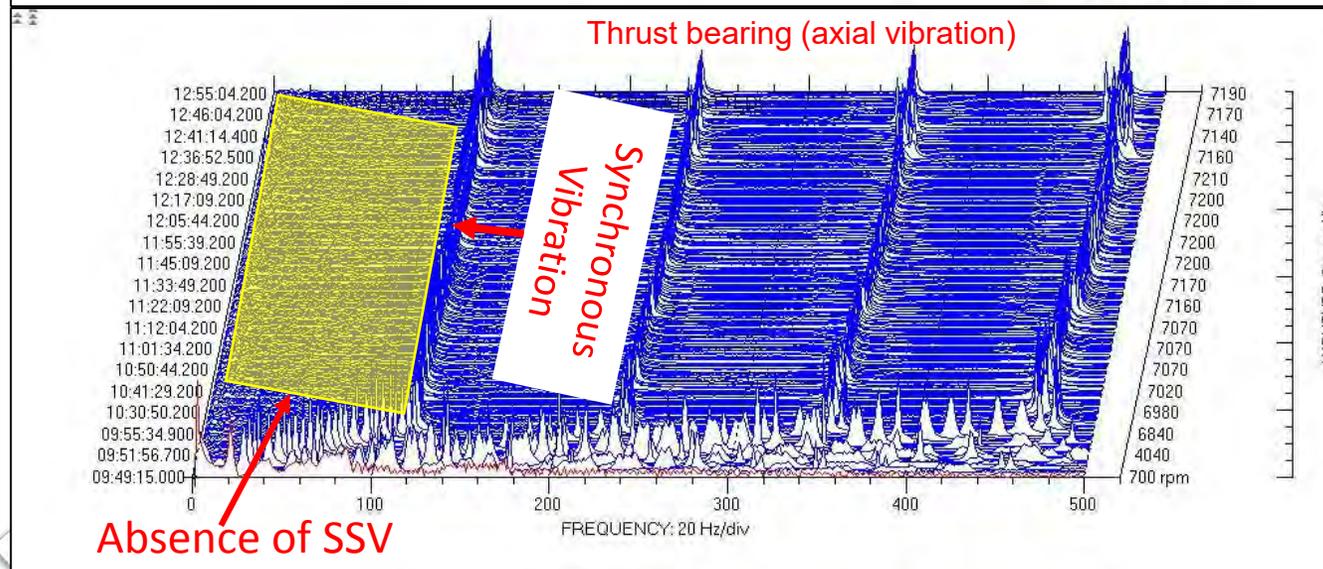
- Changing the load on thrust bearing
 - Running the compressor under axial load, varying the differential pressure in first stage between 6.3 and 9.5bar and the second stage from 2bar to 7.0bar at 7200 rpm, the subsynchronous (125/142.5Hz) did not appear. However, the rotor speed did not reached the 11,600rpm, threshold of 125/142.5Hz, because of the temperature limit of the casing.

- Instead of running the compressor under vacuum (light loading on thrust bearing), the rotor ran under differential pressure so as to rise the axial load on thrust bearing, thereby increasing axial stiffness. In this way, the rotor would have a preferable axial position to stay and the SSV would have a chance of vanishing if the source of this vibration were the pad flutter as mentioned by DeCamilo [1].

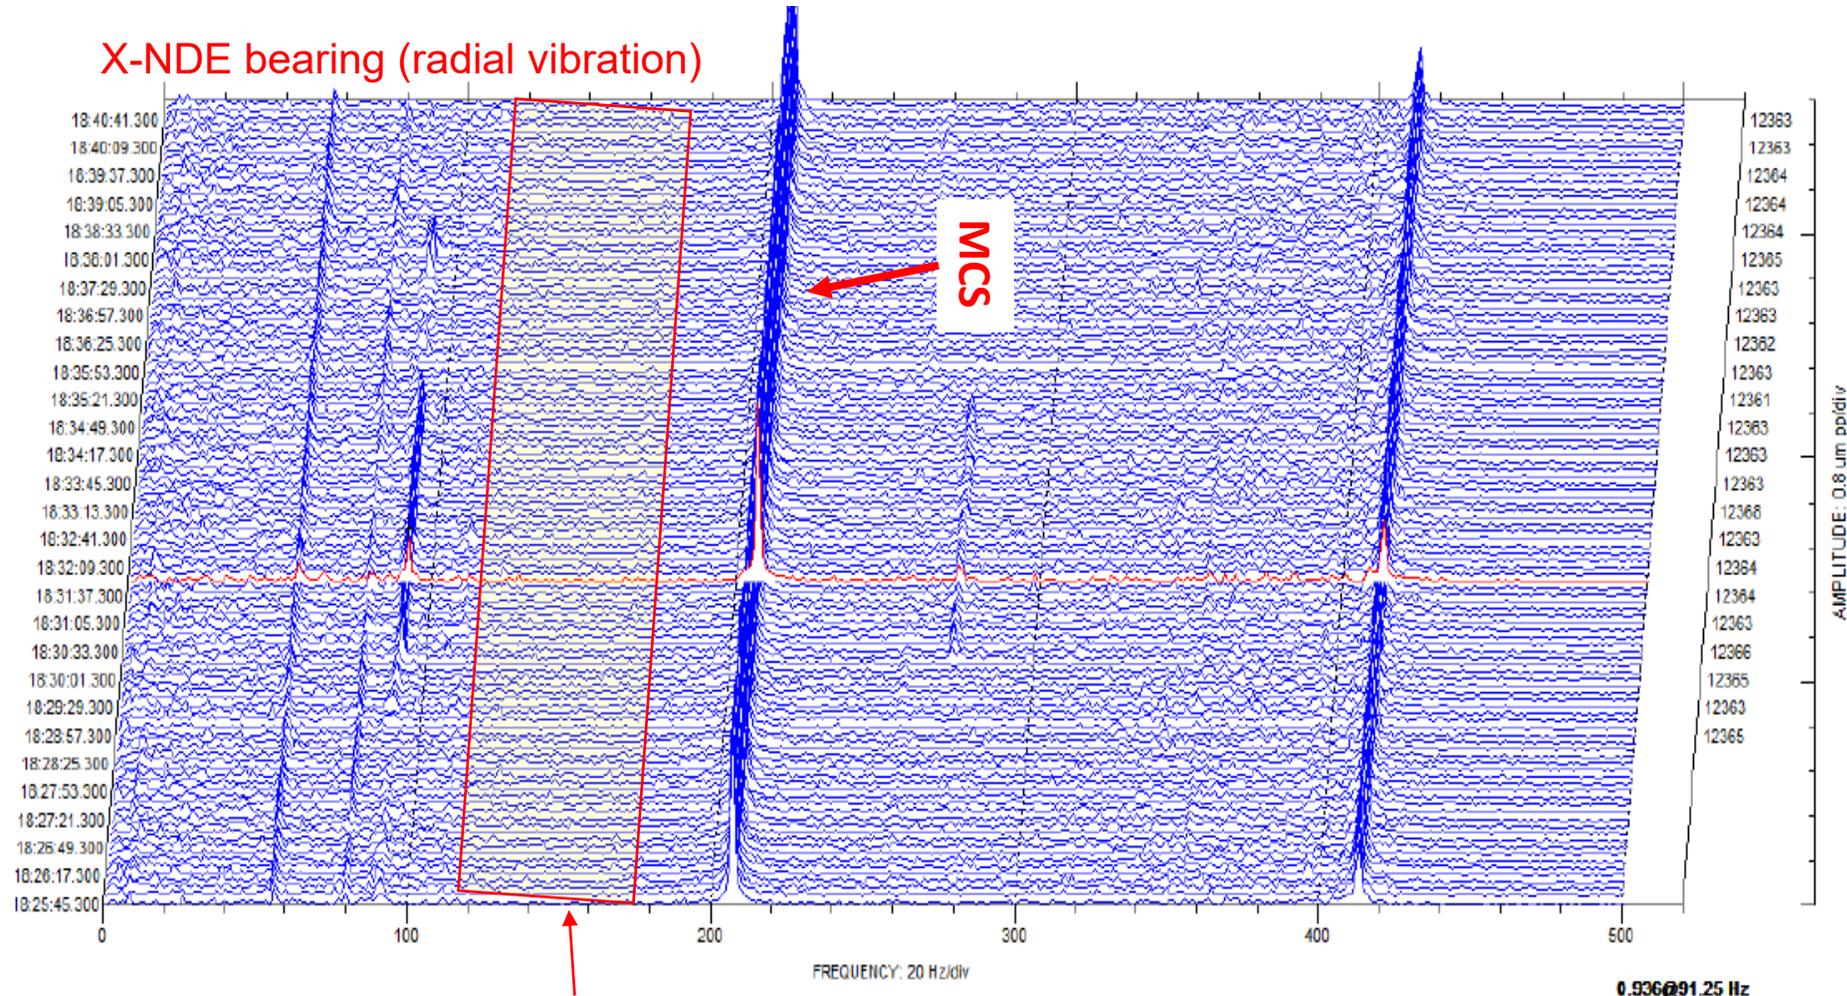
- Running in Full Load/Full Speed/Full Pressure (FLFSFP) and close to Surge

Running the compressor in FLFSFP and under harsh condition (close to surge), the subsynchronous (125/142.5Hz) did not appear, as seen on next slide. Therefore, these SSV will not be a problem when the compressor is working onsite. Moreover, it might be concluded the main cause of these SSV mentioned is due to light load and starved thrust bearing.

The subsynchronous frequencies lower than 100Hz showed on the next slide were caused by surge condition, that is not the relevant for this present study.

Absence of SSV studied (125/142.5Hz)
