RELIABILITY TESTING AND IMPROVEMENT OF POLYMER HINGE-BASED MEMS
SCANNING MIRRORS

A Thesis

Major Subject: Electrical Engineering

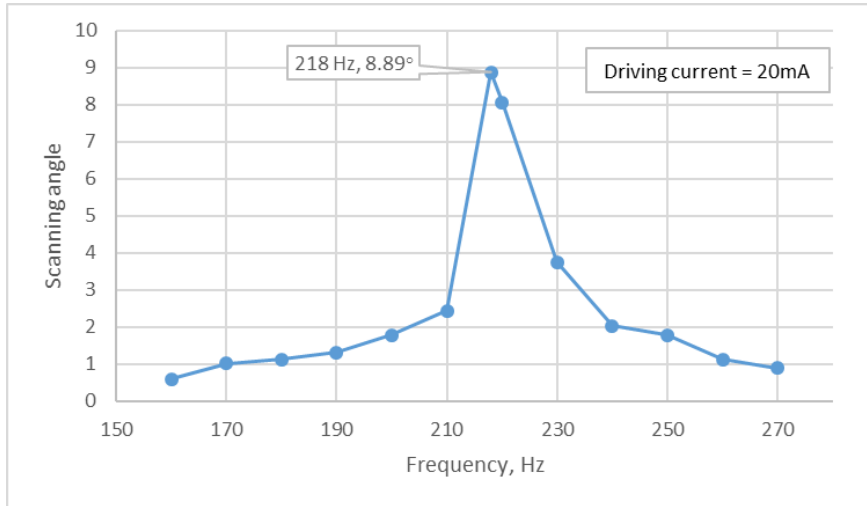
An AC signal generator was used to generate the driving signal which is passed through the inductor coil, and a parameter analyzer connected in series reads the driving current passing through the coil at the respective signal voltage amplitude. To characterize the performance of the mirror versus the frequency of the driving signal, a driving current of 20 mA was passed through the inductor coil and the frequency of the signal was swept from 50 Hz to 250 Hz. The obtained scanning angle versus the frequency plot is given in Figure 2.3 and from it the resonant frequency of the device was determined to be 218 Hz,

producing a scanning angle of $\pm 8.89^\circ$. All angles mentioned hereon are actually half-angles, meaning the device's maximum angular displacement from the center axis.

Figure 2.3 Device characterization in air, signal frequency vs. scanning angle

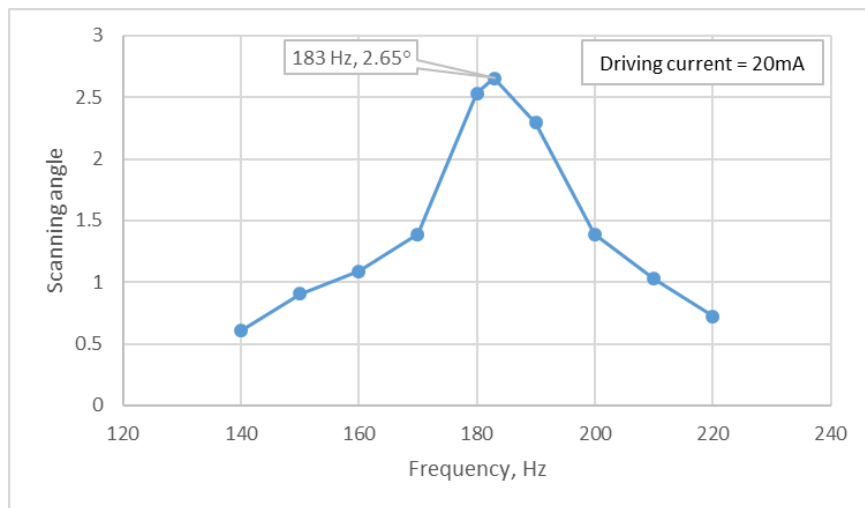
The same characterization experiment was carried out in water medium, with the mounting stand holding the device placed underwater along with the ruler. The frequency characterization determined the resonant frequency of the device now to be 183 Hz.

Figure 2.5 Device characterization in water, signal frequency vs. scanning angle

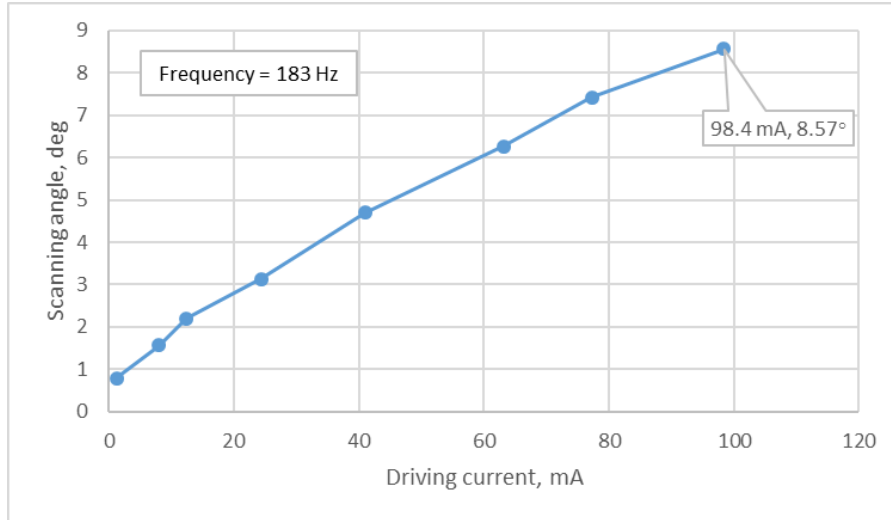
The current characterization provided us values of 22 mA and 60 mA for $\pm 3^\circ$ and $\pm 6^\circ$, respectively. The response was again linear.

Figure 2.6 Device characterization in water, driving current vs. scanning angle

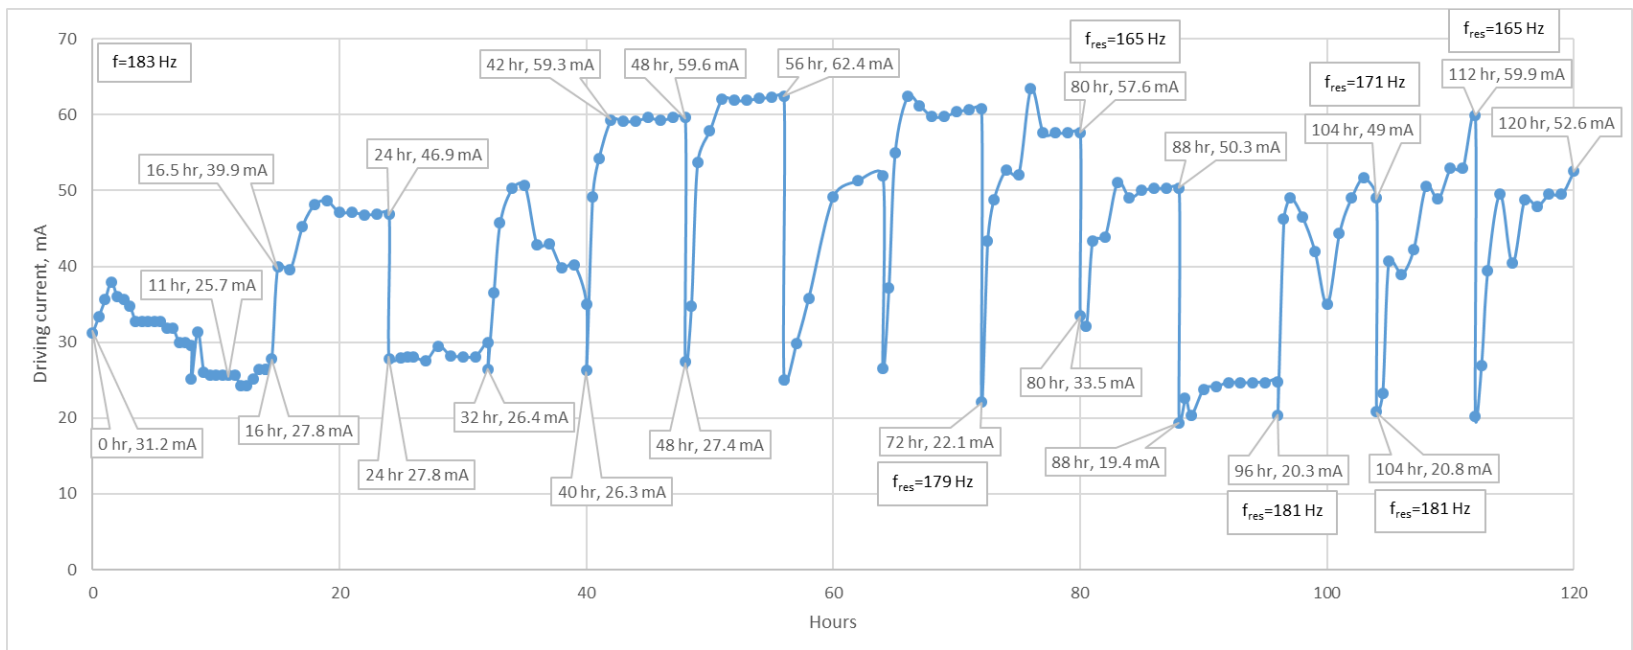
The mirror was run in 8 hour cycles each day; this was to better simulate heavy but practical running conditions for the device in industry. The device was taken out of water at the end of a cycle and put back in the next day to do the following run. The data collected over 15 such cycles is presented in Figure 2.9.

Figure 2.9 Reliability testing data, cycles

Starting from the first cycle (0-8 hours), it can be seen that the driving current required for $\pm 3^\circ$ was higher, 31.2 mA, than in the characterization test, 22 mA; however, it fell back down to around 25 mA in the second cycle (8-16 hours). It is from the third cycle (16-24 hours) that the break-in pattern began to emerge. A significant increase in driving current was required over the third cycle, with almost double the current was required by the end at 46.9 mA to keep the scanning angle at $\pm 3^\circ$, compared to the start at 26.4 mA. This would normally indicate a degradation taking place in the device but, at the start of the next cycle (24-36 hours), it was observed that the driving current required for $\pm 3^\circ$ was 27.6 mA, similar to the measurement at the start of the previous cycle. This lead to the hypothesis that a form of temporary degradation and restoration might be taking place in the device's polymer hinge structure.

Looking at the data, it can be safely affirmed that there is no general discernable upward or downward trend in readings over the 120 hour test run. However, the required driving current does vary over a significant range of values within a run cycle. The required current can be close to 20 mA at the start of a cycle and increase threefold to 60 mA driving current required to maintain $\pm 3^\circ$ angle at the end. This change is also correlated to the change in resonant frequency of the device. The resonant frequency was also measured alongside the driving current over one of the test cycles, this data is presented in Figure 2.10. It can be observed that the required current increases in part of the resonant frequency shifting further and closer to the operating frequency of 183 Hz.

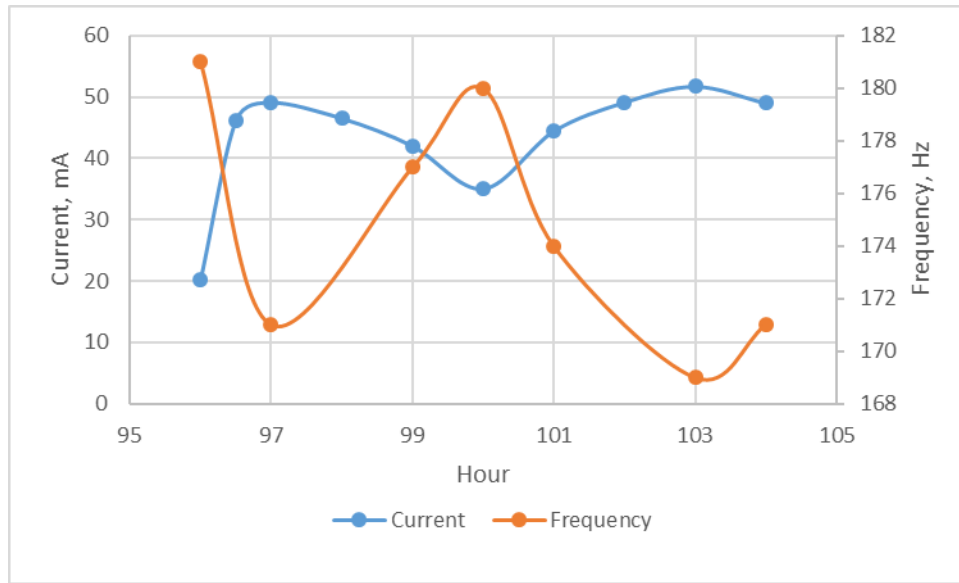
Figure 2.10 Resonant frequency vs. driving current shifts

The device seems to undergo a process of ‘break-in’ at the start of most cycles. The required current is always lower at the start and then gradually increases to a higher stable value which could possibly be considered the device’s normal region of operation over a longer runtime cycle.

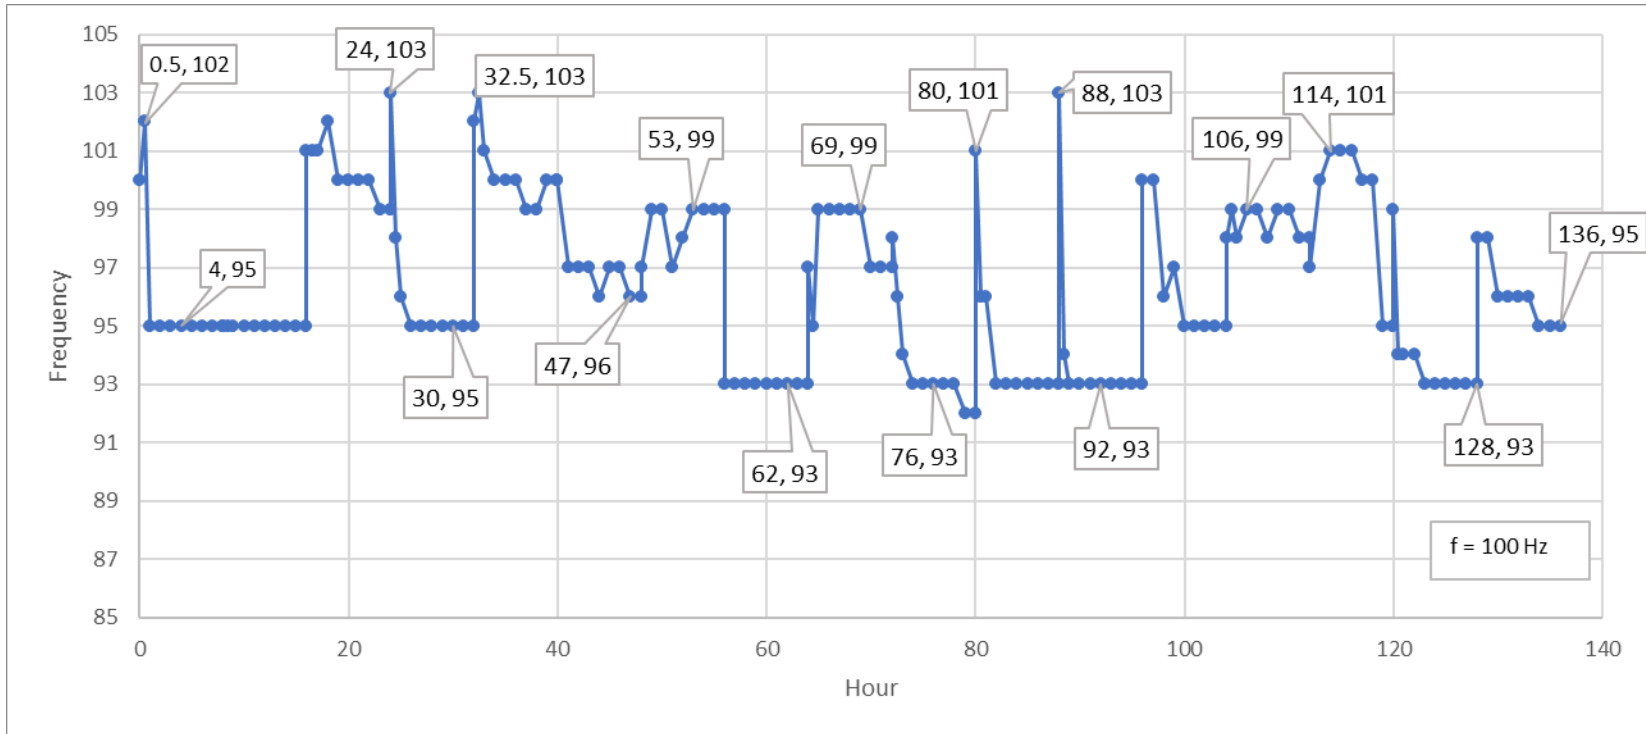
Figure 3.6 Reliability test resonant frequency data in water, new device

From the current value plot, a similarity could be observed between the data for this mirror running at $\pm 6^\circ$ and the first mirror design tested at $\pm 3^\circ$ scanning angles. The driving current required varies over a wide range here as well from the lowest recorded at 41.9 mA to the highest at 90.8 mA, but no decipherable up or downtrend could be observed in the values, meaning no degradation occurred in the device. The resonant frequency varied between 93-103 Hz, but the device could be always be operated at reasonable driving currents at 100 Hz signal frequency, which was the aim for the elliptical mirror plate based design.

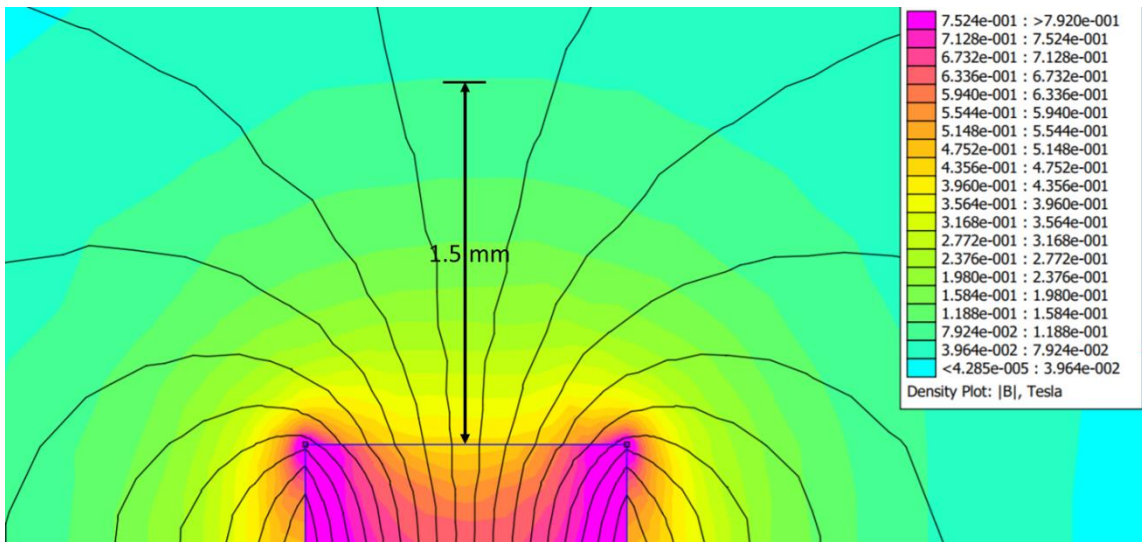
Figure 4.2 Region of interest for Hall sensor placement

Two NdFeB Grade 40 magnets were placed 7.25 mm away with opposite polarity directions, and the strongest field reading could be seen to be around 400 mT at the top surface along the center. At 1.5 mm away from the top, the field can be seen to range in

between 40 mT to 80 mT. This is a reasonable length of distance to place the sensor at so to not accidentally come into contact with the mirror during scanning. Based on this, the analog linear Hall-effect sensor SS49E from Honeywell was chosen. It operates within this magnetic field range and has a package size of 4.1 mm x 1.6 mm x 3 mm, close to the range of our mirror device's dimensions. Having a linear response also will allow for easier calibration of the Hall sensor reading to our mirror's scanning angle. The specifications of the Hall sensor are given in Figure 4.3.

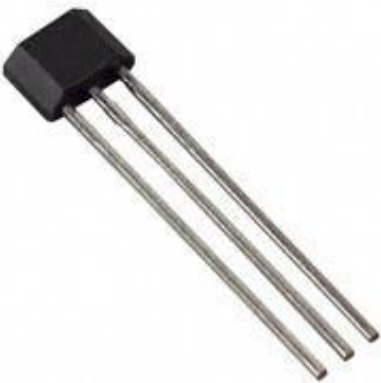
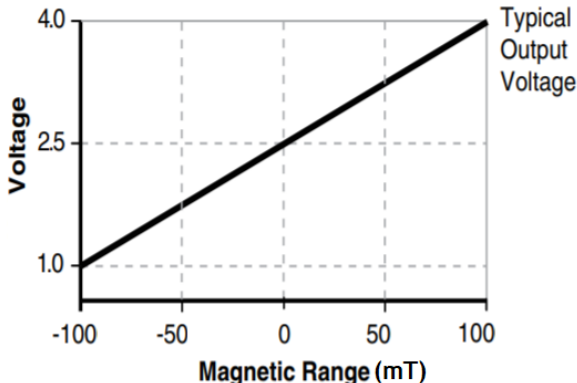
Figure 4.3 (a) Honeywell SS49E Hall sensor and (b) its response provided in specification sheet

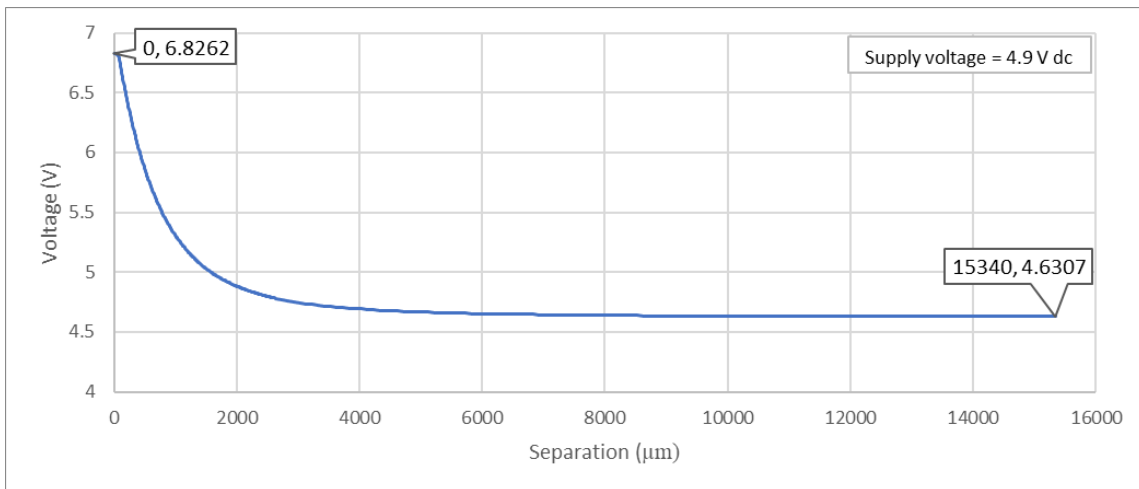
Figure 4.5 Hall sensor characterization, output voltage vs. separation

From the plots, it could be seen that the relationship in both cases is an inverse exponential versus the separation due to the magnetic field cutting the Hall sensor area decreasing in the same rate. The translation the mirror plate goes through is approximately $76 \mu\text{m}$ per 1° scanning angle, so since the objective was to keep the scanning angle fixed at $\pm 3^\circ$ or $\pm 6^\circ$, the device would be working inside a linear region of the sensitivity curve making calibration simpler.

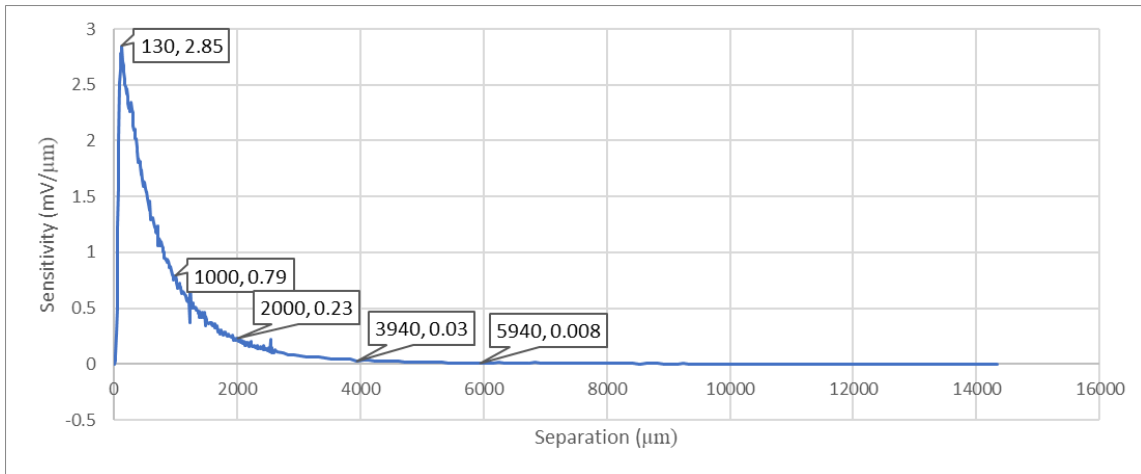
Figure 4.6 Hall sensor characterization, sensitivity vs. separation

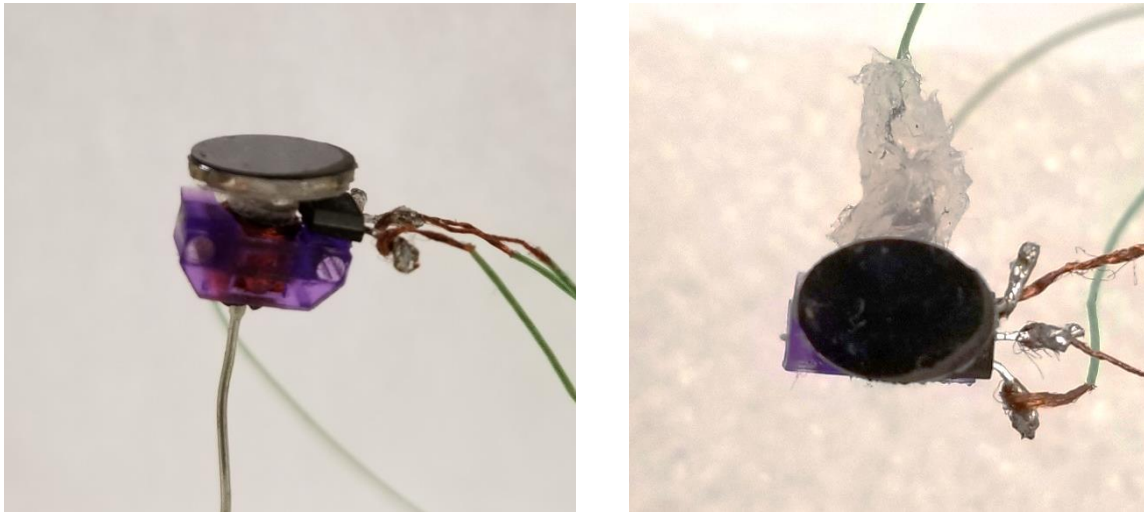
For the next step, in order to place the Hall sensor properly on the new holder and below the magnet, the Hall sensor was sanded, reducing its thickness down from 1.6 mm to 0.8 mm using a file. This allowed the Hall sensor to be placed properly with enough space provided for the mirror's motion whilst being close enough to the magnet to ensure good sensitivity. The Hall sensor was glued to the extension of the holder using silicon adhesive (RTV 108, Momentive Performance Materials).

Figure 4.8 (a) Assembled device package and (b) top view
