## **Flow Measurement for Structure Assessment in Richmond Irrigation District**

**Texas Water Resources Institute Technical Report No. 379  
Texas A&M University System  
College Station, Texas 77843-2118**

**FLOW MEASUREMENT STRUCTURE  
ASSESSMENT  
IN  
RICHMOND IRRIGATION DISTRICT**

Report prepared for the  
Richmond Irrigation District

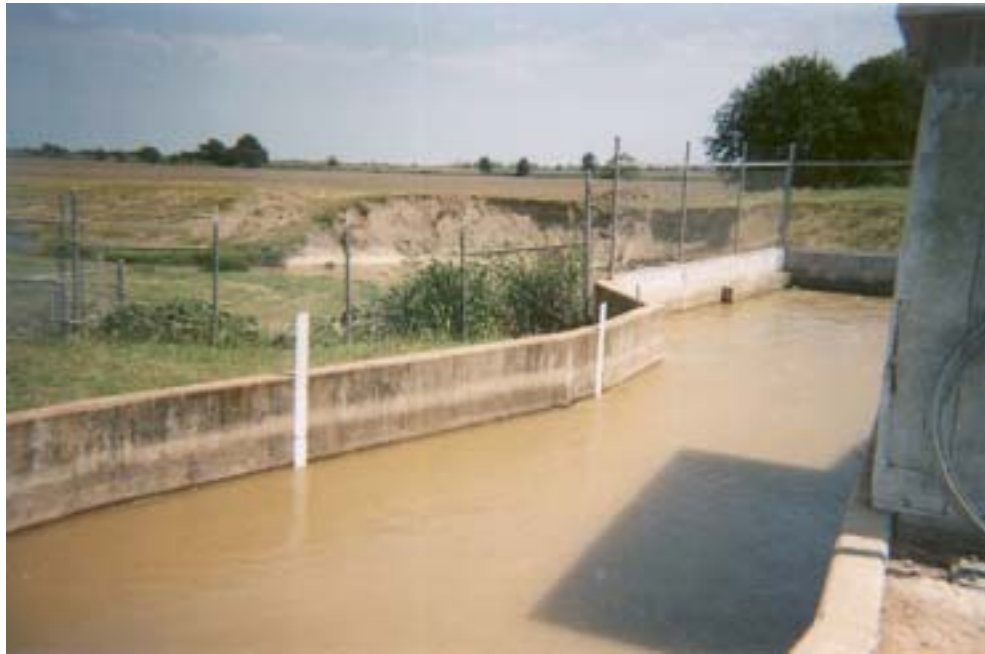
Figure 1: 10 foot Parshall flume and water level of flow measurement on May 16, 2003.

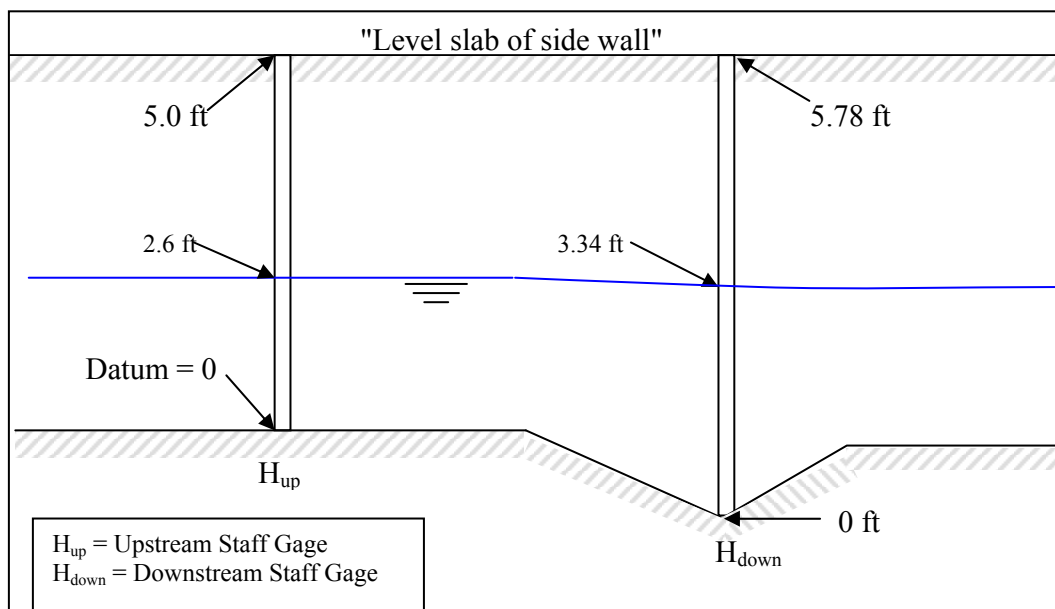
The approach to the flume (side walls of the rectangular concrete section) and the Parshall flume are level. The water levels observed during this visit are shown in the schematic below (Figure 2).

Figure 2: Parshall flume profile and staff gage locations with measurements.

(1) On May 16, the flume was submerged. Submergence is calculated from the difference in head at specific upstream and downstream locations within the flume (Figure 2). The calculations are as follows:

$$H_{\text{up}} \text{ (upstream staff gage)} = 2.6 \text{ ft (2.4 ft below the top)}$$

$$H_{\text{down}} \text{ (downstream staff gage)} = 3.34 \text{ ft (2.44 ft below the top)}$$

$$H \text{ (head): } H_{\text{up}} - (H_{\text{down}} - 0.78)$$

$$\text{Submergence: } H_{\text{down}} - 0.78 / H_{\text{up}}$$

This gives a submergence 0.984 (98 percent).

(5) *The difference between the measured flow rate (83.87 cfs) and the flow rate calculated from flume measurements (115.64 cfs) is 31.77 cfs or 27%.*

(6) *Such large errors are expected from flumes with greater than 90% submergence.*

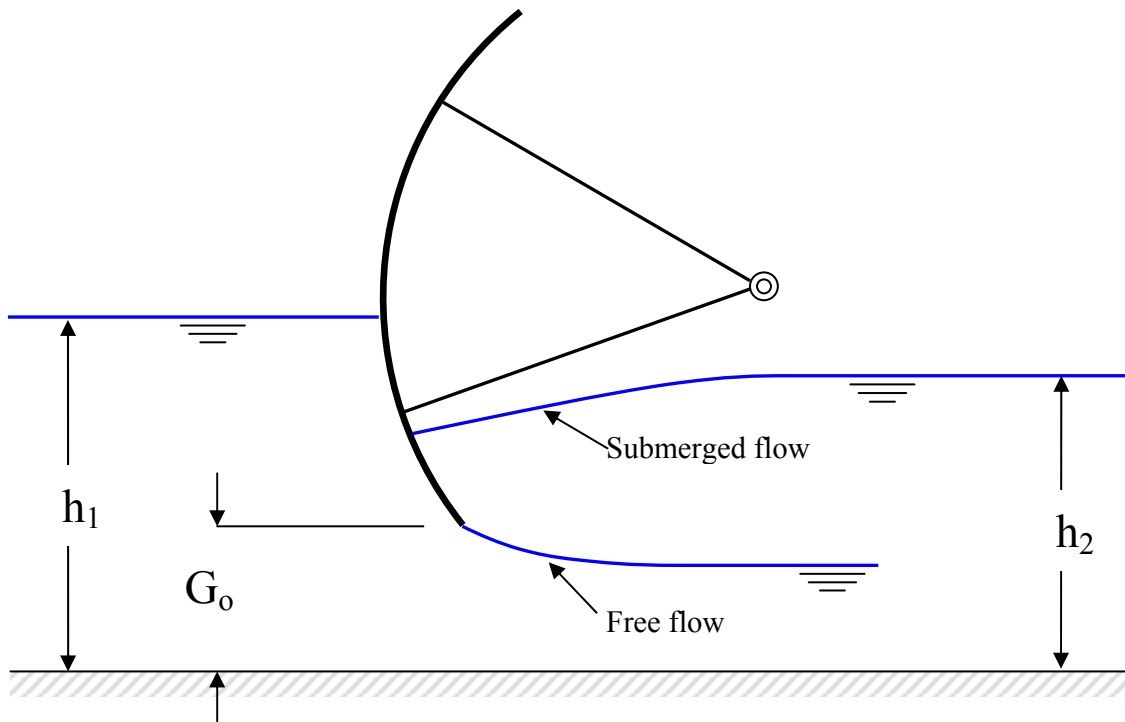
Gates can be calibrated and used for flow measurements. The accuracy of using gates varies, but can be within 10%. Figure 3 shows a diagram of the upstream radial gate and head measurement locations.

\*\*\*Figure 3 corresponds to the above calibration variables.

Figure 3: Diagram of Radial Gate showing calibration variables.

From the current-meter measurements, a *coefficient of discharge* was computed for the flow conditions on that day. *Note, that we only measured flows for a single gate opening. We recommend that complete calibration of the radial gate be performed and a discharge curve be developed.*

$$Q = C_d G_o B \sqrt{2_g H}$$

Q	= discharge (cfs)	83.87	Calculated (see table )
C <sub>d</sub>	= coefficient of discharge	0.917	Calculated
G <sub>o</sub>	= vertical gate opening (ft)	1.3	Measured
B	= gate width (ft)	16	Measured
G	= gravitational constant	32.2	(USBR)
H <sub>1</sub>	= upstream depth (ft)	2.9	Measured
H <sub>2</sub>	= downstream depth (ft)	2.6	Measured
H	= H <sub>1</sub> – H <sub>2</sub> (Head)	0.3	Calculated

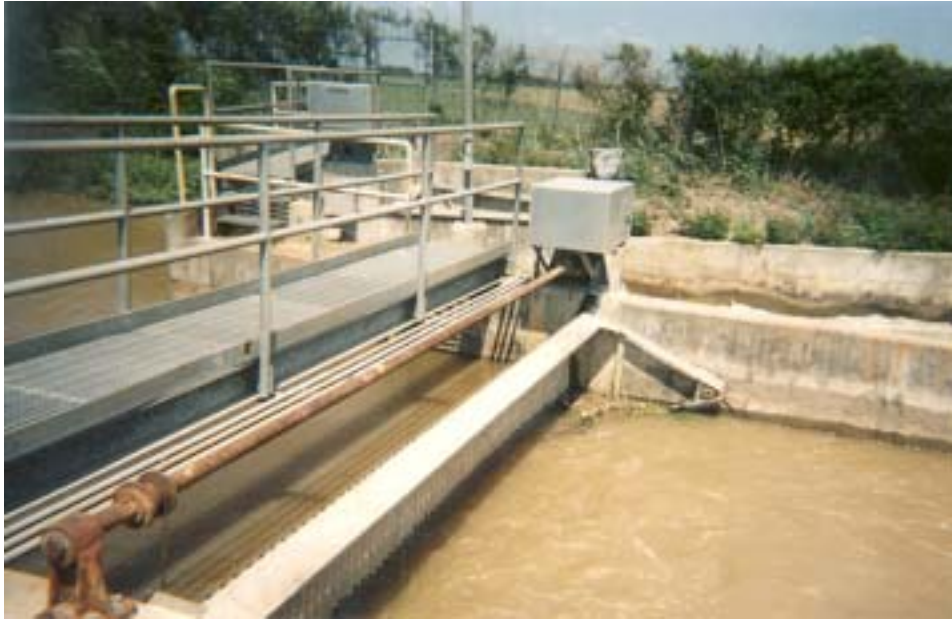
Figure 4: Shows above (figure 3) Radial Gate
