# Carters Creek Total Maximum Daily Load Implement- ation Project

Routine,  
Reconnaissance  
and Stormwater  
Monitoring Report:  
Tasks 4 and 5

Texas Water Resources Institute  
Technical Report TR-485  
January 2016

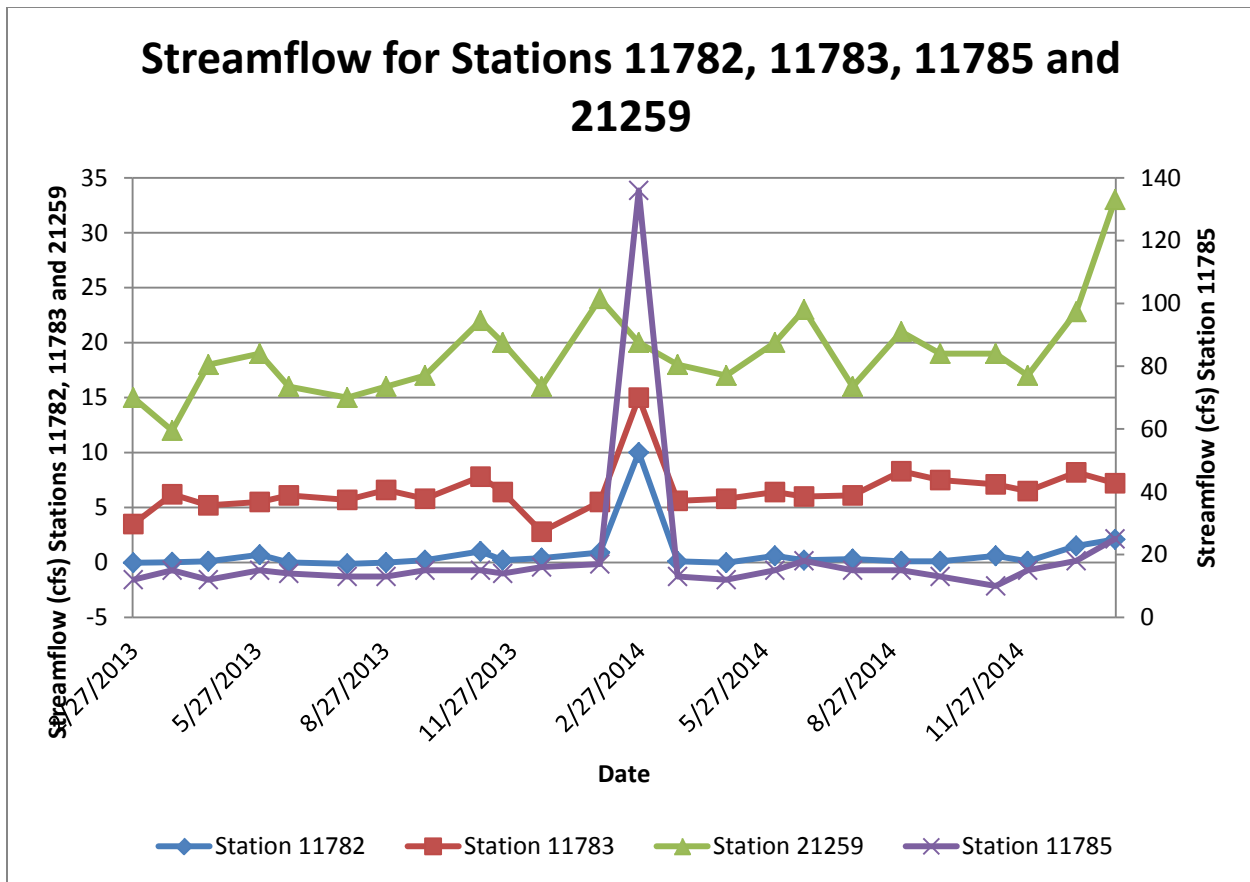
**Figure 3. Streamflow for TCEQ Stations 11782, 11783, 11785, and 21259**

Instantaneous stream flow measurements were taken during each monitoring trip to determine the volume of stream flow at the time the sample was taken. When combined with *E. coli* concentrations, the load of *E. coli* transported by the creek at a specific location and point in time can be determined. Flow varied by site (Table 3, Figure 3)

with Station 11782 having the lowest flow average at 0.98 cubic foot per second (cfs) and Station 11785 having the highest average stream flow at 19.83 cfs. Station 11782 is located on Carters Creek above its confluence with Burton Creek. At this point, the only contributions of water to the creek are groundwater base flows, irrigation runoff and rainfall runoff. No known wastewater contributions occur at this site. As a result, the recorded flows were often extremely low. In more than one instance, flow was low enough that wind blowing upstream was moving water sufficiently for the recorded flow volume to be negative. Evidence of very high flow was present at this site as large trees were washed downstream during the course of the monitoring project. The other three sampling stations all had higher average flow values due in part to the presence of wastewater inputs. These inputs provide a relatively consistent source of water to the streams which provides for a consistent maintenance of flow. High flows were also observed at these locations and produced significant erosion in some locations.

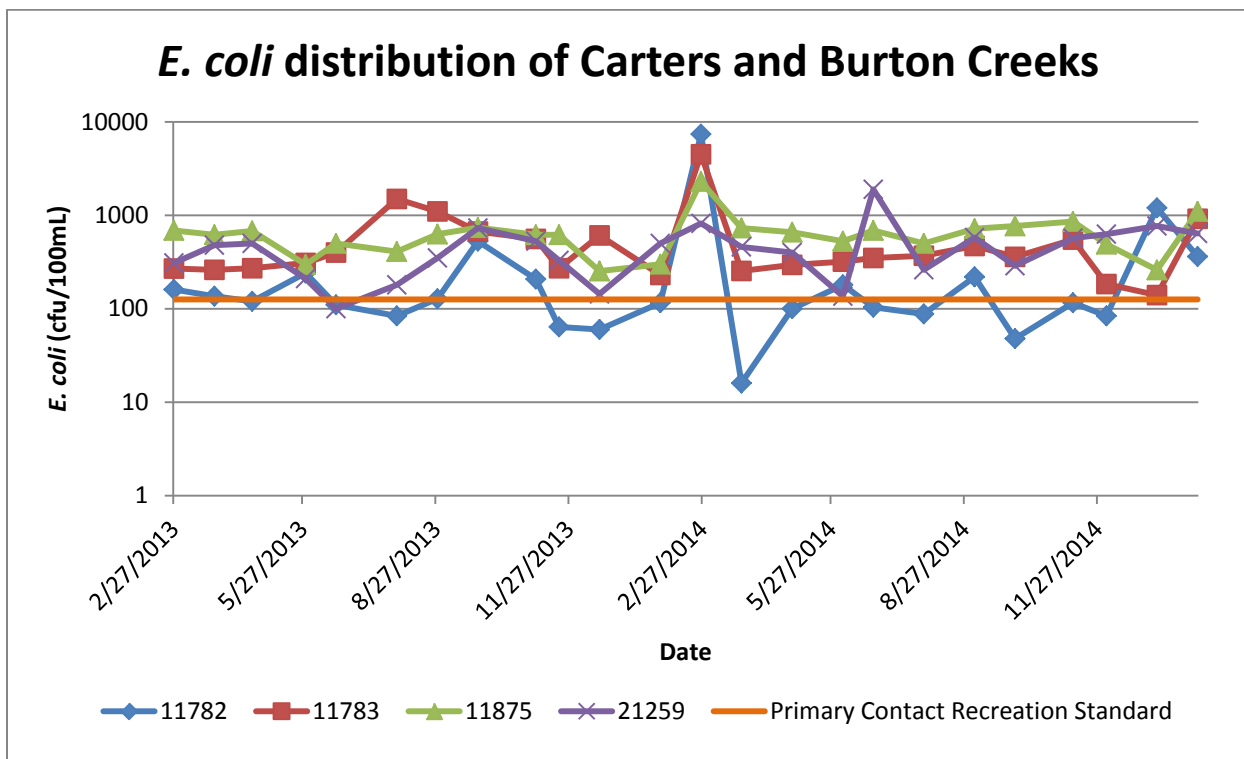
**Figure 7. *E. coli* concentration distribution for Carters and Burton Creeks**

*E. coli* concentrations recorded at each of the four stations were found to vary widely. The geometric means of the values recorded at each site during the course of this monitoring project were found to be over the Primary Contact Recreation standard of 126 cfu/100mL (Figure 7 and 8, Table 7) (TAC 2013, TCEQ 2012). Station 11782, the most upstream site, had the lowest geometric mean of 154 CFU/100 mL and was followed by station 21259, station 11783 and station 11785 with geometric means of 399, 431 and 591 CFU/100 mL respectively. Stations 11783 and 11785 did not have a statistically significant correlation between *E. coli* and streamflow (Table 7); however, the two remaining stations did have statistically significant correlations between streamflow and *E. coli* (Table 7). The strong correlations between streamflow and *E. coli* can be explained by significant rainfall events (greater than 0.5 inches) occurring within six days of monitoring. After removal of these events, no stations had statistically significant correlations. The spike in *E. coli* concentrations during the February 2014 monitoring event occurred during the highest flows at Stations 11782, 11783 and 11785. Evidence of animals in or near the creeks was observed during the September 2013, October 2013, December 2014, January 2015, and February 2015 monitoring events and could have potentially influenced water quality.

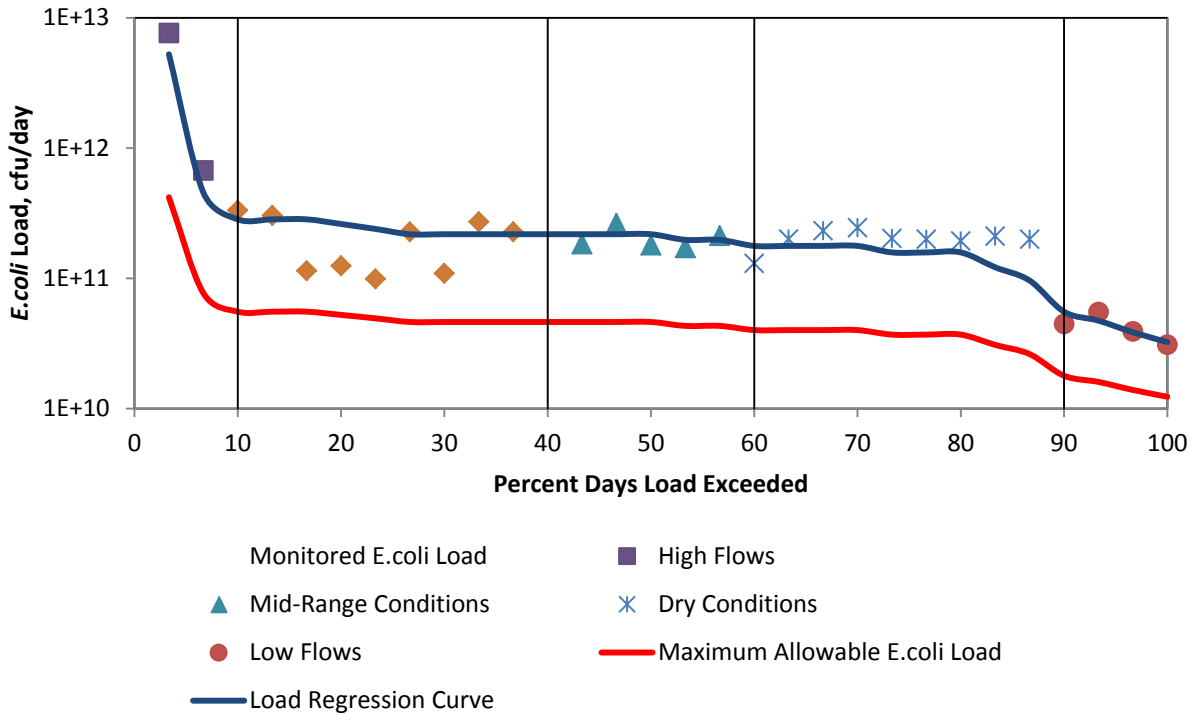
**Figure 10. Load Duration Curve for Carters Creek at Bird Pond Road, Station 11785**

Load Duration Curve Analyses (LDC) was performed in order to assess the bacterial loading for Carters and Burton Creeks. LDCs pair streamflow and *E. coli* concentrations collected on the same date to estimate the pollutant loading reductions needed to meet EPA water quality standards (Babbar-Sebens and Karthikeyan 2009; Morrison and Bonta 2008). Initially, a flow duration curve (FDC) is developed for each selected site and compares measured stream flow values to evaluate the percentage of time the specific flow value is exceeded within the time period evaluated. Flow data must be organized from largest to smallest flow and plotted against the percent of days that the specific flow value is expected to occur. The flow duration curve can then be divided into different flow categories and typically include high flow, moist conditions, mid-range flows, dry conditions and low flows. The TMDL line or maximum allowable pollutant load is developed by multiplying the FDC by the water quality standard and an appropriate unit conversion. Monitored *E. coli* loading is approximated by plotting the associated *E. coli* data with the corresponding stream flow levels. The majority of *E. coli* data should fall below the TMDL line in waterbodies that meet water quality standards, but for impaired water bodies, the *E. coli* loading is often above the TMDL line for the majority of data points, as seen in Figures 10, 12 and 13. Necessary load reductions to

meet the water quality standard are calculated by the average difference between the TMDL and regression line plotted through the observed *E. coli* loads.

The LDC analysis for each station indicates that non-point sources and the resuspension of *E. coli* from stream bed sediment are contributors to the overall *E. coli* load at all monitoring locations. At station 11782, the LDC (Figure 11) is above the TMDL line during high flows, moist conditions and mid-range conditions but dips below this line under dry conditions and low flows suggesting that point sources are not a sizable contributor of *E. coli* at this site. This finding is logical as no known point sources of *E. coli* exist upstream of this location. The LDC for stations 11785, 21259, and 11783 (Figures 10, 12, and 13 respectively) are above the TMDL at all points, indicating that *E. coli* concentrations are above the EPA standard during all flow conditions. In these cases, the probable pollutant loading types include non-point sources, instream sediment resuspension during high flows, point source contributions, physical streambed disturbances and direct deposition.

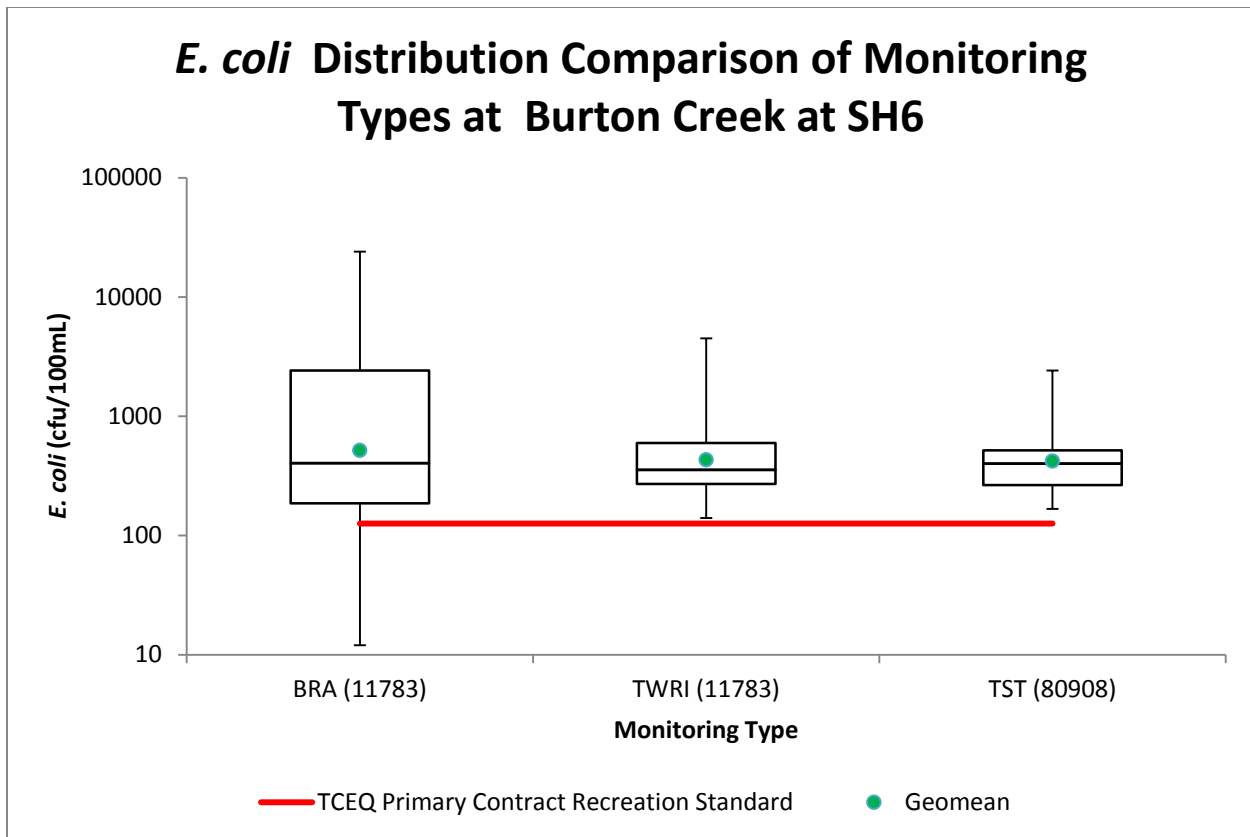
**Figure 18. Comparison of *E. coli* concentrations for the three monitoring types at Burton Creek at SH 6**

One routine monitoring station (Station 11783) and one reconnaissance monitoring station (Station 80908) were situated at the same location. This allows for a comparison of the data collected by both types of monitoring (Figure 22). *E. coli* concentration between the two sampling types were compared using the Wilcoxon/Kruskal-Wallis Sum-Rank Test and found no significant difference ( $p=0.99$ ) between the two data sets. This similarity between the two sampling types allows for a comparison and further use of this data to determine locations for intensive monitoring. A Wilcoxon/Kruskal-Wallis Sum-Rank Test was performed on the two monitoring type's results for DO, pH, and conductance. Only conductivity was not statistically different ( $p=0.86$ ) between the monitoring types, while pH ( $p<0.01$ ) and DO ( $p=0.01$ ) were statistically different. One explanation of these differences is the type of testing used by monitoring personnel. Reconnaissance monitoring events used more subjective tests that required personnel to use their judgement in assigning final water quality numbers while routine monitoring utilized automated instrumentation with a high level of repeatability between readings.

These results demonstrate that direct comparisons between routine and reconnaissance monitoring are appropriate despite the different method used to enumerate *E. coli* in each sample type. Direct comparisons of median *E. coli* concentrations were conducted using Wilcoxon statistical test to identify differences in median values. Results of this test are presented in Table 16 and demonstrate that a number of monitoring stations exhibited significantly different median *E. coli* concentrations than others. Values in bold are considered statistically different. Stations 80915 and 11782 were found to be statistically less than all but one and two other sites respectively while stations 80913 and 11785 were found to be statistically larger than all but three and four other stations respectively.
