# Carters Creek Total Maximum Daily Load Implementation Project

## Intensive Water Quality Monitoring Report: Task 7

Texas Water Resources Institute TR-486  
January 2016

**Texas Water Resources Institute Technical Report TR-486  
January 2016**

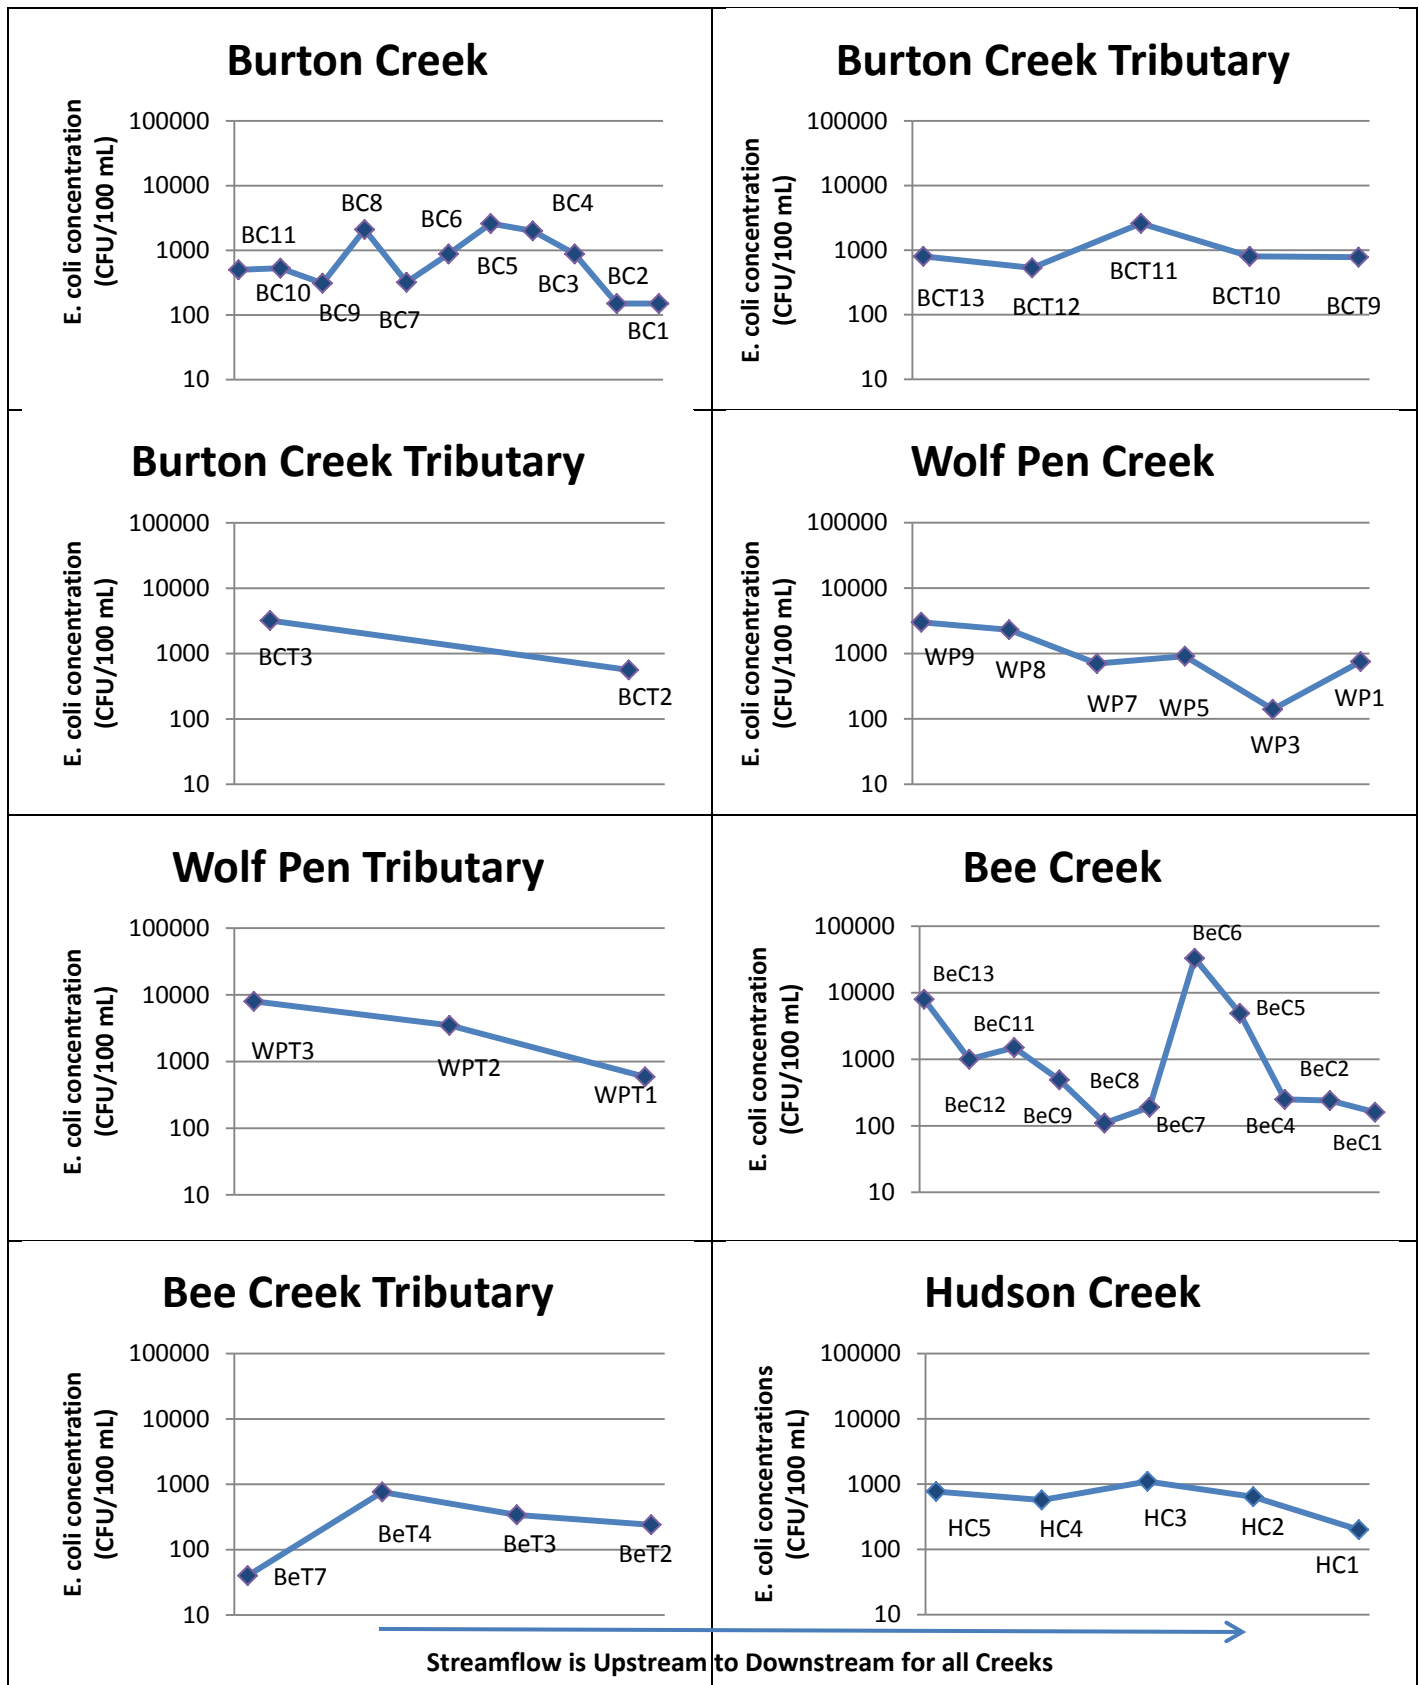
Figure 2: *E. coli* concentrations by waterbody during July 2015 intensive sampling event

*E. coli* increase and decrease observed between sites within each stream. Figure 2 illustrates the variations in *E. coli* concentrations observed during this sampling event in an upstream to downstream fashion within a single waterbody. Maps illustrating the location of specific sampling sites are located in Appendix A and are separated by subwatershed. Data for Carters Creek Tributaries 15 and 17 are not included in Figure 2 as observed *E. coli* concentrations at all four monitoring sites in each watershed were less than 150 colony forming units (CFU) per 100 mL. All *E. coli* observations are included in tables included in Appendices A – E.

Waterbodies exhibiting considerably larger increases in *E. coli* concentrations between sampling locations were noted during the first sampling event. Two reaches of Bee Creek and one of its tributaries; two reaches of Burton Creek and two of its tributaries; and two reaches of Wolf Pen Creek and two of its tributaries were found to have the highest rates of increase. These sites were further investigated during a second sampling event.

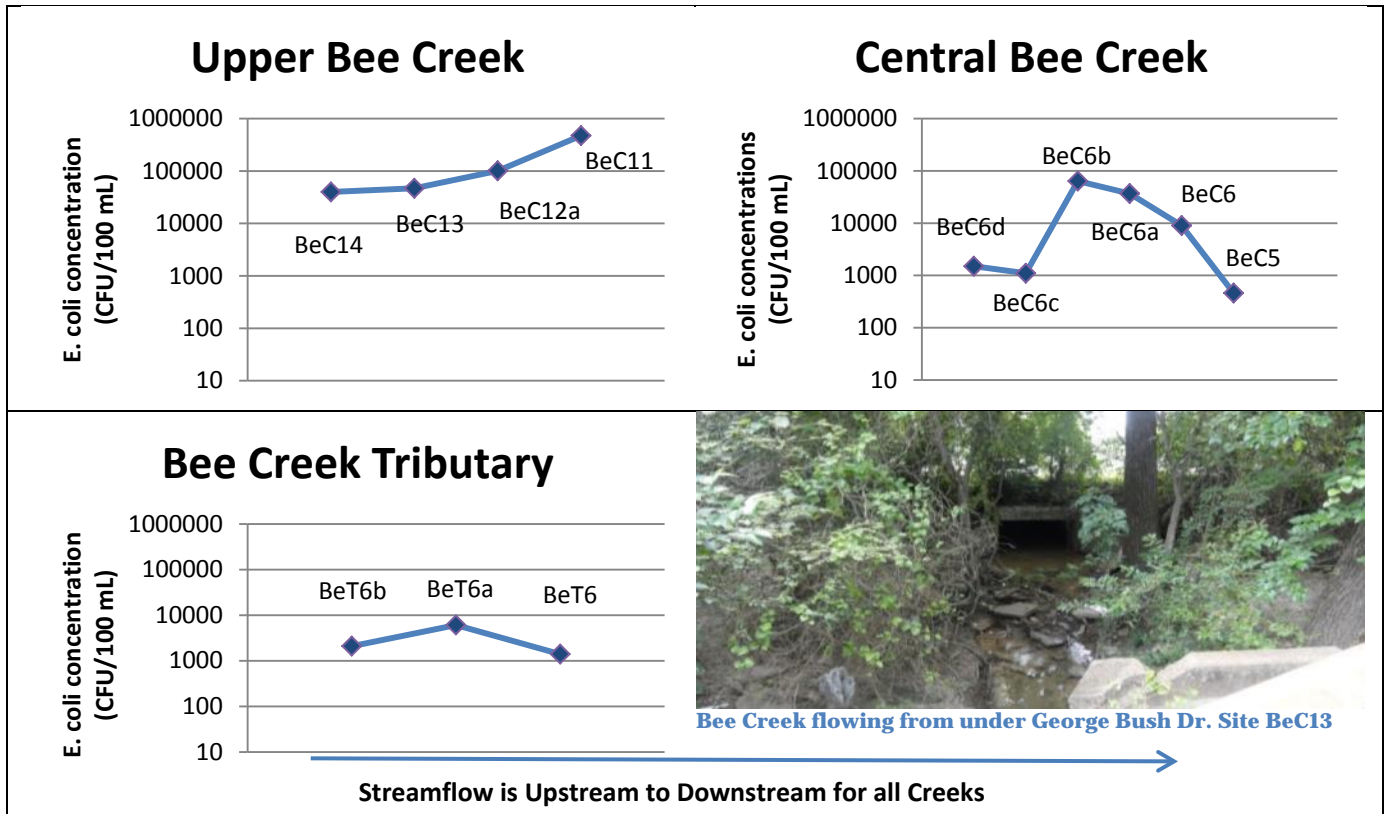
**Figure 3: *E. coli* concentrations observed in Bee Creek and its tributaries during the second round of intensive sampling**

The second round of intensive sampling provided additional insight into the specific loading areas within the sampled reaches. As in the first round of sampling, the portion of Bee Creek immediately upstream of Texas Ave. exhibited rapid increases and decreases of *E. coli* concentrations. The most upstream portion of the creek that drains from Spence Park on the TAMU campus also exhibited a considerable increase in *E. coli* concentrations that were 2 – 3 orders of magnitude higher than the primary contact recreation standard. Several reaches within the Burton Creek watershed also showed considerable changes in *E. coli* concentration within short distances. The unnamed tributary of Burton Creek that flows from Country Club Lake across Villa Maria and Texas Ave showed a rapid increase in *E. coli* immediately upstream and downstream of Villa Maria before levels declined to near the primary contact recreation standard. Downstream on Burton Creek between Broadmoor Ave. and the downstream end of Tanglewood Park, *E. coli* also increased steadily before beginning to decline. In the Wolf Pen Creek watershed, the two tributaries monitored contained the highest observed *E. coli* concentrations. These areas included the headwaters of a tributary that drain the Bonfire Memorial and an unnamed tributary that flows under Harvey Rd. from Thomas Park into the Wolf Pen Creek park greenway immediately upstream of George Bush Dr. East.

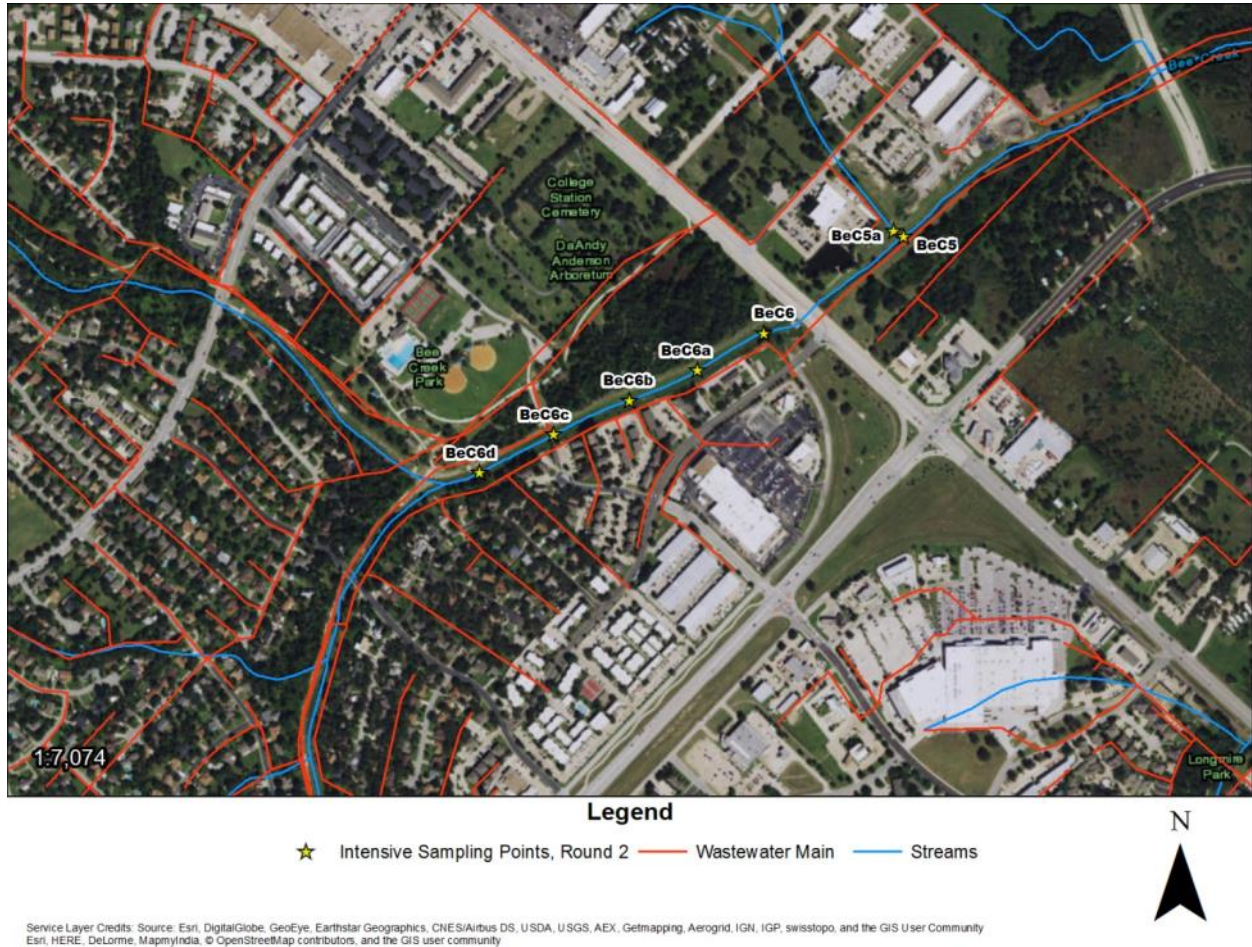
**Figure 6. Bee Creek stream segment from BeC6d through BeC5**

Wastewater infrastructure is also a potential source at many of the observed segments with spikes; however, there was no evidence of leakage when sampling or stream surveys were conducted. Several locations had unpleasant odors, but it is unknown whether the source of these smells came from wastewater infrastructure or another source. Inspection by the appropriate wastewater operators is recommended to further investigate potential sources *E. coli* sources in these segments. Segments with nearby wastewater mains are shown in Figures 5 & 6. In Figure 6, for example, the *E. coli* count increased from BeC6c to BeC6b at a rate of about 145 CFU/100 ml/ft over a distance of

about 430 ft. During sampling, no obvious source or evidence of wastewater leakage was observed.

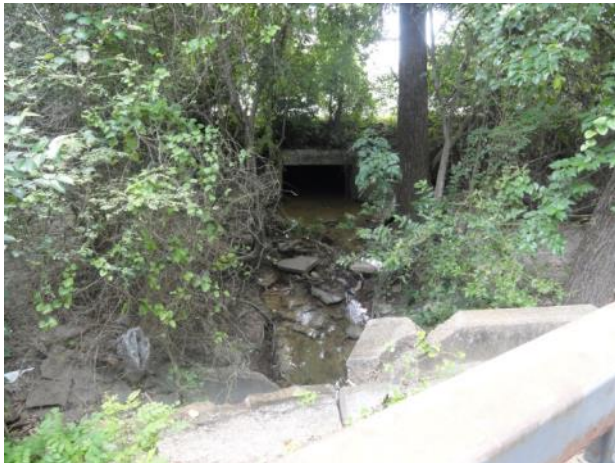
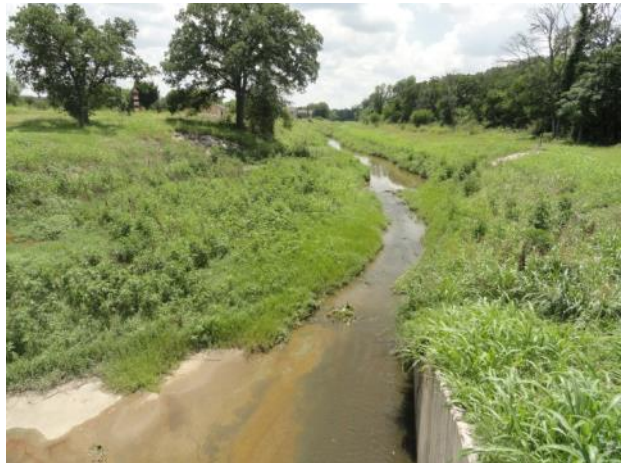
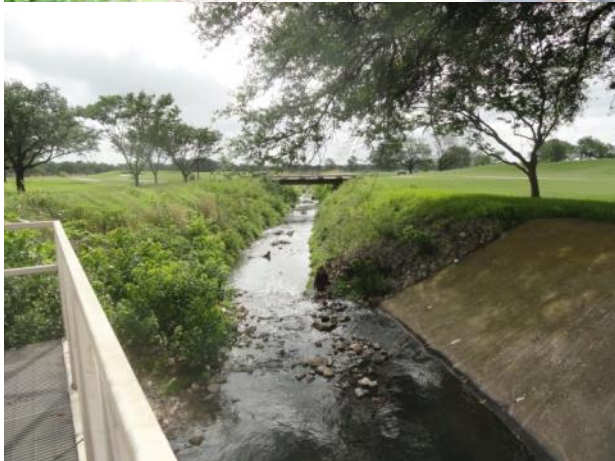
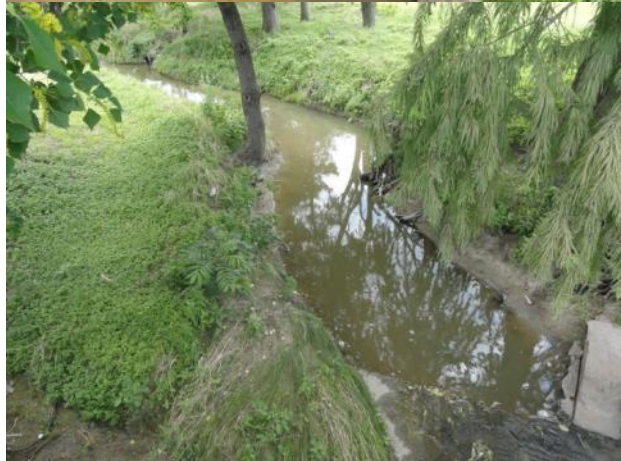
**Recommended inspection area photos. Clockwise from top left: Bee Creek exiting from under George Bush Dr., Bee Creek upstream of Texas Ave., Wolf Pen Creek near George Bush Dr. and Bizzell St., Tributary of Wolf Pen Creek downstream of New Main Dr.**

After sampling data assessment and review, several areas should be considered for further investigation. City or TAMU personnel with knowledge of the potential sources of *E. coli* in these areas (stormwater or wastewater infrastructure) would be the ideal persons to perform these inspections as they may be able to identify problems that can be readily addressed. Also, if infrastructure smoke testing or camera inspections that are currently underway in the watershed could be applied in these areas, they too may be able to identify the underlying cause of the observed *E. coli* loading in these areas. Table 5 includes the sites and descriptions of areas where inspections have the greatest potential to considerably reduce *E. coli* concentrations in stream if a specific issue can be found and subsequently corrected.
