# CARTERS CREEK TOTAL MAXIMUM DAILY LOAD IMPLEMENTATION PROJECT FINAL REPORT

Texas Water Resources Institute TR-488  
February 2016

Project Funded by:  
Texas Commission on Environmental Quality: Award: 582-13-30059

Texas Water Resources Institute Technical Report TR-488  
February 2016

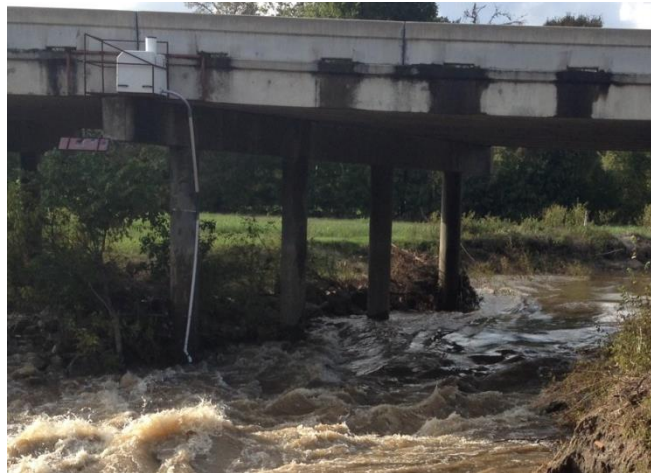
Automated sampling devices (ISCO Model 6712 Portable Samplers, Teledyne-ISCO, Lincoln, NE) were deployed on Burton Creek and Carters Creek at Stations 11783 and 21259 (Table 1, Figure 2), respectively to collect stormwater runoff influenced samples. These samplers were programmed to only sample after the creek sites rose to a predetermined level. Once samplers were enabled, they took flow-weighted composite samples of the runoff event and recorded water levels which were translated to stream flow volumes. This data allowed for *E. coli* loads in storm events to be calculated. Samples were processed for *E. coli* concentrations by SAML using the USEPA 1603 method. Only *E. coli* concentrations and water depth/stream flow were recorded for these sampling events.

*Automated Storm Sampler at Station 21259 during a runoff event*
