AN EVALUATION OF RE-VEGETATION ON STREAMBANK STABILITY AND  
EROSION

A Thesis

Major Subject: Water Management and Hydrological Science

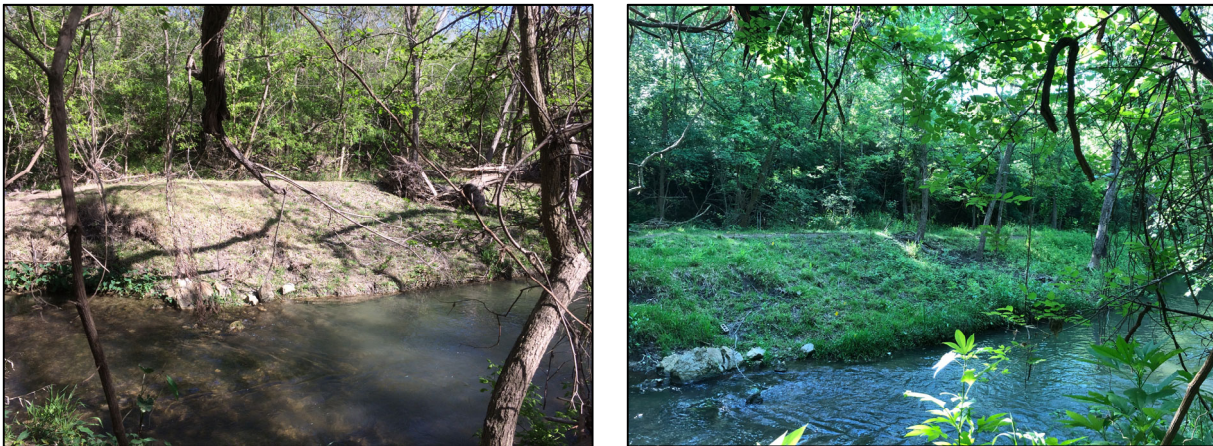
**Figure 4.1 Left photo was taken in March of 2018 while right photo was taken in April of 2019 in the treatment segment of the left bank.**

One year after planting and maintenance, several species started taking root, spreading, and flourishing in the treatment segment as shown in Figure 4.1. After a large storm in December, the wood pile was washed away and by April of 2019 vegetation began to encroach on the bare ground. In the control segment, very little change was observed as shown in Figure 4.2. Spraying of the invasive elephant ears in both segments opened up the bank to for native plants to spread and establish. The right control bank did not have any change overall. The right treatment bank, similar to the left, increased in herbaceous cover after one year as observed in Figure 4.3.

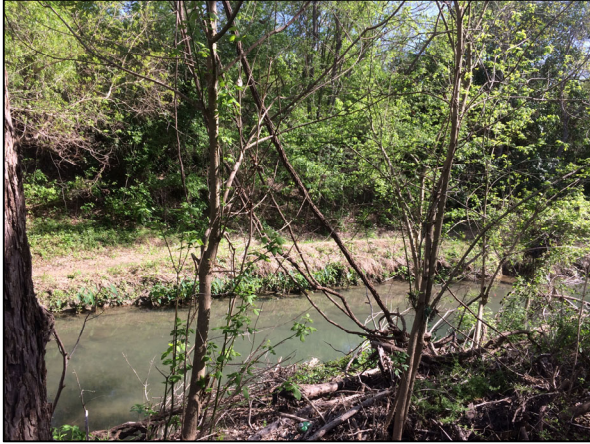
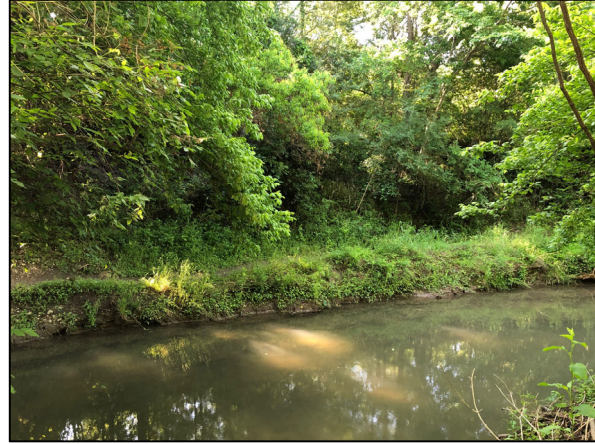
**Figure 4.2** Left photo was taken in March of 2018 while right photo was taken in April of 2019 in the control segment of the left bank.

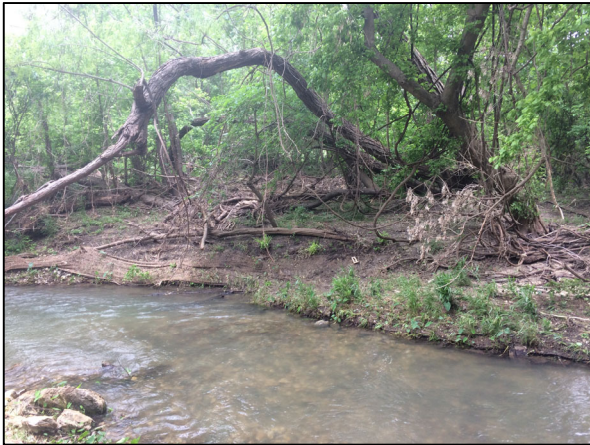
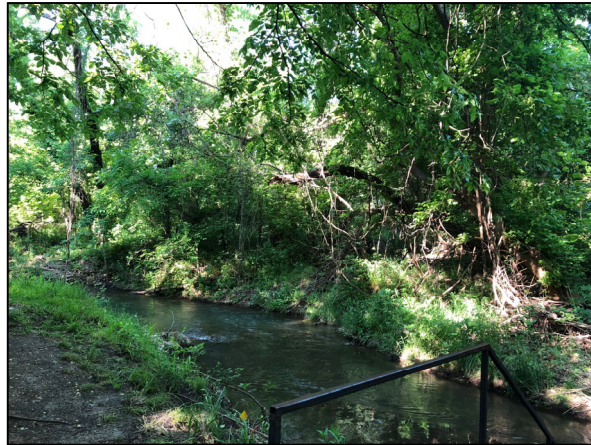
**Figure 4.3** Left photo was taken in April of 2018 while right photo was taken in April of 2019 in the treatment segment of the left bank.

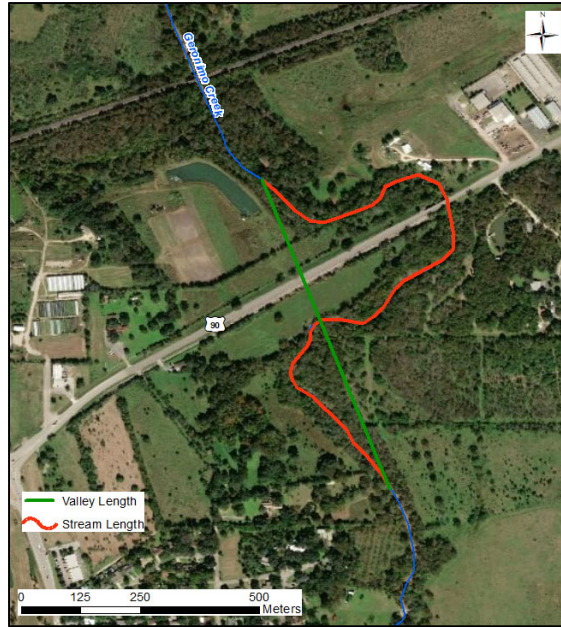
**Figure 4.4 Stream length and valley length shown for a section that includes the study site within Geronimo Creek in Seguin, TX.**

The sinuosity of the stream for a long section of Geronimo Creek that included the demonstration area resulted in a calculated overall sinuosity of 1.9 (Figure 4.4). The average slope of the stream for the 2018 data at the demonstration site was 0.007 or (0.7%). The treatment segment was steeper than the control segment, but both had relatively mild slopes smaller than 0.02 (or 2%).

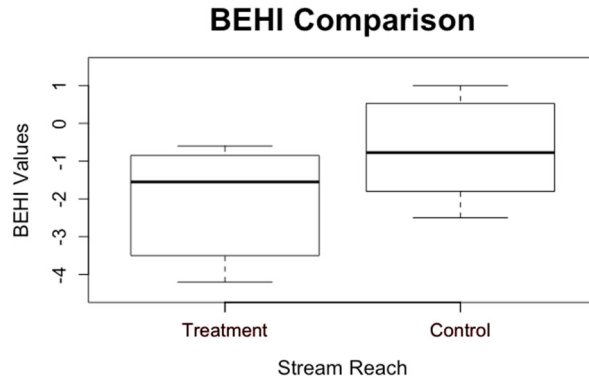
**Figure 4.5 Two independent samples t-test for the change in the control segment versus the treatment segment with statistical difference at the  $p < 0.10$  level.**

A two independent samples t-test was performed using the change or difference in BEHI values from the beginning to end of project for the control segment versus the treatment segment. The test was executed using Program R (v3.4.0; R Development Core Team 2017). The treatment segment ( $n = 8$ ) had a mean of -2.075 with a standard deviation of 1.49. The control segment ( $n = 8$ ) had a mean of -0.7 with a standard deviation of 1.29. Overall, the change in the BEHI index and rating for the treatment segment improved while the control segment had little to no change. The test resulted in a p-value of 0.06845 meaning there was a statistical difference in the change of BEHI values from the control to the treatment segments at the  $p < 0.10$  level (Figure 4.5).

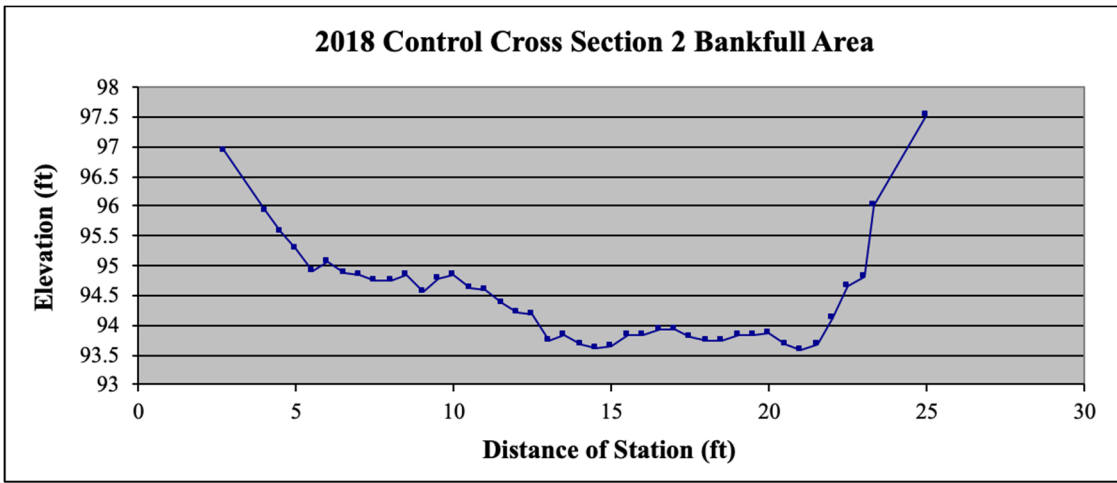
Figure A.2 2018 Bankfull Area of Control Cross Section 2.

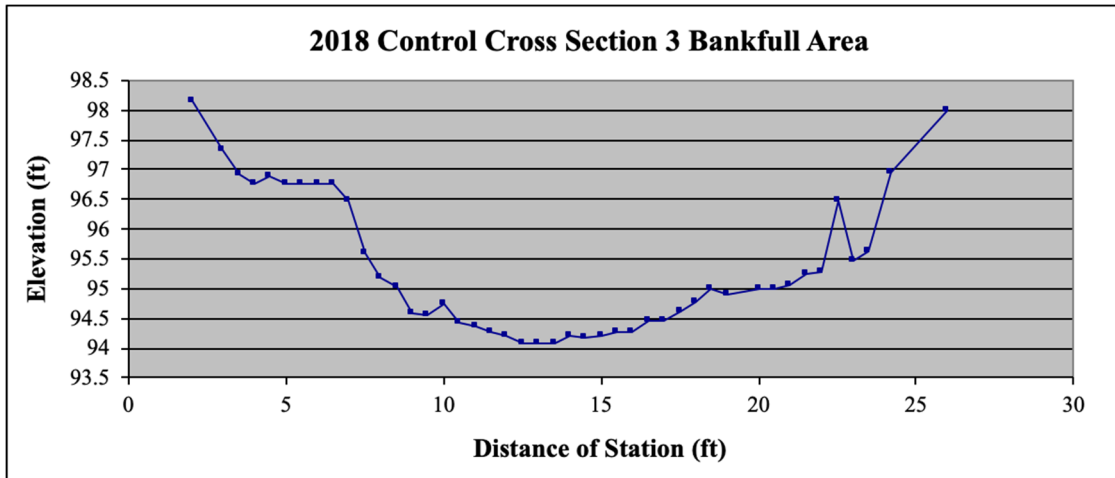
Figure A.3 2018 Bankfull Area of Control Cross Section 3.

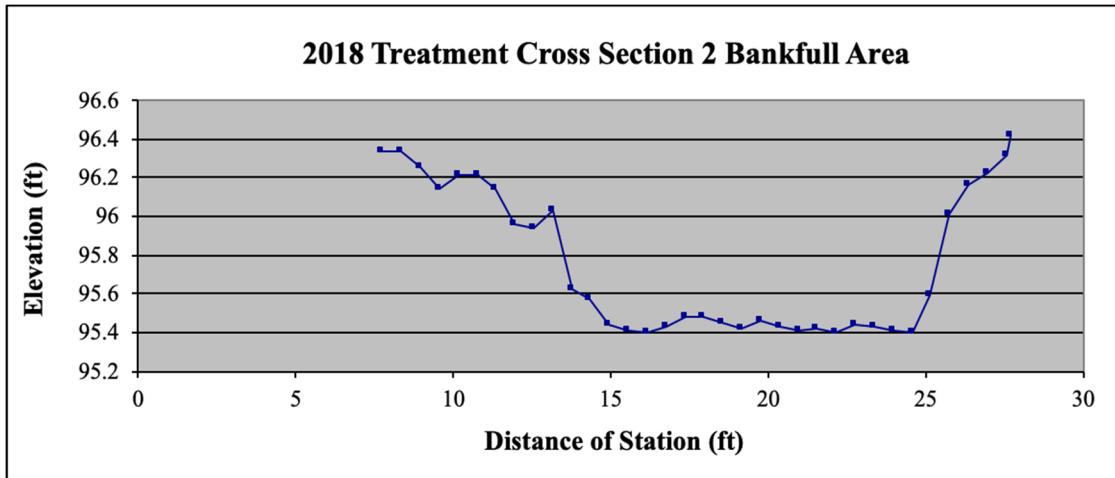
Figure A.6 2018 Bankfull Area of Treatment Cross Section 2.

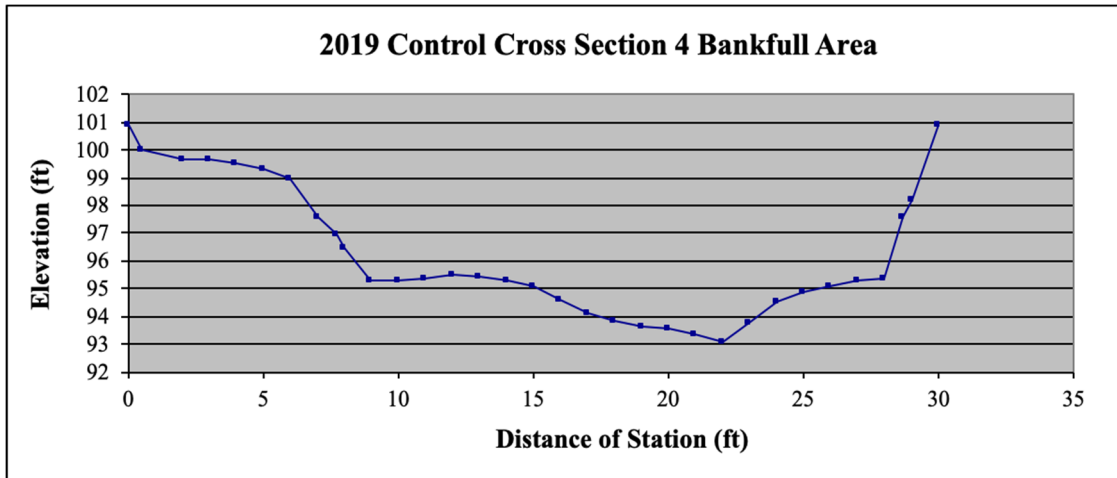
Figure A.12 2019 Bankfull Area of Control Cross Section 4.

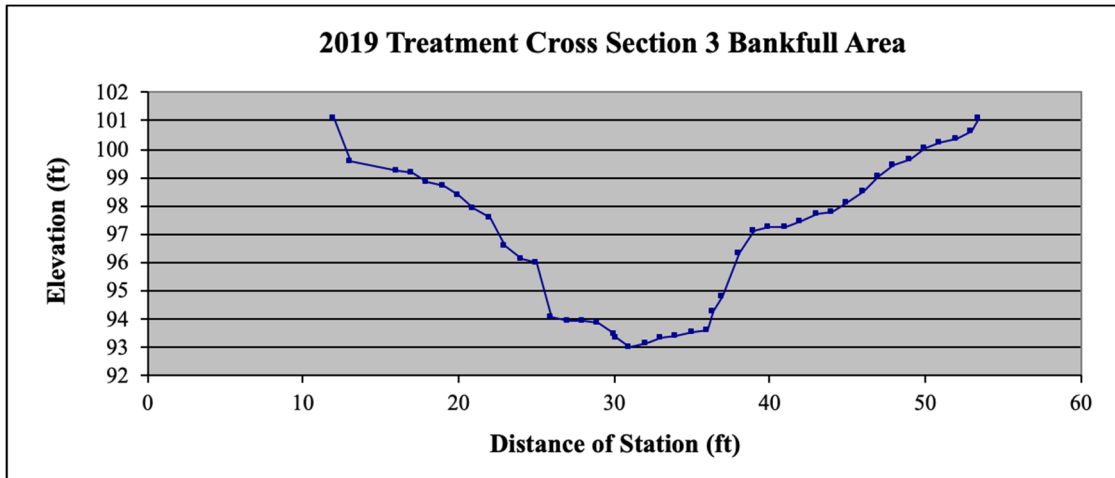
Figure A.15 2019 Bankfull Area of Treatment Cross Section 3.

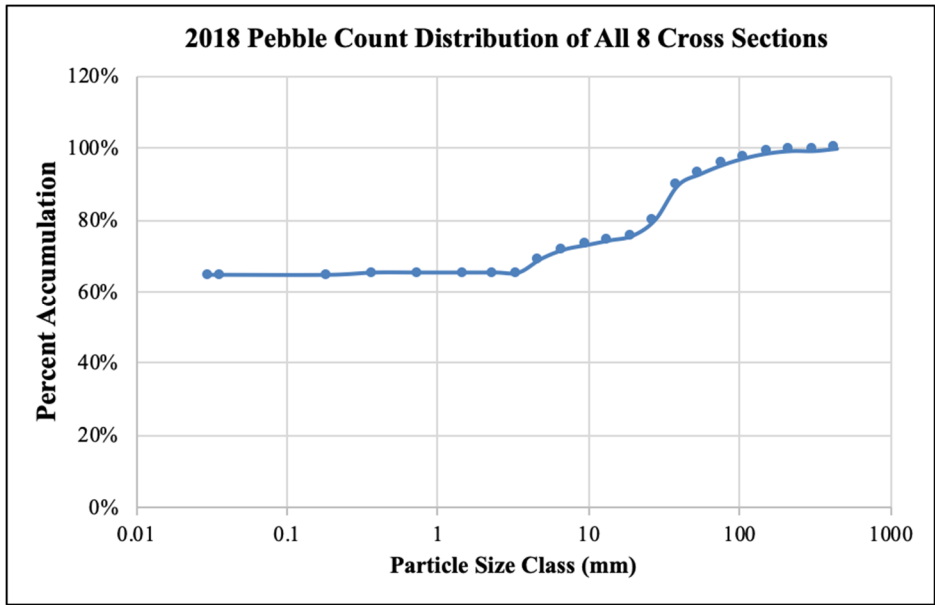
Figure A.17 2018 Pebble Count Distribution of All 8 Cross Sections.
