THE SLOOP BOSCAWEN:
HULL CONSTRUCTION AND DESIGN DURING THE MID-EIGHTEENTH CENTURY IN
THE CHAMPLAIN VALLEY

A Dissertation

DANIEL E. BISHOP

Texas A&M University

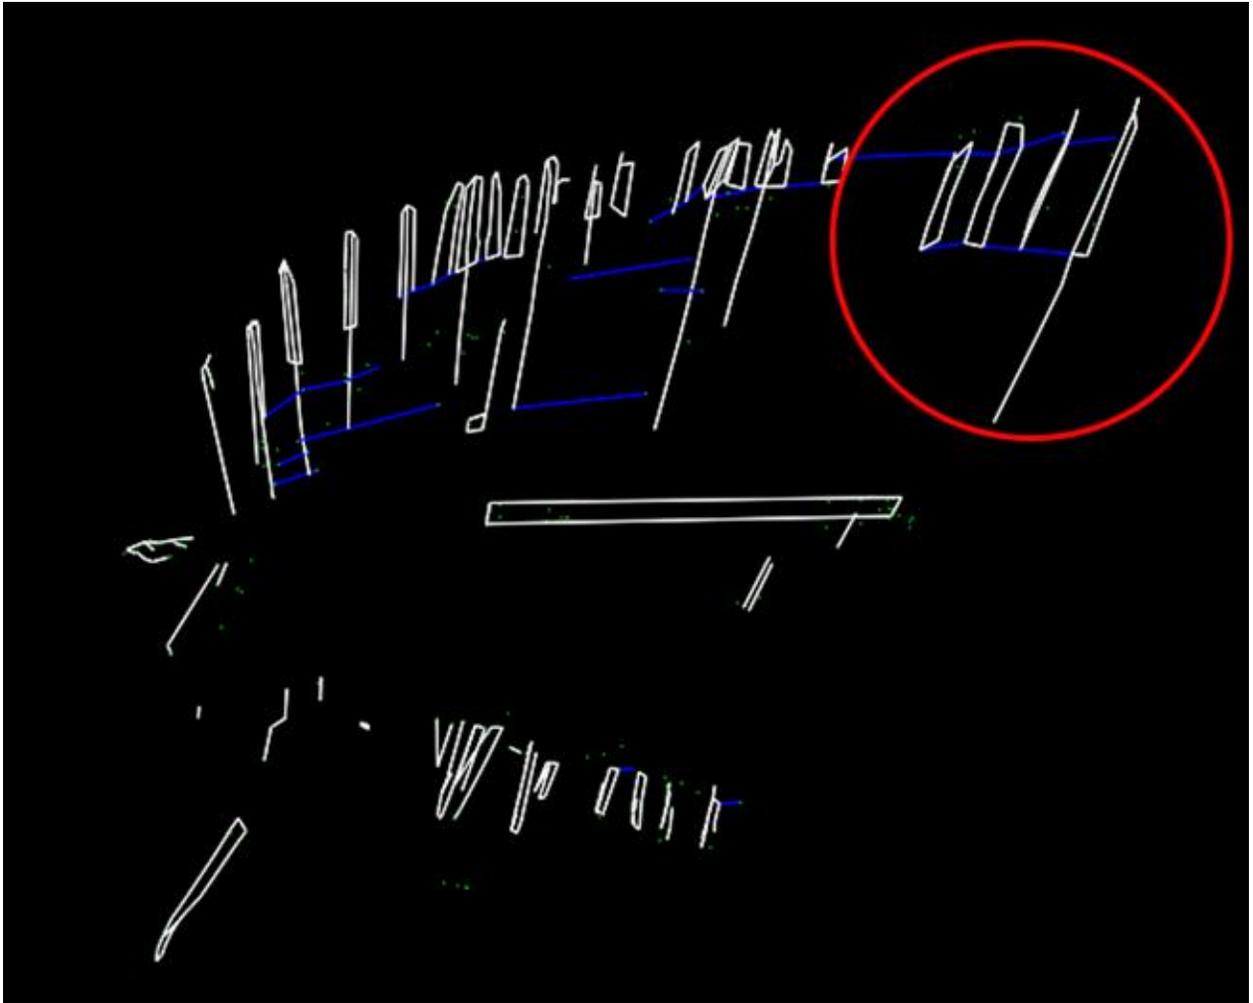
Figure 48 Area of perspective distortion on *Duke of Cumberland* model. (Image generated in iWitness V4)

In addition to the lack of lens information, other issues can arise during photogrammetric model creation. After multiple attempts to reference the *Duke of Cumberland* images, I observed a model distortion away from the photographs' perspective centers (at the furthest aft frames on the starboard side). This distortion could be caused by a few things, including (1) image quality (i.e., of the photograph itself, the camera's focus, and/or the scan of the image), (2) incorrect focal length and pixel dimension of the images, and (3) user error when selecting the reference points. A fourth explanation or contributing factor to the observed model distortion could be distortion of the vessel itself, as a great deal of force was presumably exerted on some of the futtocks, especially near midships, when the hull was dragged ashore. The first two possibilities are difficult for an iWitness user to overcome, but the third and fourth are more easily corrected. Although this distortion may be caused by one of more of the above-mentioned factors, the most likely explanation is that our two best photos of the forward half of the vessel did not have a significant angular separation between them, thus introducing a bias near midships on the starboard side (see Figure 48).

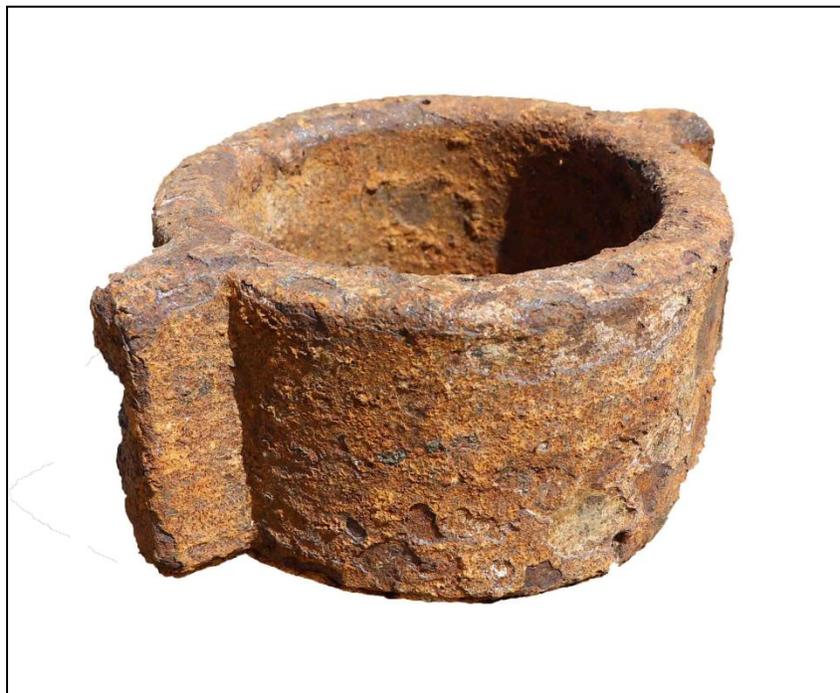
Figure 55 Iron corrosion products on one of *Duke of Cumberland's* artifacts. (Photo by author)

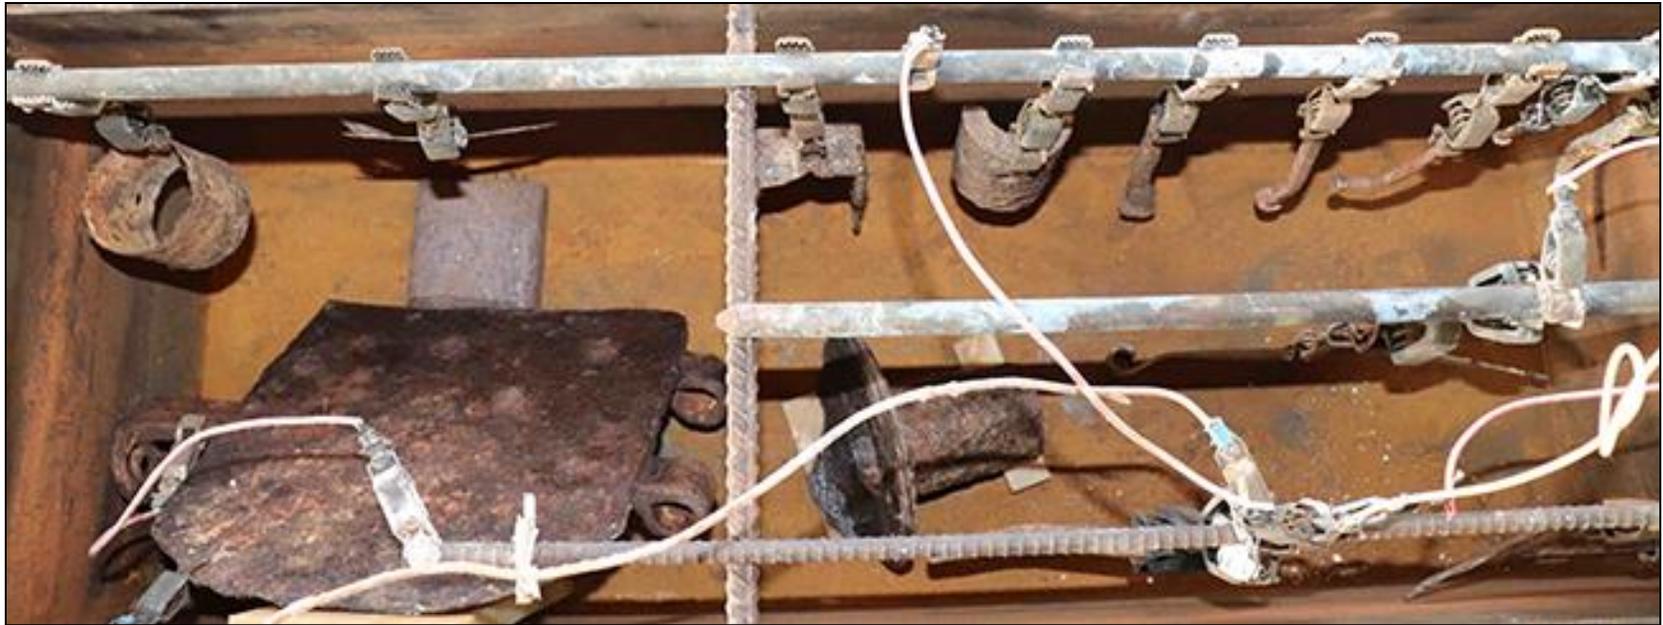
Figure 59 One of the electrolytic reduction treatment vat setups. (Photo by author)

Because the artifacts originally came from a freshwater environment, I used a 5 percent solution of sodium hydroxide in deionized (DI) water as the electrolyte in order to maintain electrolyte conductivity, effectively remove any remaining chlorides and anions within the artifacts, and to more readily measure how much of these compounds was pulled into the electrolyte solution. I used a DC power supply to control the electrical current flowing through the anode (a positive charge for the sacrificial metal) and the cathode (a negative charge for the artifact). I chose to use a low to medium current in order to consolidate the corrosion layers and eliminate any chlorides. The hydrogen that evolved off the artifacts at this current was sufficient to facilitate moderate mechanical cleaning.
