PLACEMENT GUIDELINES  
FOR BRIDGE PARAPET SYSTEMS WITH CURBED SIDEWALKS

A Thesis

Major Subject: Civil Engineering

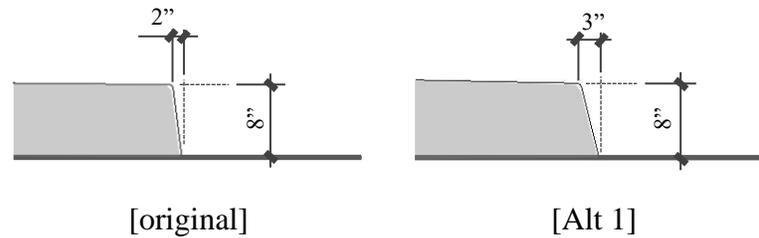
**Figure 1.1 Profiles of sidewalks with curbs**

vehicle model with the first profile, the second profile is used for the parametric simulations under MASH TL-2 and MASH TL-3 conditions.

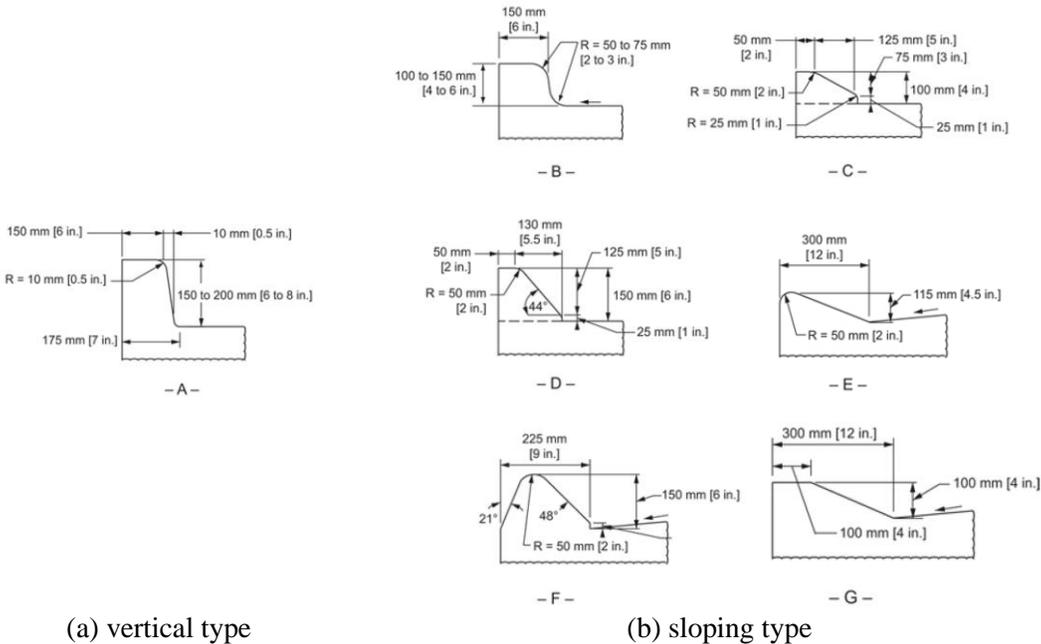
categorizes curbs into two types, i.e., vertical curbs and sloping curbs. Figure 2.1 illustrates both curb profiles. The primary difference between the two types is the desired vehicular behavior after impacts. Vertical curbs are used when errant vehicles are desired to be redirected, whereas sloping curbs induce vehicles to move up on the curb so that the errant vehicles do not significantly influence the roadways. If vertical curbs are located along low-speed roadways, they would be likely to successfully redirect the vehicles. For sloping curbs, as the slope and the height of curbs are controlled, vehicles can be led to mounting effectively. In some cases, both profiles can be combined. When curbs are used along roadways with barrier systems, other conditions related to the barrier should be considered such as the type, height or offset from the curb.

**Figure 2.1 AASHTO typical highway curbs (AASHTO 2011)**

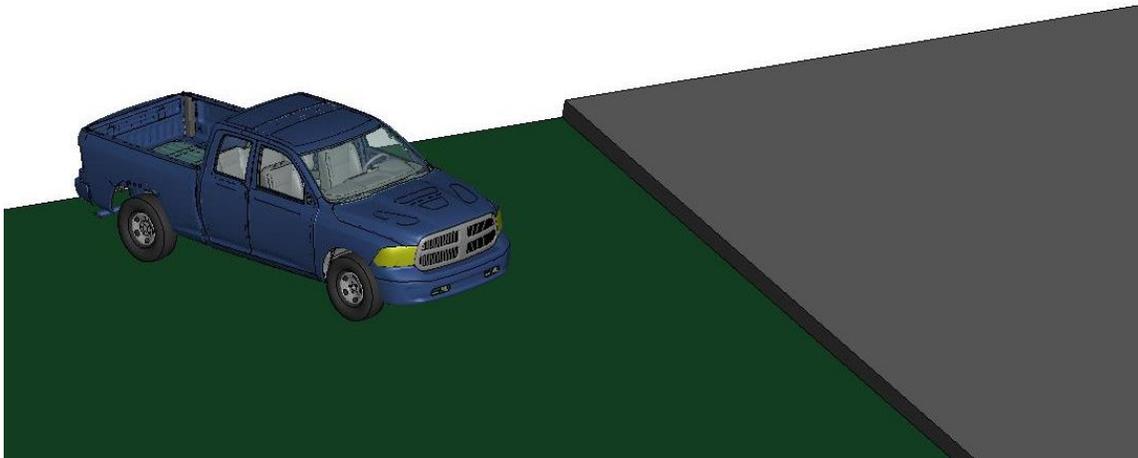
In crashworthiness experiments, an LS-DYNA model should be set up with the same conditions as full-scale testing. Since LS-DYNA provides various types of elements, materials, sections, etc., researchers can apply the most suitable options in accordance with the actual conditions. Specific capabilities of LS-DYNA such as damping or accelerometers can be also used for more sophisticated analysis. For a crash simulation one of the critical issues is how to capture the contact among a lot of parts. LS-DYNA provides different types of contacts that allows solving complex and difficult problems. Figure 2.3 shows a modeling example in LS-DYNA and the vehicle is set up to make impact with a curb after a few seconds.

**Figure 2.3 Model set-up for a pickup truck**

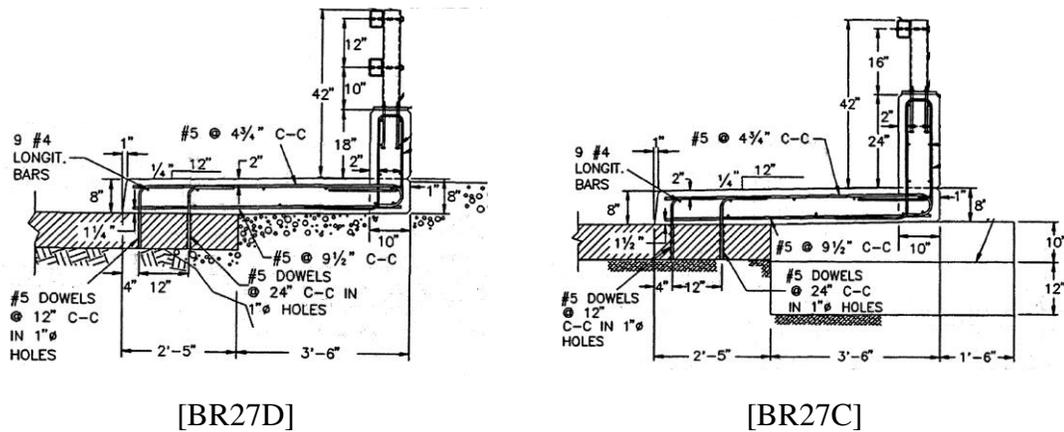
**Figure 2.4 Cross sections of BR27D and BR27C bridge railings  
(Buth, Hirsch et al. 1997)**

Since BR27D was tested under PL-1, two vehicles – a Honda Civic for small automobile and Chevrolet Pickup for pickup truck – were used. The weight of the Honda Civic was 1,800 lb and the vehicle contacted the curb at a speed of 51.7 mph and at an angle of 20.8 degrees. The Chevrolet Pickup weighed 5,400 lb and contacted the curb at a speed of 45.3 mph and at an angle of 20.2 degrees. For both tests, the bridge railings had only minor damage. Also, both vehicles received damage, especially at the initial impact position on the left front; however, the railing contained and redirected the vehicles and the test data satisfied the requirements provided by the guidelines. Since the BR27D on a deck did not have a curb, the tests showed higher safety in terms of occupant ridedown acceleration, and also satisfied the requirements. Therefore, BR27D bridge railings both on a sidewalk and on a deck were considered acceptable.

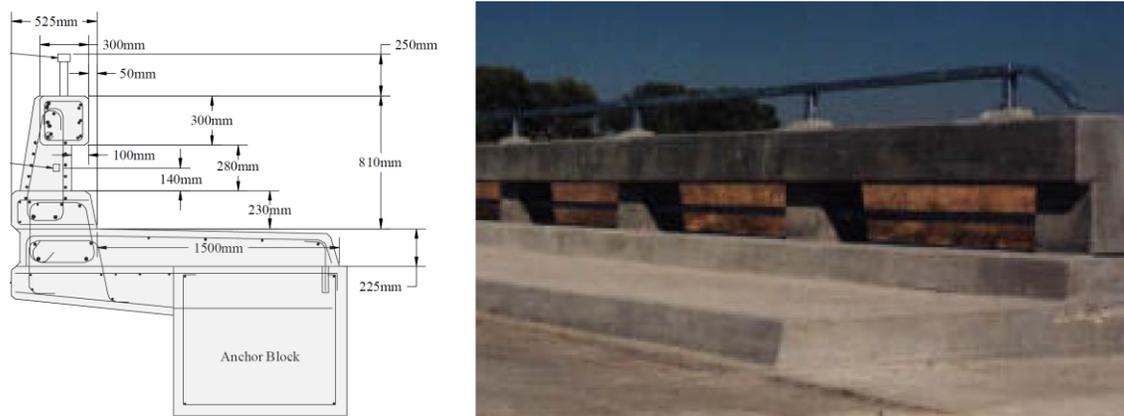
The bridge rail used in this study included a 225 mm high sidewalk with a curb. Also, one of the main design points was to make it possible to see through the rail by placing vertical elements at regular intervals between the top and bottom concrete elements. Both the handrails on top of the concrete and lower rails were attached to the system for pedestrian safety. Figure 2.5 shows the designed cross section of Type 80SW and its actual construction. The gap between the top and bottom concrete was originally designed 310 mm high, though it was reduced by 30mm due to the potential snagging risk from the first 820C test.

**Figure 2.5 Cross section and installation of Type 80SW (Meline, Jewell et al. 1999)**

For the first test, an 820C vehicle contacted the bridge system at a speed of 102 km/h and at an angle of 20 degrees. After the test, tire marks were observed at one vertical concrete element and adjacent lower rails inside the gap. This meant that, while the vehicle had an impact with the concrete parapet, the vehicle was able to reach the inner side of the bridge system and it could have a potential snagging problem. For this reason, the gap was redesigned from 310mm to 280mm as shown in Figure 2.5, and retest for an 820C vehicle was determined.

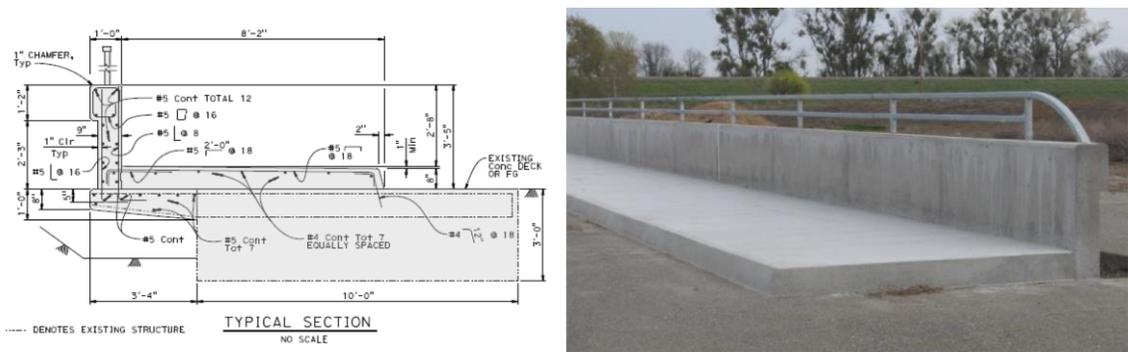
The other study undertaken by Caltrans in 2016 was to evaluate the Type 732SW under MASH TL-3 conditions (Whitesel, Jewell et al. 2016). MASH TL-3 included two tests, 3-10 for an 1100C passenger car and 3-11 for a 2270P pickup truck as indicated in Table 1-1. For both vehicles, the target impact speeds and angles were 62 mph and 25 degrees, respectively. However, as a result of the test 3-10, the bridge rail did not satisfy the requirements of MASH TL-3. For this reason, one supplementary test was executed under 2-10 conditions. Consequently, this research included a total of three crash tests, 3-10, 3-11, and 2-10.

**Figure 2.6 Cross section and installation of Type 732SW  
(Whitesel, Jewell et al. 2016)**

On the other hand, for the simulation under TL-3 conditions, the bridge parapet is modeled as indicated in Figure 2.6. The curb offset is 2 inches like the trajectory testing of this thesis, but the sidewalk slope is 1 inch. The sidewalk width is 8 feet and 2 inches, and the concrete parapet is 3 feet and 5 inches tall. Also, there are handrails on the top of the concrete. Figure 4.1 (b) shows the bridge parapet system used for the TL-3 simulation.

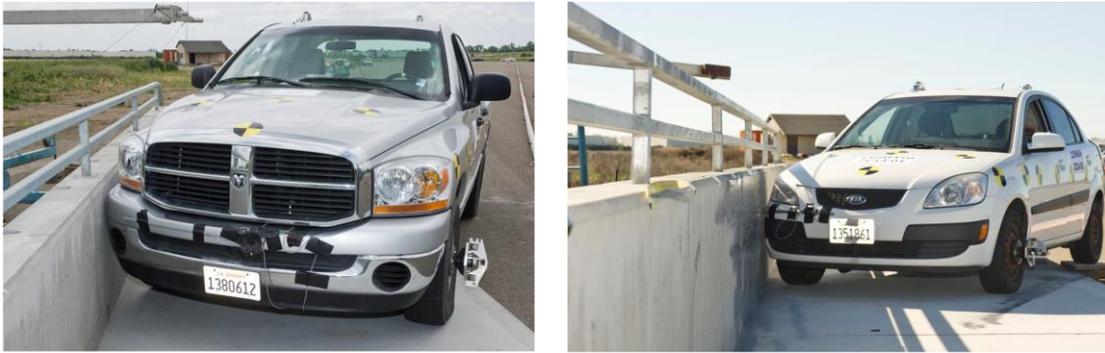
As seen in Figure 2.7, for the testing vehicles, the Dodge Ram for test 3-11 and the Kia Rio for test 3-10 and 2-10 were used. The test inertial mass of the pickup truck was 5062 lb and it had additionally ballast weighed 128 lb. The passenger car weighed 1112 lb and did not incorporate the ballast, but an anthropomorphic dummy was used.

**Figure 2.7 Testing vehicles for test 3-11 and 2-10 (Whitesel, Jewell et al. 2016)**

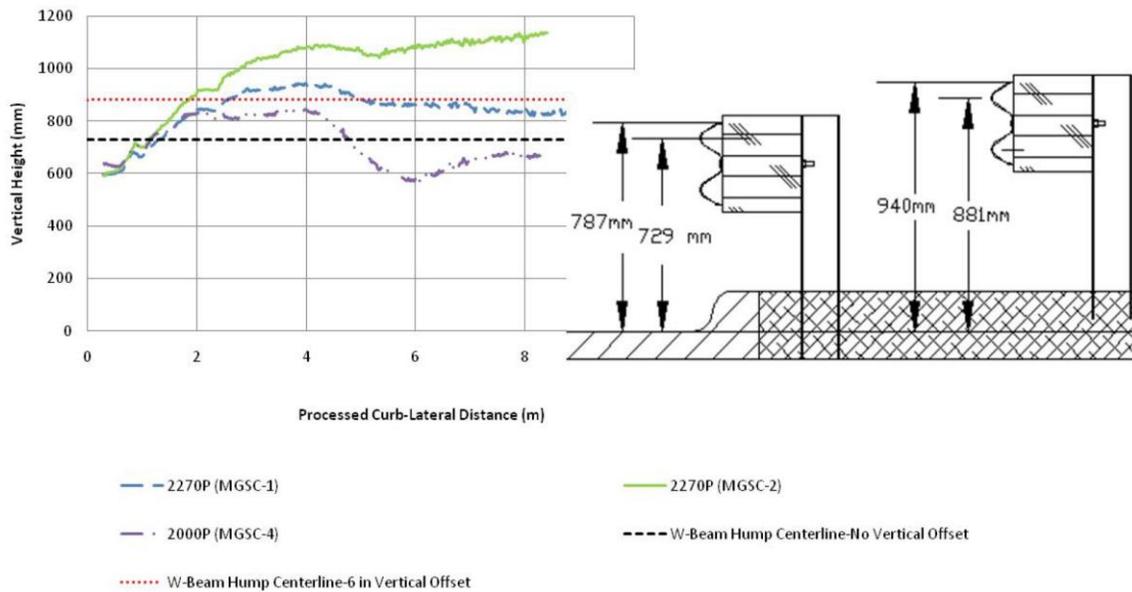
Through the analysis of the trajectory testing, researchers figured out the critical impact points of the vehicles. Then, the points were compared with the MGS height. From this process, researchers determined the relationship between the vehicular impact points and the lateral offset of the MGS. For example, Figure 2.8 shows the pickup truck case. The red and black dashed lines are the typical MGS heights above the roadway and the curb, respectively. The green, blue, and purple lines are the critical impact heights of the test pickup trucks. In the case that these lines are above the dashed line, pickup trucks can override the guardrail. This graph precisely specifies the safe range of the lateral offset of the guardrail from the curb. In the same manner, the passenger car was studied and the safe range in which the vehicle did not override the guardrail was investigated.

**Figure 2.8 Relation between the critical impact point and the lateral offset of MGS (Zhu, Reid et al. 2009)**

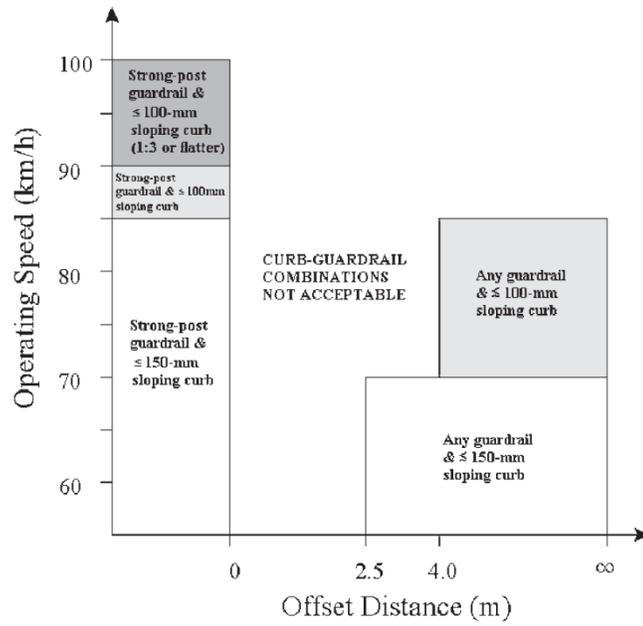
While synthesizing the literature and the analyses mentioned above, researchers analyzed the relations between vehicular speeds, curb heights, and lateral offset distances of the guardrails. Finally they recommended the guidelines for the usage of curbs and guardrails as shown in Figure 2.9.

**Figure 2.9 Guidelines for the use of curbs (Plaxico 2005)**

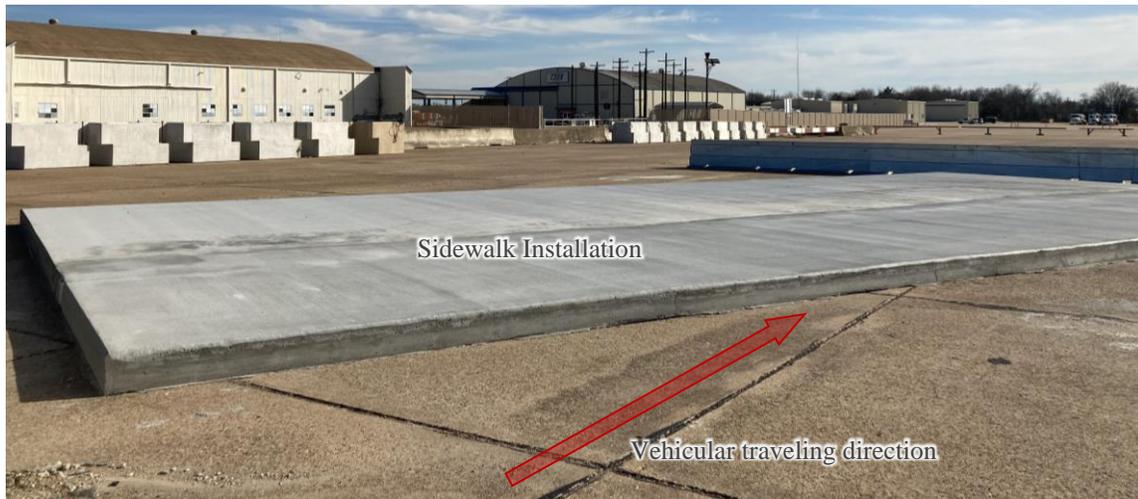
The trajectory testing is conducted at TTI's Proving Ground located on the RELIS campus of the Texas A&M University. The 60-ft long and 25-ft wide sidewalk with a curb is installed as shown in Figure 3.1. The arrow signifies the traveling direction of the test vehicle before it comes into contact with the curb. This direction is at a 25-degree angle with the sidewalk. The contact point is 20 feet upstream from the sidewalk end, which is the one third position of the whole length. The curb height is 8 inches and the curb offset is 2 inches. Figure 3.2 illustrates the dimension of the curb installation. The drawings of the test installation including the material properties and steel reinforcement are provided in Appendix B.1.

**Figure 3.1 Installation of a sidewalk with a curb**

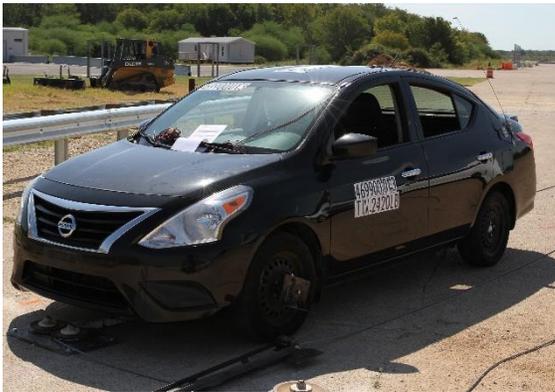
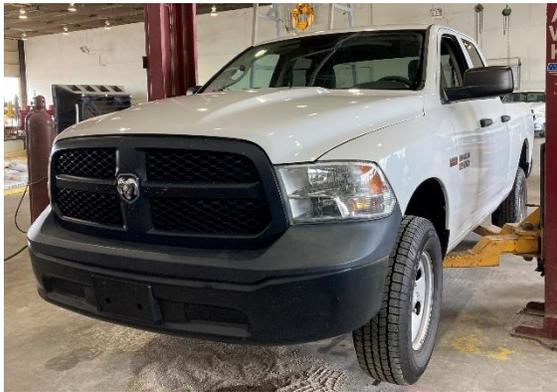
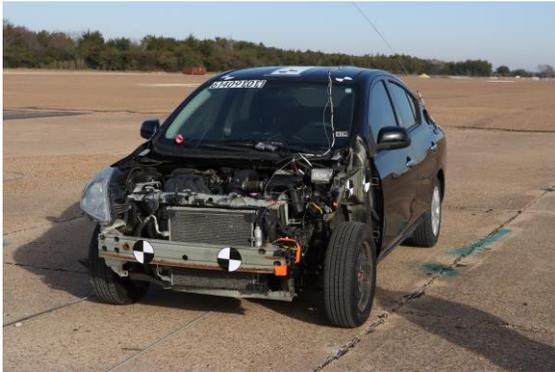
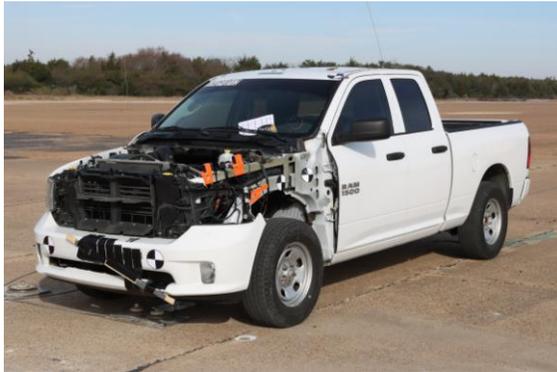
**Figure 3.4 Test vehicles**

A 2014 Nissan Versa passenger car is used for the 1100C test vehicle with a test inertial mass of 2,446 lb (1,110 kg). Since this is not to crash test any barrier system, but to ascertain only the trajectory, a dummy is not included in the vehicle. A 2014 Dodge Ram pickup truck is used as the test vehicle for the 2270P test vehicle with a test inertial

mass of 5,005 lb (2,270 kg). The C.G. height is 28.75 inches, which satisfies the minimum value, 28 inches, required by MASH. For both the 1100C and 2270P test vehicles, some plastic parts including the hood are removed before testing. This is to eliminate the unnecessary parts and capture the suspension behavior and the left front tire movement in more detail. Figure 3.4 shows each test vehicle and the vehicle dimensions are contained in Appendix B.2.

(a) 1100C test vehicle  
(before removing parts)

(b) 2270P test vehicle  
(before removing parts)

(c) 1100C test vehicle  
(after removing parts)

(d) 2270P test vehicle  
(after removing parts)

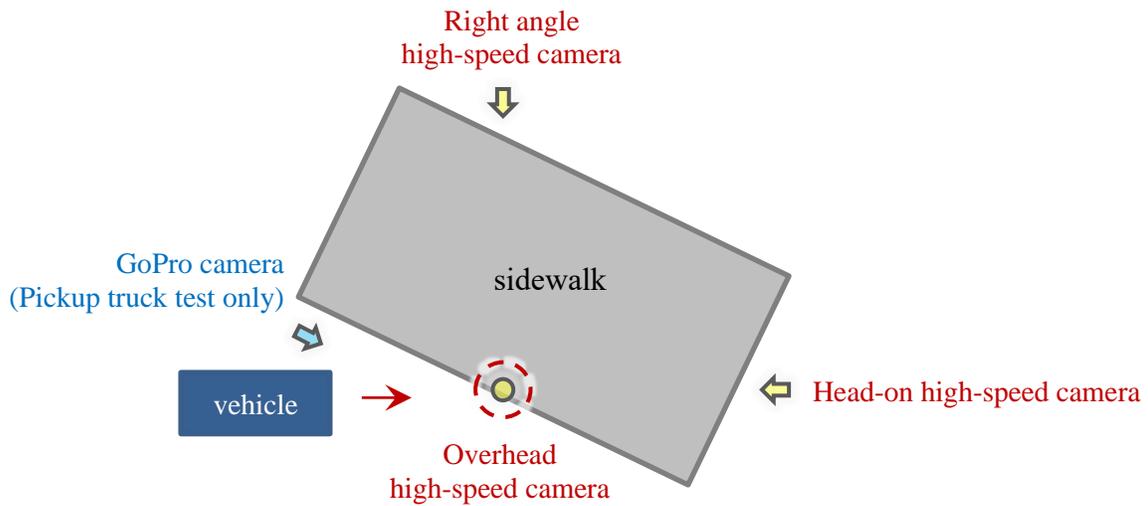
**Figure 3.5 Camera locations**

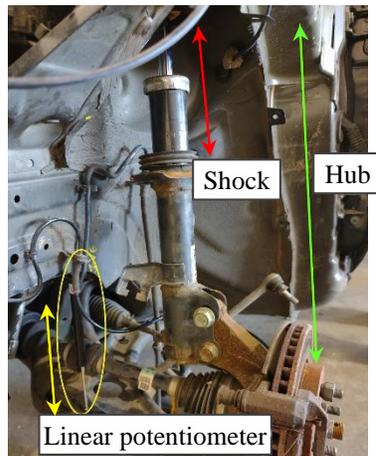
Hub	Linear potentiometer	Shock
20.7	-4.00	6.625
18.9	-3.50	4.875
18.0	-3.25	4.125
17.0	-3.00	3.500
16.0	-2.75	2.500
15.4	-2.60	2.000

**Figure 3.7 Displacement relationship of the shock and linear potentiometer**

actual displacement of the shock from the testing can be found out. The plots shown in Figure 3.7 present the relationship of the displacement between the shock and the linear displacement. Figure 3.8 and Figure 3.9 show all the devices near the left front tire.

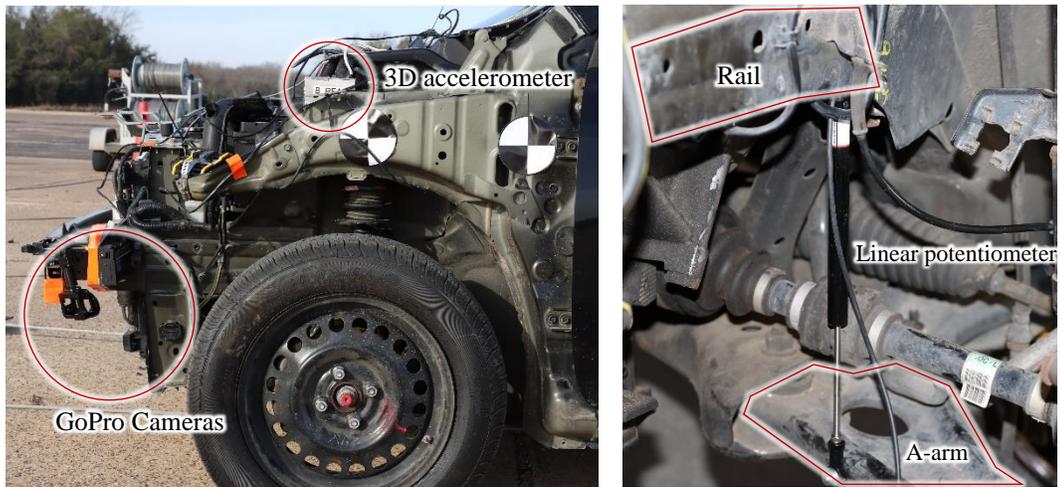
**Figure 3.8 Instrumentation inside the left front wheel well (passenger car)**

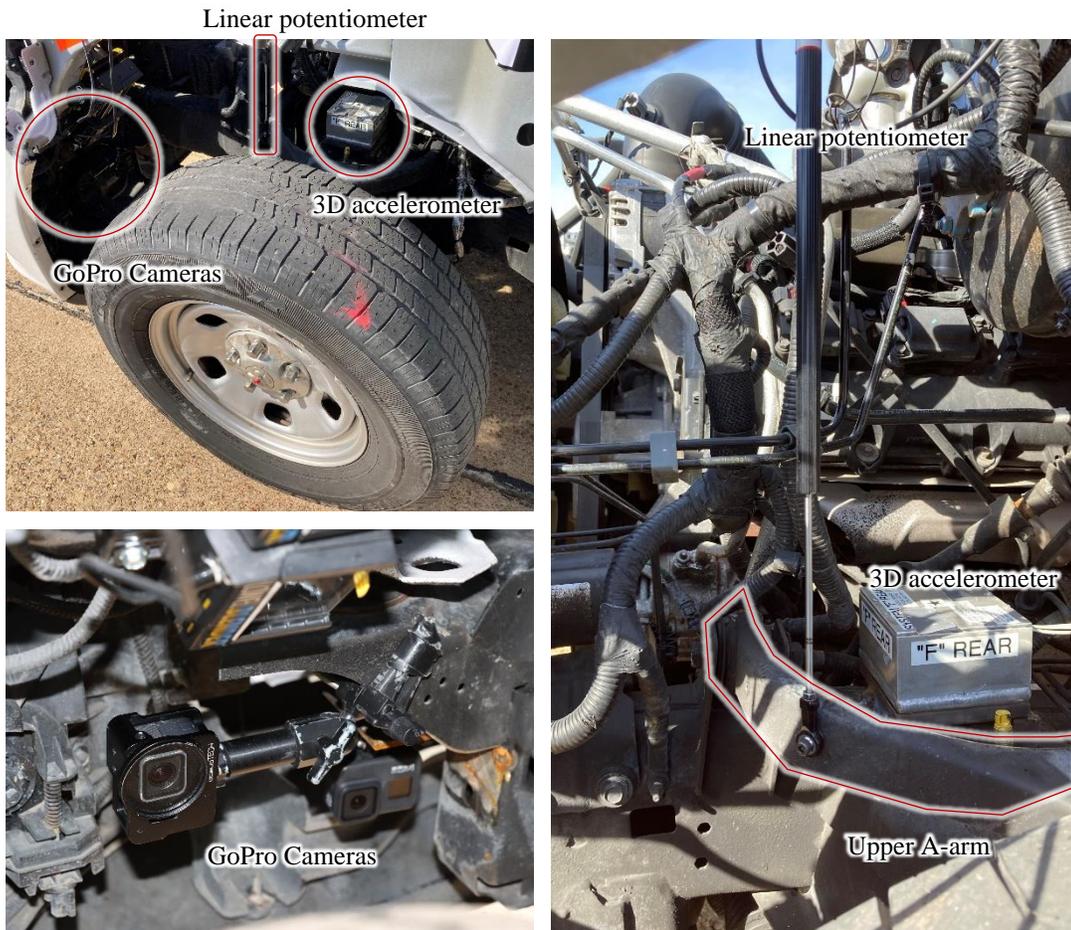
**Figure 3.9 Instrumentation inside the left front wheel well (pickup truck)**

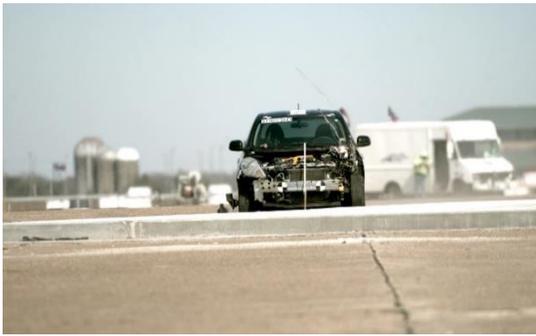
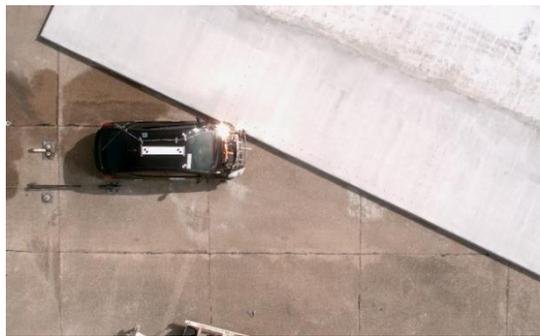
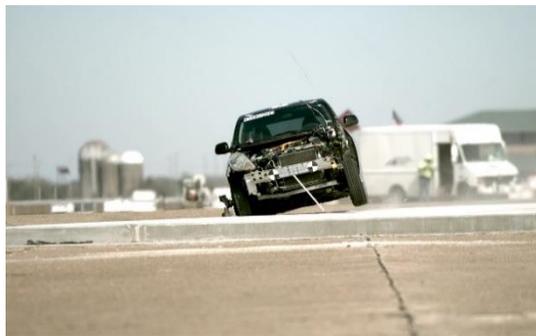
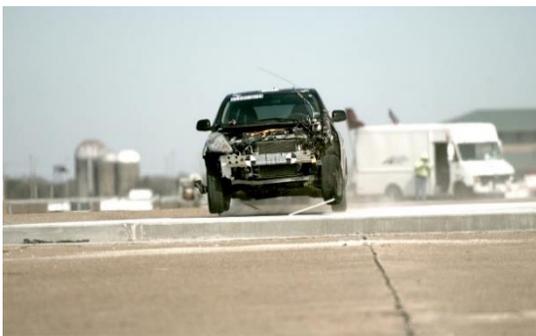
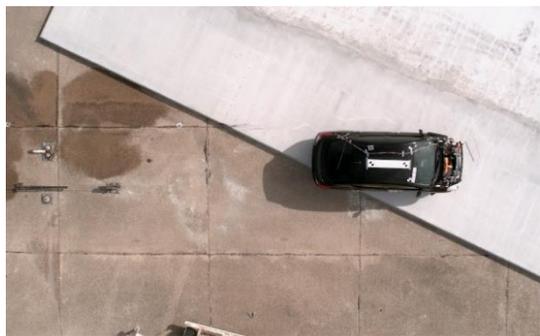
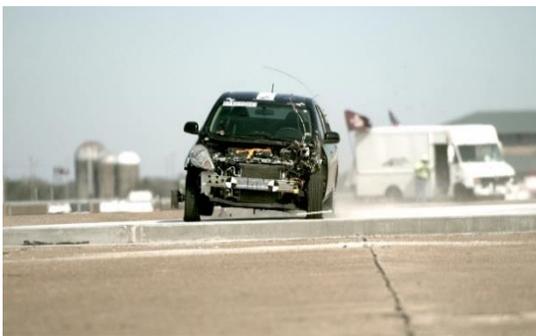
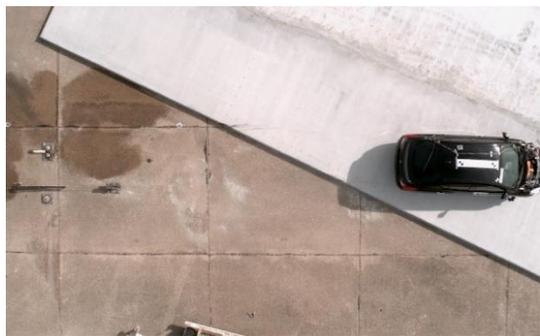
The test vehicle, a 2014 Nissan Versa, impacted the curb at a speed of 44.2 mph and at an angle of 25 degrees.

The left front tire first impacted the curb 240 inches upstream from the end of the sidewalk. This was the one-third position of the whole length. After the initial impact, the vehicle rotated in the negative direction with respect to the roll axis. The front suspension was compressed to the maximum at 0.037 seconds. Then the left rear tire impacted the curb and the vehicle started to jump gradually. After the impact of the right front tire, the vehicle rolled in the positive direction with respect to the roll axis and became airborne. Based on the target attached to the bumper of the driver's side, the vehicle jumped to the highest at 0.348 seconds, and the height was 28.18 inches. After the moment, the vehicle started to descend from the left side. It completely stopped after exiting the sidewalk. As can be seen in Figure 3.10 (b), even after the vehicle impacted the curb, the angle did not significantly change, and the traveling direction remained almost the same as before the impact. Figure 3.10 shows the sequential photos of the head-on and overhead views. Also, Appendix C.1 presents the coordinates of some targets and the left front wheel for each time step.

(a) head-on view

(b) overhead view

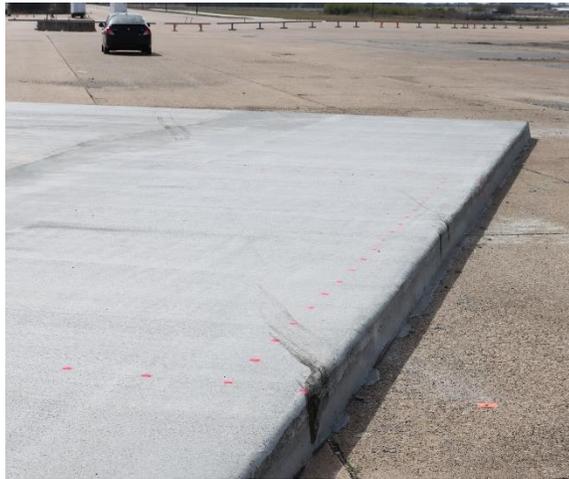
Tire traces were left along the vehicle's path as shown in Figure 3.11. These marks proved that the vehicle hit the desired impact point.

**Figure 3.11 Tire traces on the sidewalk after the test completion**

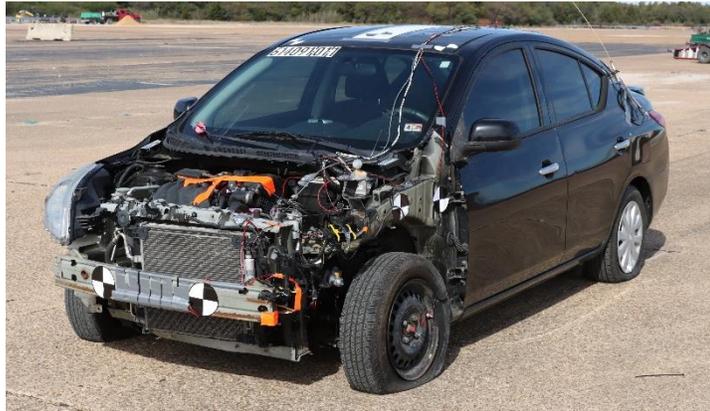
**Figure 3.12 Passenger car after the test**

No damages were observed on the vehicle body due to the lack of impact with any object. Tires were affected. There was a difference in how severe they were, but all the tires were deflated. The left front tire was most affected. The tire rim was deformed, and the tire rubber was slightly torn. For the left rear tire, the tire rim was partially broken. The right front and right rear tires were only deflated. Also, there were not visibly significant damages on the suspension, shock, and other parts inside the left front wheel well. Figure 3.12 through Figure 3.14 shows the photographs of the vehicle after the test.

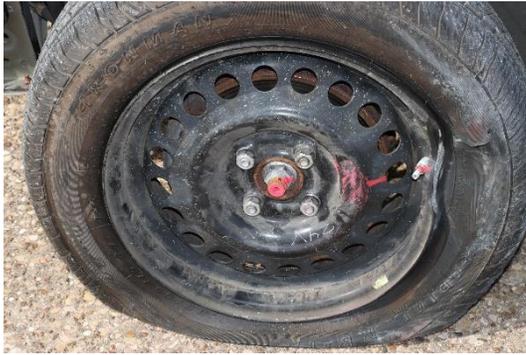
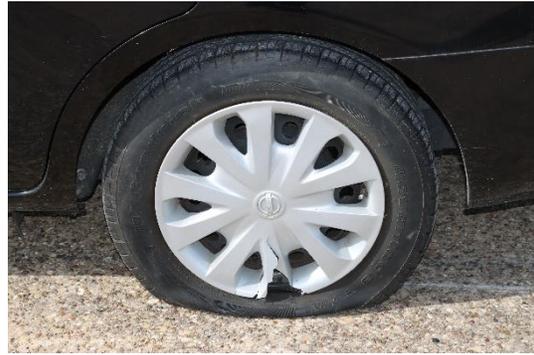
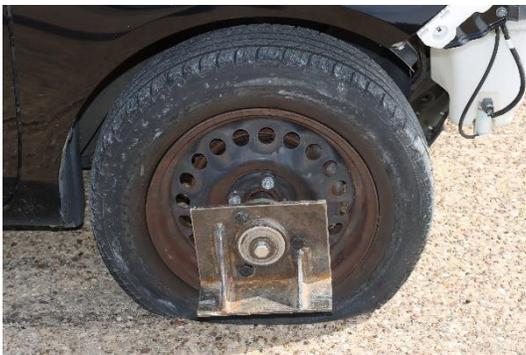
**Figure 3.13 Tire damages after the test**

(a) Left front wheel (first impact location)

(b) Left rear wheel

(c) Right front wheel

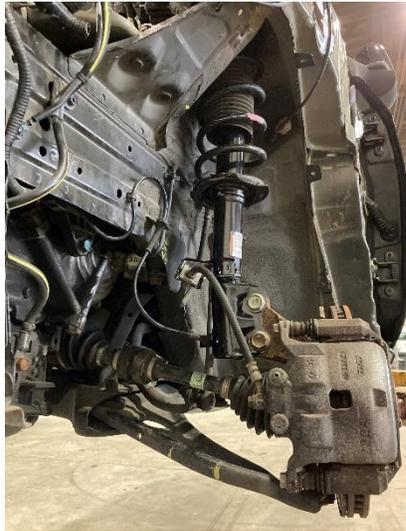
**Figure 3.14 Suspension conditions after the test**

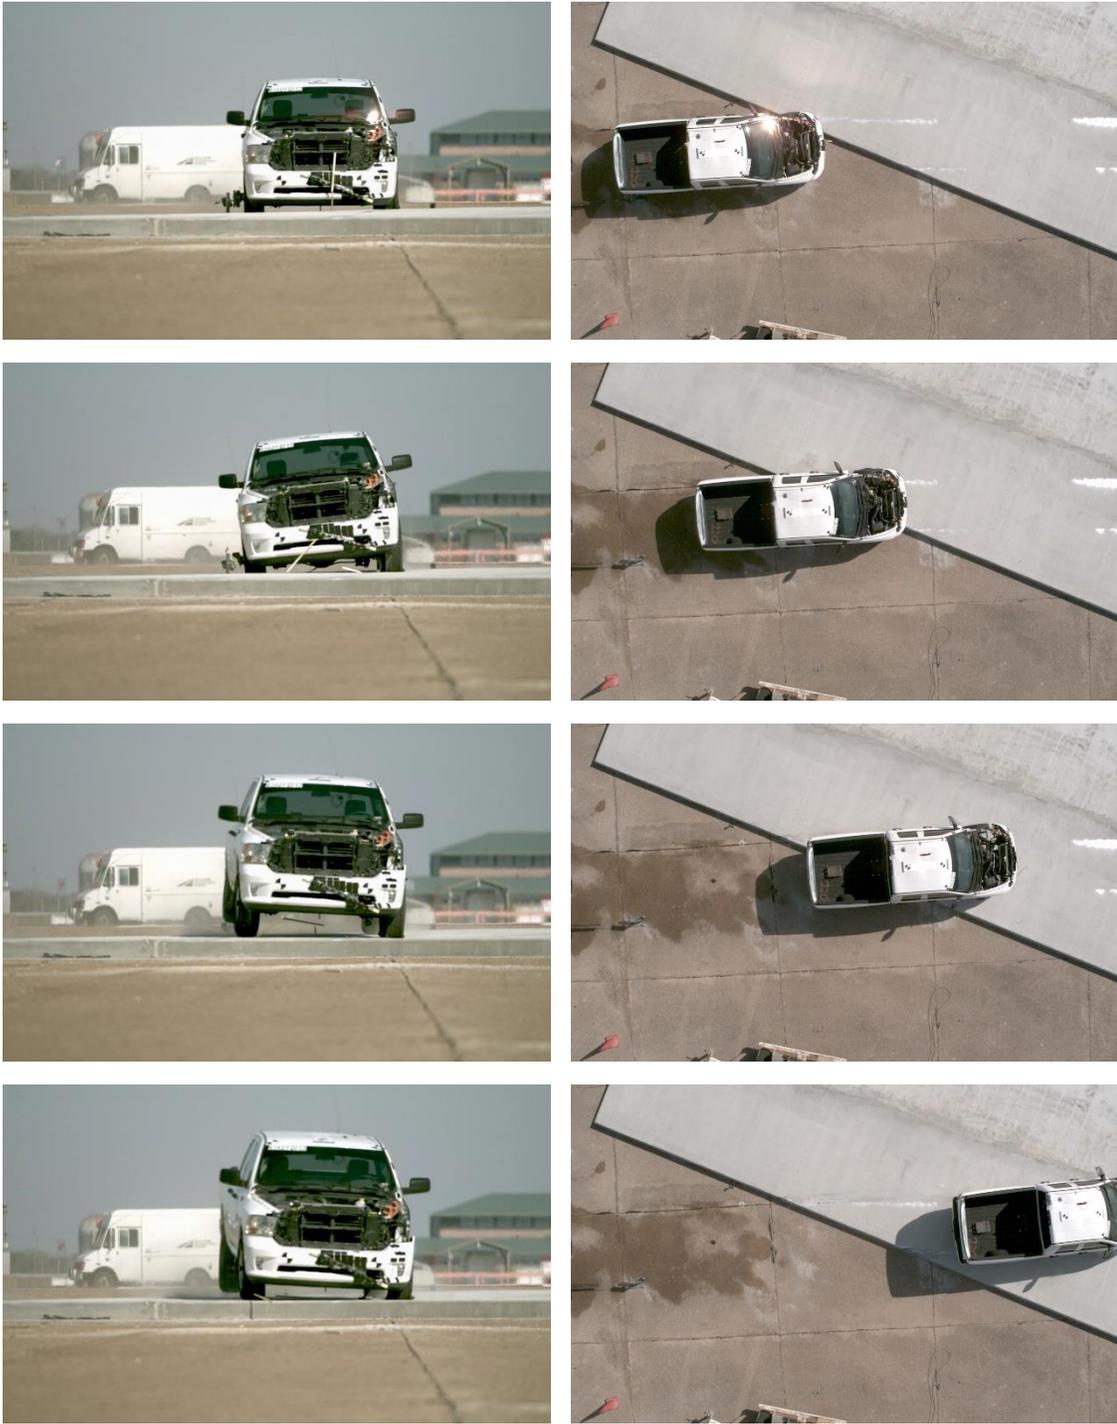
However, unlike the passenger car, the pickup truck did not become airborne. Based on the target attached to the bumper of the driver's side, the vehicle jumped to the highest at 0.406 seconds, and the height was 23.92 inches. After the right rear tire impacted to the curb, it pitched upward and then the vehicle started to descend. It completely stopped after exiting the sidewalk. As can be seen in Figure 3.15 (b), even after the vehicle impacted the curb, the angle did not significantly change, and the traveling direction remained almost the same as before the impact. Figure 3.15 shows the sequential photos of the head-on and overhead views. Also, Appendix C.1 presents the coordinates of some targets and the left front wheel for each time step.

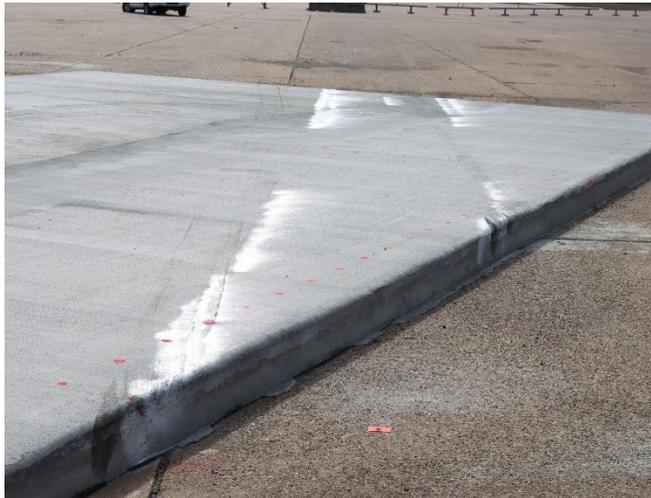
Similar to the passenger car test, the black tire traces were left along the vehicle's path as shown in Figure 3.16.

**Figure 3.16 Tire traces on the sidewalk after the test completion**

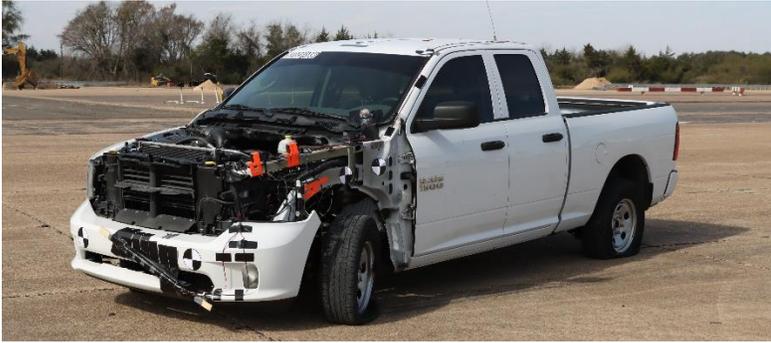
**Figure 3.17 Pickup truck after the test**

the suspension, shock, and other parts inside the left front wheel well. Figure 3.17 through Figure 3.19 shows the photographs of the vehicle after the test.

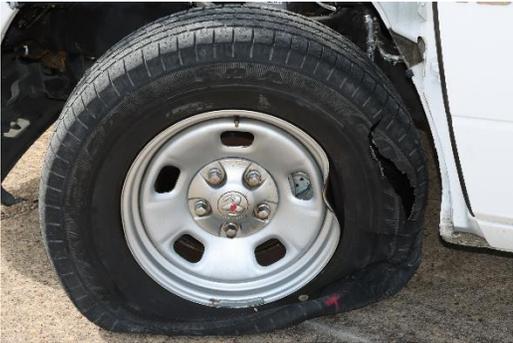
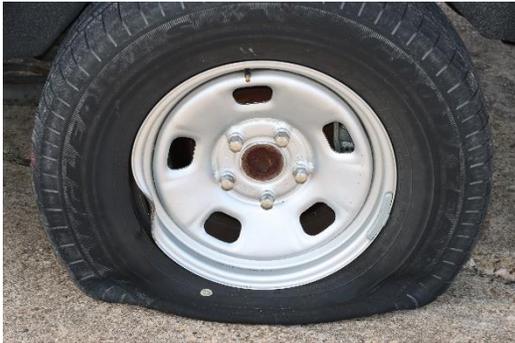
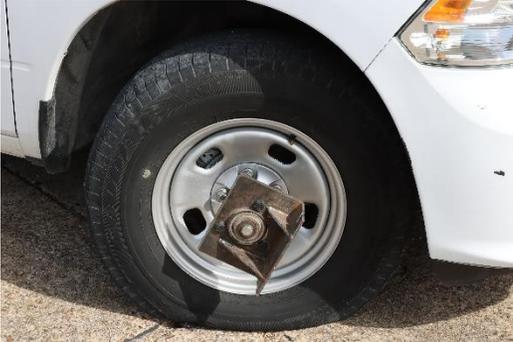
**Figure 3.18 Tire damages after the test**

The vehicle body did not impact to the system. Therefore, no damages were observed on the vehicle body. Even though the damage degree was different, all the tires were damaged. Same as the passenger car, all the tires were deflated. In the case of the left front tire, the tire rim was deformed, and the tire rubber was severely torn. For the left rear tire, the tire rim was also deformed. The right front tire was deflated to some degree. The right rear tire was slightly deflated. Also, there was not visible significant damage on

(a) Left front wheel (first impact location)

(b) Left rear wheel

(c) Right front wheel

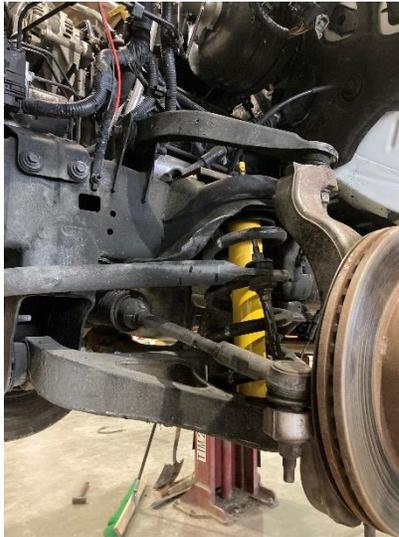
**Figure 3.19 Suspension conditions after the test**

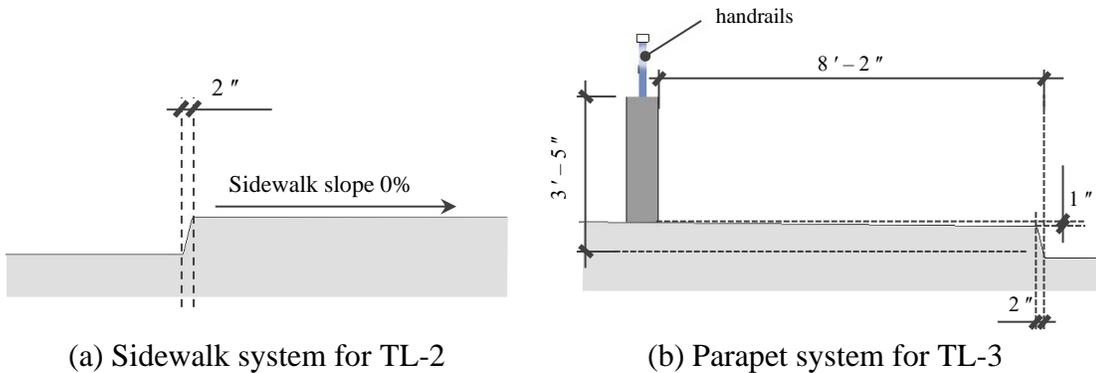
**Figure 4.1 System models for TL-2 and TL-3 conditions**

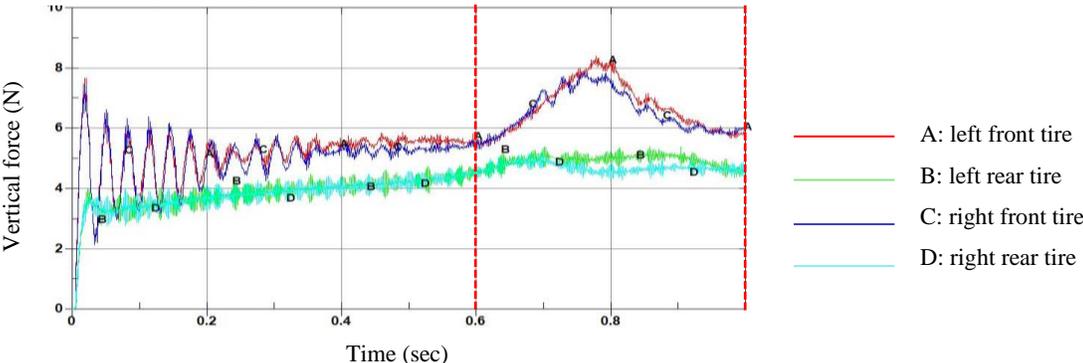
performed to reduce the dynamic noises due to the sudden application of full gravity. The simulation duration was 1.0 second. During the simulation, the vehicle did not move forward and the tires did not rotate. The vertical force of each tire location is shown in Figure 4.4. Using the force data, the weight distribution of each tire was calculated and compared with the actual measurement of the test vehicle. The values of the actual measurement is shown in Appendix B.2. Since the vehicle was experiencing dynamic oscillation at the beginning of the simulation, the weight distribution was calculated using only the forces between 0.6 and 1.0 seconds. Table 4-1 presents the weight comparisons for each tire location between the model and actual vehicles. In Table 4-1, the TL-2 test vehicle is the one used in the trajectory testing in this study, and the TL-3 test vehicle is used in the Caltrans testing (Whitesel, Jewell et al. 2016).

**Figure 4.4 Vertical forces for each tire of the vehicle**

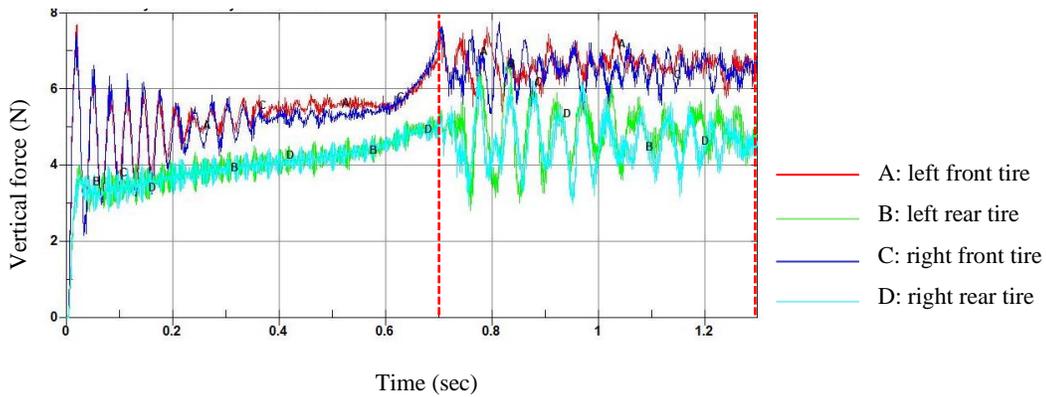
**Figure 4.6 Vertical forces for each tire of the vehicle**

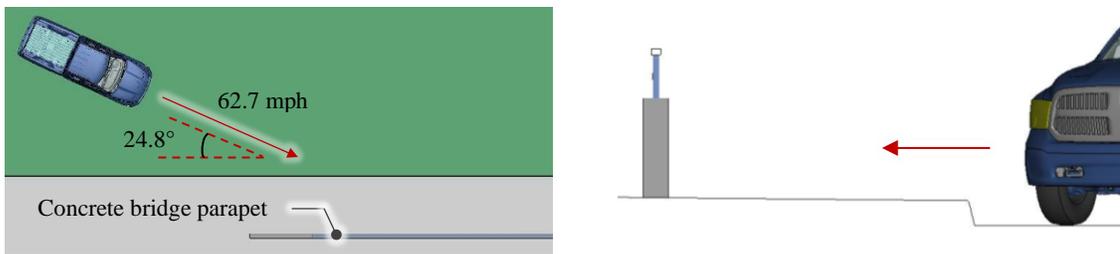
After checking the steady state behavior of the Ram model, the simulation under TL-3 conditions was first set up including the bridge parapet system. The TL-3 test conditions provided by MASH are an impact speed of 62 mph and an impact angle of 25 degrees. And according to the test results conducted by Caltrans, the actual speed and angle were 62.7 mph and 24.8 degrees as can be seen in Figure 4.7. The test inertial mass of the Caltrans testing was 5062 lb, which was approximately 99 % compared to the Ram model, 5107 lb.

**Figure 4.7 Simulation set-up under TL-3 conditions**

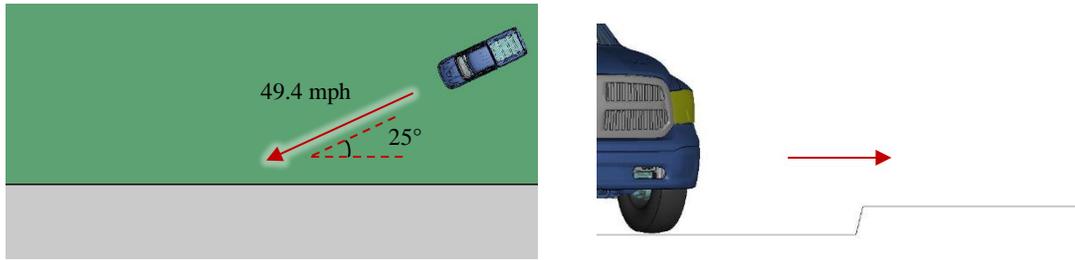
On the other hand, considering TL-2 conditions, the Ram model was set up at a speed of 49.4 mph and an angle of 25 degrees, similar to the trajectory testing. Unlike the Caltrans test, the left front tire of the vehicle initially impacted the curb. Figure 4.8 shows the model set-up under TL-2 conditions.

**Figure 4.8 Simulation set-up under TL-2 conditions**

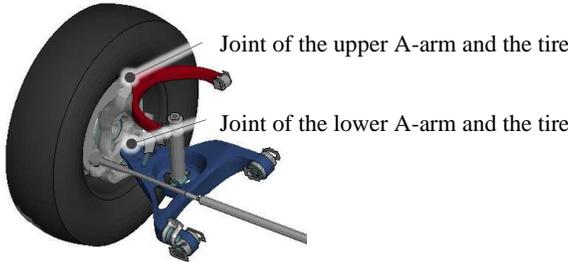
**Figure 4.9 Joint details between A-arms and a tire**

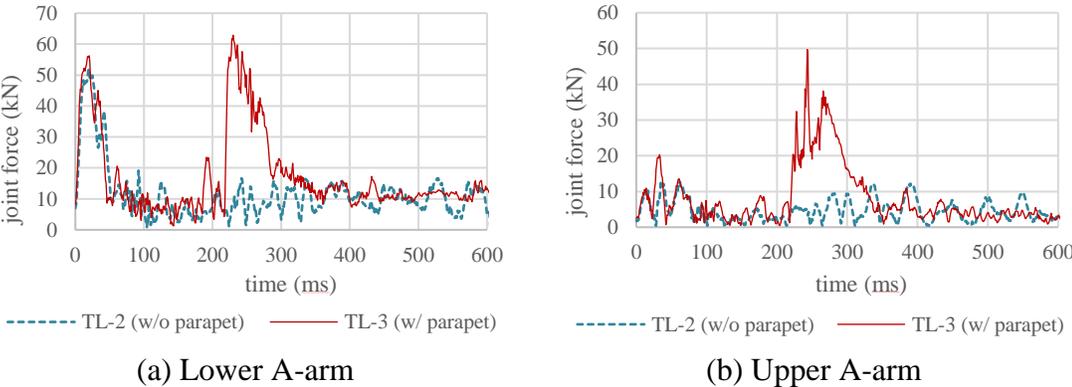
in Figure 4.10. For both graphs, the dashed line was plotted from the TL-2 simulation, and the solid line was plotted from the TL-3 simulations. Despite the different impact speeds, when the vehicle impacted the curb, the joint forces of the two simulations were similar at both the lower and upper A-arms. After that, in the case of the TL-3 simulation, the joint forces drastically increased at the impact moment with the parapet once again. At that time, the joint force of the lower A-arm increased to a similar level to that of the curb impact, whereas the upper A-arm's value increased more than 2 times compared to the moment of the curb impact. Hence, based on the values, the joint failures were considered for the second calibration.

**Figure 4.10 Joint forces**

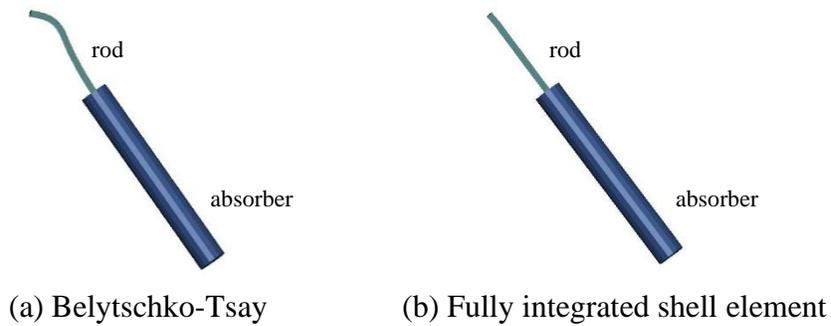
Also, the front and rear suspensions were studied. Basically, a suspension system enables a vehicle to move smoothly on rough roads and controls the stability of a vehicle. Especially, springs and shock absorbers are the main components in this role (Goodarzi and Khajepour 2017). According to the material properties of the current vehicle model, the total forces of all the front and rear springs were approximately 1.28 times compared to the actual mass of the model. Thus, the properties were scaled down to the actual value level. In addition, the shock absorbers are responsible for energy dissipation, which can control the vehicle movement. For this reason, it is crucial that shock absorbers behave correctly in the simulation in order to reflect the actual performance. A rod part generally should not bend but be stiff. However, in the current vehicle model, the element formulations of all the rods were set to Belytschko-Tsay. Hence, they changed to the Fully integrated formulation to prevent unrealistic bending of the rod parts. Figure 4.12 shows how different the shock rod behaves depending on the element formulations.

**Figure 4.12 Performance of the rods for each formulation**

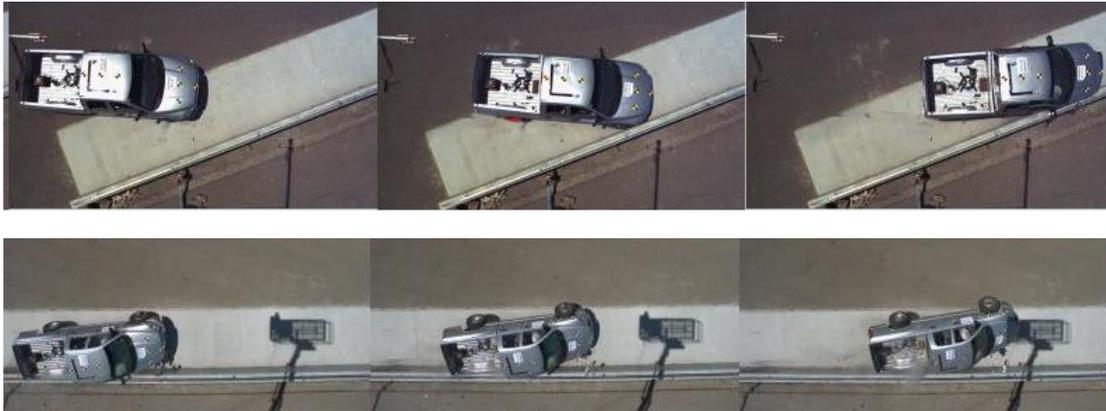
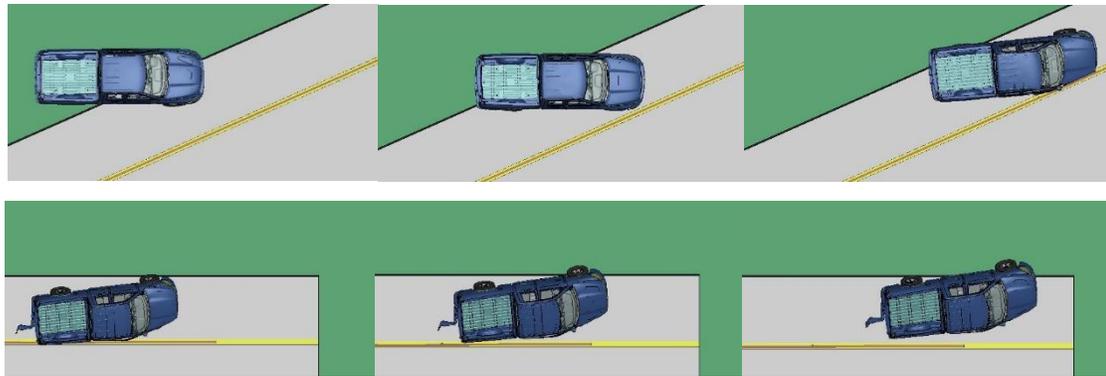
The results of the simulation were compared with the data from the Caltrans report. Figure 4.13 shows the overhead sequential photos of the simulation and the test. In the simulation, the rear bumper was partially detached after the impact, yet it was a minor issue which did not affect the vehicular movement. However, except for the rear bumper, the overall trajectories of the simulation and the test were observed similarly. Table 4-3 and Table 4-4 present the vehicle descriptions for each time step, the contact phenomena comparison, and the occupant risk factors of the simulation and the test. Appendix D also provides the graphs of the x acceleration, y acceleration, and roll, pitch and yaw angles. As can be seen, the Ram model stayed in contact with the parapet shorter than the test did. Additionally, the model has the higher yaw angle compared to the test value. This result is considered that the rebounding issue somewhat remained and affected the vehicular behavior. In the light of the vehicle descriptions and other results, the simulation tends to follow the test closely.

(a) Test

(b) Simulation

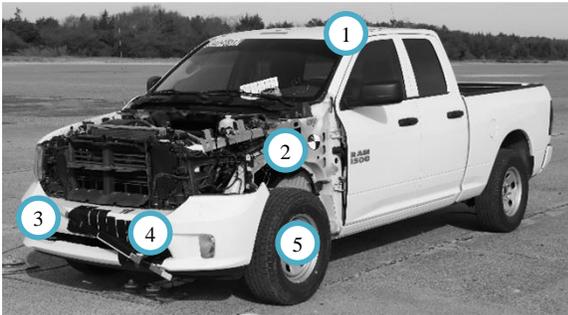
In the trajectory test, some targets were attached to the surface of the test vehicle. The locations and displacements of each target are presented in Appendix B and Appendix C, respectively. All the displacements regarding each location were compared to the simulation results. Figure 4.15 presents the locations where the data were compared: no.1 through no.4 are targets on the vehicle surface, no.5 is the center of the wheel, and no.6 is the displacement of the linear potentiometer. The displacement comparison for each location is shown in Table 4-5. The displacement magnitude was slightly different, yet less than 2 inches. Overall displacements of the simulation reasonably followed the trend of the test.

(a) Target location
