PLACEMENT GUIDELINES  
FOR BRIDGE PARAPET SYSTEMS WITH CURBED SIDEWALKS

A Thesis

Major Subject: Civil Engineering

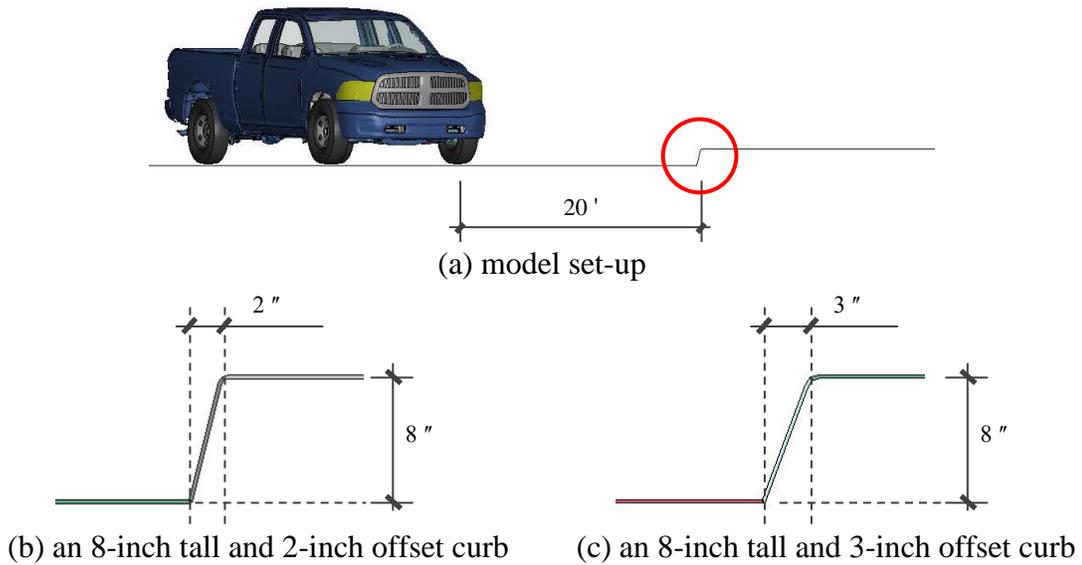
In this chapter, the simulations should comply with the impact conditions required by MASH. Therefore, the impact speed and angle were 44 mph and 25 degrees under TL-2 conditions and 62 mph and 25 degrees under TL-3 conditions. Also, as can be seen in Figure 5.1, the vehicle was simulated on both an 8-inch tall and 2-inch offset curb and an 8-inch tall and 3-inch offset curb. Since both profiles are used for TL-2 and TL-3 simulations, a total of 4 simulations were performed. The vehicle model was set up shown in Figure 5.1. It was placed approximately 20 feet away from the curb edge.

**Figure 5.1 Model set-up with the two curb profiles**

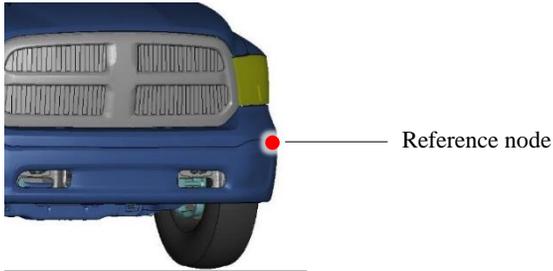
**Figure 5.2 Reference node of the pickup truck**

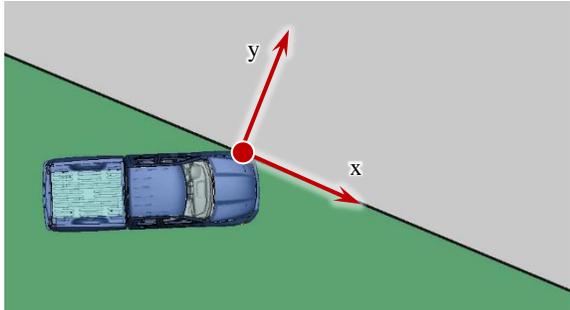
trajectory denotes the lateral distance from the curb edge, meaning that it can determine the sidewalk width. The origin of the x and y directions shows in Figure 5.3.

**Figure 5.3 Origin of the coordinate system**

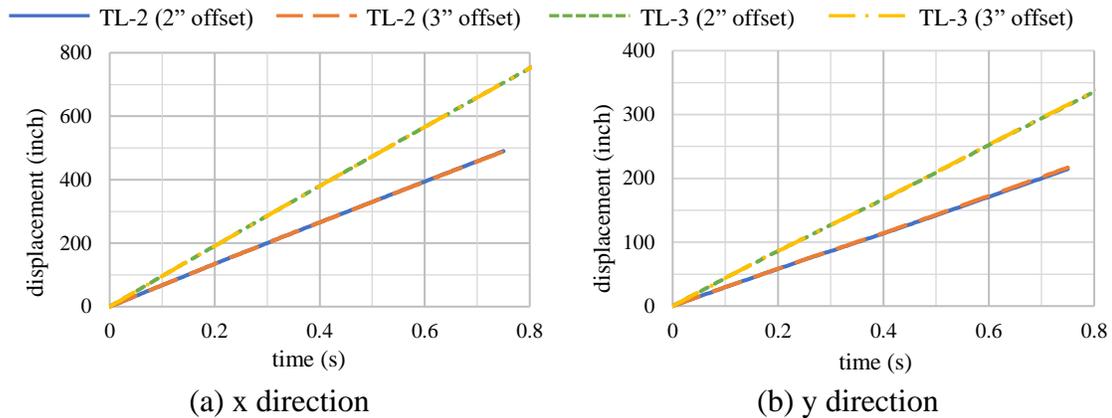
Figure 5.4 shows the x and y trajectories of the reference node with regard to time under TL-2 and TL-3 conditions together. For both plots, 0.0 second is the time when the vehicle impacts the curb. In terms of the x and y trajectories, the difference among the trajectories due to the speed was clearly observed, yet there was minor difference between the two different curb profiles.

**Figure 5.4 X and Y trajectories of the reference nodes**

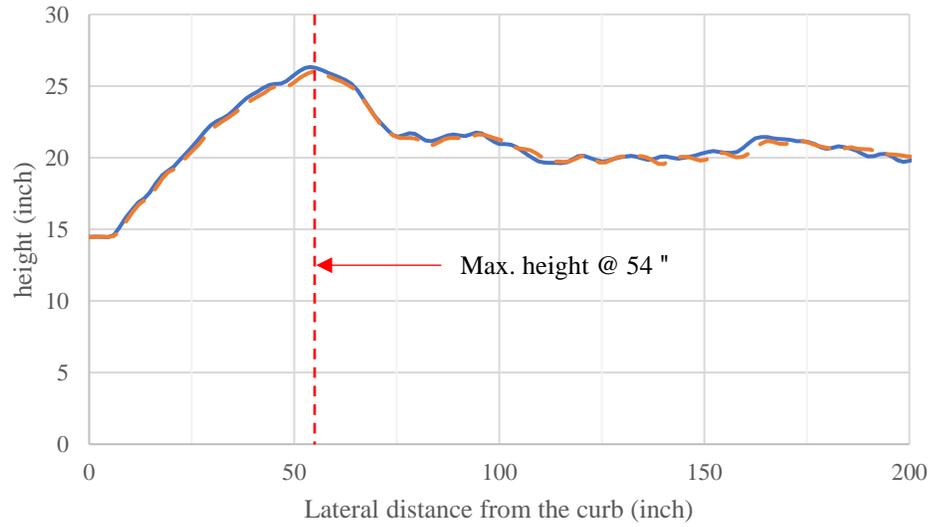
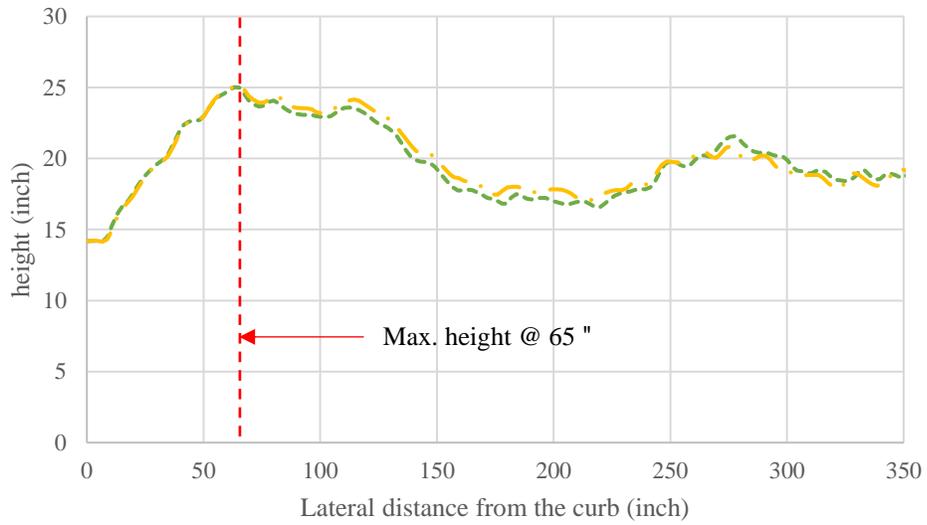
— TL-2 (2" offset)    - - TL-2 (3" offset)    - - - TL-3 (2" offset)    - . - TL-3 (3" offset)

(a) TL-2 simulations

(b) TL-3 simulations

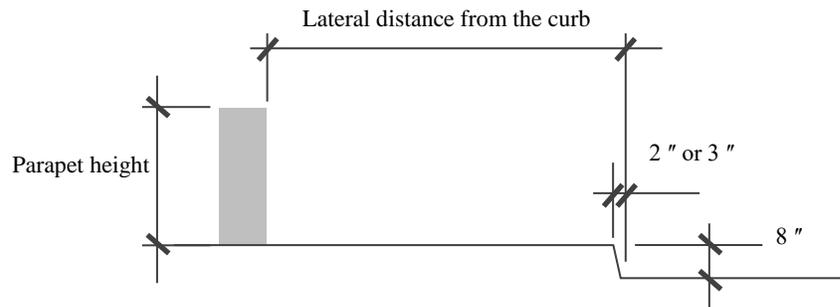
The parapet heights and lateral distance from the curb were investigated using the four vehicular trajectories presented in chapter 5.1. As can be seen in Figure 5.6, the curb height was fixed at 8 inches. For the curb slope, both the 2-inch and 3-inch offsets were considered. The lateral distance is defined as the distance from the bottom of the curb to the traffic face of the parapet. The parapet height is defined as the distance from parapet base on the sidewalk to the top of the parapet. In these fixed profiles, the ranges of the recommendable parapet heights and lateral distances were analyzed through iterative simulations under TL-2 and TL-3 conditions.

**Figure 5.6 Parameters to be studied**

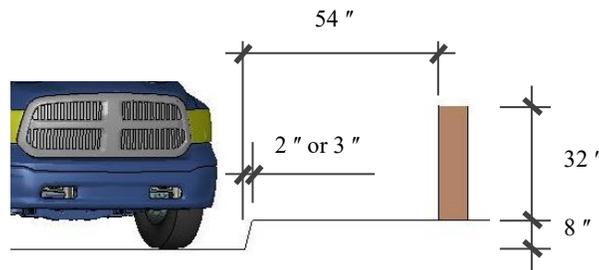
**Figure 5.7 Initial TL-2 simulation**

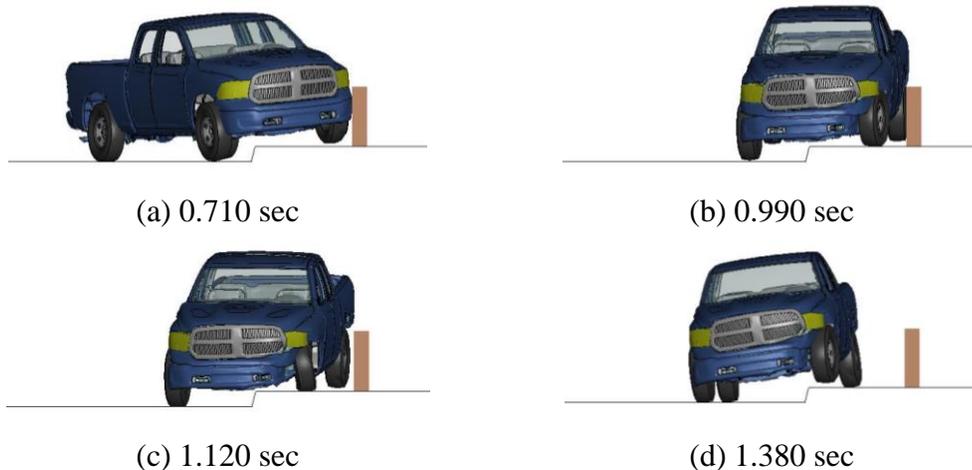
**Figure 5.8 Sequential photos of the initial TL-2 simulation**

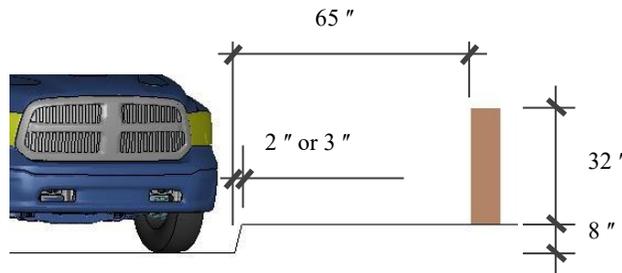
**Figure 5.9 Initial TL-3 simulation**

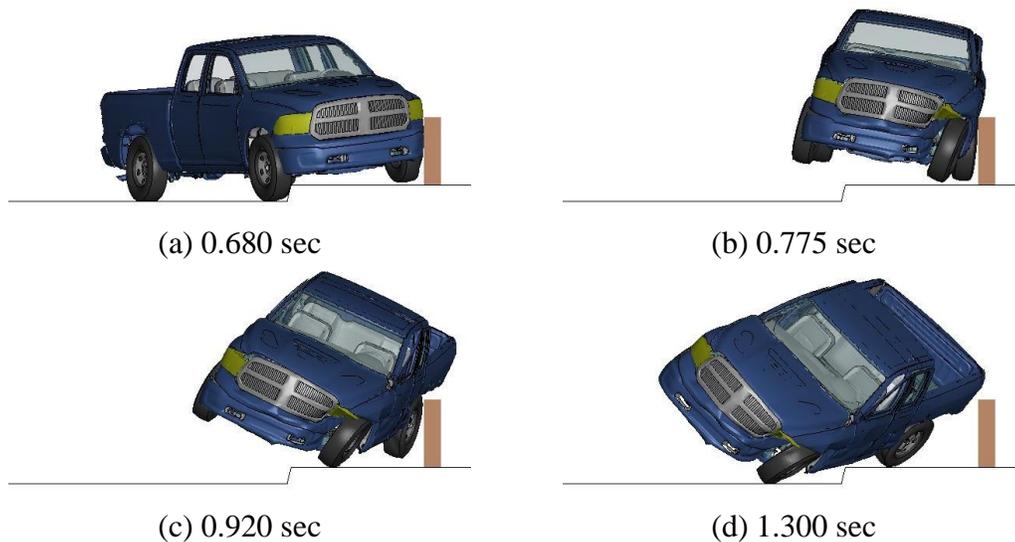
**Figure 5.10 Sequential photos of the initial TL-3 simulation**

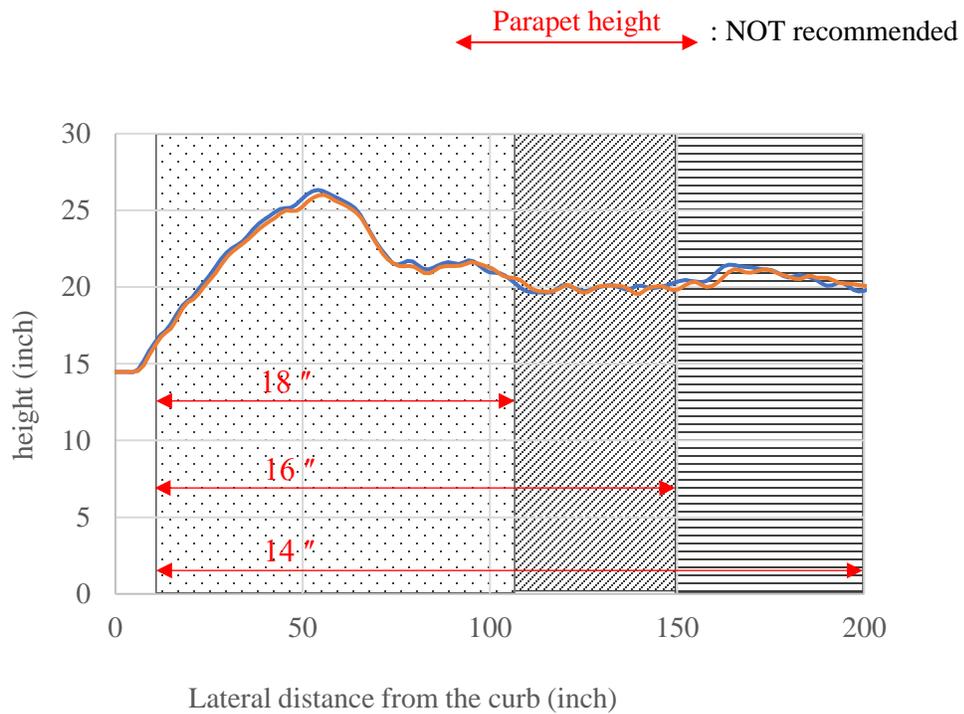
: non-recommendable

**Figure 5.11 Placement guidelines for a pickup truck under MASH TL-2 conditions (impact speed = 44 mph, impact angle = 25 degrees)**

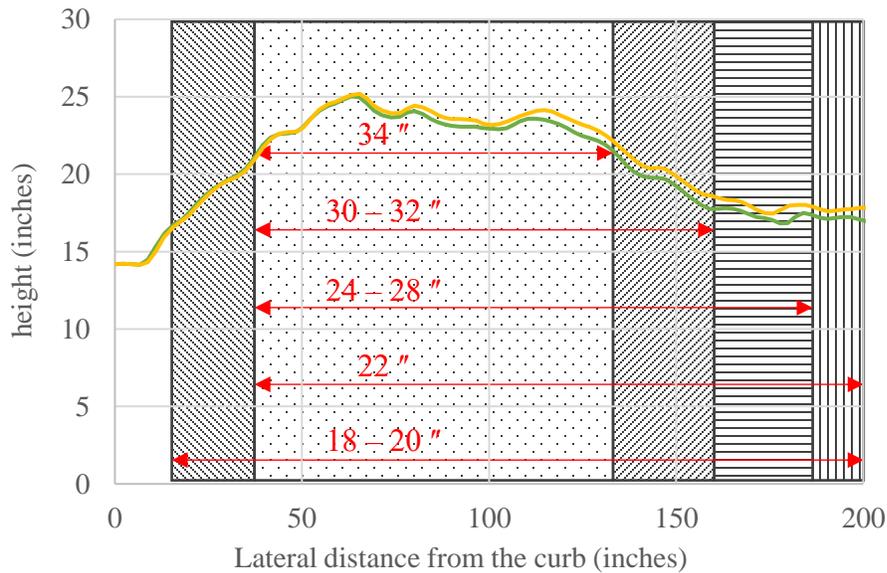
Parapet height : NOT recommended

**Figure 5.12 Placement guidelines for a pickup truck under MASH TL-3 conditions (impact speed = 62 mph, impact angle = 25 degrees)**

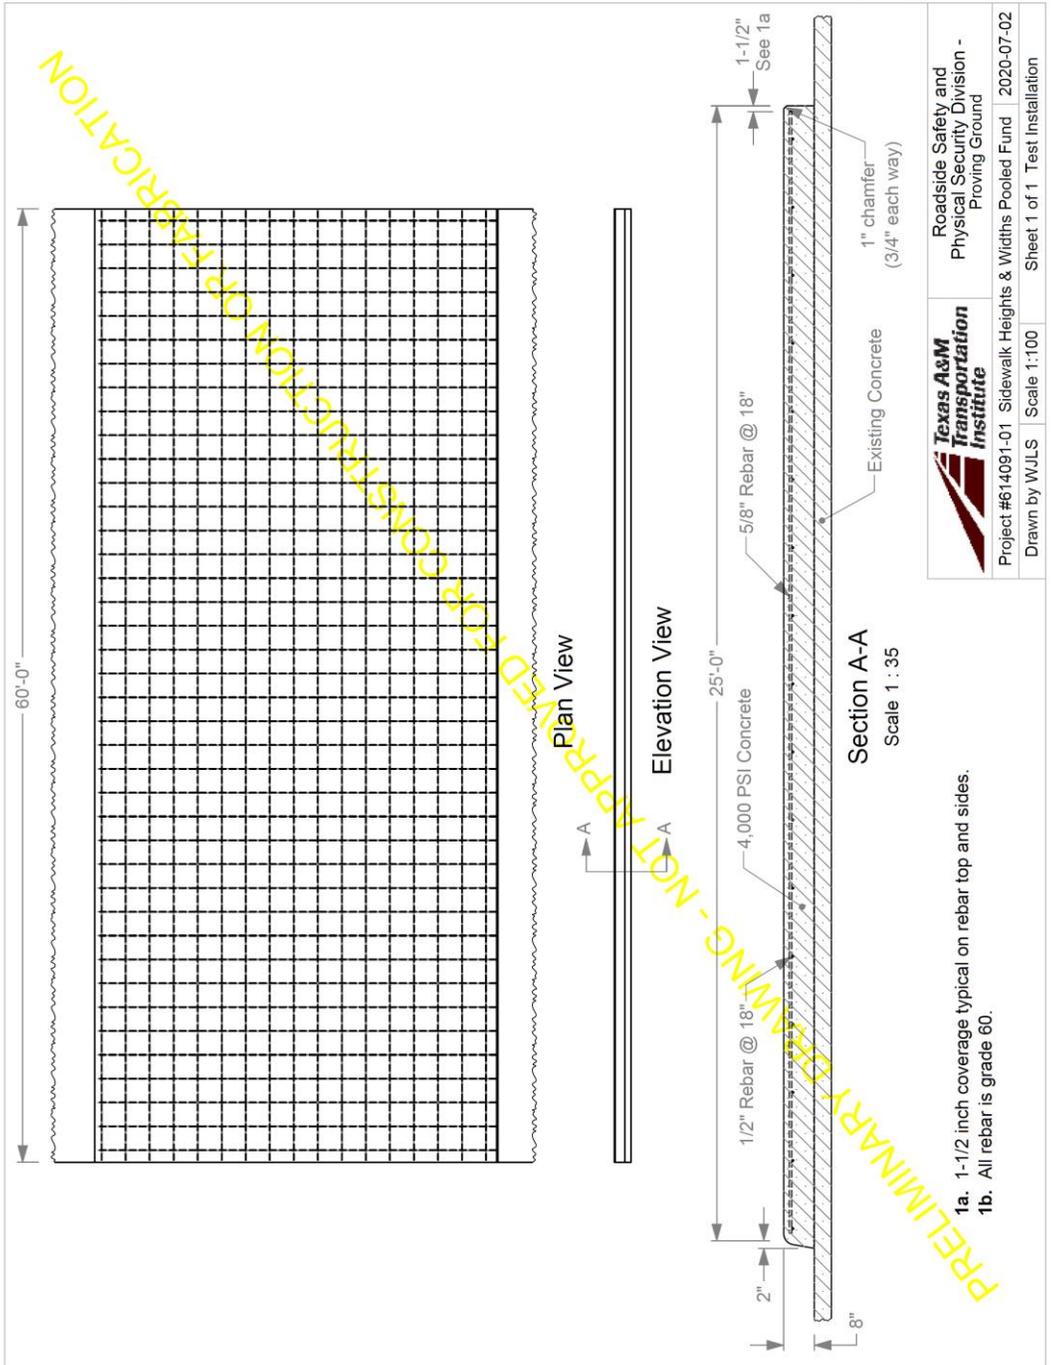
The drawings of the testing sidewalk with a curb are given including the concrete's material property and steel reinforcement.

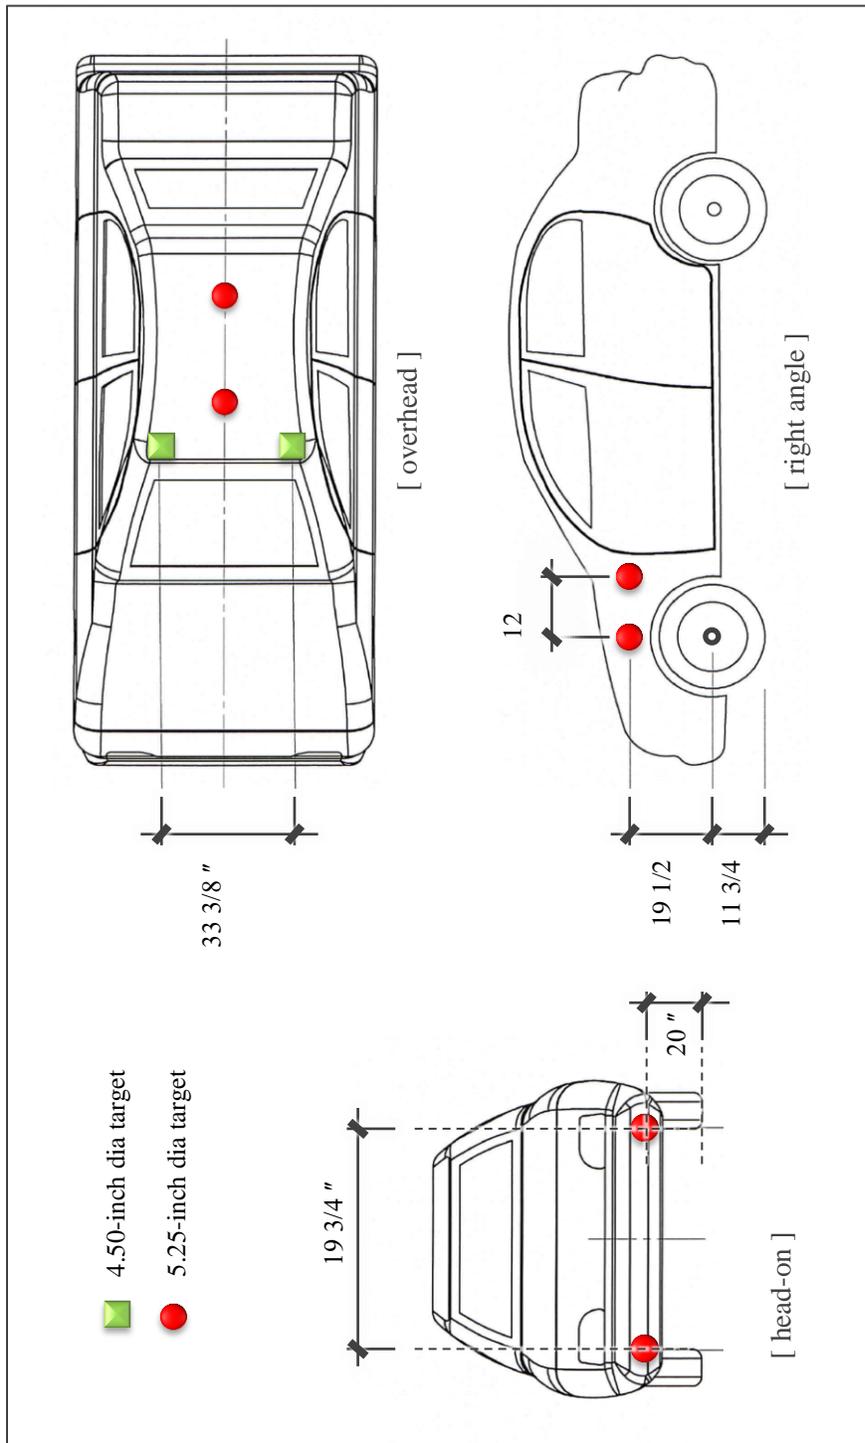
**Figure B.2 Target locations of the passenger car**

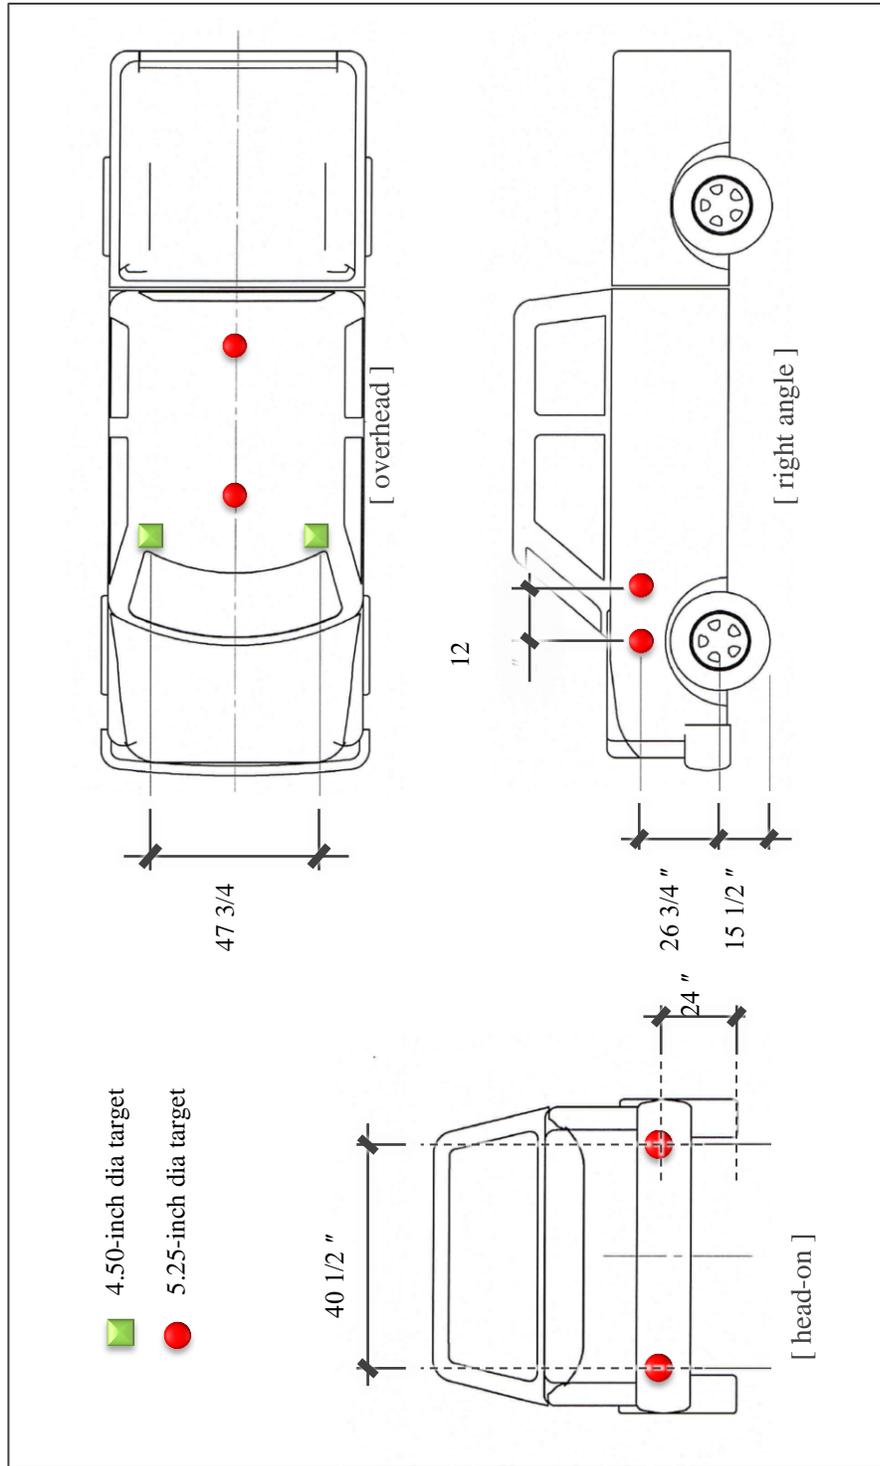
**Figure B.3 Target locations of the pickup truck**

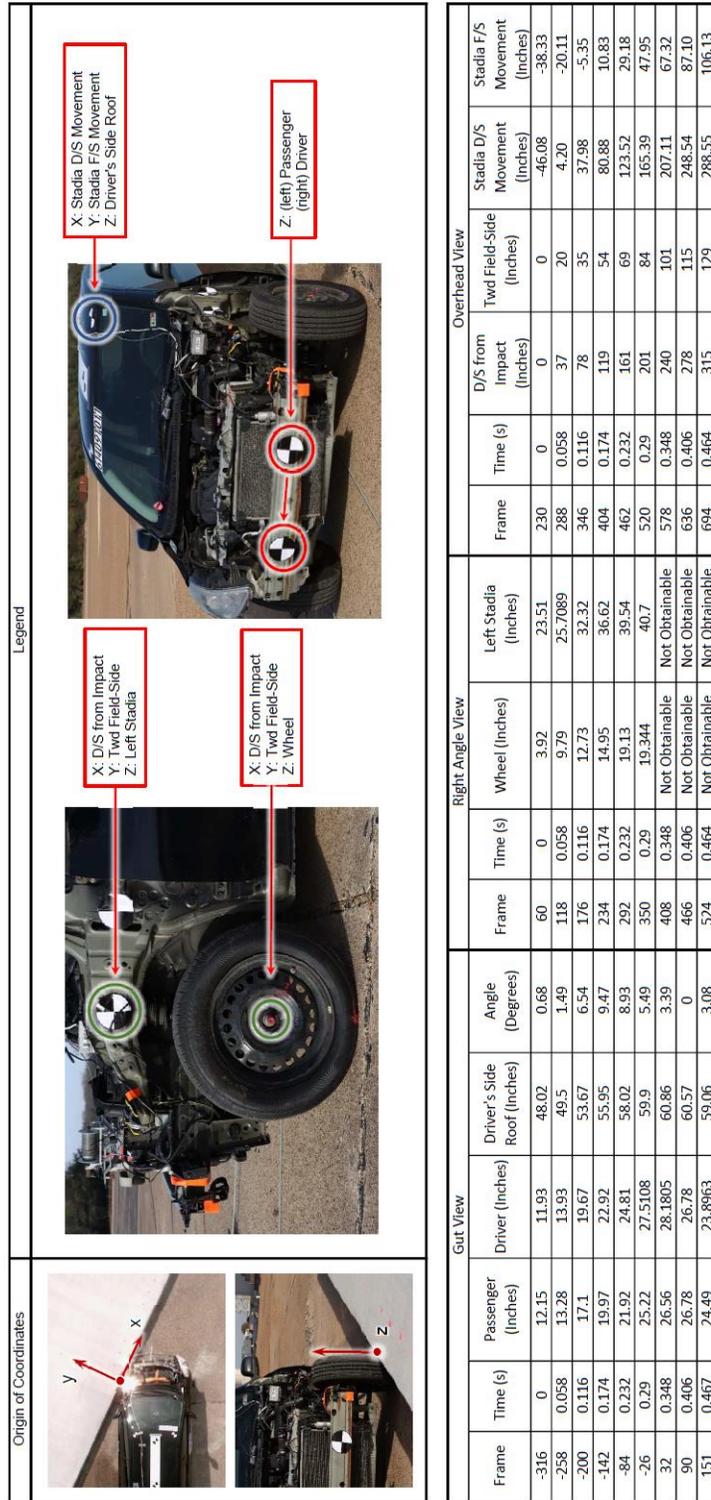
Figure C.1 Passenger car coordinates for each time frame

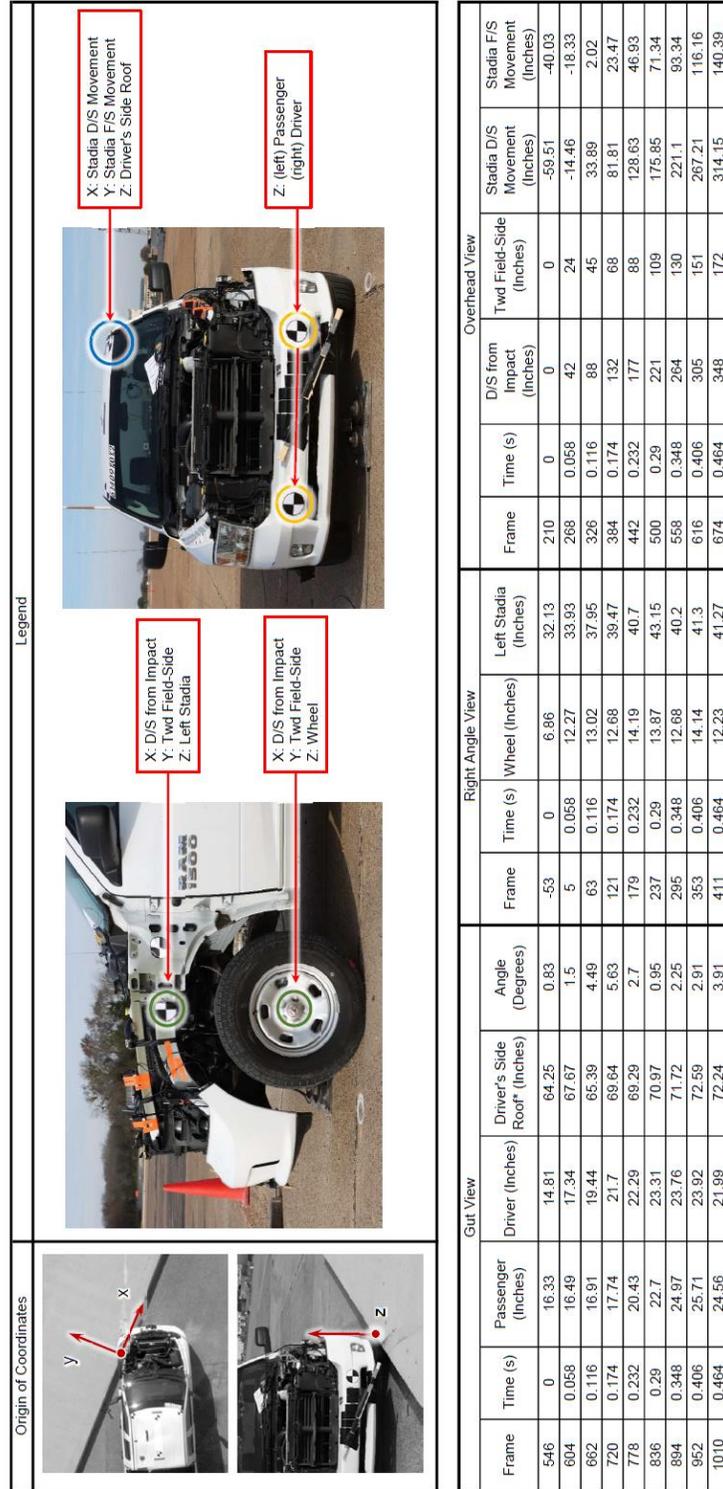
Figure C.2 Pickup truck coordinates for each time frame

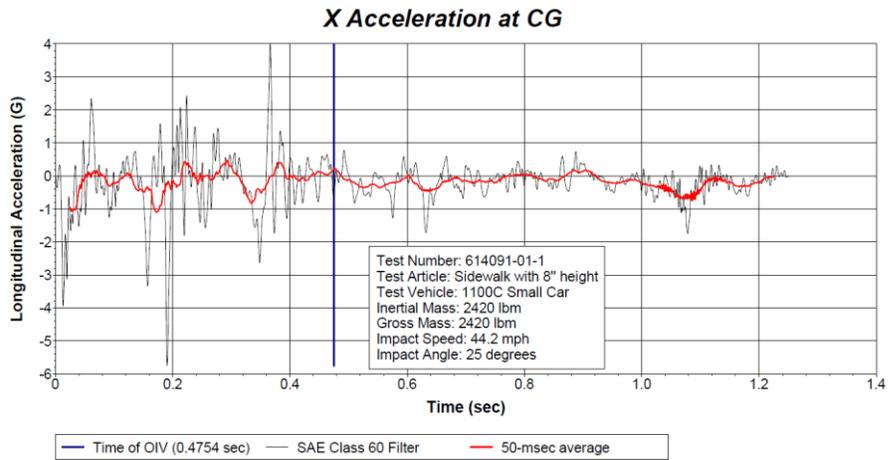
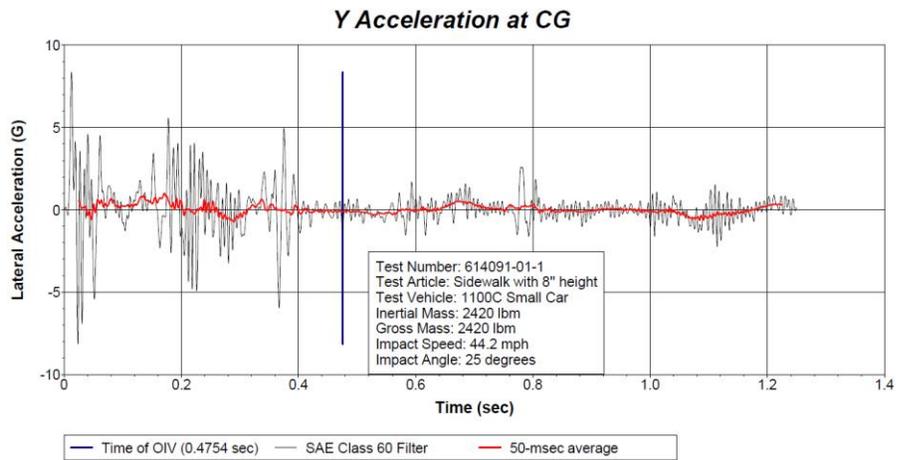
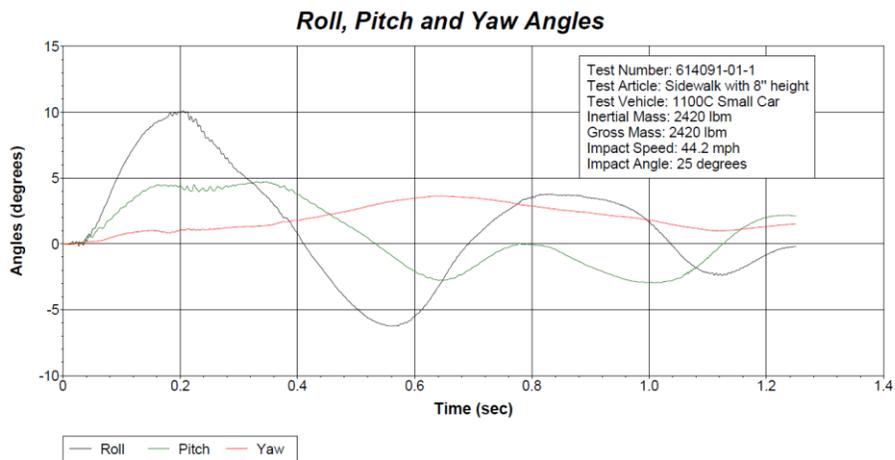
**Figure C.4 TRAP results of the passenger car**

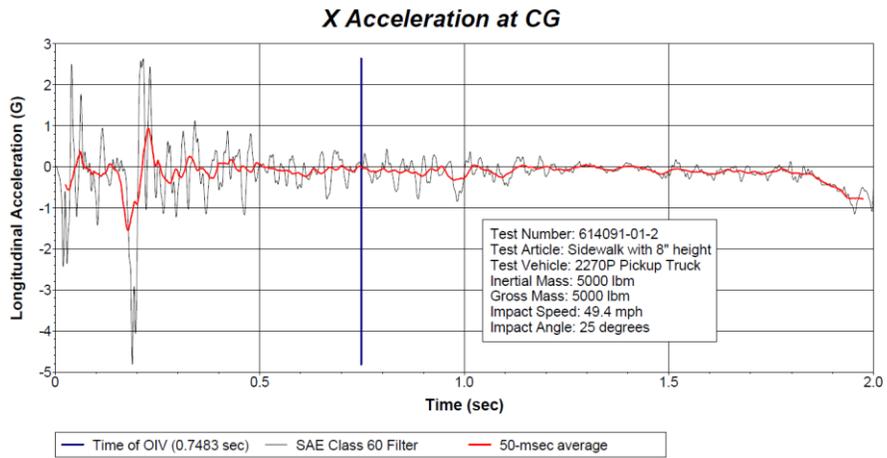
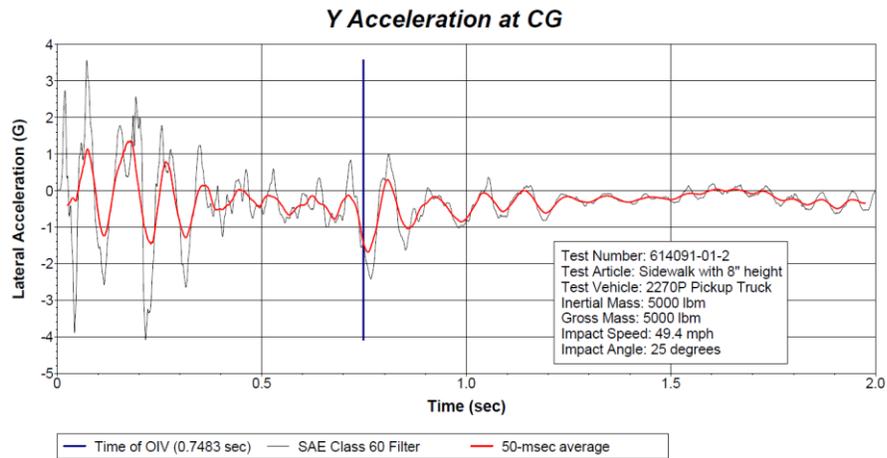
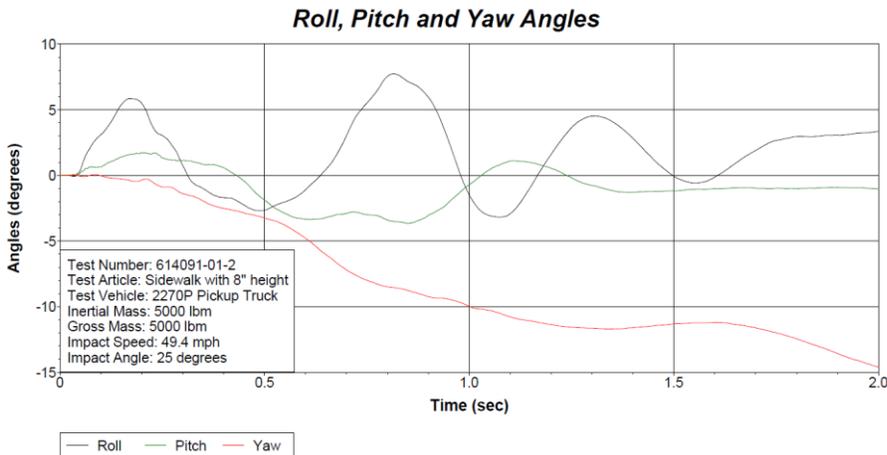
**Figure C.5 TRAP results of the pickup truck**

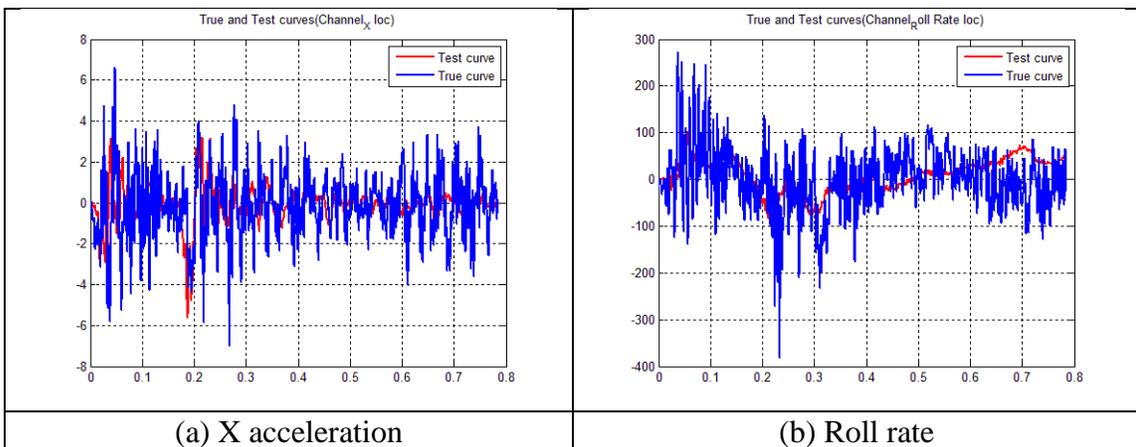
**Figure E.1 RSVVP results at the C.G. location**

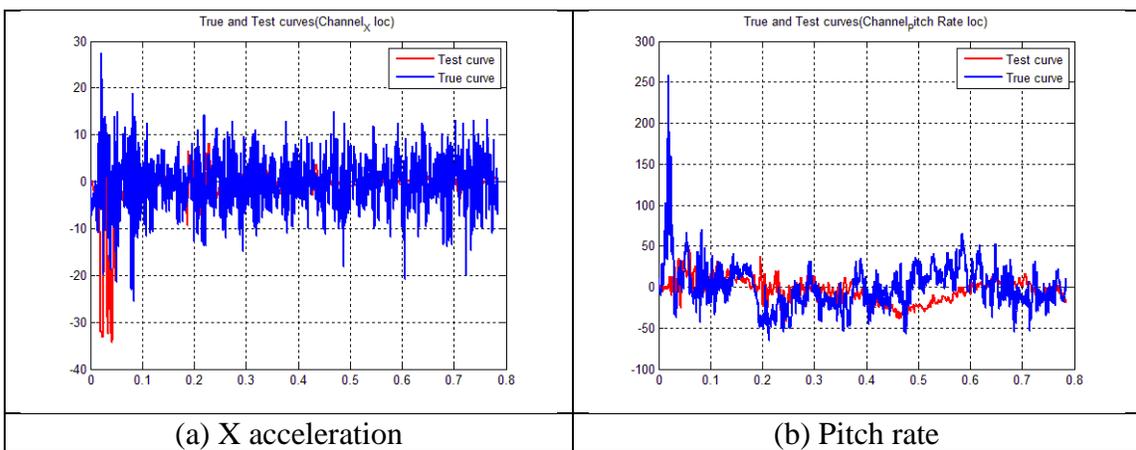
**Figure E.2 RSVVP results at the front location**
