A REMOTE SENSING APPROACH FOR ESTIMATING BANK STRENGTH AND  
PERCENT VEGETATIVE VOLUME ON TEXAS STREAMBANKS

A Thesis

Major Subject: Water Management and Hydrological Science

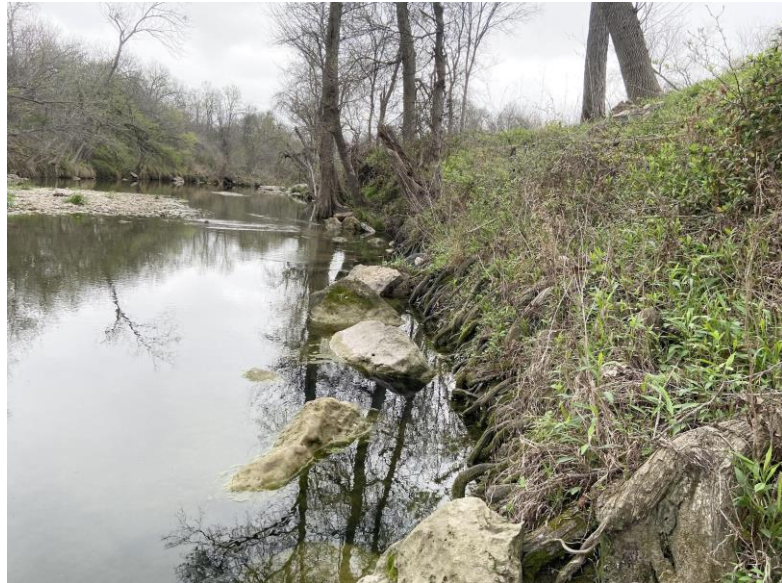
**Figure 2. View looking downstream at USGS station 08159000. The exposed tree roots can be seen on the streambank, illustrating the binding effect that they have on the streambank sediments. This photo was taken in March 2021.**

streambank erosion. The root systems of woody and herbaceous plants physically bind bank soils in place (Fig. 2), increasing the critical shear stress, or the minimum stress that is needed to move particles on the channel boundary (Gray and Leiser, 1982; Coppin and Richards, 1990; Thorne et al., 1997).

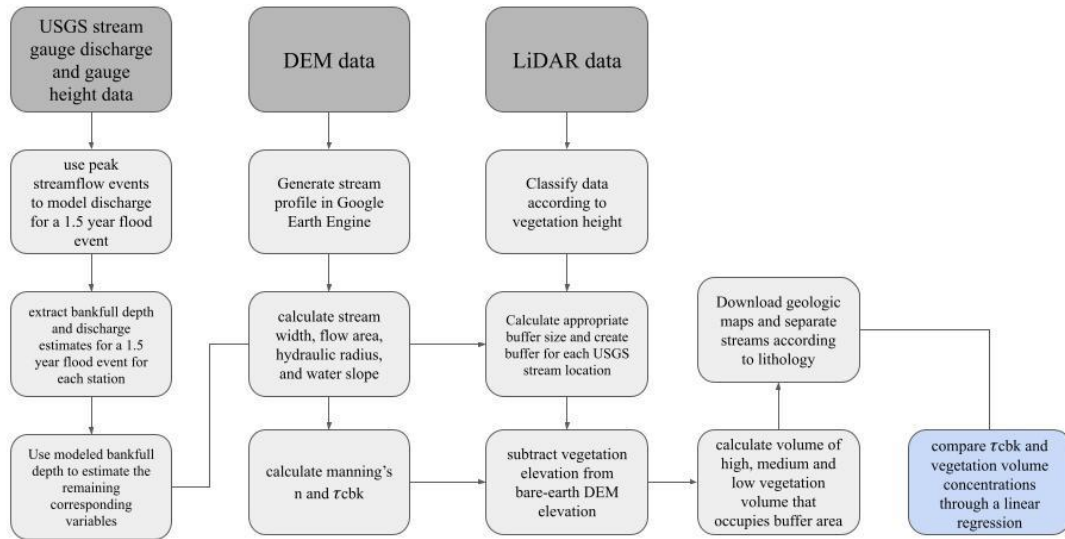
**Figure 4. Overview of the workflow for this study.**

associated with the dominant indicators range from 1.05-1.8 years, and the manually-inferred bankfull depth may not fall within this range. To avoid this situation, the aforementioned method was used. Furthermore, it is a well-accepted tenet (Gubernick et al., 2008) that bankfull discharge occurs at approximately the 1.5 year recurrence interval, and for that reason, this study chose to use the associated depth and discharge for a 1.5 year flood. A broader overview of this process, and the entirety of all the methods in this study can be visualized in Fig. 4.

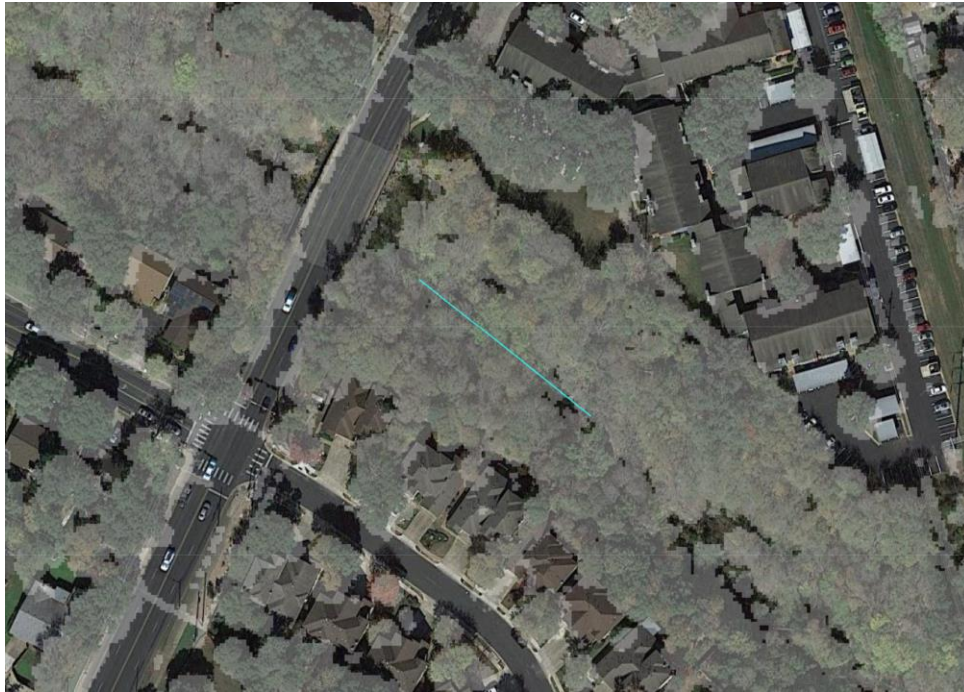
**Figure 7 Image showing the accuracy of how the LPC dedicates land area as vegetation. The transparent light gray overlay represents the vegetated area. The line in blue shows where the buffer line was drawn for this station location.**

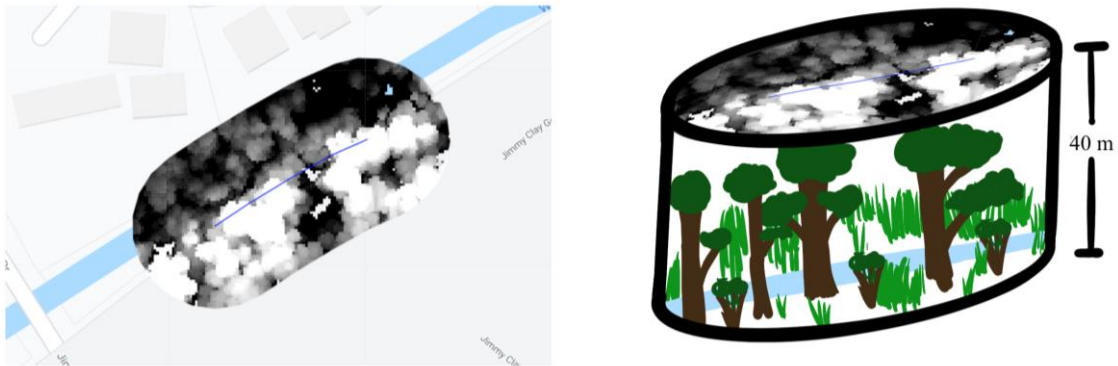
**Figure 8. Visual of the process used to extract the volume of vegetation on a streambank. The sum of all the heights of each 1x1 meter vegetation pixel (high, medium, and low) are multiplied by the area of the buffer to get a volume of vegetation. This volume is then divided by the total volume of the initial volume (bank area x 40 m) to get a percent volume of vegetation.**

Using Google Earth Engine®, each pixel elevation value in the bare-earth DEM was subtracted from each pixel elevation value in the clipped LPC. In order to calculate a vegetation volume, an initial volume was created by multiplying the area of the buffer by 40 meters, a height that exceeds any top of vegetation, shown in Fig. 8.

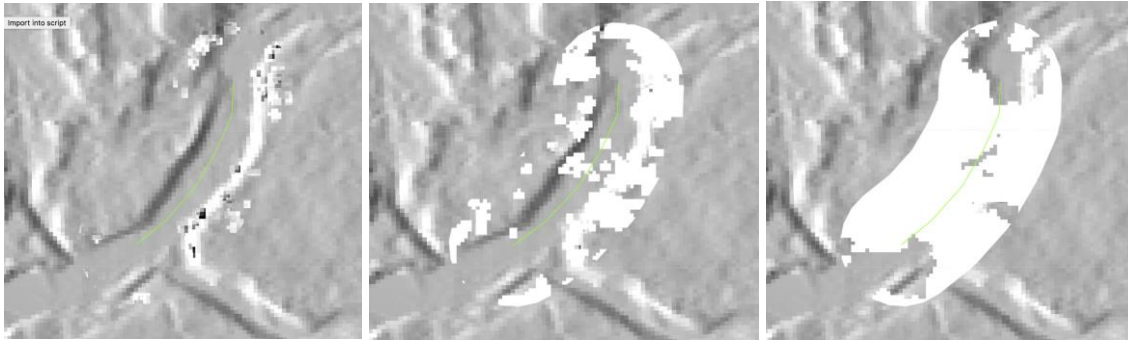
**Figure 9. Visualization of how the vegetation is gathered using the buffer system. The USGS station point lies directly on the yellow transect, which is where the stream profile was gathered. The radius of the buffer shown here is 28 meters, while extending laterally about 30 meters on each side of the transect.**

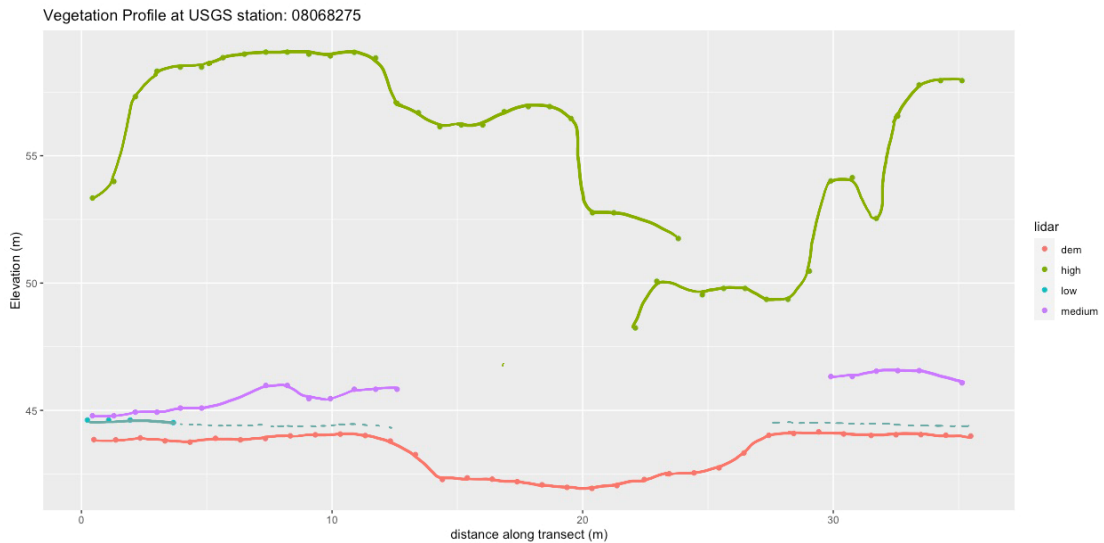
**Figure 10. Cross-sectional view of the vegetation as it exists at USGS stream location 08068275. The orange line shows the stream profile, while the green, purple, and teal lines show the different classes of vegetation and how they plot along the profile. The green line representing the high vegetation shows how the LPC is able to pick up the full extent of the canopy as it hovers over the channel. This profile is for visualization purposes only. This station’s vegetation was re-run to encompass a lateral distance of 60 meters.**

Some stations lacked Lidar data that provided separate vegetation classes, but wherever possible, the vegetation density was calculated for medium and low-lying vegetation, in addition to high vegetation. A visualization of the spatial distribution of low, medium, and high vegetation is shown in Fig. 9. For a cross-sectional view of the distribution of the vegetation, see Fig. 10.

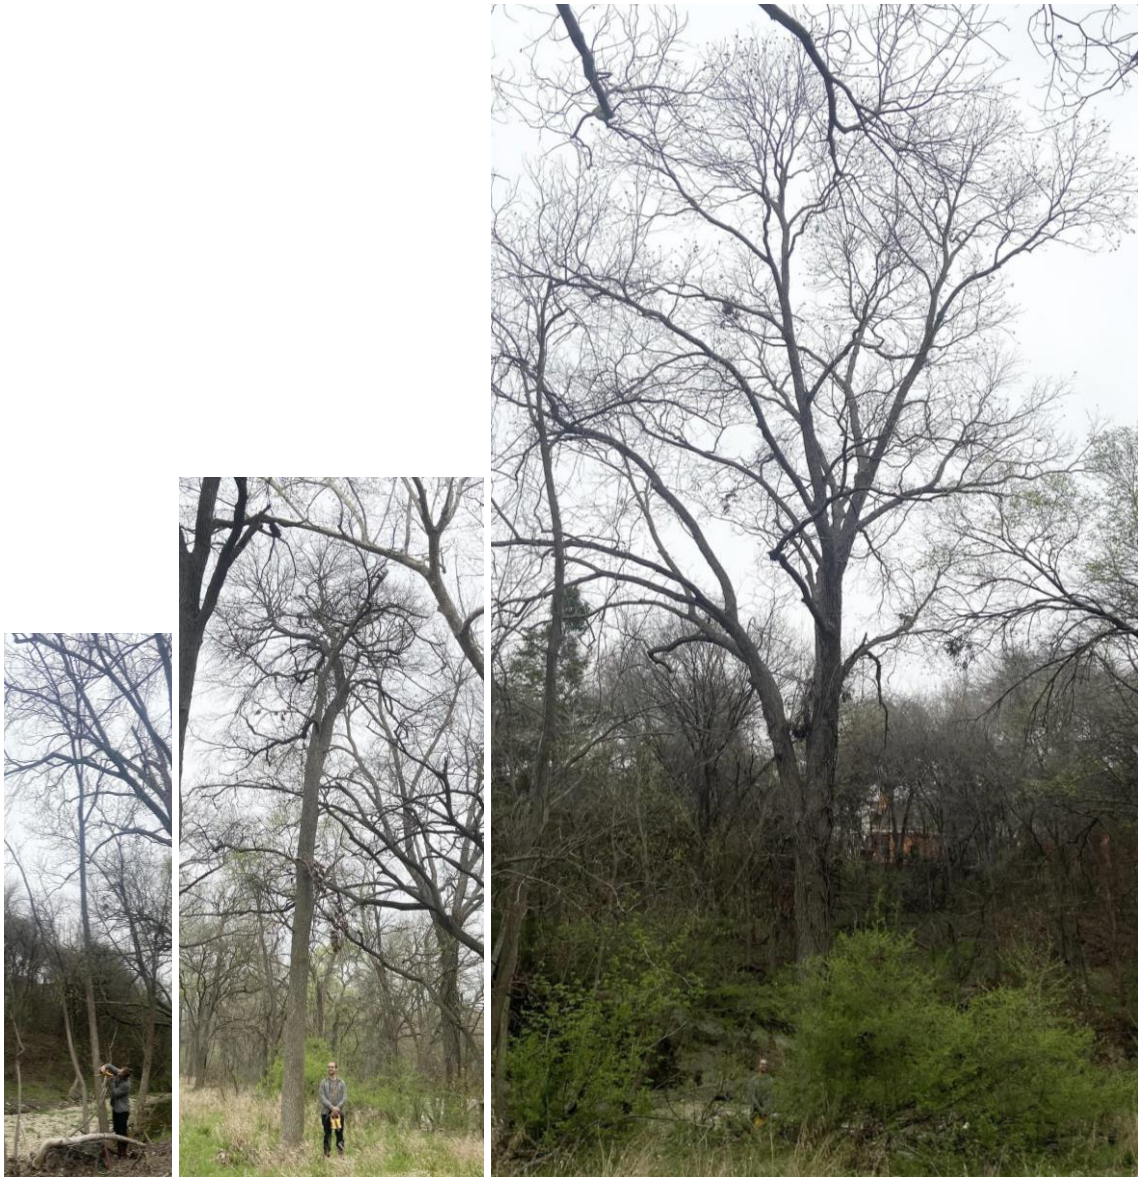
**Figure 11. These three panels show the representative trees from station 08158970. Small, medium, and large trees are shown from left to right. In the leftmost picture, the student is collecting the tree's circumference. Photos were taken in March 2021.**

A tree count was conducted within the generated buffer area at station 08158970 at Williamson Creek to provide a tangible reference for the amount of trees that could be expected given a volume of high vegetation. Pictures were taken with a human, Ben Grunau, for scale. His height is 1.77 meters. The circumference of a representative small, medium, and large tree was taken at breast height.

After conducting a tree count within the buffer generated at station 08158970, a total of 53 small trees, 26 medium trees, and 19 large trees were counted. This station's volume of high vegetation was calculated to be 45.74%, therefore for a similar volume of vegetation in the Austin area, a similar tree count can be expected to exist on the streambank within the buffer area. The circumferences of relatively small, medium, and large trees can be found in table 4.

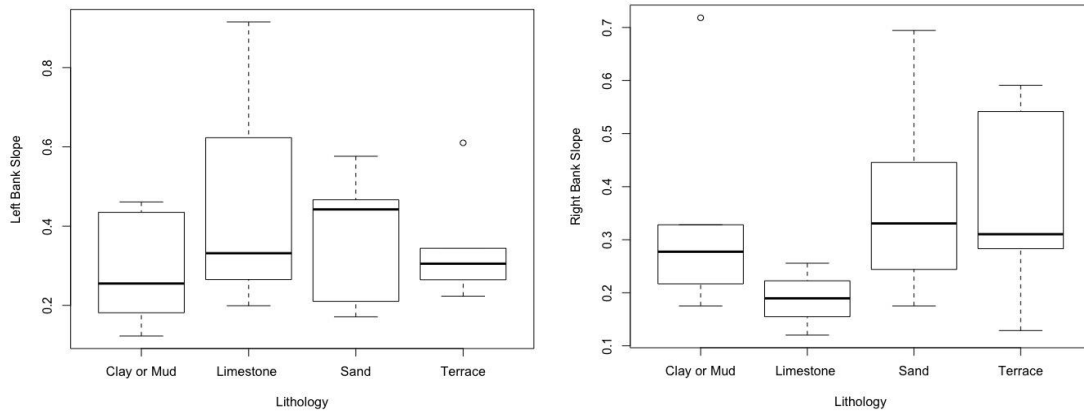
**Figure 15. Box plots of the left and right bank slopes along the stream bank profiles.**

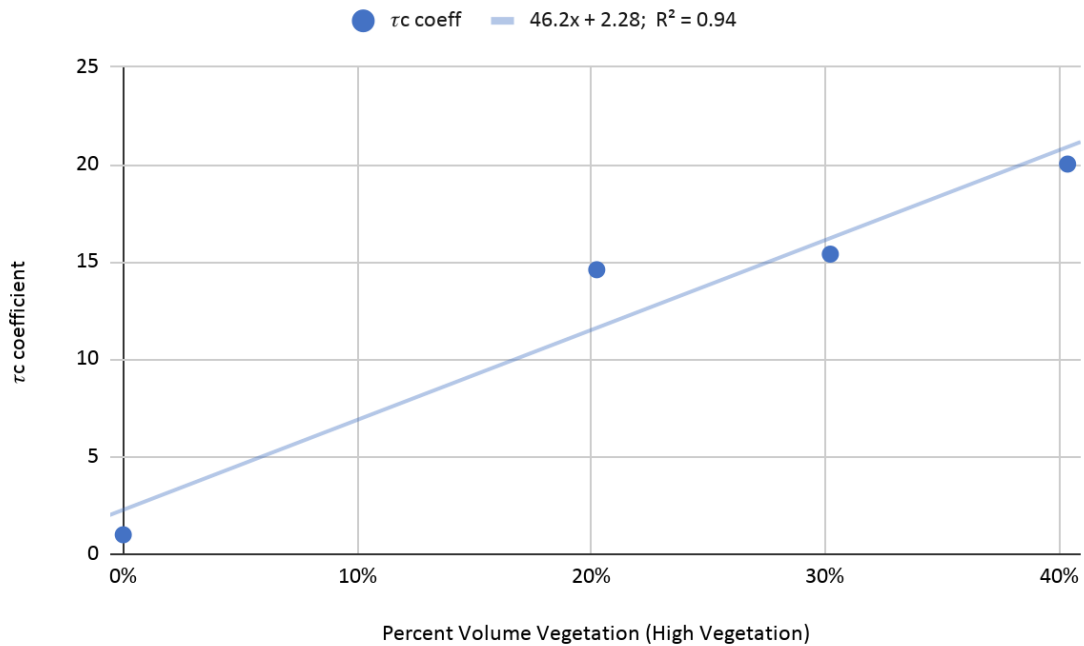
**Figure 17. Plot of PVV for high vegetation and the corresponding coefficient that can be applied to a critical shear stress equation. As shown, a bank area with a PVV of 40% is assumed to have roughly 20 times the critical shear stress as if that area were to have roughly 20 times the critical shear stress as if that area were to have no high vegetation.**

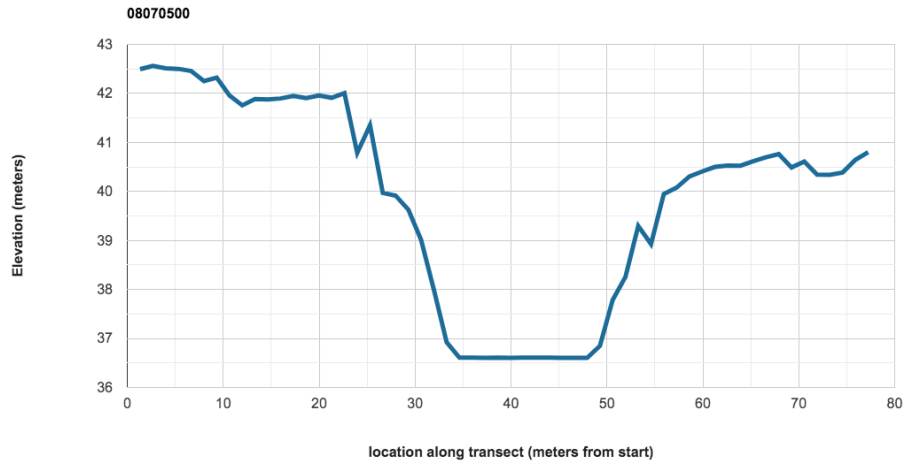
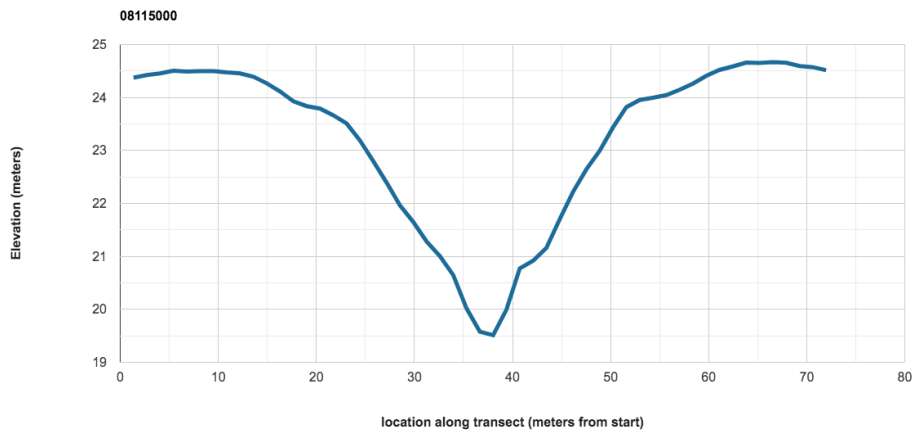
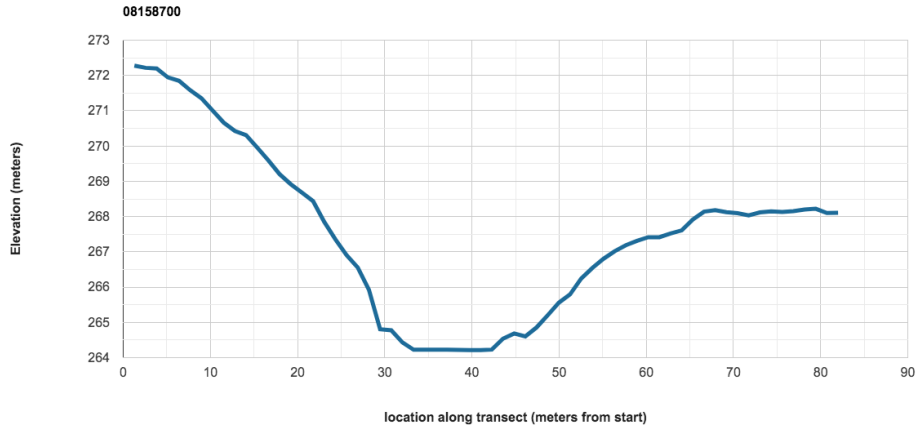
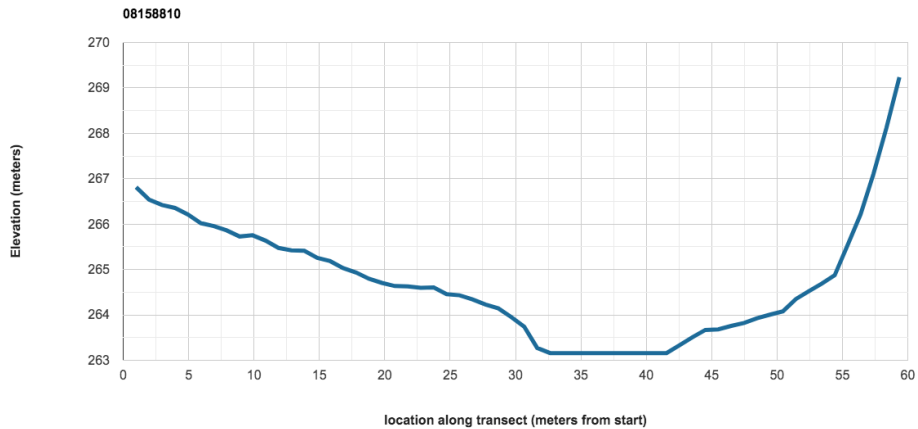
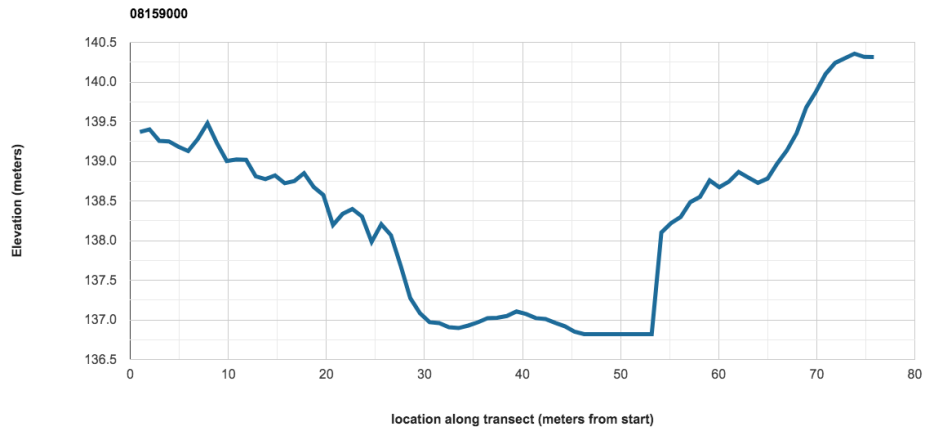
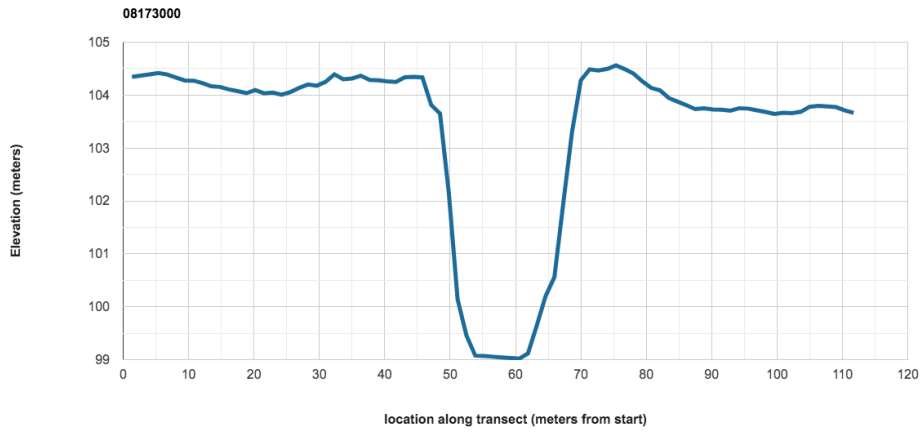
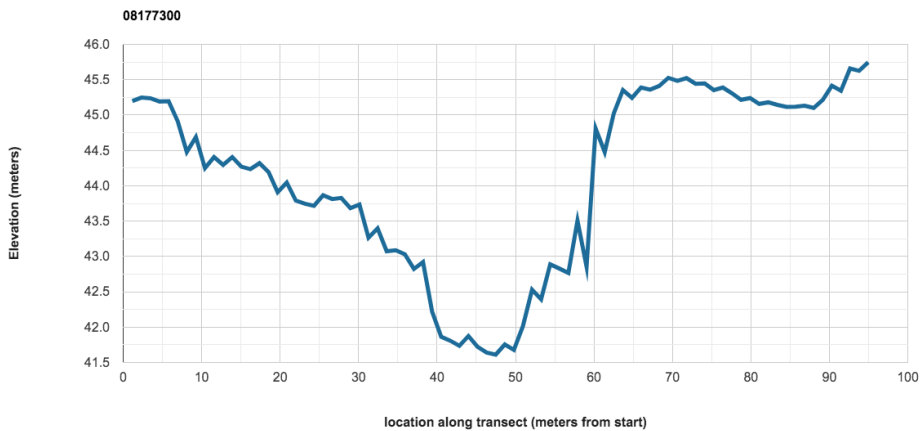
**Figure 18. Stream profile collected using a DEM at USGS station 0806275. From this profile, width, depth, cross-sectional area, and wetted perimeter were calculated.**

**Figure 19. Stream profile collected using a DEM at USGS station 08065800. From this profile, width, depth, cross-sectional area, and wetted perimeter were calculated.**

**Figure 20. Stream profile collected using a DEM at USGS station 08070500. From this profile, width, depth, cross-sectional area, and wetted perimeter were calculated.**

**Figure 21. Stream profile collected using a DEM at USGS station 08071000. From this profile, width, depth, cross-sectional area, and wetted perimeter were calculated.**

**Figure 22. Stream profile collected using a DEM at USGS station 08098300. From this profile, width, depth, cross-sectional area, and wetted perimeter were calculated.**

**Figure 23. Stream profile collected using a DEM at USGS station 08110100. From this profile, width, depth, cross-sectional area, and wetted perimeter were calculated.**

**Figure 24. Stream profile collected using a DEM at USGS station 08111700. From this profile, width, depth, cross-sectional area, and wetted perimeter were calculated.**

**Figure 25. Stream profile collected using a DEM at USGS station 08115000. From this profile, width, depth, cross-sectional area, and wetted perimeter were calculated.**

**Figure 26. Stream profile collected using a DEM at USGS station 08158700. From this profile, width, depth, cross-sectional area, and wetted perimeter were calculated.**

**Figure 27. Stream profile collected using a DEM at USGS station 08158810. From this profile, width, depth, cross-sectional area, and wetted perimeter were calculated.**

**Figure 28. Stream profile collected using a DEM at USGS station 08158970. From this profile, width, depth, cross-sectional area, and wetted perimeter were calculated.**

**Figure 29. Stream profile collected using a DEM at USGS station 08158930. From this profile, width, depth, cross-sectional area, and wetted perimeter were calculated.**

**Figure 30. Stream profile collected using a DEM at USGS station 08159000. From this profile, width, depth, cross-sectional area, and wetted perimeter were calculated.**

**Figure 31. Stream profile collected using a DEM at USGS station 08162600. From this profile, width, depth, cross-sectional area, and wetted perimeter were calculated.**

**Figure 32. Stream profile collected using a DEM at USGS station 08164390. From this profile, width, depth, cross-sectional area, and wetted perimeter were calculated.**

**Figure 33. Stream profile collected using a DEM at USGS station 08172400. From this profile, width, depth, cross-sectional area, and wetted perimeter were calculated.**

**Figure 34. Stream profile collected using a DEM at USGS station 08173000. From this profile, width, depth, cross-sectional area, and wetted perimeter were calculated.**

**Figure 35. Stream profile collected using a DEM at USGS station 08177300. From this profile, width, depth, cross-sectional area, and wetted perimeter were calculated.**

**Figure 36. Stream profile collected using a DEM at USGS station 08178880. From this profile, width, depth, cross-sectional area, and wetted perimeter were calculated.**

**Figure 37. Stream profile collected using a DEM at USGS station 08181500. From this profile, width, depth, cross-sectional area, and wetted perimeter were calculated.**

**Figure 38. Stream profile collected using a DEM at USGS station 08185065. From this profile, width, depth, cross-sectional area, and wetted perimeter were calculated.**

**Figure 39. Stream profile collected using a DEM at USGS station 08185500. From this profile, width, depth, cross-sectional area, and wetted perimeter were calculated.**

**Figure 40. Stream profile collected using a DEM at USGS station 08187500. From this profile, width, depth, cross-sectional area, and wetted perimeter were calculated.**

**Figure 41. Stream profile collected using a DEM at USGS station 08207500. From this profile, width, depth, cross-sectional area, and wetted perimeter were calculated.**

**Figure 42. Stream profile collected using a DEM at USGS station 08202000. From this profile, width, depth, cross-sectional area, and wetted perimeter were calculated.**

**Figure 43. Stream profile collected using a DEM at USGS station 0810464660. From this profile, width, depth, cross-sectional area, and wetted perimeter were calculated.**

**Figure 44. Stream profile collected using a DEM at USGS station 08158840. From this profile, width, depth, cross-sectional area, and wetted perimeter were calculated.**

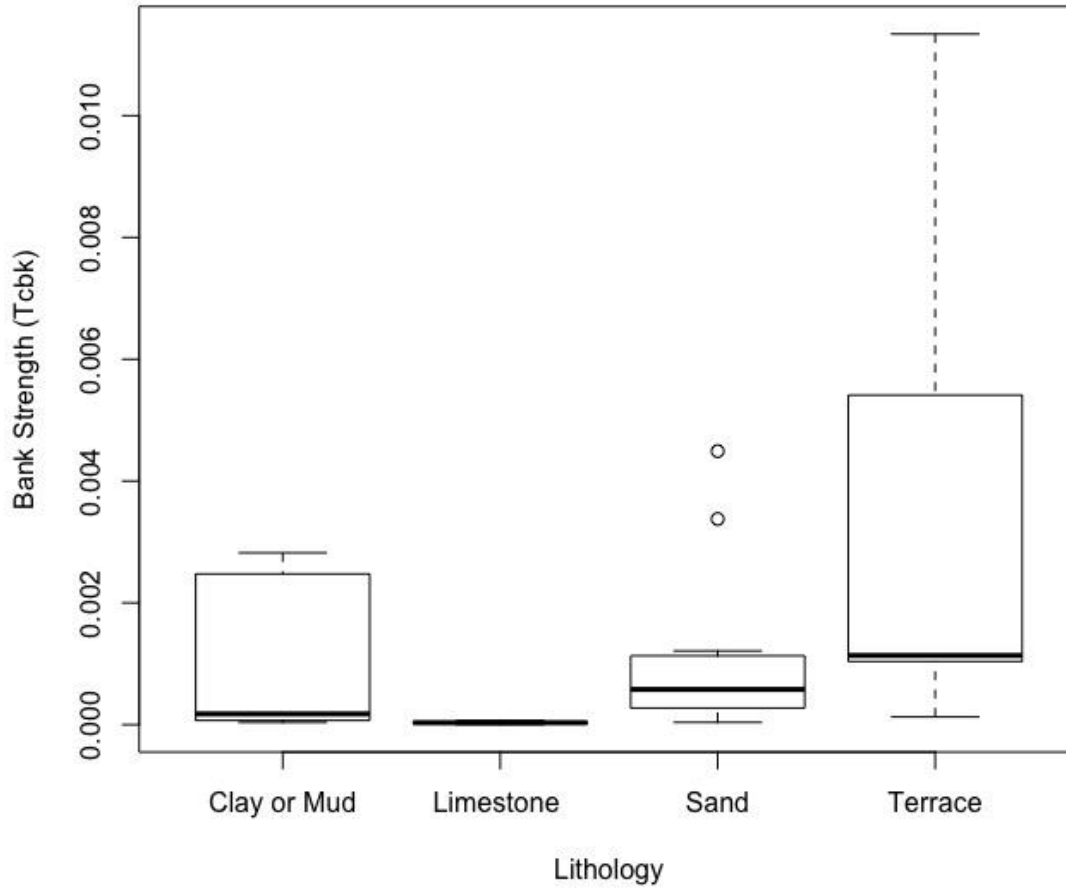
**Figure 45. Box plot of bank strength calculations ( $\tau_{cbk}$ ) as separated by lithology. Two outliers (stations 08111700 and 08172400) were removed from the sand group.**

Interestingly, the geologic substrate of each station had a significant influence in determining where this method of evaluation has the most significance. In limestone streams, it is clear that no matter the PVV, bank strength does not change in response, according to this small sample size. The reason there was little to no change in bank strength, despite an increase in PVV, could be due to the effect it has on soil aggregation. Cerda (1996) noted that vegetation is less important than lithology in influencing soil aggregate stability. In that study, three Mediterranean landscapes in southeast Spain were analyzed; the lithological influence on aggregate stability was found to be higher than the influence from the vegetation cover. In clay or mud, sand, and terrace streams, the opposite was true; vegetation had a noticeable effect on streambank strength, with results varying according to the classification of vegetation height.
