THE LAST SCHOONERS: THE TWO-MASTED SCHOONER *KATIE ECCLES* AND  
THE DECLINE OF SAIL ON LAKE ONTARIO

A Dissertation

In 2019 the author directed the Last Schooner Project, photogrammetrically documenting and surveying the wreck of the two-masted schooner *Katie Eccles* which was among the last schooners in operation on Lake Ontario. This survey produced

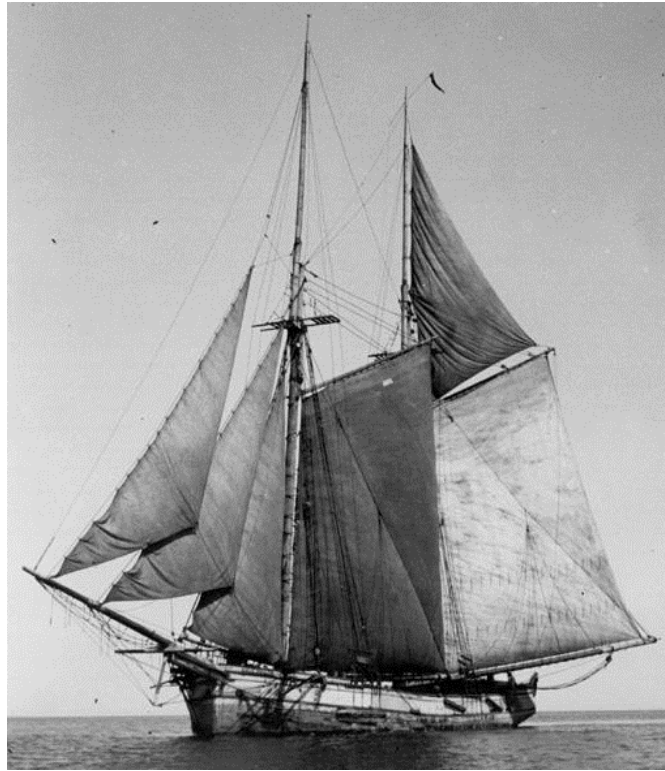
**Figure 4. The *Katie Eccles* under sail. Date unknown. (Digital image from the Fr. Edward J. Dowling, S.J. Marine Historical Collection, University of Detroit Mercy).**

rarely filled this capacity and was sufficient for its intended role in the limited-scale local grain trade (LAC 1877)(Figures 4 and 5).

The martingale tapers from top to bottom, and has a set of jaws at the top of which it fastened against the head of the bowsprit and the lower side of the jib boom (Figures 4 and 19). No measurements could be obtained for the spreader or martingale spars.

At least two wooden fenders were located, one laying on deck to port between the midships and aft hatches and the other off the port side amidships. These timbers measure 9 ft. (2.74 m) long, 9 ½ in. (0.24 m) wide, and had a slightly curved profile to conform to the hull. Two such fenders are visible in Figure 4 suspended from timberheads

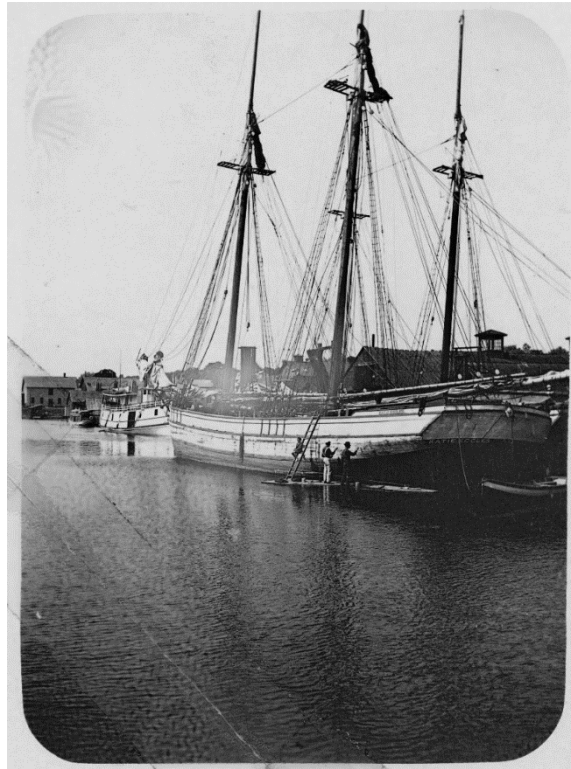
**Figure 5. *Katie Eccles* being repainted at Napanee in 1900 (N-1551 – Transportation, schooner *Katie Eccles*, Napanee [1900] – LAHS Collection, Lennox & Addington County Museum, and Archives)**

The forecastle companionway, visible in one historical photograph (Figure 5), has not been preserved. The companionway roof was cambered and sloped downward forwards, the sides curving down and overhanging the sides of the companionway. A

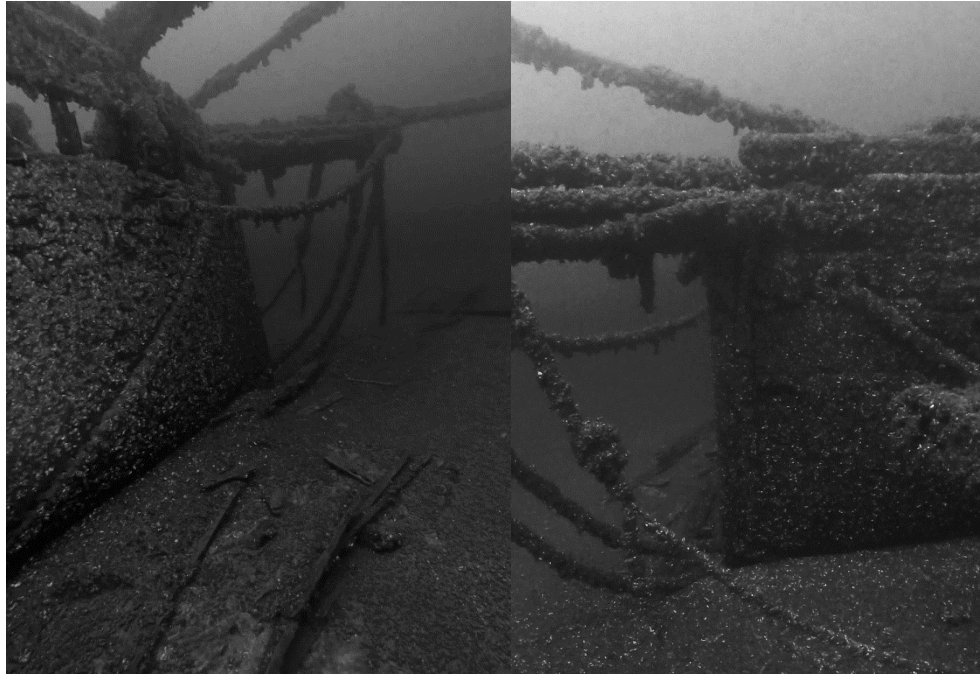
The keel and keelson assemblies could not be observed along most of their lengths. At the forward extremity of the keel, the upper extent of the forefoot is exposed. The forefoot's lower half is embedded in the bottom. The straight stem extends above

**Figure 10. The Eccles' starboard bow looking forward (left) and the port bow (Photo by author, 2021).**

the forefoot of approximately 8 ft. 6 in. (2.59 m) along its forward face. The stem is nearly vertical with a  $2^{\circ}$  forward rake. As the hood ends of the strakes remain seated along the rabbet, the overall dimensions of the stem could not be determined. The external molded dimension from the rabbet line to the forward face of the stem is approximately 1 ft. 5 in. (0.41 m) at the head of the stem, tapering to 1 ft. (0.30 m) at the foot. The forward-sided dimension of the stem could not be reliably measured.

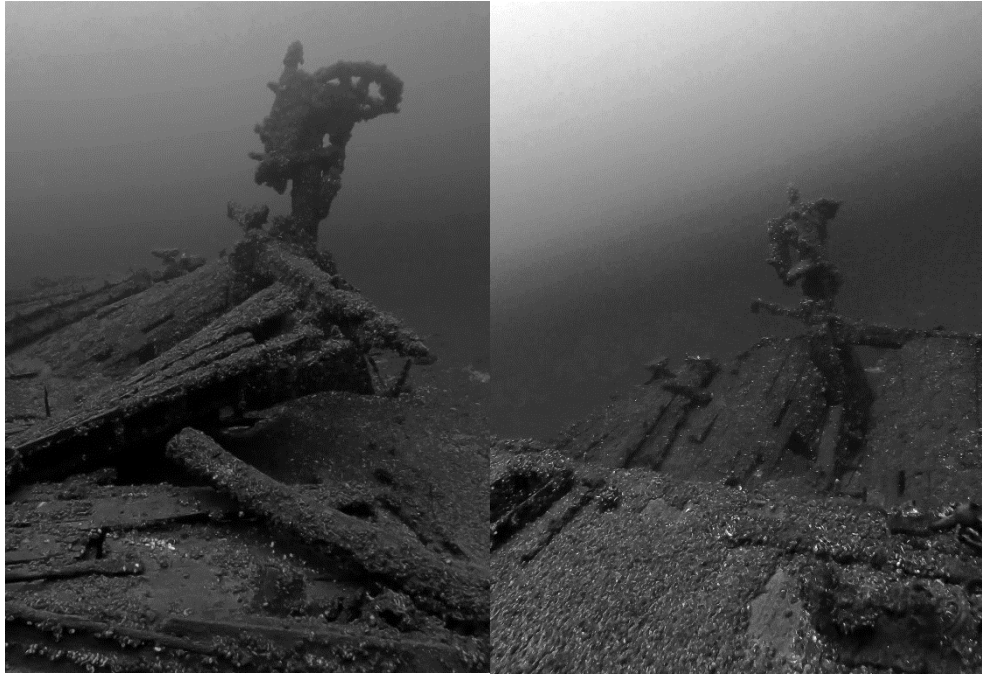
The inner post has an exposed length of 7 ft. (2.13 m) and is bolted to the forward face of the sternpost. The corners of the sternpost and inner post along this joint are chamfered, forming the rabbet with the back rabbet line following the seam between the timbers. The top of the inner post is mortised to receive the main transom timber.

The deadwood is a simple structure (Figure 11), consisting of two diagonally set timbers, one bolted atop of the other. The existence of this sternson is suggested by the 1876 Board of Lake Underwriter's rules and the necessity of integrating the keelson assembly with the inner post (Dorr 1876:29). The timbers of this diagonal deadwood

**Figure 11. (Left) The sternpost, inner post, and rudder stock. (Right) the sternpost and deadwood assembly looking aft (Photo by author, 2021).**

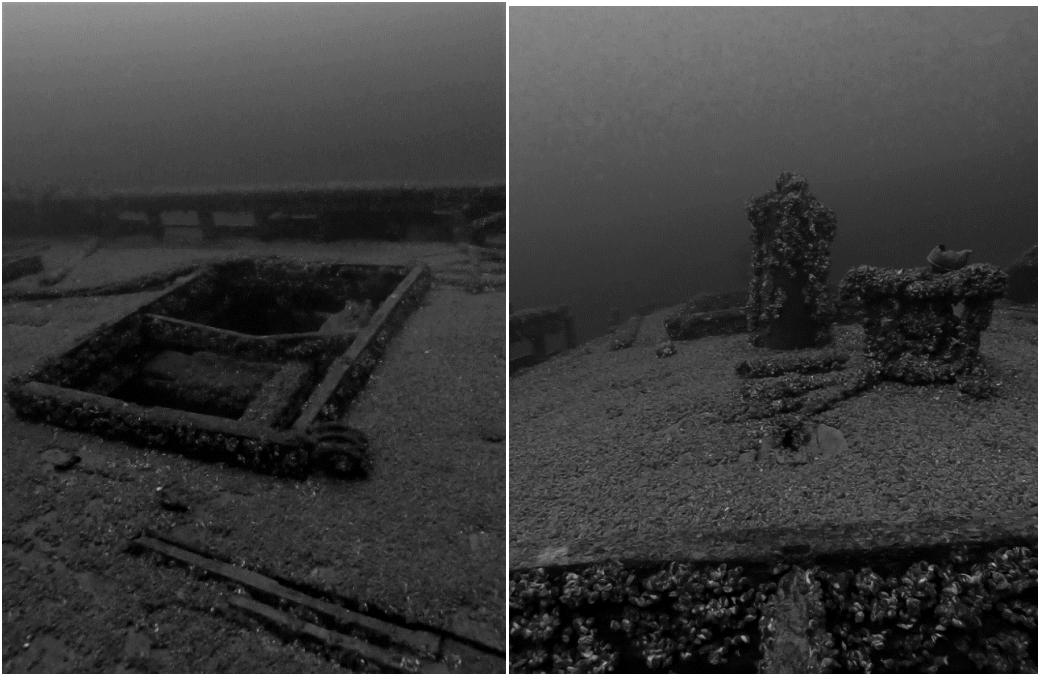
At 31 ft. 6 in. (9.60 m) along the centerline a small rectangular opening in the deck, measuring approximately 8 in. long by 4 in wide. (20.3 by 10.2 cm) was likely to allow inspection of the centerboard's pivot pin; thus, the pivot pin is located approximately 3ft. (0.91 m) aft along the centerboard's length when raised.

A metal plate 3 ft. (0.91 m) long is bent over the top of the centerboard case to cover the cap plank and uppermost strakes of the case within the opening of the midships hatch. Heavy wear on the cap plank around this plate suggests the plate was intended to protect the cap plank and centerboard from damage while loading coal by pocket chutes along elevated railway trestles. Douglas Bennet notes that the small hatches on coasting schooners prevented even distribution of coal throughout the hold, with the coal tending to mound in the center of the hatch. Trimmers were employed to shovel the mounded coal from the hatch opening out into the wings as well as fore and aft. Bennett also notes that loading with pocket docks was often through the main hatch and that the fore and aft hatches were used for access to the hold and to allow trimming coal fore and aft (Bennet 2001:44). A review of historical photographs of schooners at the Oswego and Sodus coal trestles consistently show lading with a single chute at the midships hatch, or with coal mounded at the midships hatch, indicating a similar method of lading through the midships hatch may have been employed aboard lake schooners.

**Figure 12. (Left) The centerboard visible at the midships hatch. (Right) The centerboard pennant hole and chain looking aft (© Institute of Nautical Archaeology/ Author, 2021).**

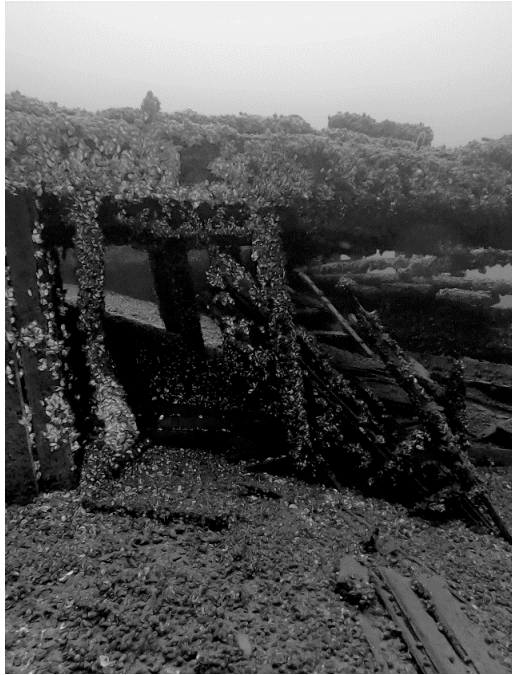
The great beam appears to consist of two sister-beams, with the after sister-beam comprised of three timbers joined with diagonal scarphs. The construction of the forward sister-beam is unknown. An athwartships coaming was fastened atop the after half-beam but has only been preserved at its outboard ends. The outboard ends of the coaming show the coaming was lower along the width of the quarterdeck gangways. These gangways were approximately 4 ft. 6 in. (1.37 m) wide, inboard of which the coaming increased in height. These higher coamings functioned as the cabin footing and have only been fragmentarily preserved. A timber fastened to the after face of the great beam beneath and of a length slightly shorter than the short coaming may have served as a shelf to which the plank ends of the quarter-deck were fastened.

**Figure 14. Looking forward from the break of the deck with the two iron stanchions at center and the row of centerline stanchions in the background (By author, 2021).**

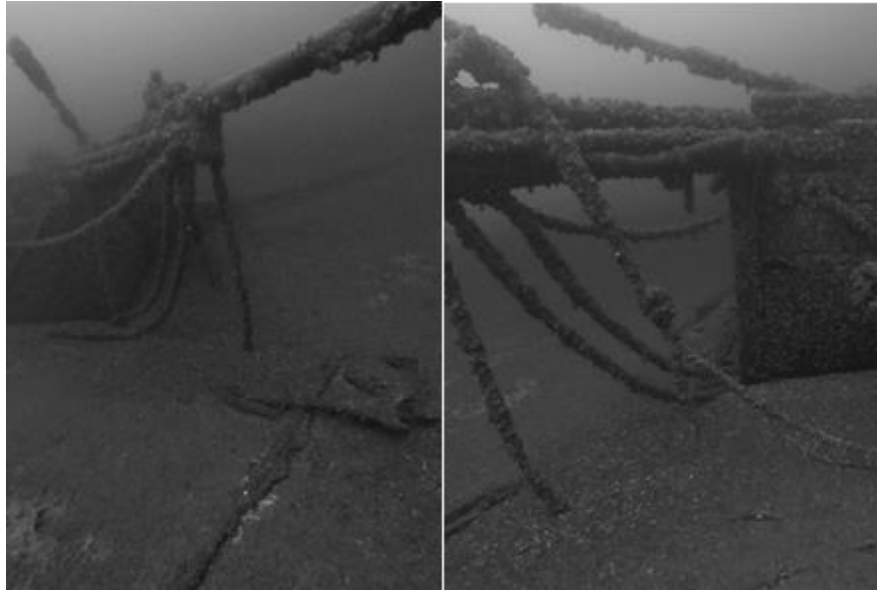
The jib boom has an overall preserved length of 28 ft. 6 in. (8.68 m), with a doubling of 12 ft. 6 in. (3.81 m). It was secured by an iron band 3 ft. 6 in. (1.06 m) forward of the chock rails, and by the bowsprit cap. The outermost section of the jib boom is broken off at approximately the attachment point for the inner jib stay and lies beneath the jib boom. An iron band is secured just below the head of the jib boom, to which are shackled the jib boom guys on its lower face.

**Figure 19. (Left) The bowsprit and jib boom with the bobstays, starboard and port bowsprit guys, jumbo jib stay, and jumbo jib boom. (Right) Portside view of the bowsprit (Photo by Author).**

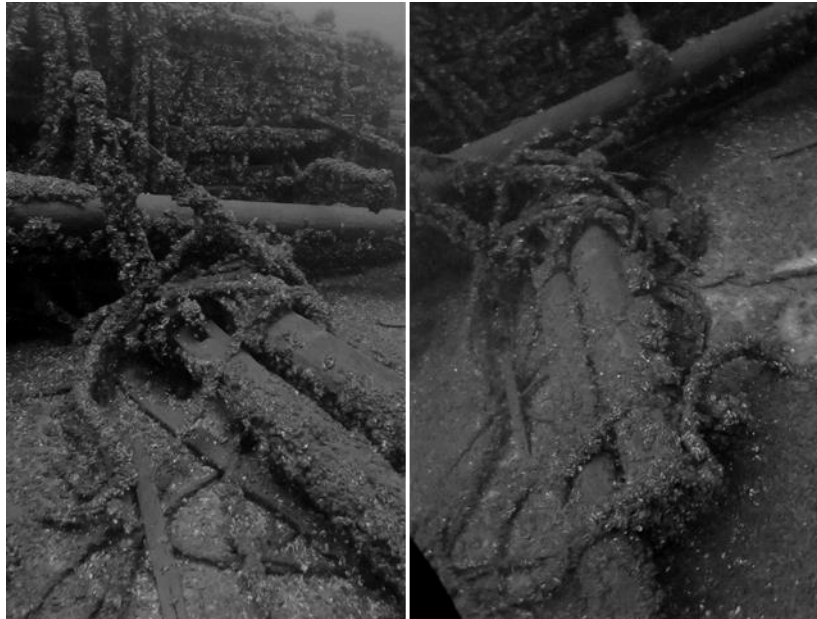
The trestletrees were fastened immediately above a set of iron hounds. Historical photographs of *Katie Eccles* show that it was outfitted with parallel crosstrees, with a platform on each side of five cross-planks fastened along their outer ends with space between each (Figures 4-5). The forward crosstree remains intact and in place to starboard, whereas the aft crosstree is partially detached and lies at an angle to the fore crosstree. Three eyes were fastened into the aft face of the doubling below the mast cap to which the peak halyard blocks were hooked.

**Figure 20. The foremast doubling with the topmast fid and the remains of the crosstrees visible.**

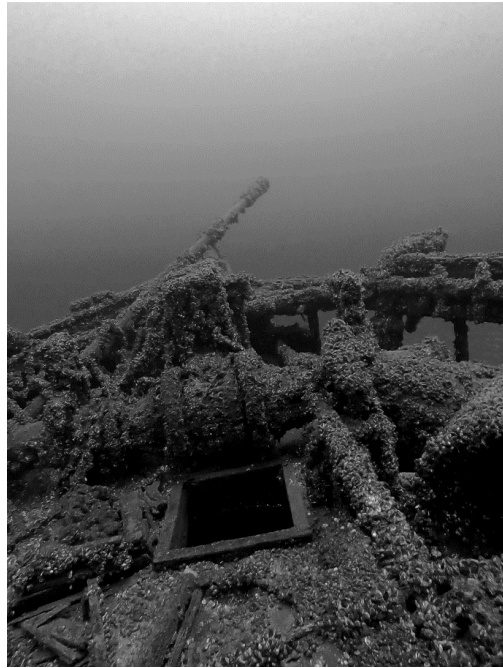
*Katie Eccles*' has a purchase-lever operated windlass, colloquially referred to as "Armstrong's patent windlass," typical of those fitted to schooners throughout the mid-to-late 19<sup>th</sup> century (Chapelle 1973:677; Harland 2003:55)(Figure 21). The wooden barrel of the windlass is situated with its centerline approximately 10 ft. 6 in. (3.20 m) along the baseline. The forward side of the windlass is immediately aft of the pawl post, the forward face of which is 7 ft. (2.13 m) aft along the baseline. While precise measurements of the barrel were prevented by poor resolution of its forward side in the photo model, an estimation of the barrel diameter at 18 in. (45.7 cm) can be made from the site orthophoto. Along the centerline of the barrel are the pawl teeth. A single iron

**Figure 21- The windlass and pawl posts on the foredeck  
(©Institute of Nautical Archaeology/Author, 2019).**

pawl is visible, articulated with the after face of the pawl post. Immediately outboard of the pawl rim on either side are the purchase rims.

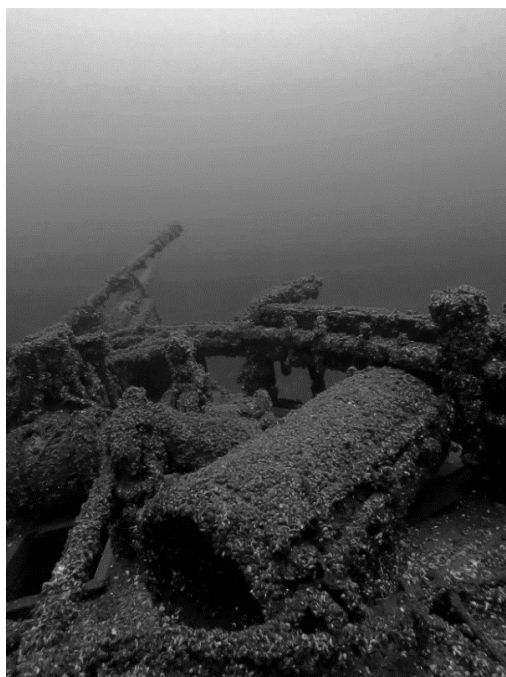
Donkey engines consisted of a simple, compact single or double-cylinder steam engine powering a geared hoisting drum. Steam was typically provided by a vertical fire-tube boiler or vertical cross-tube boiler, which provided a relatively lightweight and compact means of generating steam pressure that occupied minimal space on deck. In the vertical fire tube boilers, the internal firebox was surrounded by water within the boiler body with a single flue tube exhausting to the top of the boiler. Their limited heating surface made them inefficient. Furthermore, as the water within the reservoir did not extend to the top of the flue, overheating of tended to result in leaks (Shealy 1912:17). In water tube type boilers, several tubes containing water crossed the furnace increasing the heating surface and therefore improving efficiency in producing steam (Shealy 1912:21). Both designs saw widespread use in maritime applications.

**Figure 22. (Left) The vertical boiler resting on the fore deck. (Right) the hoisting winch set forward of the fore hatch (by Author, 2019).**

The *Eccles*' vertical boiler, likely of the vertical-cross tube type (Figure 22), is situated 19 ft. 6 in. (5.94 m) along the baseline and offset to starboard approximately 4 ft. (1.21 m). The placement of the *Eccles*' vertical boiler and winch at the foot of the foremast permitted the use of the fore gaff for unloading cargo from the main hatch. The baseplate and ash box of the boiler remains fastened to the deck, indicating the boiler's original position, though the body of the boiler has toppled to starboard with its upper end against the bulwarks slightly forward of the chock timber heads. The drainpipe and gauge cocks are visible on what is now the aft side of the boiler. On the forward side of the boiler is the pipe steam pressure gauge. The gauge itself rests on the deck aft of the boiler.
