INVESTIGATION OF LOCAL FAILURE MECHANISMS OF INVERTED-T BENT
CAPS AND STRENGTHENING USING CFRP SHEETS

A Dissertation

JILONG CUI

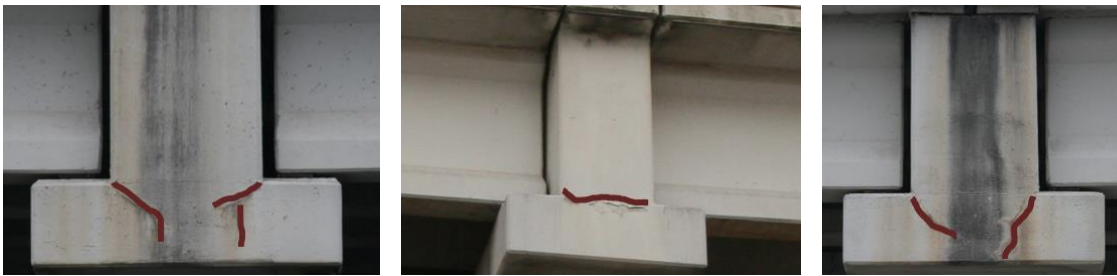
Figure 1-2. Observed Cracks on In-Service Inverted-T Bent Caps (US 290 in Austin).

early days are structurally deficient when evaluated against the current design specifications and/or lack of adequate strength to support planned increases to live load demands. Cracks observed in in-service inverted-T bent caps, as shown in Figure 1-2, describe such a weakness. These cracks typical form at the re-entrant corners at web-ledge interface and their presence is a possible indication of the structural deficiency of the bent caps.

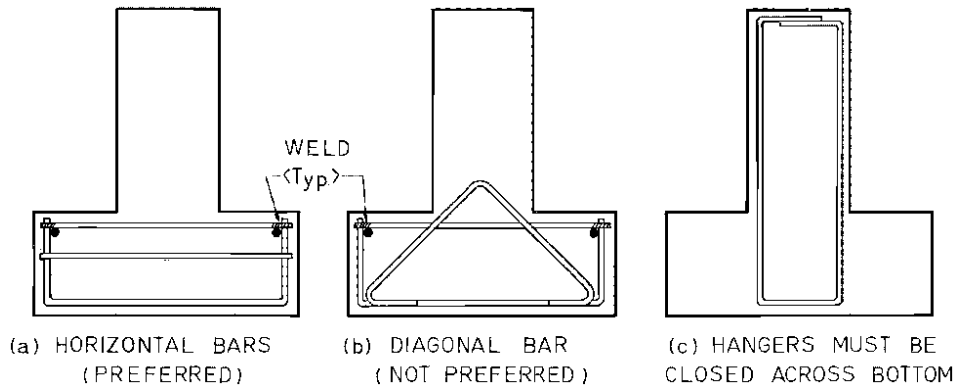
Figure 2-1. Reinforcement Details of Inverted-T Bent Caps (Reprinted from Furlong et al., 1971).

The first study that provided a comprehensive understanding of the structural behavior of inverted-T bent caps was carried out by Furlong et al. (1971). Twenty-four tests were conducted on six inverted-T bent cap specimens (two full-scale and four one-third scale) to investigate the load carrying mechanisms and reinforcement details of inverted-T bent caps. In addition to testing reinforcement details specified by the Texas Highway Department at the time, the researchers investigated the alternative reinforcement designs shown in Figure 2-1. Based on the test results, the authors noted that (a) loads must be supported by stirrups acting as hangers to transmit vertical forces into the body of the web, (b) flange reinforcement perpendicular to the web is necessary to deliver the flange forces to the hangers, and (c) the application of forces to flanges creates greater torsional forces on the web. The use of diagonal ledge bars was expected to perform behavior than the

horizontal bar, however, was not recommended because of the construction efficiency as the two layouts demonstrated a similar ultimate capacity.

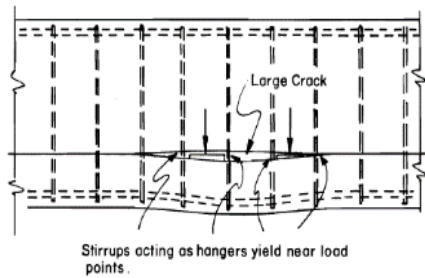
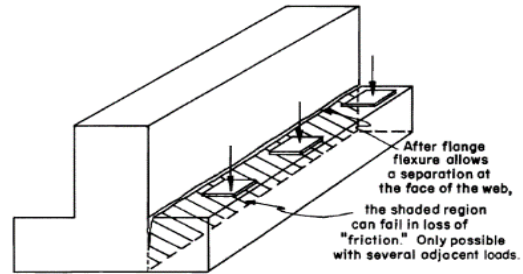
Figure 2-2. Local Failure Mechanisms of Inverted-T Bent Caps (Reprinted from Furlong and Mirza, 1974).

mechanisms. Hanger failure is the vertical separation of the bottom flange from the web. The separation begins at the web-ledge interface around the loading point. More hanger cracks (horizontal cracks on the web) will occur as the failure intensified. Excessive vertical deformation will be caused by the failure at the web-ledge interface. Ledge failure is the separation of the bottom flange deform outward and downward from the web due to the combined bending and shear. Punching shear failure is the diagonal tension failure in the concrete underneath the bearing pad due to the excessive concentrated load applied on top of the ledge. The failure is evident from the diagonal cracks emanating from the edges of the bearing pad. As inverted-T bent caps may be susceptible to local failures, the authors recommended that design of the bent cap should provide sufficient web stirrups to act as hangers to transmit loads from the ledge to the web, the transverse reinforcement strength of the ledge must be sufficient to maintain flexural tension and shear friction resistance at the face of web, and the ledge must be sufficiently deep to avoid punching shear failure.

(a) Hanger failure

(b) Ledge failure

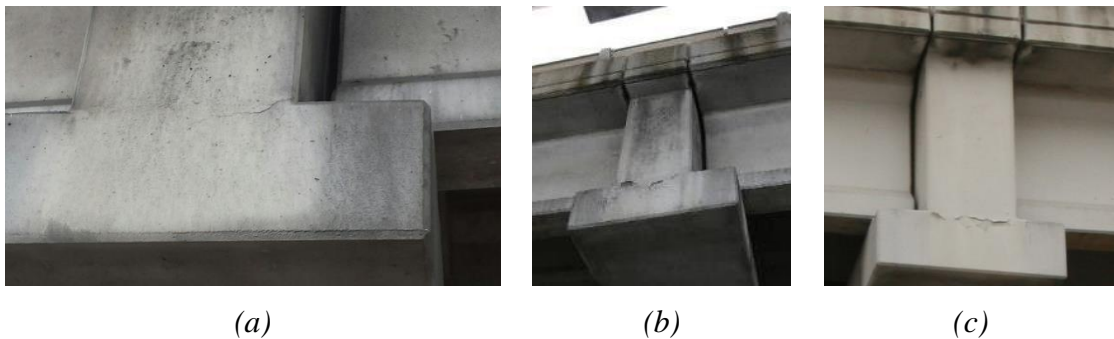
Figure 3-4. Cracking and Spalling Observed at Ends of In-Service Bent Caps.

Figure 3-4 presents the observed key damage types on the in-service bent caps. The cracks typically formed at the ledge-web interface. Although the cracks extend slightly downward, it is primary horizontal. The crack extends approximately 1 ft inward toward the centerline of the cap on one of the bent caps (Figure 3-4(a)). On the other two bent caps (Figure 3-4(b) and (c)), cracking and spalling extended along the width of the interface between the web and the ledge was observed.

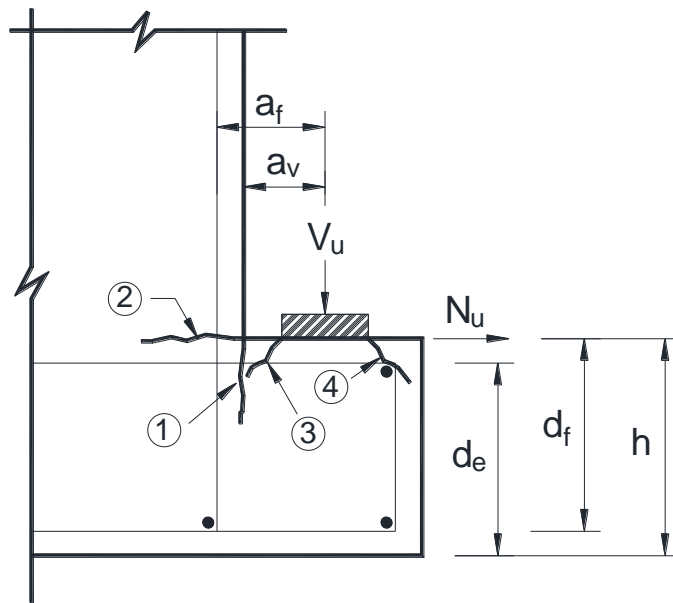
Figure 3-6. Notation and Potential Crack Locations for Ledge Beams (adapted from AASHTO LRFD 2020).

Figure 3-6 depicts the location of potential cracks in inverted-T bent caps. Design of inverted-T bent caps should ensure the section has sufficient strength to resist flexure, shear, and axial forces at the location of Crack 1; tension force in the hanger reinforcement at the location of Crack 2; punching shear points of loading at the location of Crack 3; bearing force at the location of Crack 4. Design requirements for specific components are outlined in Articles 5.8.4.3.2 through 5.8.4.3.6.

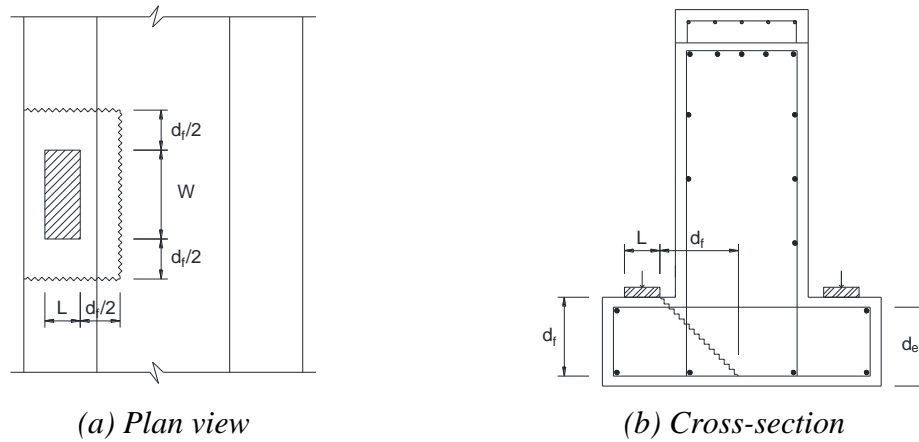
Figure 3-10. Punching Shear Failure Plane.

$$b_o = 0.5W + L + b_f + c \leq W + 2L + 2d_f \quad (3-17)$$

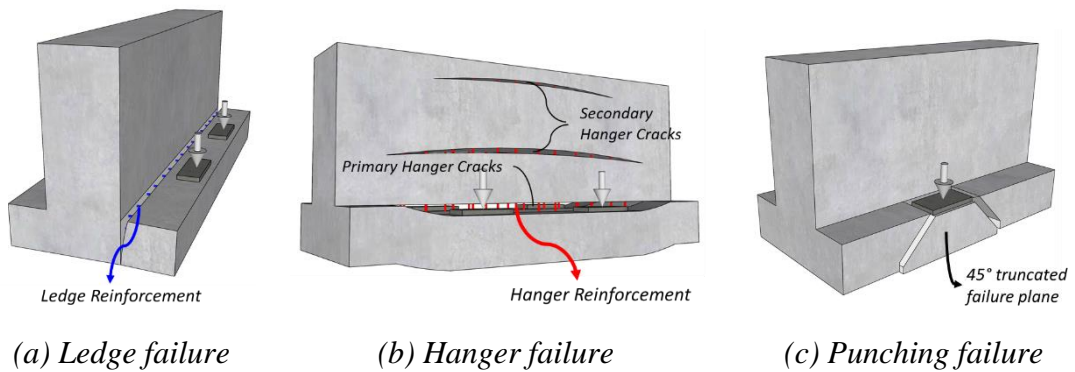
Figure 4-2. Local Failure Mechanisms of Inverted-T Bent Cap.

(a) Ledge failure

(b) Hanger failure

in the web. Punching failure (Figure 4-2(c)) occurs when the load applied on top of the ledge exceeds the tensile strength of the concrete along the surface of truncated pyramid. Once these local failures take place, it will preclude the capability of the bent cap to distribute the internal resistance. The strength of an inverted-T bent cap section can only be fully developed if the section has adequate local strengths. As such, two types of transverse reinforcement, shown in Figure 4-3, are used in inverted-T bent cap to aid in transfer of the load. The ledge transverse reinforcement (blue) are the stirrups in the ledge transferring the load from the bearing pad to the web. The web transverse reinforcement, also referred to as hanger reinforcement (red), are the vertical stirrups in the web that transfer the load into the web. The lateral bars parallel to the ledge transverse reinforcement (light blue) and the diagonal bar (green) across the corners of the web-ledge interface are auxiliary ledge reinforcement provided to ensure the ledge has enough resistance to sustain the combined bending moment and the shears along the face of the web. The diagonal bars extending from the lower end of the ledge across the region at web-ledge interface which has complex stress state due to the combined bending and shear is typically not used in modern design but is included in this study as a potential method to reduced service level cracking.

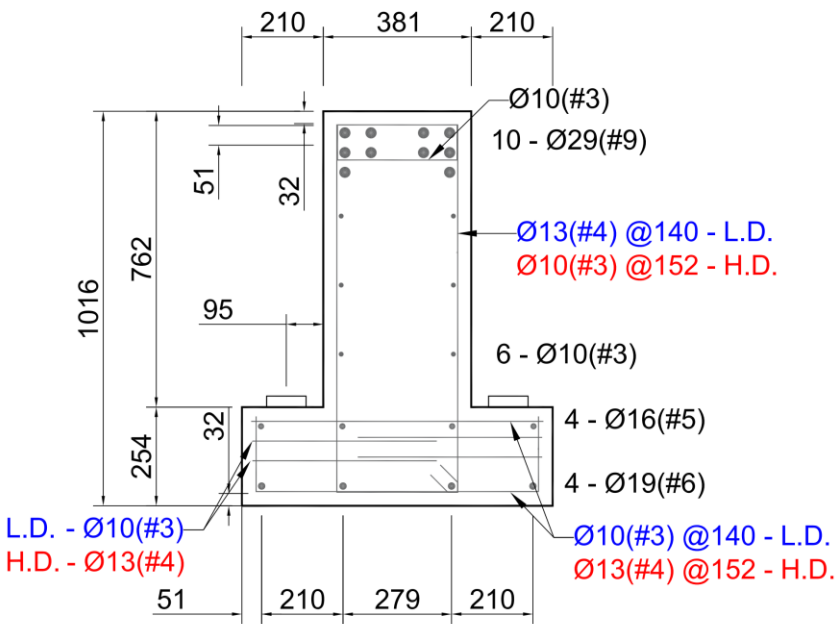
Figure 4-4. Reinforcement Details of Inverted-T Bent Cap Specimens.

centered 12 in. (305 mm) from the edge with an additional loading line was provided over the adjacent column. At each simulated girder line, an actuator was applying loads to a loading frame that transferred load to each ledge. For ledge and hanger tests, the actuator was centered on the loading frame (Figure 4-5(b)) to provide equal loads on each ledge. The interior tests increased the actuator load on the two girder lines equally whereas the exterior tests increased each actuator equally up to dead load, at which point the load over the column was held constant. For punching tests, the actuator was placed 5 5/8 in. (143 mm) off-center (Figure 4-5(c)) to allow for larger loading on one side to generate a punching failure. Both interior and exterior punching tests increased each actuator equally up to dead load. After reaching dead load, only a single actuator was increased up to failure.

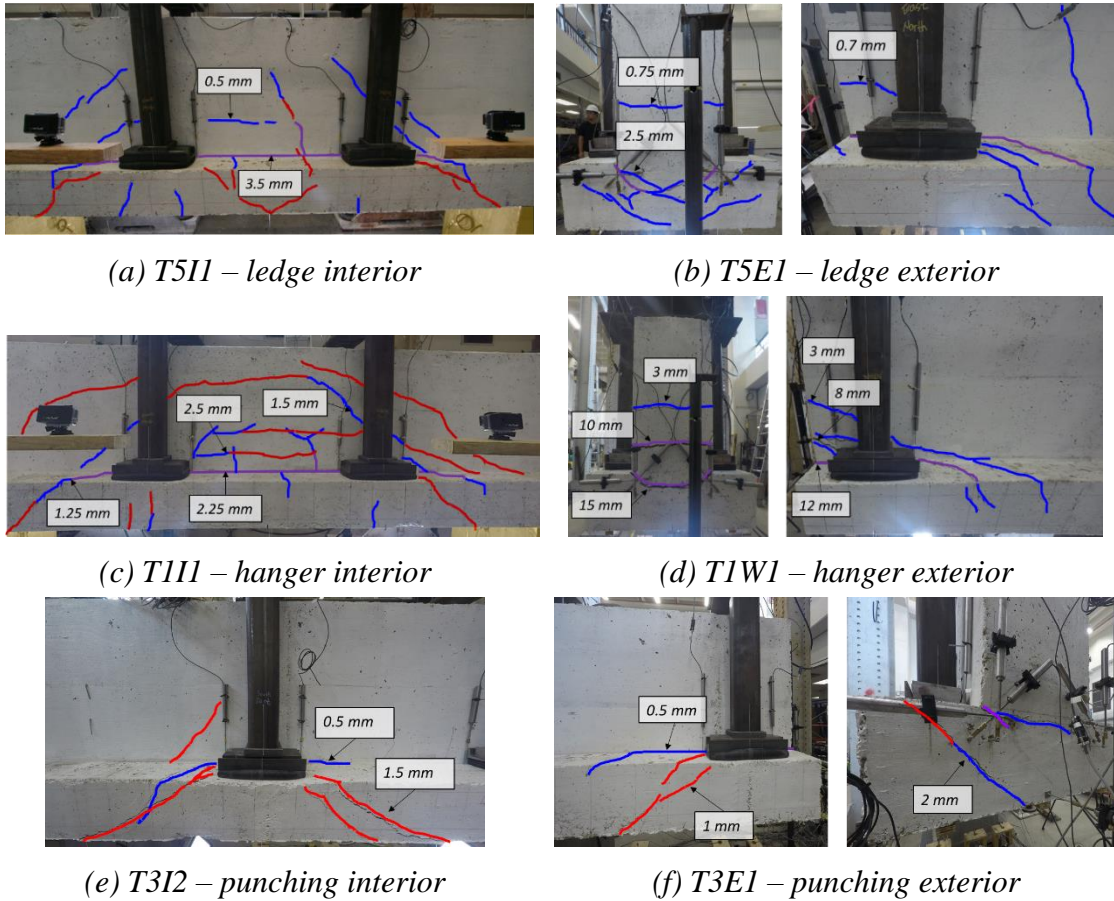
Figure 4-6. Observed Damages on Specimens at Measured Ultimate Load. Cracks formed before SLS in purple, between SLS and ULS in blue, and after ULS in red.

0.5 mm respectively for the interior ledge test. For the exterior test, it was 2.5 mm and 0.75 mm, respectively.

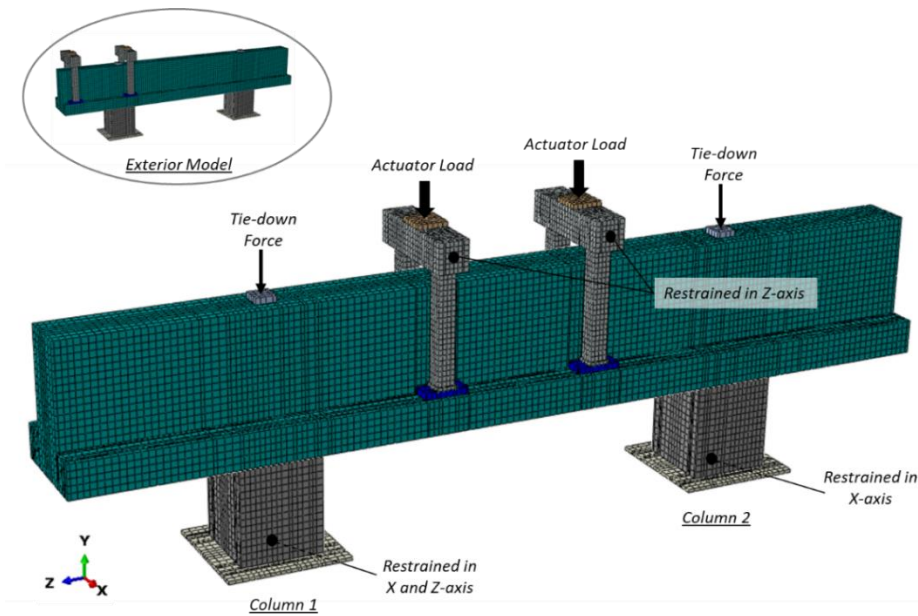
Figure 4-7. Overview of Finite Element Model.

An overview of the FE model is presented in Figure 4-7. The 3-D components including the bent caps, support columns with base plate, loading frame and the bearing plates were modeled using 8-node solid element (C3D8R) with reduced integration and hourglass control. All components were modeled with as-built dimensions except the upper beam of the loading frame (W-beam) was modeled as a rectangular shape for simplicity. Reinforcing bars were modeled using two-node linear truss element (T3D2) and embedded into the bent cap specimen assuming perfect bond between the rebar and concrete. The model was meshed with a typical element size of 2in. (50 mm).

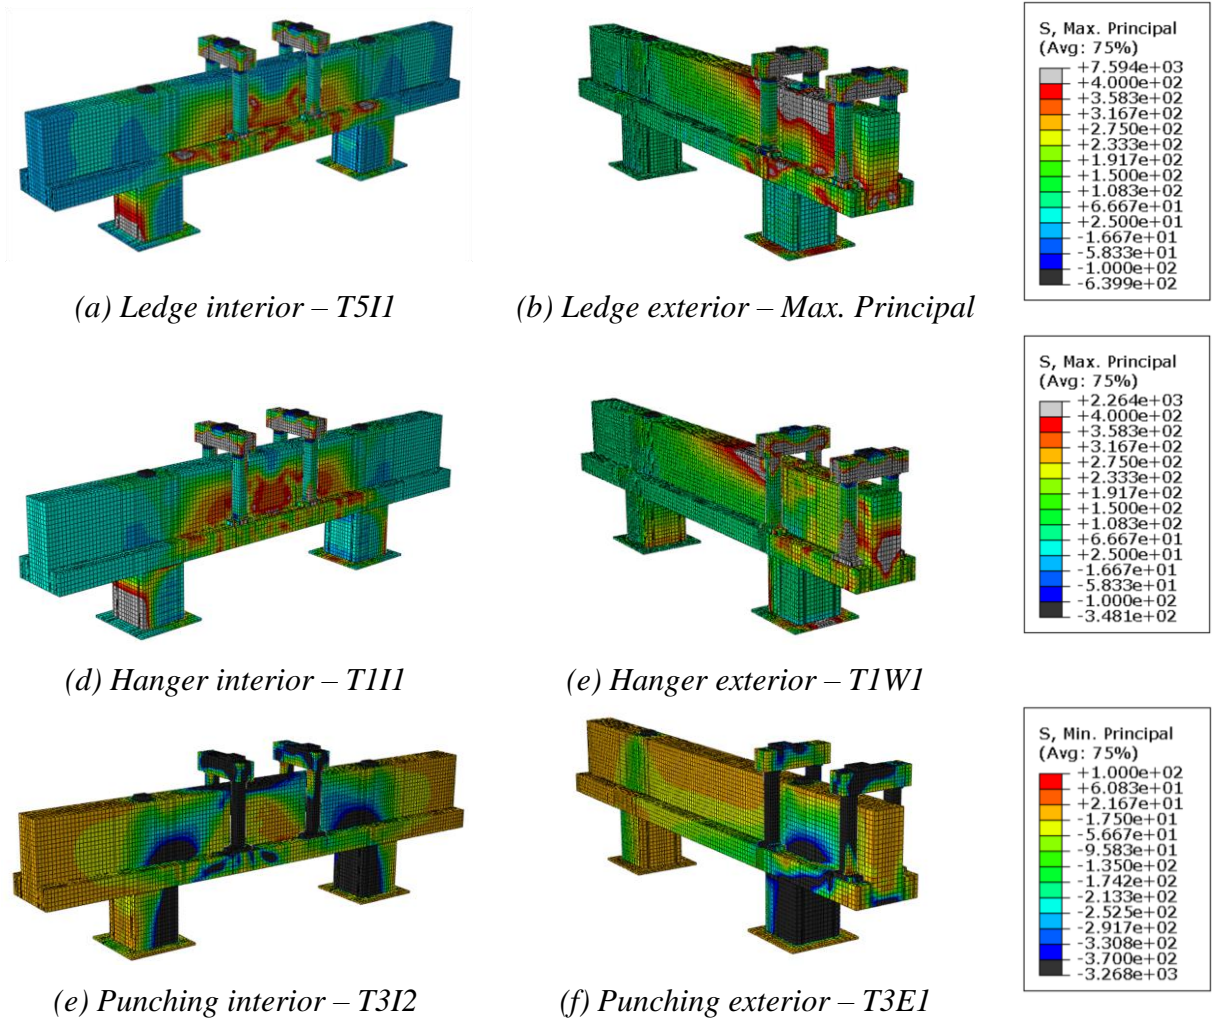
Figure 4-12. Overview of Stress Contour at Ultimate Strength. Ledge and hanger model show the maximum principal stress and punching model show the minimum principal stress.

Figure 4-12 presents an overview of the stress contours for all six cases at ultimate strength. The results of ledge and hanger models were presented by maximum principal stress contour while the result of punching model was shown in minimal principal stress contour. Figure 4-13 through Figure 4-15 compares the stress contours of the model in the regional area with the experimental observations at critical load states. The observed damages from testing are presented to provide references. The cracks on the specimens are marked in purple, blue, and red to demonstrate the cracks formed before or at SLS, between SLS and ULS, and after ULS, respectively. The upper limit of the maximum principal stress contour is set as the cracking stress of concrete. That is, red on maximum principal stress contours is indicating the region that potentially have cracked. Any stress exceeds the limit is shown in grey. The stress in concrete element may exceed the cracking stress as the value affected by the adjacent reinforcing steels. The lower limit of the minimum principal stress contour is also set as the (negative) cracking stress. The blue on minimum principal stress contour is indicating the cracking caused by the compression struts. The stress contours and the test photos are also overlaid to verify the predicted damage region.

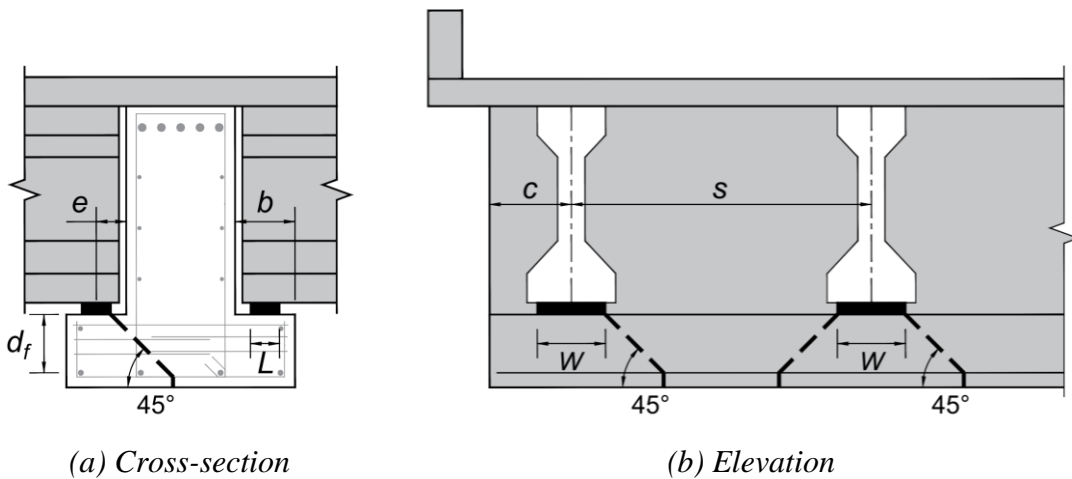
Figure 5-1. Punching Shear Failure Plane Assumed by AASHTO LRFD 2020.

It can be seen from Equations (5-1)-(5-3) that the nominal punching shear capacity of the ledge is determined based on the perimeter of the assumed failure plane which is a function of ledge depth, end distance, and size of bearing pad. The nature of these parameters enlightened a possible means to enhance the punching shear capacities of inverted-T bent cap ledges. The depth of ledge and end distance is the fixed geometry of the bent cap, whereas the pad size under the bridge girder can be more easily varied. The size effect of the bearing pad on the punching capacity of the ledges has also been shown by Nafadi et al, (2018).

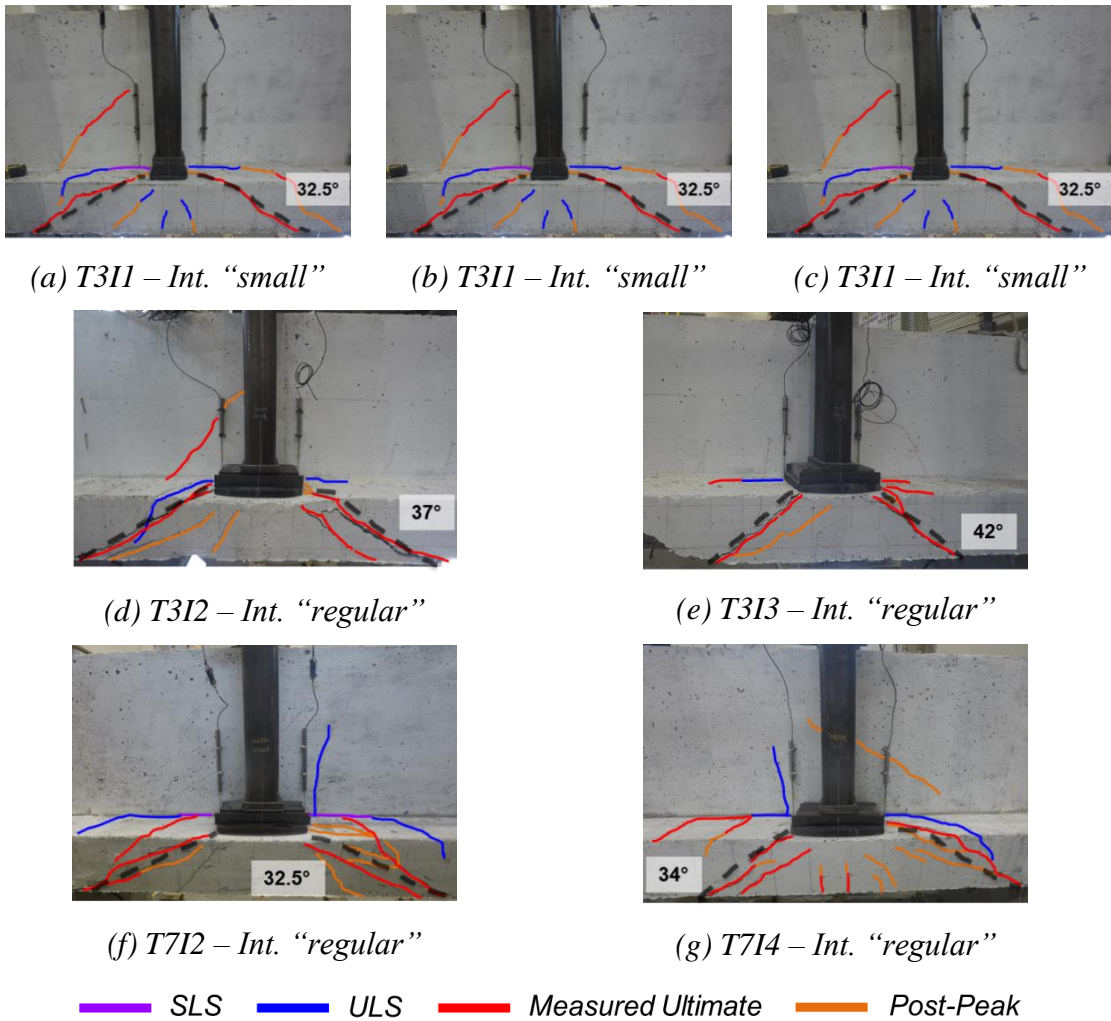
Figure 5-6. Interior Test Regions at Post-Failure.

the top of ledge. A shear crack on the web was also observed. The main cone crack start formed under the bearing pad at 100 kips (445 kN). The test region then reached the measured ultimate load of 113 kips (503 kN). The maximum width of the cone crack was 1.5 mm at the measured ultimate load and the average angle of the cone cracks was 32.5°.

Overall, a similar damage pattern, as shown in Figure 5-5 and Figure 5-6, was observed for all the tests regardless of the bearing pad size. The typical failure plane was formed initially by cracks developing at the web-ledge interface behind the bearing pad. For the exterior tests, a diagonal crack was also formed at the re-entrant corner on the end face. The interface cracks were diagonally extended on the top face of the ledge as the load increased. However, these cracks are likely ledge shear and flexure cracks, not a part of the punching shear cracks that caused the ledge failure. The main cone cracks which are evidence of punching failure were not visible at early loading stage. The cone cracks were formed shortly before the ultimate strength (triangle mark on Figure 5-7). For the exterior and interior tests, the cone cracks took place when the load increased to 97% and 91% of the measured ultimate load, respectively. The damage on the ledge increased significantly after the measured ultimate load. The cone cracks widened extensively and more cracks formed around the cone cracks.

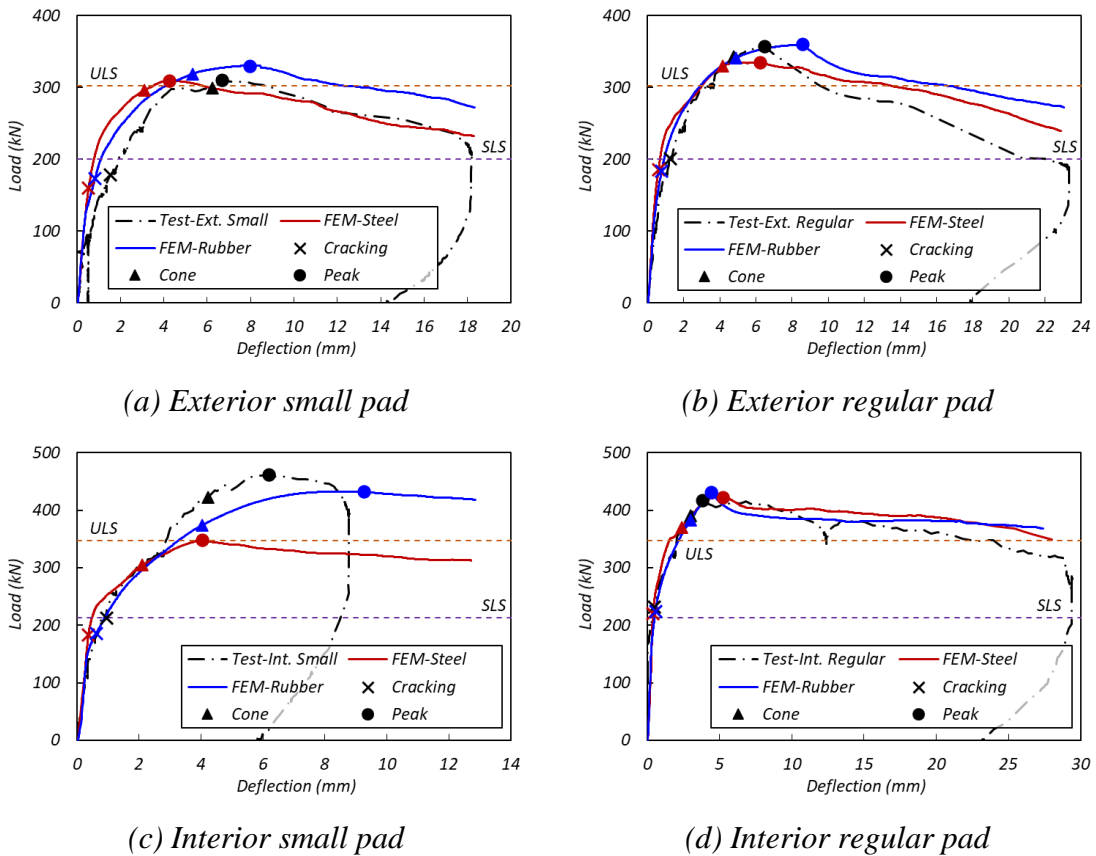
Figure 5-13. Load Deflection Response for Test on Specimen T3 – FEM vs. Test.

Figure 5-13 plots the predicted and measured load-deflection response of ledge under bearing pads. The load at initiation of cracking, formation of the cone crack, and the measured ultimate load was marked on the graphs. The cracking load was defined at the point when the tensile stress of the concrete element first reaches the cracking stress of concrete. The formation of the cone crack was identified when the stress at the compression strut under the bearing pad reaches the cracking stress of the concrete. Figure 5-14 compares the critical load values between the FEM and test results.

For the exterior “small” pad, the rubber pad model predicted a higher response than the measured test data at the post-peak stage though within an acceptable range.
