TURBOMACHINERY & PUMP SYMPOSIA | HOUSTON, TX  
**DECEMBER 14-16, 2021**  
SHORT COURSES: DECEMBER 13, 2021

## LASER WELDING FOR TURBOMACHINERY ROTOR RESTORATION

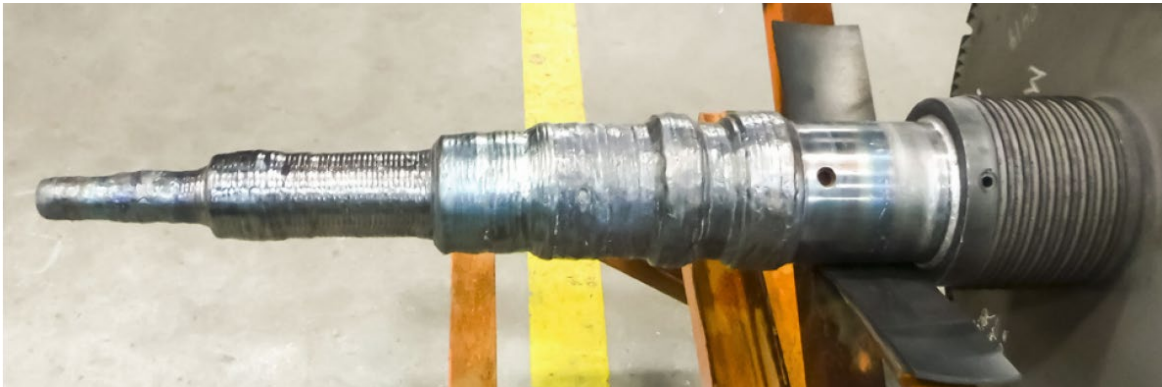
*Figure 1: An example of a SAW repair on a rotor. Note the large surface area requiring overlay, much of which was added to ensure the rotor would have enough machining stock to account for distortion induced by the repair process.*

Before the advent of laser beam welding (LBW), the most common process for shaft repair was submerged arc welding (SAW), mainly because the process is robust and offers a high deposition rate. However, this process involves high heat input, which can cause distortion of the shaft and high residual stress. Because of distortion, SAW repairs tend to require removal of all protruding features from the repair area, rebuilding of those features, and extensive overlaying to ensure sufficient machining stock to restore dimensions. Figure 1 shows an example of a SAW repaired rotor after welding. Also, because of the high residual stress from welding, repairs always require a post weld heat treatment (PWHT) before final machining, which relieves residual stresses that minimizes shaft movement (distortion) during the machining operation.

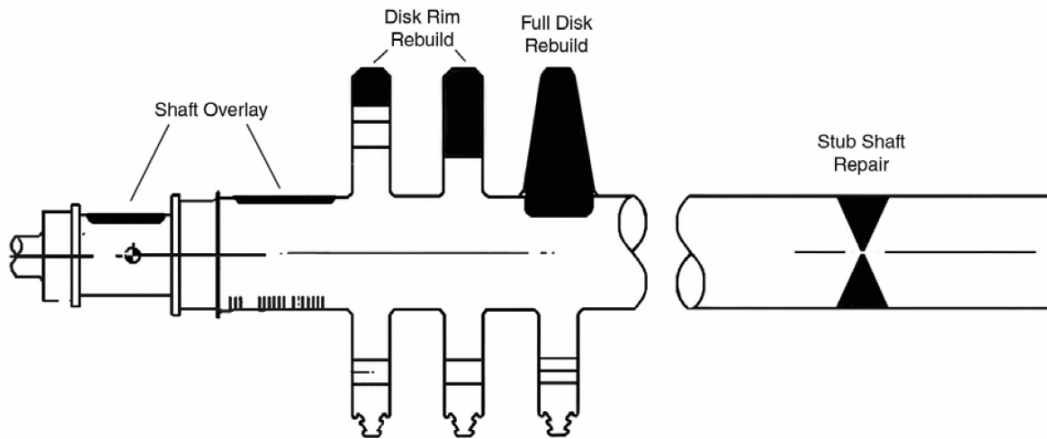
Figure 3: Examples of rotor repairs. The stub shaft repair is an example of a groove weld [10].

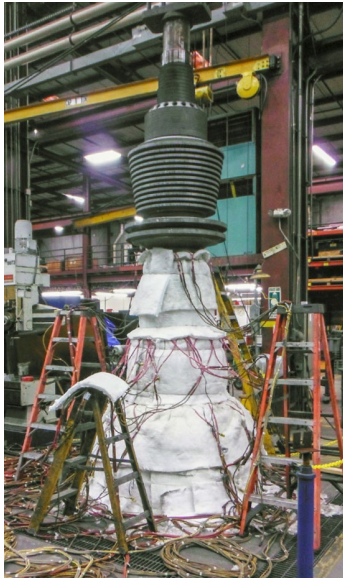
Figure 5: Example setup for a post weld heat treatment [10].

The PWHT is also a costly and time-consuming operation. Figure 5 shows the setup for a PWHT applied to a rotor. For this process, the shaft must be suspended vertically to minimize distortion. In other words, if the rotor were heat treated horizontally, the rotor would bow and sag between supports that would become permanent after the heat treatment. After suspending the shaft vertically, heating blankets and thermocouples are added which must provide intense, yet precise heat (generally over 1000 °F), and this heat must be evenly distributed. If heat is added non-uniformly, then stress will be relieved non-uniformly, which could result in detrimental distortion. Heating/cooling rates and hold times must be controlled and monitored carefully. Overall, the process is relatively complex and time-consuming, meaning it is also costly.

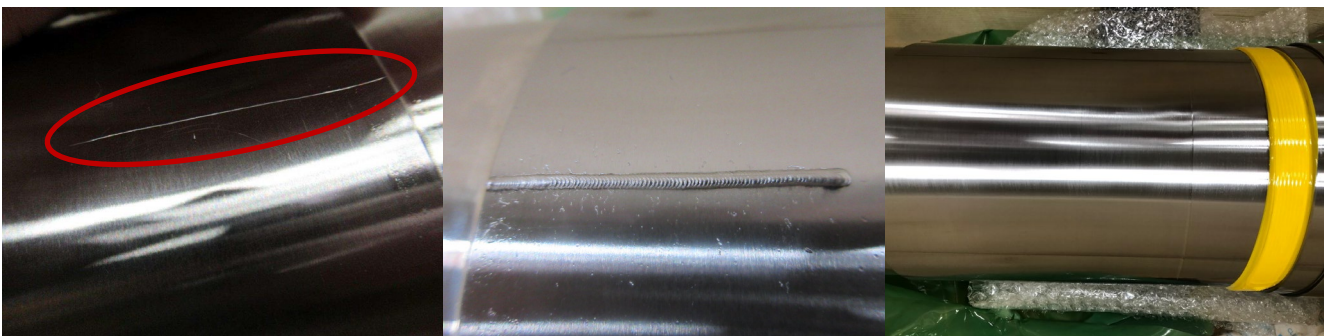
Figure 9: The scratch, which has been circled, in a journal area (left), the same scratch after LBW repair (middle), and the repaired area after final machining (right).

The second shaft was damaged by a box cutter while being unpackaged for assembly, shown in Figure 9. The scratch was approximately 0.003" deep and was repaired locally using a single weld bead, which can also be seen in Figure 9. After repair, the shaft was ground back to geometric specifications, inspected, and installed for service.

The scratch which was approximately 0.003” in depth would have rendered the shaft as scrap without a viable repair process. Traditional arc weld was eliminated as an option due to the fact that it would have required welding from the journal area through the coupling end of the shaft. Welding in the coupling area was not feasible in this case due to the strength requirements in that location. Instead, the laser welding process was utilized to perform a localized repair of the scratch, eliminating the need for welding in the coupling area while saving significant processing time. Final grind of the repair area did not require additional stock removal beyond the original drawing tolerance.
