# 49<sup>TH</sup> TURBOMACHINERY & 36<sup>TH</sup> PUMP SYMPOSIA

## Overcoming Failure of Synchronous Motor Driven Compressor Train by Application of Controlled Slip Clutch

Akira Adachi (Toyo Engineering Corporation)

Sho Oba (Kobe Steel Ltd.)

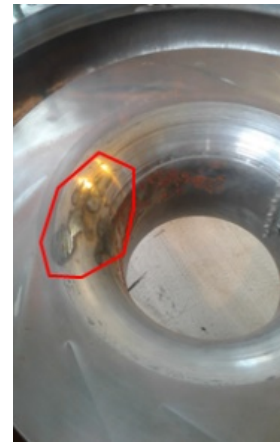
damaged 2<sup>nd</sup>  
stage casing

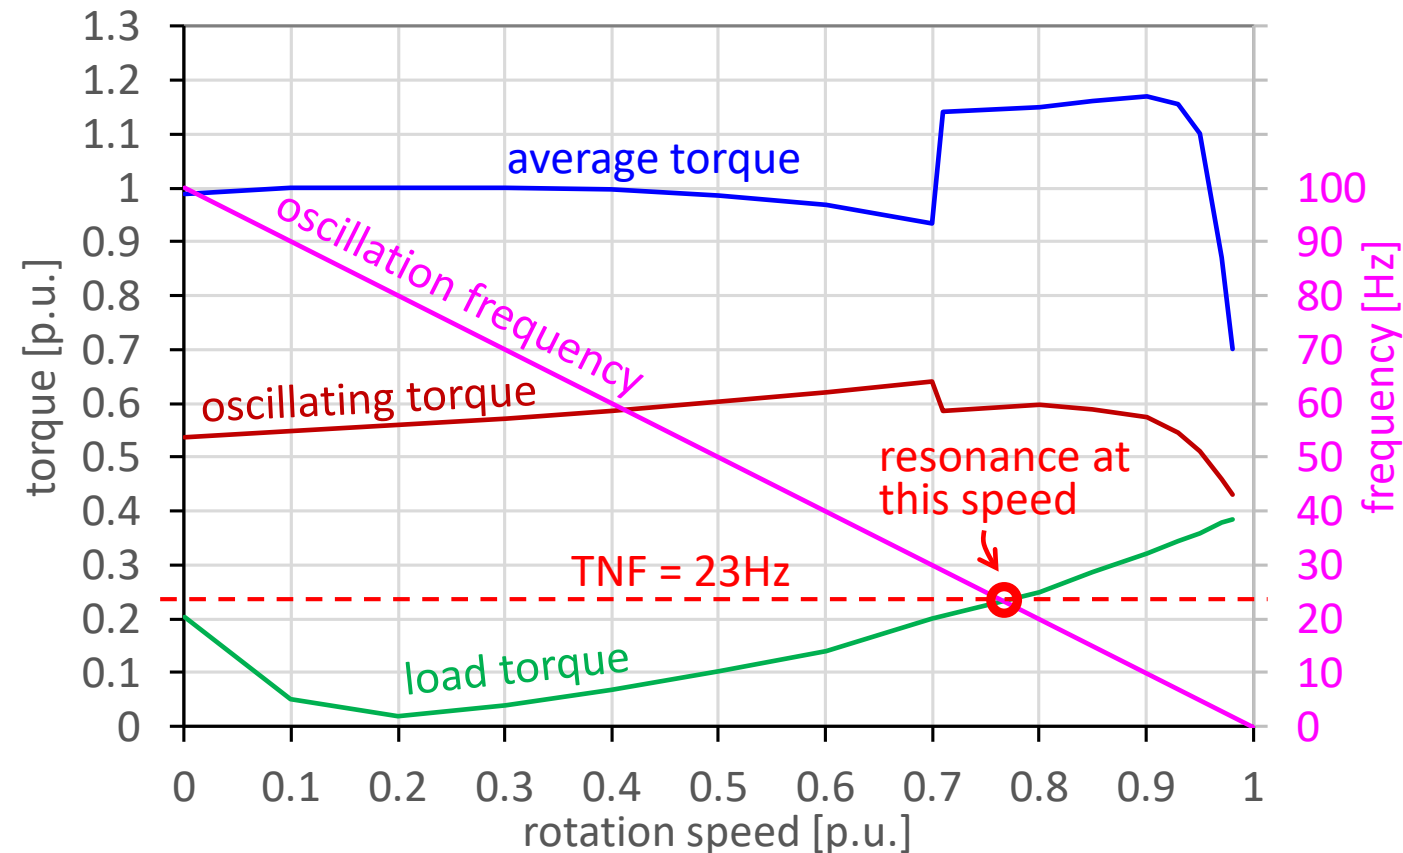
- Generated torque oscillation frequency =  $2 \times \text{slip} \times \text{line frequency}$  =  $2 \times \text{slip frequency}$   
→ Oscillating torque frequency varies from 100 Hz (at standstill) to 0 Hz (at synchronous speed) during startup
- At some point during motor acceleration, oscillating torque frequency coincides with the torsional natural frequency (TNF) of the train (= 23 Hz in this case) → Torsional resonance is inevitable during startup (at rotation speed of 0.77 p.u. = 1155 rpm in this train)

Motor startup torque characteristics

Note: In this application, 1 p.u. (torque) = 47.75 kN-m,  
1 p.u. (speed) = 1500 rpm

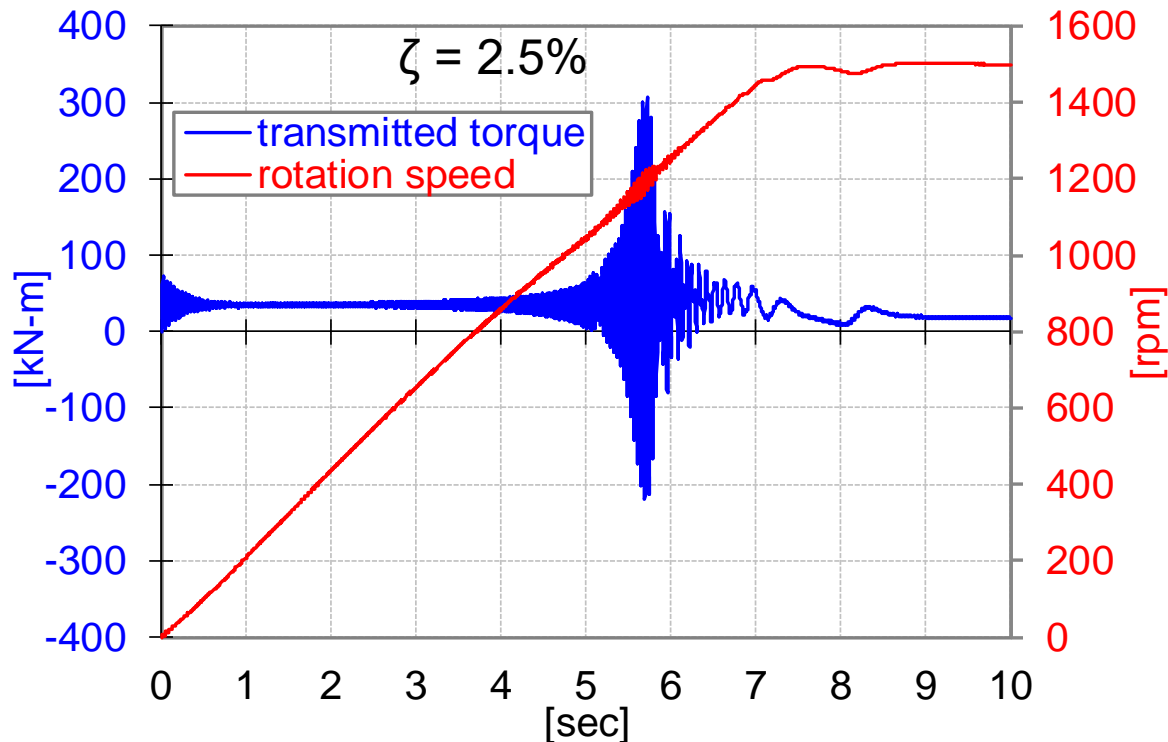
- Measured peak torque by strain gauge at the coupling spacer (388 kN-m = 8.1 p.u.) was significantly larger than the prediction by torsional analysis (300 kN-m = 6.3 p.u.)

Original analysis with  $\zeta = 2.5\%$

- Original torsional analysis was based on the assumed damping ratio ( $\zeta$ ) of 2.5%
- Actual damping ratio was found to be 1.5% by field measurement during shutdown
- Damping ratio of 2.5% was too optimistic (With damping ratio of 1.5%, torsional analysis better matched the field measurement)

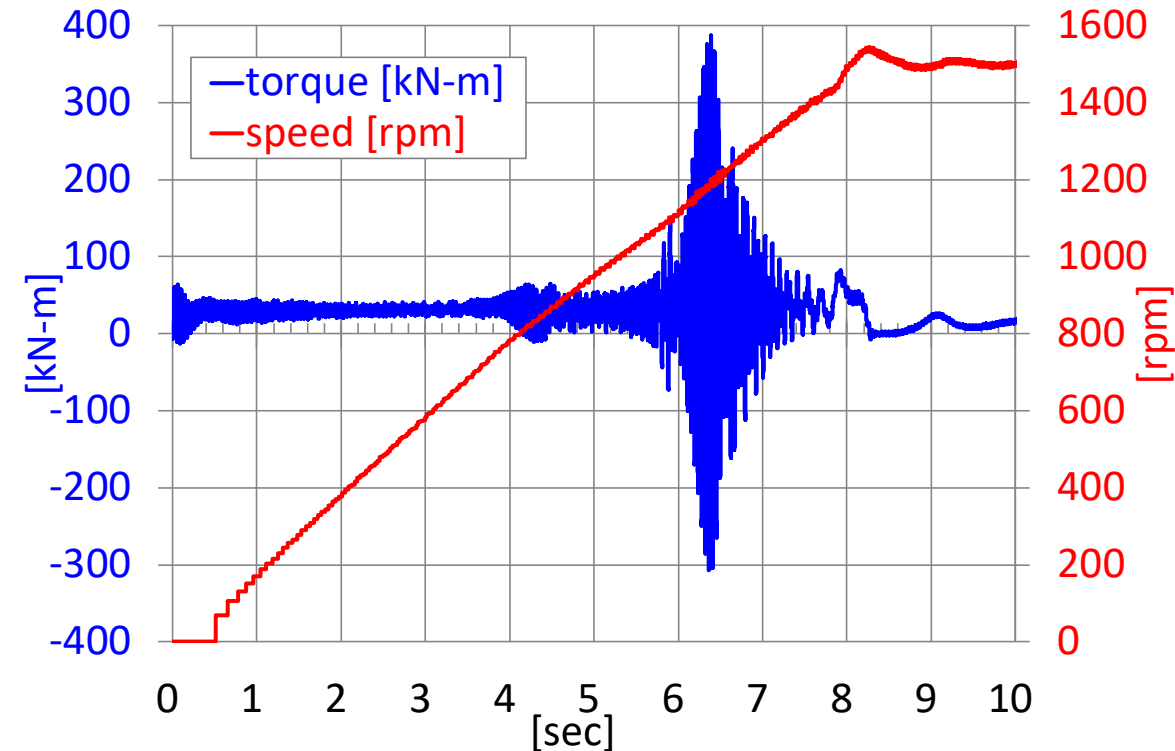
Field measurement

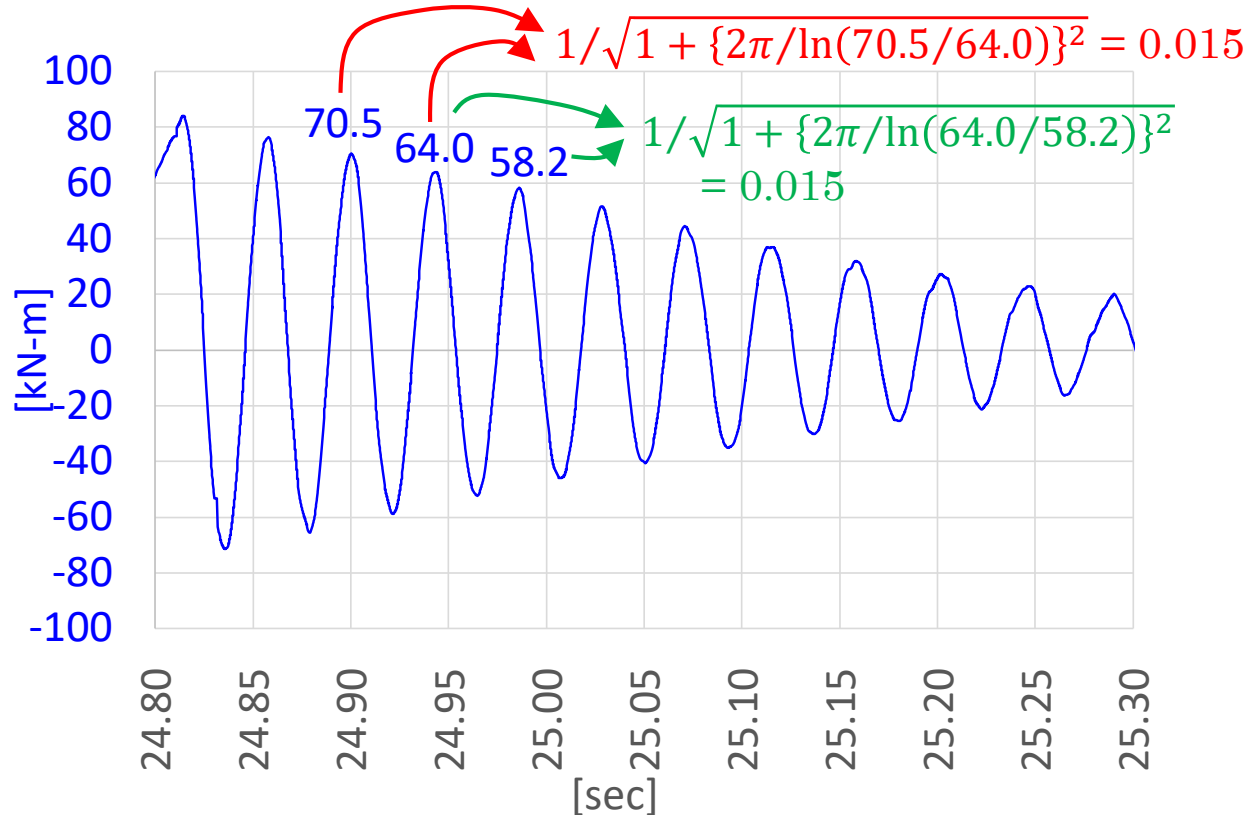
Field measurement during shutdown

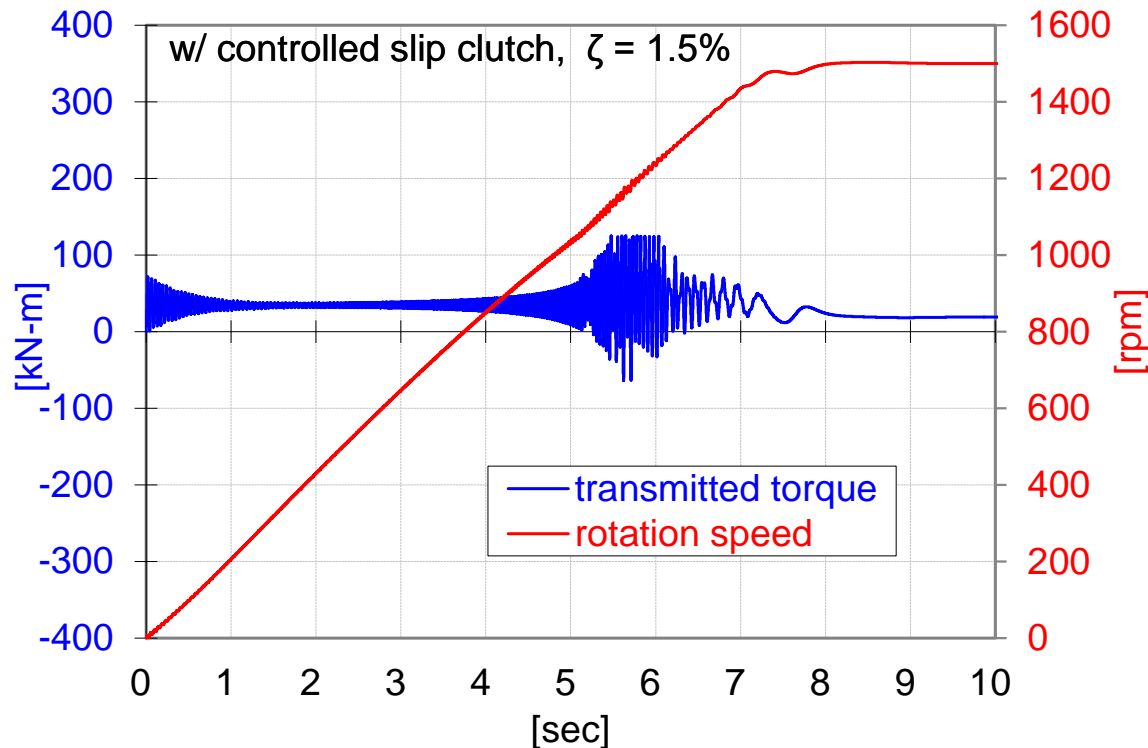
- Prediction by a detailed torsional analysis (125 kN-m = 2.6 p.u.) was promising
  - Field strain gauge measurements after the clutch installation (131 kN-m = 2.7 p.u.) verified its effectiveness (peak torque with less than 10% error from the target figure was achieved)
- After these confirmations, controlled slip clutch was adopted as the permanent countermeasure

Analysis reflecting clutch

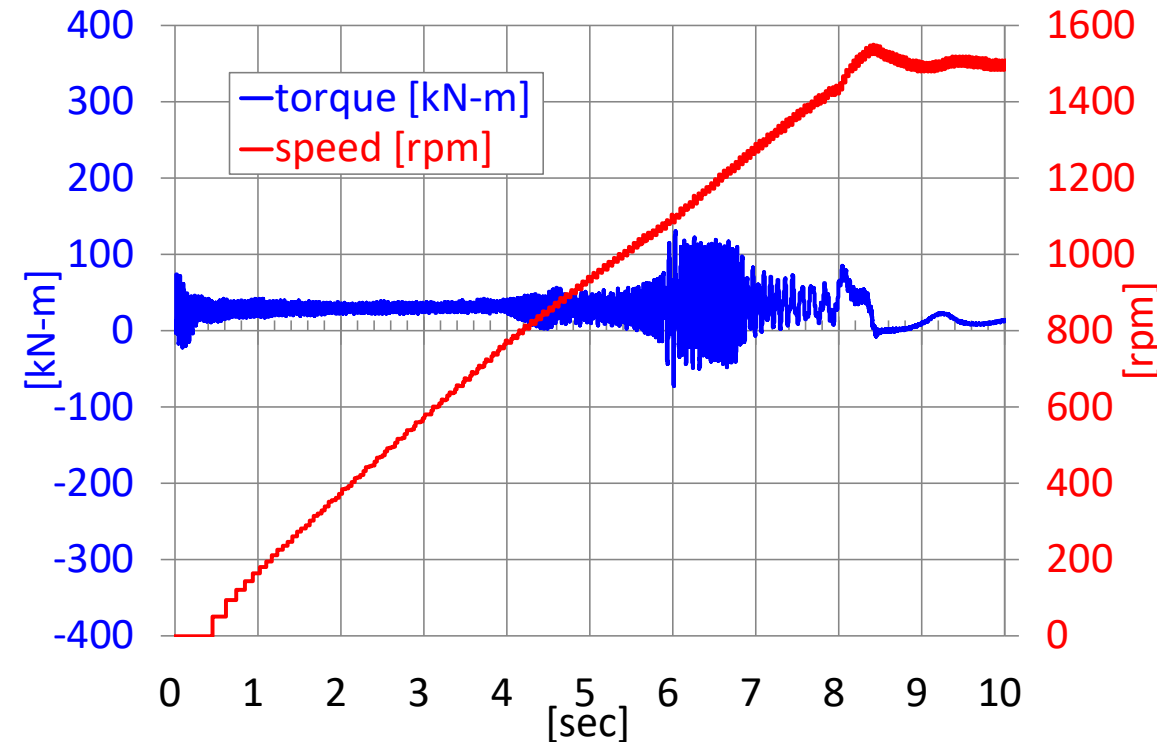
Field measurement with clutch

- After installation of this clutch, no malfunction or abnormality has been observed in the compressor train
- The compressor train has been stably and reliably operating while having experienced a number of startups
- Controlled slip clutch is confirmed as a reliable and viable option to counteract the problems associated with excessive peak torque during synchronous motor's startup
- Controlled slip clutch is a very attractive countermeasure option especially for field troubleshooting purposes, because only the driver side coupling hub needs to be modified without affecting anything else in the train while providing sufficient and reliable peak torque suppression effects

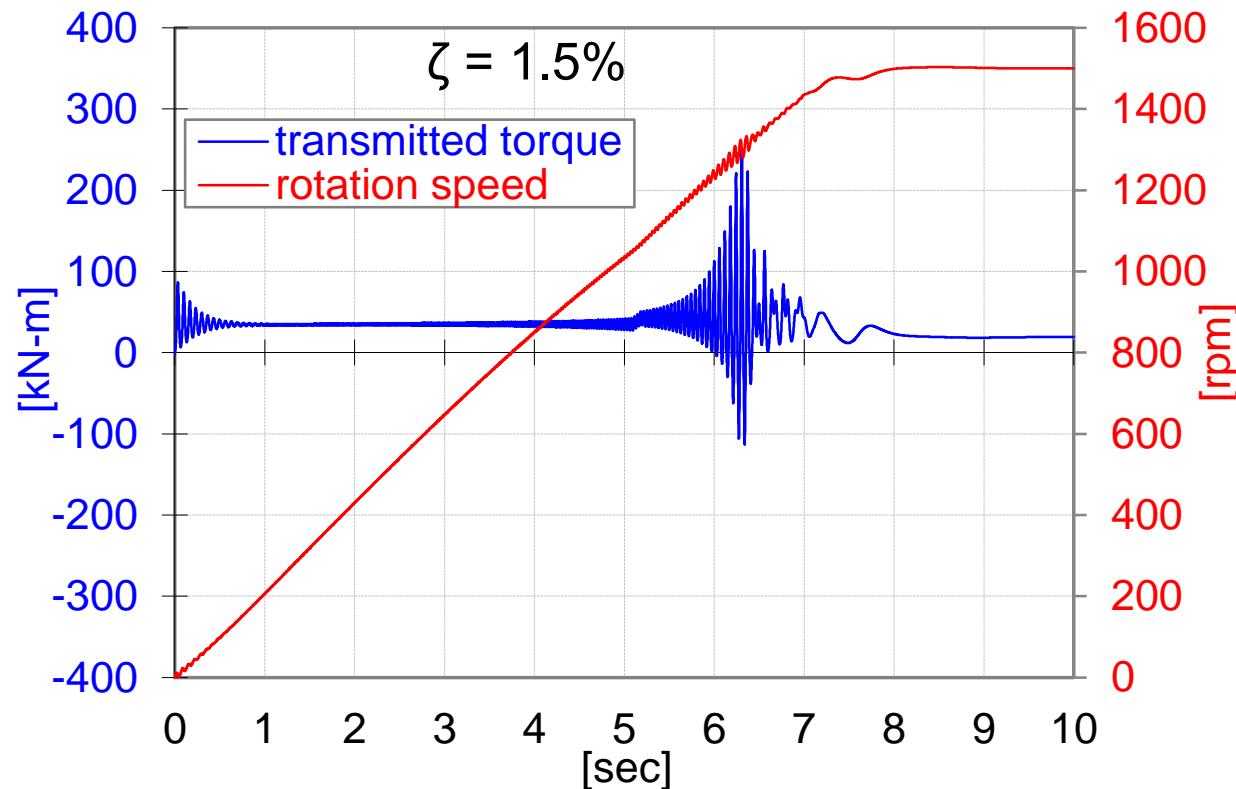
- Rubber block coupling (rubber-in-compression coupling) reduces the peak torque due to variable stiffness and additional damping by rubber blocks
- Expected peak torque = 251 kN-m (5.3 p.u.)

Analysis reflecting rubber block coupling

Note:  $\zeta = 1.5\%$  if not accounting for the additional damping and variable stiffness due to rubber blocks (This transient analysis actually reflects the additional damping (and also variable stiffness) by rubber blocks, whose stiffness and damping values are nonlinear based on angular deflection. As such, in this transient analysis,  $\zeta$  is actually variable and bigger than 1.5%)

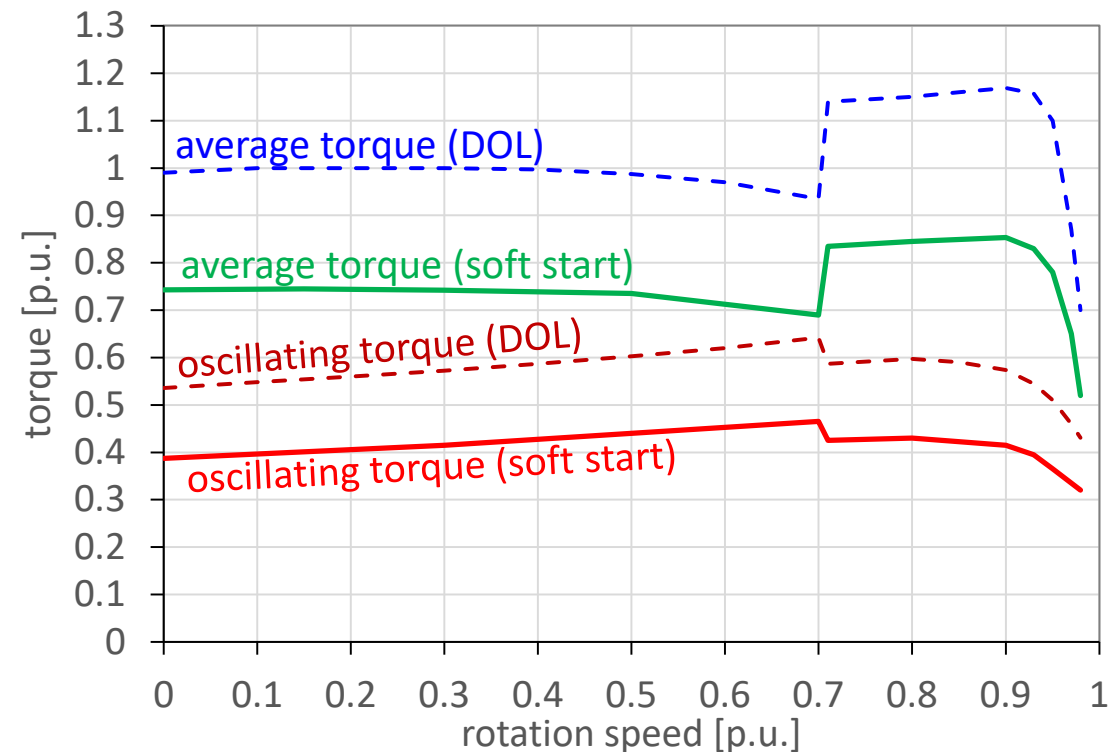
- Reduced voltage soft starter (step down transformer) (Note: this is different from VSD) lowers the oscillating torque magnitude, hence reduces the peak torque
- Expected peak torque = 300 kN-m (6.3 p.u.)
- Acceleration is slower because of lower average torque

Motor output torque curve (DOL and soft start)

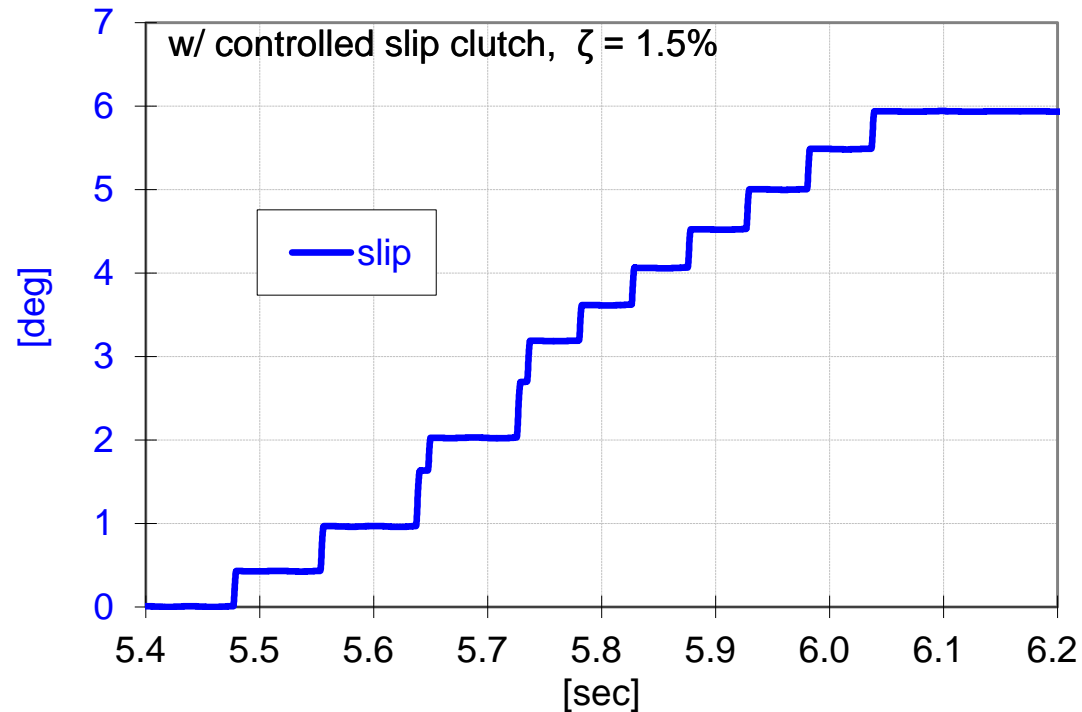
- Expected cumulative slip per each startup was around 6 deg according to torsional analysis
- Actual cumulative slip by field observation was confirmed to be in line with the prediction
- Since the clutch can accommodate at least 90 deg of cumulative slip per each startup without activating automatic torque release, observed level of cumulative slip is sufficiently below threshold

Slip prediction by torsional analysis

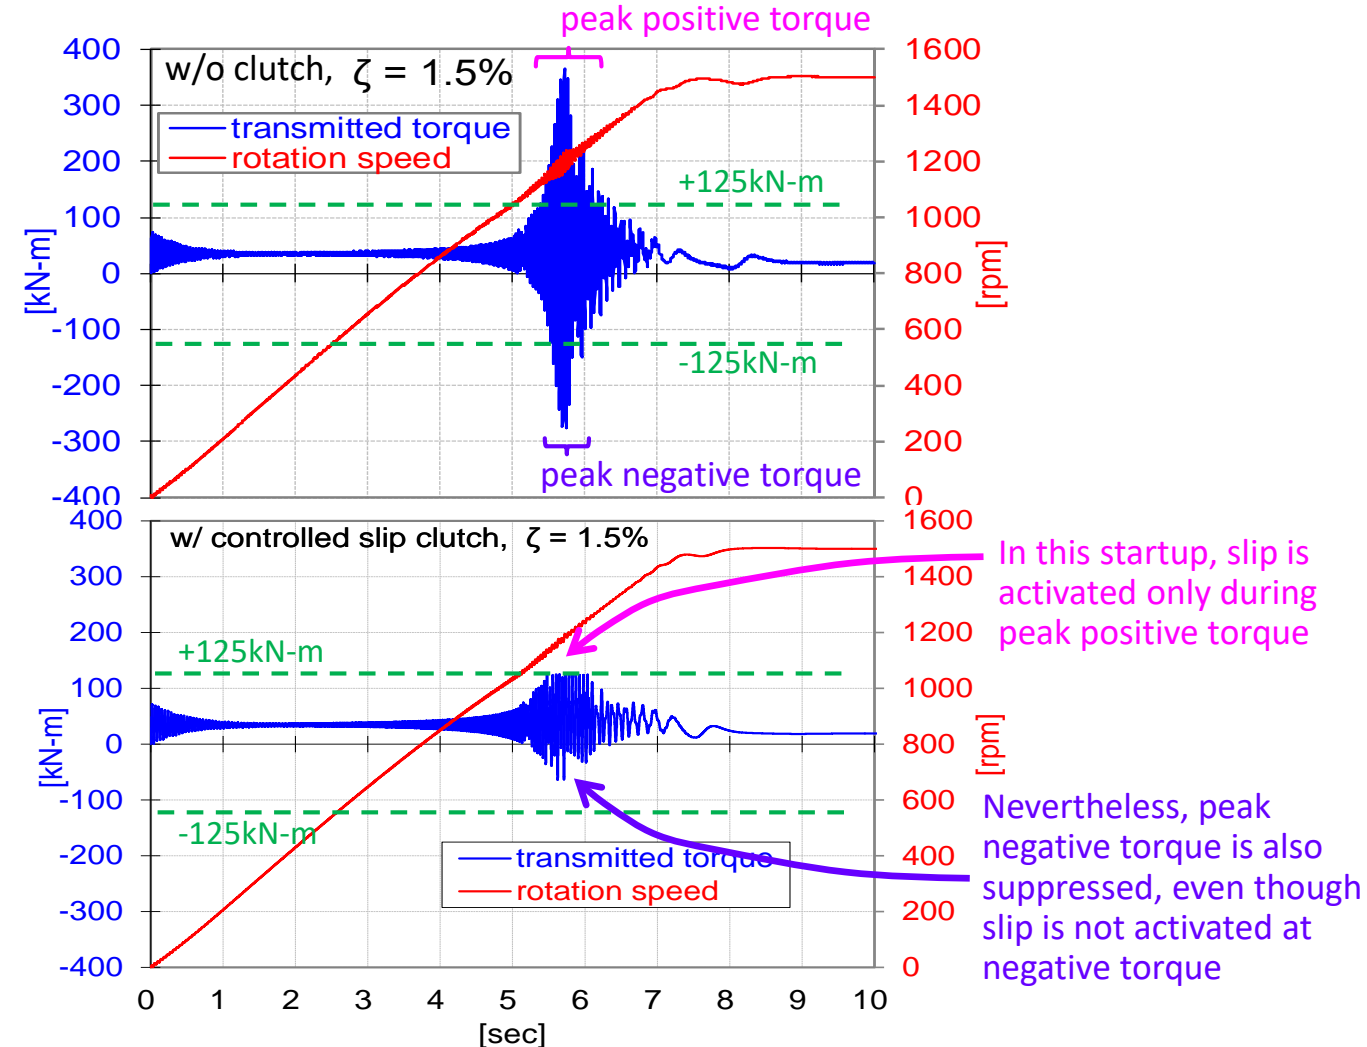
- Due to slip during peak positive (+) torque, peak negative (-) torque is also suppressed
- This is because resonance condition is detuned during slippage

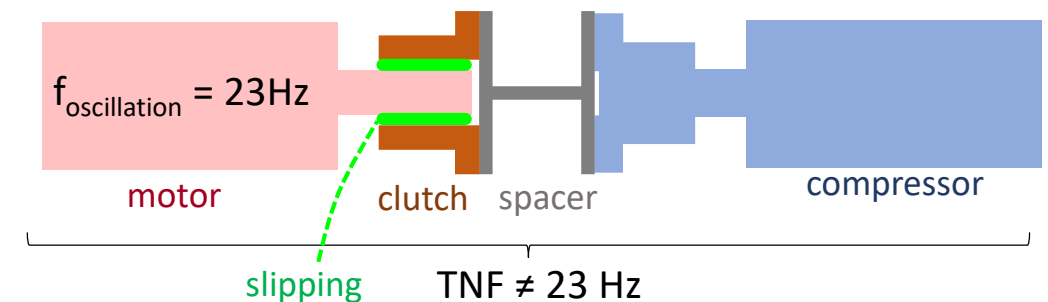
At the moment when clutch is *slipping*, TNF  $\neq$  23 Hz

→ Resonance with  $f_{\text{oscillation}} = 23\text{Hz}$  (@ 1155 rpm) is detuned
