TURBOMACHINERY & PUMP SYMPOSIA | VIRTUAL  
**DECEMBER 8-10, 2020**  
SHORT COURSES: DECEMBER 7, 2020

### High-Strength Material for Hydrogen Service, and Experimental Investigation

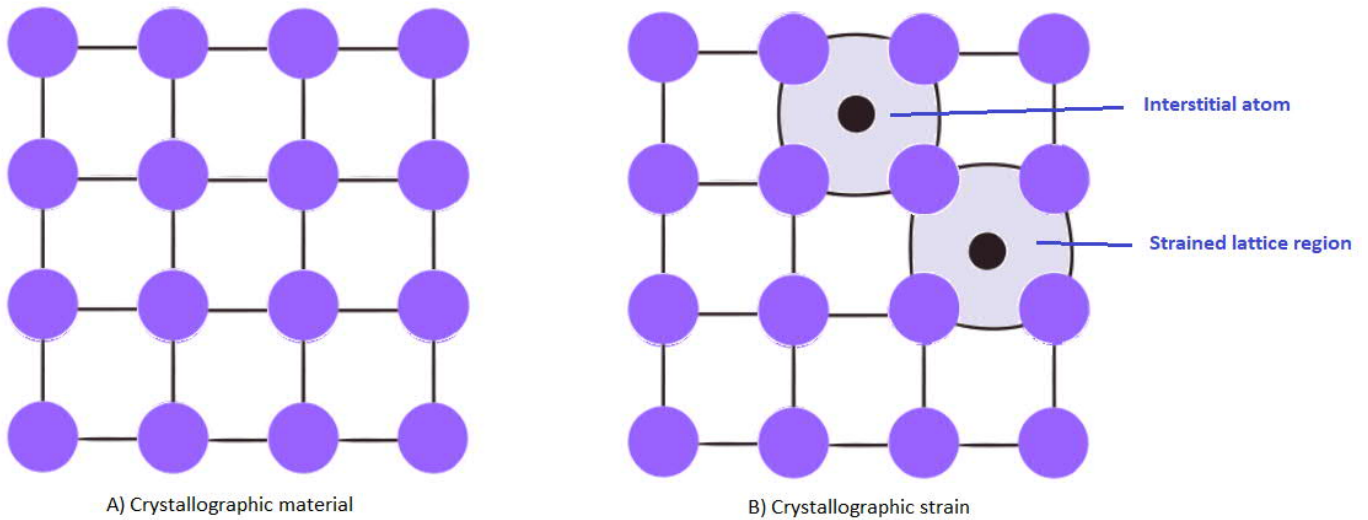
Figure 1. Figure 1A (left) depicts a crystallographic material in which metal atoms position themselves in a repetitive three-dimensional pattern in which each atom is bonded to its nearest neighboring atom. Figure 1B (right) depicts a crystallographic strain in which strain is caused when an interstitial atom is crowded into the metallic crystalline lattice, which introduces distortions and strain in the surrounding lattice.

As a hydrogen atom enters the metallic lattice structure of a component, the lattice structure is placed under strain (Figure 1). The strain caused by the hydrogen atom reduces the bonding forces between the metallic atoms (i.e. embrittlement). Hydrogen first absorbs in either its atomic form (H) or as molecular hydrogen (H<sub>2</sub>). Hydrogen molecules cannot enter a metal lattice themselves but must first be split into their representative atoms through a catalytic process (e.g., plastic deformation during plate rolling manufacturing, acid pickling, plasma welding, or cathodic protection, among others). In the case of a compression service, this would require a chemical reaction, where hydrogen is cathodically evolved on the surface of a metal part.

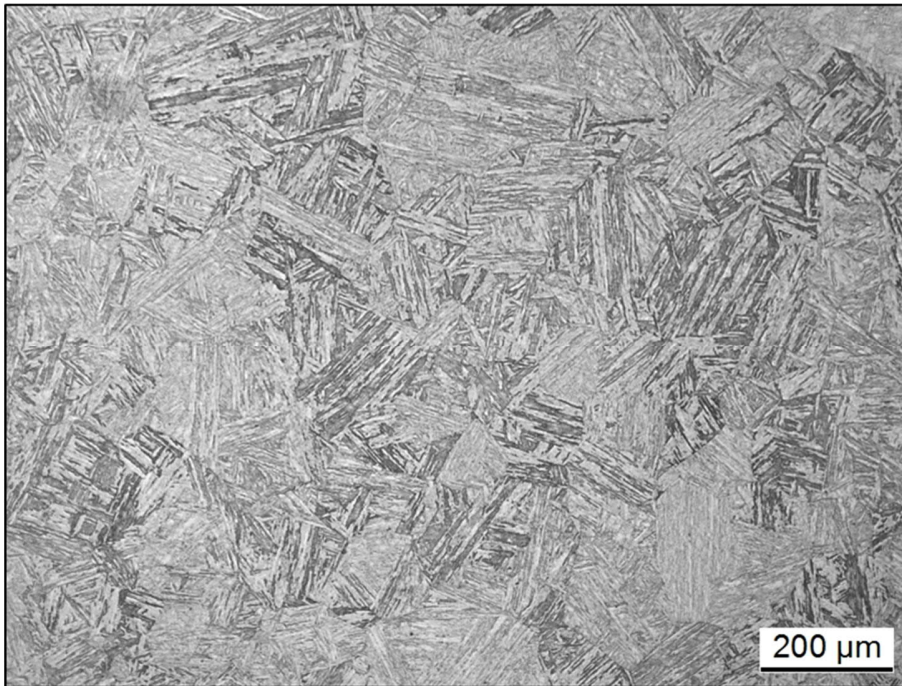
Figure 3. Microstructure of the testing material for F6NM. The microstructure is tempered martensite.

Three different materials were selected for testing and provided by two separate suppliers. The three materials have increasing chemical resistance to SSC due to their chemical composition per Table 1. The first material, ASTM A 182 Gr. F6NM (X3CrNiMo13-4, DIN 1.4313), commercially known as F6NM, is a martensitic stainless steel (Figure 3) with 13 percent chromium and 4 percent nickel that has a Body-Centered Cubic (BCC) lattice structure (Figure 6). Its corrosion resistance is similar to UNS S41000, commonly known as 410 stainless steel, but the addition of nickel and molybdenum improves its resistance to general corrosion and chloride attack.

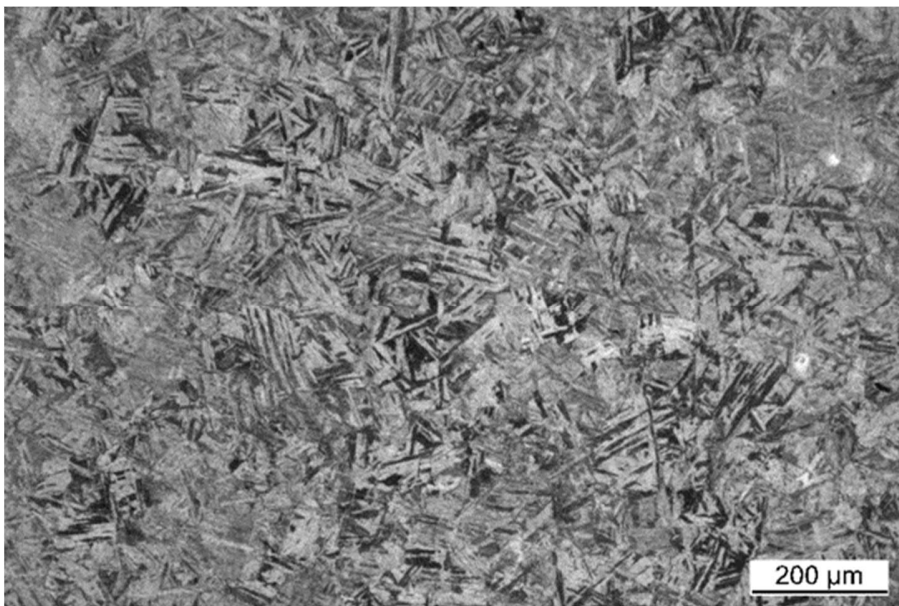
Figure 4. Microstructure of the testing material for 15-5. The microstructure is tempered martensite.

The second material was ASTM A 705, Type XM-12 (X5CrNiCuNb15-5, DIN 1.4545), commercially known as 15-5. This is a Precipitation Hardening (PH) stainless steel (Figure 4) with 15 percent chromium and 5 percent nickel with a BCC lattice structure. In most environments, the corrosion resistance of 15-5 PH stainless steel is between that of 300 series and 400 series stainless steels, while in many chemical applications it favors the more resistant 300 series corrosion characteristics. 15-5 is very similar to ASTM A 705, Type 630 (X5CrNiCuNb16-4), commercially known as 17-4, with minor differences in chromium and nickel. Both grades are considered equivalent per NACE MR0175 (ISO 15156).

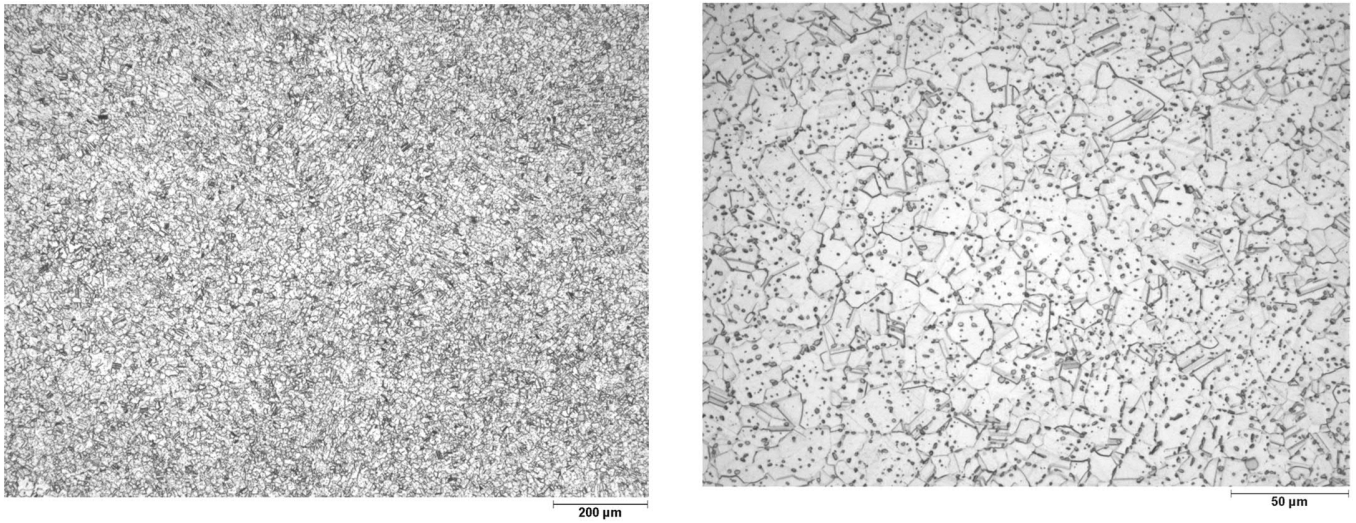
Figure 5. Microstructure of the testing material for Alloy 718 taken at 100X and 500X magnification. The material is a fine grain austenitic microstructure with  $\delta$  phase distribution and MC carbides.

The third material was industry standard AMS 5663 (DIN 2.4668), commonly known as 718. This is a precipitation hardening nickel-base alloy that has an austenitic microstructure (Figure 5) and a Face-Centered Cubic (FCC) lattice structure (Figure 6). The alloy is highly resistant to SCC and pitting in environments that contain chlorides and hydrogen sulfide.

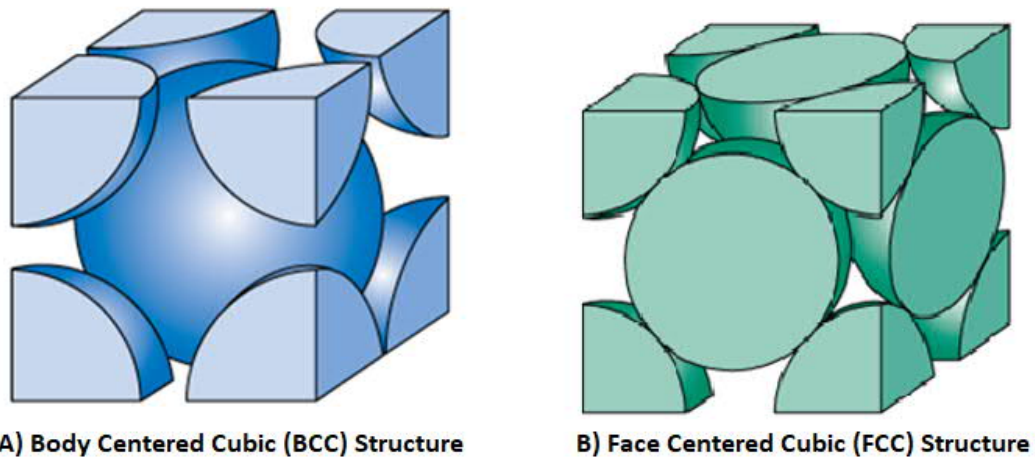
Figure 6. Graphical representation of crystal lattice structures. Images courtesy e-Education Institute by Penn State University

Figure 6A depicts a Body-Centered Cubic (BCC) structure with a total of nine lattice points—eight lattice points at the corners plus one lattice point in the center. Figure 6B depicts a Face-Centered Cubic (FCC) structures with a total of 14 lattice points—eight lattice points at the corners plus six lattice points, one for each face.

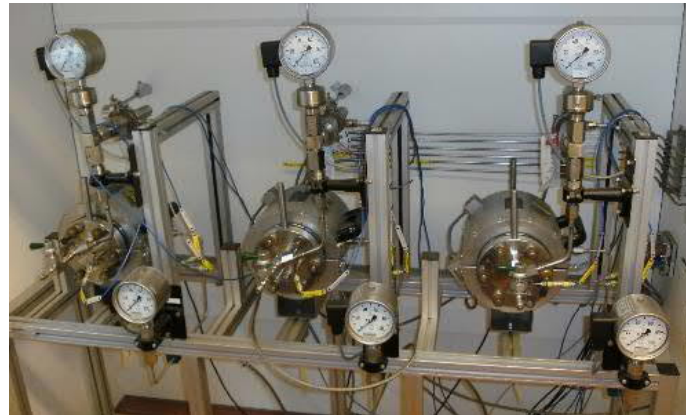
Figure 7. Heated test pressure vessels (autoclaves)

To investigate the influence of hydrogen on the susceptibility to HIC, tests were carried out under a compressed hydrogen atmosphere in heated test pressure vessels (Figure 7). These vessels are designed for pressures up to 1450 psi (100 bar) and temperatures up to 392°F (200°C). The first series of tests were conducted at a hydrogen pressure of 145 psi (10 bar), which is above the 100 psi (6.9 bar) limit per API 617 eighth edition.

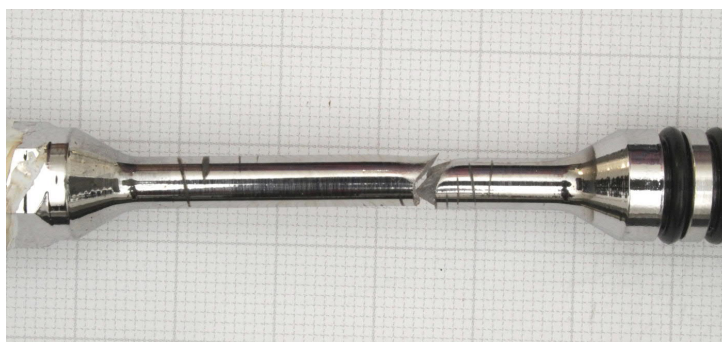
Figure 8. Overview of the F6NM test specimen.

The failed F6NM specimen is shown in Figure 8. There was no visible necking or orange peel effect as would be seen on an overload failure. The surface has a matt finish. The fractography examination revealed features typical of a hydrogen induced failure (Figures 9 - 12) that are smooth grain facets and cracks at the grain boundaries. Based on these results, one can conclude that the specimen failed due to hydrogen induced embrittlement.

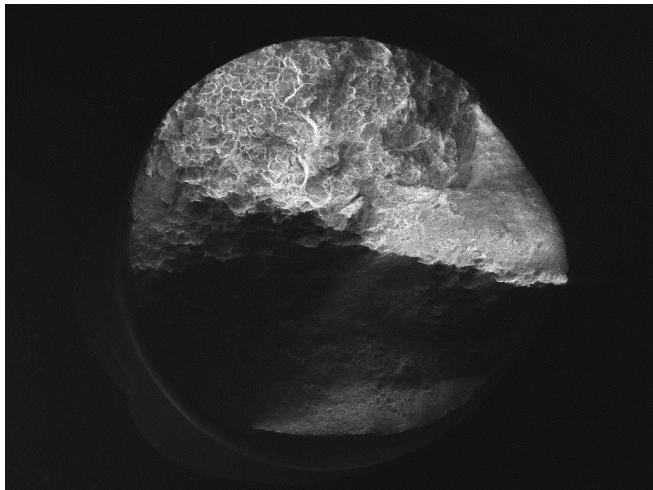
Figure 9. Fracture surface of broken F6NM specimen.

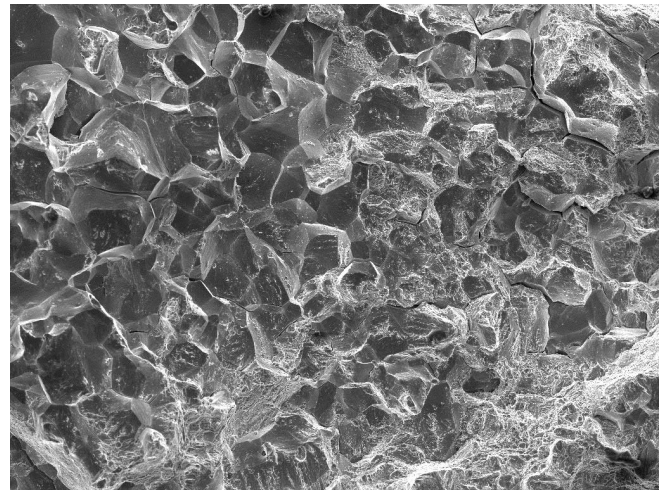
Figure 10. Transition zone: Fracture surface with inter crystalline cracking and forced fracture.

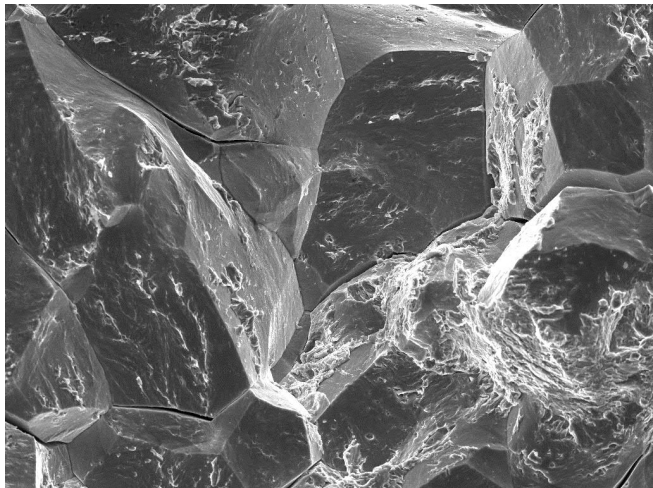
Figure 11. Intergranular cracking along the grain boundaries.

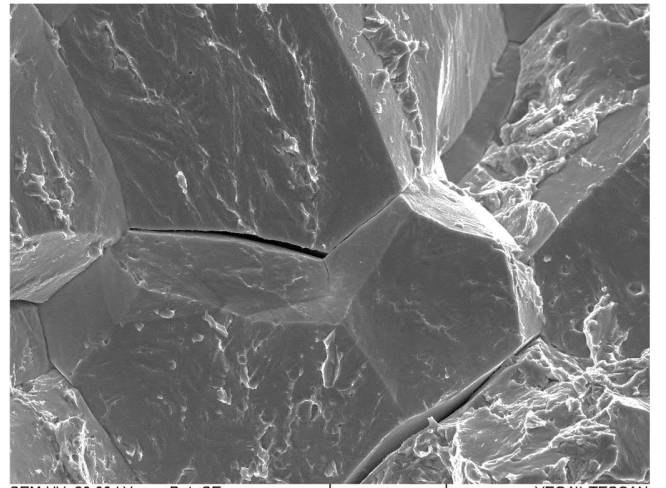
Figure 12. Higher magnification of Figure 11 with grain facets and opened grain boundaries.

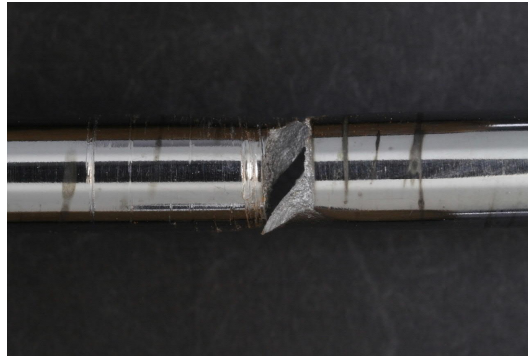
Figure 13. Detailed view of the 15-5 specimen.

The investigation of one broken 15-5 specimen is shown in Figures 13 - 15. The specimen has a flat undeformed fracture surface which changes over to a shear lip. Figure 13 displays the transition zone of the fracture where the embrittlement fracture type changed to a ductile forced fracture. In the detailed view, a typical intercrystalline fracture surface caused by hydrogen induced embrittlement with opened grain boundaries and visible grain facets can be observed. These results suggest that the specimens failed due to hydrogen induced embrittlement.

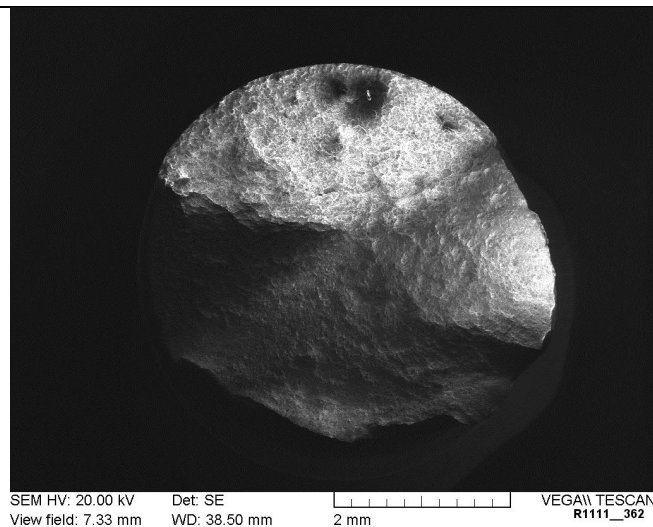
Figure 14. General view on the fracture surface.

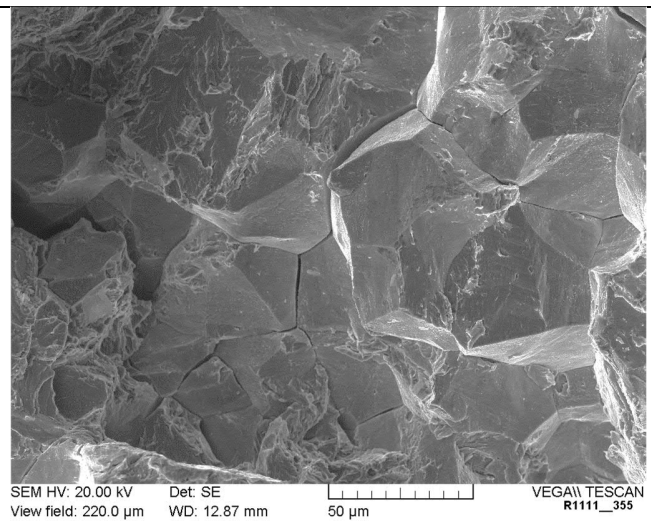
Figure 15. Inter crystalline fracture with grain facets and cracked grain boundaries.
