# Xno'ha Digital Survey 2017

## Xno'ha Digital Survey 2017

### Abstract

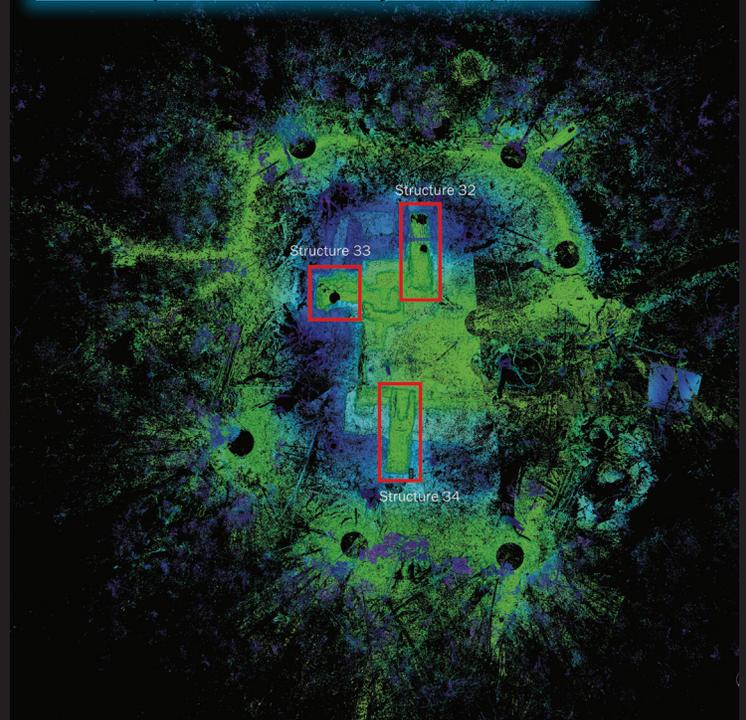
Site Plan | Structure 32 Courtyard Group, Xno'ha

Our focus was on the documentation of the excavation process at Structures 32, 33, and 34. Our aim in conducting documentation of the excavation process was to create a 3D archive of in situ data, which would help understand artifacts in their spatial and temporal context. This site had three primary operations during the field season: (1) the excavation of Chultun 01 under Structure 33, (2) the excavation trench perpendicular to the apparent major axis of Structure 34, and (3) the 3D modeling and partial excavation of a collapsed chamber in Chultun 02 in Structure 32.

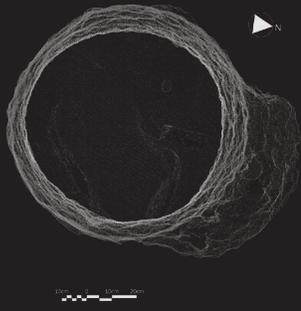
Layer 9

During the excavations of Chultun 01 and Structure 34, photogrammetric data (pictures captured for photogrammetric processing) was collected at regular intervals. Intervals at Chultun 01 were every 10-20 centimeters (depending on the stage of the excavation), while intervals at Structure 34 were determined by architectural features (these features, in turn, determined the lot designation). In the cases of Chultun 01 and Chultun 02, images were captured using a Canon Rebel Ti3, with manual settings, fixed lens length, and often with flash (no flash was used at Structure 34's trench, while all other above parameters were the same). Image capture followed a cyclical path, that is, camera position circled the feature area and (especially in the case of Chultun 01) spiraled down into the feature.
