**24-26 MAY 2022**  
**SHORT COURSES: 23 MAY 2022**  
**KUALA LUMPUR, MALAYSIA**

**TURNING GEAR MOTOR FAILURES, CONFIRMED BY MODEL BASED VOLTAGE & CURRENT METHOD**  
(Technical Brief)

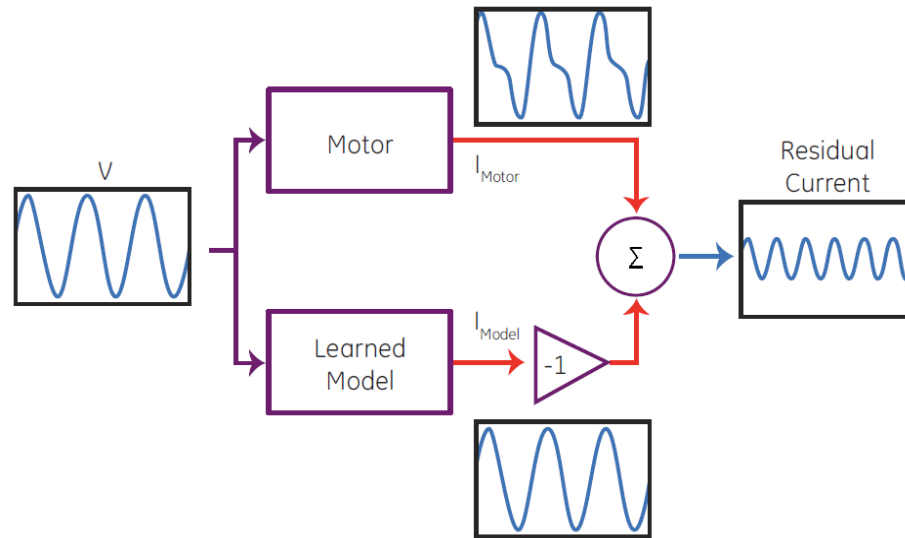
MBVI Systems are able to separate out the impact of distortions coming from the voltage supply, by making a mathematical model of the relationship between current and voltage and using this to identify those components that are coming from the internal behavior of the system. The approach used is represented in Figure 1.

**Figure 1: Model Based Motor Anomaly Detection (Courtesy of Bently Nevada)**

Bently Nevada (2012), Model Based Motor Anomaly Detection Monitor uses MBVI, a combination of voltage and current dynamic waveforms, together with learned models for motor anomaly detection. Motor fault detection is based on a learned, physics-based motor model, where constants in the model are calculated from real-time data. Automated diagnostics (Expert System) is based on the Power Spectral Density (PSD) amplitudes in particular frequency bands, in relation to learned values and alarm thresholds. The spectrum-based fault detection in MBVI Monitor is similar to MCSA, but with several important differences. The MBVI Monitor takes the input voltage waveform and passes it through the model transfer function to obtain a theoretical current waveform. The theoretical current waveform is subtracted from the measured current waveform to produce a residual current waveform (Figure 1). The residual waveform contains the “errors” between theory and reality. The Fast Fourier Transform (FFT) is applied on residual waveform to obtain residual PSD Spectrum.

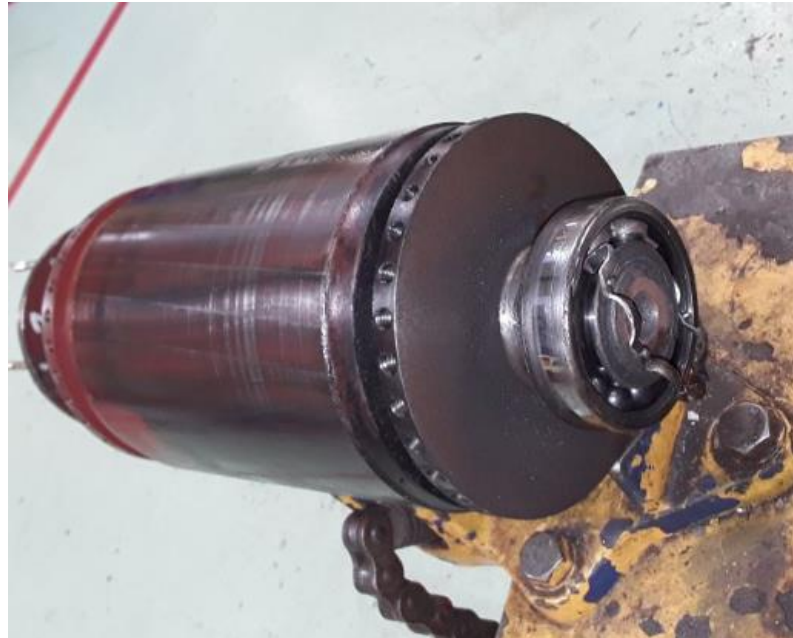
After the motor dismantling and inspection, the motor NDE bearing was found collapsed, caused a mechanical rotor rub (Figure 5). The bearing rubber seal was discovered to be damaged when changing over units. There were the signs of oil in the motor stator windings and endshields found (Figure 6).

- TGM NDE bearing got dry, possibly due to being contaminated by the oil from turning gear assembly, after bearing seal damage.
- The bearing rubber seal was discovered damaged. The seal on the NDE side was found hardened, possibly due to high temperature and this allowed oil into the motor stator windings.
- The bearing rubber seal when replaced must be the correct type, capable of withstanding the oil category.

**Figure 5: Turning Gear Motor as found damaged on May 24, 2020; NDE bearing was found collapsed**

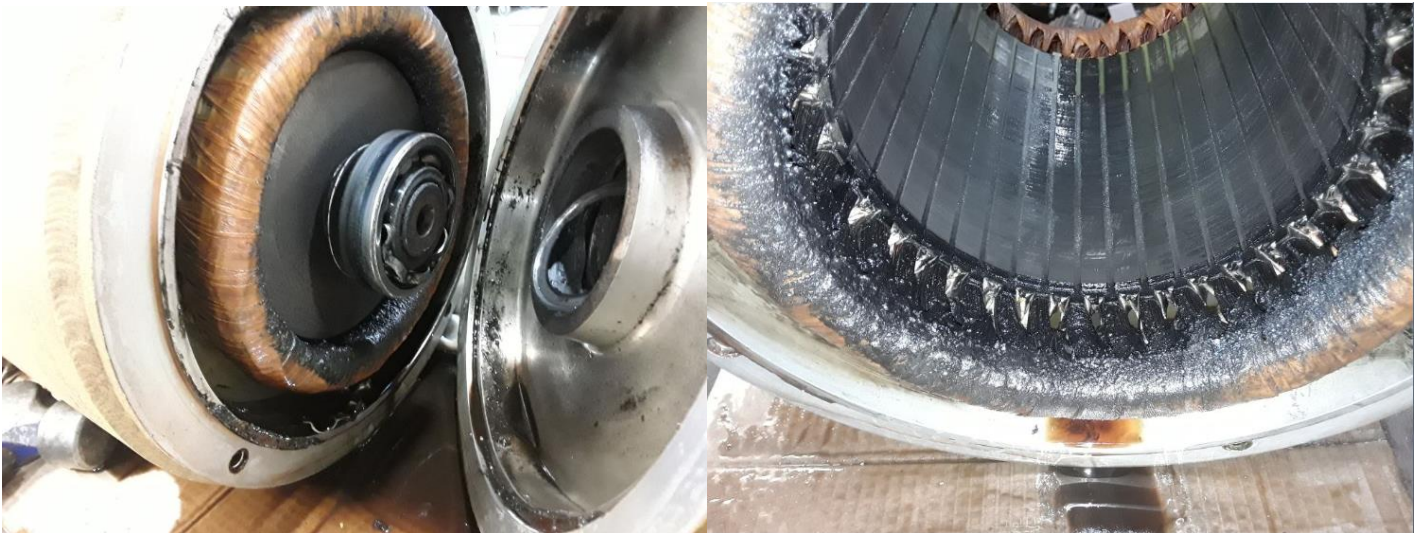
**Figure 6: Turning Gear Motor as found damaged on May 24, 2020; The signs of oil in the stator windings and endshields.**

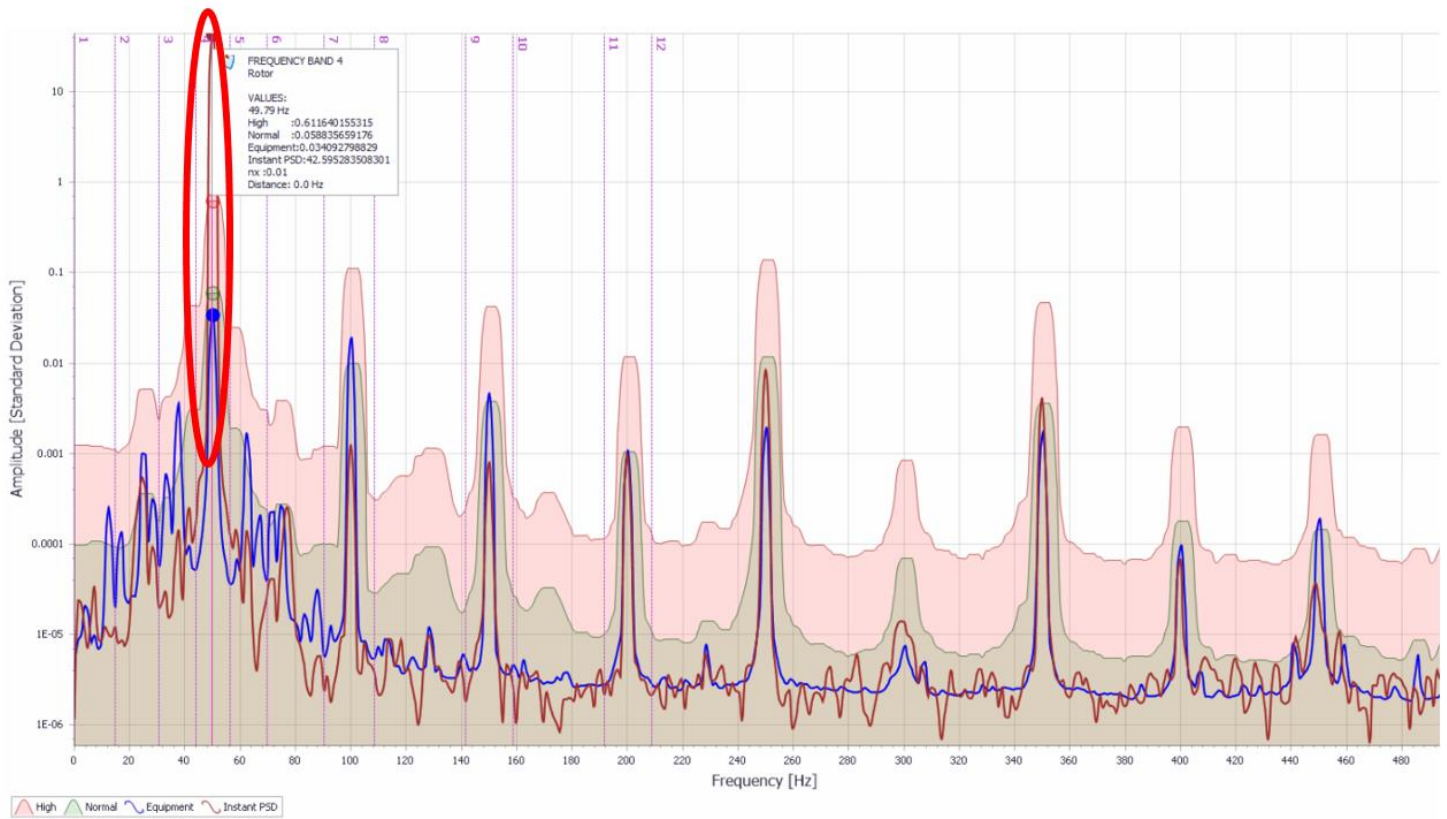
- The Power Spectral Density Plot (Figure 8) display the PSD from June 6, 2020, shows a significant increase of amplitude levels in the Rotor band 4 (42 times above the alarm threshold), suggesting possible rotor problem.

Figure 8: Power Spectral Density Plot; June 6, 2020; Red oval – Rotor band

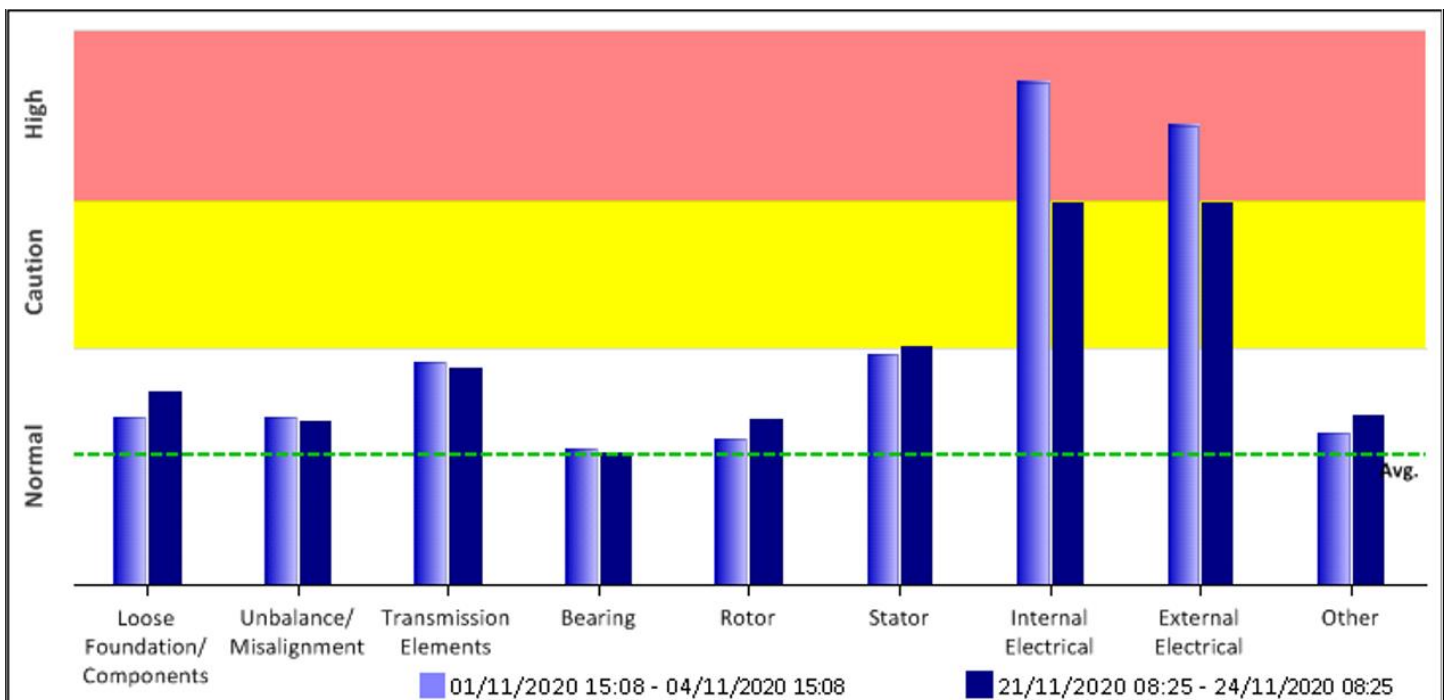
An example of Expert System results and automated advisory is shown in bar graph (Figure 9). Bar graph compares the signal of an equipment, collected during the analyzed period, with the closest fitting healthy baseline database. The bar graph represents the fault severities under different categories. Green dotted line represents the healthy average level of the closest fitting healthy baseline. There is "Caution" yellow region, which suggests attention and closer monitoring the fault parameters. The "High" red region suggests that values within this zone are normally considered to be of sufficient severity to cause damage to the machine. The example of Expert System automated report further contains Power Spectral Density (PSD) (Figure 2), used for detailed explanations of the findings. Recall that the PSD is calculated from the model residuals. The Expert System on bar graph may further suggests increased severity of the Internal and External Electrical faults, based on electrical parameters and the physics-based motor model.

The Model-Based Voltage and Current (MBVI) expert system Bar Chart (Figure 9) indicated enlarged Electrical Fault Indicators (internal and external). Electrical Internal parameters bargraph indicates problems associated with rotor, stator, winding etc. Electrical External parameters bargraph indicates electrical supply problems such as voltage/current imbalance, isolation problem of cabling, capacitor, motor connector, terminal slackness, defective contactors, etc.

Figure 9: The Expert system Bar Chart

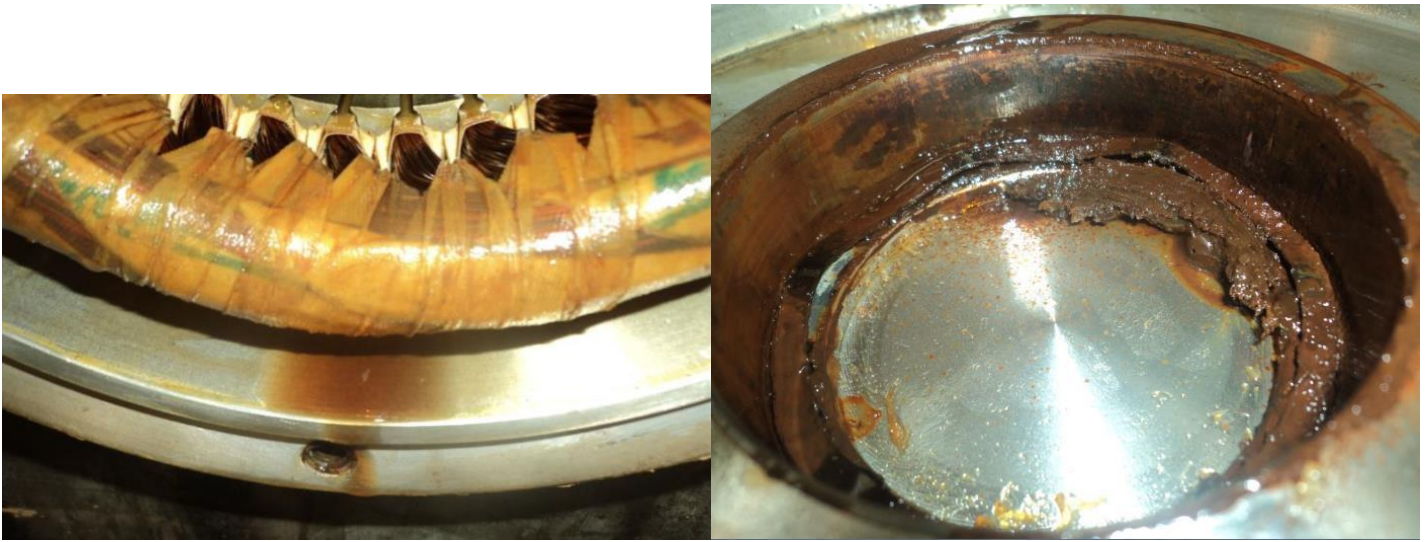
Based on Machinery diagnostics analyses, conclusions and recommendations, the Turning Gear Motor was overhauled and inspected on August 26, 2020. The inspection confirmed problems with both the stator and the rotor (Figure 11). The stator had significant amounts of oil contamination as a result of the bearing rubber seal hardening and thereby compromising the seal integrity. The NDE bearing housing and bearing showed signs of wear and need for refurbishment. The DE bearing appeared in good condition however, the bearing grease was in poor condition and was close to being ineffective. The seal on the DE bearing was hardened as well, possibly due to temperature and allowed oil into the windings.

Figure 11: Turning Gear Motor as found damaged on June 6, 2020

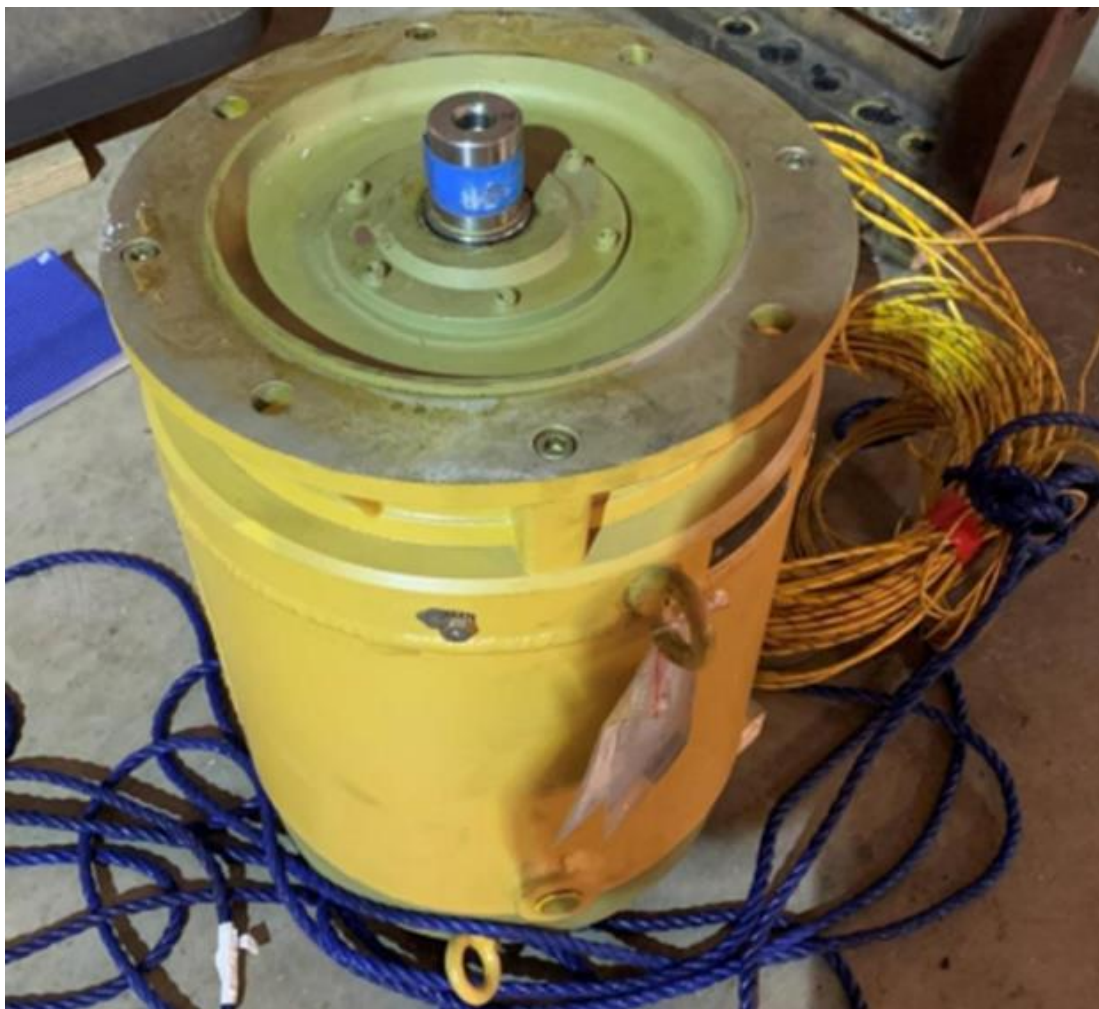
Figure 12: New Turning Gear Motor installed on August 26, 2020

The new motor was installed around the August 26, 2020 and replaced the refurbished motor installed previously in May (Figure 12).
