Implementation of Voted Flame Detectors to Prevent Spurious Fire Detection in Gas Turbines Enclosures.

Surendran Kandasamy,
Principal Engineer,
Group Technology Solutions,
PETRONAS.

ASIA TURBOMACHINERY & PUMP SYMPOSIUM

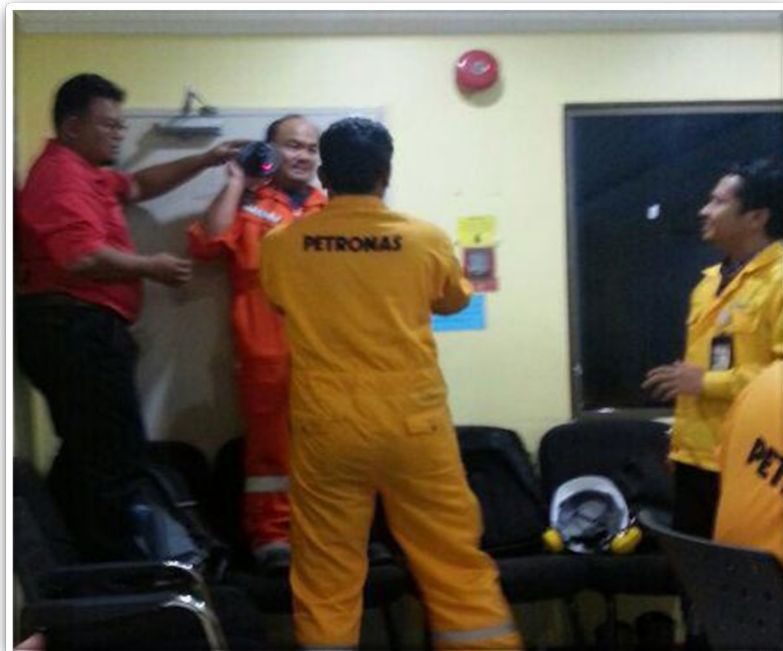
Detector Testing & Implementation

- ❑ 2oo4 configuration was selected and implemented.
- ❑ Flame detector mounting was fabricated for the new location of the 4th flame detector inside the enclosure.
- ❑ Flame Detector simulation was performed in similar sized room to verify functionality.
- ❑ Logic modification was performed, and function tested accordingly.
- ❑ All flame detectors sensitivity were set to vendor approved custom setting for turbine enclosure application
- ❑ All activities were performed with the presence of Fire and Gas Detector Vendor at site for assurance.

| No | Tag No | Rotation Angle (°) | Pitch Angle (°) | Height(m) | Type |
| 1 | FD1 | 55 | 10 | 1.3 | IR3 |
| 2 | FD2 | 50 | 15 | 2.2 | IR3 |
| 3 | FD3 | 140 | 10 | 2.2 | IR3 |
| 4 | FD4 (new) | 130 | 15 | 1.3 | IR3 |
