24-26 MAY 2022
SHORT COURSES: 23 MAY 2022
KUALA LUMPUR, MALAYSIA

High Frequency Acoustic Excitation in Centrifugal Compressor and Adjacent Piping Vibration

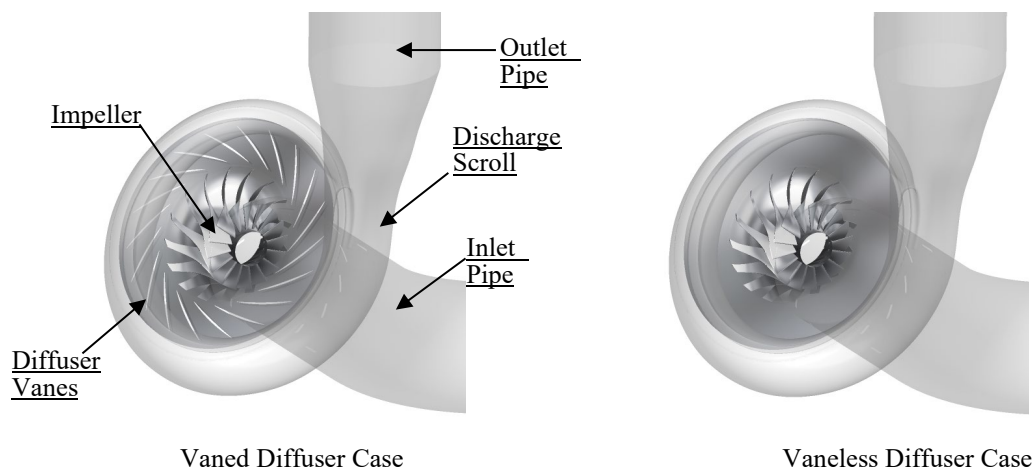
A single compressor stage, which consists of an impeller (16 blades), diffuser (vaned or vanless) and discharge scroll casing, was modeled together with connected pipe on inlet and outlet via unsteady CFD analysis as shown in Figure 1. The turbulence model and y^+ for the CFD were respectively Stress-Blended Eddy Simulation (SBES) and about 30. The computed static pressure field in the impeller/diffuser and the wall surface of discharge scroll/pipe is illustrated respectively in Figure 2 and Figure 3. In the case of a vaned diffuser, there is a periodic pressure distribution in the circumferential direction with 16 harmonics due to the blade and vane interactions; and the pressure pulsation propagates to the discharge scroll and downstream pipe as well. In the case of a vaneless diffuser, on the other hand, the smooth pressure distribution is shown in the diffuser, discharge scroll and pipe. Figure 4 shows the time vs static pressure at the tie-in point between the discharge scroll and pipe along with its spectrum for both the vaned diffuser case and vaneless diffuser case. The large pulsation with 16 harmonics is clearly generated in vaned diffuser case, and it is also noted that the small pulsation with 16 harmonics is visible in the spectrum even in case of a vaneless diffuser, but the magnitude is significantly different from that of a vaned diffuser.

Figure 1. Model for CFD Analysis

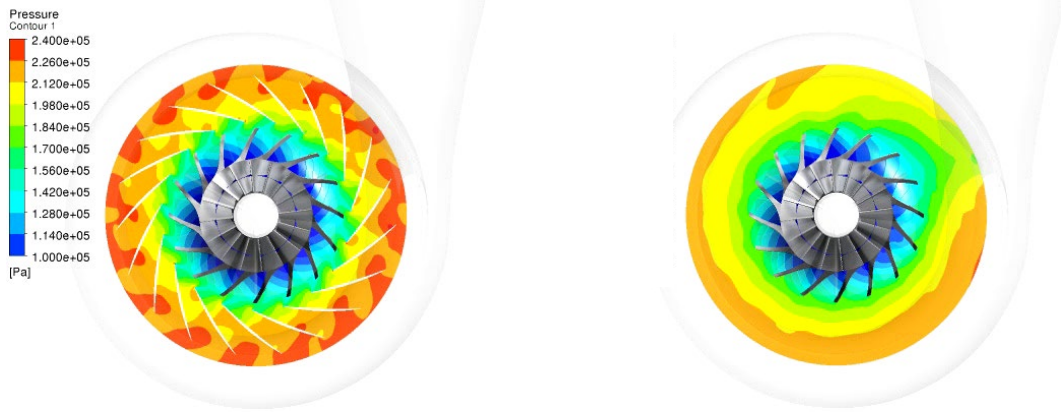
Vaned Diffuser Case Vaneless Diffuser Case

Figure 2. Static Pressure Field in Impeller and Diffuser

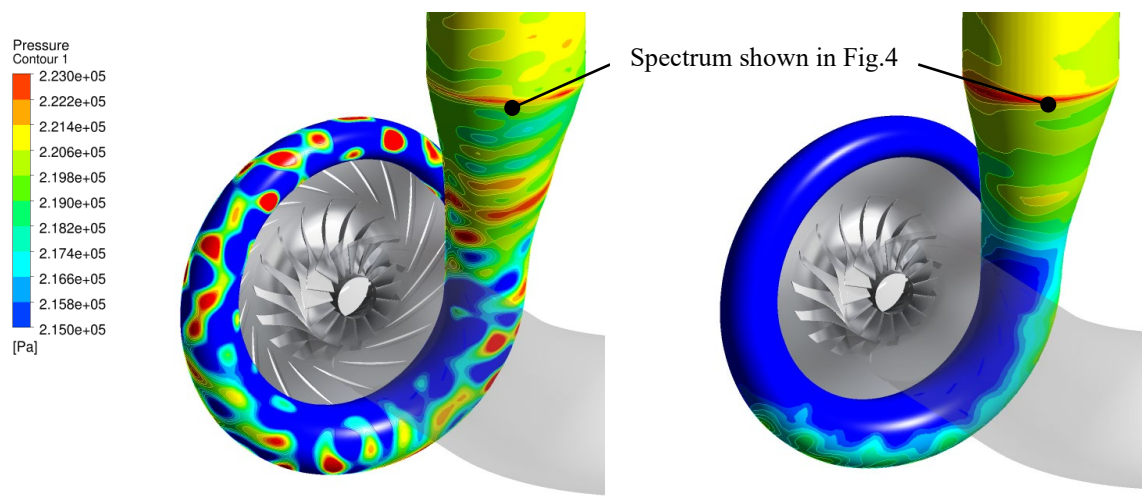
Vaned Diffuser Case Vaneless Diffuser Case

Figure 3. Static Pressure Field on Wall Surface of Discharge Scroll and Pipe

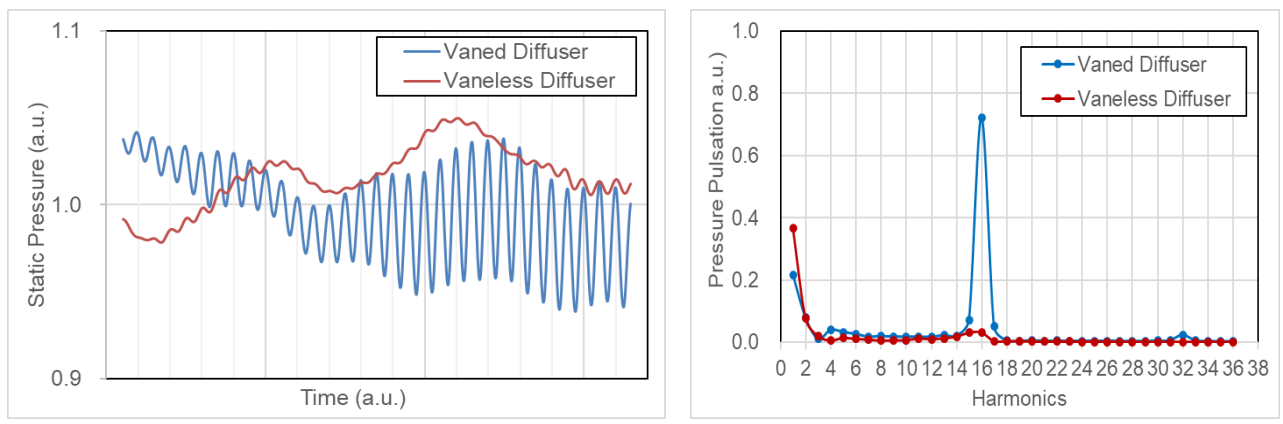
Figure 4. Static Pressure vs Time and Spectrum (at the Discharge Flange)

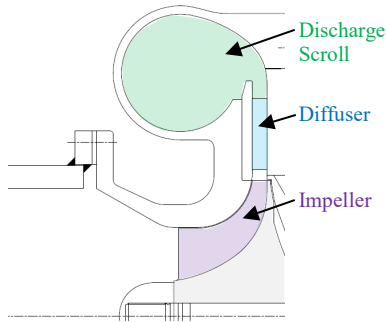
The testing campaign took place in the OEM’s laboratory with a single stage compressor shown as Figure 5 and Table 1. The test compressor was driven by a turbine open to atmospheric air at inlet, and the outlet was connected to piping system of laboratory equipped with valves, a silencer and so on, then finally air was discharged to atmosphere. The overview of the test setup with instruments is shown in Figure 6. Pressure transducers for measurements of pressure pulsation were installed not only in the pipe but also in the diffuser of the compressor.

Figure 5. Compressor Stage (Meridional View)

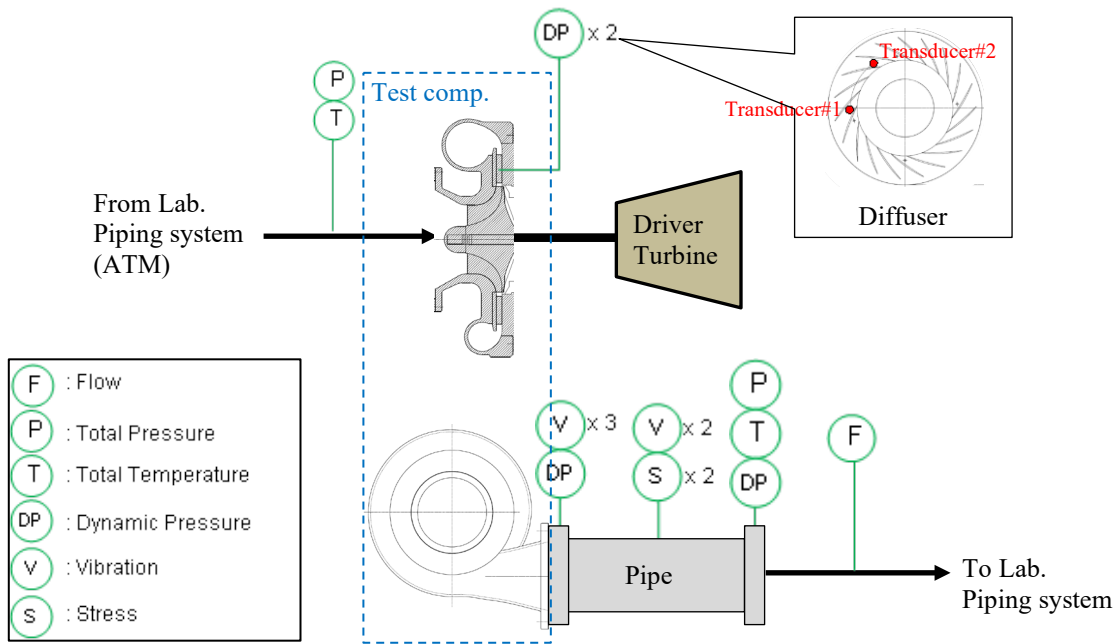
Figure 6. Schematic of Test Rig Setup Overview with Measurement Points

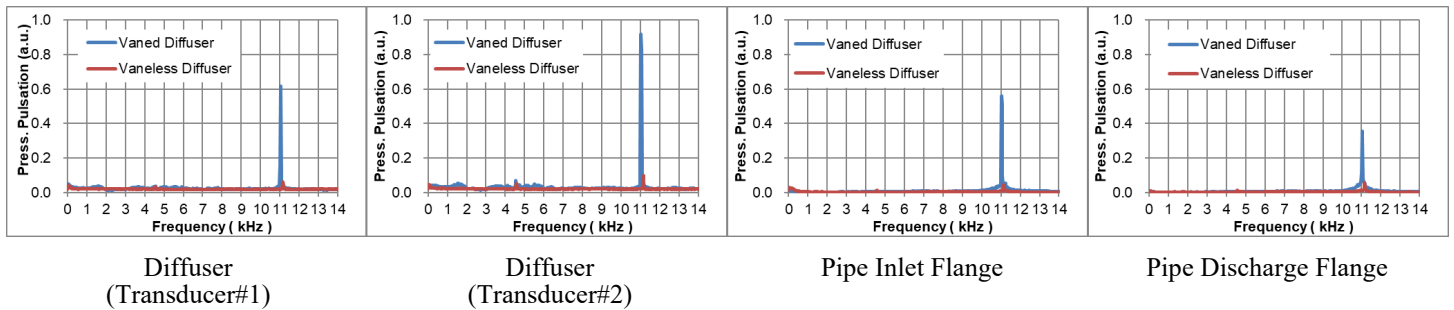
Figure 7 shows spectrums of pressure pulsation in the diffuser and inlet/outlet flange of downstream pipe for both vaned diffuser case and vaneless diffuser case when the compressor was running near the design point. As seen in results of CFD analysis, the peak at 11 kHz corresponding to BPF is remarkable in case of vaned diffuser and a small peak is still visible in case of vaneless diffuser. The magnitude of pressure pulsation for vaned diffuser is more or less 10 times larger than that for vaneless diffuser. It is also noted in vaned diffuser case that the pressure pulsation is gradually decreasing as distance from the acoustic source (diffuser) increases.

Figure 7. Spectrum of Pressure Pulsation for both Vaned and Vaneless Diffuser (Measured by Test)

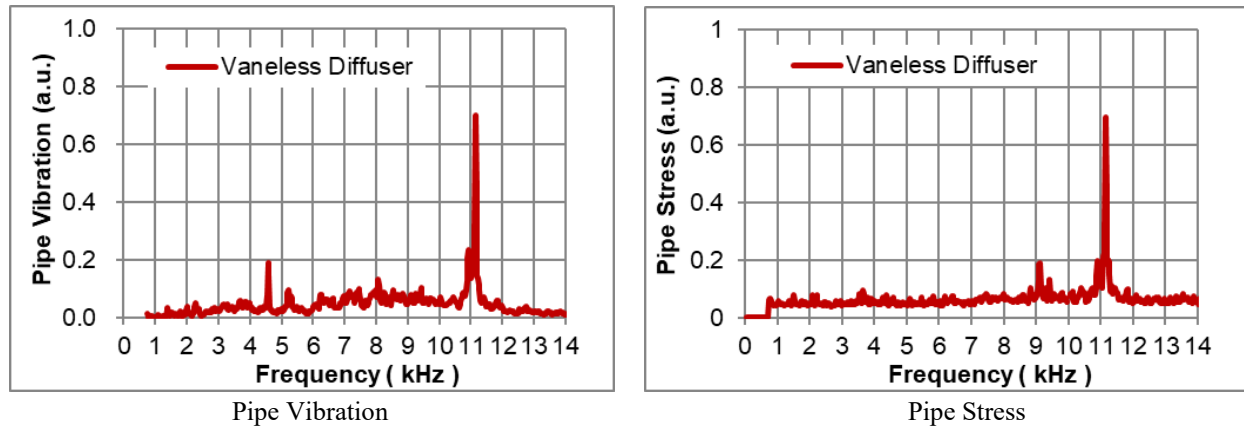
Figure 8 representatively shows one of the spectrums of vibration and stress for the vaneless diffuser case. Comparison in vibration and stress between vaned diffuser and vaneless diffuser was not made since the stiffer pipe was used for tests with vaned diffuser than tests with vaneless diffuser thus vibration response could not be well measured in testing with vaned diffuser. The spectrum of vibration and stress shows the peak at 11 kHz, just like the pressure pulsation, however the peak is not steep like pressure pulsation but with certain width of band. It is considered that numerous modes of vibration should be excited by pressure pulsation since there must be many natural frequencies near BPF and therefore a band of vibration response should be created.

Figure 8. Spectrum of Pipe Vibration and Stress for Vaneless Diffuser (Measured by Test)

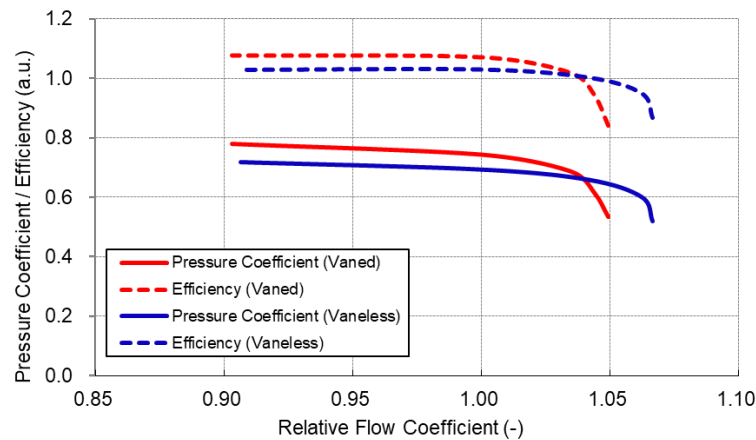
The gain of achieving lower pressure pulsations and lower accompanying mechanical loading with the vaneless diffuser is at a cost of adverse effect on the aerodynamic performance as shown in Figure 9. Both the pressure coefficient and efficiency with the vaneless diffuser are lower than with the vaned diffuser. Here the difference in efficiency was in the order of 2~3%. On the other hand, the operating range was extended by applying the vaneless diffuser, because the choke flow region moved to right side in the graph. In the testing, surge flow could not be verified due to the limitation of instruments, therefore the minimum flow shown in the graph was not the surge limit point.

Figure 9. Compressor Aerodynamic Performance (Measured by Test)

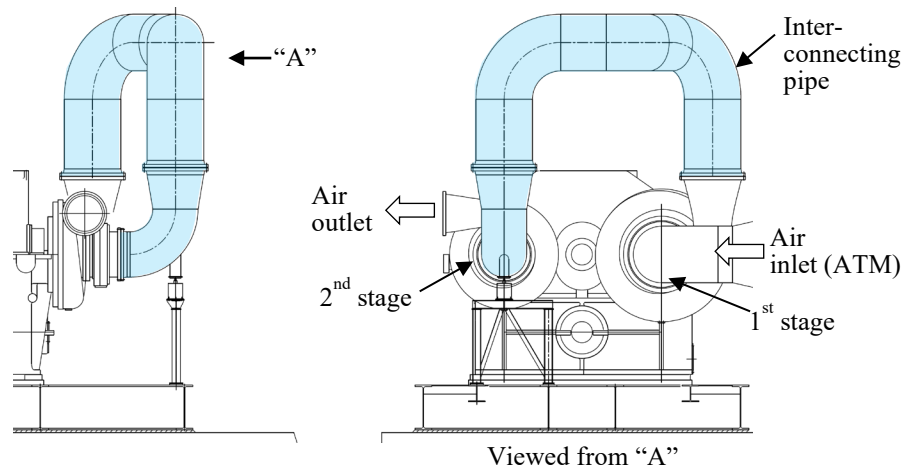
The inter-connecting pipe between 1st stage and 2nd stage is directly mounted on the scroll casings of the integrally geared type process air compressor as shown in Figure 10. Table 2 shows the basic specification of the compressor stages. The 1st stage compressor is constructed by an open impeller (number of blades :16) and a vaned diffuser, as the combination between rotating speed (7,528 rpm) and number of impeller blade (16) the BPF is approximately 2,000 Hz. The vibration frequency which will be discussed in this paper is BPF of 1st stage compressor.

Figure 10. Machine Construction

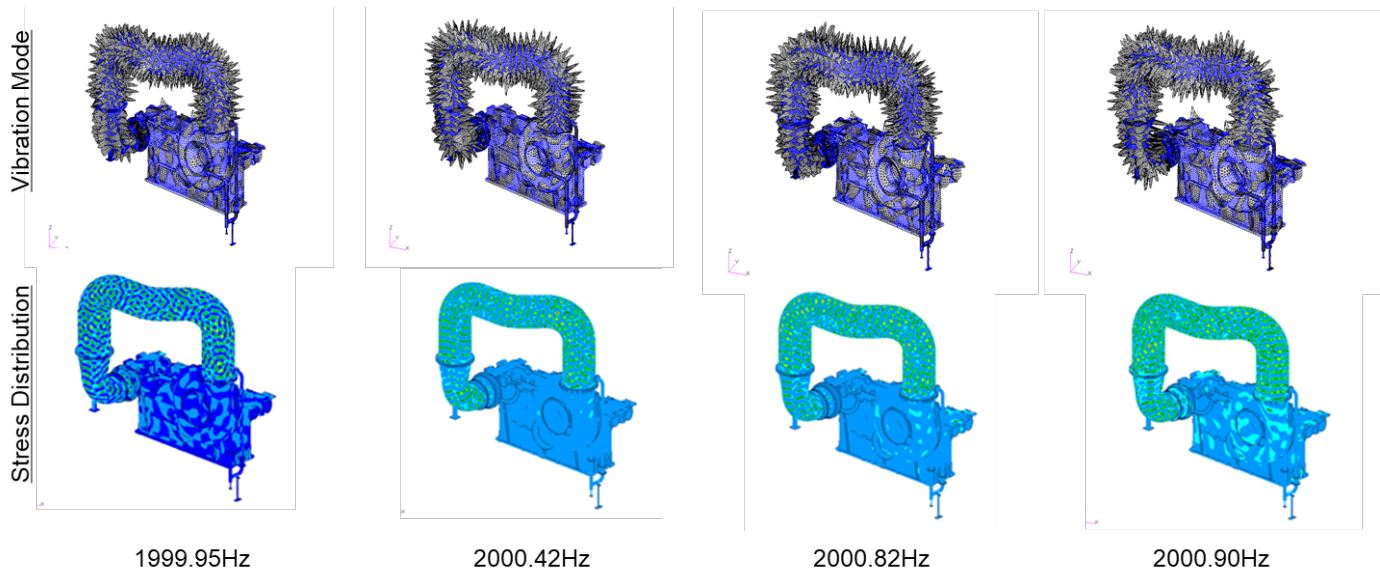
Figure 11 presents the calculated displacement and stress distributions of the vibration at natural frequencies around 2,000 Hz which are analyzed by FEA. As there are generally numerous natural frequencies existing in such high orders, about 100 natural frequencies are calculated within +/- 1% of 2,000 Hz in this case. The high frequency vibration modes in the pipe show complex shell wall modes and generates local high stress points.

Figure 11. Calculated Vibratory Displacement and Stress at Natural Frequencies around 2,000 Hz

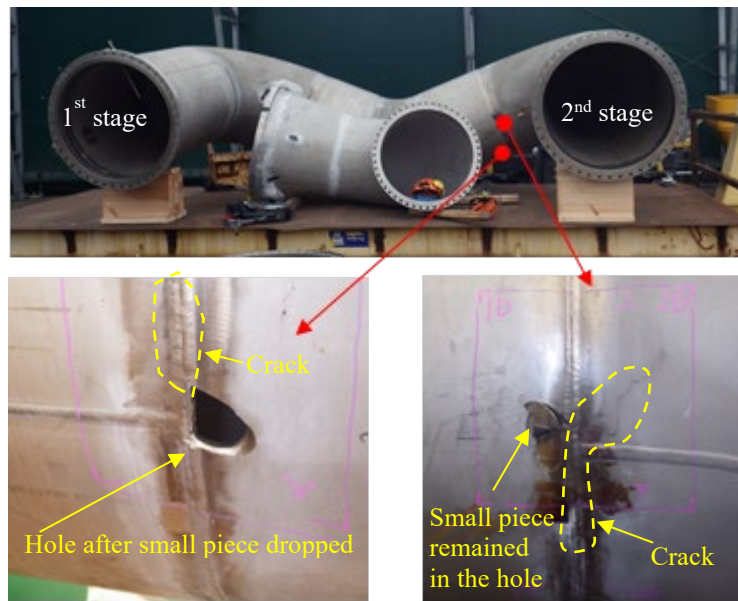
After dismantling the inter-connecting pipe from compressor package, the pipe was visually inspected. It was confirmed that in addition to the cracks, small pieces of the pipe were dropped off from the pipe as shown in Figure 12. The detailed inspections were carried out on the piece of fractured area and following points were identified (Figure 13).

Figure 12. Overview of Fracture Failure of Inter-connecting Pipe

- Vaned diffuser was replaced with vaneless diffuser: reducing excitation source
- The pipe thickness was increased (1.5 times thicker than original): reinforcing the pipe
- A rubber expansion joint between compressor and pipe was installed: adding damping and mechanically decoupling the pipe from discharge scroll

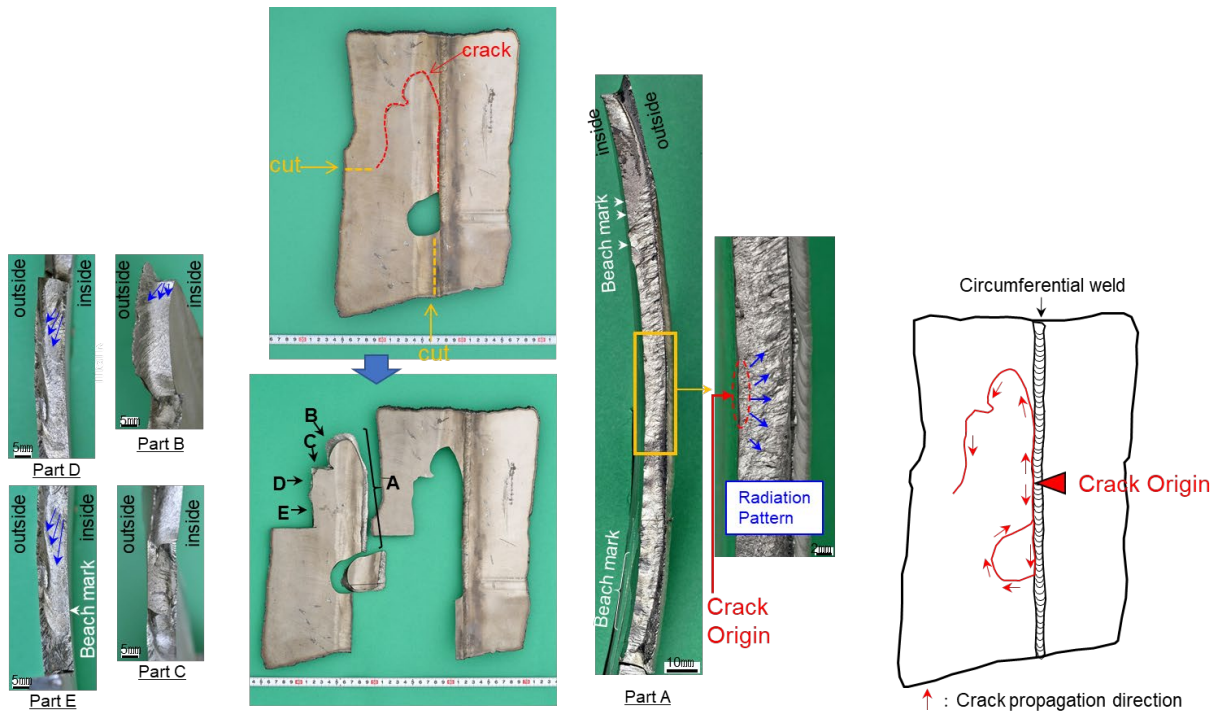
- The cracks originated at the boundary of circumferential welding on the pipe, which was revealed by radiation patterns, which are a typical feature of a crack origin.
- The crack propagated along the welding seam at the beginning of failure with beach marks, which are a typical feature of fatigue fracture.
- The crack propagation tracked in small circles along with the vibration mode at BPF.

Figure 13. Detailed Inspection on Fracture Surface

- The failed pipe must be vibrated and stressed by pressure pulsations, which were generated by interaction in pressure field between 1st stage impeller blade and diffuser vanes, since the dominant frequency (2,000 Hz) of the measured stress was corresponding to BPF of 1st stage impeller.
- Due to the complex shell wall vibration mode for high order natural frequencies, the stress could be locally high.

- As the result, the crack initiated from welding seams which could be one of the weakest points in the pipe and propagated along with the complex vibration mode.

In addition to the above, the welding procedure, treatment procedure after weld and inspection (NDT) procedure were also improved in order to achieve the higher fatigue strength at the welded locations. The fatigue strength of various weld styles can be defined by S-N curves. For example, Figure 15 provides the typical S-N curves with welding configurations with NDT requirements which are specified in IIW (International Institute of Welding). Referring to this recommendation, welding from both inner and outer surfaces were implemented, the smooth surfaces were provided by grinding and moreover dye penetrant test (PT) and radiographic test (RT) were performed on 100 percent of welds.

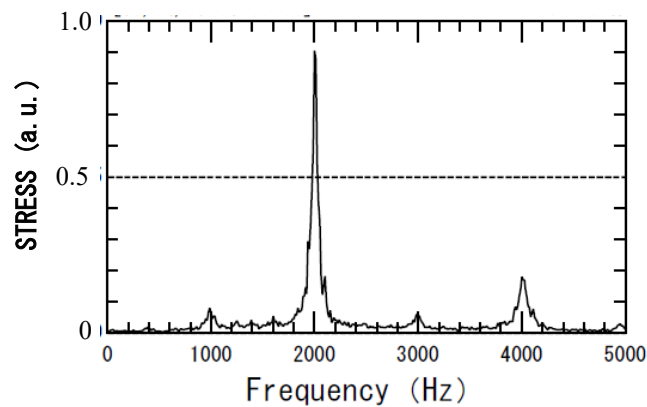
Before the fracture failure happened, the stress in the inter-connecting pipe had been measured by using strain gauges. Figure 14 shows the spectrum of stress at one of the measured locations. The dominant frequency of the stress is 2,000 Hz which corresponds to BPF of the 1st stage impeller. It is also noted that there is a certain width of band around the peak, which could be caused by the excited vibration response for various natural frequencies near BPF. It could also be caused by some small amount of damping.

Figure 14. Spectrum of Measured Stress on Failed inter-connecting Pipe

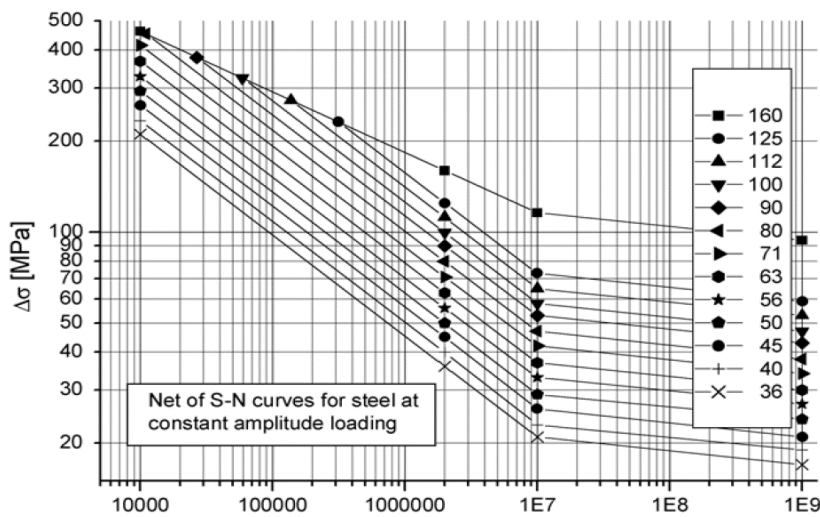
Figure 15. S-N Curves for Steel and Welding Configuration IIW document IIW-1823-07)

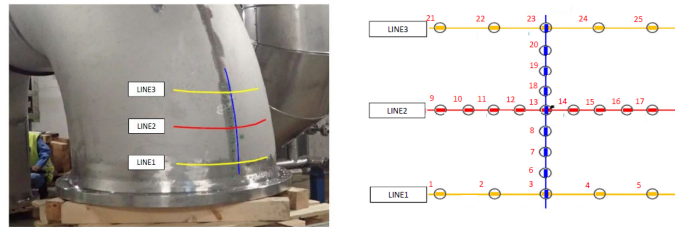
After implementation of countermeasures, in order to ensure the safe operation, accelerometers and strain gauges were installed on the pipe, furthermore a pressure transducer was also installed at the flange of compressor discharge scroll. In order to capture the complex high frequency vibration mode, in other words not to miss the highest stress, many strain gauges were installed as shown in Figure 16. The measurements were made from plant start up until the plant rated load was achieved. Figure 17 shows spectrum plots of pressure pulsation, pipe vibration and pipe stress under plant rated load operation. The main component of these spectra is 2,000 Hz corresponding to BPF of 1st stage as expected. It is also noted that the pressure pulsation generated by 2nd stage impeller acoustically propagated upward relative to flow direction as the small component of approximately 2,500 Hz corresponding to BPF of 2nd stage is visible in the spectra of pressure pulsation and vibration; however the spectrum of stress does not show the component with 2,500 Hz because the vibration is too low to get a certain level of stress. In comparison with original design, the measured stress was significantly reduced (95% reduction) as shown Figure 18.

Figure 16. Strain Gauges Arrangement for On-site Measurement

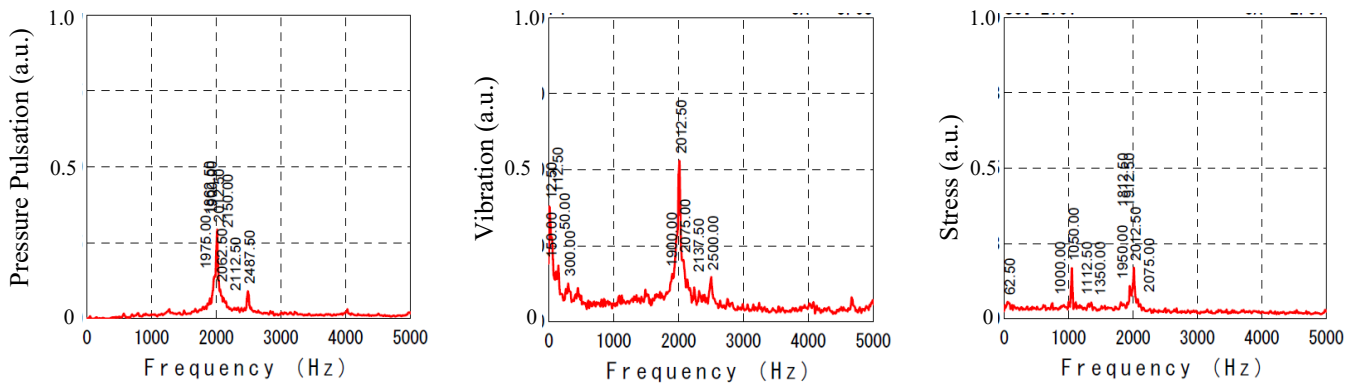
Figure 17. Spectrum of Vibration, Stress and Pressure Pulsation

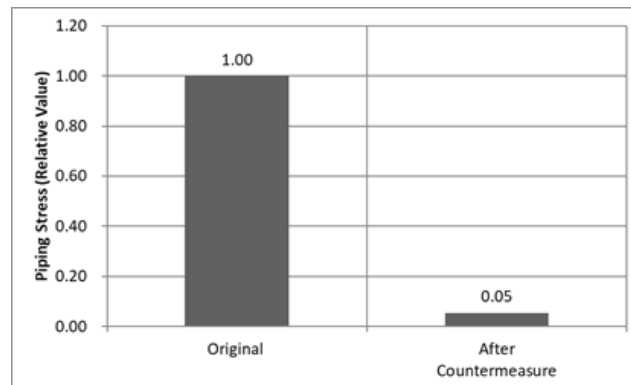
Figure 18. Comparison of Measured Stress on Pipe

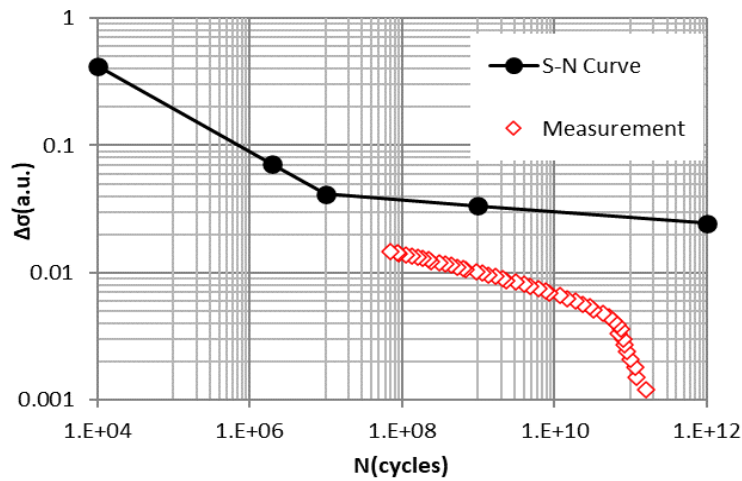
In order to determine the fatigue lifetime of the pipe, the measured stress was analyzed by a rainflow counting method and fatigue lifetime was evaluated based on a cumulative fatigue damage theory (M. Matsuishi and T. Endo, 1968). An outcome of this analysis is shown in Figure 19 which displays the plots of counted stress with applicable S-N curve. As the measured stress was located below the S-N curve at any cycle up to one tera-cycle, the fatigue cumulative damage coefficient was calculated to be 0 (zero). It is expected that the pipe is free from fatigue failure and ensures safe operation.

Figure 19. Fatigue Lifetime Evaluation by Rainflow Accounting Method
